Building and Timber Pest Inspection Report

Inspection Date: Wed, 18 Feb 2026

Property Address: 2/12 Murrumbidgee Ave, Sylvania Waters
NSW 2224, Australia

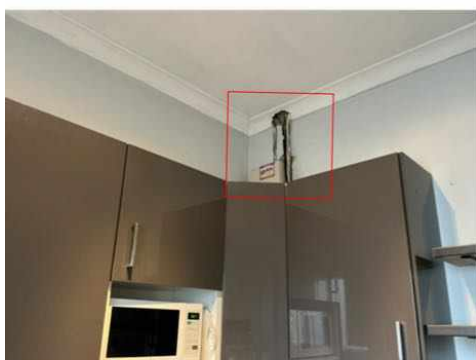
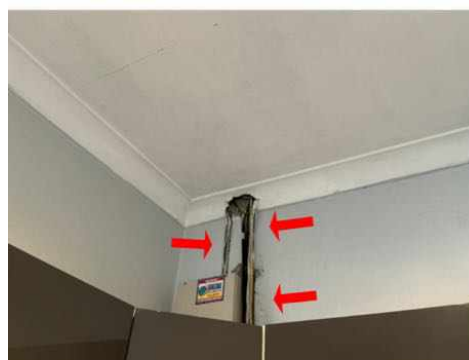
Finding 1.01

Building:	Main Building
Location:	Kitchen/ laundry
Finding:	Electrical wires exposed
Information:	Exposed electrical wiring was identified. Exposed electrical wiring represents a potential safety hazard including for fire and personal contact. Contact a licensed electrician urgently for further inspection investigation and rectification.

The electrical wiring in the kitchen / laundry, requires an electrician to have them overseen and secured immediately, in the interest of safety. It is advised that a plumber also specialising in roof plumbing be commissioned, as paint bubbling in the hallway may have developed, due to roof leakages. The shower room and kitchen / laundry are missing exhaust devices. These should be sought urgently with the installation by an electrician, in preventing excess moisture developing. The shop requires painting in most rooms. It was explained that the shower room has been used as a suntan spray room. Sediment has formed on the ceiling. It requires restoration by a painter. Whilst holes in ceilings and sections of flooring & wall finishings missing in the kitchen / laundry, they require finishing at the owners earliest convenience. These minor defects can have secondary effects on other building elements, if left unattended.

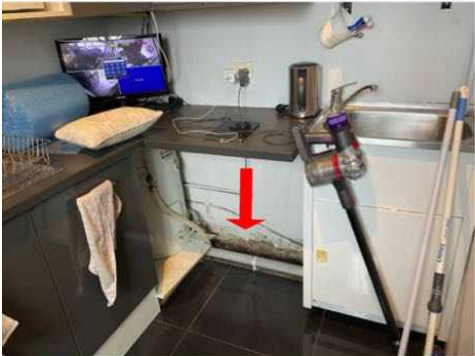
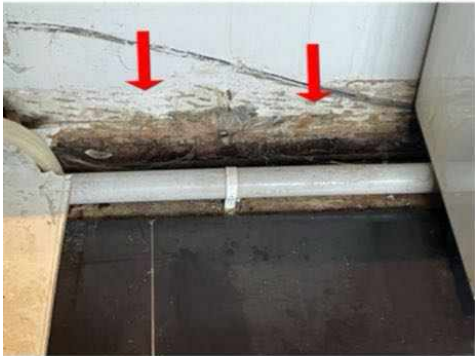
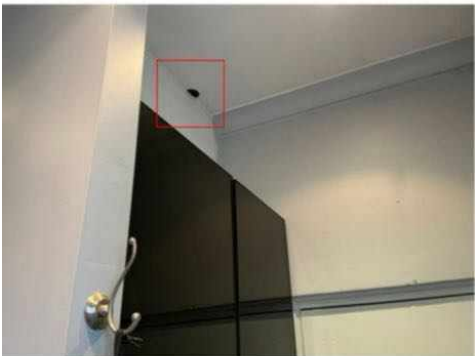
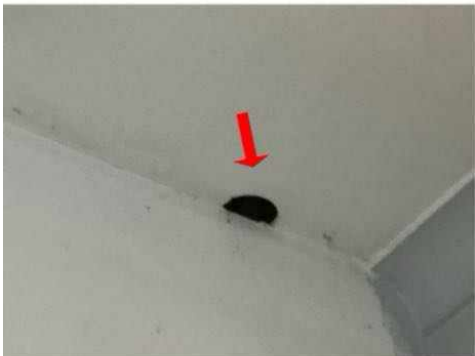
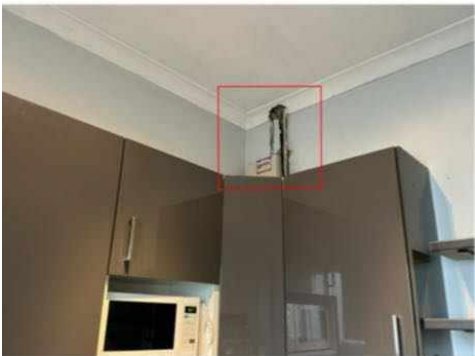
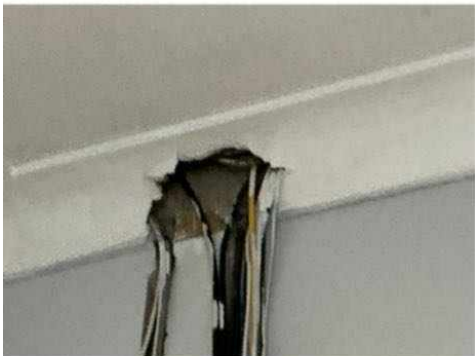
Finding 3.01

Works that have not been completed to a satisfactory level create potential for the development of building defects and may impede on the safety and integrity of the overall structure.

It is highly recommended that the relevant trades be appointed to complete these works and ensure the safety of the area and the longevity of all associated building

elements.

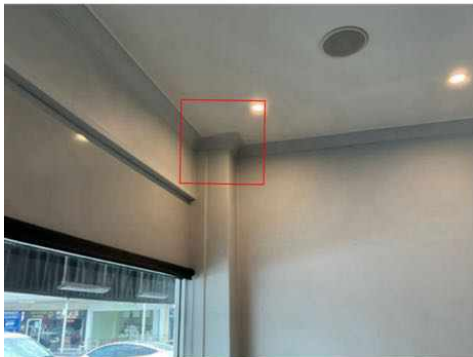
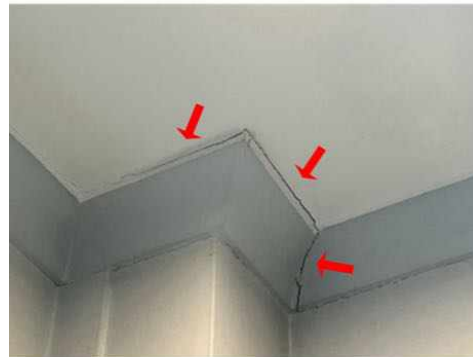
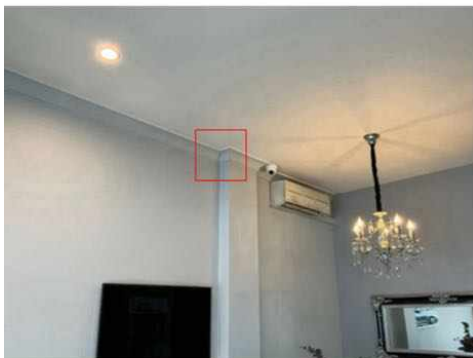
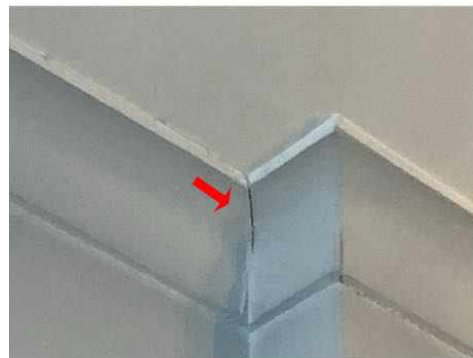
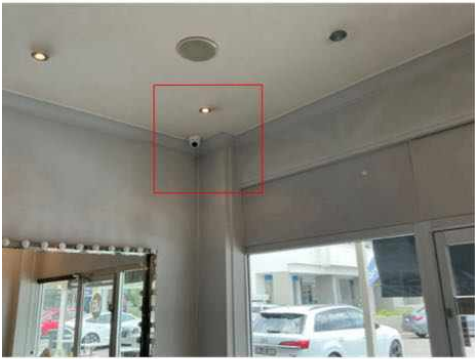
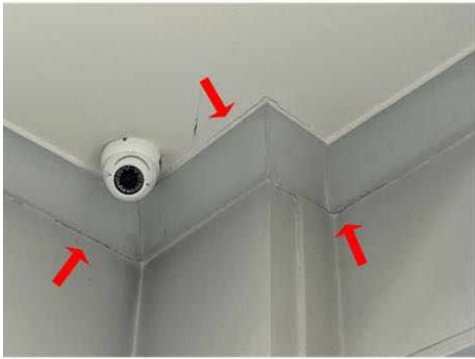
Finding 3.02

Building: Main Building
Location: All Areas
Finding: Paint finish - Substandard- cornice/ architrave sections, shower room ceiling
Information: The paint finish in this area was found to have been completed to a substandard level. Substandard painting is generally classified as an appearance defect. However, the substandard appearance may also be indicative of poor surface preparation and substandard workmanship.

If this applies, further areas of poor and incomplete finishes could develop over time. Furthermore, substandard paint finishes in areas exposed to moisture, e.g. external areas or wet areas, could lead to deterioration of underlying building materials.

Substandard paint finishes should be sanded back, filled, leveled and repainted, as applicable. Where inadequate paint protection has led to the deterioration of the associated building element, repair and/or replacement of this building element may be required.

A painting contractor should be appointed as soon as possible to perform necessary works to aid the appearance of the affected area and to ensure that the area is protected against further deterioration. Alternatively, the homeowner following manufacturer instructions may be able to provide this service.

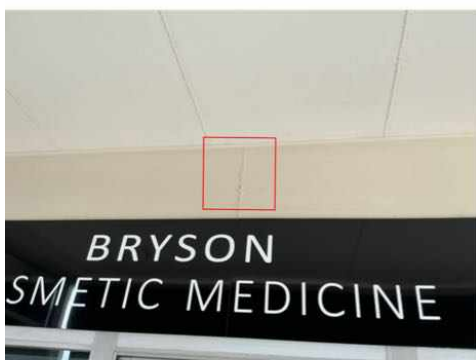
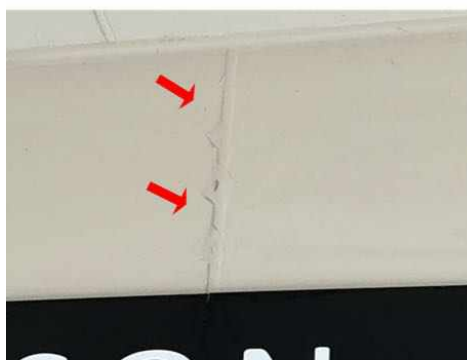
Finding 3.03

Information: The paint finish in this area was found to have been completed to a substandard level. Substandard painting is generally classified as an appearance defect. However, the substandard appearance may also be indicative of poor surface preparation and substandard workmanship.

If this applies, further areas of poor and incomplete finishes could develop over time. Furthermore, substandard paint finishes in areas exposed to moisture, e.g. external areas or wet areas, could lead to deterioration of underlying building materials.

Substandard paint finishes should be sanded back, filled, leveled and repainted, as applicable. Where inadequate paint protection has led to the deterioration of the associated building element, repair and/or replacement of this building element may be required.

A painting contractor should be appointed as soon as possible to perform necessary works to aid the appearance of the affected area and to ensure that the area is protected against further deterioration. Alternatively, the homeowner following manufacturer instructions may be able to provide this service.

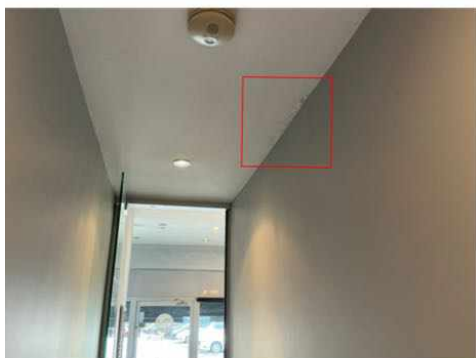
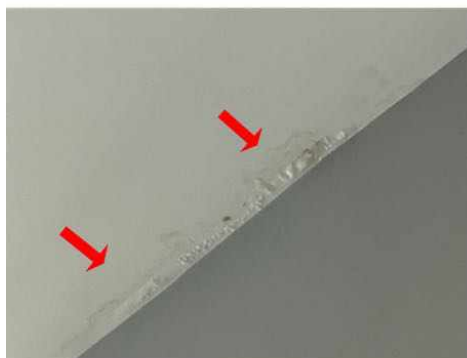
Finding 3.04

Building:	Main Building
Location:	All Areas
Finding:	Painted surface - Bubbling
Information:	Sections of paint in this area was found to have bubbled and deteriorated. Paint bubbling is generally an indication of excessive moisture in the area, that is currently hidden by the painted surface.

The presence of excessive moisture can have major implications on associated building elements if left unattended. While only seemingly minor at this stage, the damage cannot be determined due to the paint obstructing any further inspection of the damage.

It is highly advised that the affected paint be cleaned to allow a further, more invasive inspection by a licensed plumber. Failure to act on this defect may necessitate major works in the future.

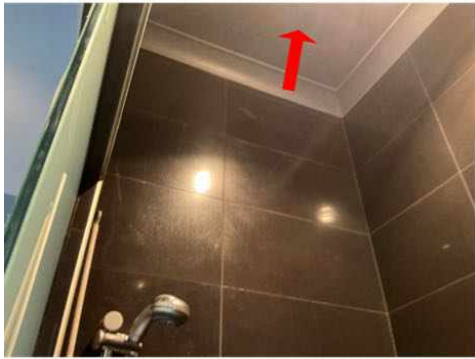
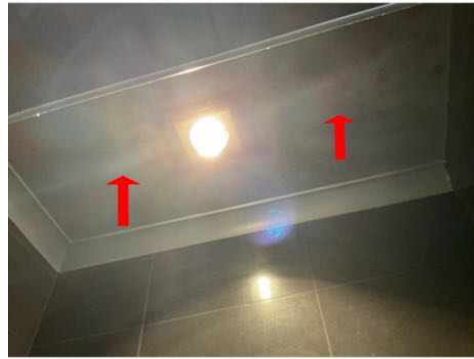
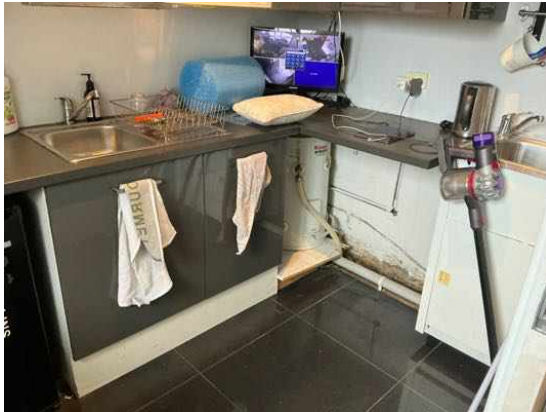
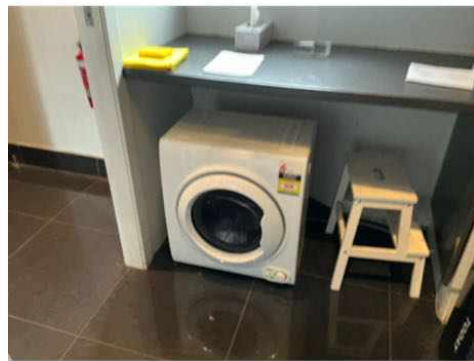
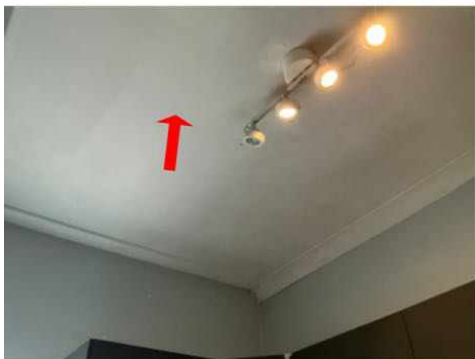
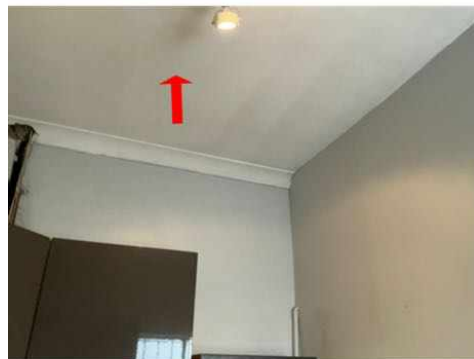
Finding 3.05

Building:	Main Building
Location:	Shower room, kitchen/ laundry
Finding:	Exhaust fan - Missing
Information:	An exhaust fan has not been installed in this area. Missing exhaust fans may lead to the development of more significant defects such as moisture damage to surrounding building materials from inadequate ventilation. Inadequate ventilation in internal areas creates an environment that is conducive to the formation and development of mould and other respiratory hazards. It is highly advised that a licensed electrician be appointed to retrospectively install an exhaust fan. Failure to perform works to aid the ventilation of the area may lead to the development of these secondary defects.

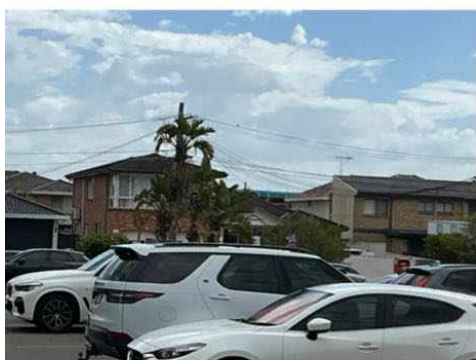
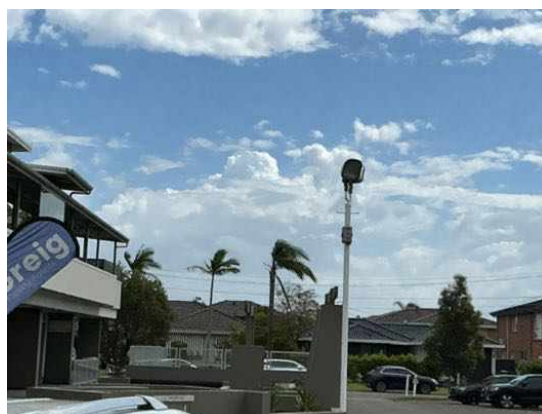
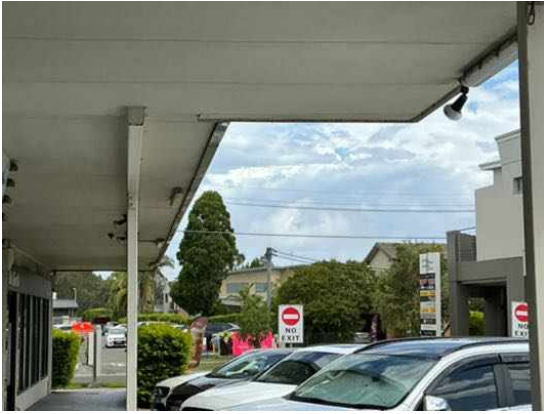
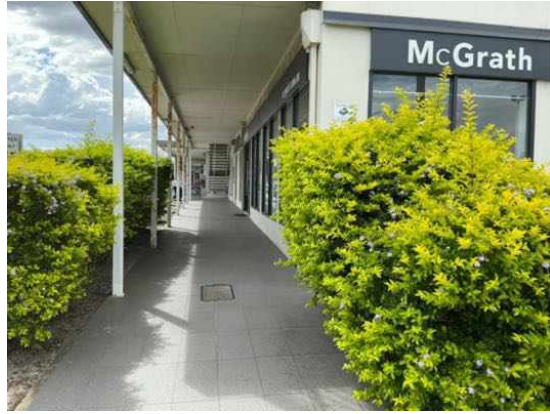
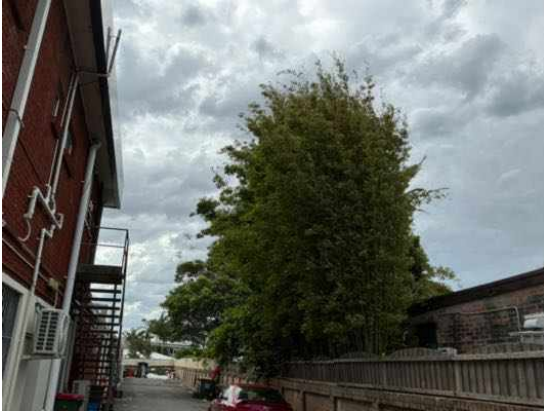
Building:	Main Building
Location:	All Areas-
Finding:	Trees to be inspected within the property.
Information:	Trees can be conducive to termite activity and nesting. Trees over 100mm on the property, should be drilled and tested for termite activity.

Regular inspections every 6-12 months- or advised by the termite management system installer.
