# Building and Timber Pest Inspection Report

Inspection Date: Wed, 1 Apr 2026

Property Address: 98 Willan Dr, Cartwright NSW 2168,  
Australia

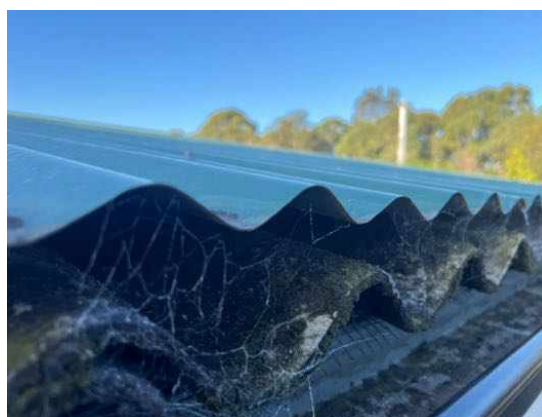
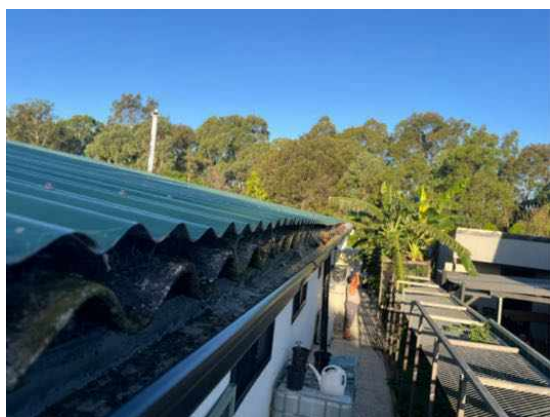
Building:	Main Building
Location:	Roof Exterior
Finding:	Roof overlay installation - Refer to 3.2
Information:	Roof overlay installations may conceal defects within the original roof covering, including deterioration, leaks, or structural issues. They may also increase roof loading and reduce ventilation, potentially contributing to condensation and moisture-related deterioration over time. Access for inspection and maintenance of the original roof covering is also restricted. Internal areas showed signs of moisture, including paint

The presence of internal moisture in conjunction with the roof overlay increases the likelihood of concealed defects within the roof structure or waterproofing system, which could not be confirmed at the time of inspection due to the non-invasive nature and access limitations.

Further investigation by a licensed roofing contractor and/or plumber is recommended to determine the source of moisture and assess any concealed damage. If left unaddressed, this condition may result in progressive deterioration and potentially significant repair costs.

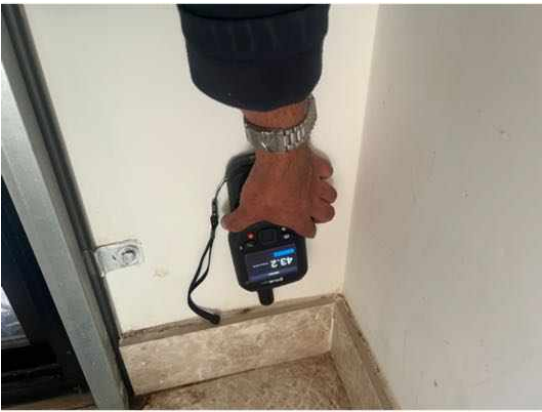
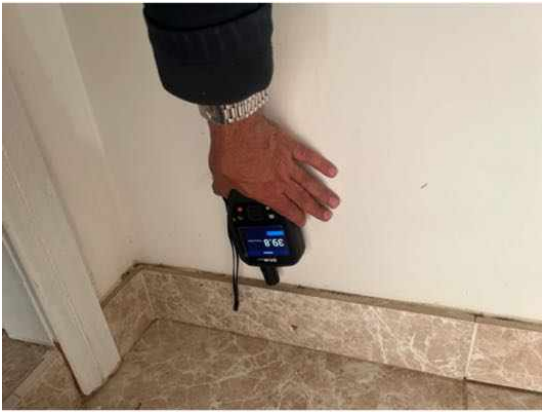
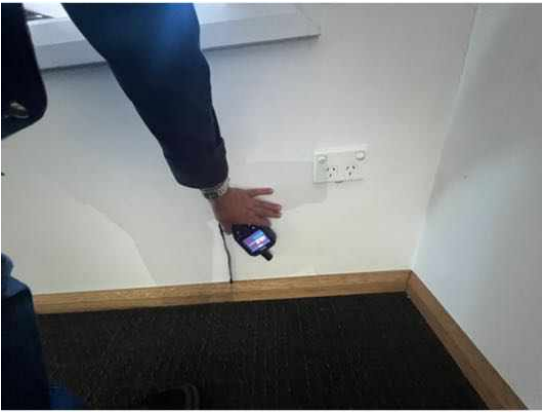
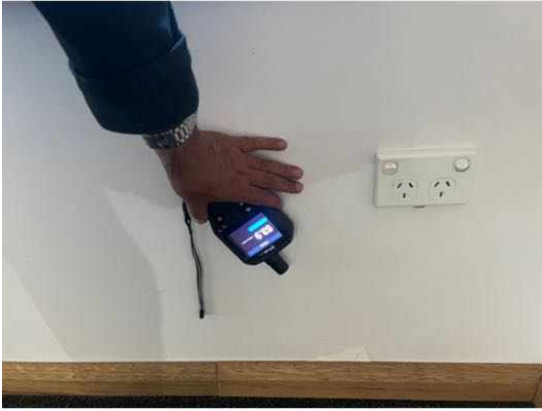
### Finding 3.03

Building:	Main Building
Location:	All Internal Areas - Front , Side, lounge , Garage
Finding:	Elevated Moisture – Further Investigation Recommended
Information:	Elevated moisture readings were detected in several locations, with some areas also showing minor signs of dampness while others did not present visible surface issues, although no significant structural damage was evident at the time of inspection, dampness can contribute to deterioration if left unaddressed. Inspector was not able to inspect the external wall due to space constraints. A further investigation by a licensed plumber or waterproofing specialist is recommended to confirm the source and ensure no concealed issues are developing.

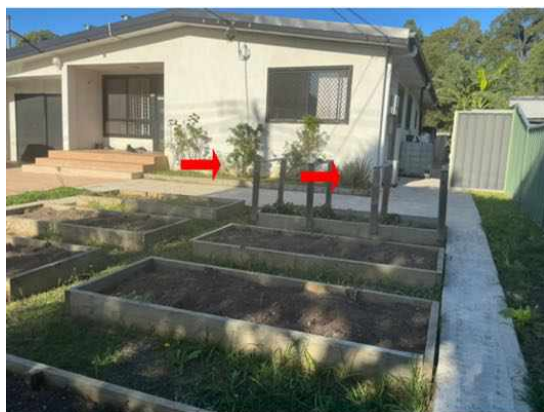
### Finding 3.04

Building:	Main Building
Location:	All External Areas - Front
Finding:	Render Finish Covering Damp Membrane
Information:	During the inspection, it was noted that the applied render finish is covering the damp-proof membrane. This is affecting the membrane's ability to prevent moisture movement above it, leading to moisture-related issues over time. It is recommended to consult a qualified builder to ensure the damp-proof membrane is properly exposed, maintaining its effectiveness in preventing moisture ingress.

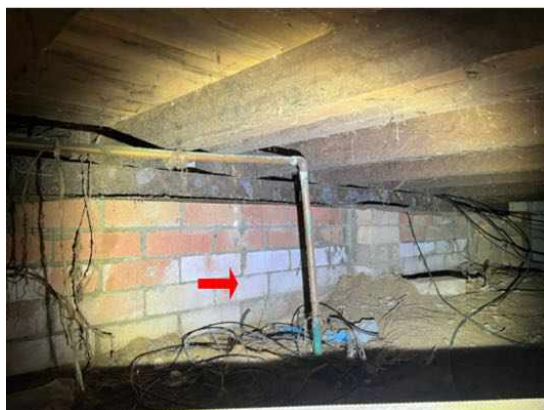
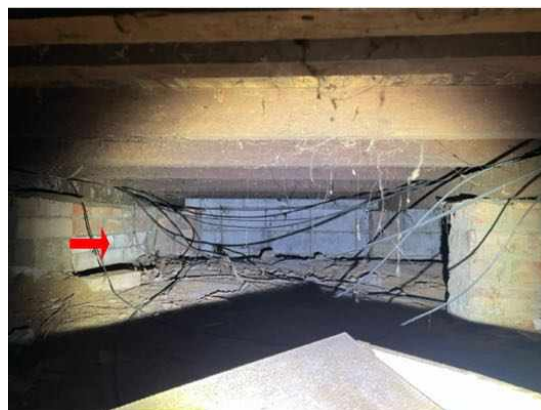
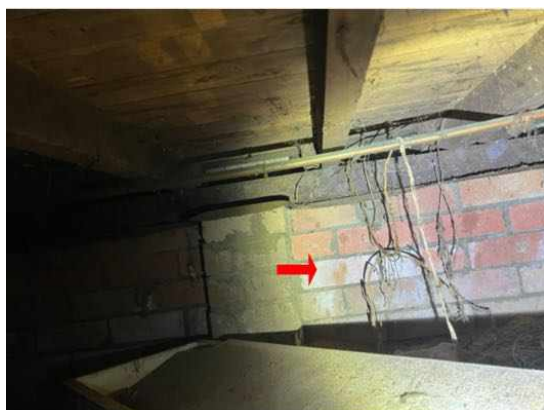
Building:	Main Building
Location:	Subfloor
Finding:	Subfloor Moisture , Efflorescence and excessive debris
Information:	Debris , efflorescence and visible damp staining were observed along the lower brickwork within the subfloor, indicating active or historic rising damp.

The presence of salt deposits and discolouration suggests that moisture is migrating through the masonry via capillary action, likely due to inadequate subfloor drainage or ventilation

These conditions may contribute to further degradation of mortar joints, promote mould growth, and increase the risk of timber pest activity if left unaddressed. Elevated moisture was also noted in the subfloor timbers along with moisture staining to some areas.

The area should be further assessed by a damp remediation specialist, and improvements to subfloor ventilation and moisture control are recommended

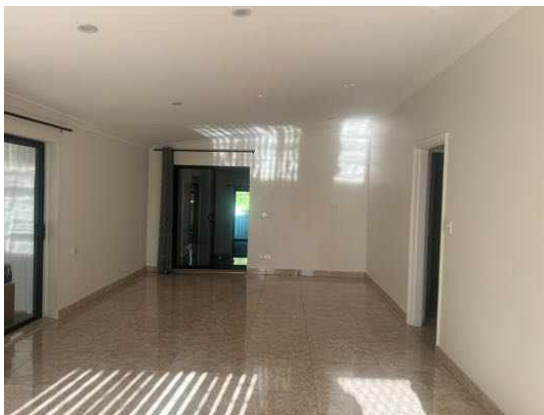
Building: Main Building  
Location: All Internal Areas - lounge , hallway , kitchen , rear lounge  
Finding: Flooring - Uneven to some areas  
Information: The internal flooring in this area is out of level and uneven. Uneven flooring is likely to indicate minor defects such as expected movement of the foundations of the property, but may also indicate subsidence of the associated subfloor stumps.

It is advised that the flooring be closely monitored to identify any further movement. Where flooring remains relatively unchanged for an extended period of time (i.e. several months), it is likely that this defect has been caused by expected movement of the foundations of the property.

However, where flooring is uneven further, potentially invasive inspection of the subfloor structures and stumps in this area is required. In this case, works to repair are likely to be required, and would be carried out by a registered builder specialising in re-stumping.

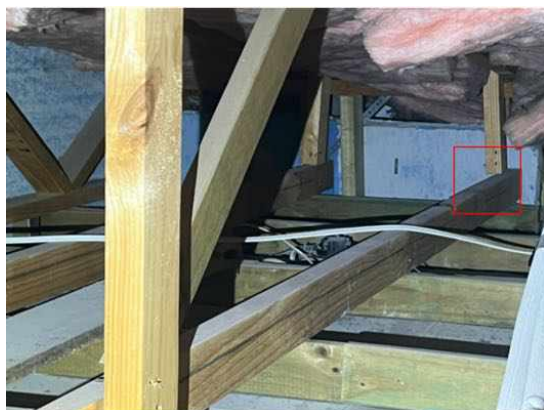
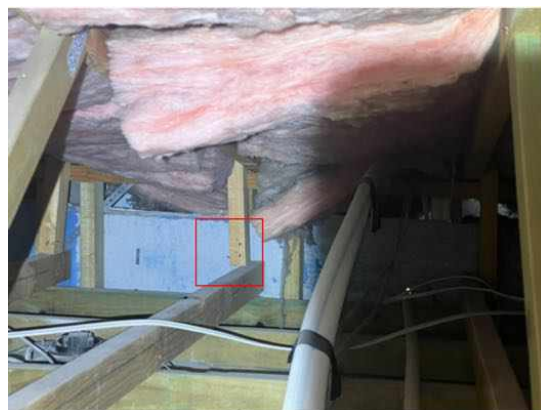
Building:	Main Building
Location:	Roof Void
Finding:	Installation - substandard or incomplete - Timber not fully supported
Information:	The installation of this building element appears to have been completed to a substandard level of workmanship or is incomplete. Generally substandard repairs or installation are related to poor workmanship, the use of inappropriate materials, or a failure to complete installation to a suitable standard.

Where installation is substandard and/or incomplete, the client should contact the responsible trade to undertake rectification. Unfinished and substandard building works are likely to degrade more quickly and may create potential for secondary defects to associated building elements.

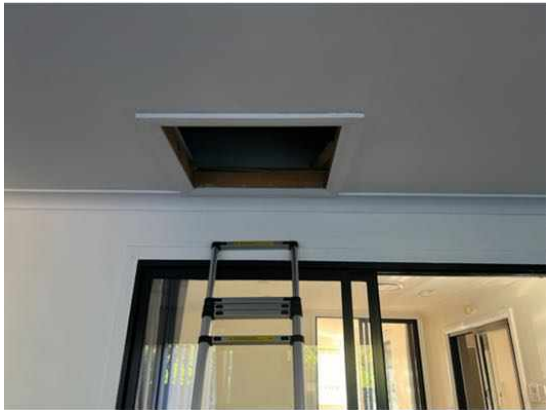
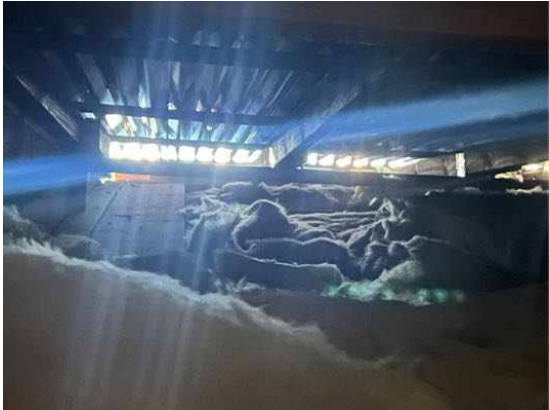
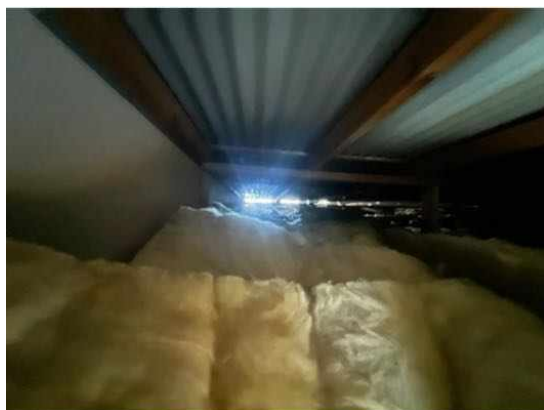
Building: Main Building  
 Location: Roof Void  
 Finding: Roof Void – No Sarking & Light Ingress  
 Information: Light ingress is visible through multiple roof tile laps, which is typical of older tile roofs without sarking and may allow minor wind-driven moisture or dust into the space, though no active leaks were observed.

Consider retrofitting sarking or roof wrap in the future to improve thermal and moisture performance.

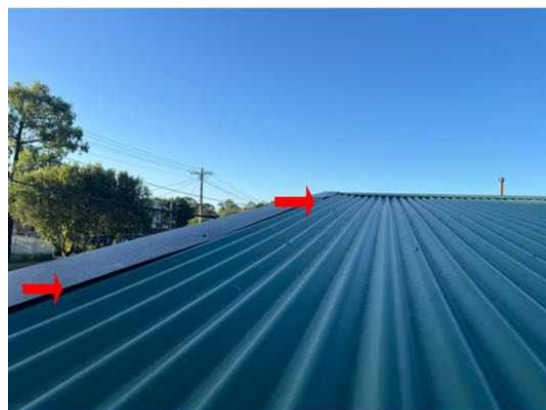
### Finding 3.30

Building:	Main Building
Location:	Roof Exterior
Finding:	Flashing defective - Lifting to some areas
Information:	The metal flashing at the wall junction appears inadequately installed, with visible gaps and lifting and reliance on surface sealant rather than a properly chased and continuous detail. The junction does not appear fully weather-tight, increasing the risk of moisture ingress into the wall cavity or roof structure over time. Defective flashing installation can lead to concealed deterioration if not addressed. Recommend assessment and rectification by a qualified roofing contractor to ensure compliant and effective weatherproofing.

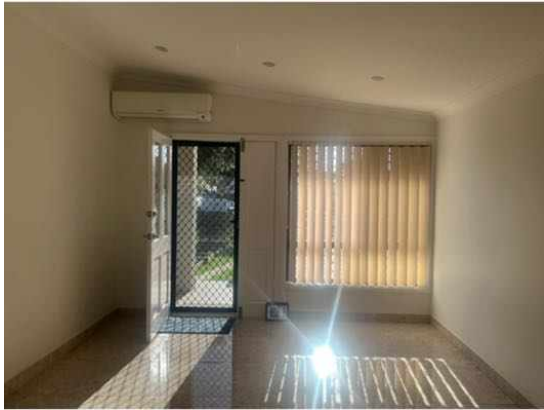
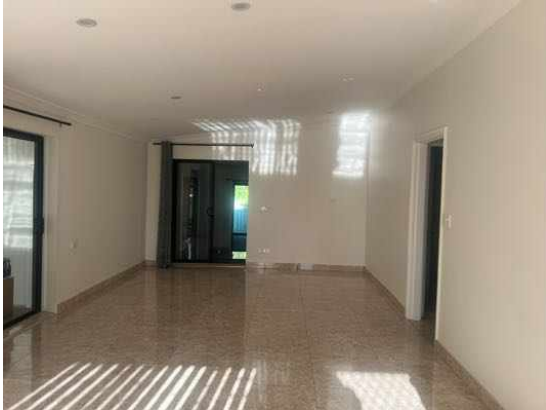
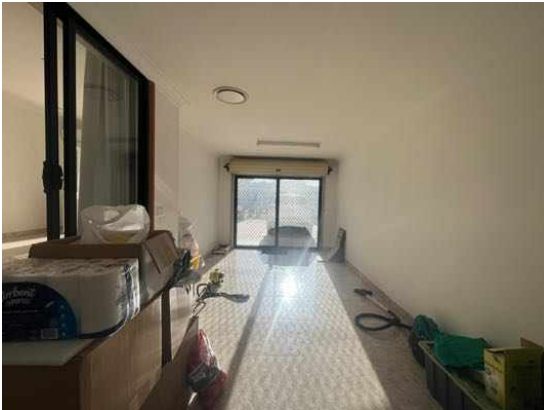
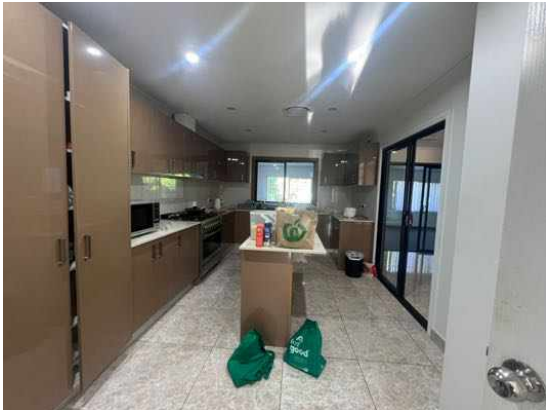
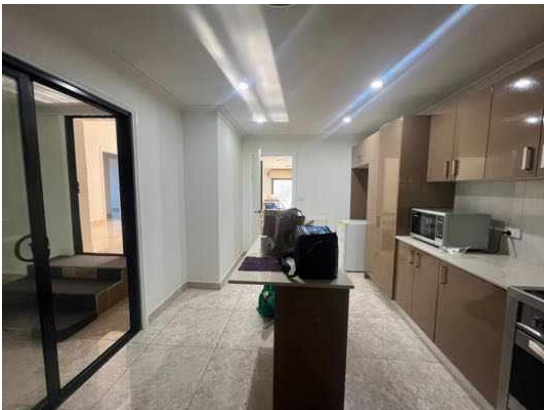
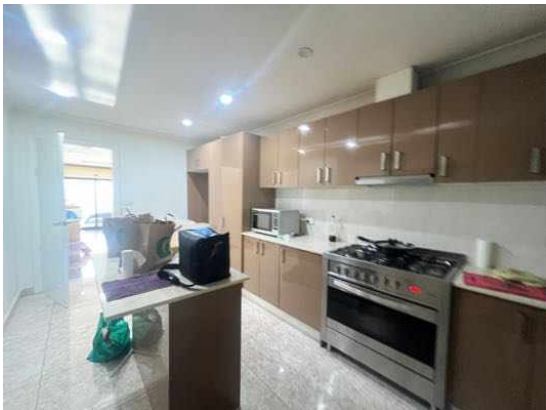
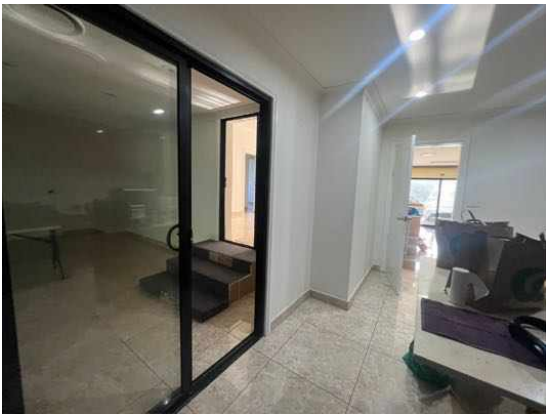
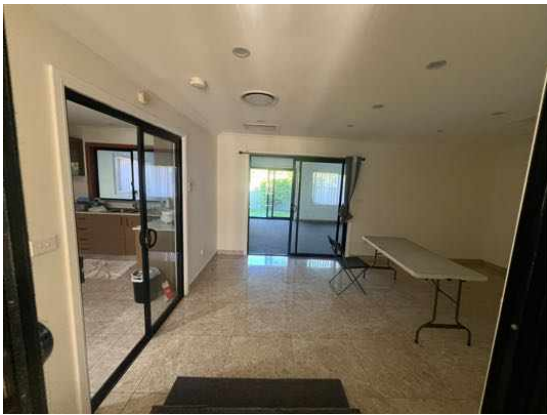
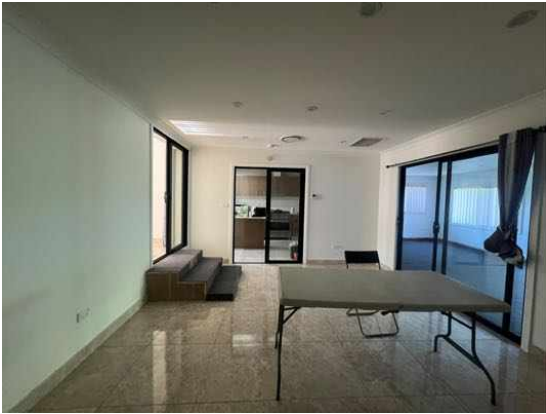
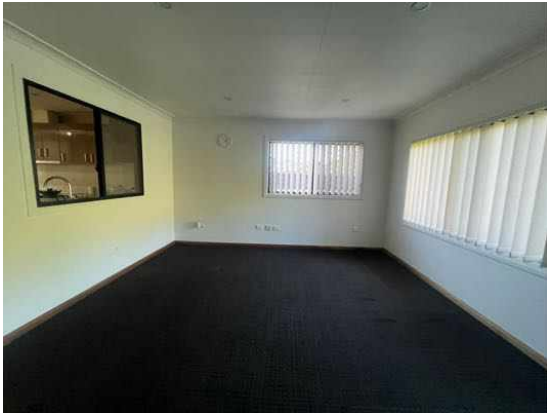
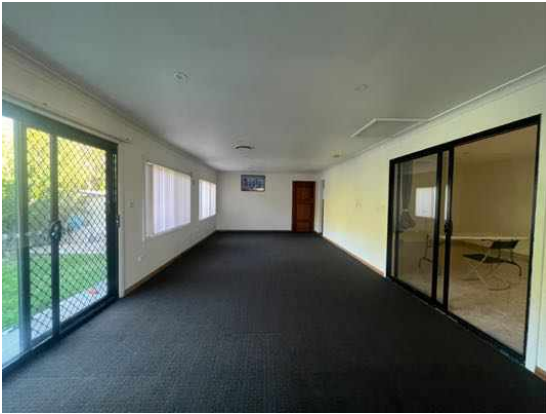
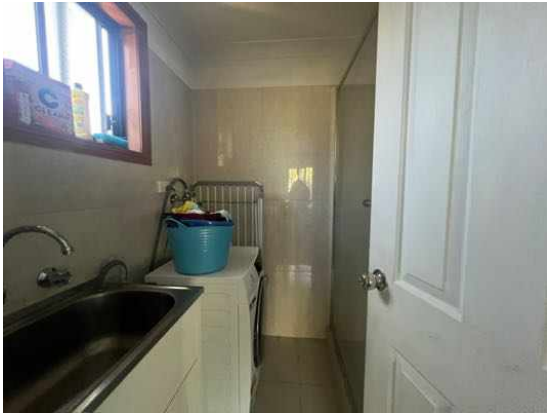
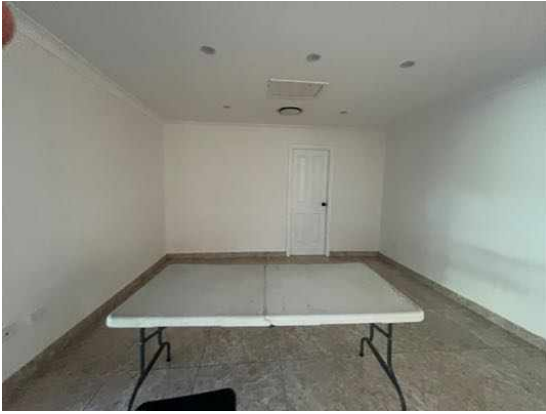
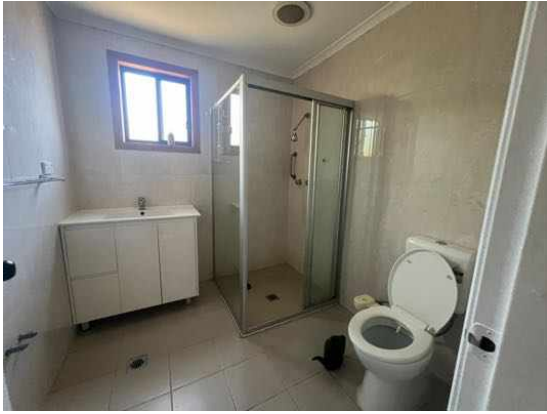
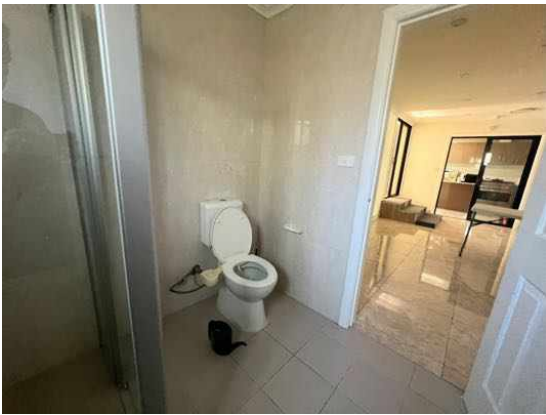
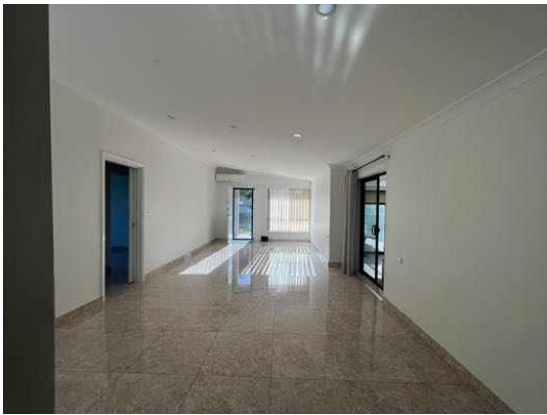
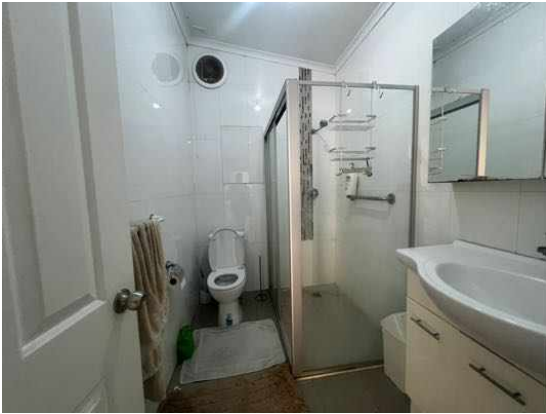
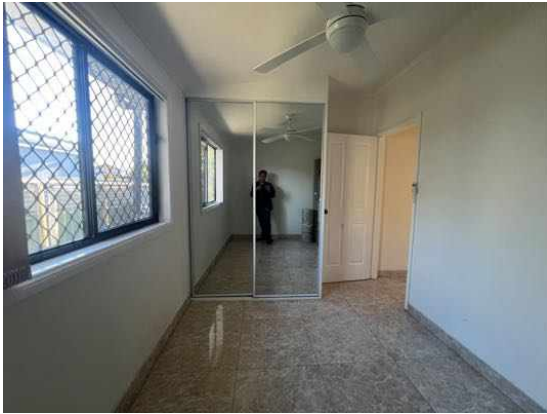
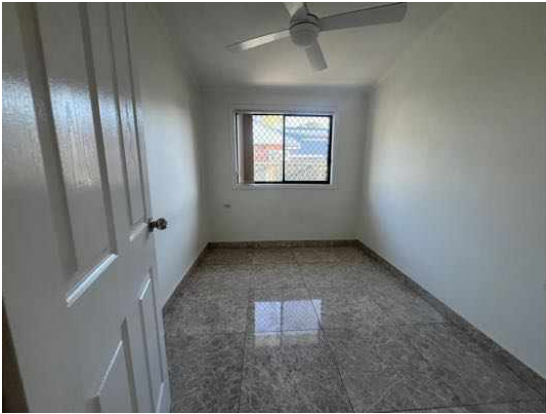
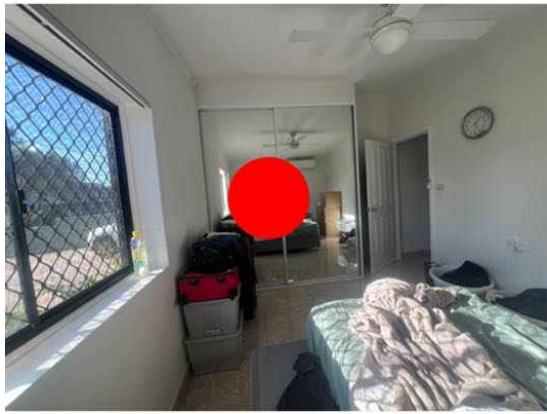
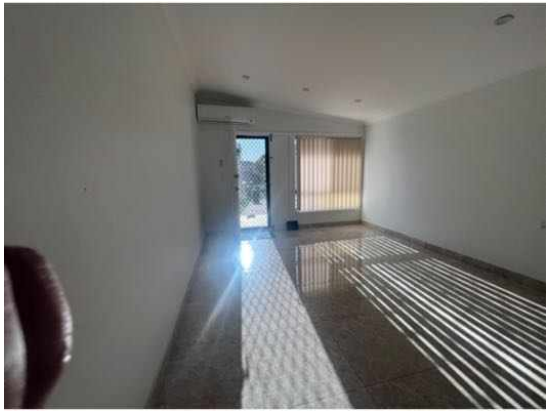
Noted Item

Building: Main Building  
Location: All Internal Areas  
Finding: Additional Photos - Obstructions and Limitations  
Information: These photographs are an indication of the obstructions and limitations which impeded full inspection of the property at the time of inspection. These obstructions can hide an array of defects and should be removed to allow full inspection to be carried out. A re-inspection is recommended once the areas are made accessible.

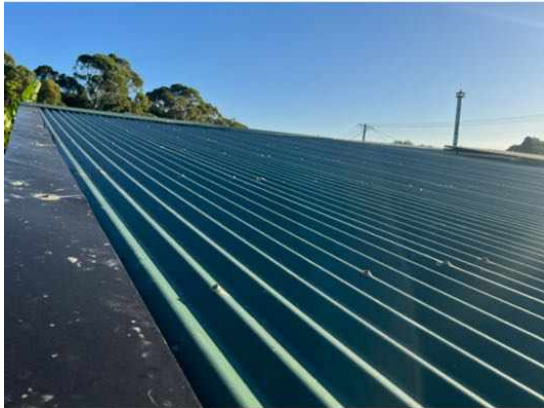
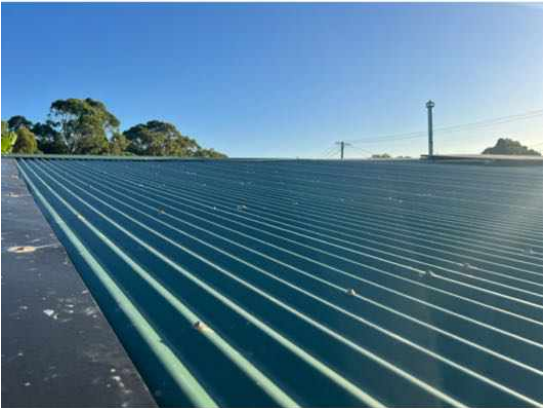
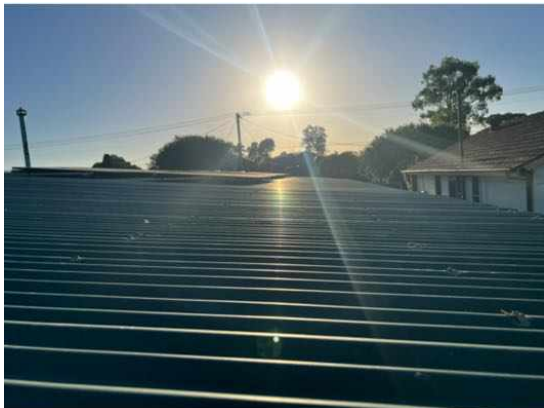
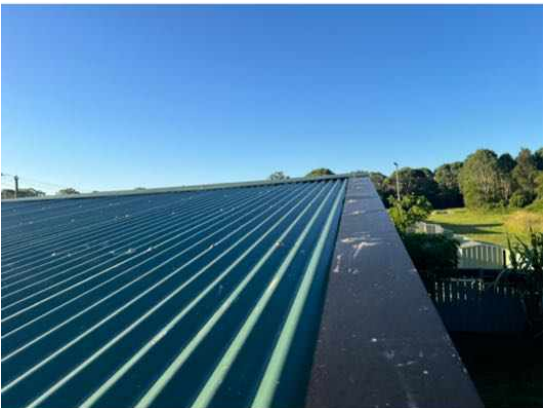
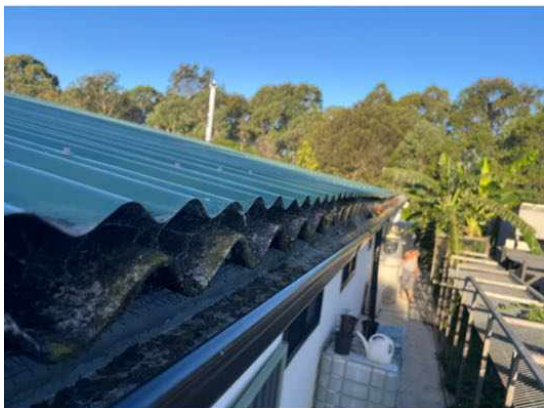
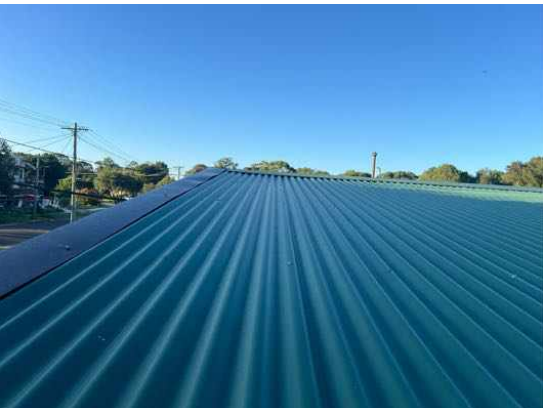
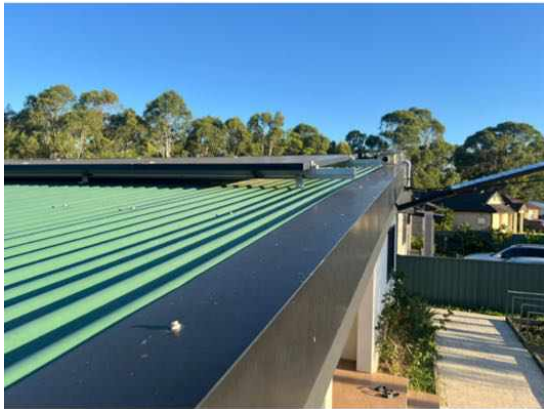
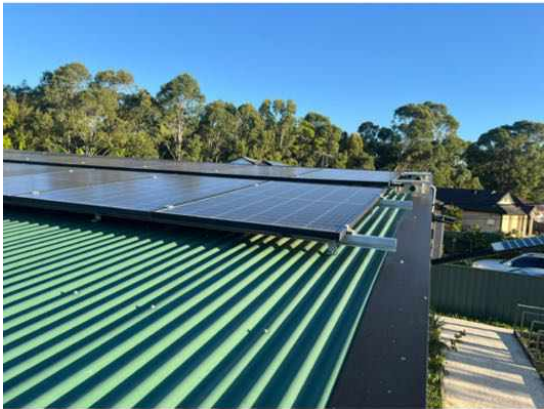
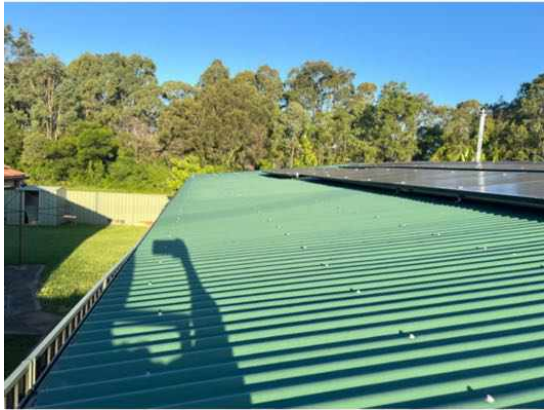
Noted Item

Building: Main Building  
Location: Roof Exterior  
Finding: Additional Photos - Obstructions and Limitations  
Information: These photographs are an indication of the obstructions and limitations which impeded full inspection of the property at the time of inspection. These obstructions can hide an array of defects and should be removed to allow full inspection to be carried out. A re-inspection is recommended once the areas are made accessible.

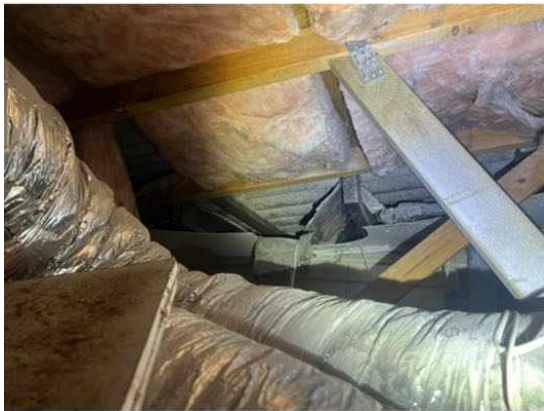
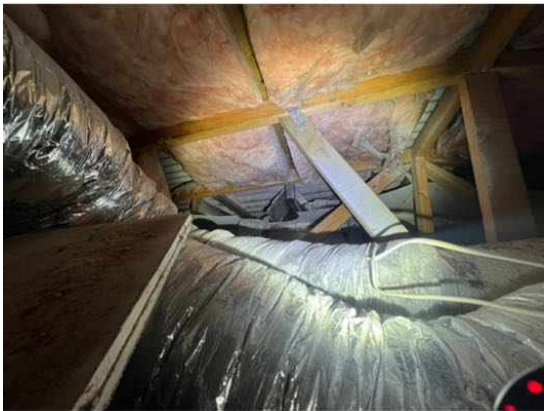
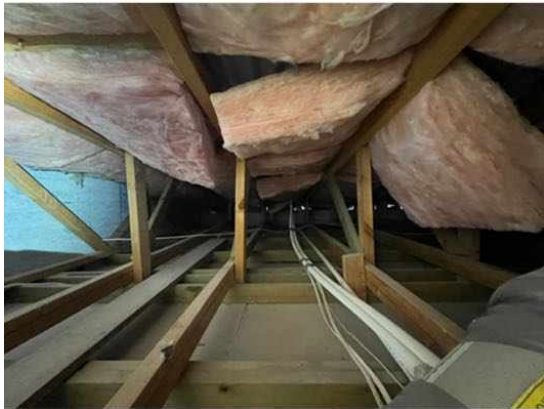
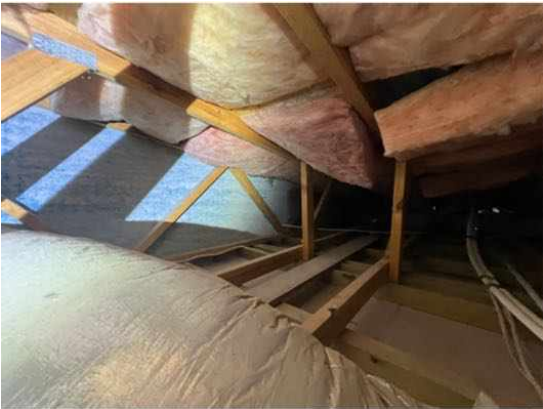
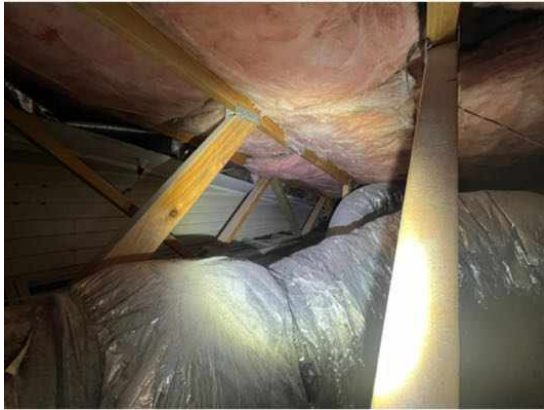
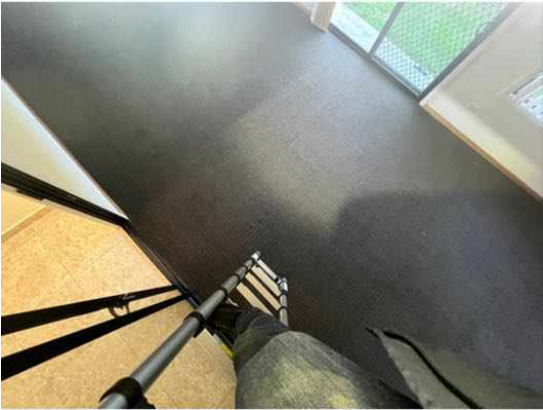
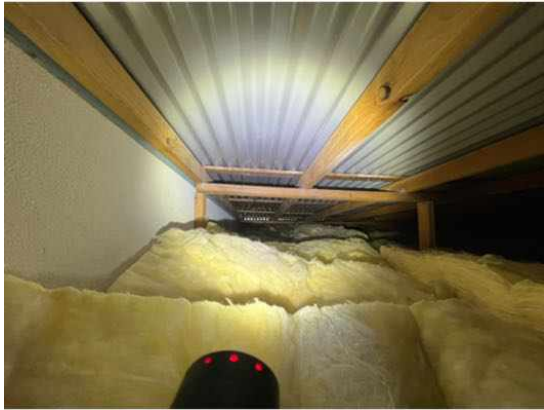
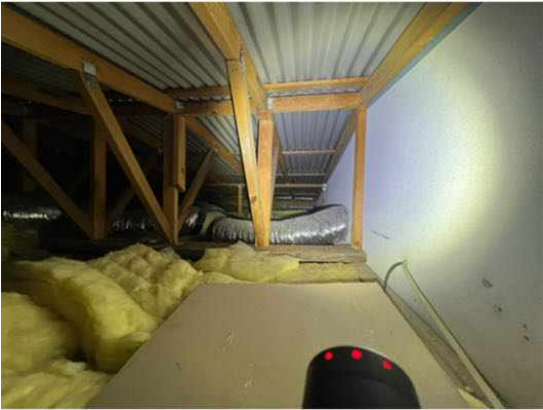
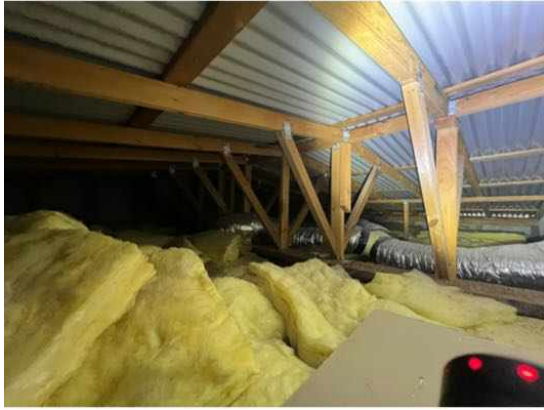
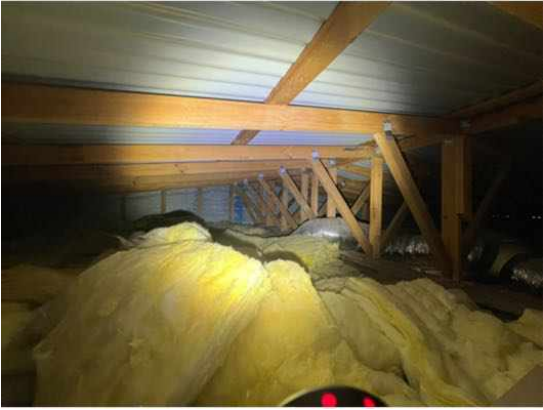
**Noted Item**

Building: Main Building  
Location: Roof Void  
Finding: Additional Photos - Obstructions and Limitations  
Information: These photographs are an indication of the obstructions and limitations which impeded full inspection of the property at the time of inspection. These obstructions can hide an array of defects and should be removed to allow full inspection to be carried out. A re-inspection is recommended once the areas are made accessible.

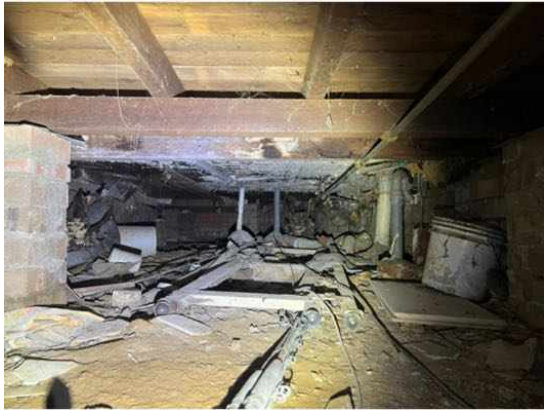
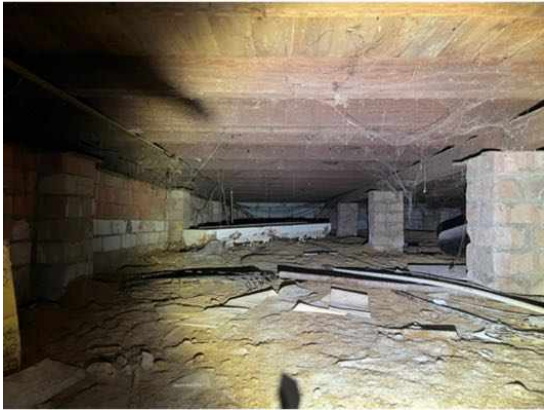
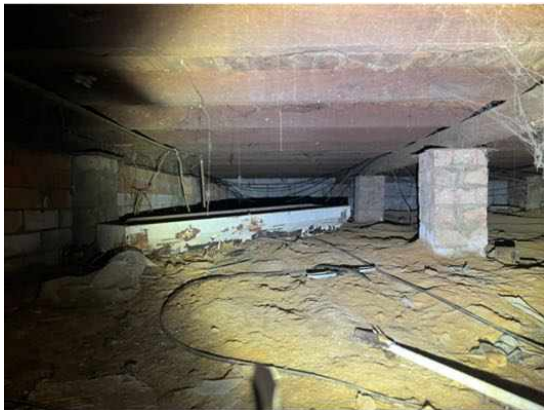
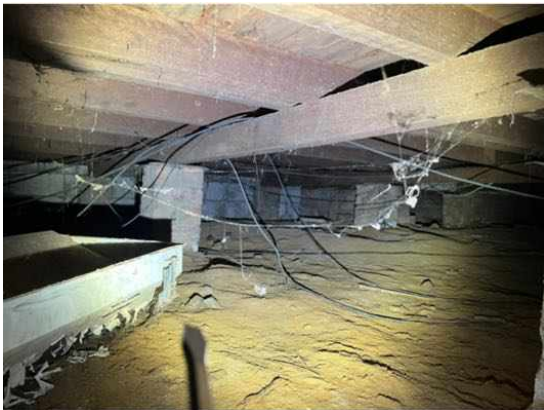
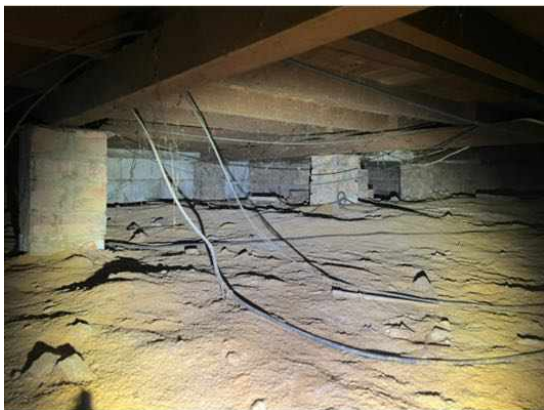
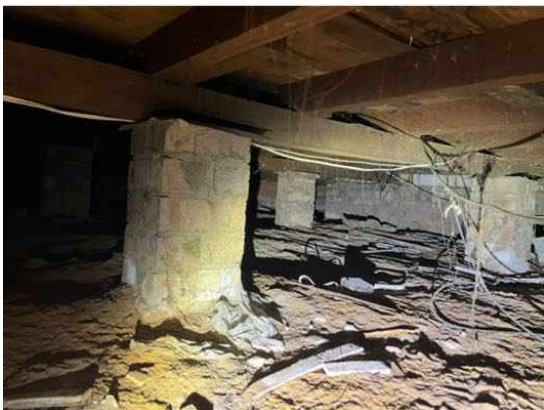
Noted Item

Building: Main Building  
Location: Subfloor  
Finding: Additional Photos - Obstructions and Limitations  
Information: These photographs are an indication of the obstructions and limitations which impeded full inspection of the property at the time of inspection. These obstructions can hide an array of defects and should be removed to allow full inspection to be carried out. A re-inspection is recommended once the areas are made accessible.
