Building and Timber Pest Inspection Report

Inspection Date: Thu, 26 Mar 2026

Property Address: 7/18 Liverpool Rd, Croydon NSW 2132, Australia

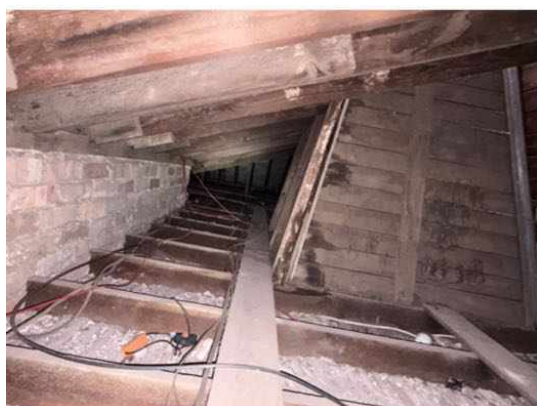
Finding 1.01

Building:	Main Building
Location:	Roof Void
Finding:	Party wall - Missing
Information:	There must be a party wall in this area, separating the dwellings. This party wall creates a barrier between the adjoining dwellings, preventing the transmission of sound, temperature and fire between them.

Based on the current Australian Standards, this is a non-compliance and hence a safety hazard and should be rectified urgently to become compliant.

A complying party wall was missing inside the roofvoid. A licensed builder must be appointed urgently for rectifications.

A licensed builder should be engaged immediately for the works.

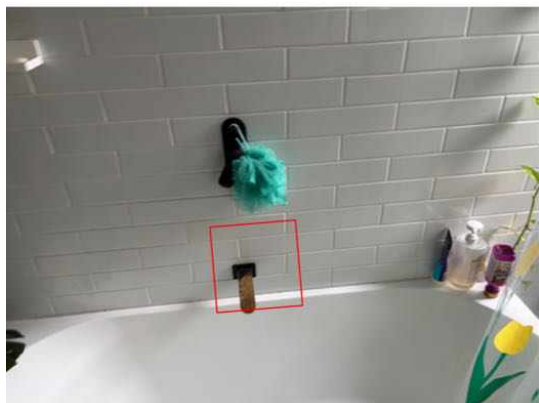
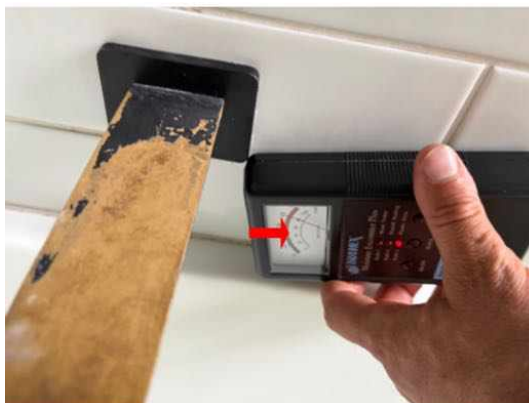
Finding 2.01

Building:	Main Building
Location:	Bathroom
Finding:	Water leak - Suspected
Information:	A water leak is suspected in this area as excessive moisture was detected at the time of inspection. Another potential cause maybe moisture ingress behind the tiles from around the wall fittings and penetrations.

Internal water leaks can be detrimental to surrounding building elements; their potential causes include damage to plumbing fittings and fixtures, through to water damage and deterioration of associated building elements.

Attracting termites, corrosion, mould, decay and water damage are potential outcomes where a minor water leak is left unattended. More serious defects may also result, such as electrical hazards, or water damage to structural building elements.

Excessive moisture was identified to the walls in the bathroom shower. There maybe a water leak OR otherwise moisture maybe penetrating around the fittings. A licensed plumber must be appointed urgently for further assessment and repairs.

In extreme cases, structural damage may develop due to a prolonged water leak. It is highly advised that internal water leaks be addressed by a licensed plumber as a matter of relative urgency.

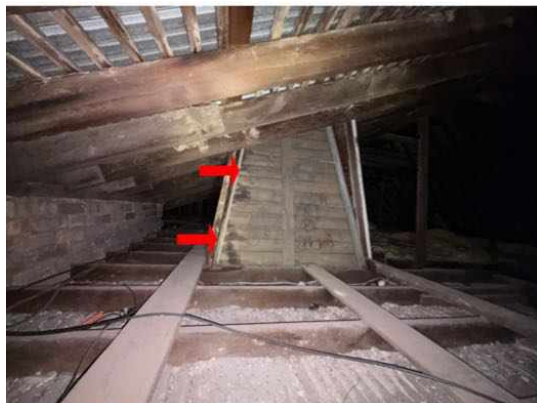
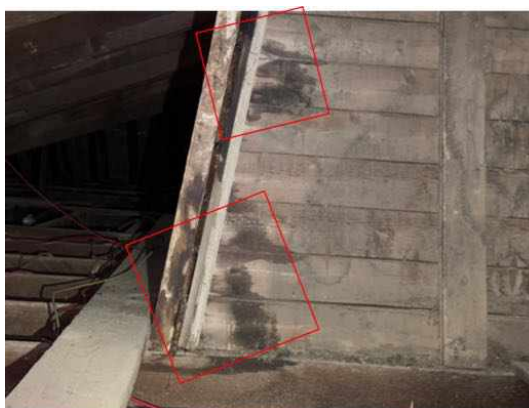
Finding 3.01

Building:	Main Building
Location:	Roof Void
Finding:	Water staining
Information:	Water staining was evident in this area at the time of inspection. Water staining indicates that surfaces have been exposed to excessive moisture over time. The minerals and other elements in the water lead to staining, which may graduate to corrosion and deterioration if left unmanaged.

While mostly an appearance defect, water staining can be indicative of more serious defects, which may be currently concealed by other building elements.

Where water staining is active, a licensed roof plumber must be consulted to identify the cause of the staining and to provide advice on any repair work that may be required. Replacement of any broken or damaged structures is advised.

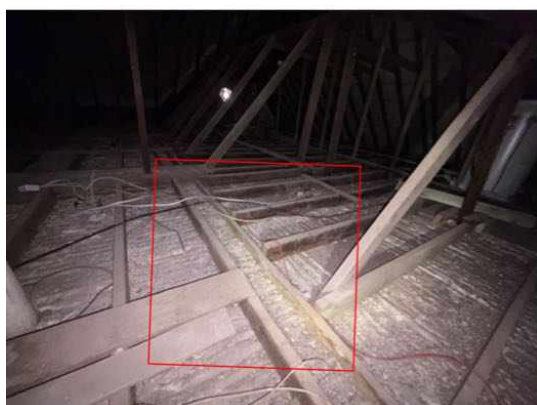
Finding 3.02

Building:	Main Building
Location:	Roof Void
Finding:	Insulation - Missing
Information:	Upon inspection of the roof void it was noted that insulation is not present.

Insufficient insulation will result in a comparatively higher cost to heat and cool a property as there is a lack of Insulation (or uneven coverage of insulation) which works as a barrier to heat transfer. This helps to keep out unwanted heat in summer and preserves warmth inside your home in winter. It can also help soundproof your home from unwanted airborne noise transfer.

Where insulation is absent, the area does not meet current Australian Standards. Installation of adequate insulation is required and should be conducted as soon as possible.

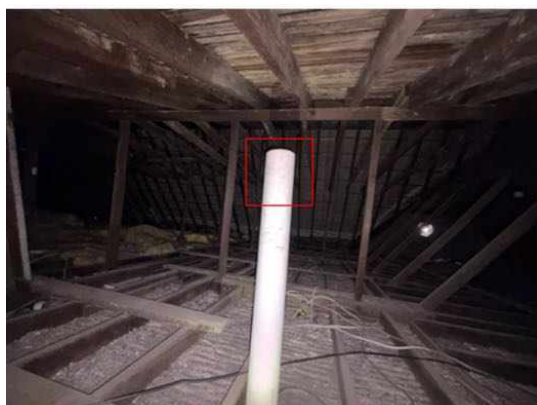
Finding 3.03

Building:	Main Building
Location:	Roof Void
Finding:	Plumbing vent - Suspended in the roofvoid
Information:	The pipe vent was found to lead directly into the roof space, rather than venting to the

exterior of the building. A licensed plumber should be appointed as soon as possible to provide further consultation on the scope of these works and to provide quotations for any necessary works.

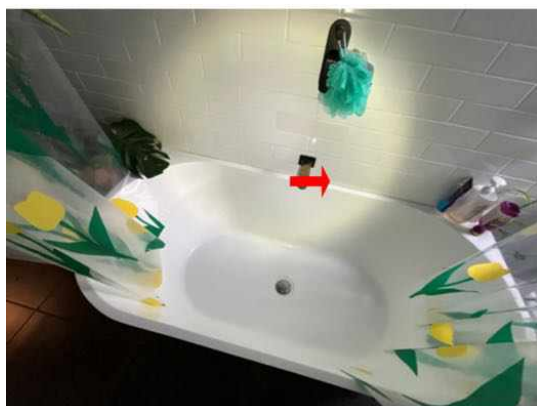
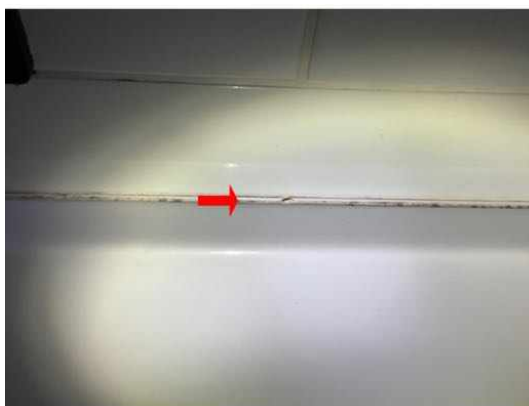
Finding 3.04

Building: Main Building
Location: Bathroom
Finding: Sealant and grouting - Missing or damaged
Information:

It was noted on inspection that sealant or grout is degraded to this area.

Different materials and floor areas move at different rates, generally causing cracking to grout or sealant at this point. A flexible sealant is required to allow for expected expansion and contraction, while keeping the joint water tight and protective of all associated building materials.

Flexible and mould resistant materials should be applied to affected areas to prevent any subsequent water damage that is likely to occur. Regular maintenance and replacement of damage or missing or damaged sealant and grout is highly recommended to the wet areas, as this is a regular wear and tear defect. Sealant and grouting in areas that come into regular contact with water should be maintained for the long term care of your property.

A sealant specialist should be appointed to complete these works as soon as possible.

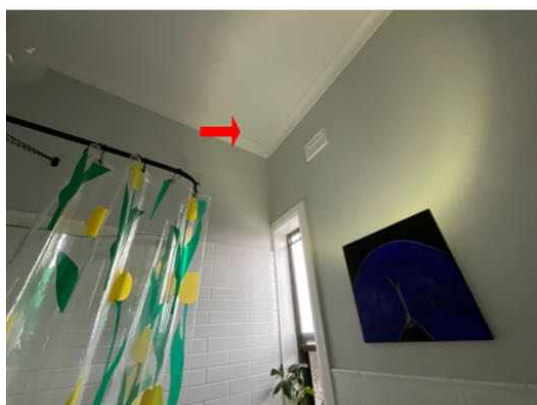
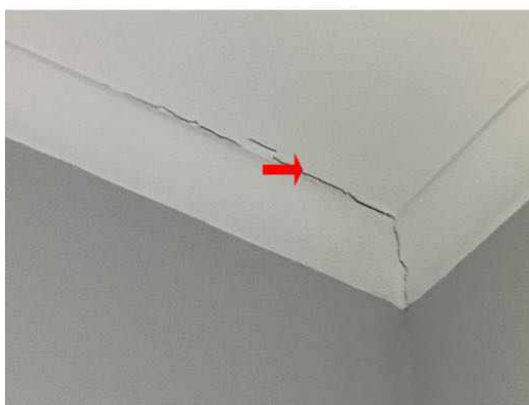
Finding 3.05

Building: Main Building

Location: Bathroom

Finding: Cracking - Damage Category 1 - Fine (up to 1mm)

Information: Although fine cracks are quite noticeable, they are often only considered to be an appearance defect, and usually do not indicate any structural damage. Generally, the cause of a fine crack is indicative of a separation between building materials and finishes (e.g. paint, plaster, etc.) along joins.

Cracking of this nature can generally be repaired with minor sanding, filling and/or repainting. Such works should be performed by a qualified painter or a general handyman.

Monitoring of all cracking should be conducted frequently. Always contact a building inspector should cracks widen, lengthen, or become more numerous.

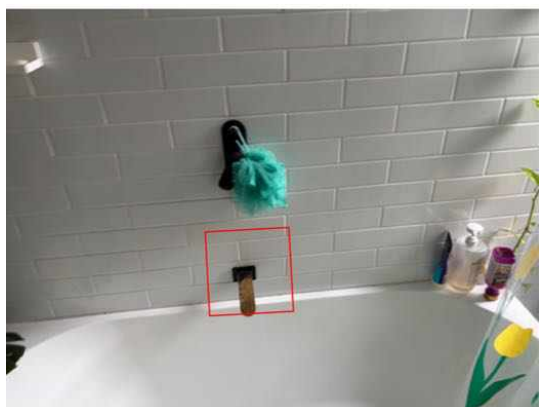
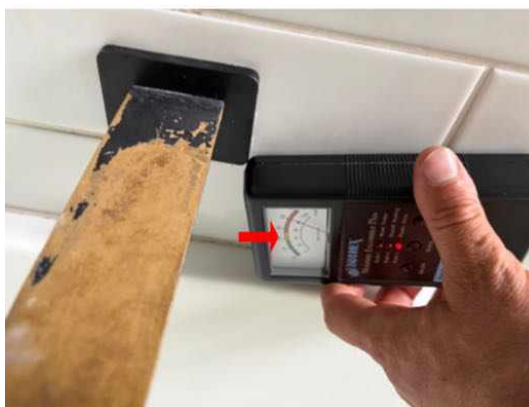
Finding 6.01

Building:	Main Building
Location:	Bathroom
Finding:	Water leak - Suspected
Information:	A water leak is suspected in this area as excessive moisture was detected at the time of inspection. Another potential cause maybe moisture ingress behind the tiles from around the wall fittings and penetrations.

Internal water leaks can be detrimental to surrounding building elements; their potential causes include damage to plumbing fittings and fixtures, through to water damage and deterioration of associated building elements.

Attracting termites, corrosion, mould, decay and water damage are potential outcomes where a minor water leak is left unattended. More serious defects may also result, such as electrical hazards, or water damage to structural building elements.

In extreme cases, structural damage may develop due to a prolonged water leak. It is highly advised that internal water leaks be addressed by a licensed plumber as a matter of relative urgency.
