# Building and Timber Pest Inspection Report

Inspection Date: Wed, 4 Feb 2026

Property Address: 1/375 Lawrence St, Wodonga VIC 3690,  
Australia

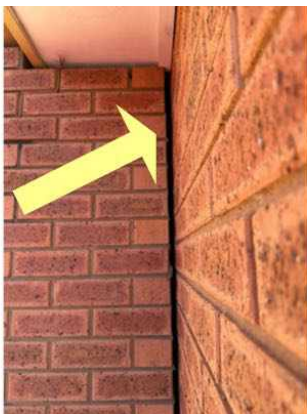
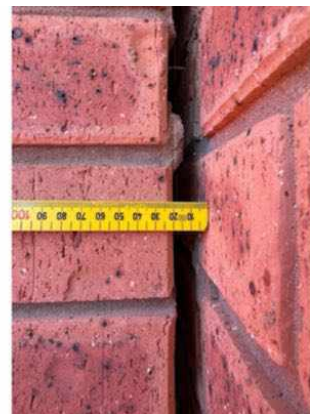
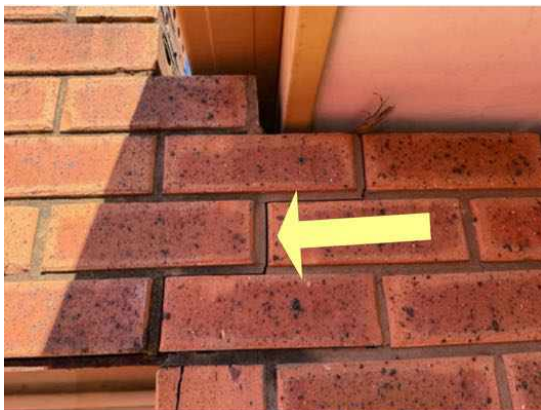
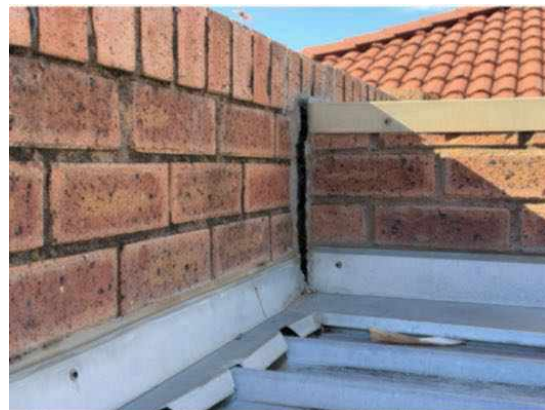
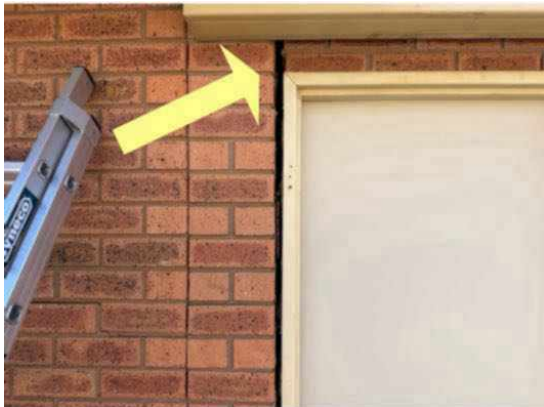
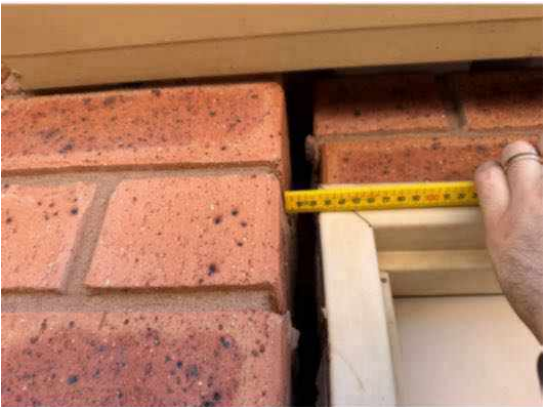
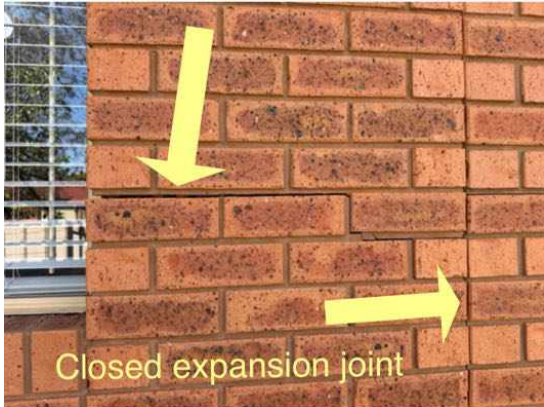
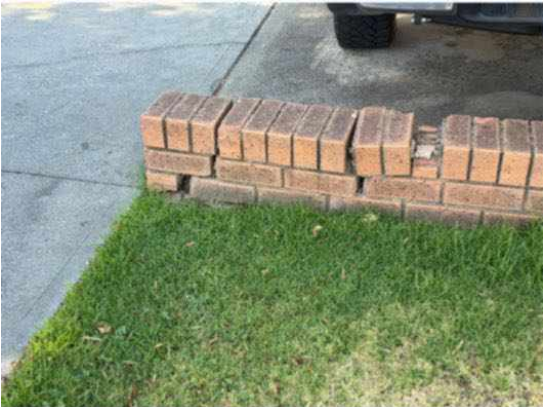
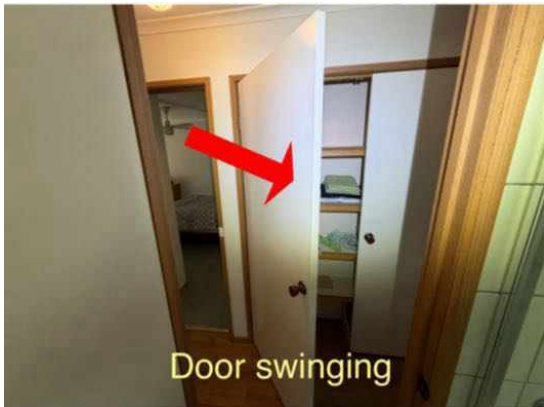
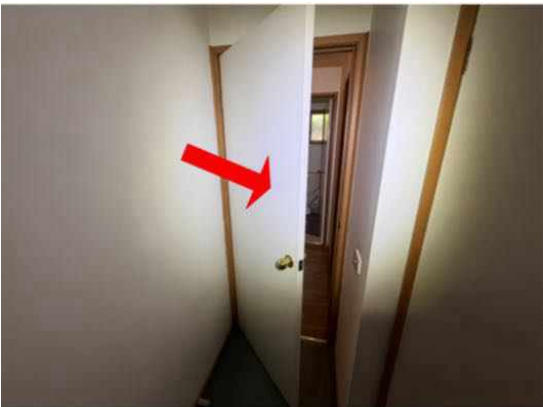
#### Finding 2.01

Building: Main Building  
Location: Garage Front & Rear, Brick Garden Edging  
Finding: Brickwork - Step cracking, Movement  
Information: Step cracking & evidence of movement was identified to areas of the brickwork at, but not limited to the front and rear of the garage. Some internal doors also appeared to be swinging shut, which can also be an indicator of movement.

The client should closely monitor the cracking to identify any further movement. It is also advised that a structural engineer be engaged, prior to clients completion of due diligence, to provide further specialist advice & recommendations, to avoid the development of secondary building defects.

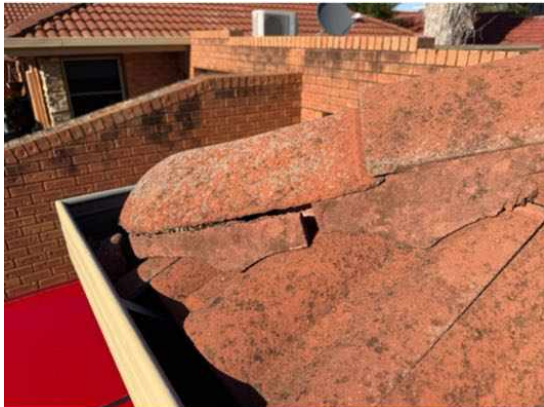
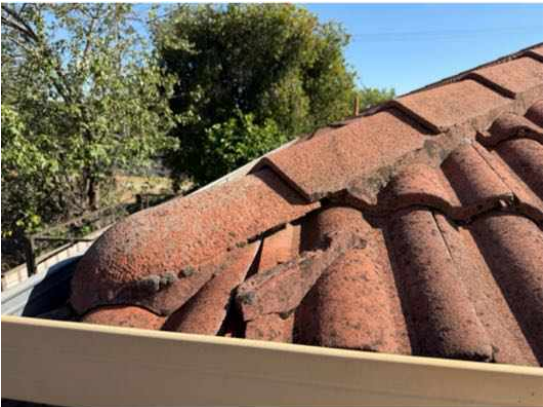
**Finding 3.01**

Building:	Main Building
Location:	Roof Exterior
Finding:	Roof Exterior - Cracking, General Weathering
Information:	Areas of general weathering & cracking in the tile pointing were identified to the roof exterior. While weathering of the tiles is consistent with the age of the property, maintenance works are advised to avoid the development of secondary building defects, overtime.

Recommend consulting with a licensed roofing contractor in the short term, to provide further advice on maintenance works needed.

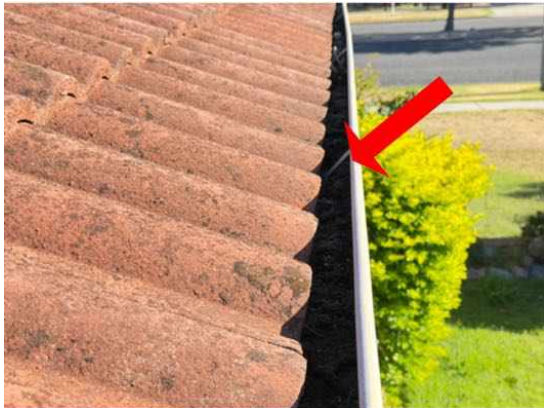
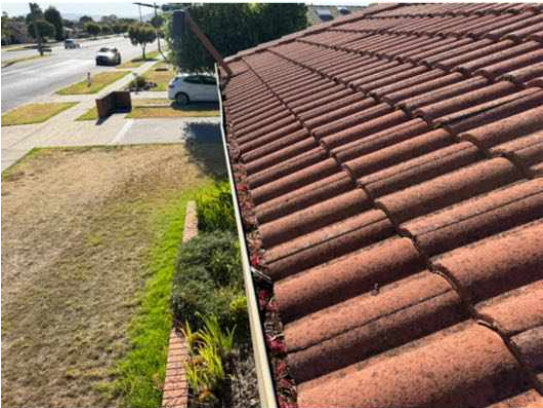
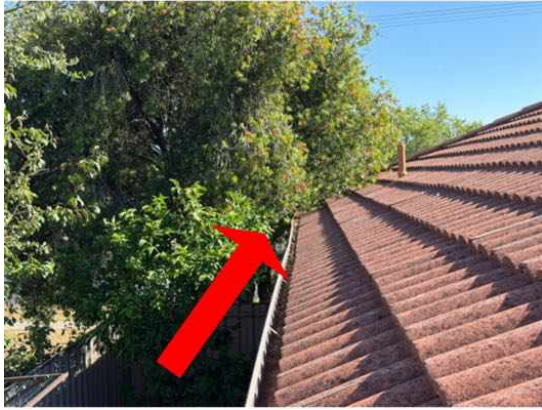
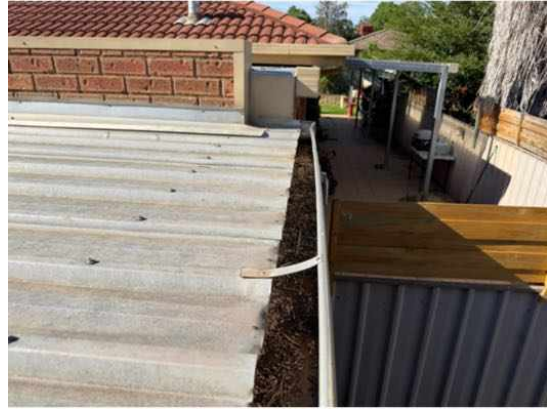
**Finding 3.02**

Building: Main Building  
Location: Gutters  
Finding: Debris & Vegetation in Gutters  
Information: It appears that there is debris & overhanging vegetation present in the guttering. Gutters should be free of debris to prevent blockages, accumulated water overflows and/or flooding of the eaves.

Recommend engaging a handyman to remove debris from the gutters and cut back overhanging vegetation, to prevent accumulated blockages.

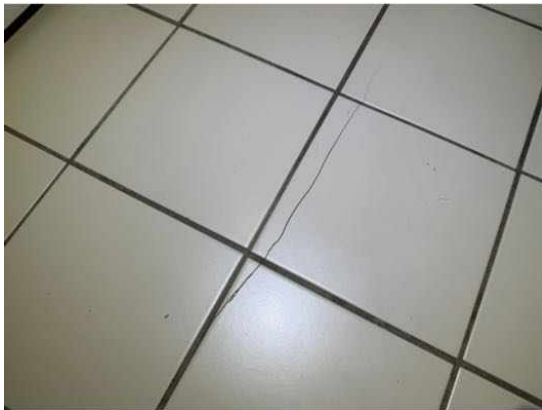
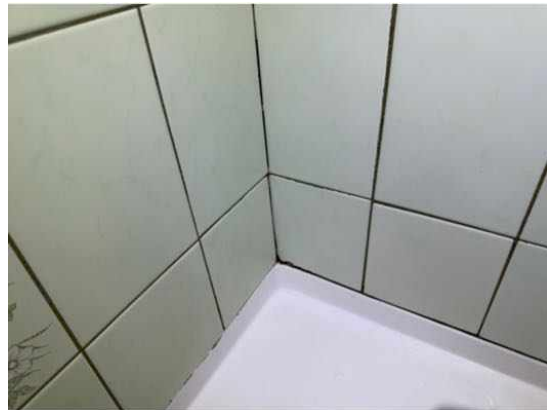
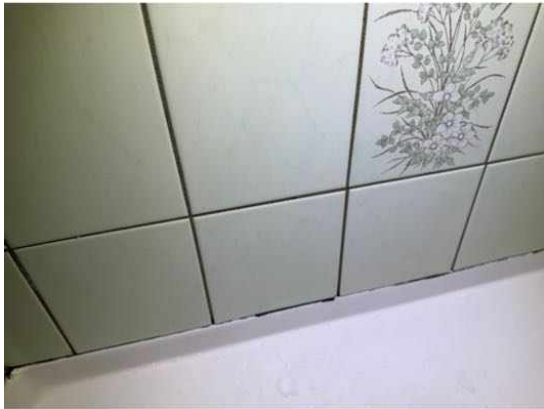
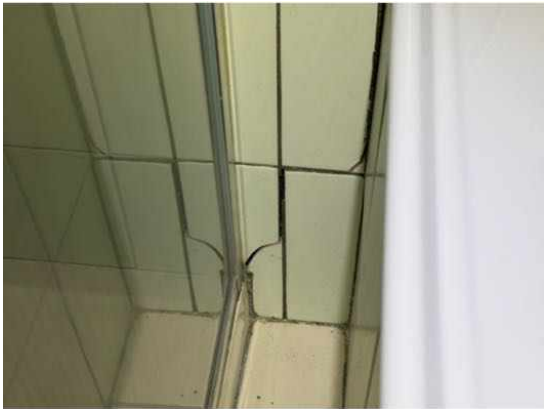
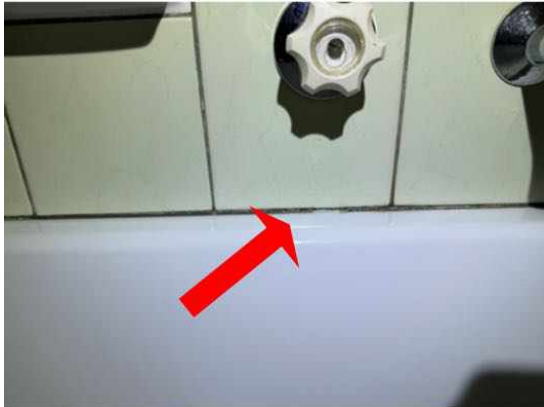
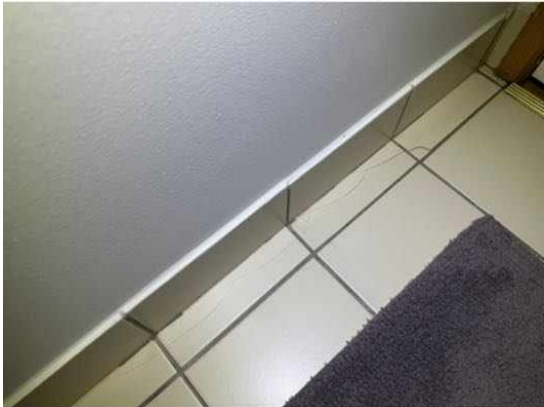
### Finding 3.03

Finding: Sealant / grouting - deteriorated or missing & Cracked Tiles

Information: It appears that the sealant and grout has deteriorated in some tiled areas, a common defect in buildings of a similar age. Areas of cracked tiles were also noted, which can allow for moisture ingress behind the tiles, if neglected.

Sealant and grouting in areas that come into regular contact with water should be maintained for the long term care of your property.

Recommend engaging a licensed tiling contractor in the short term, to provide maintenance works where necessary.

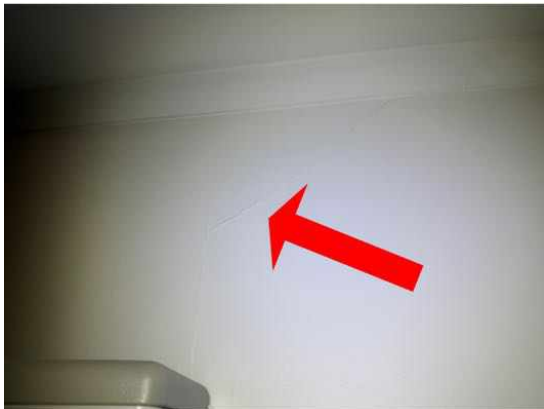
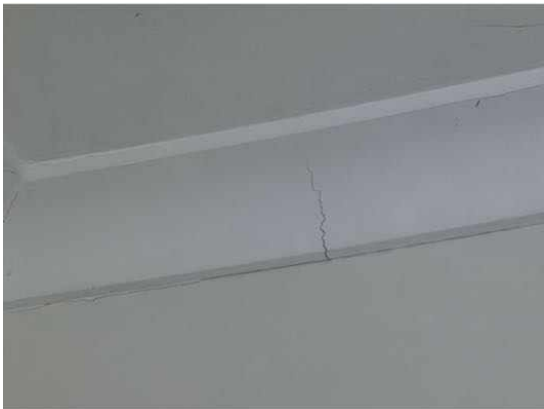
**Finding 3.04**

Building: Main Building  
Location: All Internal Areas  
Finding: Plaster - Cracking  
Information: There appears to be some cracking in areas of the ceiling and wall linings throughout the building. It is advised that the client monitor these areas.

Should cracking widen, lengthen, or become more numerous, the client should consult with a structural engineer for further evaluation, at their earliest convenience.

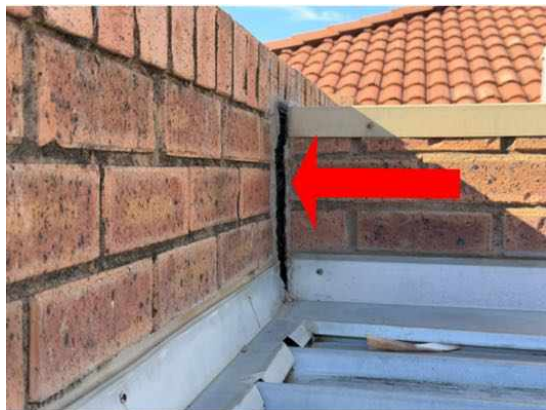
**Finding 3.05**

Building:	Main Building
Location:	Garage roof exterior
Finding:	Roof Seal - Missing / cracked
Information:	It appears that the movement of the garage brickwork has resulted in a gap of the roof plumbing. This can allow for water ingress into the building, if neglected. Recommend engaging a licensed roof plumber to provide maintenance works where necessary to ensure the roof exterior is sufficiently sealed.

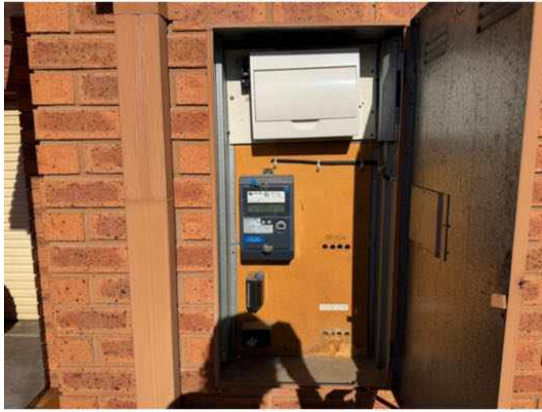
### Finding 6.01

Building:	Main Building
Location:	Switchboard
Finding:	Termite Management System - no evidence of a chemical installation
Information:	The application of a termite barrier is strongly recommended, as it appears no termite management system has been installed, with no evidence or durable notice to suggest works taking place. Generally, a durable notice is placed in the meter box to indicate current termite barriers.

Such barriers are highly effective in preventing termite attack on the building and therefore should be installed.

Recommend seeking further advice from a licensed pest controller.

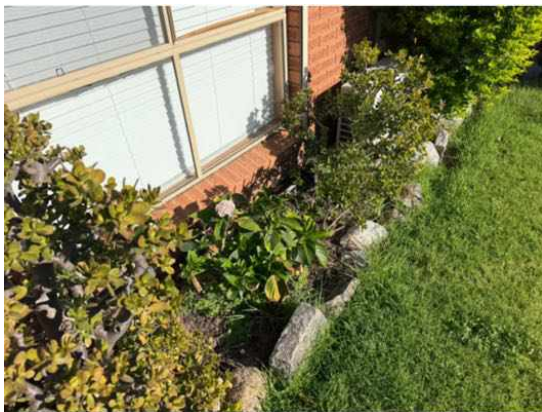
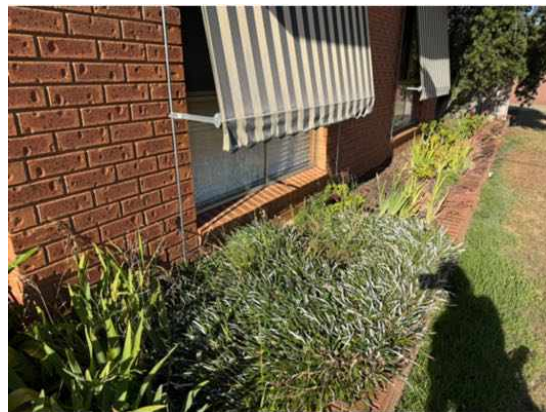
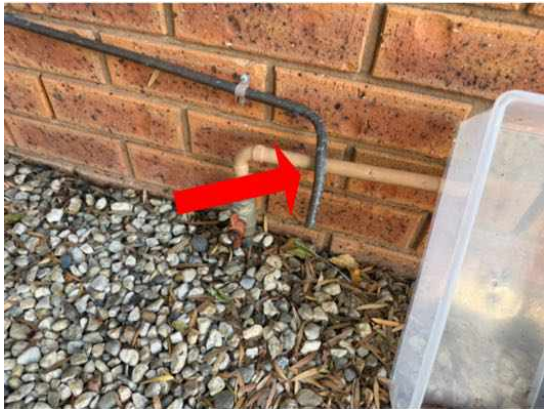
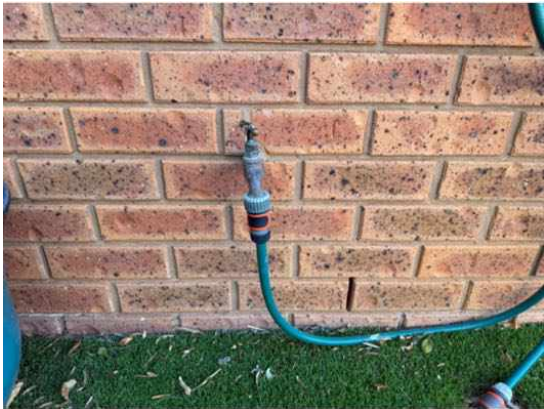
## Finding 6.02

Building: Main Building  
Location: All external areas  
Finding: Potential Water pooling - against property  
Information: Potential areas of water pooling around the perimeter of the property were identified.

Where insufficient drainage of taps, hot water system & aircon overflows, and garden beds against the house are present, water pooling is likely to occur, and can create areas conducive to timber pests.

Recommend consulting with a licensed plumber and/or landscaping contractor to provide further advice.

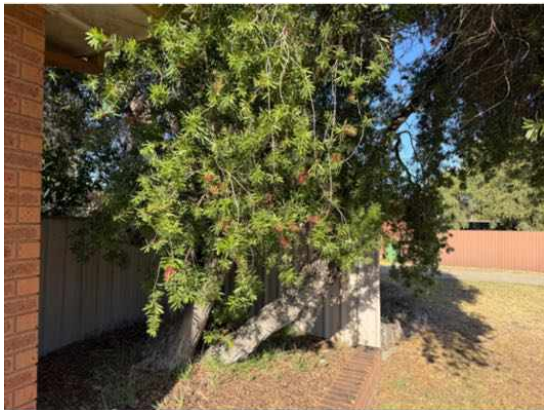
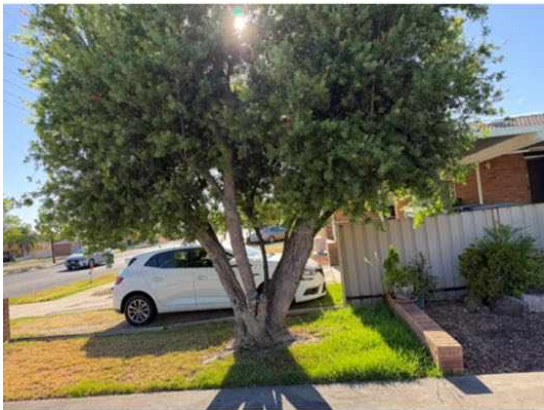
**Finding 6.03**

Building: Main Building  
Location: All External Areas  
Finding: Surrounding trees - conducive to termites  
Information: Where timber materials are in direct contact with the ground and consequently moisture, they become conducive to termite activity. The surrounding trees create an environment conducive to termite activity.

Where feasible, any trees in close proximity to the building should be removed or test drilled (inspected) at least annually to reduce the risk of termite infestation & detect any early signs of termite activity.

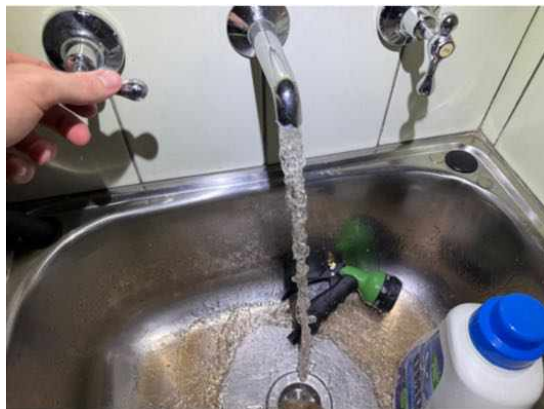
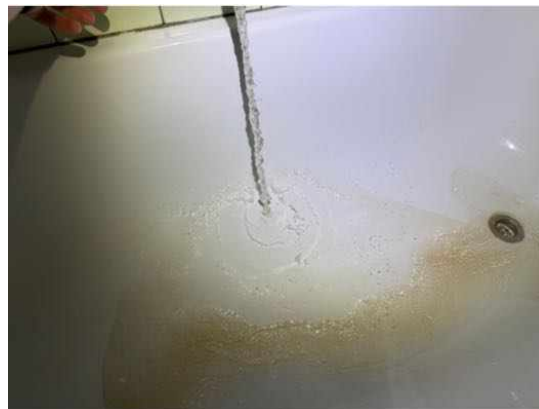
Building:	Main Building
Location:	Laundry, Bath
Finding:	Taps - Rusty coloured water
Information:	It appears that the water emitting from the bath & laundry taps is rusty-coloured. While this is a relatively common defect in buildings of a similar age, it is advised that the client consult with a licensed plumber, to further inspect the pipework and provide further remedial advice.

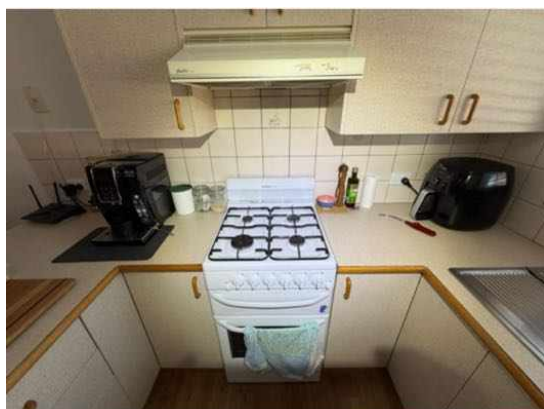
Building:	Main Building
Location:	Rangehood & Stove
Finding:	Rangehood & Stove - Not Operating
Information:	It appears that the range-hood & stove were not operating at the time of inspection. Recommend engaging a licensed electrician at clients discretion, to provide further advice and maintenance works where necessary.

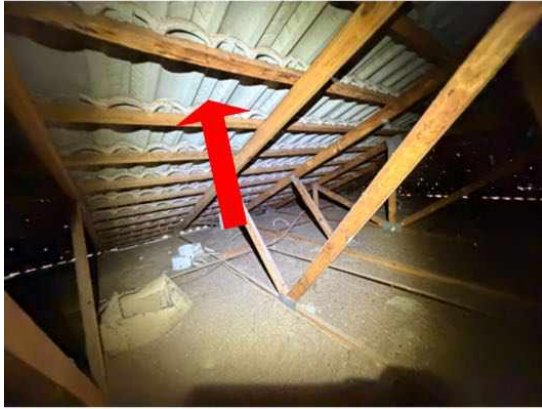
Building:	Main Building
Location:	Roof Void
Finding:	Sarking - Not Present

Information: It is noted for your information that sarking has not been installed on the roof, which is common in buildings of a similar age. Sarking is a laminated aluminium foil which assists in insulating the property and acts as a vapour-barrier to the roof void.

The client can consult with a licensed roofing contractor at their discretion, to provide further advice.

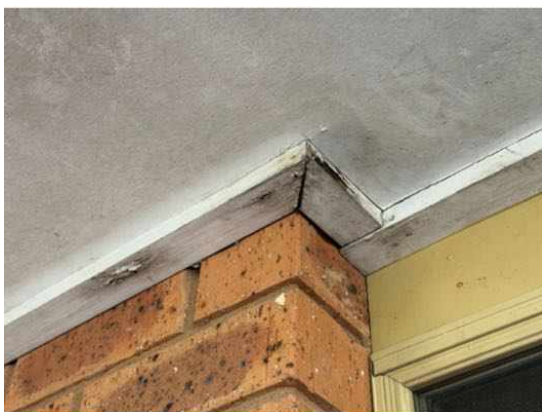
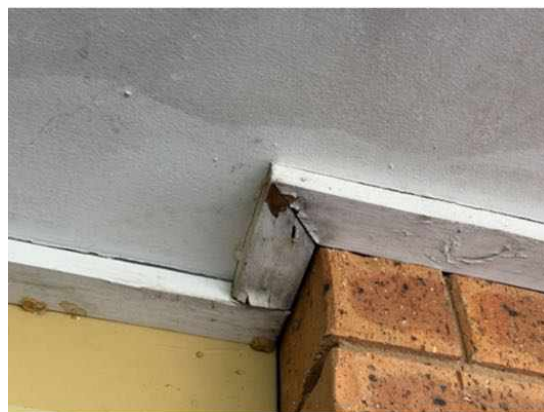
Building: Main Building  
Location: Eave trims  
Finding: General weathering - External trims  
Information: Areas of weathering were identified to some external trims, a common occurrence in buildings of a similar age.

A licensed painting contractor can be engaged at clients discretion to apply protective sealant or coating to areas of weathered external timbers.
