Building and Timber Pest Inspection Report

Inspection Date: Tue, 7 Apr 2026

Property Address: 167 Oxford St, Cambridge Park NSW 2747,
Australia

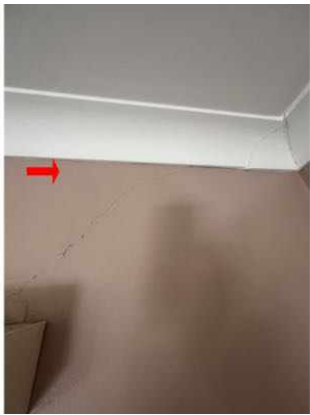
Finding 2.03

Building:	Main Building
Location:	Bedroom wall
Finding:	Damage to Internal Walls (Cracks)- Category 2
Information:	It has been observed that damage to Bedroom wall above the door frame has cracks visible during inspection. The degree of damage falls within Category 2, described as noticeable cracks . Such cracking may cause doors and/or windows to stick slightly, and are generally less than 5mm in width.

The above is considered a defect requiring rectification, I advise an inspection by a licensed carpenter/ builder to do a more invasive inspection and remedy the situation.

Always contact your building inspector should cracks widen.

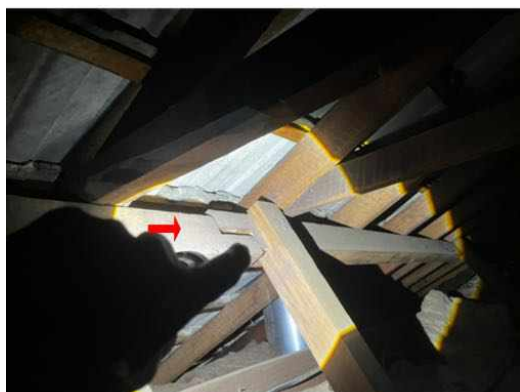
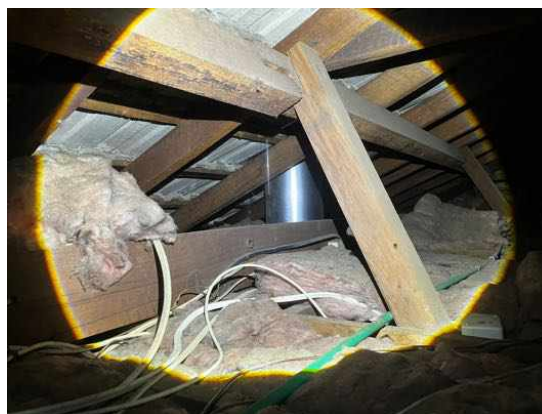
Finding 2.04

Building:	Main Building
Location:	Roof
Finding:	Roof structure - Connections (Sagging)
Information:	The roofing structure was found to be sagging in certain sections at the time of inspection. Upon closer inspection within the ceiling void, it is suspected that the sagging is a direct result of inadequate connections, which appear to have deteriorated over a prolonged period of time.

Sagging roof structures are likely to create strain on associated building elements, creating potential for secondary damage. The roof is also unlikely to have sufficient support, which will lead to further sagging if left unmanaged.

It is critical to ensure that the fastenings holding important roof elements together remain structurally sound (i.e. not corroded) and tightly fastened. Any failure in fastenings can lead to movement of roof members, which is likely to result in an uneven or sagged appearance of the roof exterior. Improper nailing at the point where the ceiling joist connects to the bottom of the rafter may also cause sagging.

Remedial works are highly advised and should be performed by a registered builder or roofing contractor as soon as possible.

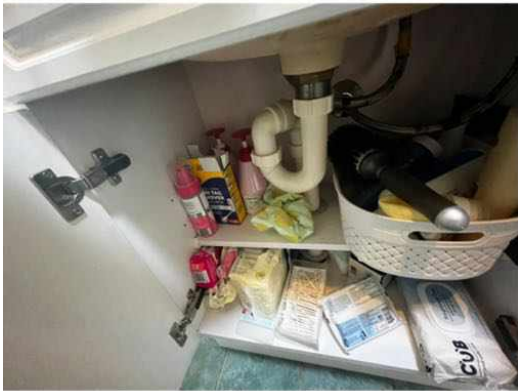
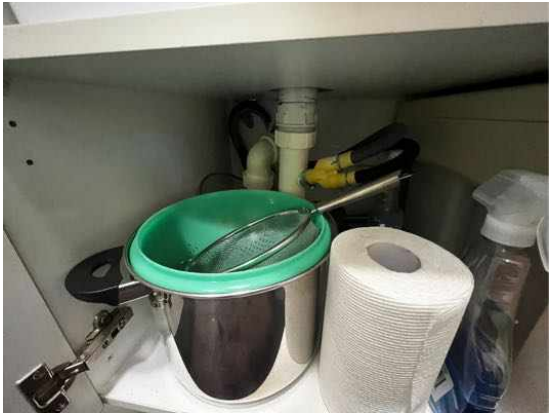
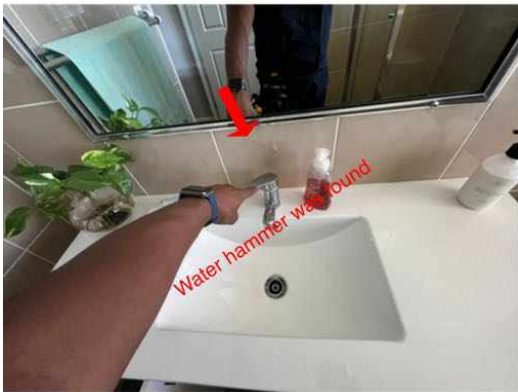
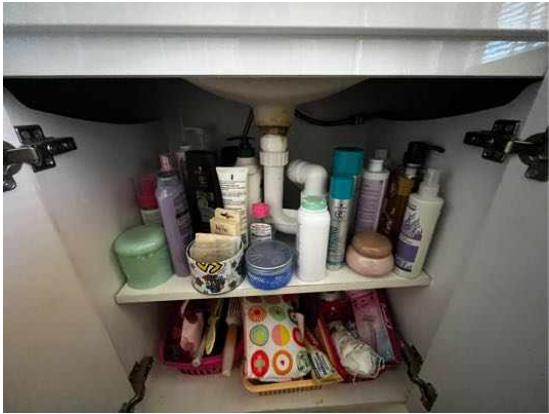
Finding 3.01

Building: Main Building
 Location: All Areas
 Finding: Cabinetry Plumbing - Kitchen/ Pantry cum Laundry
 Information: Upon Inspection of the Kitchen and the Pantry/ Laundry and BBQ Kitchen all cupboards where sinks and basins with drainage plumbing were inspected and no evidence of leaks were present at the time of inspection.

Water hammer was found when taps turned on and off at the premises.

For your information only no remedial works are required at the time of inspection.

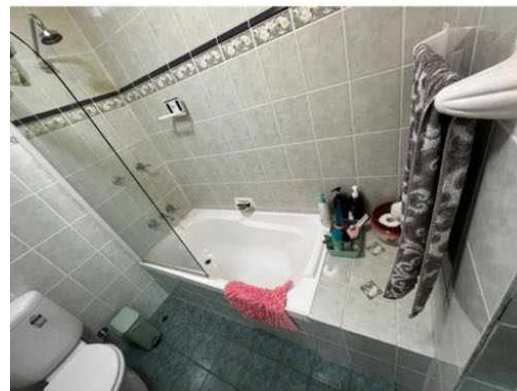
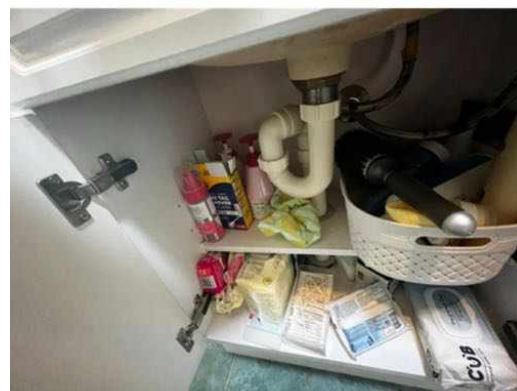
Building:	Main Building
Location:	Bathroom
Finding:	Sealant and grouting - Missing or damaged
Information:	It was noted on inspection that sealant or grout is degraded to the tiled shower alcove and or other areas of the bathroom.

Different materials and floor areas move at different rates, generally causing cracking to grout or sealant at this point. A flexible sealant is required to allow for expected expansion and contraction, while keeping the joint water tight and protective of all associated building materials.

There appears to be excessive mould to the sealant and grout which will likely require scraping out and replacement.

Flexible and mould resistant materials should be applied to affected areas to prevent any subsequent water damage that is likely to occur. Regular maintenance and replacement of damage or missing or damaged sealant and grout is highly recommended to the wet areas, as this is a regular wear and tear defect. Sealant and grouting in areas that come into regular contact with water should be maintained for the long term care of your property.

A sealant specialist or tiling contractor should be appointed to complete these works as soon as possible

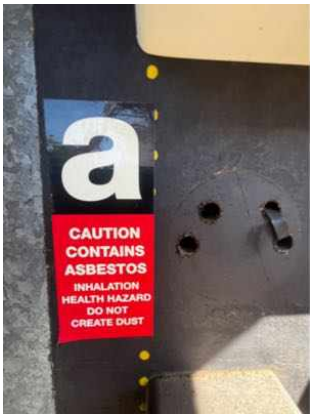
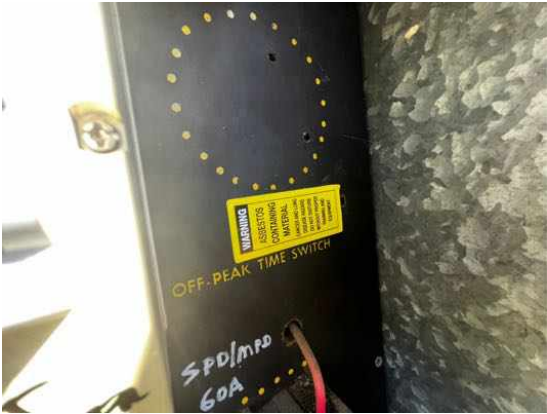
Building:	Main Building
Location:	Electrical Switchboard
Finding:	Termite Management System - no evidence of a chemical installation no Durable Notice
Information:	The application of a post-construction chemical termite barrier is highly recommended for all properties, particularly if live termite activity has been found on the site previously. Such barriers are highly effective in preventing termite attack on any timber building elements throughout the property.

A durable notice should be placed in the switchboard unit to indicate current termite barriers. At the time of inspection, it appeared as though no termite management system has been installed, with no evidence to suggest preventative works taking place.

The client may consider gaining further advice from a pest controller as to the costs and procedures involved with this application. It is recommended that obtaining such advice be a short-term priority.

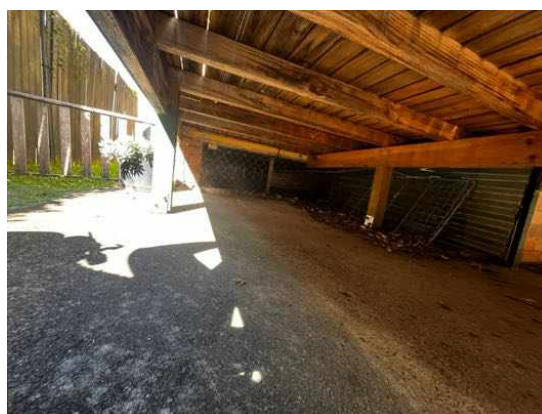
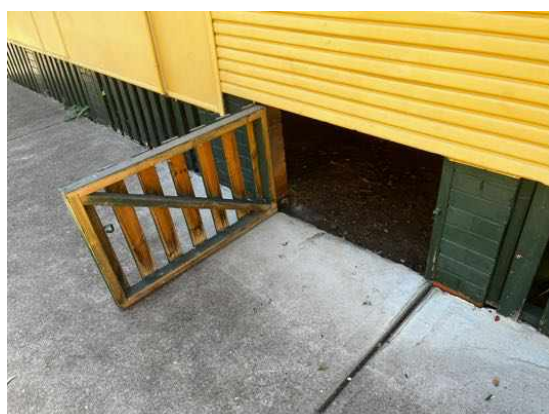
Finding 6.05

Building: Main Building
Location: Yard
Finding: Building materials in direct ground contact - conducive to termites
Information: Where timber elements are in direct contact with the ground and consequently moisture or dampness they become conducive to termite activity. Whether timber is used as a building element part of a fencing structure or stored as an unused item they can provide an environment that is attractive to termite infestation.

When met with excessive moisture timber begins to decay and develop wood rot. Any timbers that are in direct contact with external grounds especially if left untreated or non-durable also provide ingress for subterranean termites into that particular element.

The removal of any such materials that may be conducive to termite activity should be removed as soon as possible to minimise the risk of termite attack.

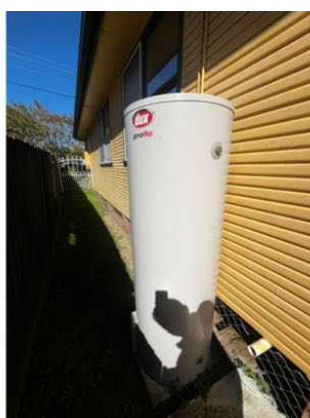
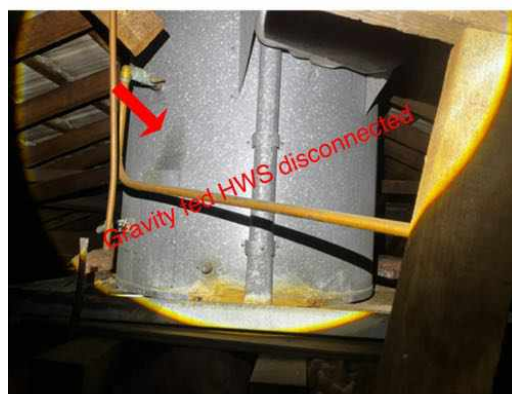
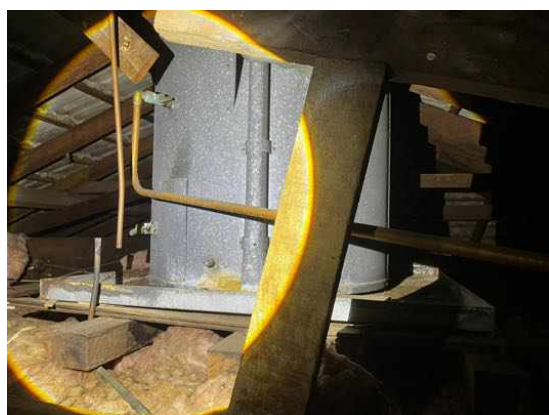
Building: Main Building
 Location: Yard
 Finding: Hot Water Unit
 Information: The HWS appeared to be working in good condition during the inspection.

Water pressure appears to be normal, however, this is not an opinion of a licensed plumber.

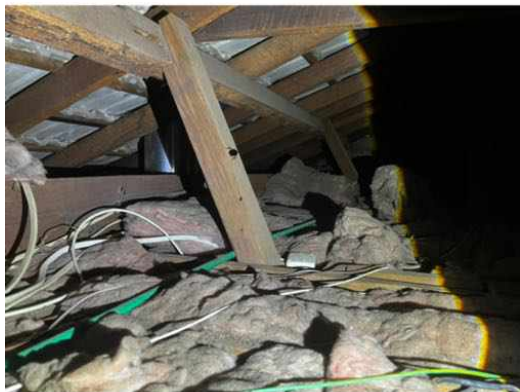
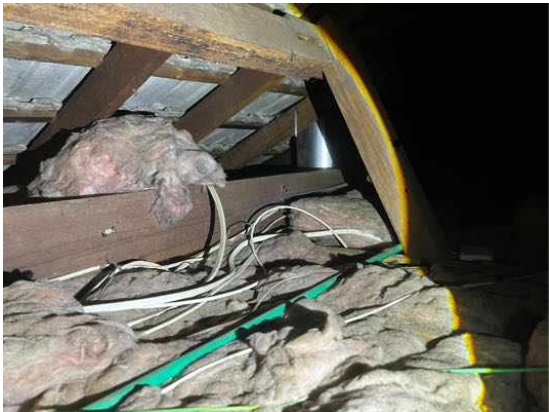
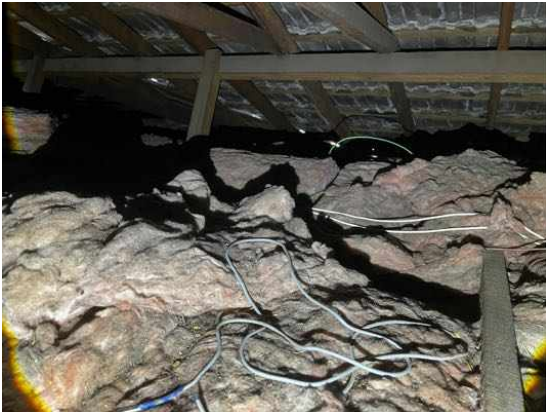
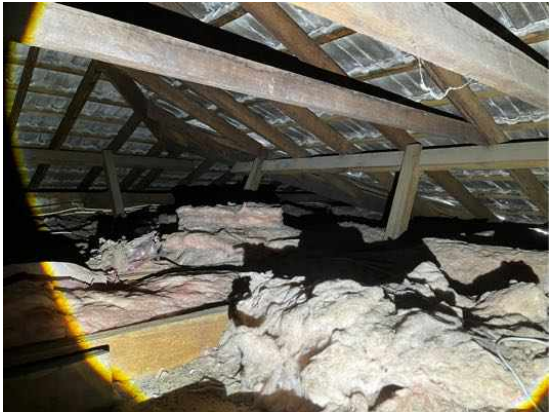
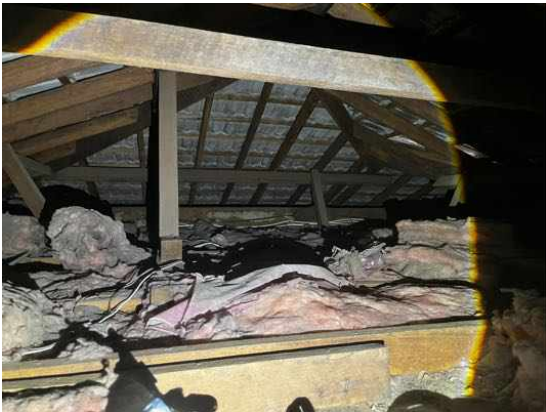
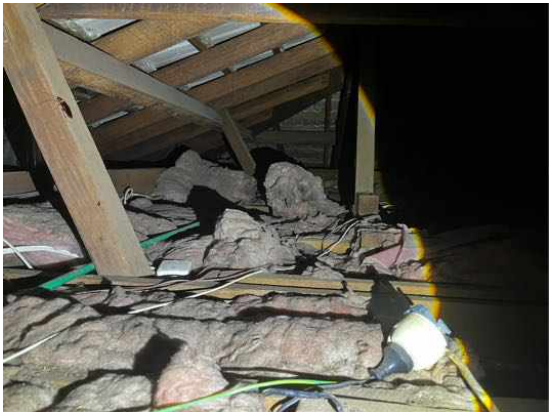
Building: Main Building
 Location: Roof Void
 Finding: Obstructions and Limitations - Roof space
 Information: These photographs are an indication of the obstructions and limitations which impeded full inspection of the Roof Space/Void at the time of inspection such as Stored items, Skylight tubes, Electrical wires, insulation and cross beams, rafters, low clearance as of the pitch in the roof.

Signs or Rust in the roofing sheets are visible during inspection. For a longevity of the structure and the property the buyer can consider replacing the rusted sheets if preferred.

These obstructions can hide an array of defects and should be removed to allow full inspection to be carried out.

A re-inspection is recommended once the areas are made accessible.

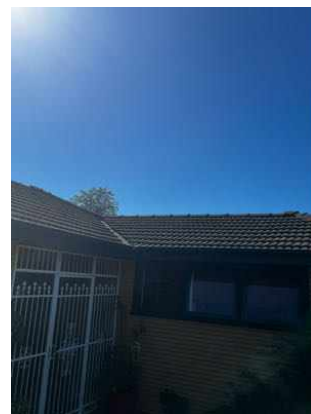
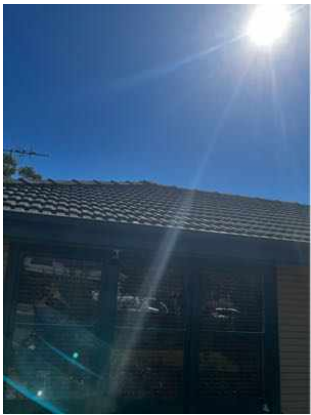
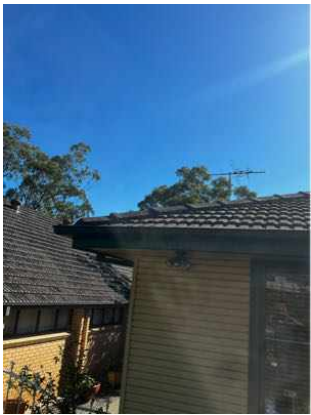
Building: Main Building
Location: Roof Exterior
Finding: Roof tiles - Weathered
Information: Upon inspection of the exterior roofing, the majority of roof tiles were considered to be in a fair condition. While weathering of the tiles is consistent with the age of the property, maintenance works are required.

Consult a roofer if assistance required.
