# Building and Timber Pest Inspection Report

Inspection Date: Thu, 22 Jan 2026

Property Address: 20 Mountain View Parade, Maudsland QLD  
4210, Australia

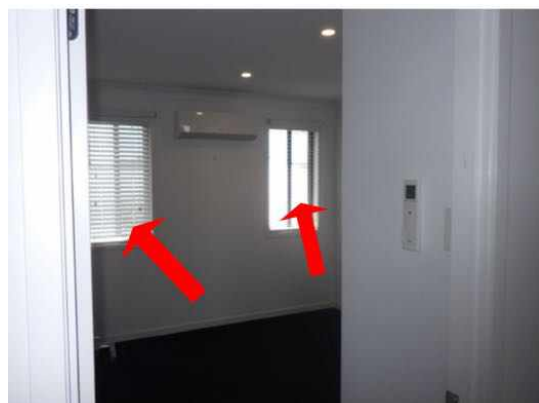
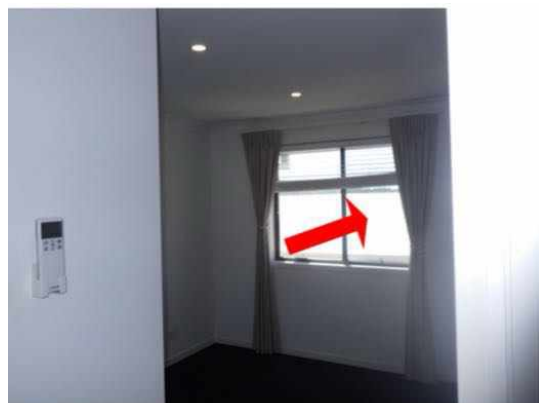
Information: It was noted that the windows of the upper level bedrooms are less than 1.7m from the floor and have a fall greater than 2m on the exterior from the sill and as such are required to only open upto 125mm or have security grills fitted.

At the time of inspection it was observed, previously installed safety catches have been removed.

This is noted as a safety concern and this regulation may not have been in place at the time of construction.

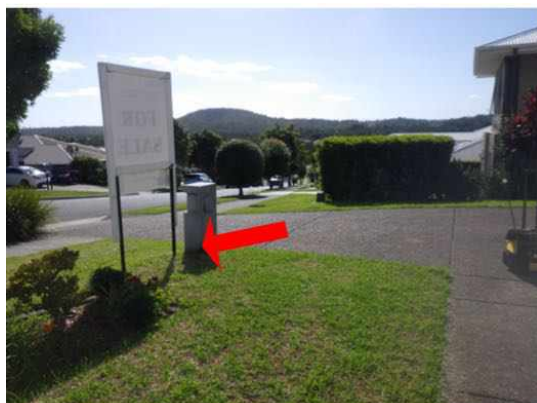
### Finding 3.01

Building:	Main Building
Location:	Yard - Front > Centre
Finding:	Mailbox
Information:	At the time of inspection the mailbox to the front of the property showed signs of damage. The damage appears consistent with impact at some time.
	A general handy man could be engaged to repair or replace the damaged mailbox.

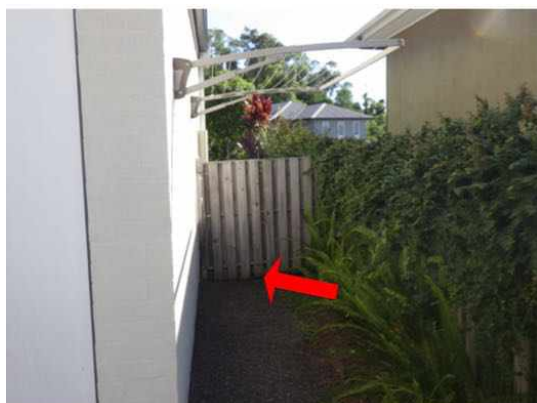
### Finding 3.02

Building:	Main Building
Location:	Yard - Side > Front Left
Finding:	Gate - Sticking/ jamming
Information:	At the time of inspection the gate to the left side of the property was sticking or jamming on the concrete footpath, during standard operation.
	A fencing contractor or general handyman could be engaged to adjust or repair the gate as required.

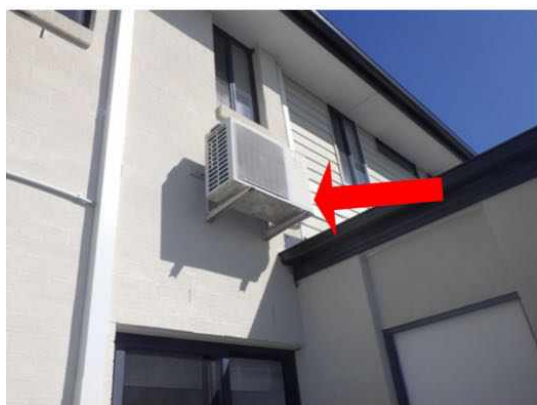
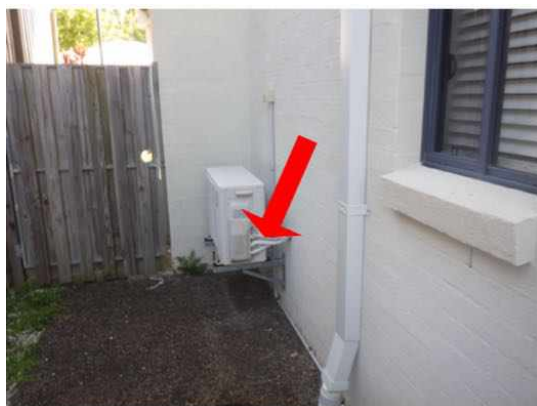
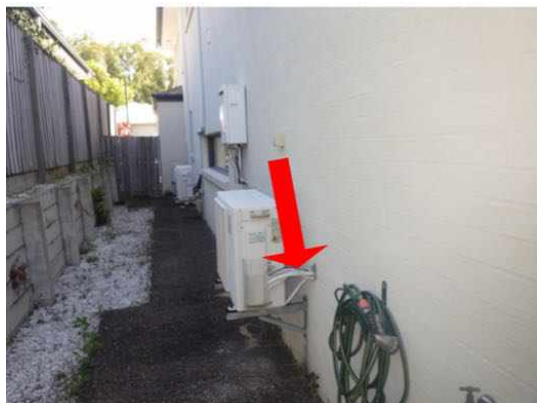
### Finding 3.03

Building: Main Building  
Location: Exterior walls > Front Right, Centre Left  
Finding: Pipework - Insulation deteriorated  
Information: At the time of inspection sections of the air conditioning units pipe work insulation showed evidence of damage and deterioration. It is suspected that this deterioration has developed as a result of excessive exposure to weather, including UV exposure in daylight. Deteriorated insulation reduces the effectiveness of the material in helping to maintain the desired temperature and work most efficiently.

If left in an exposed position, it is likely that the deterioration will continue and worsen over time, potentially resulting in secondary building defects as well as a further loss in insulating properties.

Some areas of replacement of pipe insulation is likely to be required. Further preventative measures to remove or protect the material from future exposure are also advisable. Consultation with a licensed air conditioning installer is advised to gain quotes for the repair and/or replacement of deteriorated insulation.

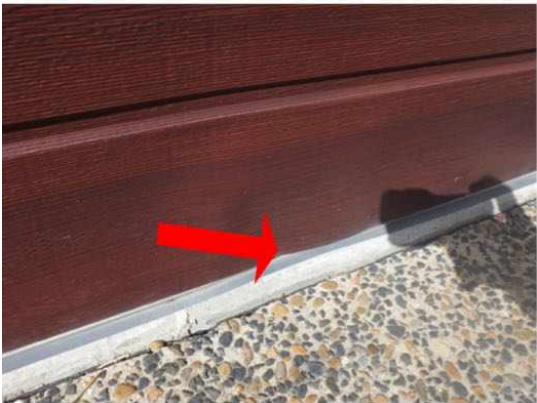
### Finding 3.04

Building:	Main Building
Location:	Garage > Front
Finding:	Garage door - dent
Information:	The garage door has dent likely to have resulted from impact damage be it accidental or deliberate impact at sometime.

Repair and/or replacement of the garage door would improve the condition of the garage but certainly not an urgent item

A qualified sectional door installer or supplier could be engaged to check out the operation and overall condition of the door to determine if repair is an option.

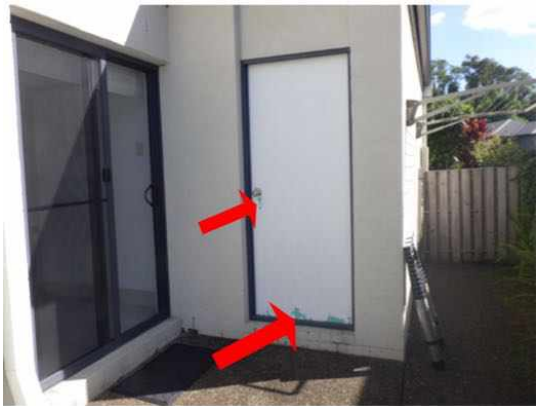
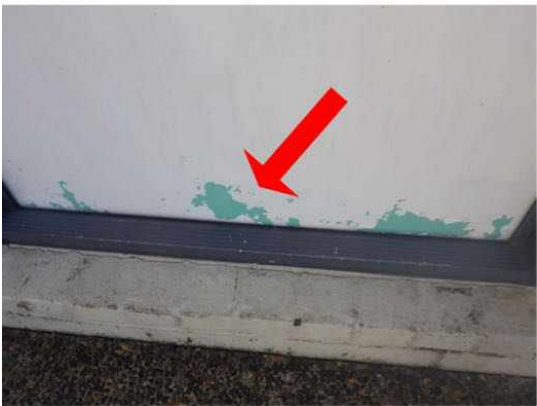
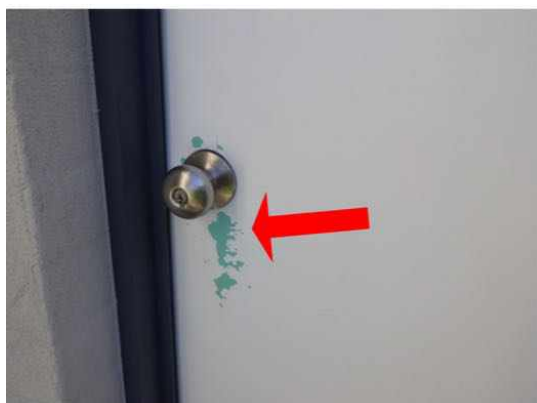
**Finding 3.05**

Building: Main Building  
Location: Garage > Rear Left  
Finding: Painted surface - Deteriorated  
Information: At the time of inspection sections of paint to the garage area exterior door were found to have deteriorated. Deteriorated paint is generally an indication of exposure to moisture or poor workmanship.

The presence of excessive moisture can have implications on painted areas and associated building elements if left unattended. While only seemingly minor at this stage, the cause of the damage is assumed to be from continual weather exposure.

It is advised that the affected paint work be rectified by a qualified painter.

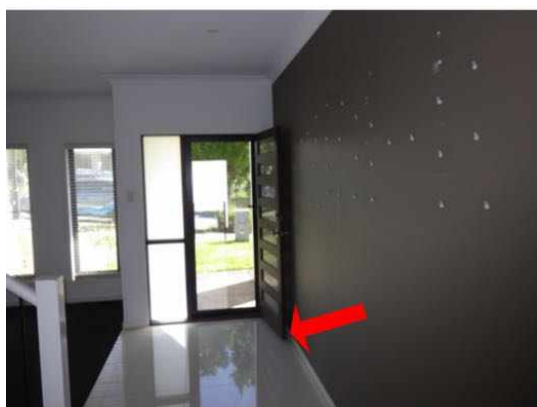
### Finding 3.06

Building:	Main Building
Location:	Entry > Front Left
Finding:	Door stop - Missing
Information:	The entry door stop is missing or is inadequate to stop the door handle from damaging the wall.

Re-installation or replacement of the door stop is advised to prevent any subsequent damage to the wall linings or associated structures.

A general handyman may be appointed to perform these works at client discretion.

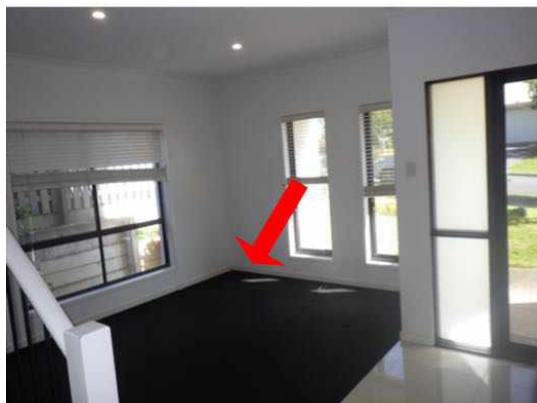
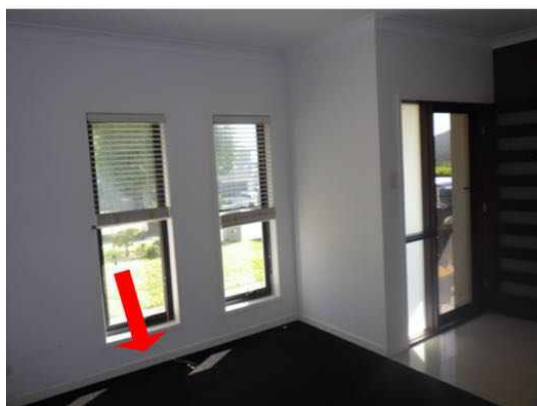
### Finding 3.07

Building:	Main Building
Location:	Lounge Room > Front, Centre
Finding:	Skirting Damaged
Information:	At the time of inspection the MDF timber skirting in the lounge room showed signs of damage or deterioration. The deterioration appears consistent with moisture exposure.

A qualified carpenter or general handyman could be engaged to replace the skirtings as required.

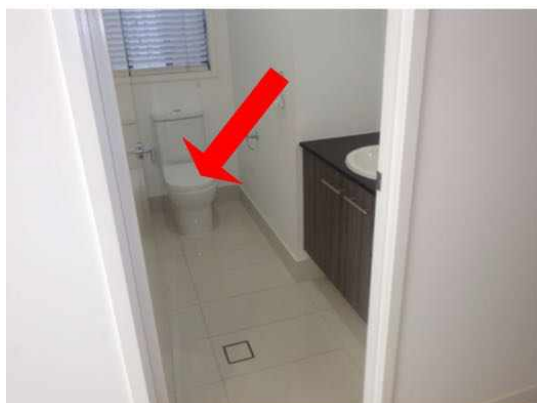
### Finding 3.08

Building:	Main Building
Location:	Powder Room > Centre
Finding:	Toilet seat - Loose
Information:	The toilet seat in the powder room was found to be loose at the time of inspection. It is suspected that this defect has developed due to general wear and tear.

If left unmanaged, the toilet seat could deteriorate further, leading to destabilisation and the potential for water leaks to the toilet pan area.

It is recommended that the seat be repaired by a licensed plumbing or general handyman.

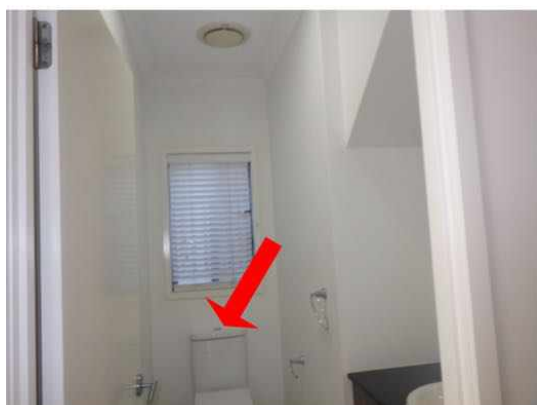
### Finding 3.09

Building: Main Building  
 Location: Powder Room > Centre,Rear  
 Finding: Cistern  
 Information: At the time of inspection the WC toilet cistern right side flush button did not activate water flow during standard operation.

A qualified plumber could be engaged to undertake repair work on the toilet cistern.

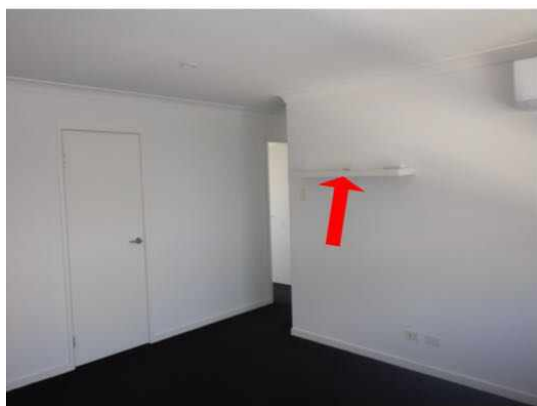
### Finding 3.10

Building: Main Building  
 Location: Rumpus Room > Front Left  
 Finding: Shelving  
 Information: At the time of inspection the wall hung shelf in the rumpus room showed signs of movement or separation.

The shelving may have been previously overloaded.

A qualified carpenter or general handyman could be appointed to undertake repairs at the clients discretion.

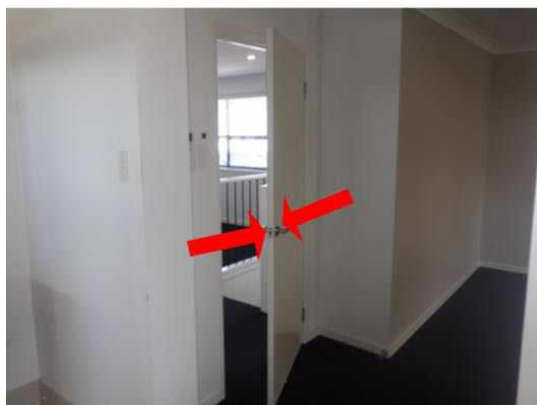
### Finding 3.11

Building: Main Building  
 Location: Bedroom - Master > Front  
 Finding: Door Handle  
 Information: At the time of inspection it was noted that the door handle latch set, to the main bedroom door has been installed the opposite way to which it would normally operate. The latch set mechanism should be removed, rotated 180 degrees and re-installed. Additionally it appears the door handle has been replaced at some time, with the new door handle passage set back plate being too small for the door handle cut out.

The client could engage a general handyman to reverse the latch set and/or replace the door handle.

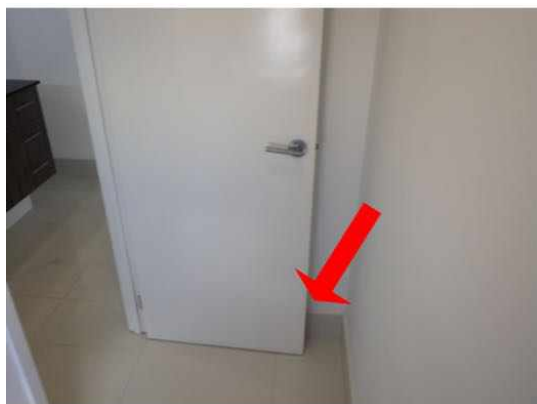
### Finding 3.12

Building: Main Building  
 Location: Ensuite - WC > Front Left  
 Finding: Door stop - Missing  
 Information: The ensuite WC area door stop is missing or is inadequate to stop the door handle from damaging the wall.

Re-installation or replacement of the door stop is advised to prevent any subsequent damage to the wall linings or associated structures.

A general handyman may be appointed to perform these works at client discretion.

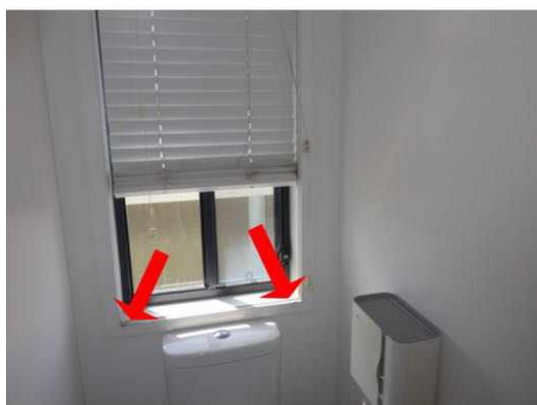
### Finding 3.13

Building: Main Building  
 Location: Ensuite - WC > Rear  
 Finding: Architraves Damaged  
 Information: At the time of inspection the ensuite WC area window MDF timber architraves showed signs of minor damage or deterioration. The deterioration appears consistent with moisture exposure.

A qualified carpenter or general handyman could be engaged to repair or replace the timber architraves as required.

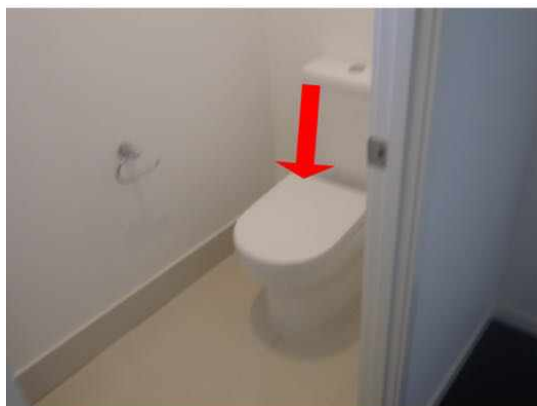
### Finding 3.14

Building: Main Building  
 Location: Toilet (WC) > Centre  
 Finding: Toilet seat - Loose  
 Information: The WC area toilet seat was found to be loose at the time of inspection. It is

suspected that this defect has developed due to general wear and tear.

If left unmanaged, the toilet seat could deteriorate further, leading to destabilisation and the potential for water leaks to the toilet pan area.

It is recommended that the seat be repaired by a licensed plumbing or general handyman.

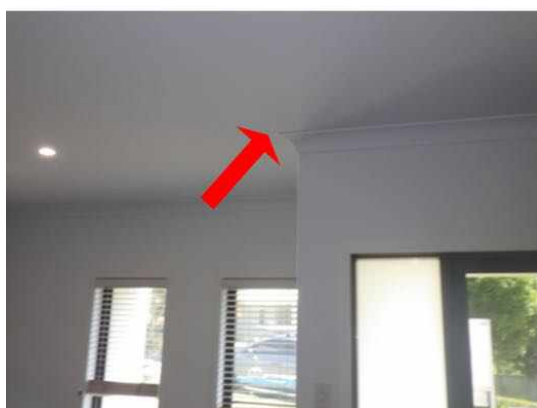
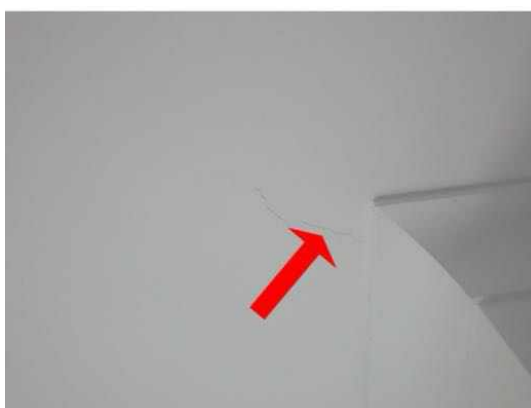
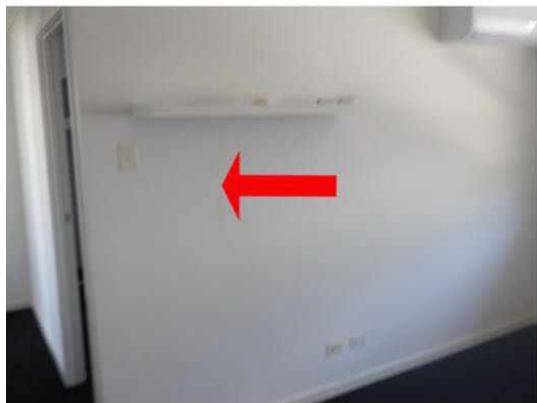
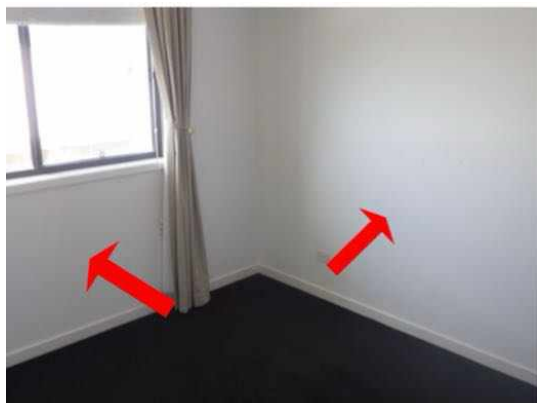
### Finding 3.15

Building:	Main Building
Location:	Internal Areas > Existing
Finding:	Wear and Tear
Information:	At the time of inspection the building interior showed signs of minor cracking and/or scuffing to walls, ceilings, cornices and timber trims (as per example photos).

The level of damage appears consistent with the removal of previous fixtures or fittings, general deterioration and/or wear and tear.

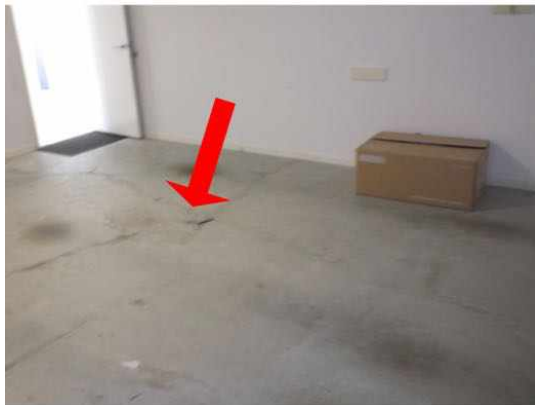
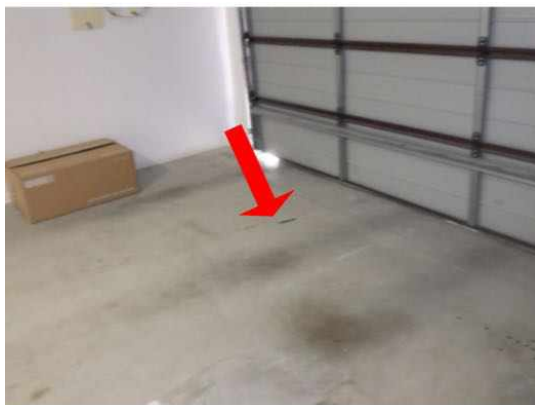
### Finding 3.16

Building:	Main Building
Location:	Garage > Centre
Finding:	Cracking in concrete slab - Category 1
Information:	Cracking coded as Category 1 was identified in the garage floor concrete slab (as per example photos). A Category 1 crack is described as a fine but noticeable crack, with the slab at an otherwise reasonable level.

To be considered Category 1, the approximate width of the crack is less than 1.0mm, or a less than 10mm change in offset when a 3m straight edge is placed over the defect.

Category 1 cracks should be monitored for a period of 12 months. At the end of the monitoring period, identified cracks that are rated greater than Category 2 are considered defects, and require rectification.

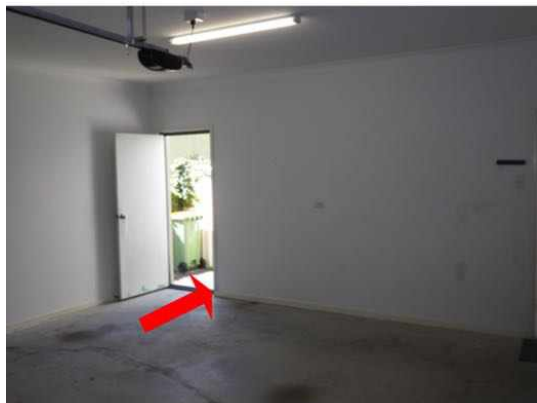
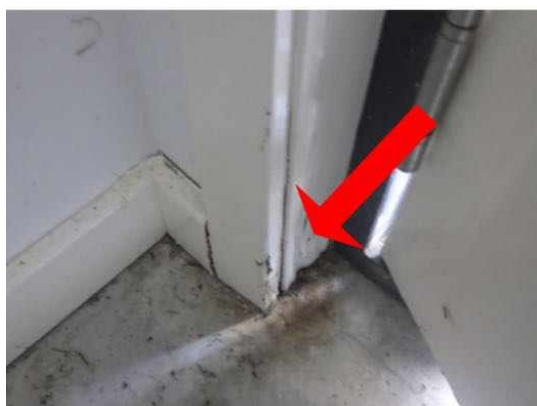
### Finding 3.17

Building:	Main Building
Location:	Garage > Rear Left
Finding:	Wood Rot
Information:	At the time of inspection an area of the timber architraves and skirting board to the garage area external door frame showed signs of wood rot. The wood rot damage appears to be caused from moisture exposure.

The client could engage a qualified carpenter or general handyman to undertake repair work.

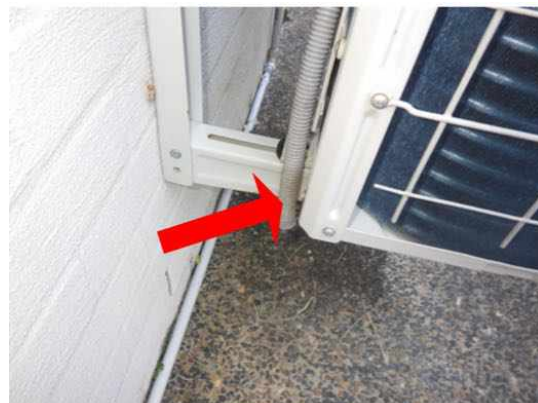
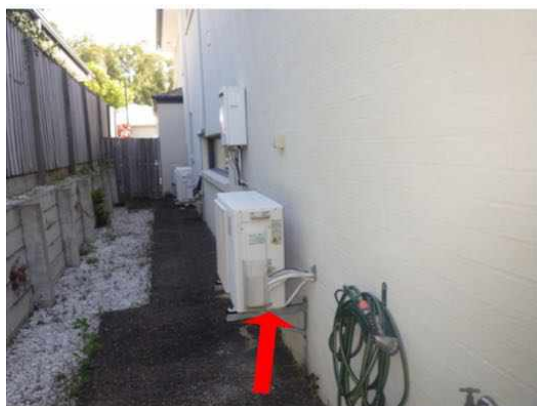
### Finding 6.02

Building:	Main Building
Location:	Exterior walls > Centre Right
Finding:	Overflows - Not plumbed for drainage
Information:	The air conditioning unit overflows are not plumbed or connected to suitable drainage, which can result in the surrounding areas becoming excessively damp. These damp conditions can lead to secondary defects such as rot, rust or corrosion of associated building elements, the formation of fungal decay, or even the creation of potential slip hazards. When coupled with poor site drainage, pooling of water may also attract termite activity to this area. It is highly recommended that a qualified plumber be appointed to install adequate drainage to the overflows. These works will ensure that the areas remain dry and free of any secondary defects.

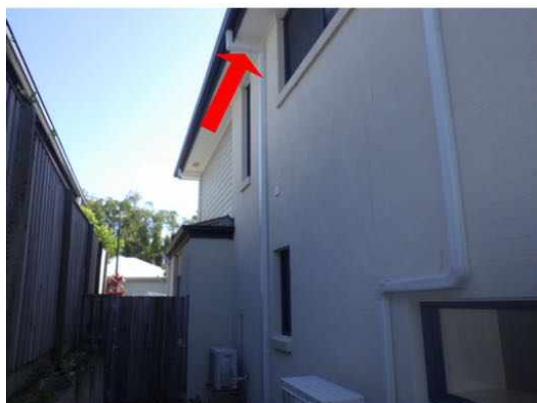
**Finding 6.03**

Building: Main Building  
 Location: Exterior walls > Centre Right  
 Finding: Stormwater pipe - Leaking  
 Information: The down pipe to the right side exterior wall of the building is dripping water from the top section join or S bend at the time of inspection.

Where roof plumbing doesn't drain adequately, the area at the base perimeter can become excessively damp, potentially creating an environment that is susceptible to rust and corrosion of surrounding building elements, as well as attracting termites and other pests.

It is recommended that a plumber or handyman be appointed to repair the down pipe as necessary.

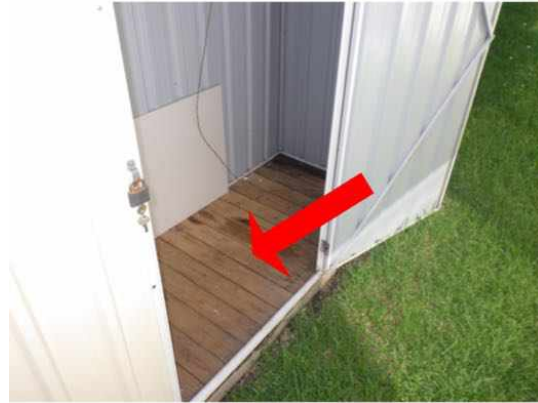
**Finding 6.04**

Building: Main Building  
 Location: Shed > Ground Level  
 Finding: Timber - In ground contact  
 Information: At the time of inspection it was noted the timber floor to the garden shed on the left side of the property is in direct contact with the finished ground level.

Any timbers in direct ground contact provide opportunity for concealed termite entry and are likely to be subject to premature rot and decay as the soil retains moisture or damp conditions against the timbers.

Frequent pest inspections are highly advised to readily identify any termite activity in these areas.

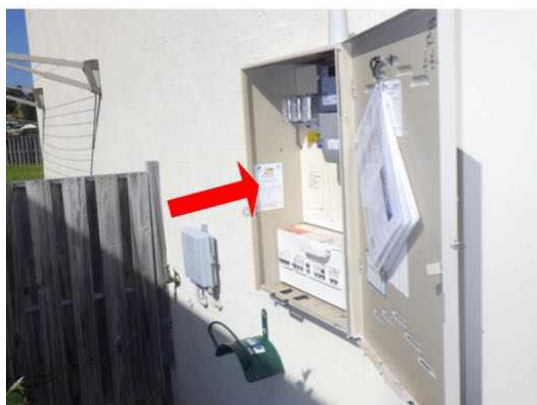
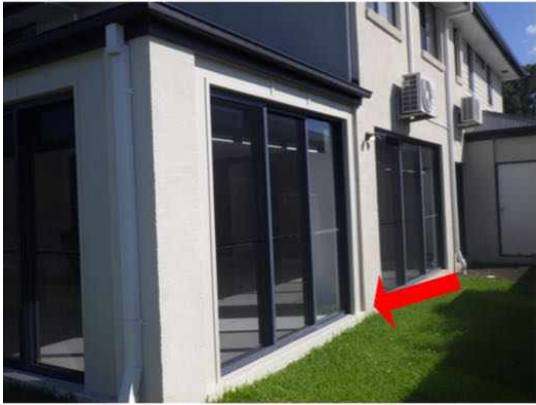
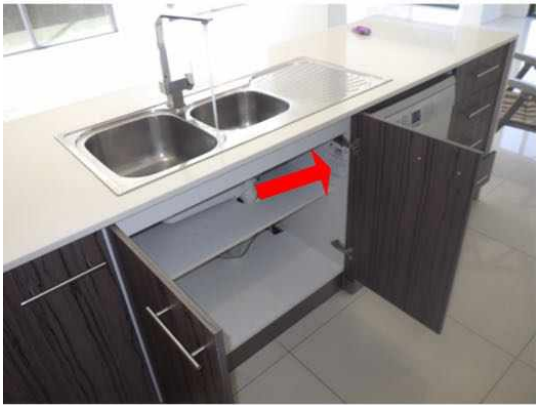
In this instance evidence of a previously installed physical barrier was observed, along with a durable notice inside the electrical meter box and the kitchen area under sink cabinetry (dated 30/01/2015). This system requires regular annual inspections.

No evidence of regular or annual inspections was found.
