Building Inspection Report

Inspection Date: Mon, 12 Jan 2026

Property Address: 10 Feathertop Wy, Nar Nar Goon North VIC
3812, Australia

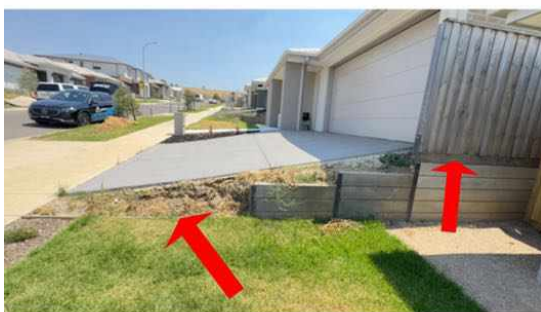
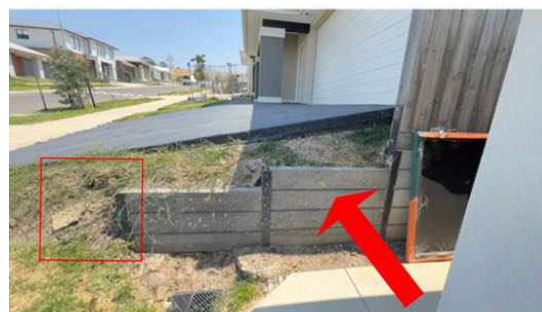
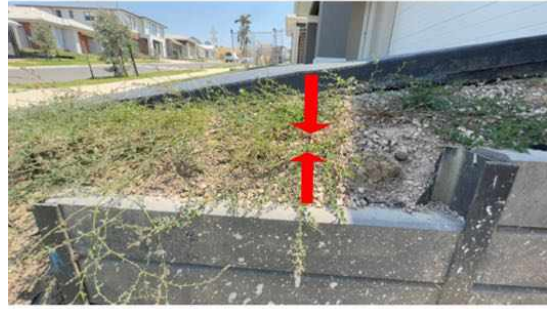
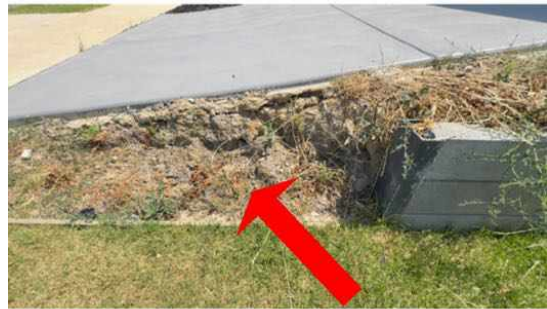
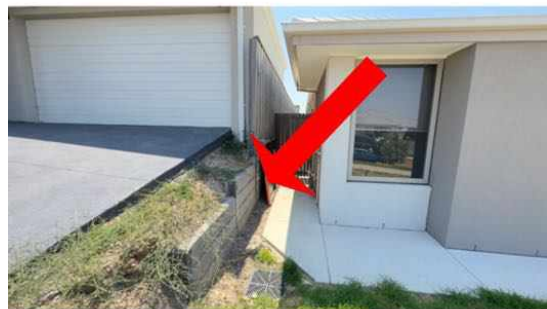
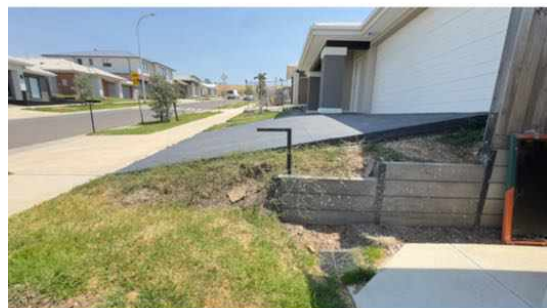
Defects 2.01

Building: Main Building
 Location: Yard - Front > All Areas
 Finding: Retaining Wall Masonry - Missing & Inadequate Height - Retaining Walls
 Information: Sections of the retaining wall were observed to be missing and / or at an inadequate height in these areas. This can compromise the structural function of the retaining walls, reducing its ability to restrain soil and manage ground loads. This condition may lead to soil movement, erosion, drainage issues, and potential instability of adjoining ground or structures.

The defect is likely attributable to substandard construction.

A suitably qualified licensed builder or structural engineer should be engaged immediately to assess the retaining walls along all boundaries of the property and specify what appropriate remedial works are required. Repairs or reconstruction should be carried out as soon as practicable to reinstate structural performance, manage soil retention, and reduce the risk of further ground movement or damage to nearby structures.

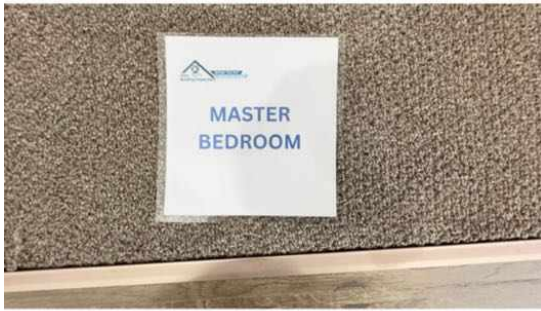
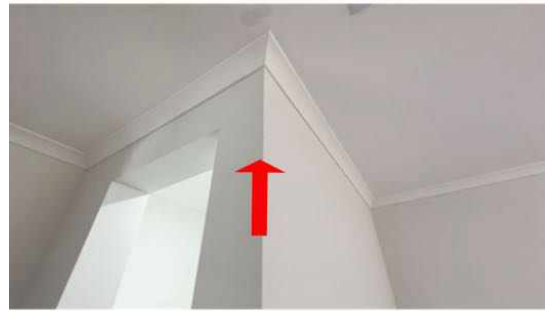
Defects 3.05

Building:	Main Building
Location:	Bedroom - Master >
Finding:	Walls - Plaster Walls Damaged
Information:	Minor damage to plaster wall surfaces was observed in this area, including small dents, chips, and surface imperfections. This type of damage is commonly associated with general wear and tear, minor impact, or movement over time.

While the damage is not considered structural in nature, it detracts from the overall presentation and finish of the property. Ongoing deterioration may occur if left unattended.

A suitably qualified plasterer or competent handyman should be engaged, at the client's discretion, to carry out minor patching, sanding, and repainting as required to

restore the affected areas to an acceptable standard.

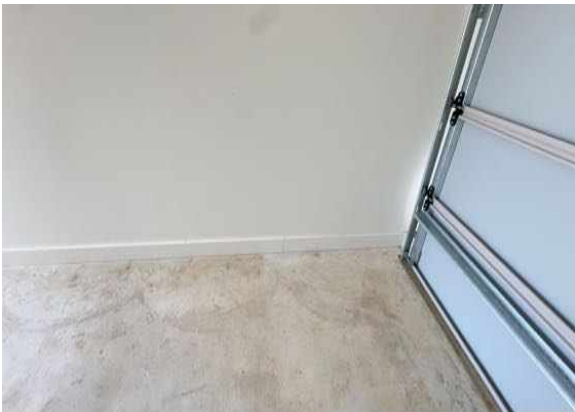
Defects 3.06

Building:	Main Building
Location:	Garage
Finding:	Concrete - Discolouration
Information:	Concrete surfaces were visually inspected and discolouration was observed in this area. Discolouration may affect the aesthetic appearance of the surface and could indicate exposure to environmental factors, staining, and wear.

Possible causes include weathering, sun exposure, water staining, or contact with chemicals or organic matter.

A qualified cleaning specialist should be engaged when practical to clean or treat the affected areas. Prompt attention will improve appearance and maintain the surface condition.

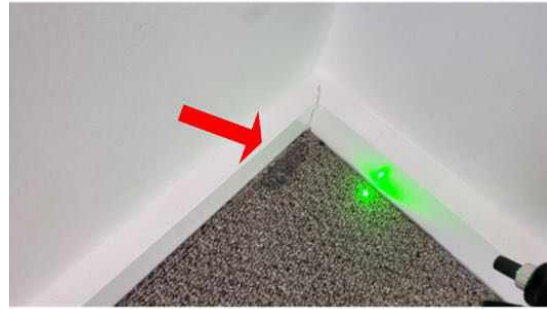
Defects 3.09

Building:	Main Building
Location:	Bedroom - Master
Finding:	Floors - Carpet Damaged
Information:	The carpet was inspected and found to be damaged in this area, with signs of burning. Damaged carpet can reduce comfort, detract from the appearance of the space, and, over time, expose the subfloor to additional wear or moisture.

This condition may result from everyday use or accidental impact.

A qualified flooring installer should be engaged when practical to clean, repair and or replace the affected carpet. Timely attention will restore visual appeal, comfort, and the longevity of the flooring.

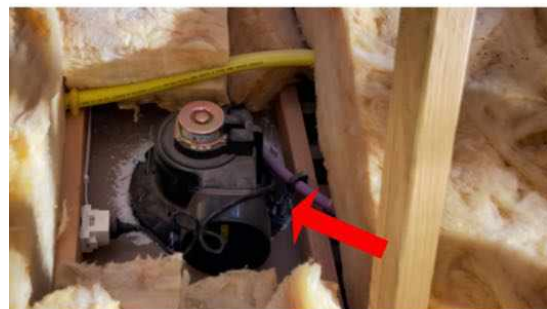
Defects 3.10

Information: The exhaust fans in the roof void are not ducted to the atmosphere. The issue is observed where fan outlets discharge directly into the roof space instead of venting outside.

This has likely occurred due to incomplete installation or missing ducting. Unducted fans may cause moisture buildup, condensation, and potential damage to insulation, ceiling linings, or timber, increasing the risk of mould growth and structural deterioration.

A licensed HVAC technician or licensed roof plumber is required to install proper ducting to vent the exhaust fans to the atmosphere. This should be rectified immediately to prevent moisture-related damage and maintain the performance of the ventilation system.

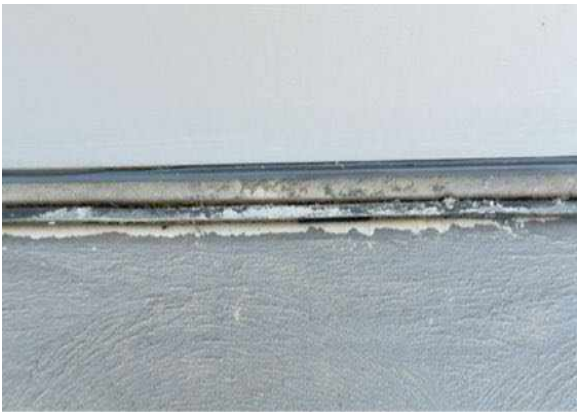
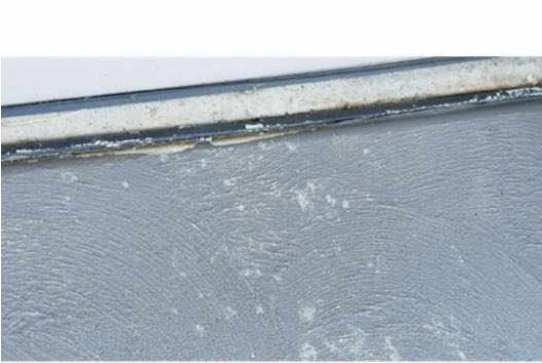
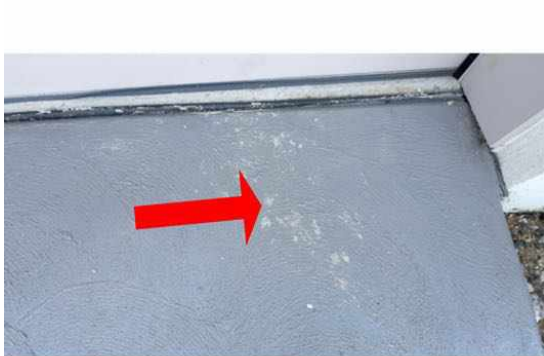
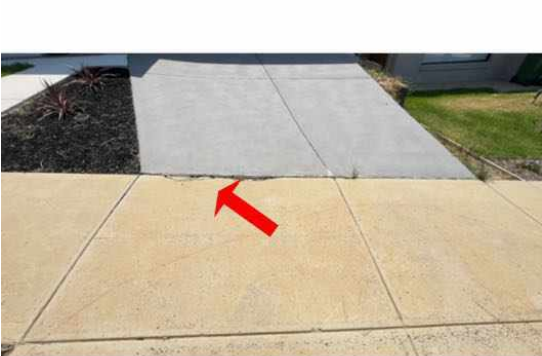
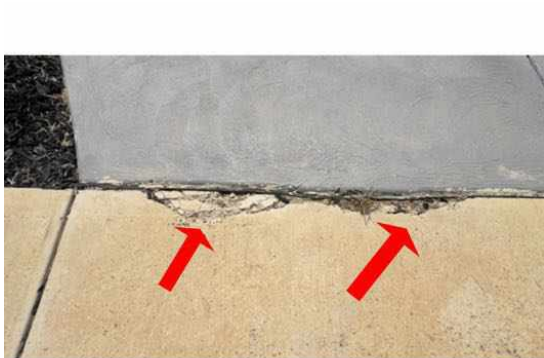
Defects 3.13

Building: Main Building
Location: Driveway
Finding: Concrete - Poor Surface Finish
Information: Concrete surfaces were visually inspected and poor surface finishing was observed in this area, including rough textures, uneven troweling and inconsistent concrete painted surface profiles.

While primarily cosmetic, these defects reduce aesthetic appeal, and increase susceptibility to surface wear or deterioration over time. This condition may be caused by rushed or substandard finishing during construction, inadequate curing, or poor quality concrete mix.

A qualified concreter should be engaged when practical to treat affected areas. Prompt attention will improve appearance, durability, and long-term performance of the driveway.

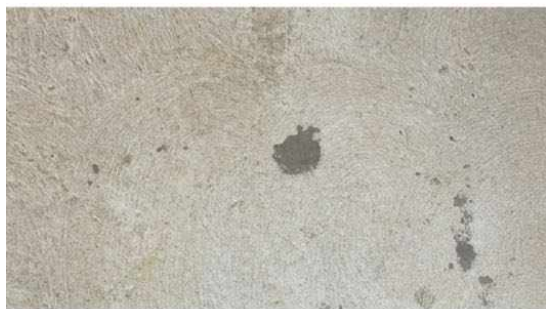
Defects 3.14

Building: Main Building
Location: Yard - Back
Finding: Concrete - Poor Surface Finish
Information: Concrete surfaces were visually inspected and poor surface finishing was observed in this area, including rough textures, uneven troweling and inconsistent concrete surface profiles.

While primarily cosmetic, these defects may allow water pooling, reduce aesthetic appeal, and increase susceptibility to surface wear or deterioration over time. This condition may be caused by rushed or substandard finishing during construction, inadequate curing, or poor quality concrete mix.

A qualified concreter should be engaged when practical to grind, resurface, or treat affected areas. Prompt attention will improve appearance, durability, and long-term performance of the driveway.

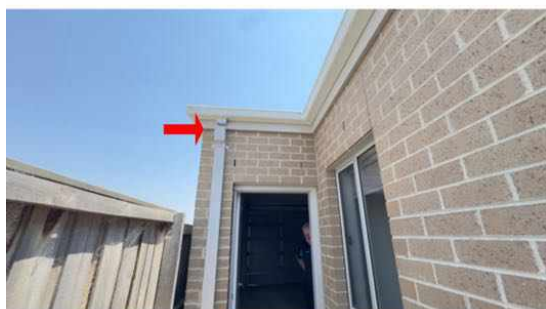
Defects 3.16

This has likely occurred due to missing connections, poor installation, or design oversight. Uncontrolled water discharge may cause erosion, pooling, water ingress

near the building, and potential damage to landscaping, paving, or foundations.

A licensed roof plumber is required to inspect and connect the downpipes to the stormwater system in this area. This should be rectified immediately to ensure proper drainage and prevent potential water damage.

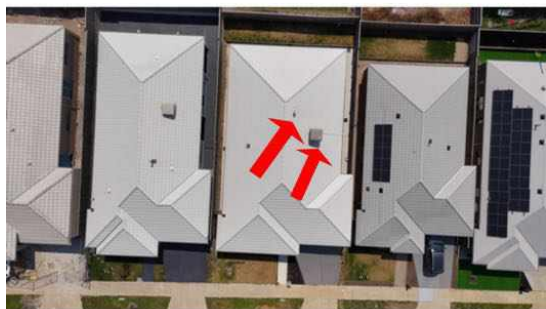
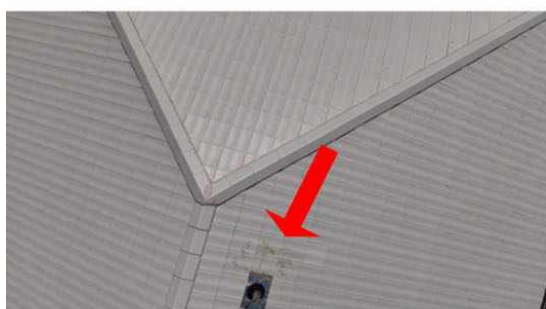
Defects 3.17

Building:	Main Building
Location:	Roof Exterior
Finding:	Roof Plumbing - Roof Tiles Discolouration
Information:	Roof tiles in this area were observed to exhibit surface discolouration at the time of inspection. The discolouration appears to be cosmetic in nature and is likely the result of residue or staining left behind from previous trade works that were not adequately cleaned upon completion.

While this condition does not appear to affect the immediate performance of the roof covering, it detracts from the overall presentation and, if left untreated, may contribute to long-term staining or accelerated surface deterioration.

A suitably qualified roof maintenance contractor or cleaning specialist should be engaged immediately to clean the affected tiles using appropriate methods. This will improve the appearance of the roof and assist in maintaining the longevity of the roofing materials.

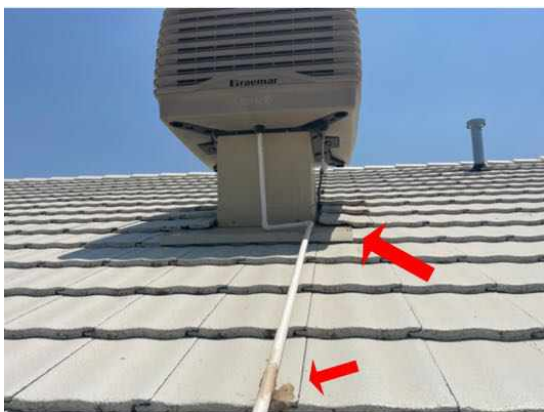
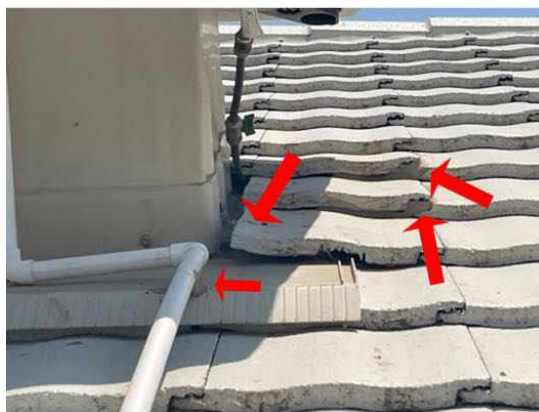
Defects 3.18

Building:	Main Building
Location:	Roof Exterior
Finding:	Roof Plumbing - Substandard Workmanship (HVAC)
Information:	Roof plumbing works associated with the HVAC installation were observed to be of a substandard quality at the time of inspection. Deficiencies in workmanship may compromise the effective management of rainwater and increase the risk of water ingress, moisture damage, and premature deterioration of surrounding roofing materials.

This condition appears to be the result of poor installation practices and/or inadequate detailing of roof penetrations associated with the HVAC system.

A licensed roof plumber, in conjunction with a suitably qualified HVAC contractor if required, should be engaged immediately to assess the installation and carry out rectification works to ensure all roof plumbing and penetrations are compliant, weatherproof, and installed in accordance with relevant Australian Standards and manufacturer requirements. Prompt rectification is advised to reduce the risk of future water ingress and associated damage.

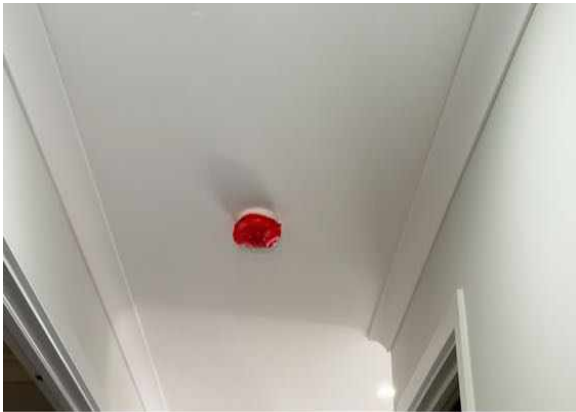
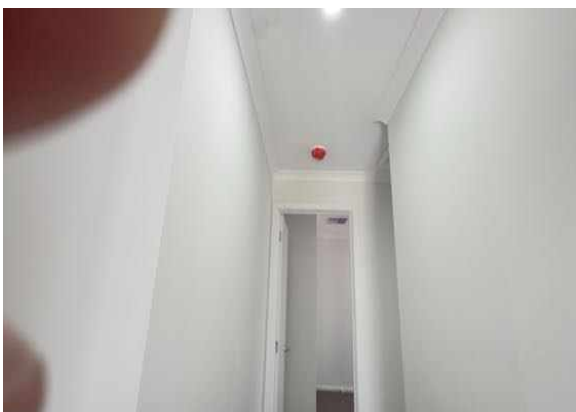
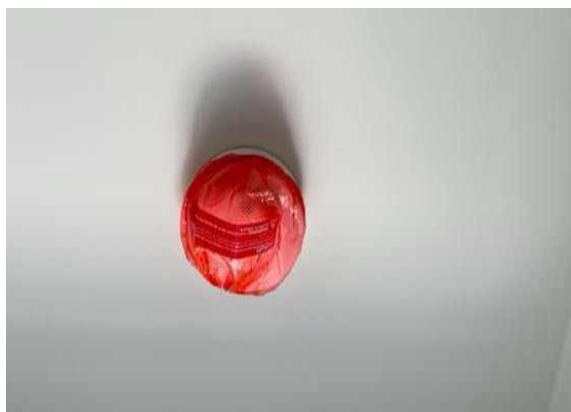
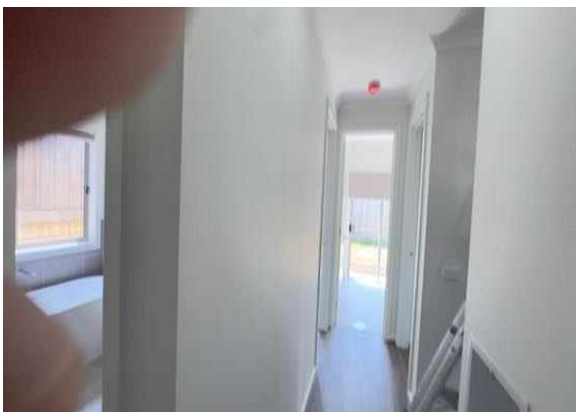
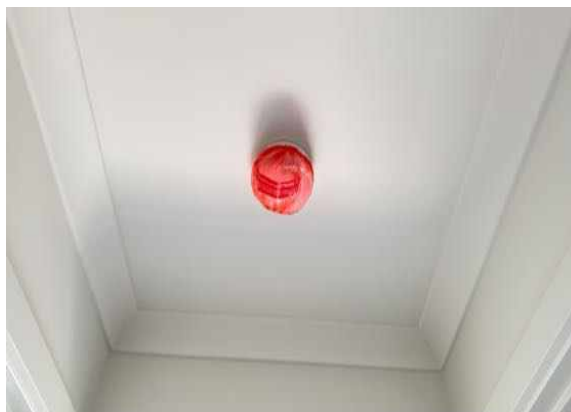
Noted Item

Smoke detectors are critical life-safety devices, and non-compliant, outdated, or non-operational units may not provide adequate warning in the event of a fire.

It is recommended that a licensed electrician be engaged immediately to test, service, and upgrade smoke detectors as required to ensure correct operation and compliance with current safety requirements.
