Building and Timber Pest Inspection Report

Inspection Date: Thu, 9 Apr 2026

Property Address: 2/110 Ford St, Ivanhoe VIC 3079, Australia

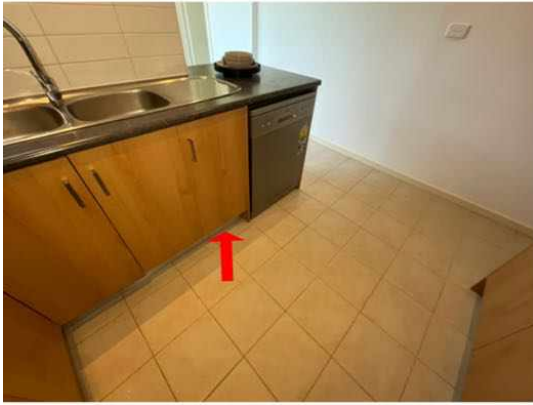
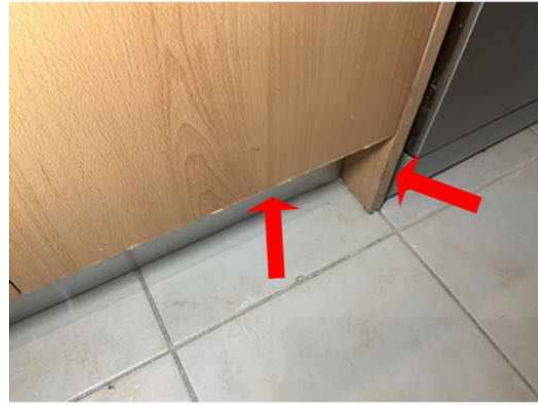
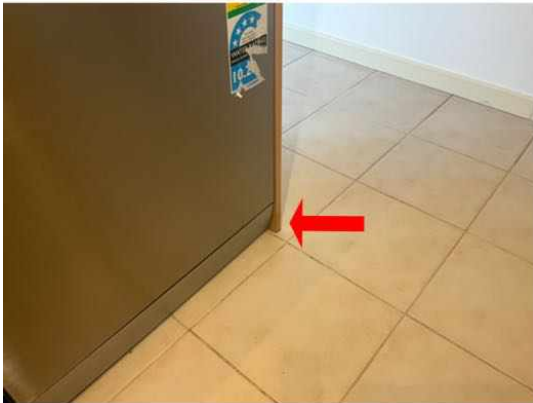
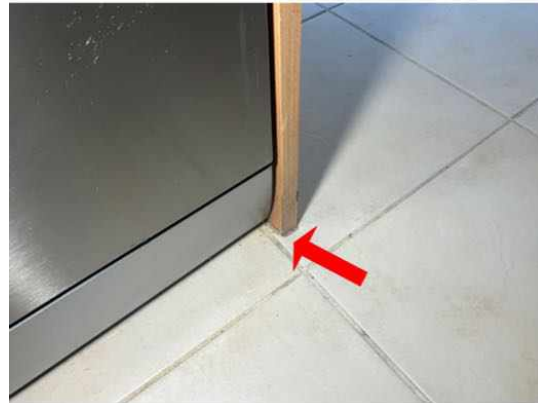
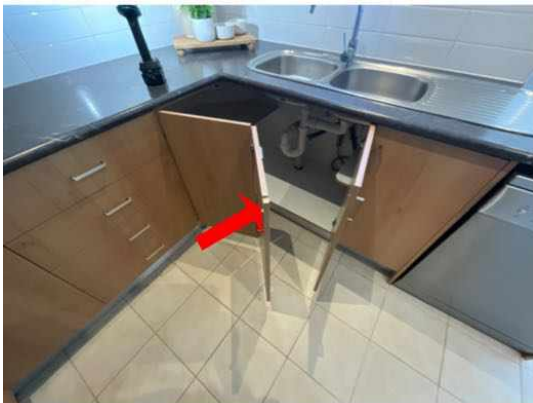
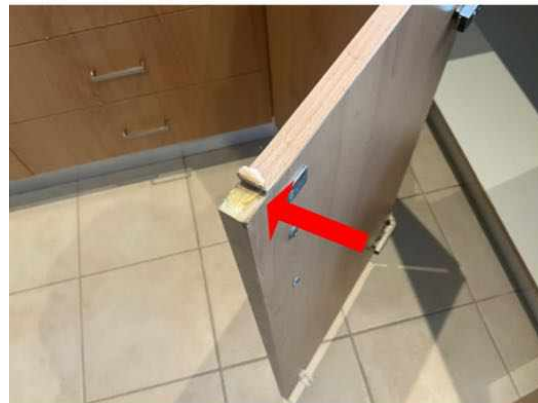
Finding: Damage to the kitchen cupboards - edging peeling off

Information: Evidence of damage was identified to the kitchen cupboards at the time of inspection. It appears that the edging on the cupboards were peeling off.

The cupboard doors may be re edged. Failing that , replacement of the cupboard doors may need to be undertaken.

A kitchen specialist or competent handyman may be engaged to inspect the damaged areas and repair or replace any items where necessary.

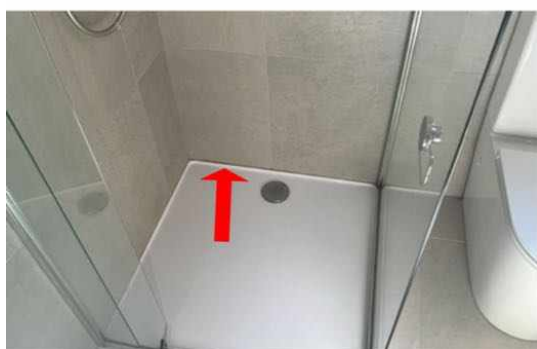
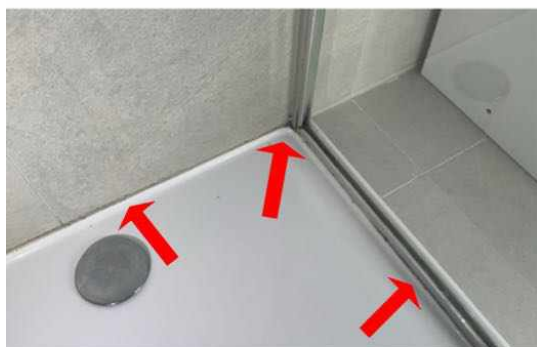
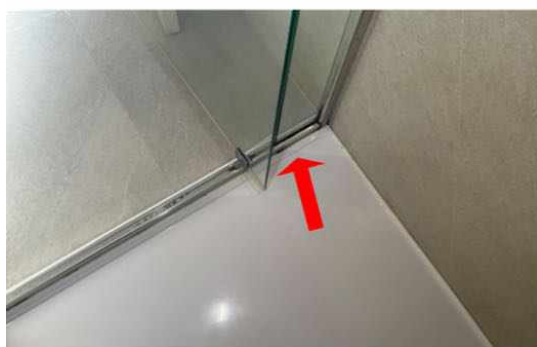
Finding 3.03

Finding: Sealant - Degraded and mouldy within shower area

Information: Sealant is degraded / mouldy in the shower area. Sealant is used to protect gaps and crevices in building materials to ensure that they are water-tight and prevent water penetration to the associated structures.

Failure to do so may lead to further deterioration of the sealant which in turn may lead to water damage to the surrounding area.

Where sealant is damaged or mouldy, the area should be cleaned of mould. Should this not be effective and the sealant be damaged, a tiling contractor should be appointed to scrape out and re-apply any silicone where necessary.

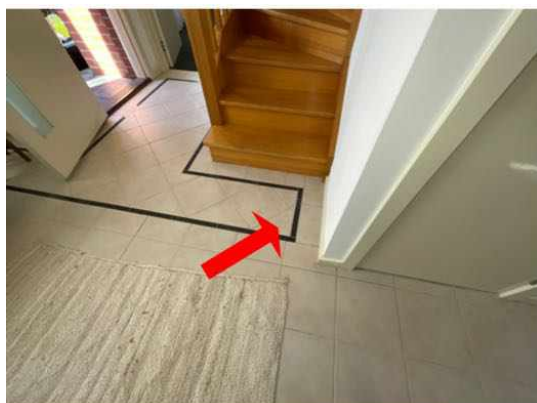
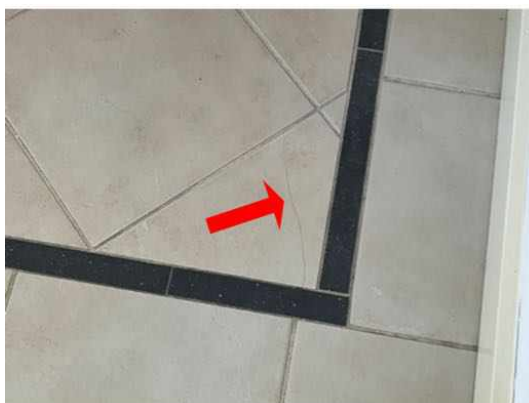
Finding 3.04

Finding: Floor tiles - Cracked

Information: Cracking in the floor tiles was evident in this area at the time of inspection. It is suspected that this cracking has occurred either as a result of the floor being uneven and lacking a solid or suitable foundation for the tiles to be laid on, settlement in the floor foundations or impact damage to the area.

Cracked tiles throughout the household detract from the overall appearance of the affected areas, as well as creating potential for water penetration to adjoining building elements. If left unmanaged, water damage may occur as a result of constant water penetration over a prolonged period of time.

While not considered a matter of urgency, replacement of cracked floor tiles is advised as a solution. A tiling contractor or general handyperson may be appointed to perform these works at client discretion.

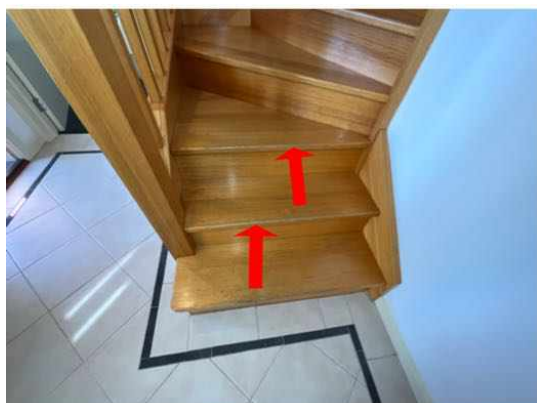
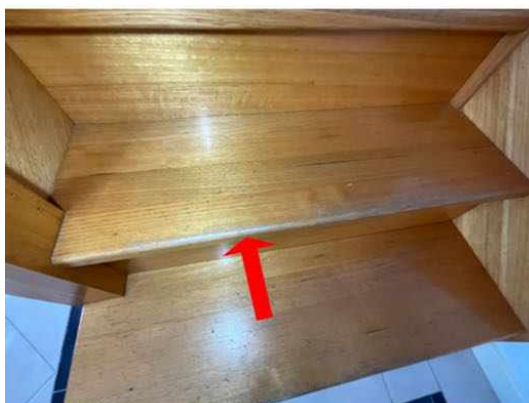
Finding 3.05

Finding: Stairs worn on the front edge

Information: Upon inspection, whilst the stairs appeared in a generally good condition, some worn / rubbed patches were noted around the front edge of the individual stairs.

It is suspected this has occurred due to constant use and a lack of maintenance.

The stairs should be monitored for any further deterioration and should that occur, remedial works may be carried out.

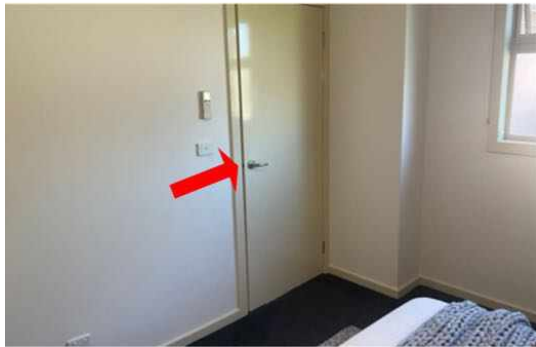
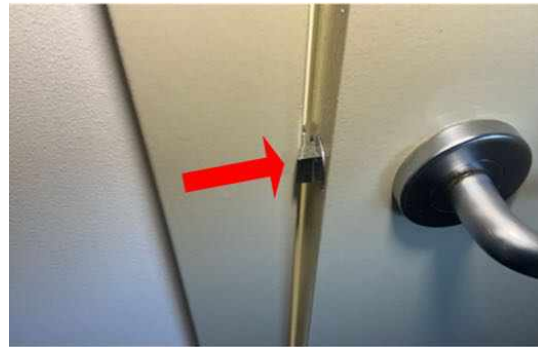
Finding 3.06

This is a common defect and is expected in a property of this age, whether being due to substandard installation or general deterioration of the door hardware.

Readjustment of the striker plate is recommended at client discretion. Works such as these can be completed by a general handyman or qualified carpenter.

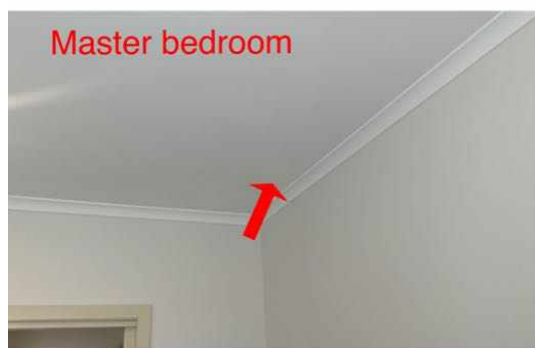
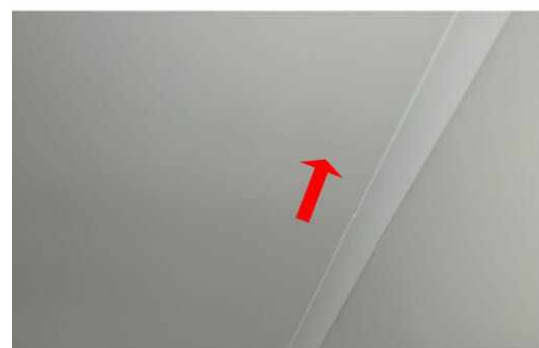
Building:	
Location:	All Areas
Finding:	Cracking - fine
Information:	Some fine cracking was noted throughout the property.

Although fine cracks are quite noticeable, they are often only considered to be an appearance defect, and usually do not indicate any structural damage. Generally, the cause of a fine crack is indicative of a separation between building materials and finishes (e.g. paint, plaster, etc.) along joins.

Note: photos included are indicative of fine cracking noted at the the time of inspection. Other fine cracks may be present but not recorded here.

Cracking of this nature can generally be repaired with minor sanding, filling and/or repainting. Such works should be performed by a qualified painter or a general handyman.

Monitoring of all cracking should be conducted frequently. Always contact a building inspector should cracks widen, lengthen, or become more numerous.

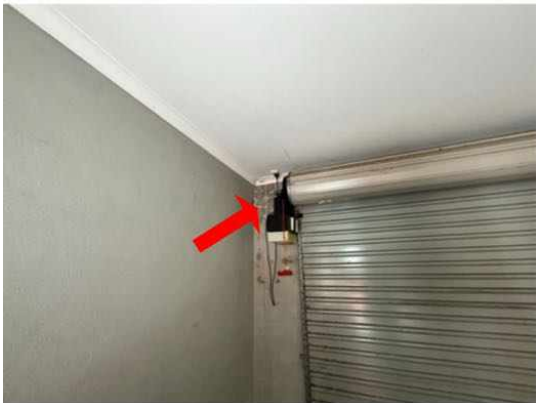
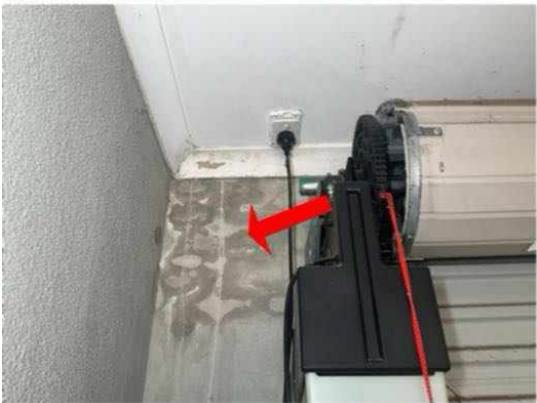
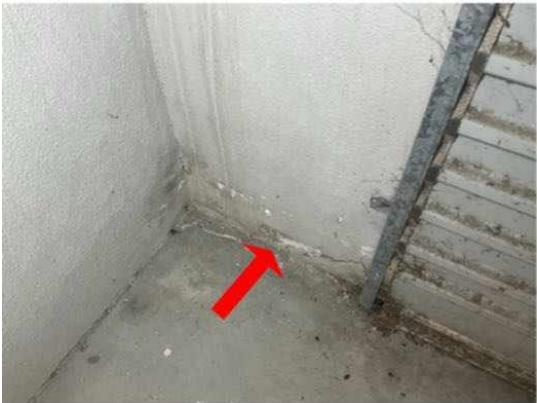
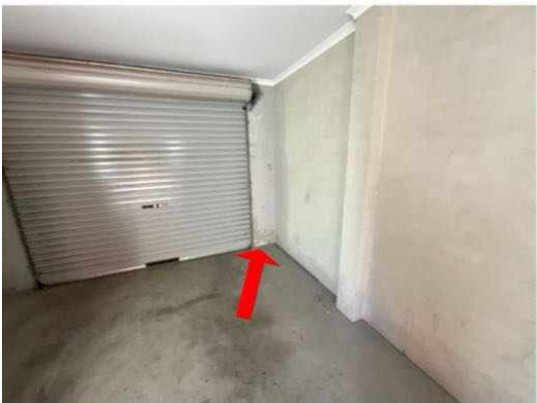
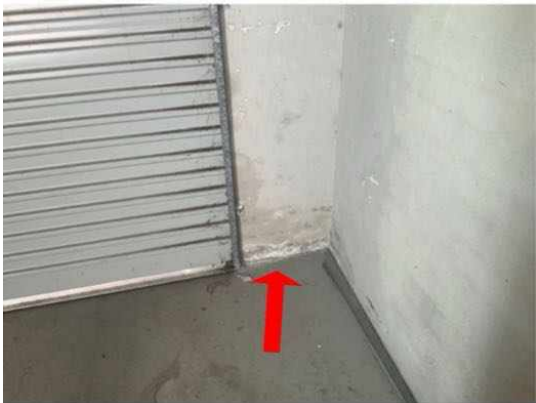
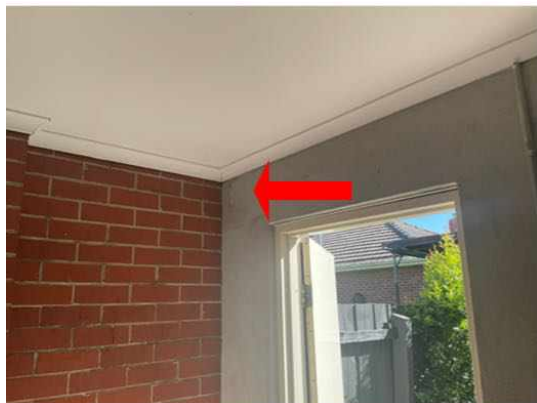
Finding 3.10

Information: Dampness to sections of the garage wall was identified at the time of inspection . It is suspected that this dampness may have occurred due to moisture either from moisture rising from the ground below or from leaking of the guttering above. Garage walls did not have to have any damp proof course to prevent moisture rising up the wall , and this defect is quite common. It was noted that some sections of the rendered walls were “Drummy” which can be caused by moisture underneath the render causing it to release from the solid wall. Peeling/ bubbling painted surfaces is also an indicator of moisture within the brick surface.

Dampness and excessive moisture can also create an environment which is conducive to termite and pest infestation, along with the formation of mould.

It is recommended where possible that measures be put in place to lessen the amount of moisture within the garage. This can include moving any garden beds away from the edge of the garage where relevant and ensuring all gutters and roof plumbing is working effectively.

A plumber may be engaged to inspect the area and make the necessary changes. A renderer may be engaged to remove damaged render and re-render where necessary.

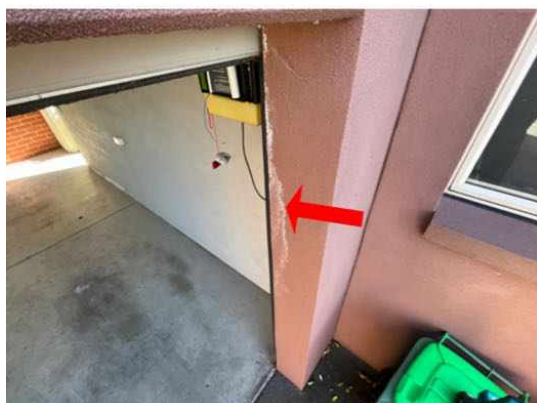
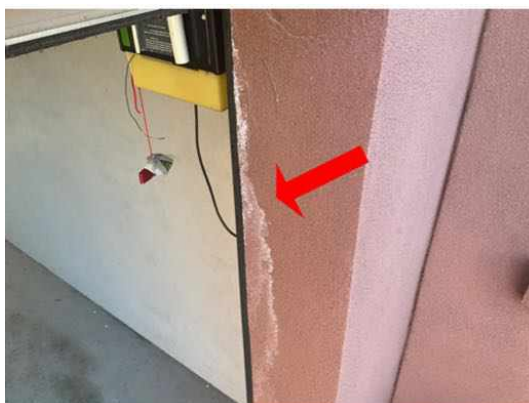
Finding 3.11

It is typically seen as white salt deposits on the surface. While detracting from the overall appearance of the affected area, efflorescence is not likely to develop into secondary damage if left unmanaged.

Generally, soluble salt deposits can be removed by dry brushing with a stiff-bristled brush. Repeated dry brushing is an ideal treatment for eliminating this forming of efflorescence. A cleaning contractor or general handyperson may be appointed to perform these works at the discretion of the client.

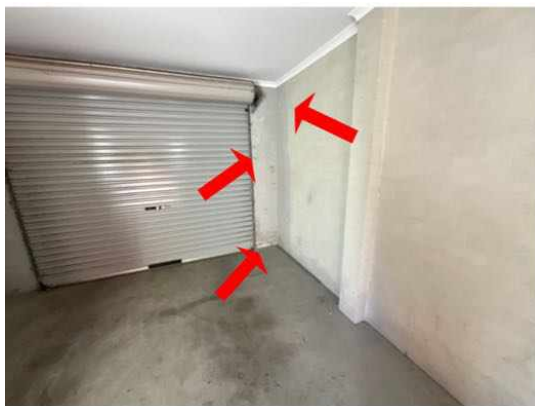
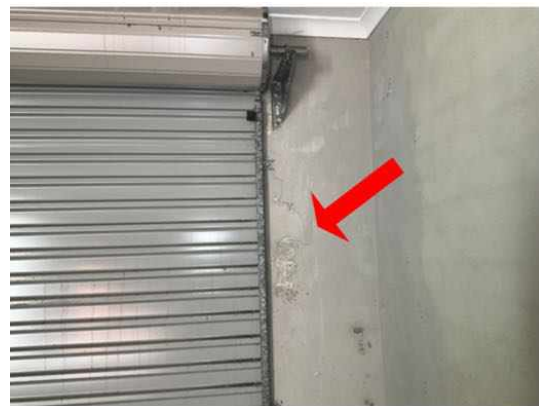
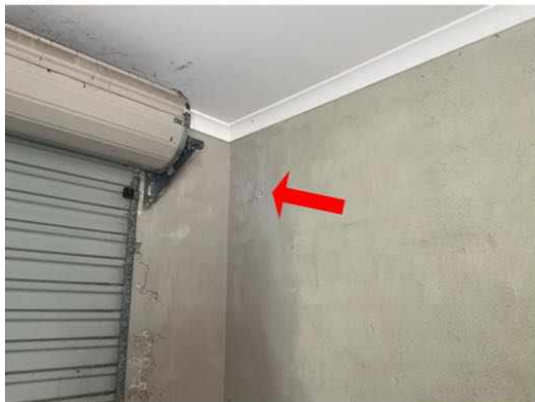
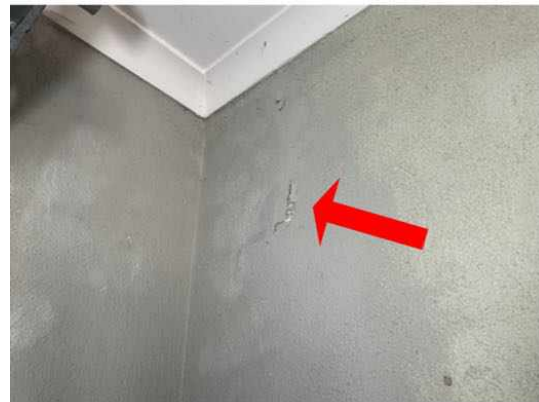
Finding 3.12

Information: Drummy wall areas were identified at the time of inspection. The term 'drummy' refers to render/ plaster that may have become detached from the wall. Such defects are generally caused by physical or moisture damage to the area. Drummy wall area may also be a direct result of poor workmanship during the construction process.

Wall areas may swell and shrink with changes in air humidity or if the area has sustained moisture damage. Any exposure to moisture is capable of causing the rendered areas to become drummy and/or cracked over a prolonged period of time. Where cracking occurs, Drummy rendered areas may require removal and replacement.

Specialist trades are available for these types of services. It is advised that a renderer be appointed to perform works as necessary.

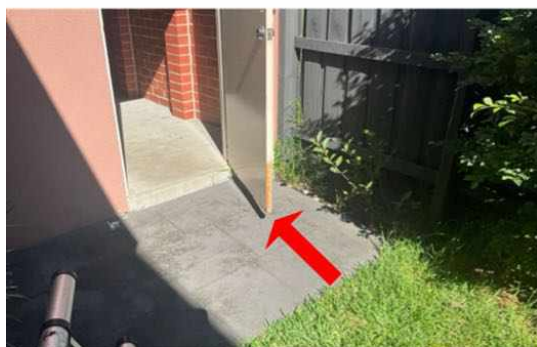
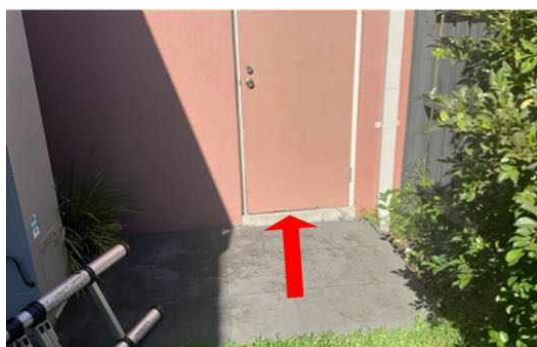
Finding 3.13

Finding: Door showing signs of damage to the base

Information: At the time of inspection there appeared to be some slight moisture damage at the base of the door in this area.

Doors should be sealed on all faces including top and bottom to prevent moisture seeping into the door structure and potentially causing secondary damage.

A suitably qualified handyman or painter should be engaged to remove doors, repair any damage, paint the door including top and bottom and rehang them.

If the door cannot be repaired, a new door may be required.

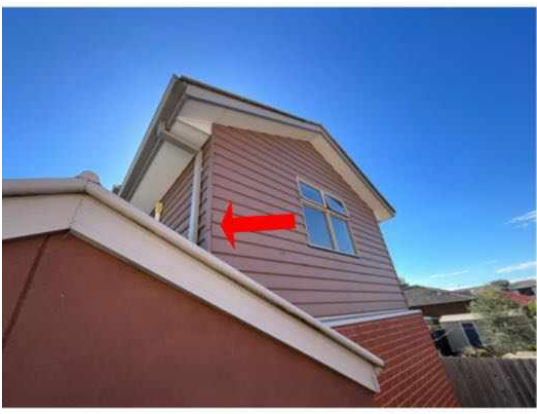
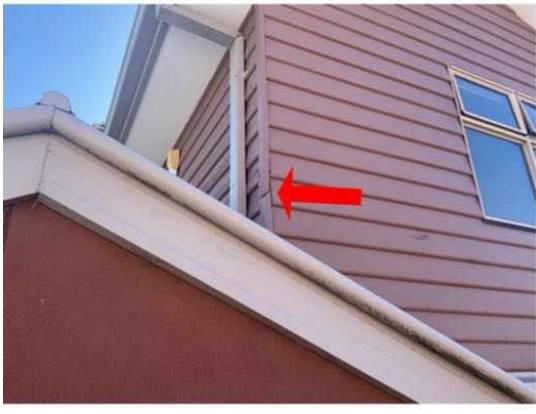
Finding 3.14

Finding: Weatherboards - weathered with moisture damage and some slight wood rot noted

Information: Some of the external weatherboards show signs of weathering and moisture damage with some minor wood rot noted in several sections. This is suspected to have developed over a prolonged period of time due to frequent weather exposure, which is expected in a property of this age and condition.

Weatherboards are sealed and protected by paint and other sealants. When these sealants deteriorate over time, they allow water penetration to the weatherboards, causing moisture damage and possible wood rot. If left unmanaged, the wood rot is likely to develop further, possibly necessitating major repair or replacement works in the long-term future.

To maintain the condition of the external wall cladding, any severely affected weatherboards should be repaired as a priority. Where weatherboards have rotted due to excessive moisture other than rain penetration, the cause of the moisture should be identified immediately by a licensed plumber. A qualified carpenter should be appointed to repair and replace rotting weatherboards.

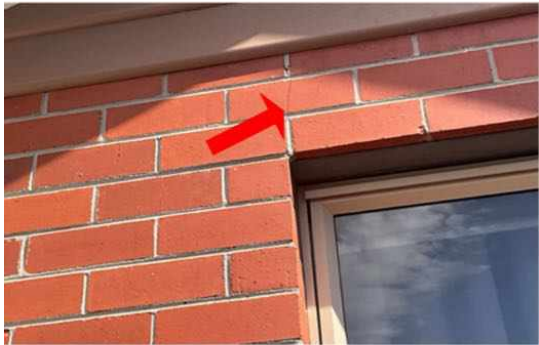
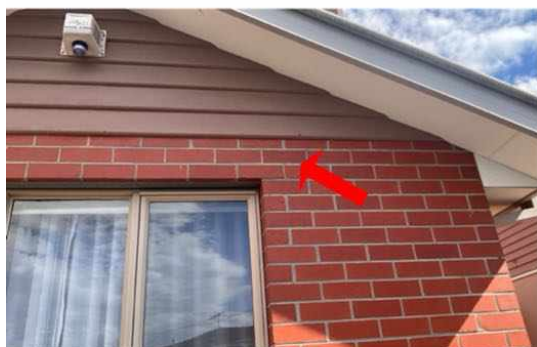
Finding 3.15

Finding: Brickwork - Cracking [Fine]

Information: Although fine cracks are quite noticeable, they are often only considered to be an appearance defect and usually do not indicate any major structural damage. Generally, the cause of a fine crack is indicative of a separation between brickwork and mortar throughout the structure, but single bricks may also show cracks of this nature.

It is highly recommended that the cracking been monitored for a period of time to determine any further movements. Should no further movement occur, cracking of this nature can be repaired with minor filling and should be conducted via qualified bricklayer

Always contact a building inspector should cracks widen lengthen or become more numerous.

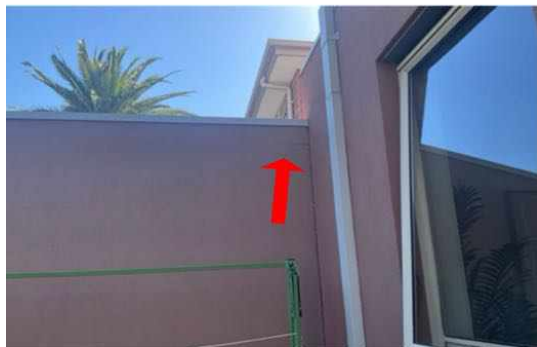
Finding 3.16

Finding: Rendered wall - noticeable cracking

Information: Noticeable cracking to the rendered wall was identified at the time of inspection.

This type of cracking is often consistent with general movement of the foundations of the property and is not considered a major structural defect.

Whilst it is more of an appearance issue, repairs may be required as failure to act may allow moisture to enter the crack and cause secondary damage to other building elements.

Please note: no comment can be made on the condition of the solid wall underneath the render which would only be noticeable from an invasive inspection.

Consultation with a suitably qualified renderer should be sought to determine costs involved with any repairs necessary.

Should cracks increase in size or number, speak with your building inspector for further advice.

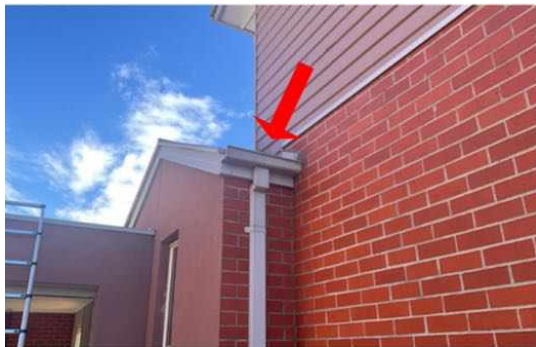
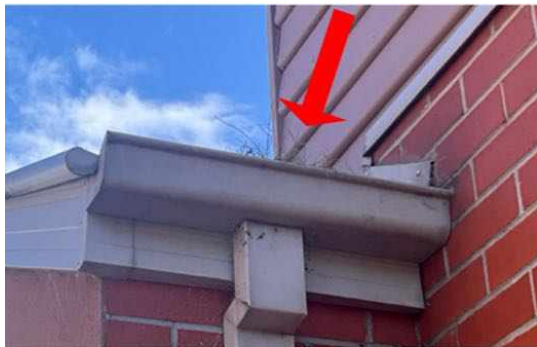
Blocked gutters are likely to lead to high levels of moisture in the affected areas. Such moisture will not only cause rust and decay of the associated building materials, but can also provide conditions that are conducive to termite and timber pest activity.

Blockages in gutters should therefore be removed immediately to ensure dry conditions are maintained.

It is highly advised that blocked gutters be cleared by the homeowner or a general handyperson as a matter of urgency. Failure to do so may result in moisture entering the property causing more significant damage.

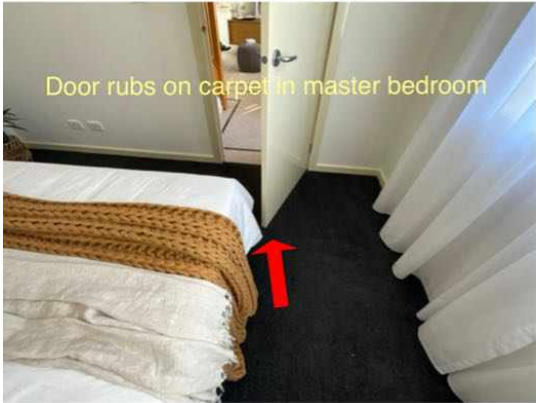
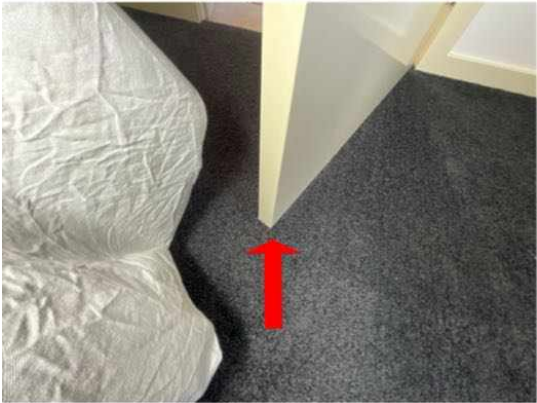
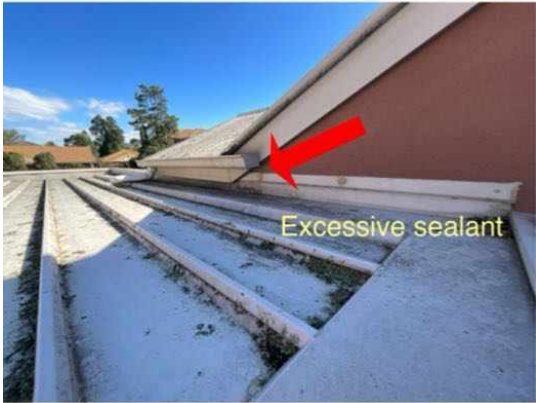
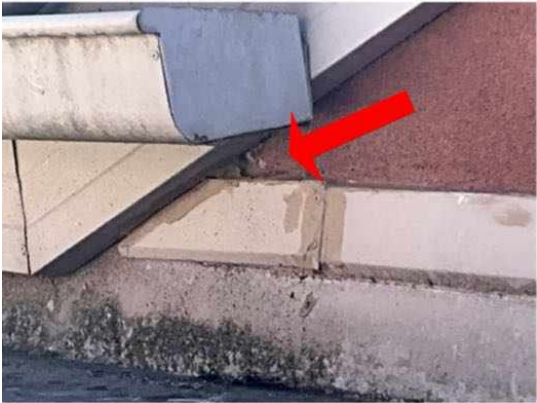
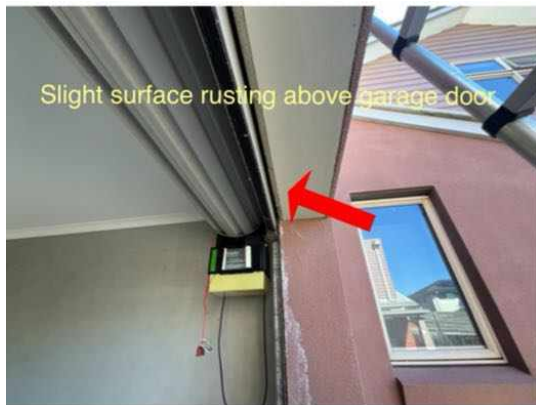
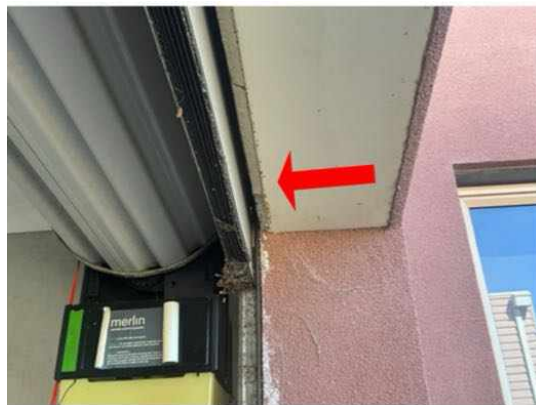
Finding 3.24

Building:
Location: All Areas
Finding: Additional Photos - minor defects

Information: Additional photos are provided for your general reference. Arrows have been included where necessary to highlight areas of importance.

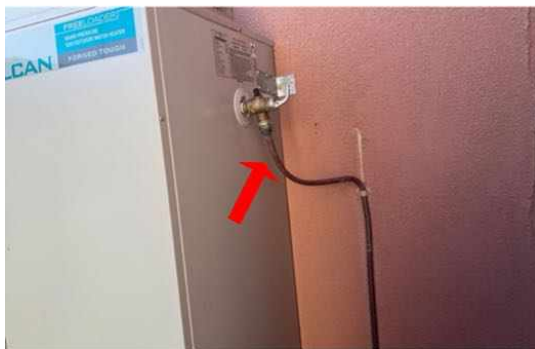
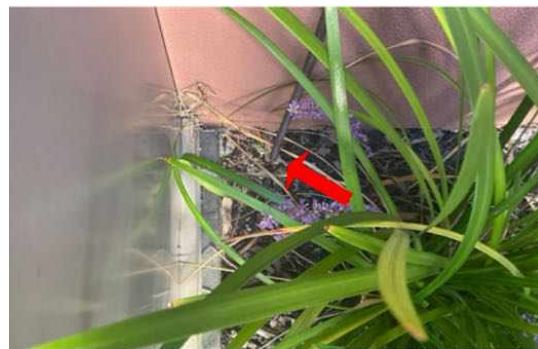
These damp conditions can lead to secondary defects such as rot, rust or corrosion of associated building elements or the formation of fungal decay. When coupled with poor site drainage, pooling of water may also attract termite activity to this area.

It is recommended that a qualified plumber be appointed to install adequate drainage to the overflow or that it be diverted away from the edge of the building. These works will ensure that the area remains dry and free of any secondary defects.

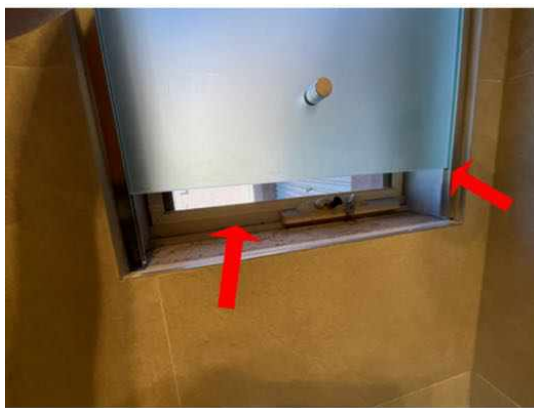
Building:
 Location: Ensuite
 Finding: Additional Photos for your information - sliding glass window
 Information: It was noted at the time of inspection that the ensuite shower had a glass sliding window in front of the wind out window. This sliding window was stiff and difficult to open. It also did not stay open on the way up - it was reliant on the window sitting on a lip within the frame.

As it did not stay up by itself, it may fall down and smash which would pose a safety hazard.

Caution should be taken in the area.
