Building Inspection Report

Inspection Date: Mon, 2 Mar 2026

Property Address: 6 Chagall Parade, Clyde North VIC 3978,
Australia

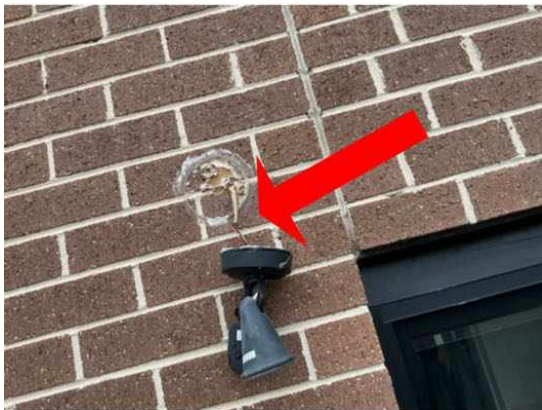
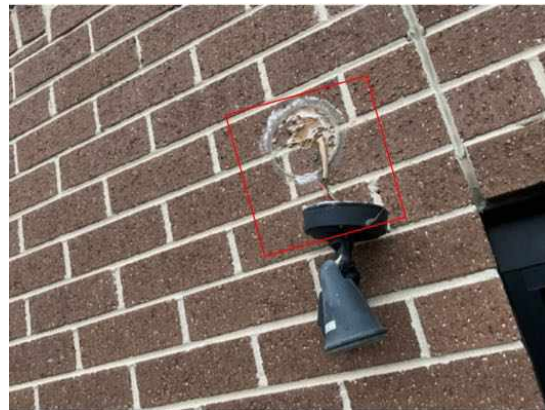
Defects 1.01

At the time of inspection, the external light fitting located in the side yard behind the garage was observed to be improperly secured, with the base plate detached from the brick wall. Electrical wiring was visibly exposed at the mounting point, and the wall penetration around the fitting appeared unfinished and inadequately sealed.

Exposed electrical wiring and loosely mounted fittings present a potential electrical safety risk and may allow moisture ingress into the wall cavity. Inadequate sealing around penetrations through the external brickwork can also contribute to long-term moisture-related deterioration of internal building elements.

A licensed electrician should be engaged without delay to properly secure the light fitting, ensure all wiring connections are safely enclosed within an approved junction or mounting box, and adequately seal the wall penetration to prevent moisture ingress.

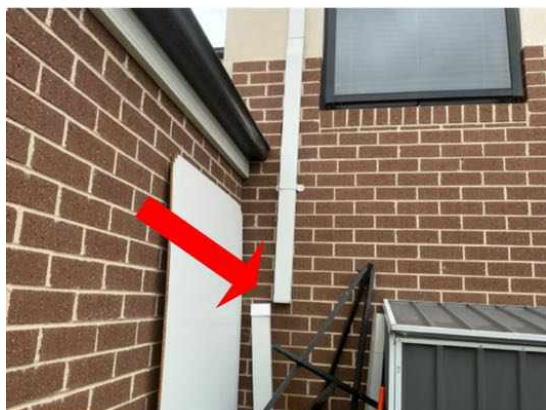
Defects 3.01

At the time of inspection, the downpipe located in the side yard directly behind the garage was found to be completely disconnected. The pipe has separated from its connection point, resulting in rainwater from the associated gutter discharging directly adjacent to the external wall and surrounding ground surface.

Uncontrolled discharge of roof water in this manner may lead to saturation of the footing area, increased risk of moisture ingress to the building envelope, potential foundation movement, and conditions conducive to timber pest activity. Ongoing water concentration at the base of the wall can also contribute to premature deterioration of external finishes and structural elements.

This defect requires immediate attention. A qualified plumber should be engaged without delay to reconnect and properly secure the downpipe and ensure it is effectively connected to an appropriate stormwater drainage system.

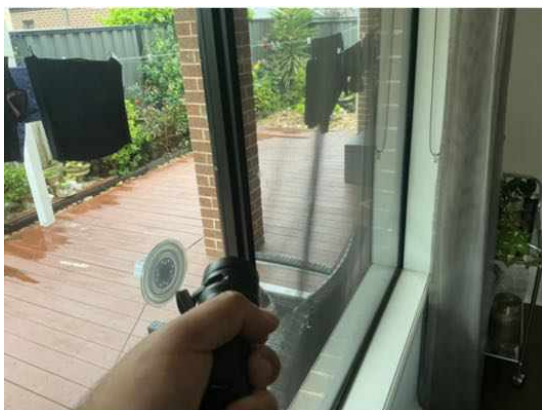
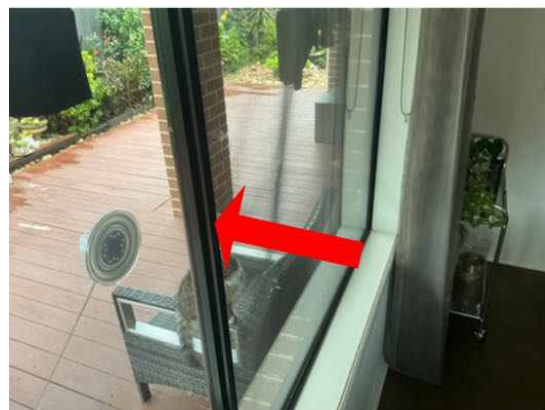
Defects 3.03

Information: Several windows throughout the property were jammed and difficult to operate at the time of the inspection. Windows provide ventilation to the adjoining area and should be at a fully operational level to ensure user comfort. Restricted function of the window may also pose as a potential safety hazard if required for emergency egress from the building.

Generally, factors such as general age of the building element and a lack of maintenance are the usual causes for this type of defect.

Replacement of window hardware or frame may be required, as well as minor repairs and cleaning. A registered builder or general handy person will be required to repair the affected windows.

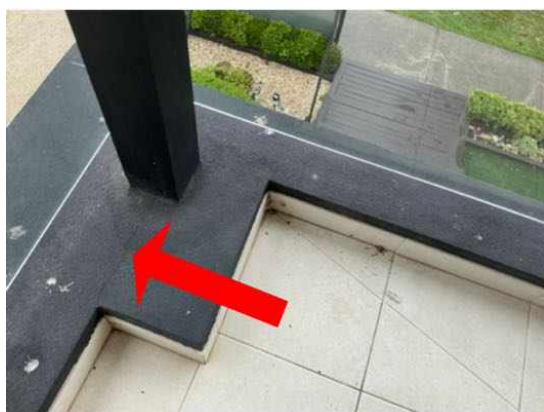
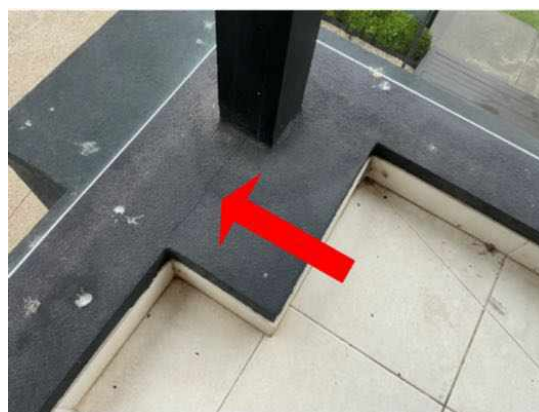
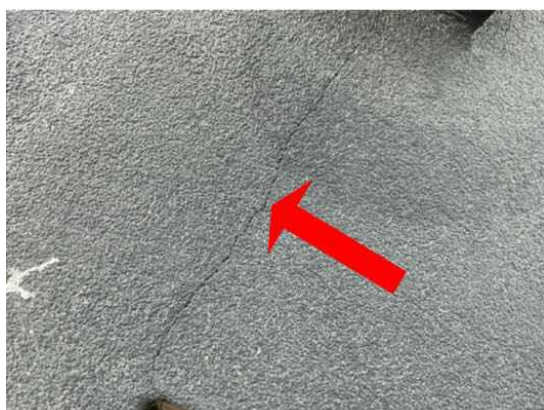
Defects 3.04

Building: Main Building
Location: Balcony
Finding: Minor Crack to Balcony Render
Information:

A minor crack was observed to the rendered surface within the balcony area at the time of inspection. The crack appears superficial and limited in extent, with no immediate evidence of significant structural movement associated with the affected section.

Such cracking is commonly associated with minor settlement, thermal movement, or normal material shrinkage over time. In its current condition, the defect appears to be primarily cosmetic in nature.

If rectification is desired for appearance purposes, a qualified renderer may be engaged to patch and refinish the affected area to match the surrounding surface.

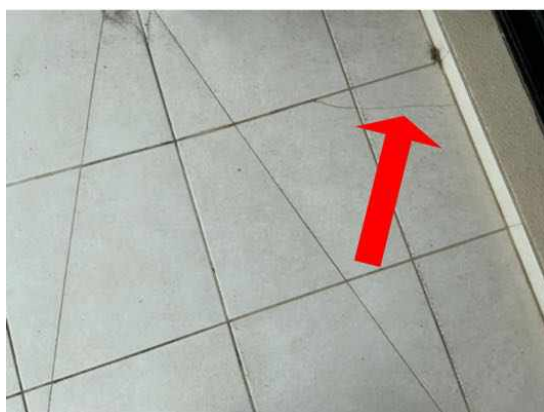
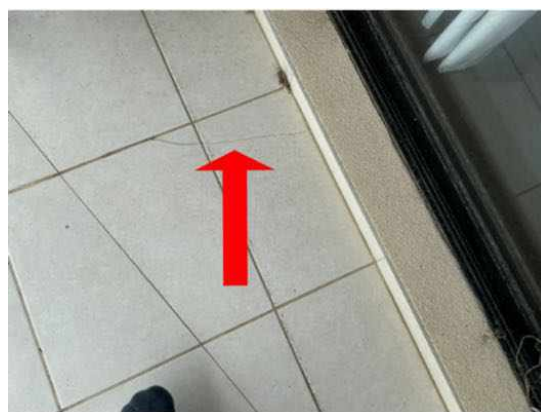
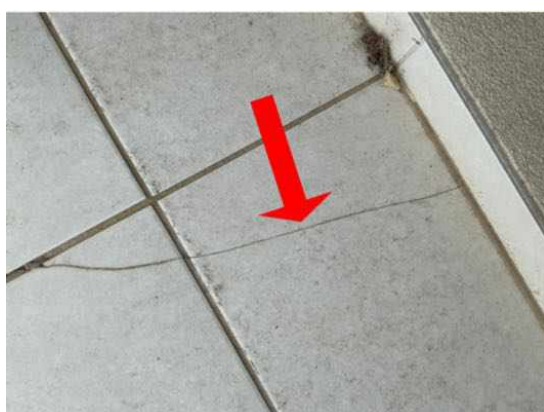
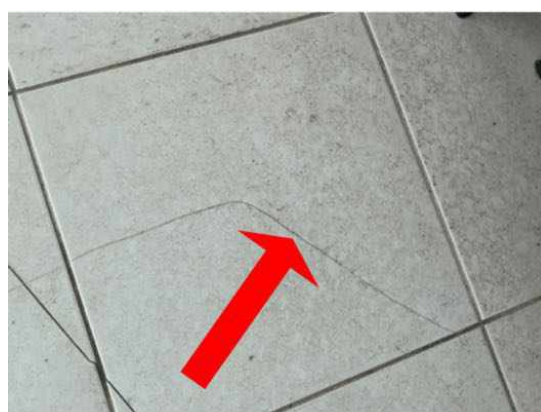
Defects 3.05

Building: Main Building
Location: Balcony
Finding: Cracked Balcony Floor Tiles
Information:

At the time of the final inspection, several floor tiles to the balcony area were observed

to be cracked. The cracking appears localised to individual tiles; however, the affected tiles were visibly damaged at the time of assessment.

Cracked tiles may allow moisture ingress beneath the tiled surface, potentially leading to deterioration of the tile bed, substrate, or associated waterproofing membrane over time. If left unrectified, this may result in further tile failure or water-related damage to underlying structural elements.

A qualified tiler should be consulted to carefully remove and replace the cracked tiles. During rectification, the underlying substrate and waterproofing should be checked to ensure they remain intact and serviceable.

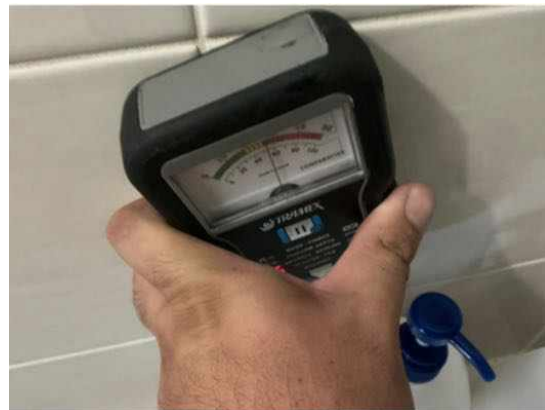
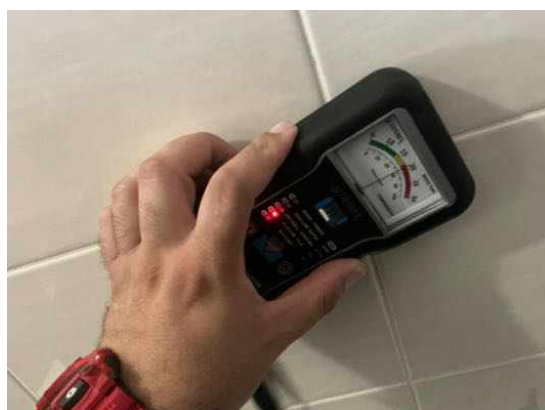
Defects 3.06

Building:	Main Building
Location:	Ensuite - Master
Finding:	Shower - Damp
Information:	Damp is evident to the lower 300mm of wall to the shower alcove. This defect is quite common, and is suspected to have been caused by moisture permeating through the grouting in this area, which shows evidence of deterioration. Leaking pipes within the adjoining wall is also a possible cause.

Damp (or structural damp) refers to the presence of unwanted moisture in the structure of a building, either as the result of intrusion from outside, or condensation

from within the structure. In the shower area, internal water leaks or other sources of excessive moisture are generally the cause of damp.

Unmanaged damp in the shower recess is likely to facilitate the formation and development of mould and fungi growth, decaying associated building materials and compromising their structural integrity. It is important to address damp conditions, as the World Health Organisation notes that excess moisture leads - on almost all indoor materials - to growth of microbes such as moulds, fungi and bacteria, which subsequently emit spores and other matter into the indoor air. Exposure to these contaminants is associated with a wide range of respiratory and other health-related problems.

Consultation with a qualified plumber or bathroom specialist is advised immediately to identify the cause of damp and to perform remedial works as required. Where excessive mould growth is present, further inspection by a specialist environmental health inspector should also be considered.

Always ensure that sealant and grout is in good condition to prevent any moisture issues occurring in the future.

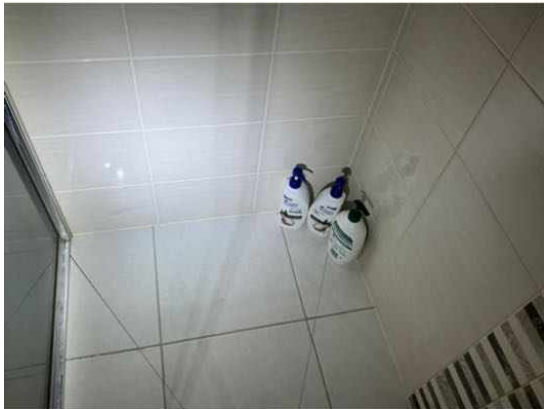
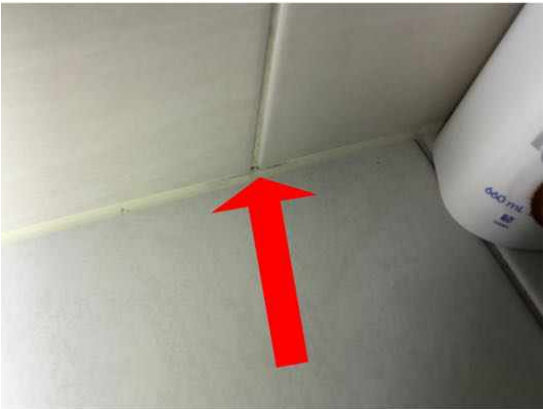
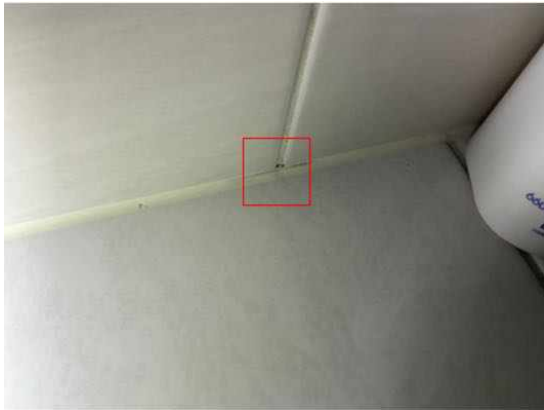
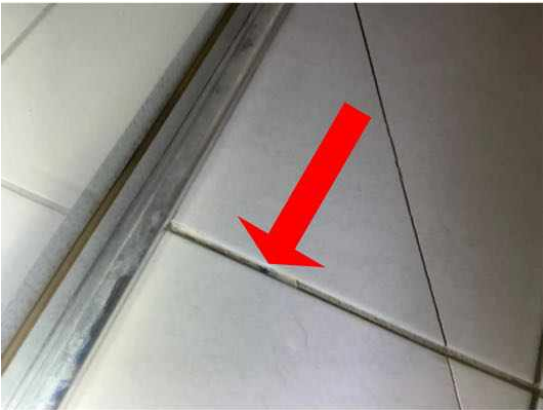
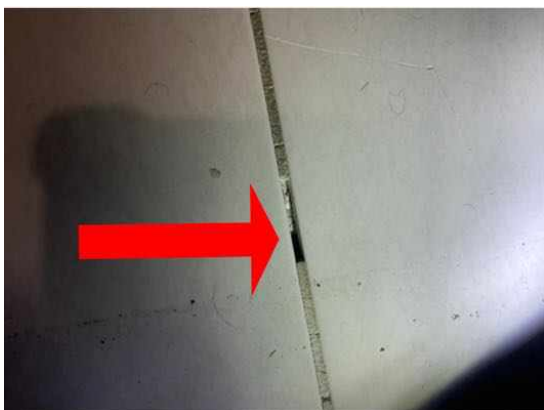
Defects 3.07

Building: Main Building
Location: Ensuite - Master

Finding: Sealant and grouting - Deteriorated

Information: It was noted on inspection that sealant or grout is degraded to the tiled shower alcove and or other areas of the bathroom.

Different materials and floor areas move at different rates, generally causing cracking to grout or sealant at this point. A flexible sealant is required to allow for expected expansion and contraction, while keeping the joint water tight and protective of all associated building materials.

Flexible and mould resistant materials should be applied to affected areas to prevent any subsequent water damage that is likely to occur. Regular maintenance and replacement of damage or missing or damaged sealant and grout is highly recommended to the wet areas, as this is a regular wear and tear defect. Sealant and grouting in areas that come into regular contact with water should be maintained for the long term care of your property.

A sealant specialist or tiling contractor should be appointed to complete these works as soon as possible

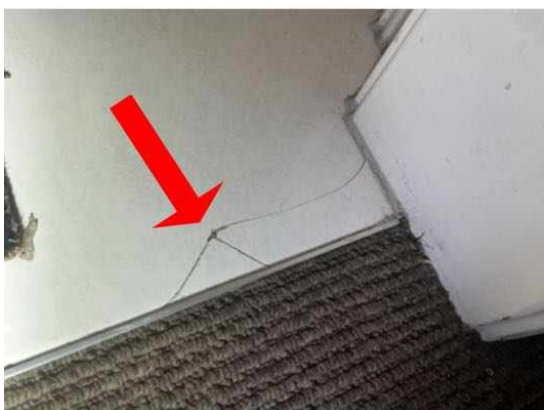
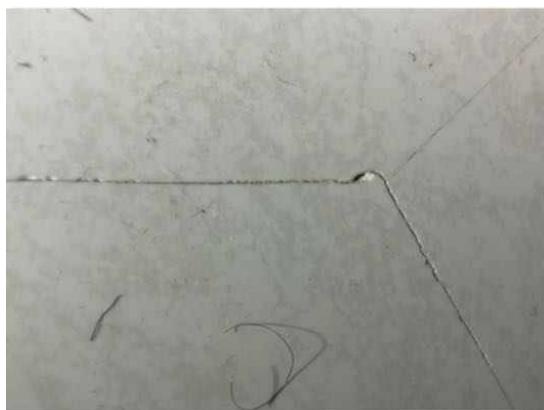
Defects 3.08

Building: Main Building
 Location: Ensuite - Master
 Finding: Broken Floor Tiles – En-Suite Bathroom
 Information:

Multiple floor tiles within the en-suite bathroom were observed to be broken at the time of inspection. The damage appears localised to several tiles; however, the affected areas present visible deterioration to the finished floor surface.

Broken tiles may allow moisture penetration through joints and cracks, potentially affecting the tile bedding and underlying timber frame . If not addressed, this may result in further tile loosening or deterioration of the substrate over time.

A qualified tiler should be consulted to remove and replace the damaged tiles. During rectification, the underlying substrate and waterproofing should be checked to ensure they remain intact and serviceable.

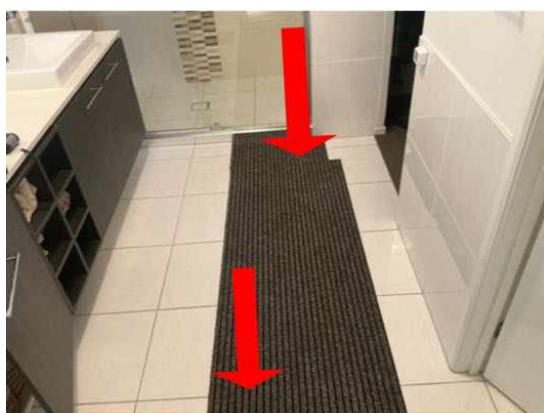
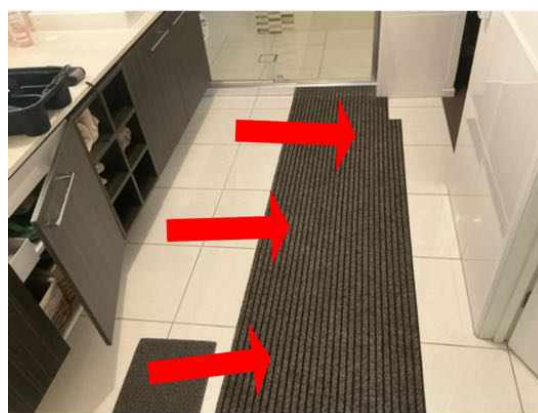
Defects 3.09

Building:	Main Building
Location:	Ensuite - Master
Finding:	Movement to En-Suite Floor Tiles
Information:	At the time of inspection, the en-suite bathroom floor was found to exhibit noticeable movement underfoot, with sections of the tiled surface feeling bouncy. In several areas, movement of individual tiles was evident when pressure was applied. This condition is likely attributable to inadequate fixing of the upper-level flooring sheets to the underlying floor joists, resulting in minor deflection of the substrate and subsequent movement of the tiled finish.

Excessive movement within the substrate can lead to progressive deterioration of grout lines, loosening of tiles, and potential compromise of the timber framing system over time. Continued deflection may result in further tile cracking or debonding if not addressed.

A flooring specialist or qualified tiler should be consulted to assess the extent of substrate movement and recommend appropriate rectification measures. This may involve securing the flooring sheets to the underlying joists and reinstating the tiled surface as required to ensure a stable and durable finish.

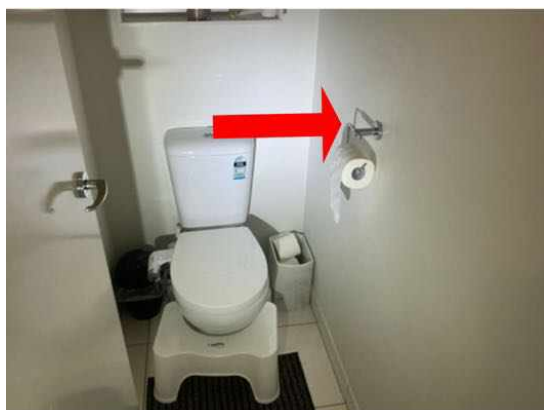
Defects 3.10

Building: Main Building
 Location: Ensuite - Master
 Finding: Toilet roll holder - Loose
 Information: The toilet roll holder was found to be loose at the time of inspection. While not a major operational defect, function can deteriorate if the problem is left unmanaged.

It is advised that the homeowner performs remedial works to re-attach the toilet roll holder to its original fixing. A general handyperson may be required to perform these works.

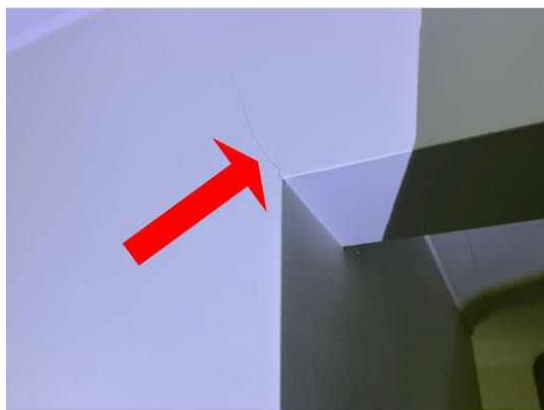
Defects 3.11

Building: Main Building
 Location: Living Room
 Finding: Minor Crack to Internal Plaster Wall
 Information:

A minor crack was observed to the plaster wall adjacent to an internal opening at the time of inspection. The crack was small in width and limited in extent, with no indication of significant structural distress.

Such cracking is commonly associated with normal building movement, minor settlement, or material shrinkage over time. In its current condition, the crack appears cosmetic in nature.

If rectification is desired for appearance purposes, the affected area may be filled, sanded, and repainted by a qualified painter or plasterer to restore a uniform finish.

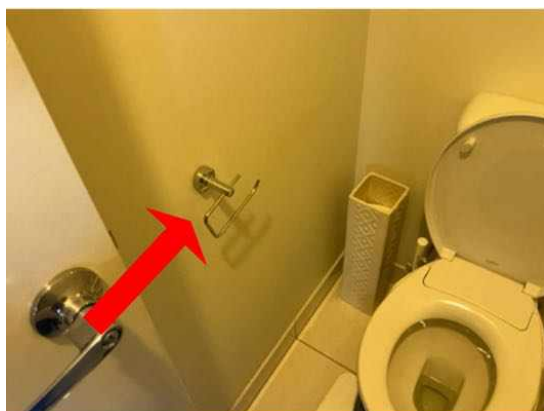
Defects 3.12

Building:	Main Building
Location:	Toilet (WC) - Upstairs
Finding:	Toilet roll holder - Loose
Information:	The toilet roll holder was found to be loose at the time of inspection. While not a major operational defect, function can deteriorate if the problem is left unmanaged.

It is advised that the homeowner performs remedial works to re-attach the toilet roll holder to its original fixing. A general handyperson may be required to perform these works.

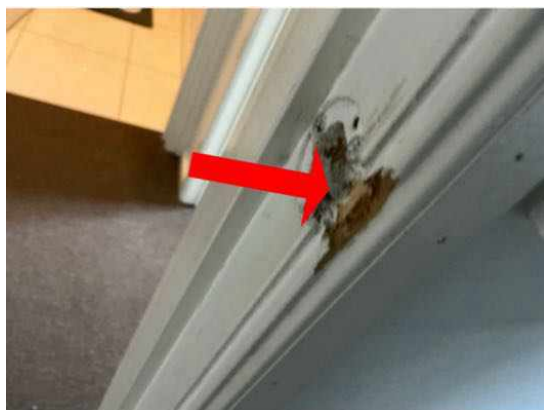
Defects 3.13

Building:	Main Building
Location:	Bedroom 4
Finding:	Missing Striker Plate – Bedroom 4 Door
Information:

At the time of inspection, the door to Bedroom 4 was found to be missing the striker plate to the door jamb. As a result, the door latch is unable to properly engage, and the door does not open and close as intended.

The absence of the striker plate prevents secure latching of the door and may lead to misalignment, unnecessary wear to the latch mechanism, and reduced functionality of

A qualified carpenter or handyman should be engaged to supply and install a suitable striker plate and adjust the door hardware as required to ensure proper alignment and secure operation of the door.

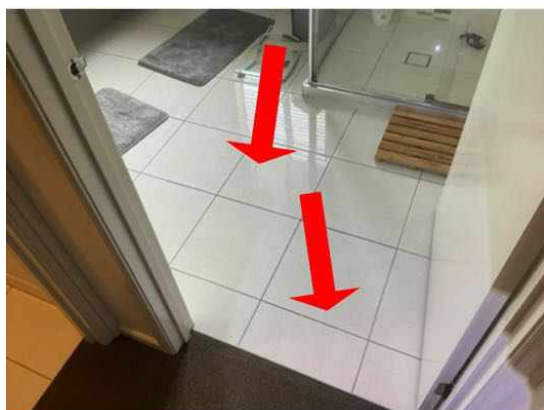
Defects 3.14

Information: At the time of inspection, the floor tiles within the second bathroom were found to exhibit movement underfoot. In particular, sections near the entry area felt slightly bouncy, and minor movement of individual tiles was noticeable when pressure was applied. This condition is consistent with possible inadequate fixing of the flooring substrate to the underlying joists, resulting in deflection and subsequent movement of the tiled finish.

Ongoing substrate movement can lead to progressive grout cracking, tile loosening, and potential compromise of the timber-framing over time. If not rectified, further tile deterioration or debonding may occur.

substrate movement and recommend appropriate rectification measures. This may involve securing the flooring sheets to the supporting structure and reinstating the tiled surface as required to provide a stable and durable finish.

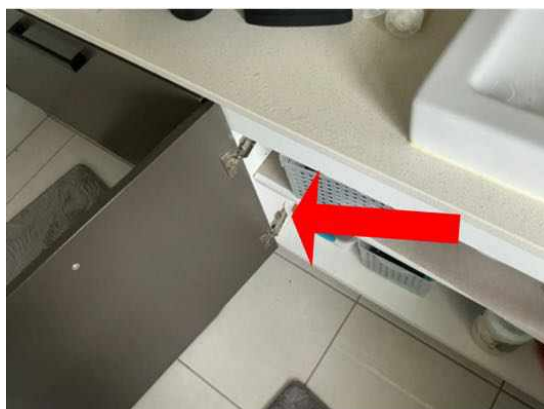
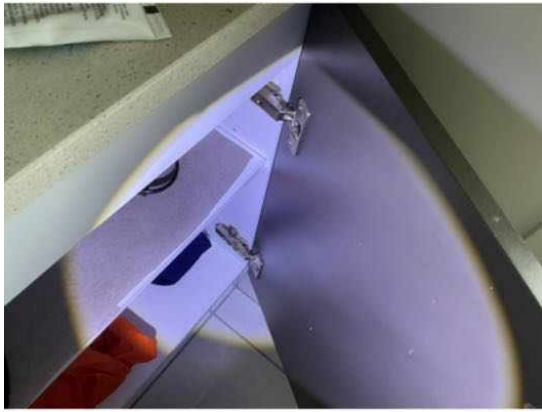
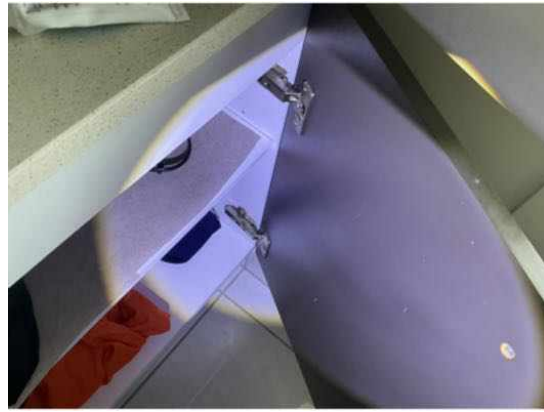
Defects 3.15

Building: Main Building
 Location: Bathroom 2
 Finding: Loose Vanity Cabinet Hinges – Bathroom 2
 Information:

At the time of inspection, the vanity cabinet door hinges within Bathroom 2 were found to be loose. The fixings appear to have loosened over time, resulting in minor movement and misalignment of the cabinet doors.

Loose hinges may affect the proper operation of the doors and, if left unattended, may lead to further wear to the hinge hardware or damage to the cabinet carcass.

A qualified carpenter or handyman should be engaged to resecure and tighten the hinges and adjust the cabinet doors as required to ensure correct alignment and smooth operation.

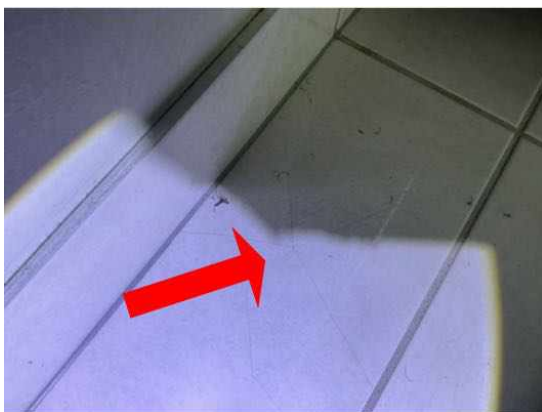
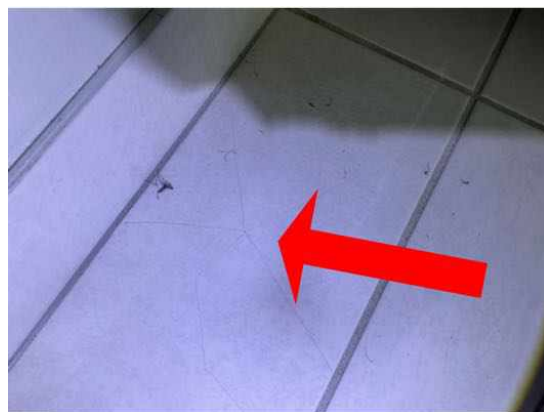
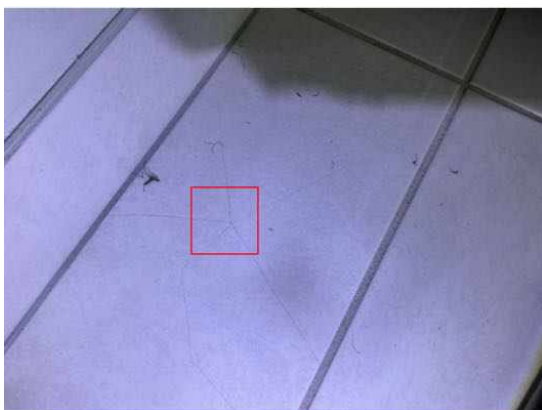
Defects 3.16

Building: Main Building
 Location: Bathroom 2
 Finding: Cracked / Broken Tiles – Bathroom 2
 Information:

At the time of inspection, several tiles within Bathroom 2 were observed to be cracked or broken. The damage appears localised to individual tiles; however, the affected areas present visible deterioration to the tiled surface.

Cracked or broken tiles may allow moisture penetration through the damaged sections and grout lines, potentially affecting the tile bedding and underlying waterproofing system over time. If not addressed, this may result in further tile loosening or substrate deterioration.

A qualified tiler should be consulted to carefully remove and replace the damaged tiles. During rectification, the underlying substrate and waterproofing should be checked to ensure they remain intact and serviceable.

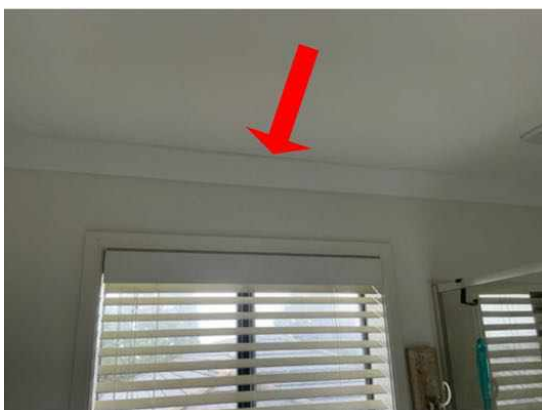
Defects 3.17

Building: Main Building
 Location: Bathroom 2
 Finding: Minor Sag / Gap to Cornice – Bathroom 2
 Information:

At the time of inspection, the cornice within Bathroom 2 was observed to exhibit a minor sag with a small gap visible at the junction between the cornice and adjoining surface. The separation appears slight and limited in extent.

Such gaps commonly occur due to normal building movement, minor settlement, or material shrinkage over time. In its current condition, the issue appears to be minor and predominantly cosmetic in nature.

If rectification is desired, a qualified plasterer may be engaged to assess the affected section and undertake filling and re-finishing as required to restore a uniform appearance.

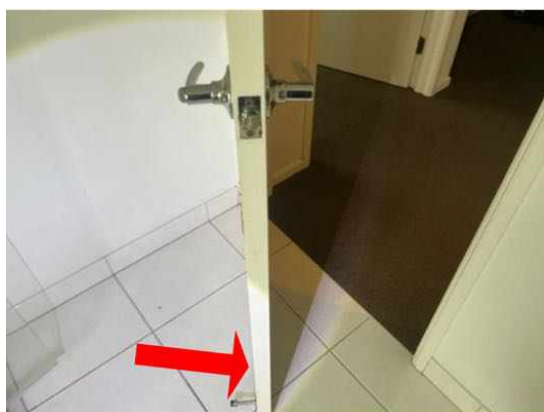
Defects 3.18

Building: Main Building
 Location: Bathroom 2
 Finding: Minor Moisture Damage to Bottom of Bathroom Door
 Information:

At the time of inspection, minor deterioration was observed to the lower edge of the bathroom door. The damage appears consistent with previous exposure to moisture, which may be attributable to water splash, elevated humidity, or condensation within the bathroom environment. The affected area was limited to the bottom section of the door.

Prolonged exposure to moisture can cause swelling, paint deterioration, or minor timber fibre breakdown at the base of internal doors, particularly in wet areas. In its current condition, the issue appears minor and primarily cosmetic.

If rectification is desired for appearance purposes, the affected section may be lightly sanded, sealed, and repainted. Care should also be taken to ensure adequate ventilation within the bathroom to minimise ongoing moisture exposure.

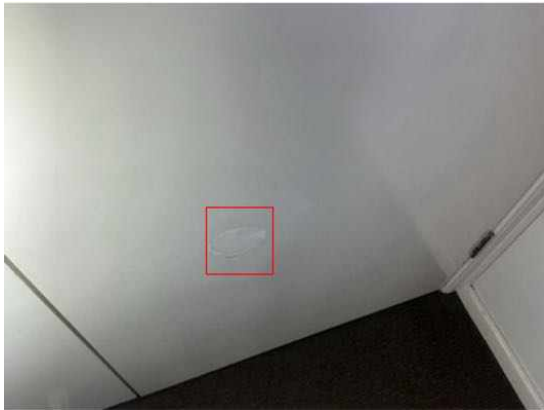
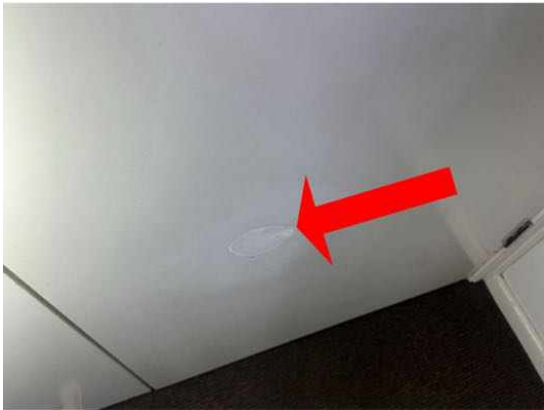
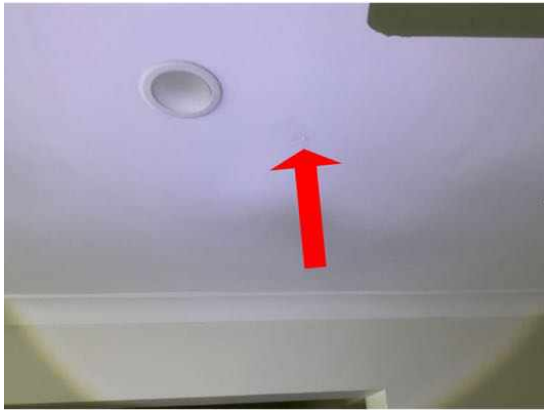
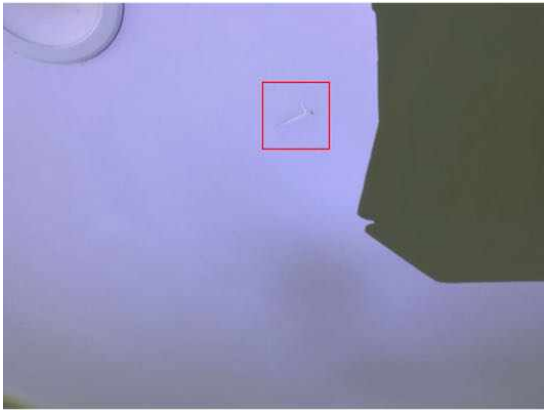
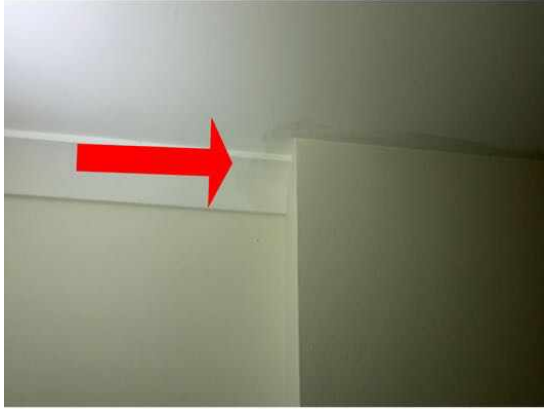
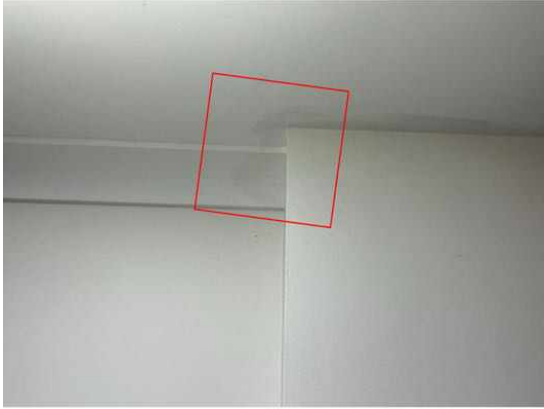
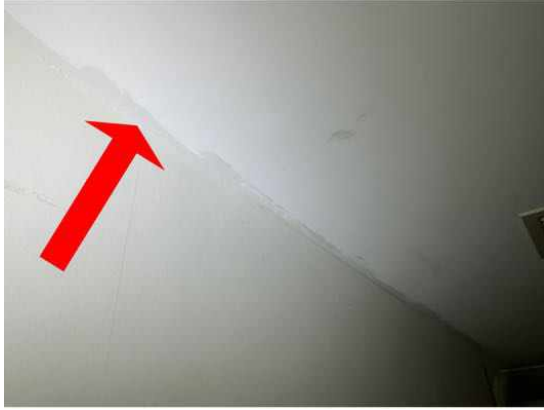
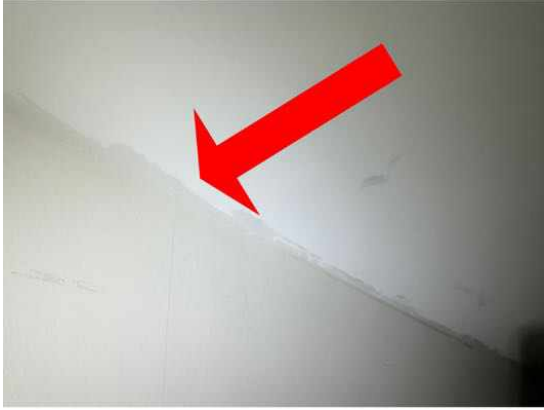
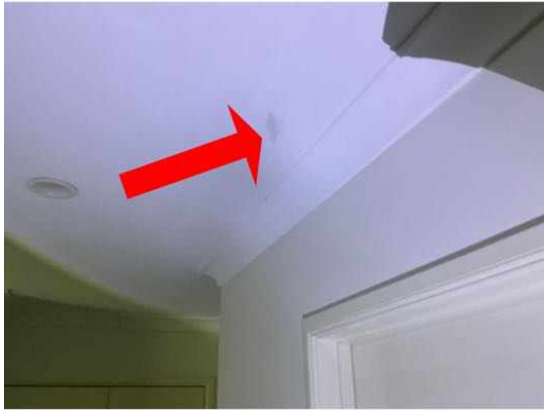
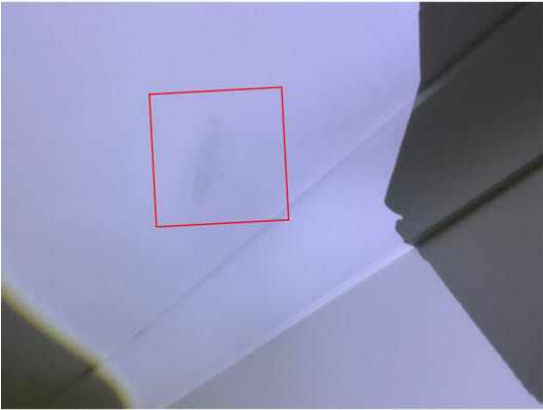
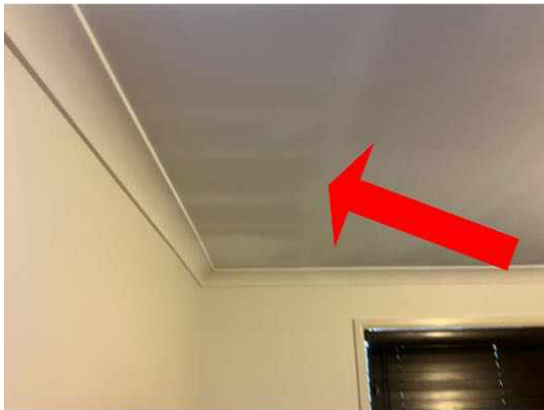
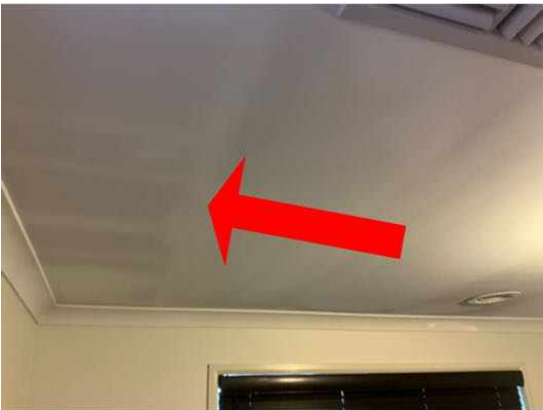
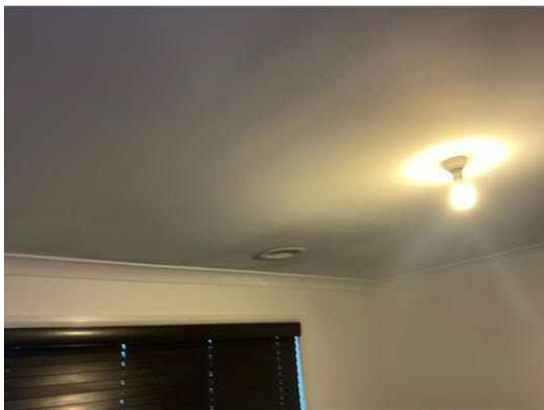
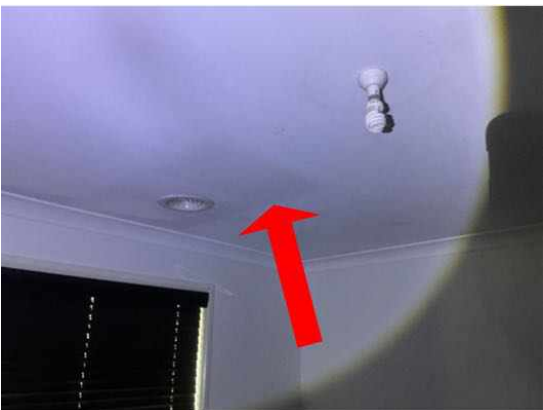
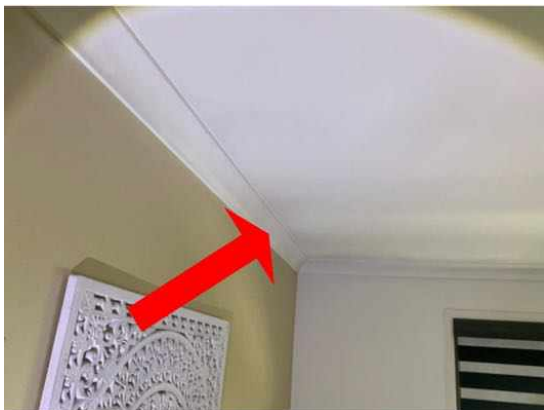
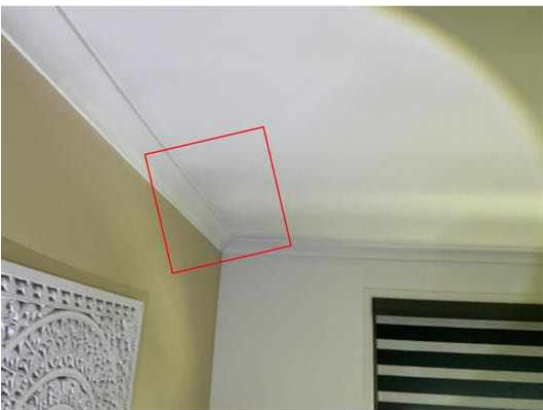
Defects 3.19

Building:	Main Building
Location:	All Internal Areas
Finding:	General Cosmetic Wear and Tear Observations
Information:

At the time of inspection, general wear and tear was observed throughout the property. This included areas of paint overspray between ceilings and walls, patch repairs that appear not to have been properly sanded or refinished, and sections with a poor paint finish. In the upstairs bedrooms, minor ceiling staining and areas of colour variation were also noted. Non-invasive moisture testing was conducted to the affected ceiling areas, and no abnormal moisture readings were detected at the time of inspection. The variation in appearance appears consistent with previous patching and repainting using differing paint types or colour batches.

These observations are considered cosmetic in nature and do not, in isolation, constitute structural or major building defects. The issues relate primarily to finish quality and presentation rather than performance of building elements.

achieve a consistent and uniform finish.

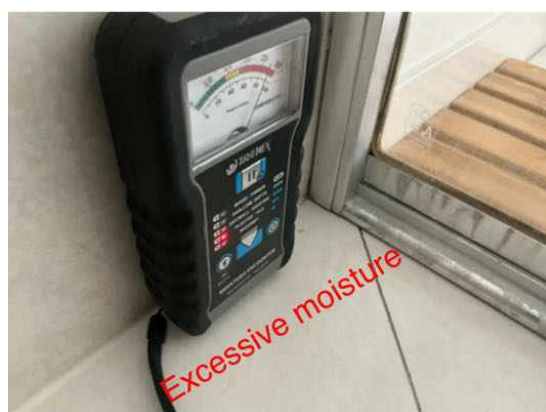
Defects 3.20

Building:	Main Building
Location:	Bathroom 2
Finding:	Shower damp - Sealant and grout
Information:	Damp is evident to the lower 400mm of wall to the shower alcove. This defect is quite common, and is suspected to have been caused by moisture permeating or leaching through the grouting and sealant in this area, which shows evidence of deterioration. Leaking pipes within the wall is also a possible cause however this seems unlikely in this instance as there is no moisture build up around the taps or transferring to the other side of the wall. There appears to be no sealant around the tap spindles which may be a small contributing factor.

Always ensure that sealant and grout is in good condition to prevent any moisture issues occurring in the future.

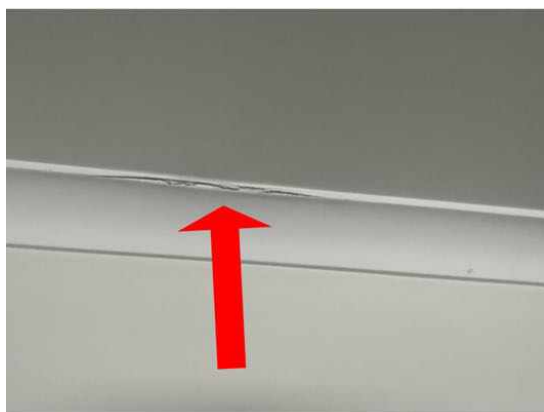
Defects 3.21

Location: Bedroom 2
 Finding: Damaged Cornice – Bedroom 2
 Information:

A qualified plasterer should be engaged to investigate the cause of the damage and carry out appropriate rectification works, including repair or replacement of the affected cornice section as required.

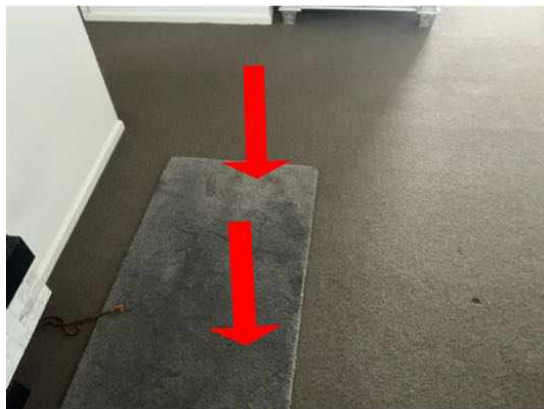
Defects 3.22

Building: Main Building
 Location: Living Room
 Finding: Localised Squeaking to Upper-Level Flooring – Living Area
 Information:

If rectification is desired, a qualified carpenter or flooring specialist should be consulted to assess the affected area and secure the flooring sheets to the underlying joists as required to minimise movement and associated noise.

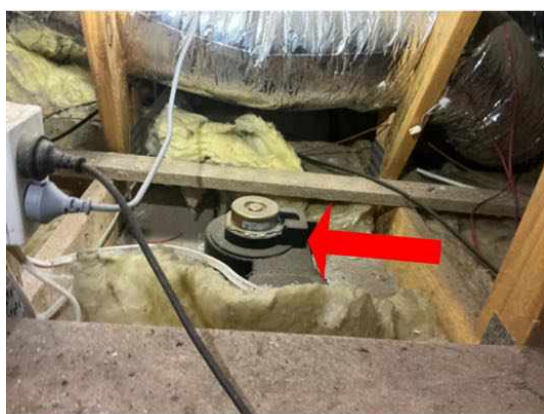
Defects 3.23

Building:	Main Building
Location:	Roof Void
Finding:	Bathroom Exhaust Fans Not Ducted to External Atmosphere
Information:	The exhaust fans installed in the bathrooms were observed to be discharging directly into the roof cavity rather than being ducted to the external atmosphere. This configuration does not comply with best practice ventilation standards, as it allows moist air to accumulate within the roof space.

It is recommended that a licensed ventilation specialist or electrician be engaged to install compliant ducting that vents the exhaust air to the outside of the building, in accordance with current building regulations and ventilation standards.

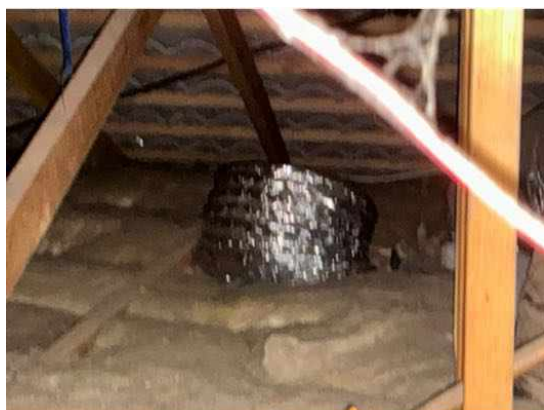
Defects 3.24

Building:	Main Building
Location:	Roof Void

A licensed HVAC technician should be engaged to review the ducting within the roof space, confirm its purpose, and ensure all ductwork is correctly installed, supported, and functioning as intended.

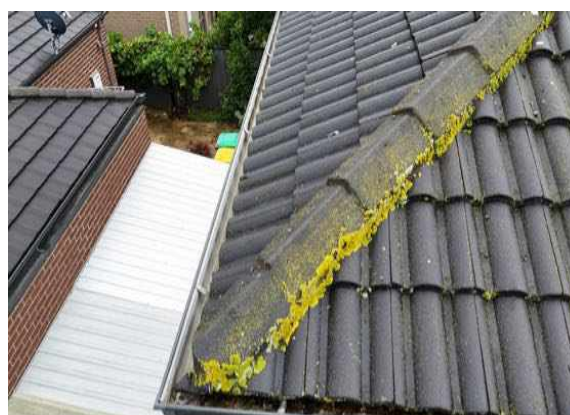
Defects 3.31

Building: Main Building
Location: Roof Exterior
Finding: Broken and Improperly Repaired Roof Tile
Information:

A qualified roofing contractor should be engaged to safely clean the affected roof areas using appropriate methods. Following cleaning, the condition of the ridge capping and pointing should be assessed, and any deteriorated mortar or flexible pointing repaired as required to ensure ongoing weather tightness and durability of the roof covering.

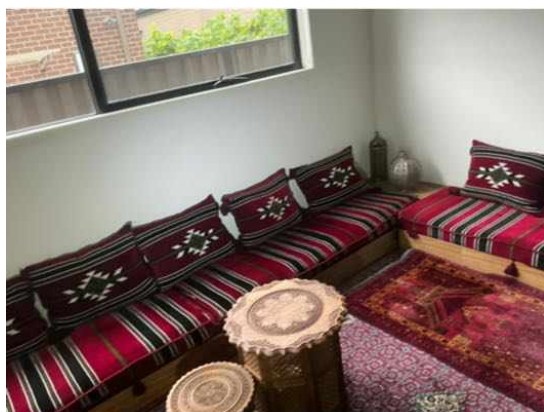
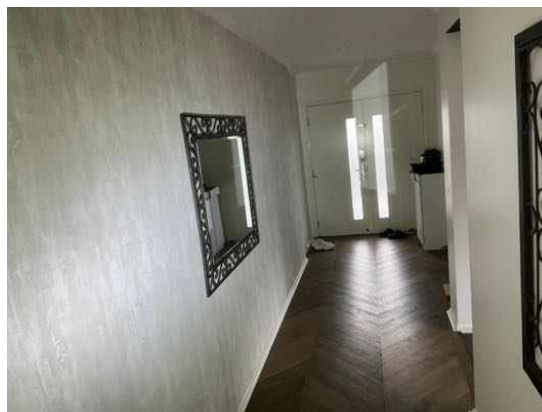
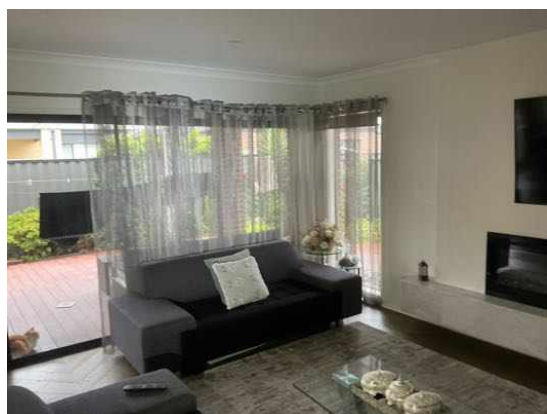
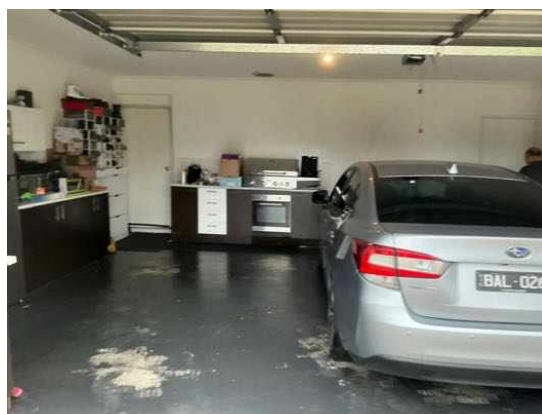
Building: Main Building
 Location: All Internal Areas
 Finding: Obstructions and Limitations - Interior
 Information: These photographs are an indication of the obstructions and limitations which impeded the inspection of the internal areas of the property at the time of inspection. These obstructions can hide an array of defects and should be removed to allow full inspection to be carried out. A re-inspection is recommended once the areas are made accessible.

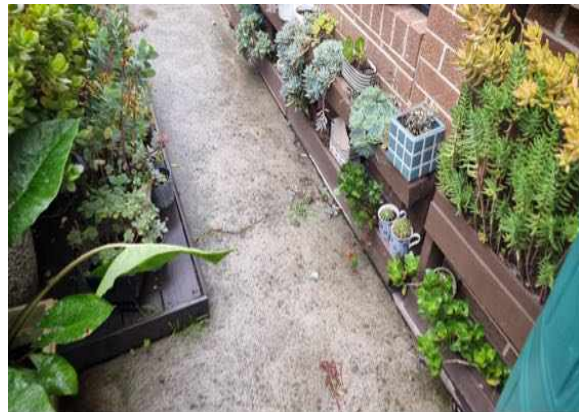
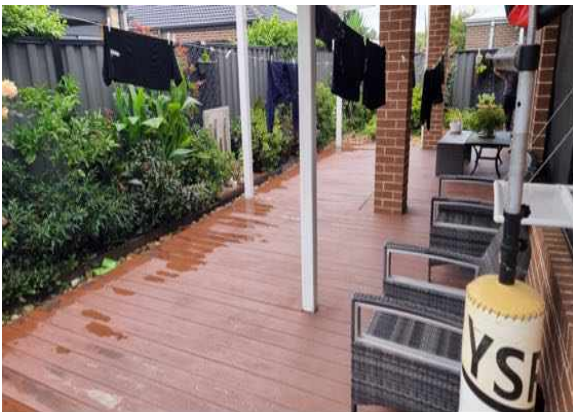
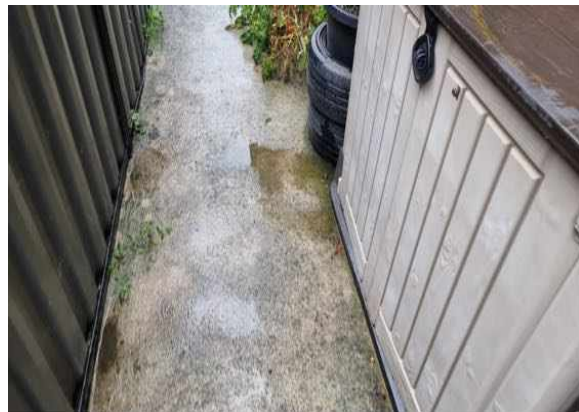
Noted Item

Building: Main Building
 Location: All External Areas
 Finding: Obstructions and Limitations - Exterior
 Information: These photographs are an indication of the obstructions and limitations which impeded the inspection of the external areas of the property at the time of inspection.

These obstructions can hide an array of defects and should be removed to allow full inspection to be carried out. A re-inspection is recommended once the areas are made accessible.

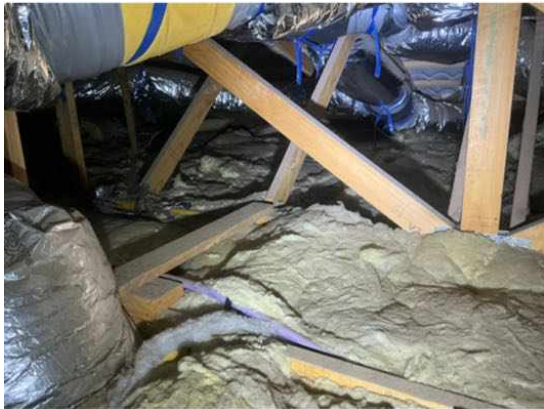
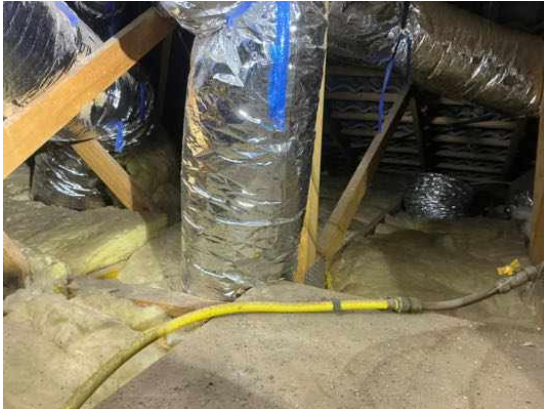
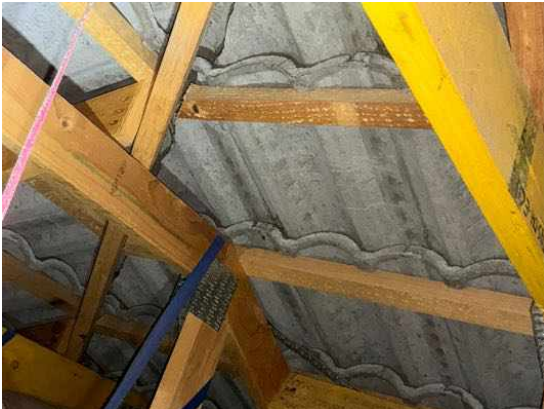
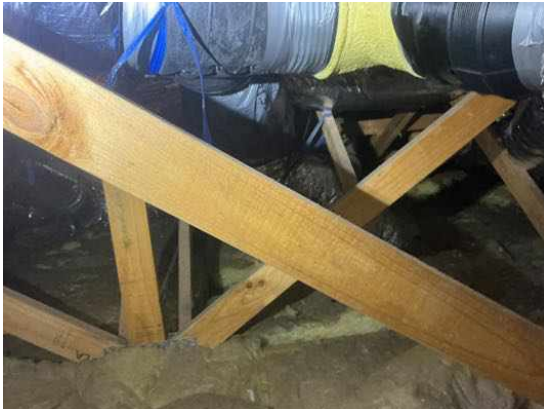
Noted Item

Building:	Main Building
Location:	Roof Void
Finding:	Obstructions and Limitations - roof cavity
Information:	These photographs are an indication of the obstructions and limitations which impeded the inspection of the roof cavity area of the property at the time of inspection. These obstructions can hide an array of defects and should be removed to allow full inspection to be carried out. A re-inspection is recommended once the areas are made accessible.
