Building and Timber Pest Inspection Report

Inspection Date: Wed, 1 Apr 2026

Property Address: 3/8A Clydesdale Drive, Upper Coomera
QLD 4209

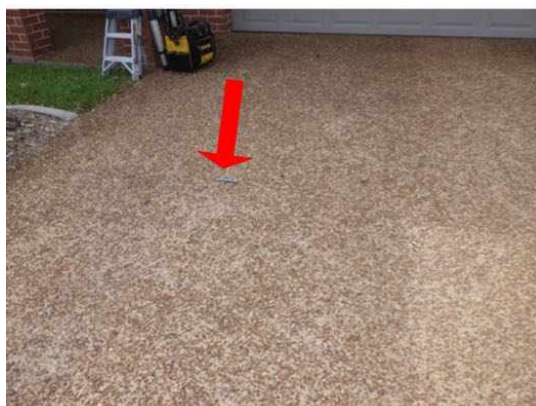
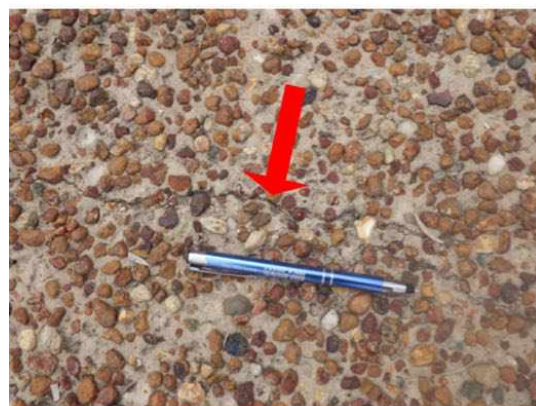
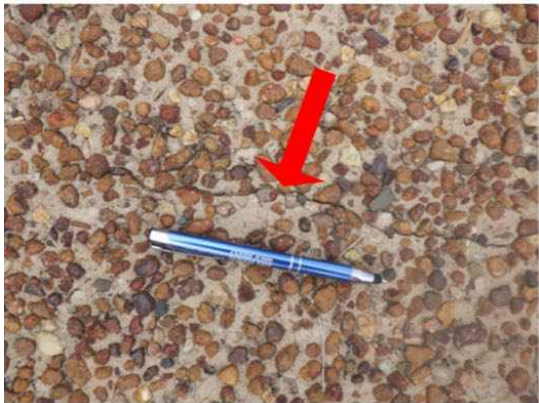
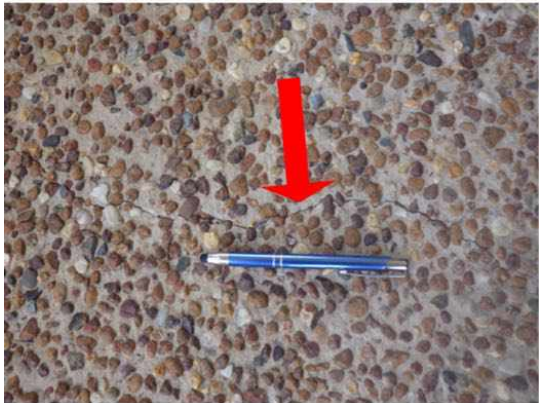
Building: Main Building
Location: Driveway > Ground Level
Finding: Cracking in concrete slab - Category 1
Information: Cracking coded as Category 1 was identified in the driveway and footpaths concrete slabs. A Category 1 crack is described as a fine but noticeable crack, with the slab at an otherwise reasonable level.

To be considered Category 1, the approximate width of the crack is less than 1.0mm, or a less than 10mm change in offset when a 3m straight edge is placed over the defect.

Category 1 cracks should be monitored for a period of 12 months. At the end of the monitoring period, identified cracks that are rated greater than Category 2 are considered defects, and require rectification.

Monitoring of all cracking should be conducted frequently. Always contact a building inspector should cracks widen, lengthen, or become more numerous.

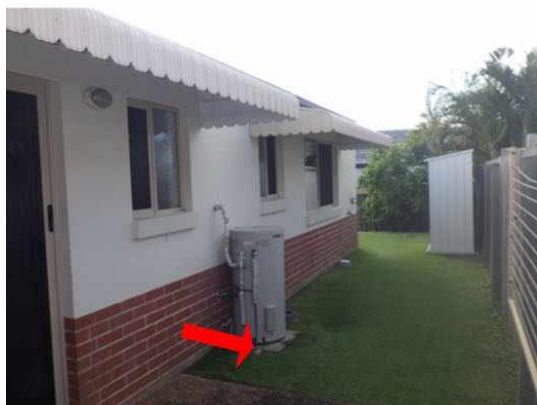
Building: Main Building
 Location: Exterior walls - right side > Centre Right
 Finding: Stormwater Grate
 Information: The stormwater grate cap to the hot water service overflow pipe on the right side of the building was missing at the time of inspection.

It is recommended that a general handyman be appointed to replace the stormwater line grate cap as necessary, to help prevent any potential stormwater line blockages.

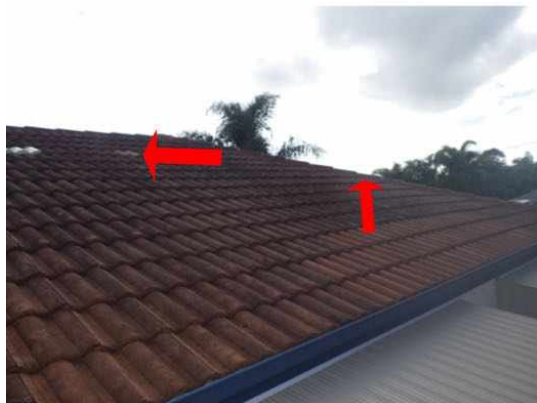
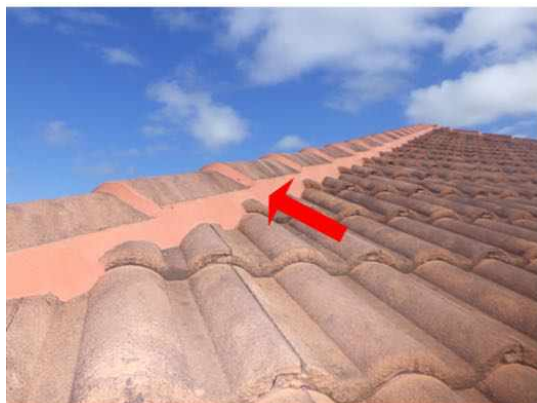
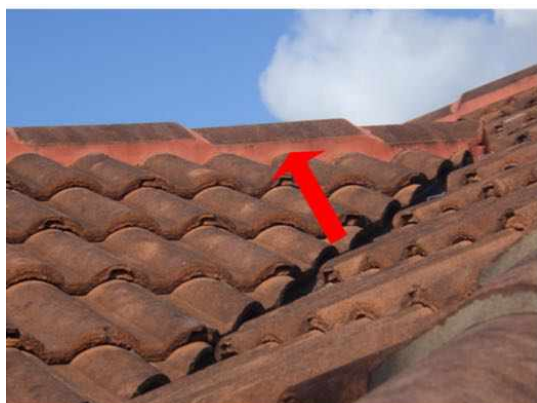
Finding 3.04

Building: Main Building
 Location: Roof Exterior > Existing
 Finding: Roof tiles - Weathered
 Information: Upon inspection of the exterior roofing, the majority of roof tiles were considered to be in a fair condition, with evidence of minor cracking and previous repair work to roof areas. While weathering of the tiles is consistent with the age of the property, maintenance works will likely be required.

The client should consult a roofing contractor to gain advice on costs of any remedial works that may be required in the short to medium term. Remedial works are likely to increase the longevity of the exterior roofing structure.

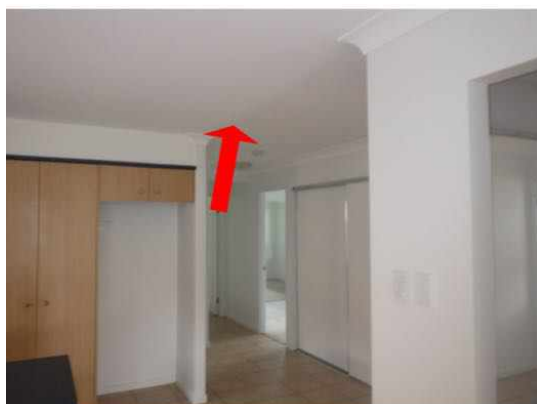
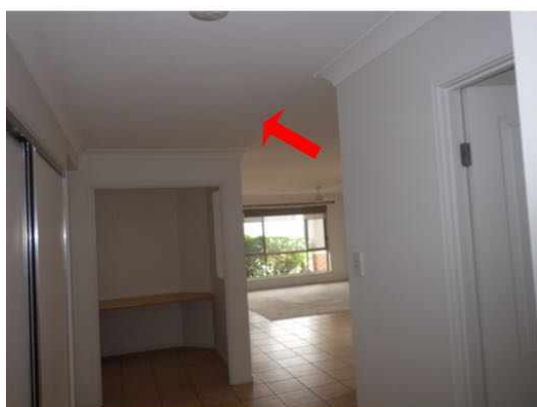
Finding 3.05

Building:	Main Building
Location:	Hallway > Centre
Finding:	Cracking - Ceiling
Information:	There is cracking to an area of the hallway ceiling.

The cracking appears minor in nature and is generally only ever an appearance defect. While such cracking may be noticeable in some cases, it is quite common and does not indicate any structural damage.

Cracking of this nature can generally be repaired with minor sanding, filling and/or repainting. Such works should be performed by a qualified painter or a general

handyman.

Monitoring of all cracking should be conducted frequently. Always contact a building inspector should cracks widen, lengthen, or become more numerous.

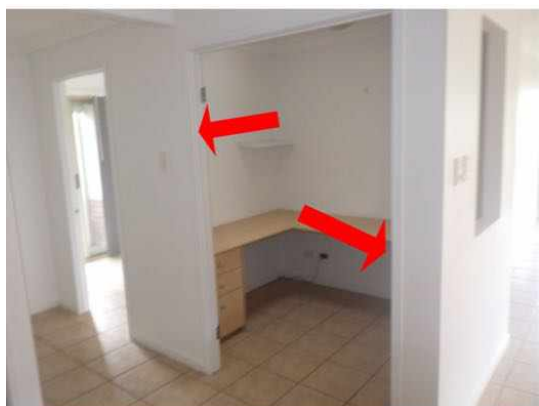
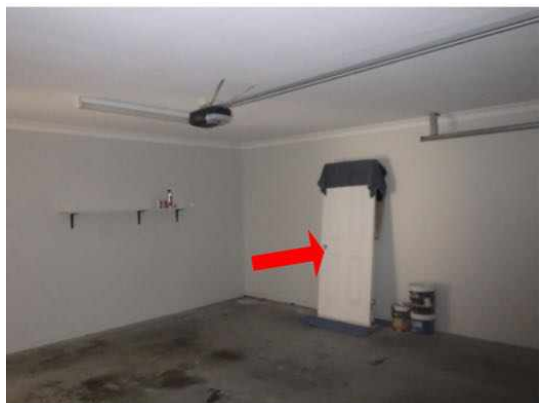
Finding 3.06

Building:	Main Building
Location:	Study > Front
Finding:	Door - Missing
Information:	The doors to study area opening were missing at the time of inspection. It appeared the doors have been previously removed (reasons unknown).

Note - The missing doors may be stored in the garage area, at the time of inspection.

A qualified carpenter or general handyman could be appointed to reattach the doors. These works should be conducted at the clients discretion.

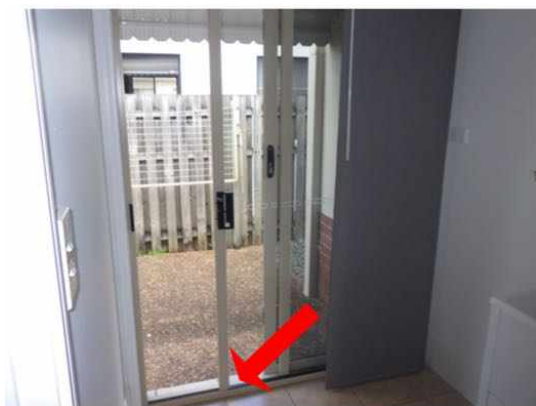
Finding 3.07

Building:	Main Building
Location:	Laundry > Rear
Finding:	Door - Stiff to slide
Information:	The aluminium sliding door to the laundry area was difficult to operate at the time of the inspection. Doors provide ventilation to the adjoining area and should be at a fully operational level to ensure user comfort. Restricted function of the door may also pose as a potential safety hazard if required for emergency egress from the building.

Generally, factors such as general age of the building element and a lack of maintenance are the usual causes for this type of defect.

An aluminium sliding door service agent may be required to repair/replace the affected door rollers.

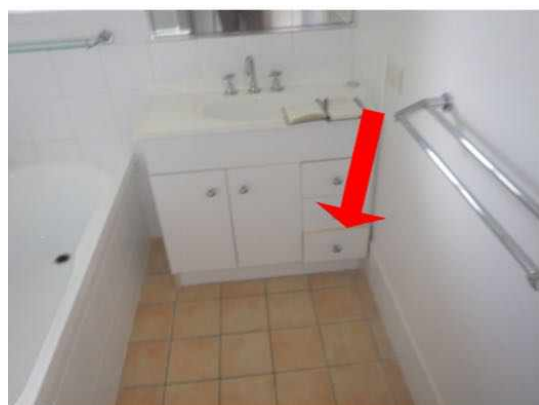
Finding 3.08

Building:	Main Building
Location:	Bathroom > Rear Right
Finding:	Cabinetry - Drawers jamming
Information:	The bathroom cabinetry bottom drawer was found to be sticking or jamming at the time of inspection. The sticking or jamming drawer detract from the operational state of the cabinetry. To improve operation of the affected drawer, a general handyman may be appointed to repair the affected drawer. Such works should be completed at discretion of the client.

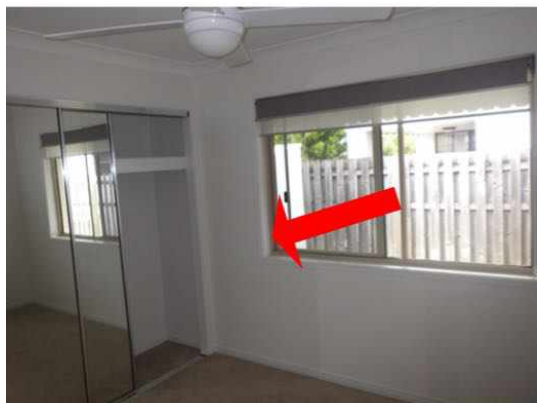
Finding 3.09

Building:	Main Building
Location:	Bedroom 2 > Rear Left
Finding:	Wood Rot
Information:	At the time of inspection the bottom of the left side timber reveal and sill to the bedroom 2 area aluminium sliding window was soft to touch and showed signs of wood rot. The wood rot damage appears to be caused from excessive moisture, possibly from water tracking along the sliding window track.

The client could engage a qualified carpenter to investigate further and/or undertake rectification work as required.

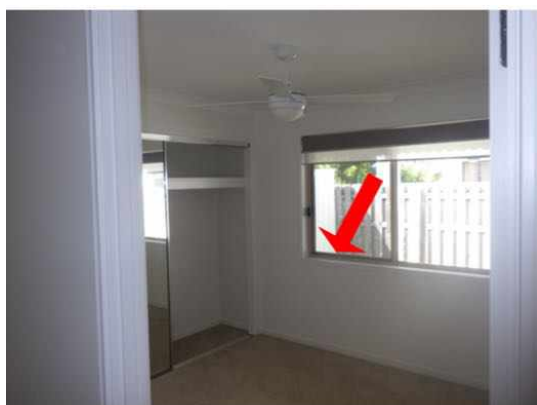
Finding 3.10

Information: The aluminium sliding window in bedroom 2 was stiff to operate at the time of the inspection. Windows provide ventilation to the adjoining area and should be at a fully operational level to ensure user comfort. Restricted function of the window may also pose as a potential safety hazard if required for emergency egress from the building.

Generally, factors such as general age of the building element and a lack of maintenance are the usual causes for this type of defect.

An aluminium window service agent will be required to repair the affected windows.

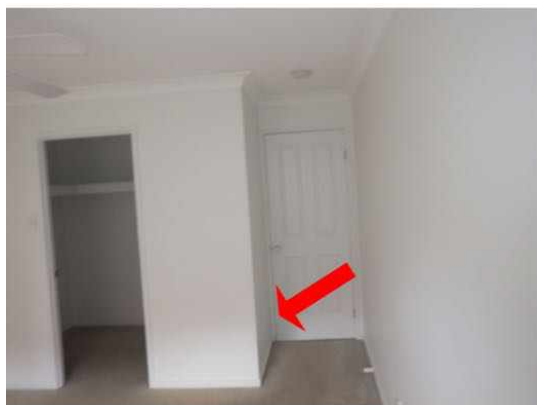
Finding 3.11

Information: Binding and/or jamming of the main bedroom door on the door frame was evident during standard operation. This defect inhibits the functionality of affected door as well

as creating potential for secondary defects to associated building elements, such as damage to the door framing.

A door that binds to the associated door frame or sill may have several causes, such as poor installation of the door or deteriorated hinges.

A qualified carpenter or general handyperson could be appointed to perform minor rectification works at client discretion.

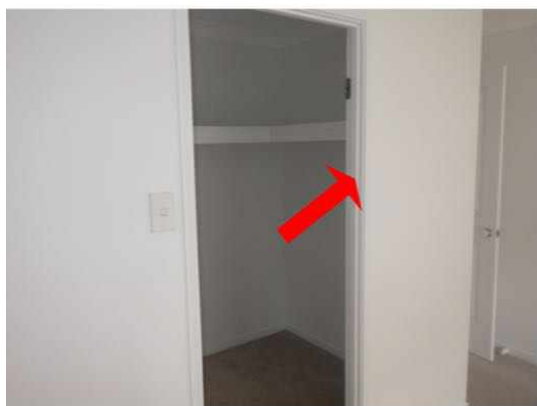
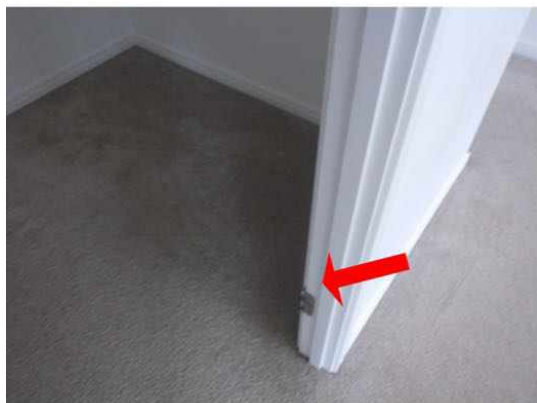
Finding 3.12

Building:	Main Building
Location:	Walk In Robe > Front
Finding:	Door - Missing
Information:	The door to the main bedroom/walk in robe opening was missing at the time of inspection. It appeared the door has been previously removed (reasons unknown).

Note - The missing door may be stored in the garage area, at the time of inspection.

A qualified carpenter or general handyman could be appointed to reattach a door. These works should be conducted at the clients discretion.

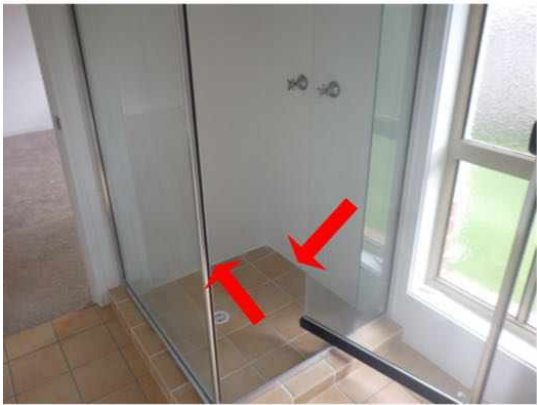
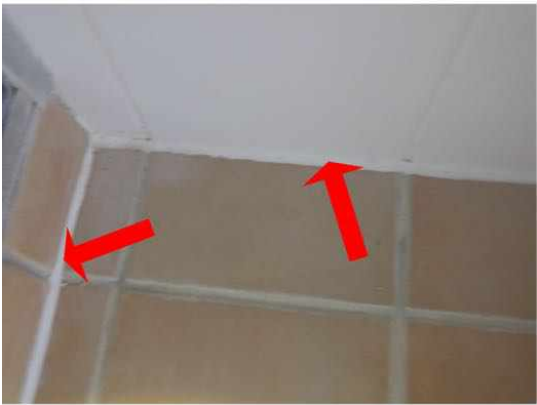
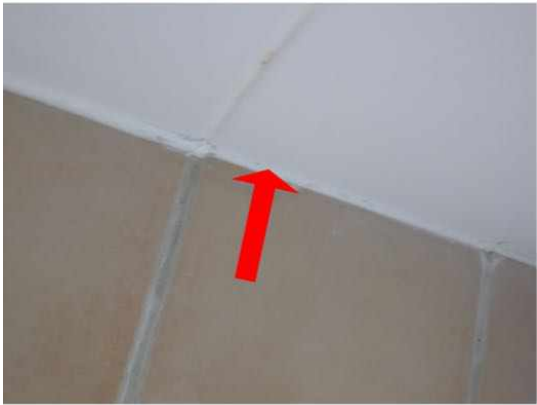
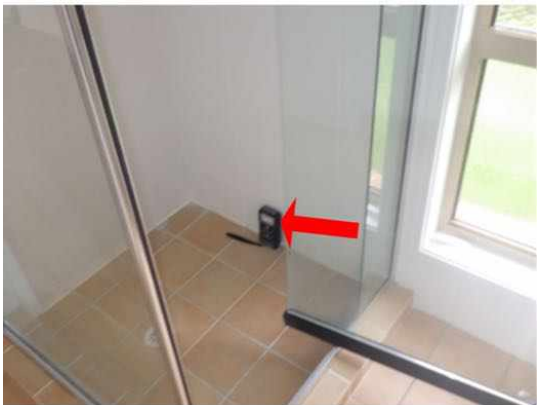
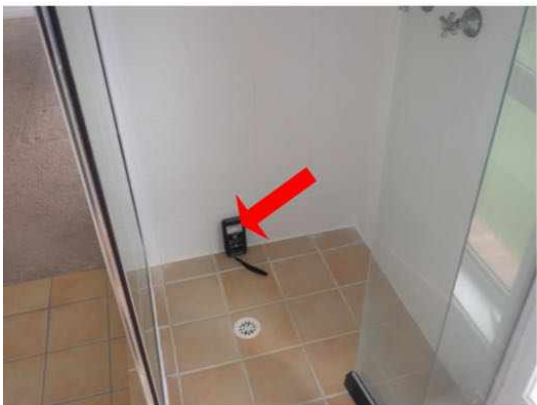
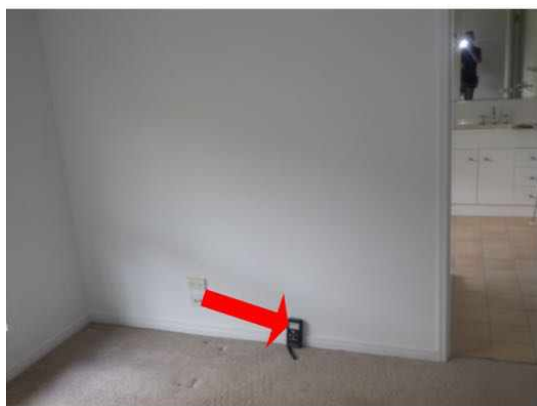
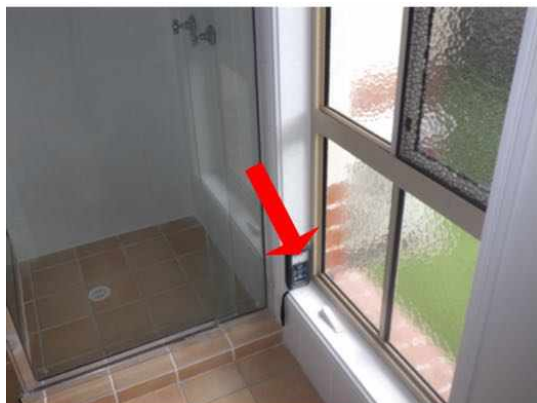
Finding 3.13

Building:	Main Building
Location:	Ensuite > Front Left
Finding:	Shower damp - Monitor
Information:	Damp was evident to the lower 300mm of wall to the ensuite shower alcove at the time of inspection. There was no elevated moisture level readings around the tap area, and no elevated readings transferring to the other side of the wall in the areas where moisture readings were able to be obtained. Both sealant and grout appear in fair condition at present. Additionally, it was noted there appears to have been poorly applied previous repair work to the shower base silicone sealant.

It is recommended a sealant specialist is engaged to replace the shower base sealant and/or grout where required.

Monitoring the area is advised and if any visual signs of excessive moisture appear (peeling paint, mould) then consultation with a qualified plumber or bathroom specialist would be advised to identify the cause of damp and to perform remedial works as required.

Always ensure that sealant and grout is in good condition to prevent any moisture issues occurring in the future.

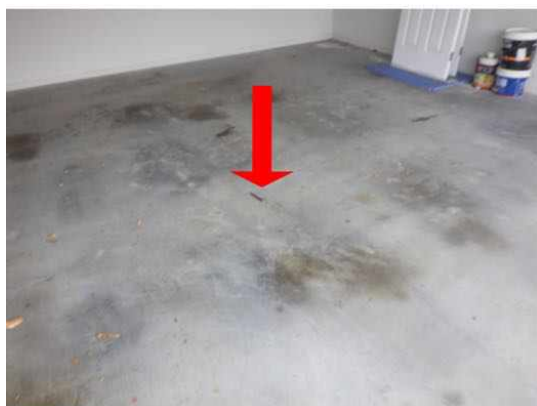
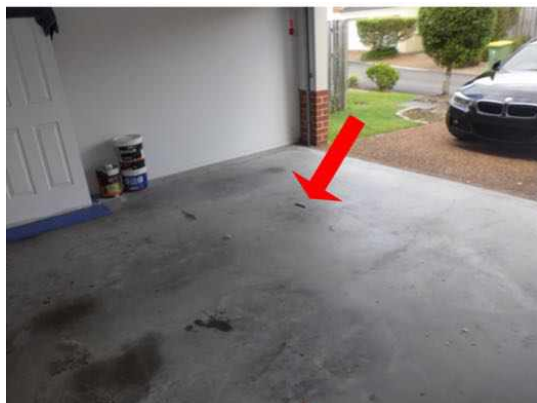
Finding 3.14

Building:	Main Building
Location:	Garage > Centre
Finding:	Cracking in concrete slab - Category 1
Information:	Cracking coded as Category 1 was identified in the garage floor concrete slab. A Category 1 crack is described as a fine but noticeable crack, with the slab at an otherwise reasonable level.

To be considered Category 1, the approximate width of the crack is less than 1.0mm, or a less than 10mm change in offset when a 3m straight edge is placed over the defect.

Category 1 cracks should be monitored for a period of 12 months. At the end of the monitoring period, identified cracks that are rated greater than Category 2 are considered defects, and require rectification.

Monitoring of all cracking should be conducted frequently. Always contact a building inspector should cracks widen, lengthen, or become more numerous.

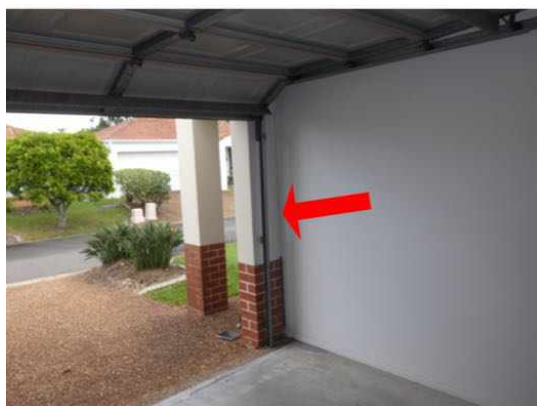
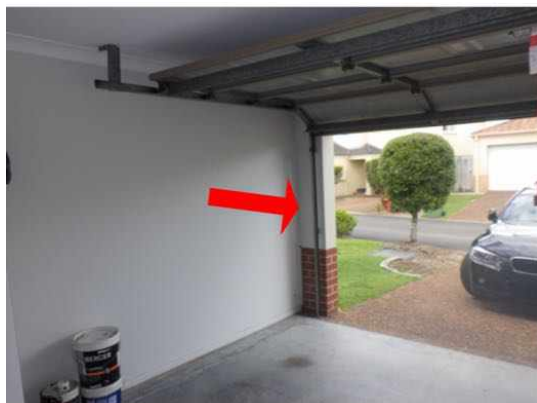
Finding 3.15

Building:	Main Building
Location:	Garage > Front Left,Front Right
Finding:	Cracking - wall internal corner
Information:	There is timber trim missing and cracking to the wall internal corners both sides of the garage door opening.

The cracks appear minor in nature and generally are only ever an appearance defect. While such cracking may be noticeable in some cases, it is quite common and does not indicate any structural damage.

Cracking of this nature can generally be repaired with minor sanding, filling and/or repainting. Such works should be performed by a qualified painter or a general handyman.

Monitoring of all cracking should be conducted frequently. Always contact a building inspector should cracks widen, lengthen, or become more numerous.

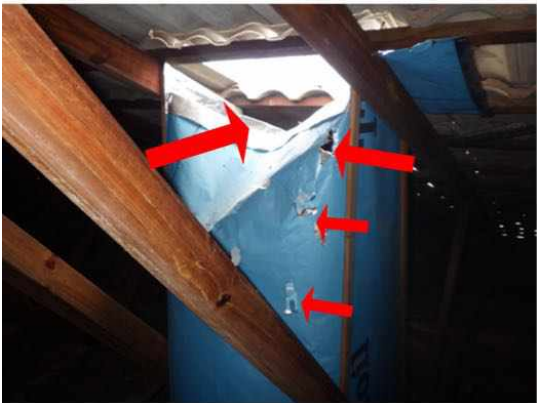
Finding 3.16

Building:	Main Building
Location:	Attic > Centre
Finding:	Skylight - Damaged/blocked shaft
Information:	It was noted at the time of inspection that the skylight shaft in the ceiling space has been blocked/damaged, and is therefore not fully functional.

While seemingly minor, skylights allow natural light to filter into the surrounding area. Without such light, the area may be susceptible to the formation and development of mould, which creates a respiratory health hazard for all persons that come into contact with the area.

Where the skylight shaft has been blocked (even partially) or damaged, it is recommended that a carpenter or general handyperson be appointed to perform rectification works as necessary.

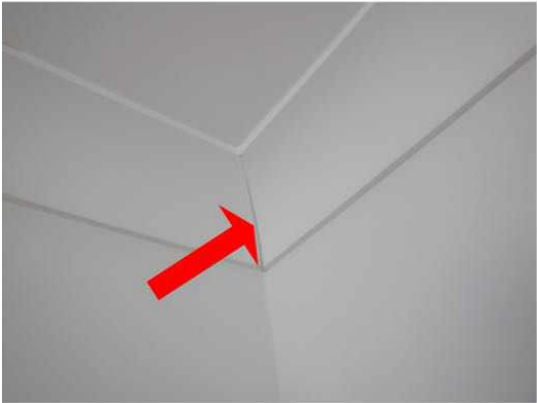
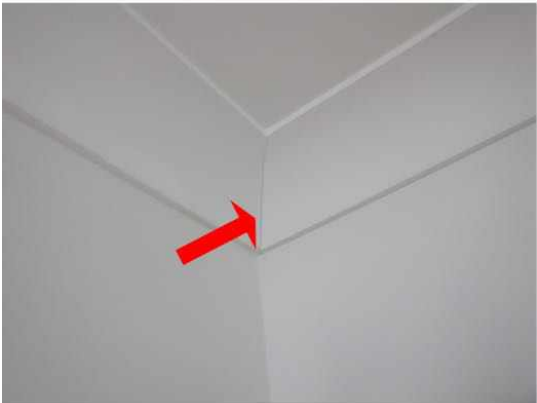
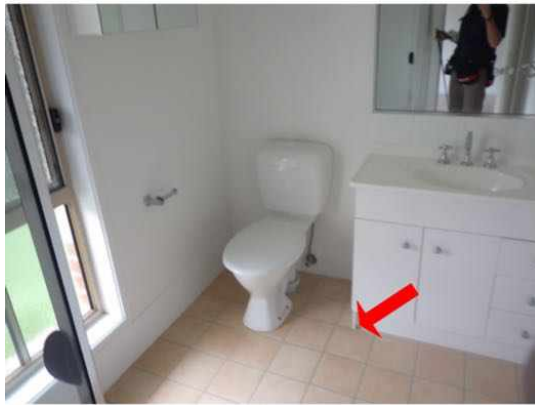
Finding 3.17

Building: Main Building
Location: Internal Areas > Existing
Finding: Wear and Tear
Information: At the time of inspection the building interior showed signs of minor cracking and/or scuffing to floors, walls, ceilings and cornices (as per example photos).

The level of damage appears consistent with normal building movement and/or general wear and tear.

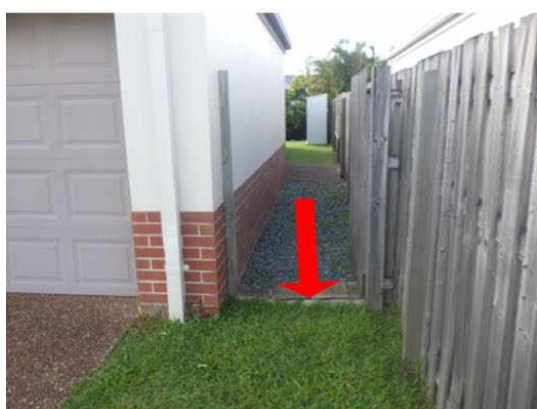
Any timbers in direct ground contact provide opportunity for concealed termite activity and are likely to be subject to premature rot and decay as the soil retains moisture or damp conditions against the timbers.

Removal of any untreated timber or tree stumps which are in direct contact with external ground is recommended. Frequent pest inspections are advised to readily identify any termite activity in these areas.

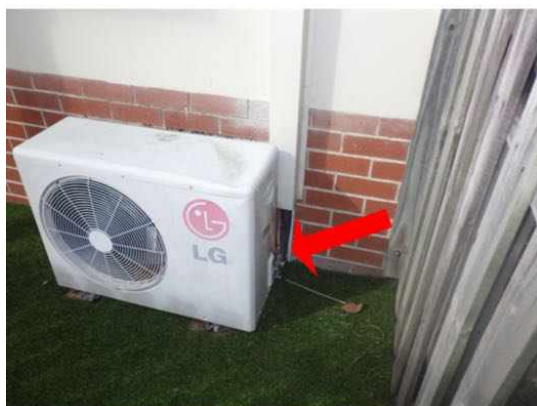
Finding 6.02

Building: Main Building
 Location: Exterior walls - left side > Centre Left
 Finding: Overflow - Not plumbed for drainage
 Information: The air conditioning unit overflow on the left side of the property is not plumbed or connected to suitable drainage, which can result in the surrounding area becoming excessively damp. These damp conditions can lead to secondary defects such as rot, rust or corrosion of associated building elements, the formation of fungal decay, or even the creation of potential slip hazards. When coupled with poor site drainage, pooling of water may also attract termite activity to this area. It is highly recommended that a qualified plumber be appointed to install adequate drainage to the overflow. These works will ensure that the area remains dry and free of any secondary defects.

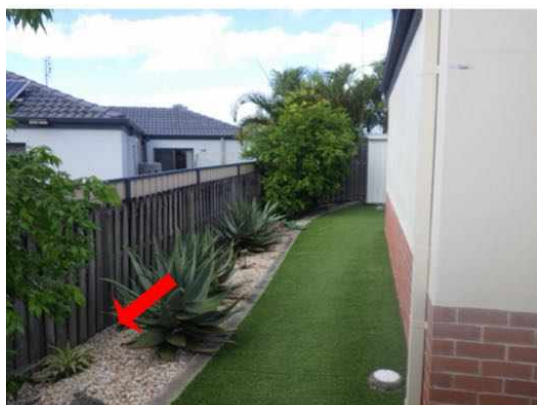
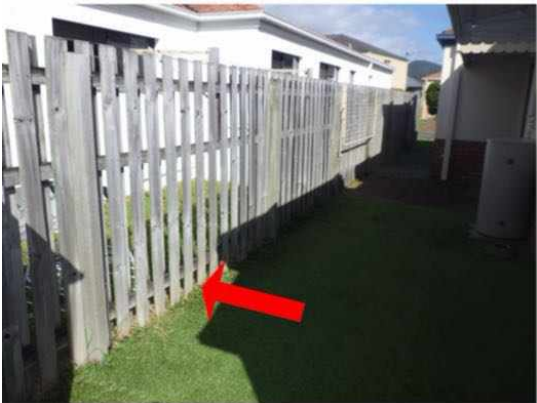
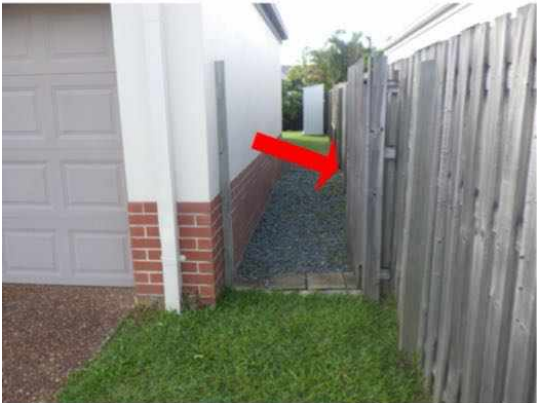
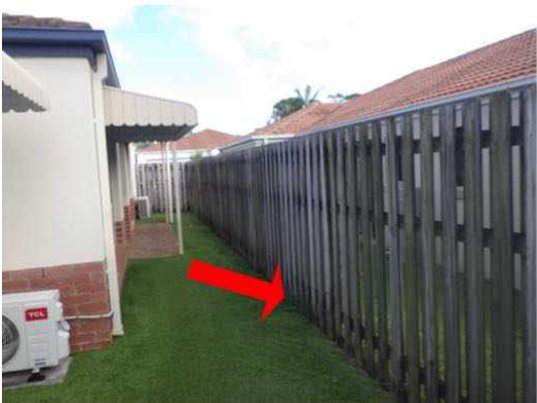
Finding 6.03

Building: Main Building
 Location: Yard - Back & Sides > Ground Level
 Finding: In ground contact
 Information: It was noted that the garden beds and finished ground levels cover the base of the timber fence palings (as per example photos).

Any timbers in direct ground contact provide opportunity for concealed termite entry and are likely to be subject to premature rot and decay as the soil retains moisture or damp conditions against the timbers.

Frequent pest inspections are advised to readily identify any termite activity in these areas.
