Building Inspection Report

Inspection Date: Tue, 24 Mar 2026

Property Address: 15 Kinedana St, Eden Hills SA 5050,
Australia

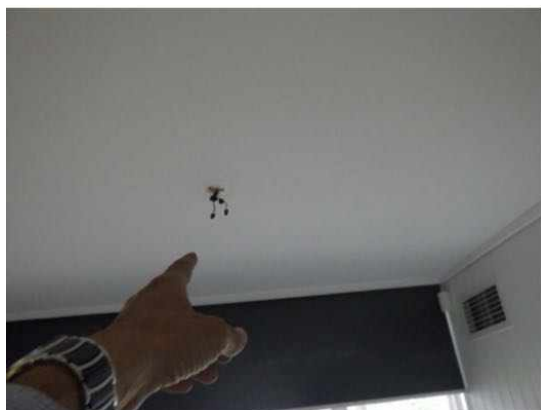
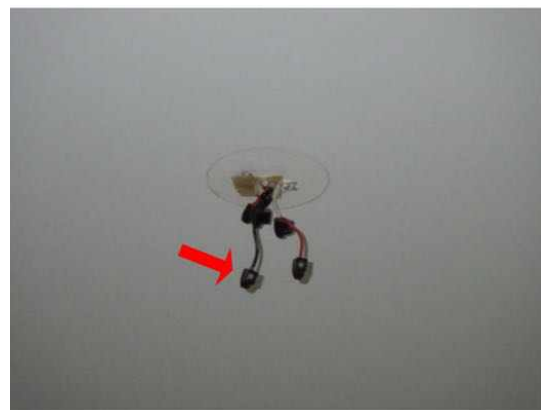
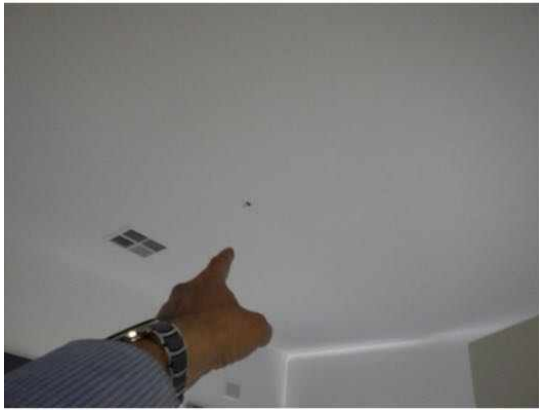
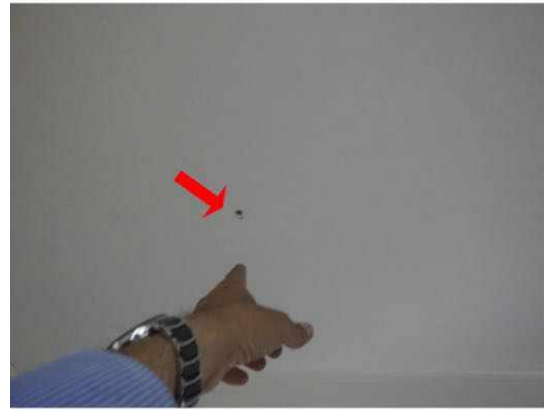
Defects 1.01

Building:	Building 1
Location:	All Areas
Finding:	Electrical fitting - Broken / Missing / Exposed
Information:	At the time of inspection it was electrical fitting in this entry area, internal area was found to be broken & exposed. Apart from that at the time of inspection it was also noticed that electrical fittings were missing from this master bedroom area.

Breakage occurs generally when the building materials have aged and decayed, but may also be indicative of impact damage to the building element (accidental or deliberate).

Left unmanaged, the fitting is unlikely to cause further damage to surrounding building elements. However, the broken fitting does expose electrical works, and may create a safety hazard if there is potential contact with persons in the area.

Repair and/or replacement of the broken fitting is advised. A Licensed electrician should be appointed to repair/replace the fitting immediately.

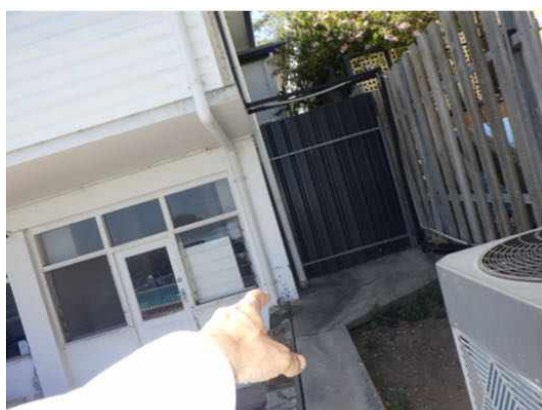
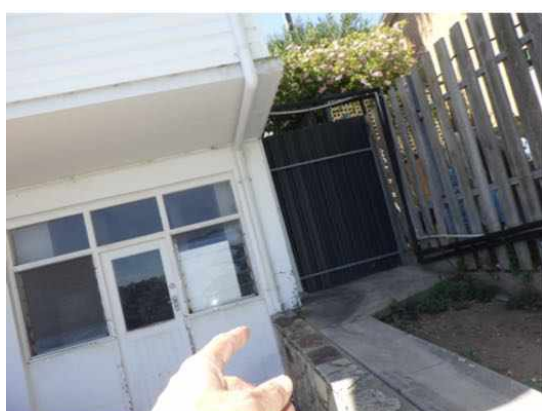
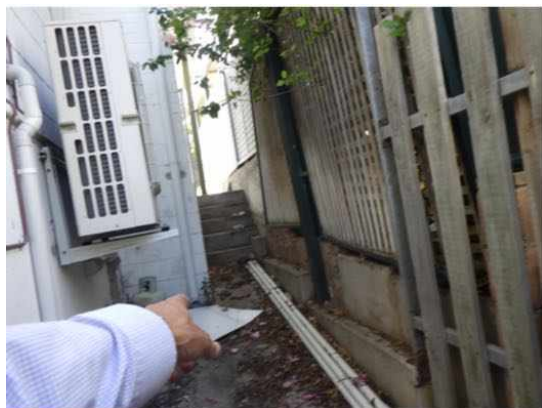
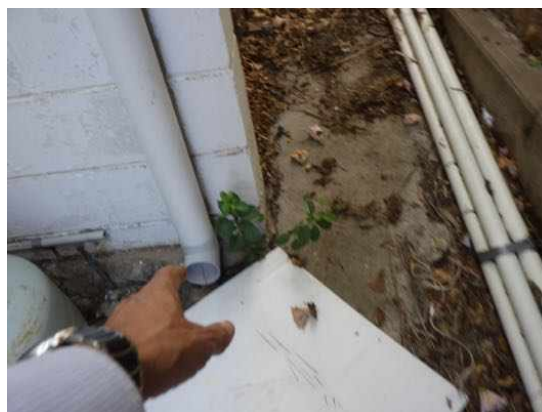
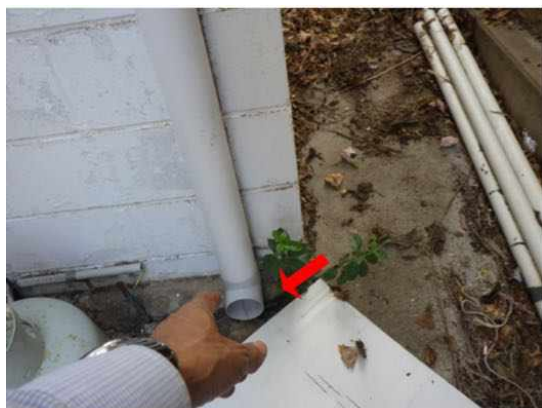
Defects 2.01

Building:	Building 1
Location:	All External Areas
Finding:	Site drainage - Inadequate
Information:	The site drainage in this area was found to be inadequate at the time of inspection, creating potential for subsequent water damage to associated building elements.

It is important that water does not lie against the base of walls; surrounding paths and ground levels should be sloped to drain water away from walls. Downpipes should not discharge stormwater onto lower walls or plinths. Stormwater should be carried away by large, regularly cleaned drains. Ground levels may need to be lowered to expose a buried DPC.

Where site drainage is inadequate, installation of an Agricultural (Aggie) Drain may be required. A qualified plumber should be appointed as soon as possible to further inspect the property and perform any remedial works as necessary. Water damage and secondary defects are likely to occur if left unmanaged.

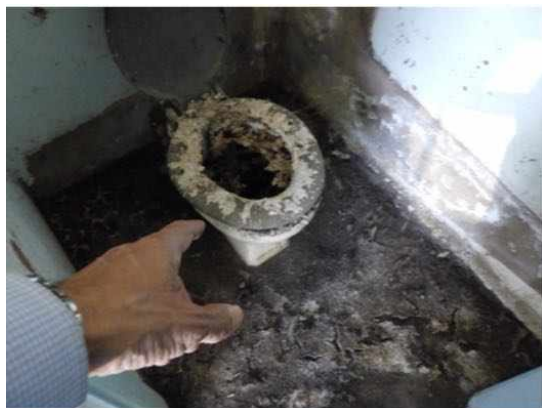
Defects 2.02

Building:	Building 1
Location:	All External Areas
Finding:	External rear area - Toilet assembly - Blocked
Information:	At the time of inspection it was noticed that toilet assembly is blocked in this sub floor area. Blockages prevent building elements from operating as intended, detracting from the overall function of the affected building elements. Additionally, the lack of general maintenance may lead to the development of more significant defects, such as damage to surrounding building materials.

Blockages should be removed and addressed promptly, as they will lead to the development of secondary building defects. The blockage should be removed as the primary rectification works. Secondly, check for any secondary or concealed damage, and then attempt to address the cause of the blockage to prevent recurrence or any water damage to associated structures.

Depending on the location of the blockage and the building elements affected, a licensed plumber may be required to perform necessary remedial works.

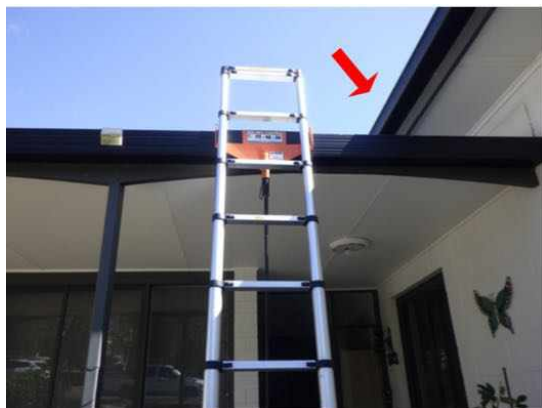
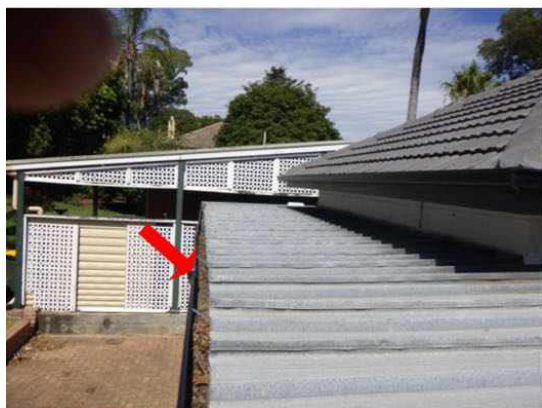
Defects 3.01

Blocked gutters are likely to lead to high levels of moisture in the affected areas. Such moisture will not only cause rust and decay of the associated building materials, but can also provide conditions that are conducive to termite and timber pest activity. Blockages in gutters should therefore be removed immediately to ensure dry conditions are maintained.

Consult a Licensed Plumber for further specific advice on remedial works that may be required. In the interim, it is highly advised that blocked gutters be removed by the homeowner or a general handyperson as a matter of urgency.

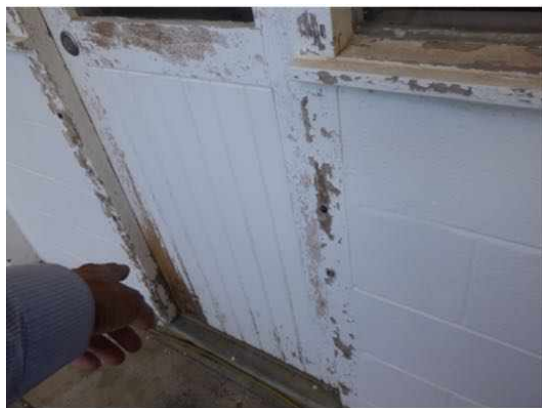
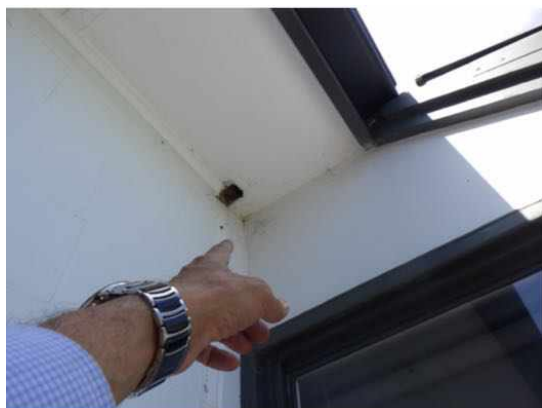
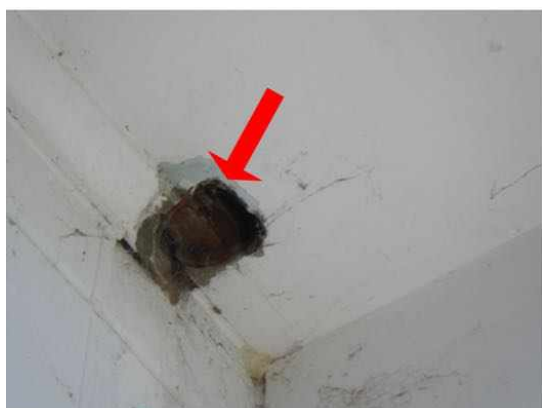
Defects 3.02

Building:	Building 1
Location:	All External Areas
Finding:	Building element - Damaged
Information:	At the time of inspection it was noticed few sections of buildings elements were damaged around the property. Breakage occurs generally when the building materials have either aged and decayed, or as a result of damage (accidental or deliberate).

Repair and/or replacement of broken elements is advised to ensure that additional secondary defects do not arise as a consequence. Such works are necessary, as all building elements play a key role in the operation and function of the overall structure and its performance.

A relevant tradesperson should be appointed to repair or replace the affected building element prior to any subsequent damage being caused.

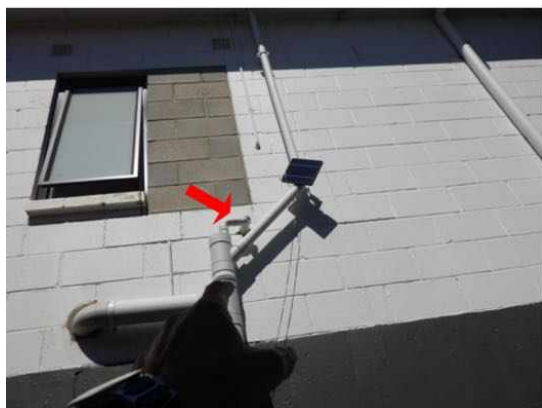
Defects 3.03

Building:	Building 1
Location:	All External Areas
Finding:	External walls - Holes
Information:	Significant holes were identified around pipe penetrations in this wall section. It is suspected that the installation of this pipework was completed to a substandard level of workmanship or is incomplete.

Gaps and holes around pipework makes the area susceptible to insect and vermin ingress, as well as allowing water penetration to the cavity wall. As such, associated building elements are likely to deteriorate at an accelerated rate, and major implications are expected if holes around the pipework are left unmanaged.

All excessive holes, gaps or cracks should be adequately filled by a suitable sealant or trimmings as soon as possible to prevent any further damage. Such works may be conducted by a general handyperson or licensed plumber.

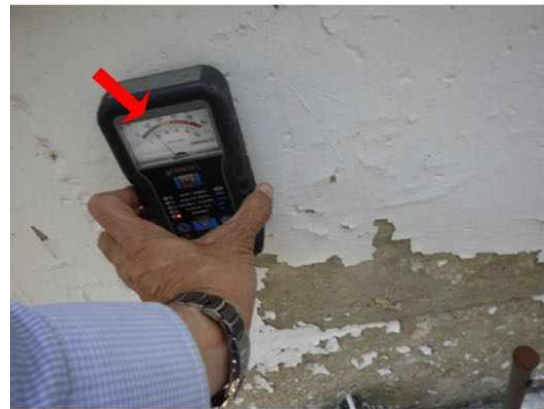
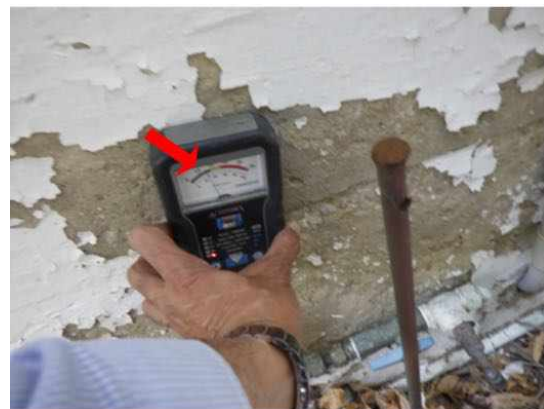
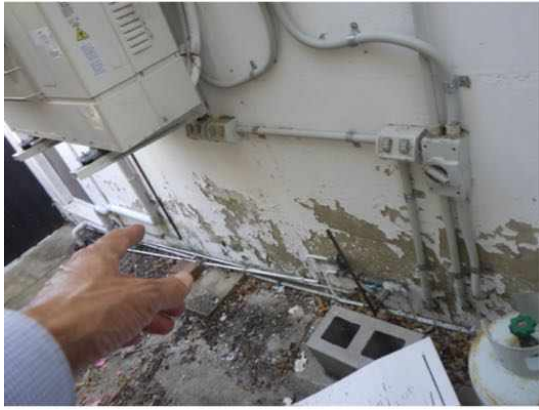
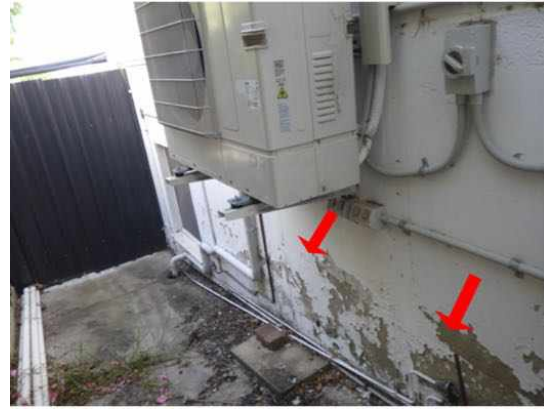
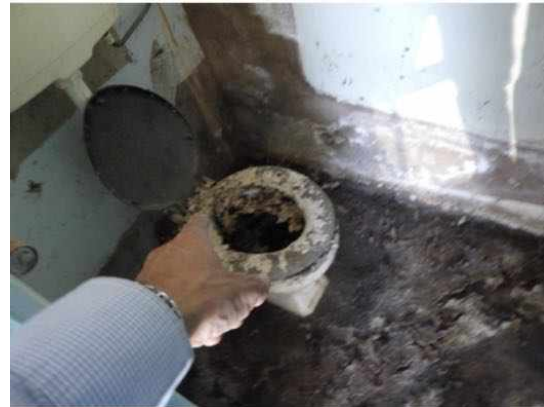
Defects 3.04

Building:	Building 1
Location:	All External Areas
Finding:	External Walls - Damp
Information:	At the time of inspection it was noticed that mild moisture readings were noted in few external wall sections around the property.

Damp (or structural damp) refers to the presence of unwanted moisture in the structure of a building, either as the result of intrusion from outside, or condensation from within the structure. Generally, structural damp is caused by rain penetration, rising damp, and leaks from plumbing pipes.

Unmanaged damp facilitates the formation and development of mould, fungi growth and wood rot, decaying associated building materials and compromising their structural integrity. Damage to finishes is also likely to occur, including lifting, bubbling, peeling and staining of paint, plaster and wallpaper.

The first step in addressing damp is to diagnose the cause. The identified cause should be addressed first prior to repairing the appearance and other defects which have resulted from the rising damp. If the original cause is not resolved, further cases of damp are likely to ensue, resulting in secondary defects.

Consultation with a qualified plumber is advised immediately to identify the cause of damp and perform remedial works as required. Where excessive mould growth is present, further inspection by a specialist environmental health inspector should also be considered.

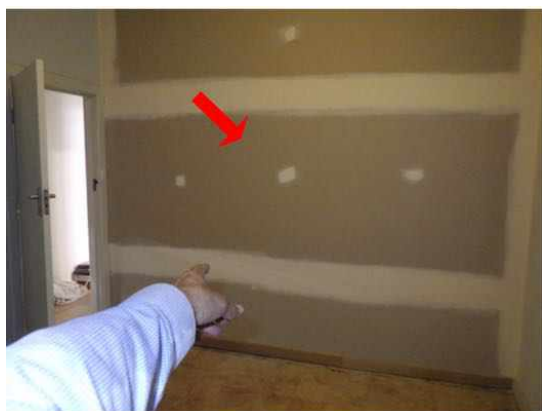
Defects 3.06

Whilst incomplete or missing paint finish is generally an appearance defect, it can also lead to the development of secondary building defects over time. Incomplete areas of paint finish expose the area to moisture, potentially accelerating the deterioration of underlying building materials.

Incomplete paint finishes should be sanded back, filled, leveled and painted, as applicable. Where inadequate or missing paint protection has led to the deterioration of the associated building element, repair and/or replacement of this building element may be required.

A painting contractor should be appointed as soon as possible to perform necessary works to aid the appearance of the affected area and to ensure the area is protected against further deterioration. Alternatively, the homeowner following manufacturer instructions may perform these works.

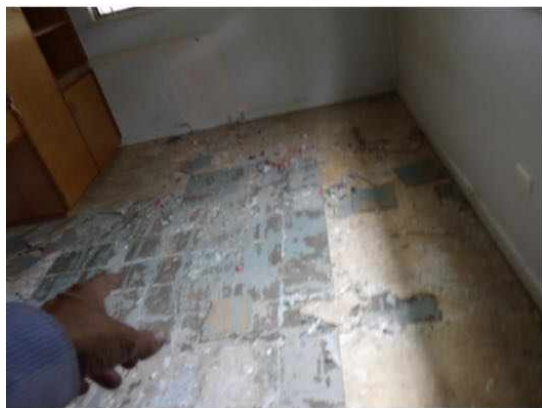
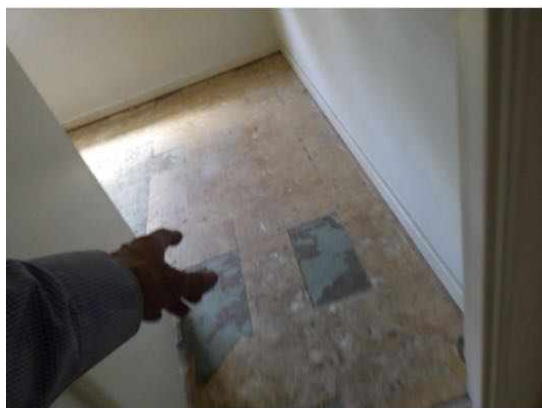
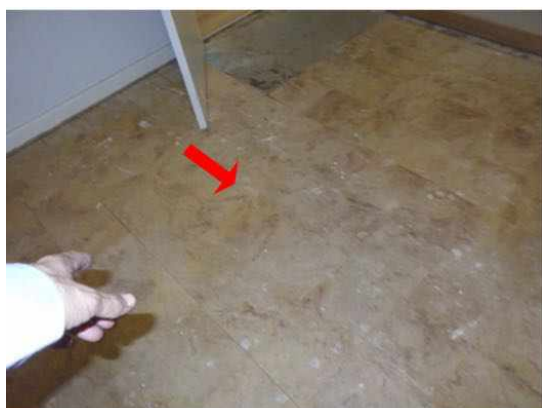
Defects 3.07

Building:	Building 1
Location:	All Internal Areas
Finding:	Carpet - Missing/ Not installed
Information:	At the time of inspection it was noticed that carpet is missing / not installed in this bedrooms area. Although some building elements may seem irrelevant or unnecessary, all building elements play a key role in the operation and function of the overall structure and its performance.

Replacement of any missing building element should be conducted as soon as possible to ensure that no damage or functional issues occur to associated building materials.

The appropriate tradesperson should be appointed as soon as possible to replace the missing building element.

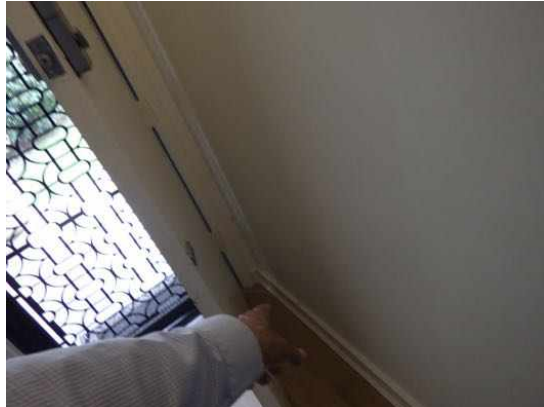
Defects 3.08

Building:	Building 1
Location:	All Internal Areas
Finding:	Door stop - Missing
Information:	The door stop is missing or is inadequate to stop the door handle from damaging the wall. Although some building elements may seem irrelevant or unnecessary, all building elements play a key role in the operation and function of the overall structure and its performance.

Re-installation or replacement of the door stop is advised as soon as possible to prevent any subsequent damage to the door or associated structures. A general handyman may be appointed to perform these works at client discretion.

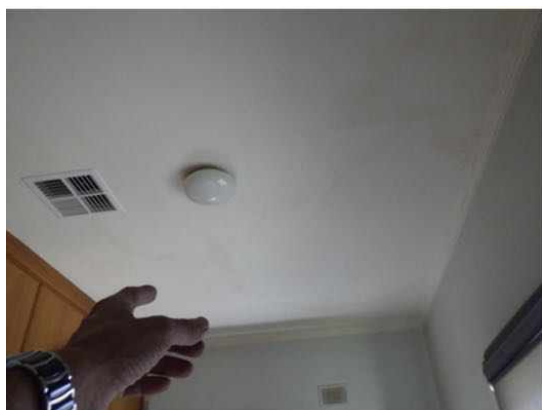
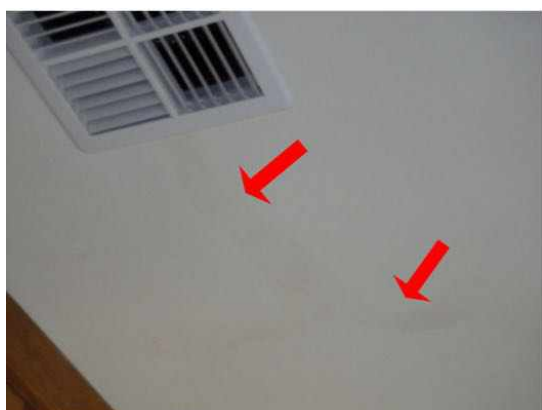
Defects 3.09

Building:	Building 1
Location:	All Internal Areas
Finding:	Ceiling - Water stained
Information:	Water staining to ceiling linings in this bedroom-3 area was evident at the time of inspection. Water staining indicates that surfaces have been exposed to excessive moisture over time. The minerals and other elements in the water lead to staining, which may graduate to corrosion and deterioration if left unmanaged.

While mostly an appearance defect, water staining can be indicative of more serious

defects, which may be currently concealed by interior ceilings.

Where water staining is active, a licensed plumber must be consulted to identify the cause of the staining and to provide advice on any reparation works that may be required. Replacement of any damaged structures is advised.

Conversely, where water staining is old and inactive, affected building materials may be repaired or replaced at client discretion.

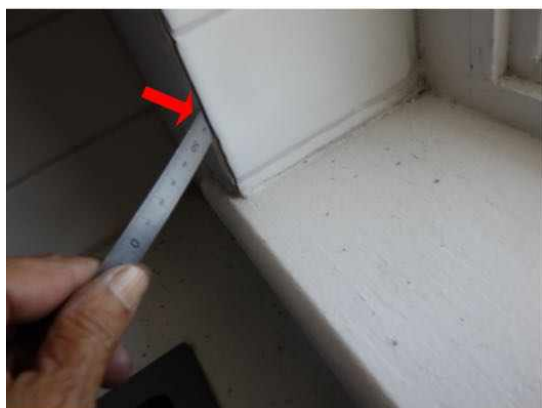
Defects 3.11

Building: Building 1
 Location: All Internal Areas
 Finding: Grout - Missing/ Deteriorated
 Information: Grout is missing/ deteriorated in this laundry area. Grout is used to protect gaps and crevices in building materials to ensure that they are water-tight and prevent water penetration to the associated structures.

Where grout is missing, a tiling contractor should be appointed immediately to apply grout and re-apply any silicone where necessary. Failure to do so is likely to lead to water damage to the surrounding area.

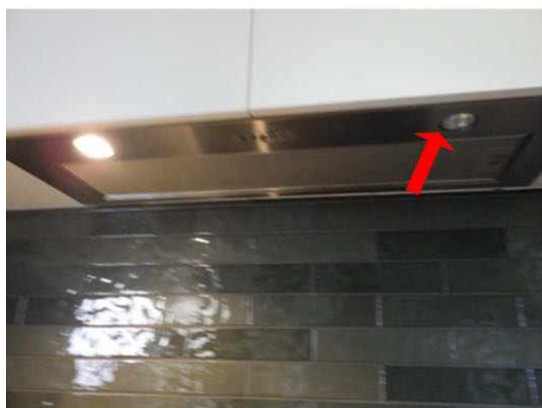
Defects 3.12

Building:	Building 1
Location:	Kitchen
Finding:	Rangehood - Light not working
Information:	While the range hood appears to be working at a satisfactory level, the one light to the appliance was not working at the time of inspection.

A licensed electrician should be appointed to replace the light on the range hood to restore it to a fully operational state.

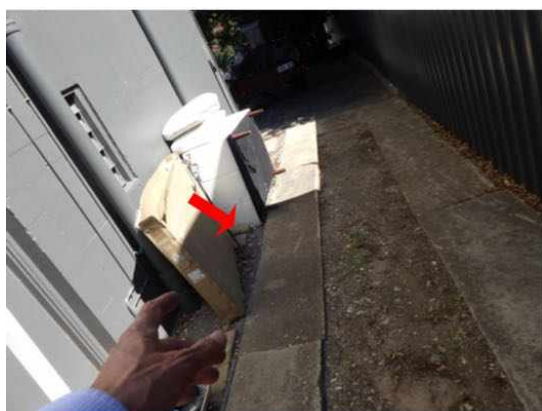
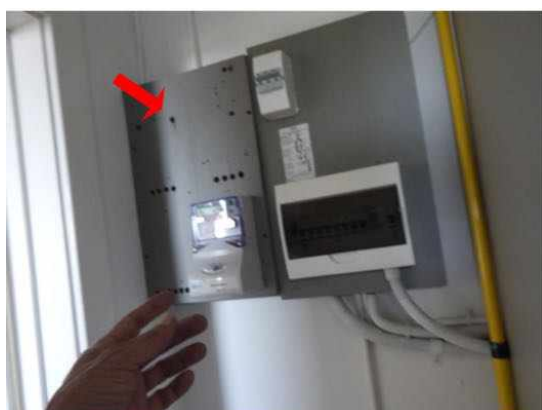
Building:	Building 1
Location:	All External Areas >
Finding:	Termite Management System - No evidence of a chemical installation
Information:	The application of a post-construction chemical termite barrier is highly recommended for all properties, particularly if live termite activity has been found on the site previously. Such barriers are highly effective in preventing termite attack on any timber building elements throughout the property.

A durable notice should be placed in the switchboard unit to indicate current termite barriers. At the time of inspection, it appeared as though no termite management system has been installed, with no evidence to suggest preventative works taking place.

The client may consider gaining further advice from a pest controller as to the costs and procedures involved with this application. It is recommended that obtaining such advice be a short-term priority.

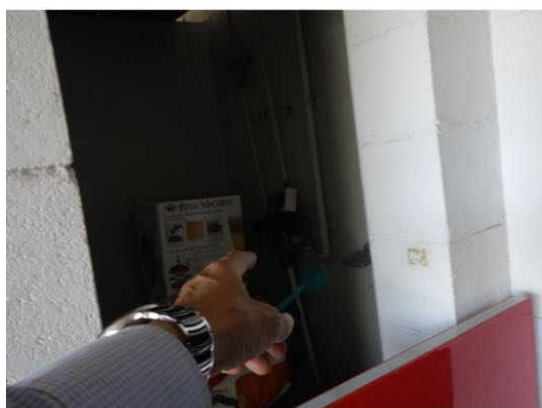
Building: Building 1
Location: All External Areas
Finding: External Area - Shower area- Obstructions and Limitations
Information: At the time of inspection it was noticed that shower area is blocked with stored materials in the external sub floor area. These photographs are an indication of the obstructions and limitations which impeded full inspection of the property at the time of inspection. These obstructions can hide an array of defects and should be removed to allow full inspection to be carried out. A re-inspection is recommended once the areas are made accessible.

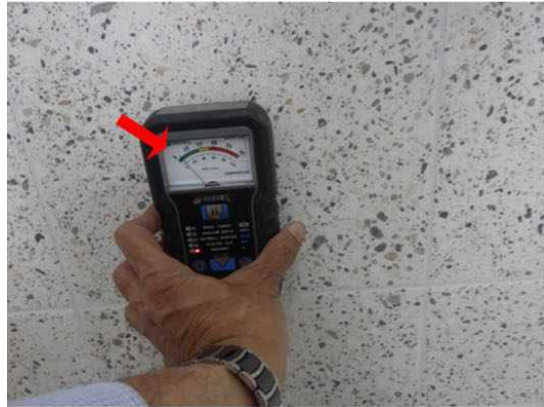
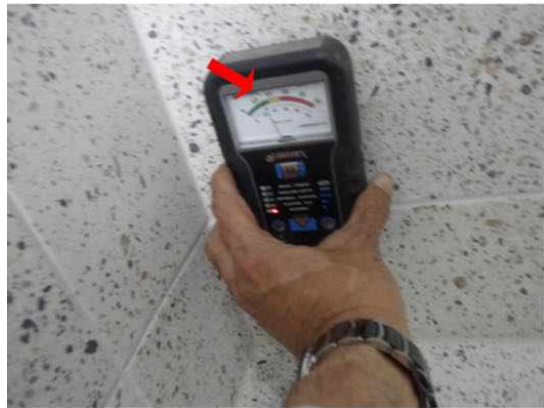
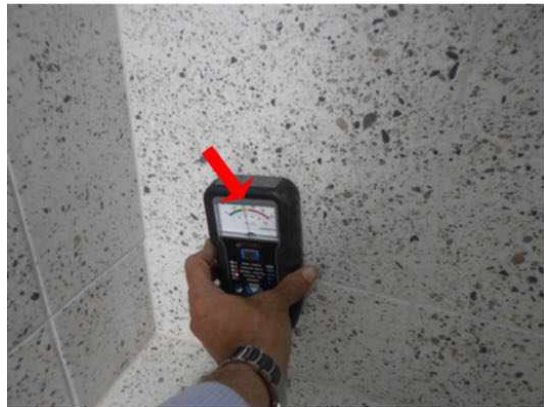
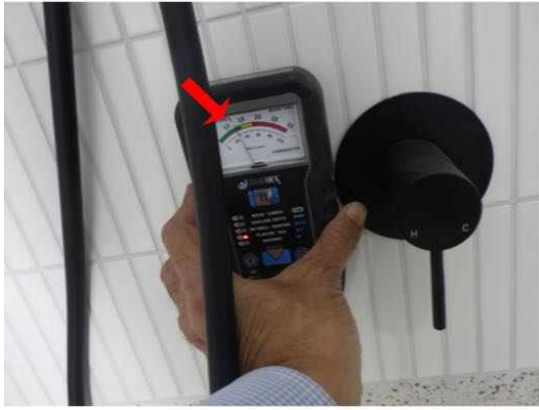
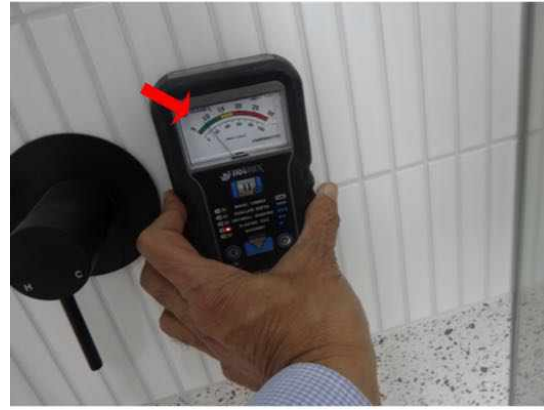
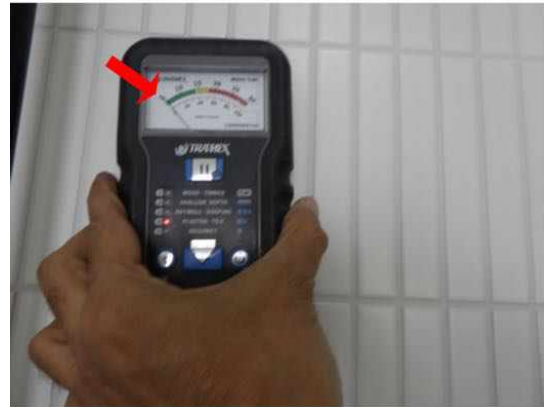
Building: Building 1
Location: Bathroom-Ensuite
Finding: Shower Alcove - No Damp
Information: At the time of inspection it was noticed that damp is not evident to the shower alcove.

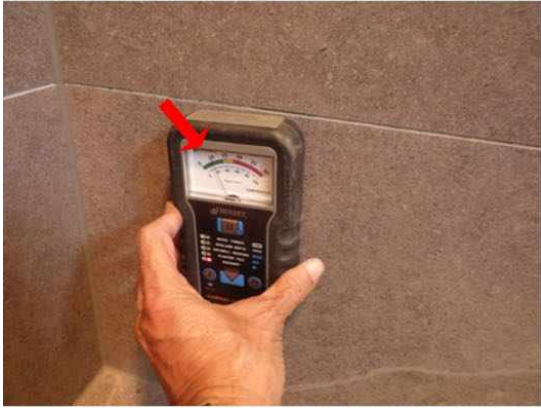
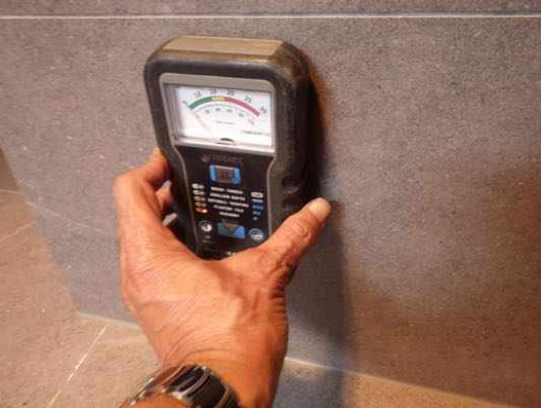
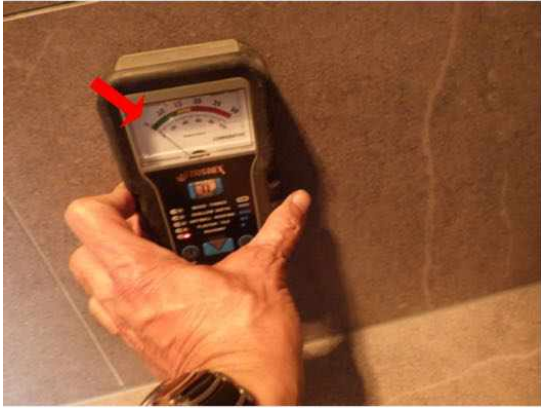
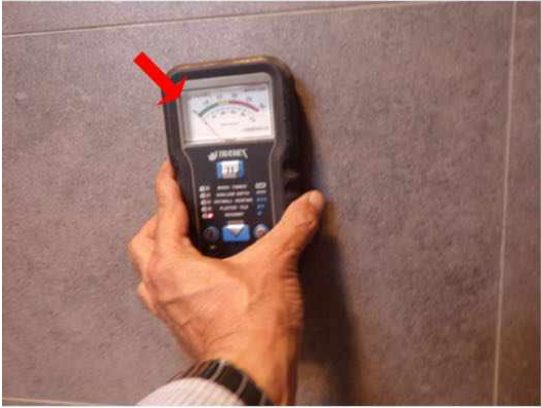
Building: Building 1
 Location: Bathroom 2
 Finding: Shower Alcove - No Damp
 Information: At the time of inspection it was noticed that damp is not evident to the shower alcove.
