# Building and Timber Pest Inspection Report

Inspection Date: Wed, 8 Apr 2026

Property Address: 9 Ravine Dr, Wollert VIC 3750, Australia

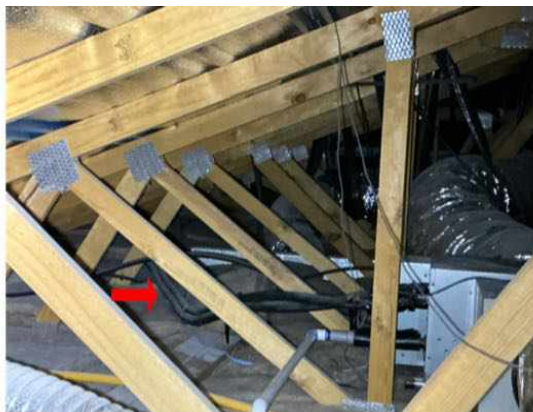
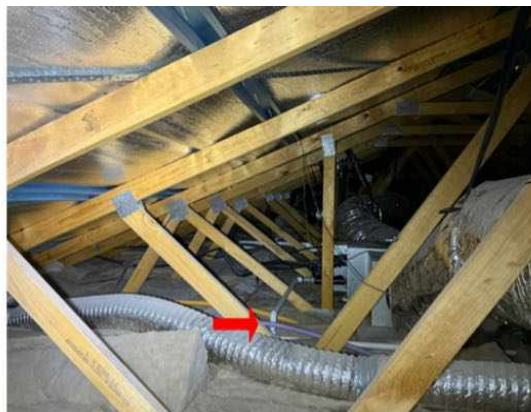
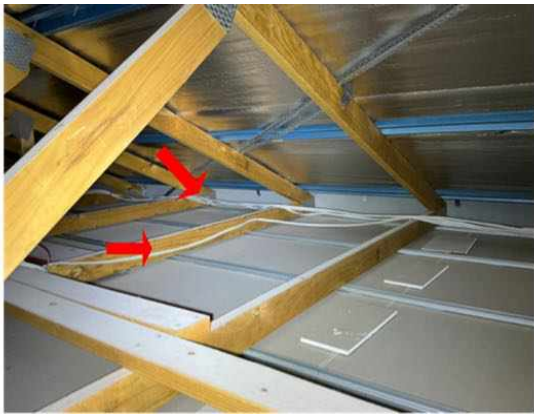
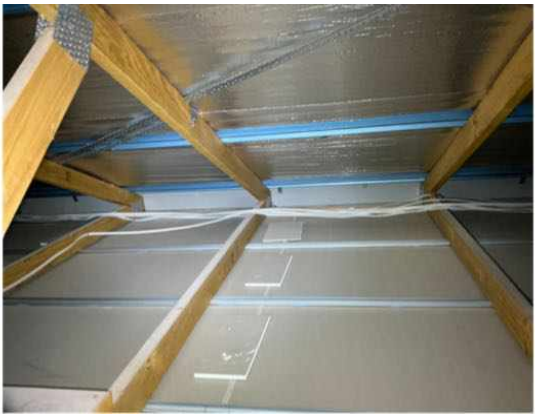
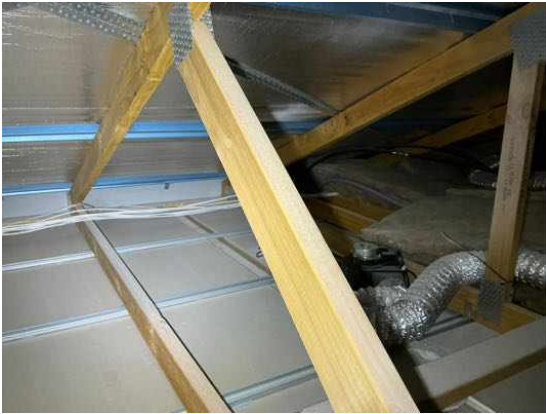
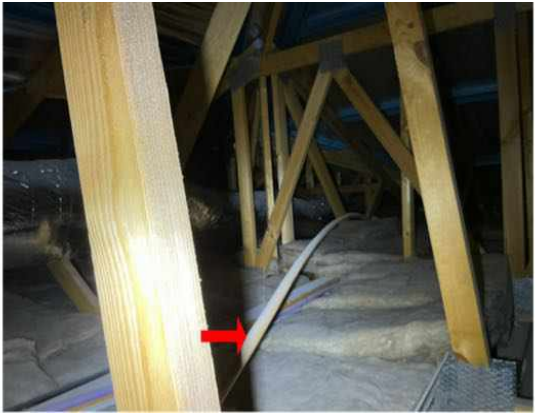
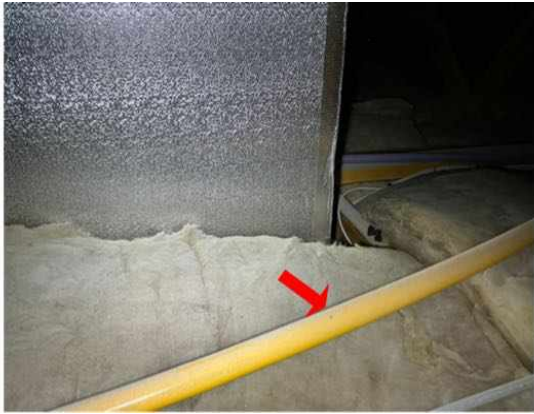
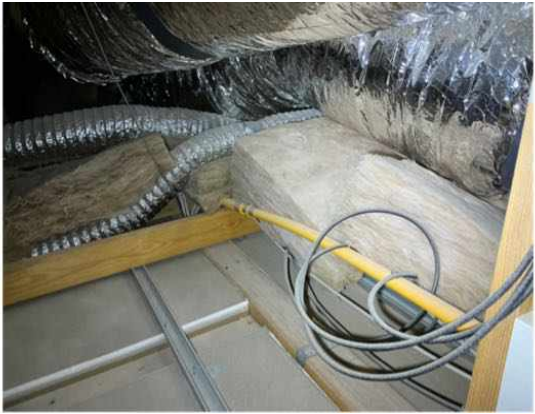
Building: Main Building  
Location: Roof Void  
Finding: Inadequate Support to Wiring and Pipework Within Ceiling Cavity  
Information: Electrical wiring and plumbing pipework within the ceiling cavity were observed to be inadequately supported, with sections not properly clipped or secured to structural members. This condition is typically associated with poor installation or incomplete works and allows movement of services over time. Unsupported wiring may be more susceptible to mechanical damage, increasing the risk of electrical faults or fire, while inadequately supported pipework may place strain on joints and fittings, potentially leading to leaks or failure. While no active faults were observed at the time of inspection, this condition presents a potential safety hazard if left unaddressed. Please note this is not an electrical or plumbing report, and the above is provided as a professional opinion based on visual inspection only.

Engage suitably qualified trades (licensed electrician and/or plumber) to properly secure and support all wiring and pipework in accordance with relevant standards, ensuring they are clipped at appropriate intervals and protected from damage.

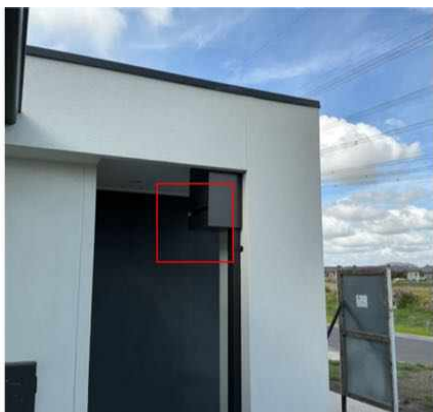
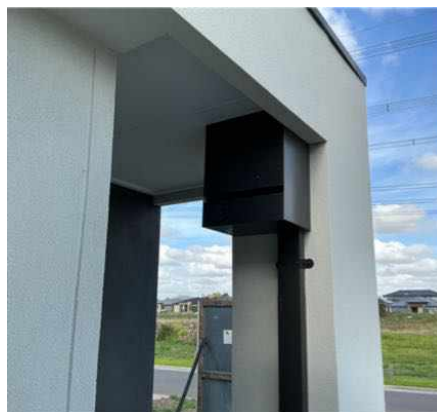
**Finding 2.01**

concentrated water flow in this location can lead to deterioration of door frames, internal finishes, and adjacent building elements, and may contribute to moisture-related damage over time. Given the potential for direct water entry into the property, this condition is considered a major defect.

Engage a licensed roof plumber to redirect the rain head overflow to an appropriate discharge point away from the building, ensuring water is safely conveyed to a compliant stormwater system and does not impact the entry area.

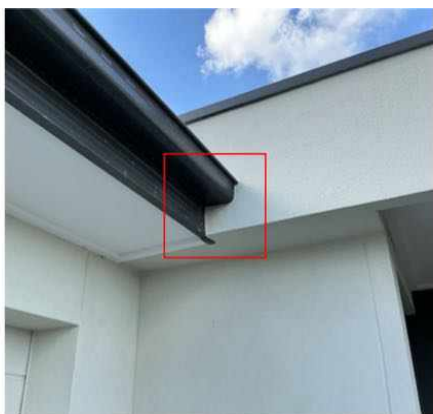
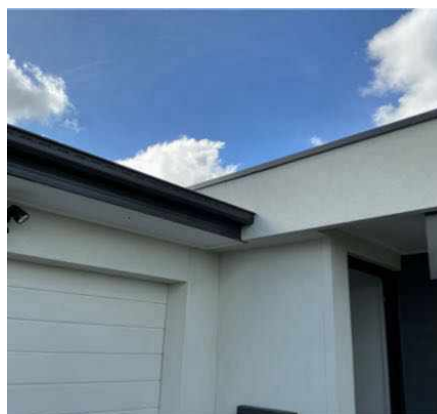
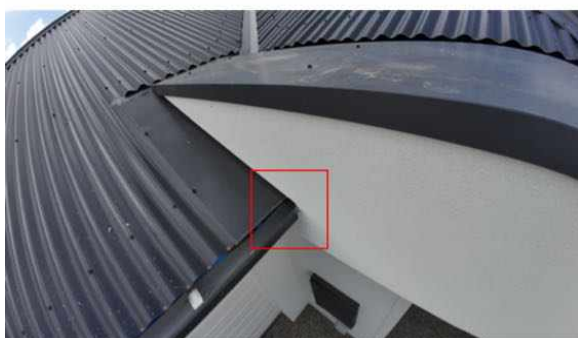
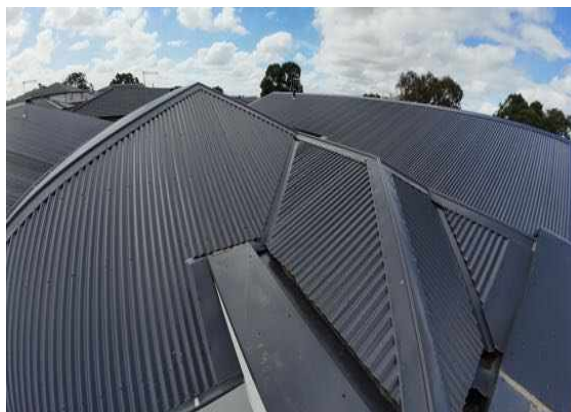
## Finding 2.02

Building:	Main Building
Location:	Exterior walls - front
Finding:	Gutter and Fascia Set into Adjacent Wall Cladding
Information:	The gutter and fascia have been installed in a manner that is set into or in direct contact with the adjacent wall cladding. This configuration restricts proper drainage and allows water to track behind the cladding or become trapped at the junction, particularly during rainfall or overflow events. The lack of appropriate separation and flashing at this interface significantly increases the risk of moisture ingress into the wall assembly. Ongoing exposure to moisture in this area can lead to deterioration of cladding materials, decay of structural framing, and concealed damage within the wall cavity. Given the potential for hidden damage and continued water ingress, this condition is considered a major defect.

Engage a suitably qualified builder or roof plumber to urgently assess the junction and implement appropriate rectification works, including installation of compliant flashing and separation detailing to prevent water ingress and protect surrounding building elements.

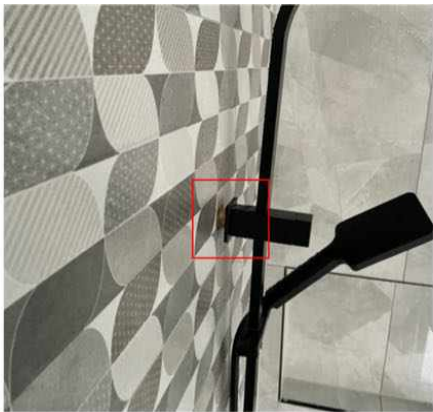
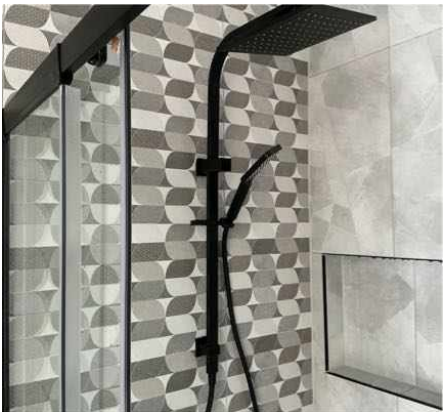
### Finding 2.03

Building:	Main Building
Location:	Ensuite - Master
Finding:	Incomplete Shower Rose Connection Causing Water Discharge
Information:	<p>The connection between the shower rose assembly and the wall plumbing was observed to be incomplete, resulting in water being expelled from the wall fitting during use. This indicates a failed or improperly installed connection, allowing water to escape at the wall interface and potentially enter concealed wall cavities. Ongoing water discharge in this manner can lead to rapid deterioration of internal wall linings, timber framing, and insulation, as well as promote mould growth and associated health concerns. Given the active nature of the leak, concealed damage may already be occurring, although this was not visible at the time of inspection.</p>
Recommendation:	<p>Engage a licensed plumber as a matter of urgency to rectify the connection, ensure all fittings are watertight, and assess for any concealed moisture damage within the wall cavity.</p>

A further major defect was identified within the ensuite, where the shower rose connection is incomplete, resulting in water being discharged from the wall fitting during use. This condition presents an immediate risk of moisture ingress into concealed wall cavities and may lead to deterioration of internal linings, framing, and insulation, along with potential mould development if not rectified promptly.

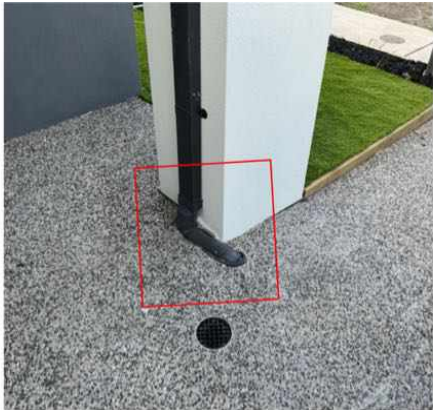
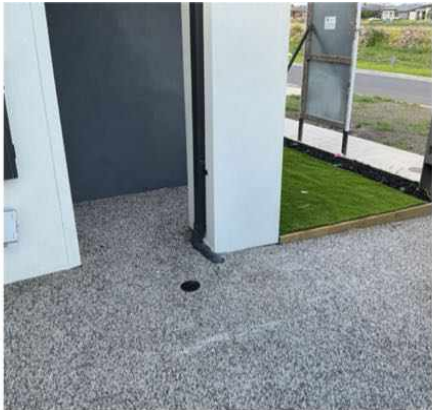
**Finding 3.01**

Building: Main Building  
Location: Exterior walls - front  
Finding: Downpipe Set into Concrete Paving Without Mechanical Protection  
Information: The downpipe has been set into and runs across the concrete paving with the upper section exposed and lacking adequate mechanical protection. This configuration leaves the pipe vulnerable to physical damage from foot traffic, equipment, or general use of the paved area. Damage to the pipework may result in leaks or ineffective discharge of stormwater, potentially leading to water accumulation adjacent to the building and associated moisture-related issues. The installation does not reflect typical good plumbing practice, where stormwater pipework should be adequately protected, enclosed, or routed to minimise the risk of damage.

Engage a licensed plumber to assess the installation and provide appropriate mechanical protection to the pipework or reroute the downpipe to a more suitable configuration, ensuring durability and proper stormwater discharge.

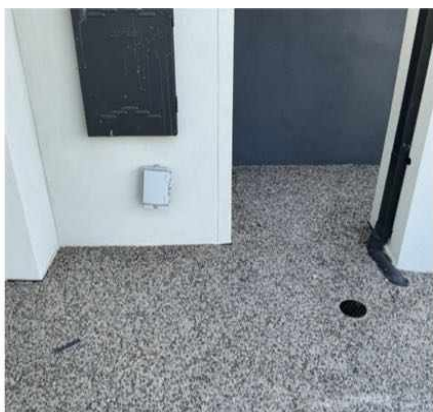
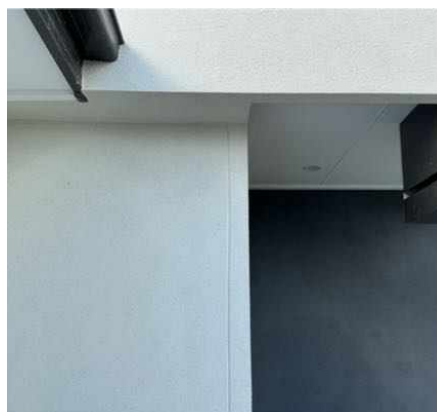
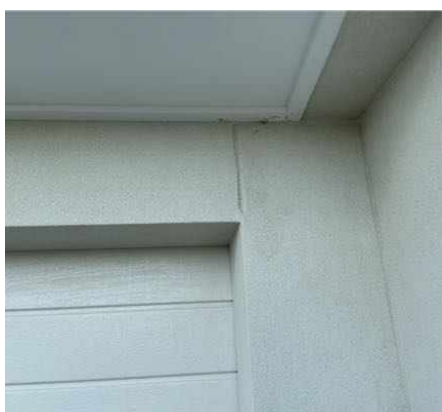
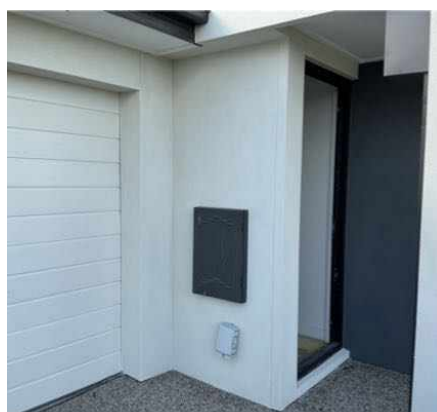
### Finding 3.02

Building: Main Building  
 Location: All Areas  
 Finding: Articulation Joints Covered by Render  
 Information: Render has been applied over articulation joints, preventing the joints from functioning as intended. Articulation joints are designed to accommodate movement within the structure, and covering them restricts this movement, increasing the likelihood of cracking and stress transfer to adjacent wall sections. This condition may result in progressive cracking of the render and underlying masonry, and can allow moisture ingress through compromised areas over time. Given the impact on structural movement and the potential for ongoing deterioration, this is considered a major defect.

Externally, articulation joints have been covered by render, preventing them from functioning as intended. This restricts normal structural movement and is likely to result in cracking and potential

Engage a suitably qualified builder or remedial contractor to reinstate the articulation joints by removing render from these locations and installing appropriate flexible jointing to allow for movement and prevent further damage.

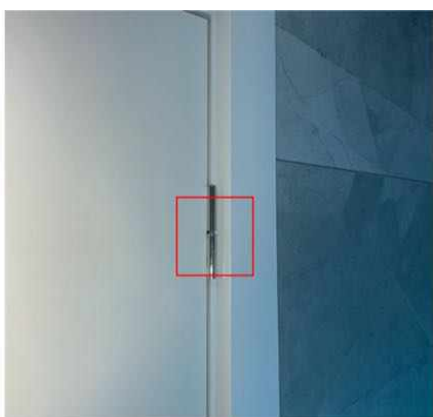
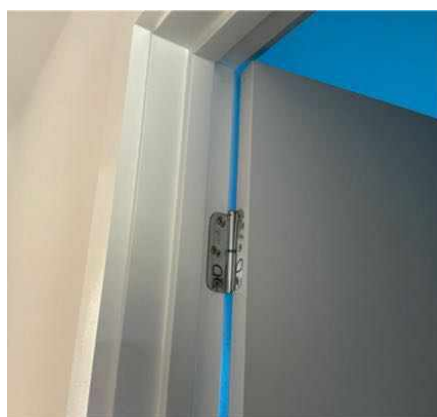
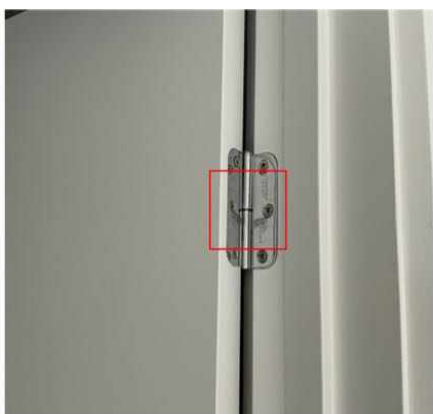
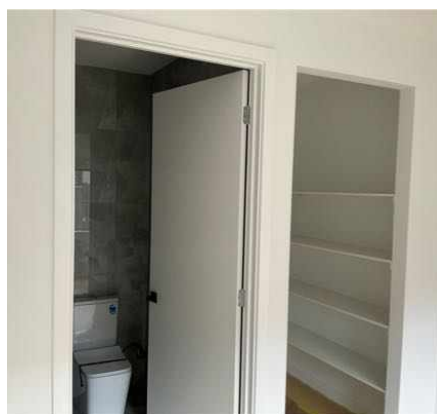
### Finding 3.03

Location: Bathroom and ensuite  
 Finding: Lift-Off Door Hinges Inadequately Installed  
 Information: Lift-off door hinges were observed to be inadequately installed, resulting in a loose door leaf. This condition is typically associated with poor fixing, misalignment, or insufficient anchoring of hinge components, allowing movement of the door during operation. Continued use in this state may lead to increased wear on the hinges, potential damage to the door or frame, and reduced functionality over time. No associated structural damage was noted at the time of inspection.

Engage a suitably qualified carpenter to reinstall or secure the hinges correctly, ensuring the door leaf is properly aligned and operates as intended.

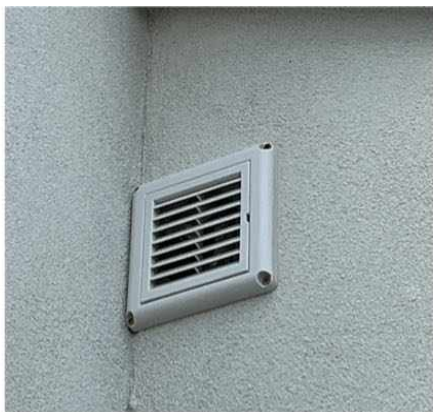
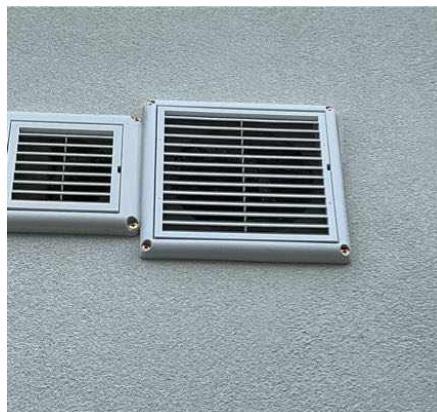
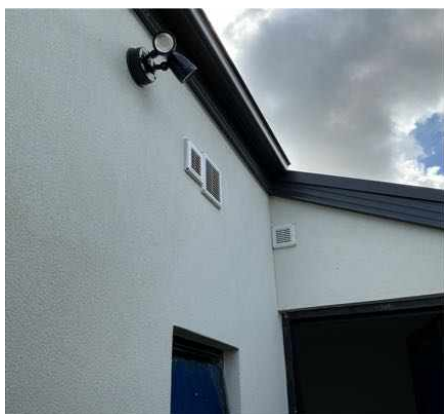
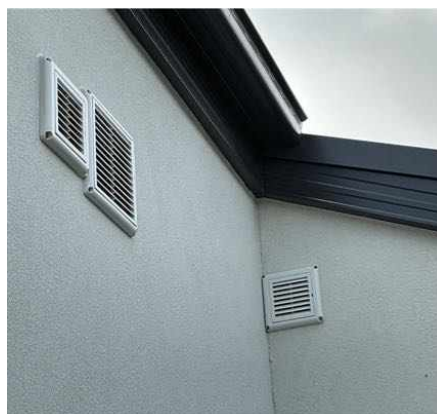
### Finding 3.04

Building: Main Building  
 Location: Exterior walls - right side  
 Finding: Ductwork Inadequately Connected to External Vent Covers  
 Information: Ductwork associated with exhaust ventilation was observed to be inadequately connected to the external vent covers, indicating incomplete or poorly secured installation. This condition may allow moist air to discharge into ceiling or wall cavities rather than externally, potentially leading to condensation build-up, mould growth, and

deterioration of surrounding building materials over time. While no associated damage was observed at the time of inspection, the current configuration reduces the effectiveness of the ventilation system.

Engage a suitably qualified tradesperson (such as a licensed electrician or HVAC technician) to properly connect and secure the ductwork to the external vent covers, ensuring all exhaust air is discharged to the outside as intended.

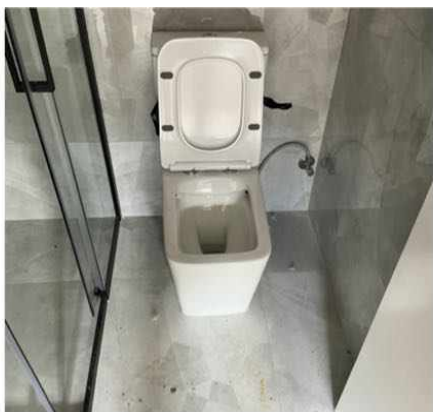
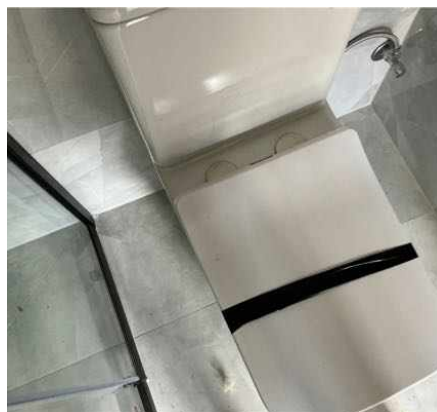
### Finding 3.05

Building: Main Building  
 Location: Ensuite  
 Finding: Loose Toilet Seat  
 Information: The toilet seat was found to be loose, likely due to worn or inadequately tightened fixings at the hinge points. This condition may result in movement during use and can lead to further loosening or damage to the seat or pan if left unaddressed. No associated damage was noted at the time of inspection.

Engage a suitably qualified tradesperson or handyman to tighten or replace the fixings and ensure the toilet seat is securely mounted and functioning as intended.

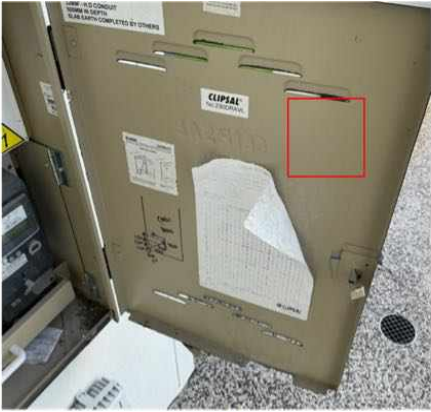
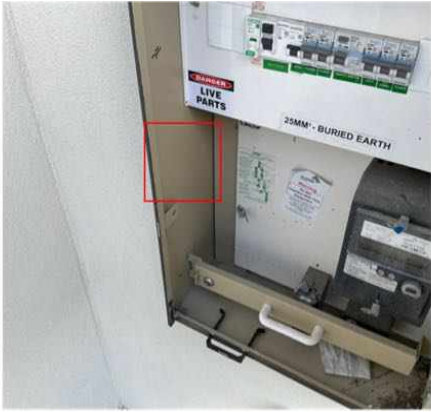
Building:	Main Building
Location:	Meter Box
Finding:	Termite Management System - no evidence of a chemical installation
Information:	The application of a post-construction chemical termite barrier is highly recommended for all properties, particularly if live termite activity has been found on the site previously. Such barriers are highly effective in preventing termite attack on any timber building elements throughout the property.

A durable notice should be placed in the switchboard unit to indicate current termite barriers. At the time of inspection, it appeared as though no termite management system has been installed, with no evidence to suggest preventative works taking place.

The client may consider gaining further advice from a pest controller as to the costs and procedures involved with this application. It is recommended that obtaining such advice be a short-term priority.

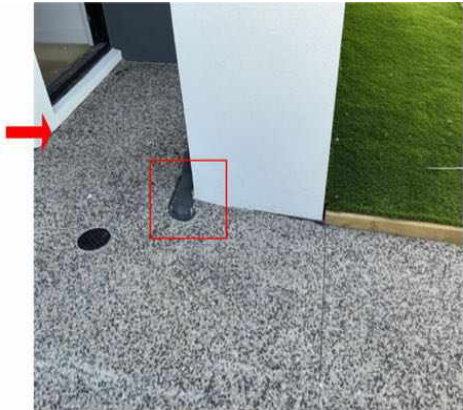
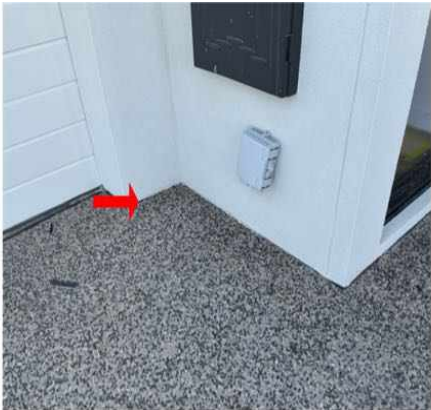
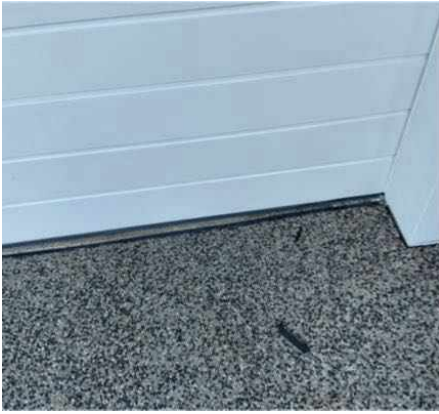
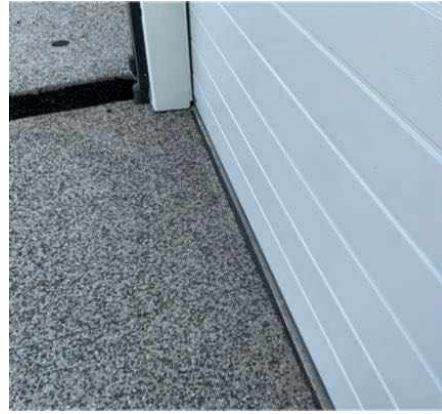
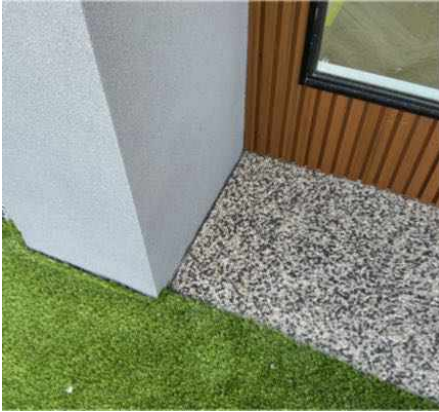
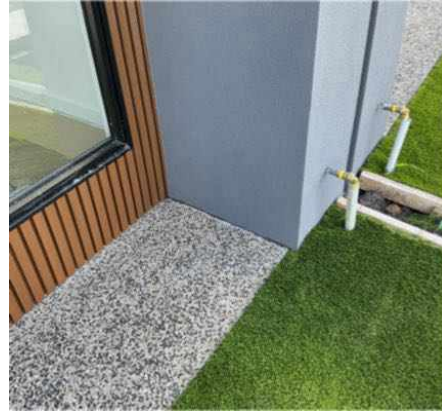
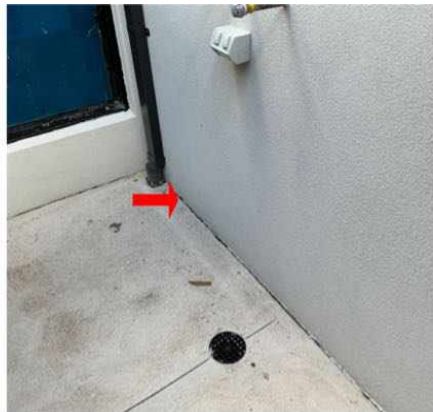
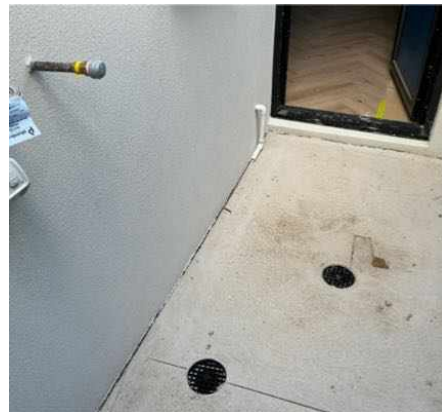
**Finding 6.02**

Building: Main Building  
Location: All Areas  
Finding: Paving articulation joints - Inadequate  
Information: The articulation or control joints to the exterior paving were deemed as insufficient at the time of inspection.

Articulation joints must be cleaned of all non-compressive material and then sealed with an appropriate flexible sealant. Failure to perform these necessary works is likely to lead to excessive moisture ingress into these joints, or cracking to the brick walls during extreme weather conditions, which may carry major implications for associated building elements if left unmanaged.

These preventative works are important in ensuring the structural integrity of the associated structure. Appointment of a qualified builder or sealant contractor is advised to perform remedial works as necessary.

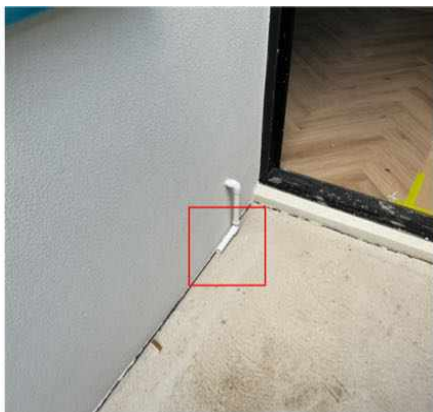
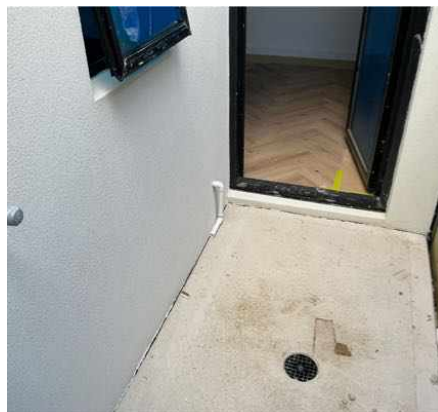
### Finding 6.03

Building:	Main Building
Location:	Exterior walls - right side
Finding:	Air conditioner - Disconnected overflow
Information:	The Air Conditioner (A/C) overflow was found to be disconnected from storm water drainage and is creating excessive moisture in the surrounding area.

Such leaking creates an environment which is conducive to an array of defects, including water damage to associated building elements and the attraction of termite or timber pest infestation.

It is highly recommended that a licensed plumber be appointed to connect the A/C

overflow in order to prevent such an environment from being created. These minor works should be carried out as soon as possible.

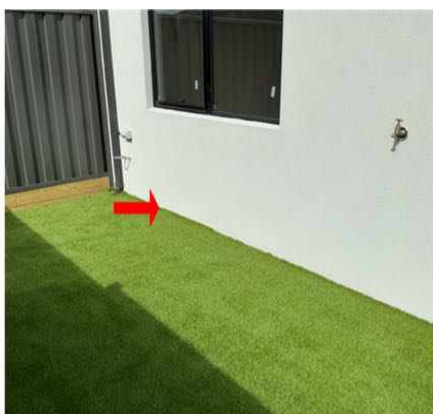
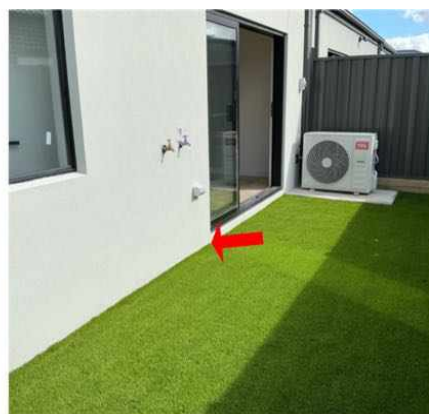
### Finding 6.04

Building: Main Building  
 Location: All Areas  
 Finding: Slab Edge - Exposure  
 Information: An inspection zone of at least 75mm in relation to the exposed slab edge, between the bottom brick and the perimeter pavement, is required. This inspection zone should be maintained in order to force termites into the open where they can be detected more readily during regular inspections. The slab edge should not be concealed by anything that may prevent inspection of the area, including render, landscaping, soil, turf, paving, concrete cladding or other structures.

If the slab edge is not properly exposed there is a high risk of termite attack. Sometimes, in order to determine the type of slab, a suitably qualified person such as an architect or builder may be required to consult the construction plans.

Where the slab edge cannot be properly inspected, it is highly recommended that termite or timber pest inspections be carried out every 6-12 months to aid protection of the property against infestation.

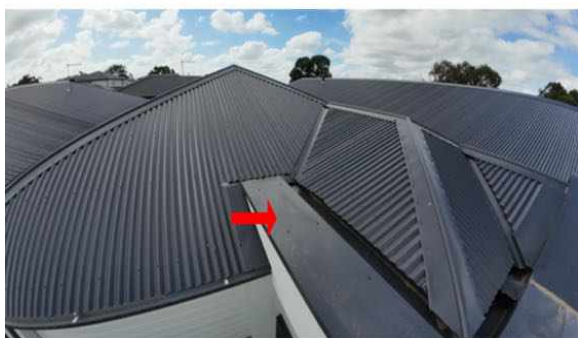
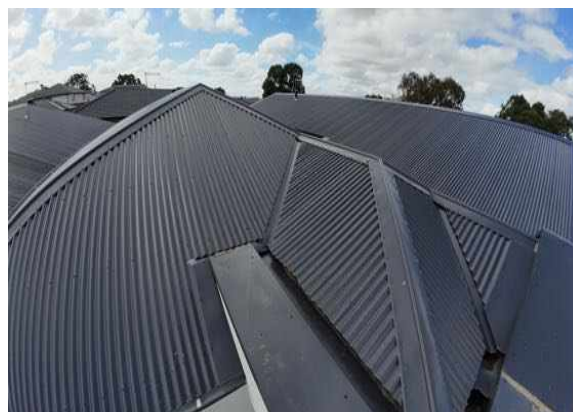
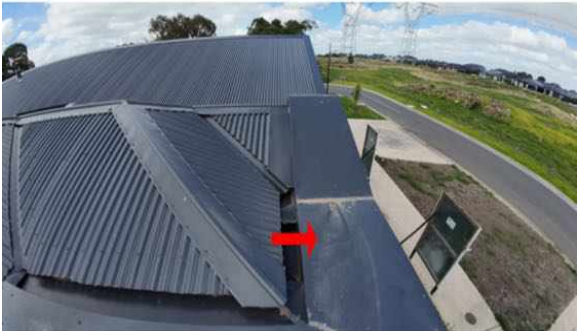
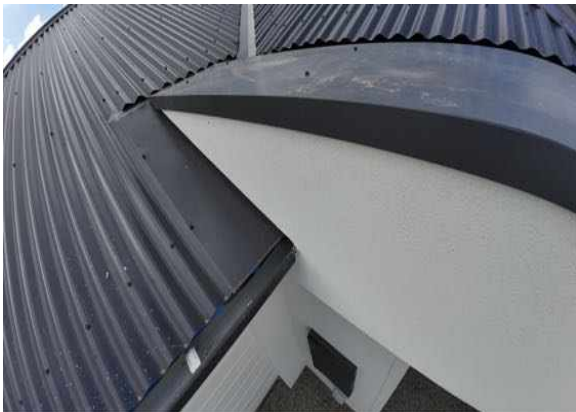
Building: Main Building  
Location: Roof Exterior  
Finding: Ponding to Parapet Flashing  
Information: Evidence of ponding water was observed to the parapet flashing, indicating inadequate falls or deformation of the flashing preventing effective drainage. This condition allows water to remain on the surface rather than being directed to appropriate discharge points, increasing the likelihood of water ingress through laps, joints, or fixings. Prolonged ponding can accelerate deterioration of flashing materials, compromise waterproofing, and lead to concealed moisture damage within adjacent wall and roof structures. Given the ongoing exposure to standing water and associated risk of ingress, this condition is considered a major defect. Please note this is not a plumbing report, and the above is provided as a professional opinion based on visual inspection only.

Engage a licensed roof plumber to assess and rectify the falls and detailing of the parapet flashing, ensuring water is effectively directed to drainage points and does not pond on the surface.
