Building and Timber Pest Inspection Report

Inspection Date: Sat, 28 Mar 2026

Property Address: 22 Chambery Rd, Petrie QLD 4502, Australia

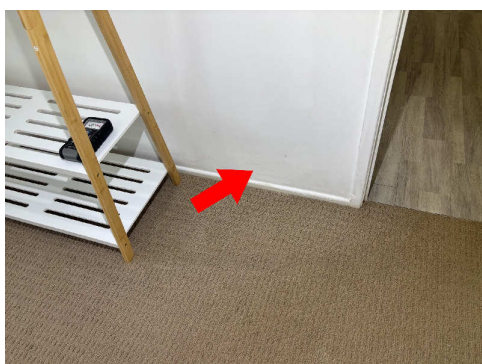
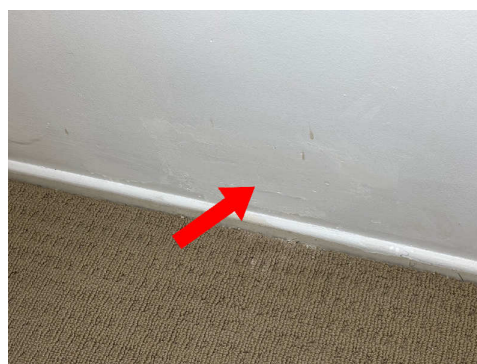
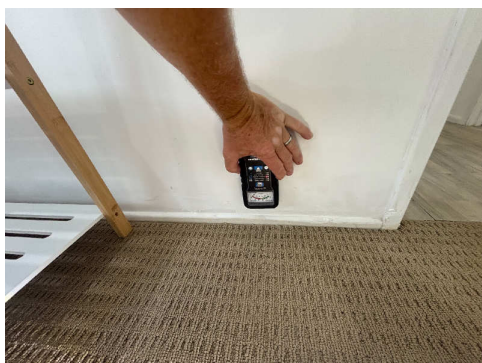
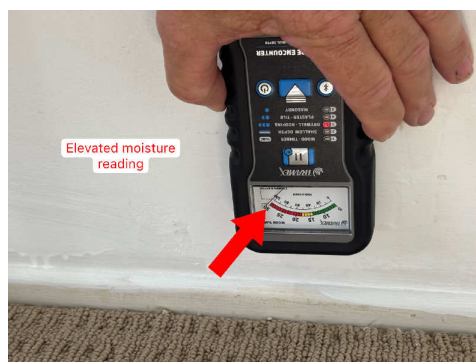
Finding 3.01

Finding: Bedroom 3 - evidence of moisture damage

Information: At the time of the inspection, it was noted that there was evidence of moisture damage to the wall in bedroom 3. The shower is on the other side of this wall. Elevated moisture readings were found in this area. This moisture may have been caused by a leak from the shower.

An invasive inspection may be required to determine the source of the moisture and if there is any damage in the wall cavity.

Moisture in a wall cavity can create a conducive environment for termite activity and can cause damage to the associated building materials.

A bathroom specialist (The grout guy, Megasealed) could be engaged to replace the grout and seal the wall and floor tiles to prevent moisture getting behind the tiles. This should be done as a short term priority.

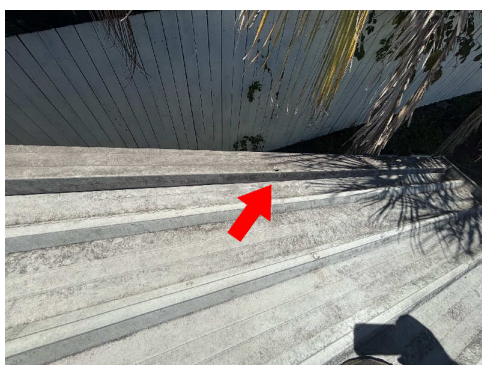
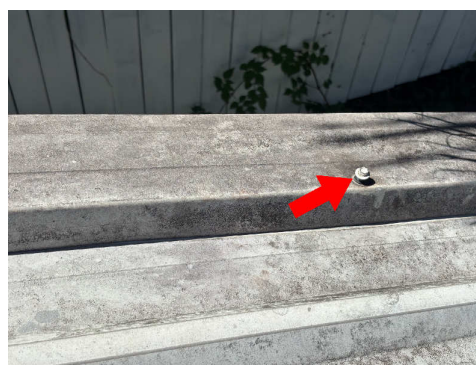
Finding 3.02

Finding: Roof exterior - loose roof fastener

Information: At the time of the inspection, it was noted that there was a loose roof fastener on the roof.

A building maintenance professional or roofing contractor should be engaged to re-secure the roof fastener. This should be done as a short term priority.

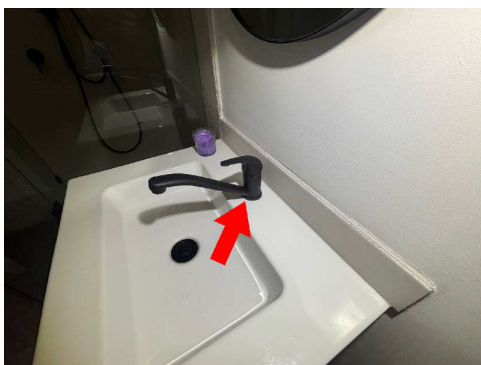
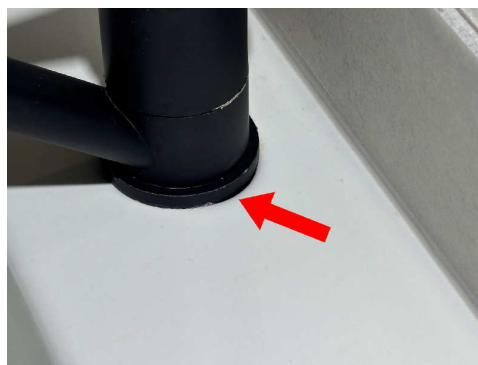
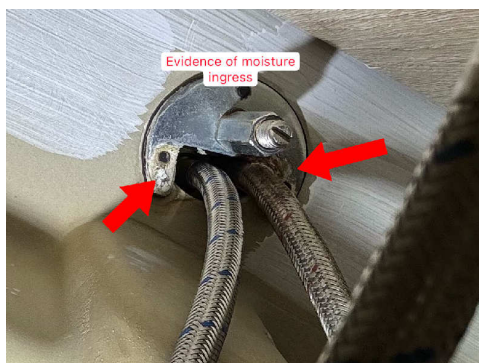
Finding 3.03

Finding: Bathroom - basin tap mal-aligned

Information: At the time of the inspection, it was noted that the mixer tap to the basin in the bathroom was mal-aligned and as a result there is a hole which can allow moisture into the vanity cabinet. There is evidence on the underside of the tap of moisture getting through the hole.

A licensed plumber should be engaged to re-align the mixer tap. This should be done as a short term priority.

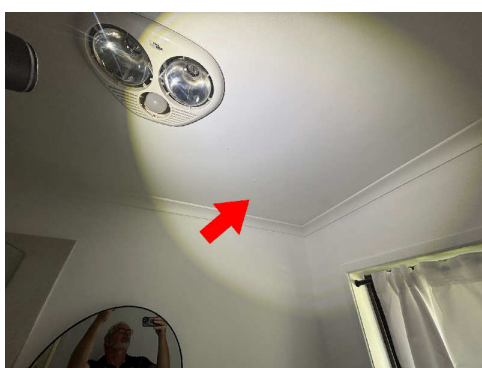
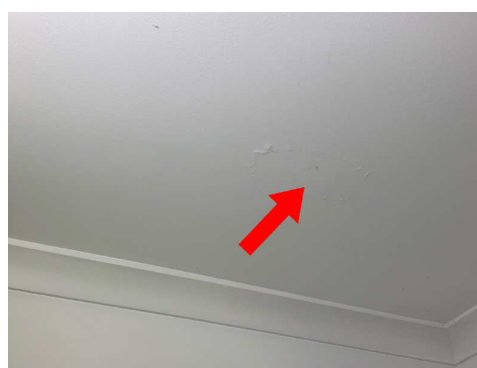
Finding 3.04

Building: Main Building
Location: Bathroom
Finding: Bathroom - paint peeling

Information: At the time of the inspection, it was noted that there was some minor paint peeling to the ceiling in the bathroom.

Peeling paint can be caused by moisture, poor preparation or age. There was no evidence of moisture found in this area. The ventilation fan in the bathroom does not appear to work and as a result moist air will not be extracted from the bathroom. A licensed electrician should be engaged to assess the ventilation fan.

A painter or building maintenance professional could be engaged to rectify this issue. This can be done at the clients discretion.

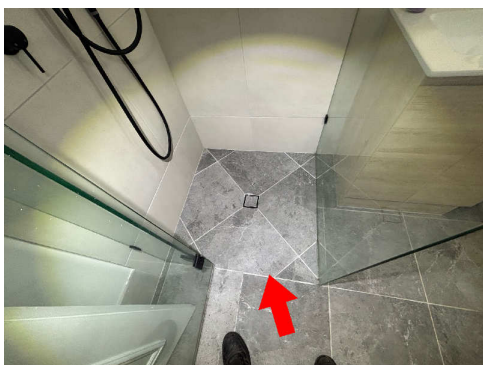
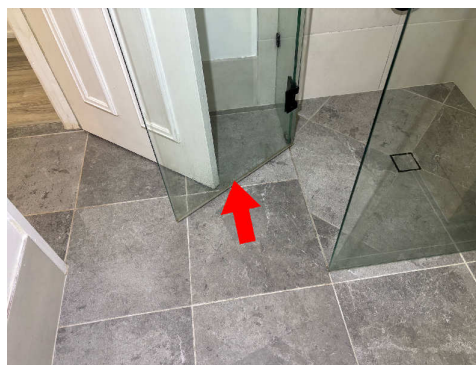
Finding 3.05

Information: At the time of the inspection, it was noted that the seal on the shower screen door does not touch the floor and there is no lip on the shower floor. As a result moisture cannot be contained in the shower when in use.

A bathroom specialist should be engaged to install an effective seal. This should be done as a short term priority.

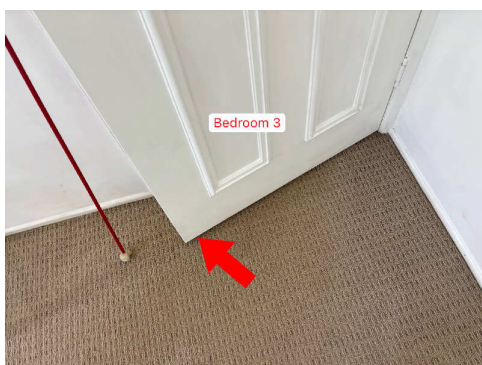
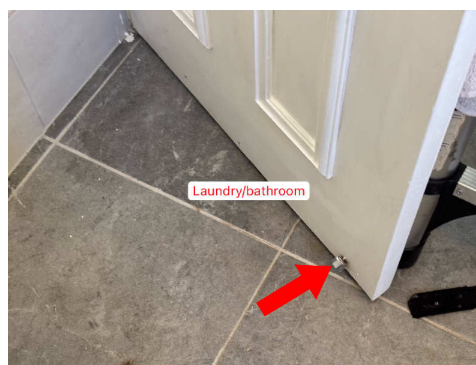
Finding 3.06

Finding: Door stops - Missing

Information: At the time of the inspection, it was noted that the door stop in bedroom 3 and laundry/bathroom is missing or is inadequate to stop the door handle from damaging the wall.

Re-installation or replacement of the door stop is advised as soon as possible to prevent any subsequent damage to the door or associated structures. A building maintenance professional may be appointed to perform these works at client discretion.

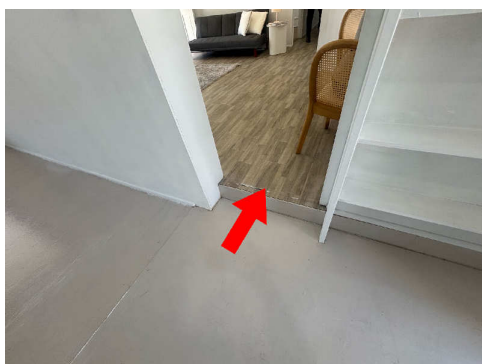
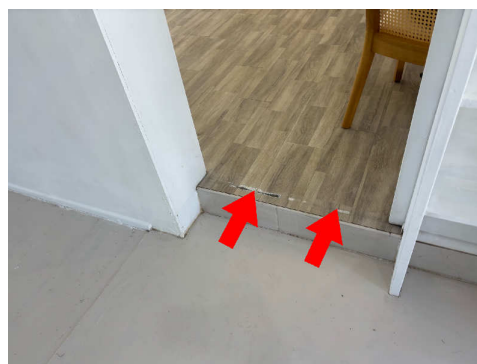
Finding 3.07

Information: At the time of the inspection, it was noted that the sliding door to the garage was binding on the overlay floor and causing damage. The runners for the sliding door need to be adjusted to stop the door from binding.

A building maintenance professional should be engaged to carry out this minor repair. This can be done at the clients discretion.

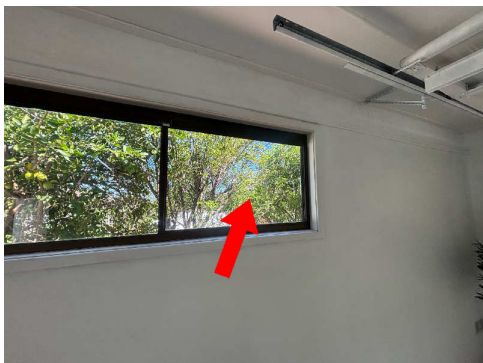
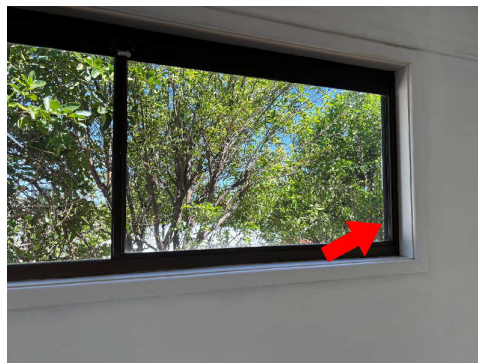
Finding 3.08

Information: At the time of the inspection, it was noted that there was no latch to the sliding window in the garage. As a result the window can be opened from the exterior allowing access to the dwelling.

A building maintenance professional should be engaged to install a latch to the window. This should be done as a short term priority.

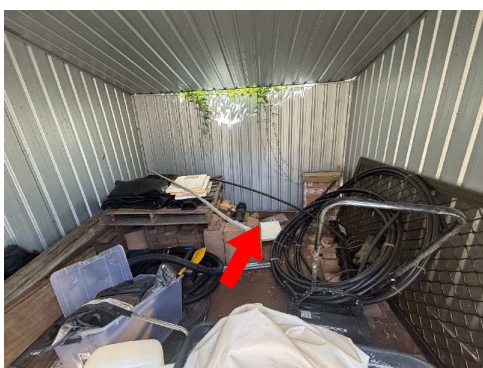
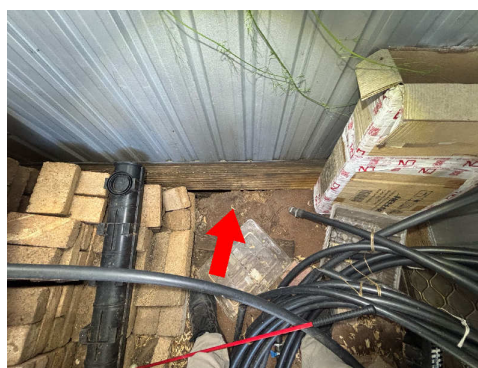
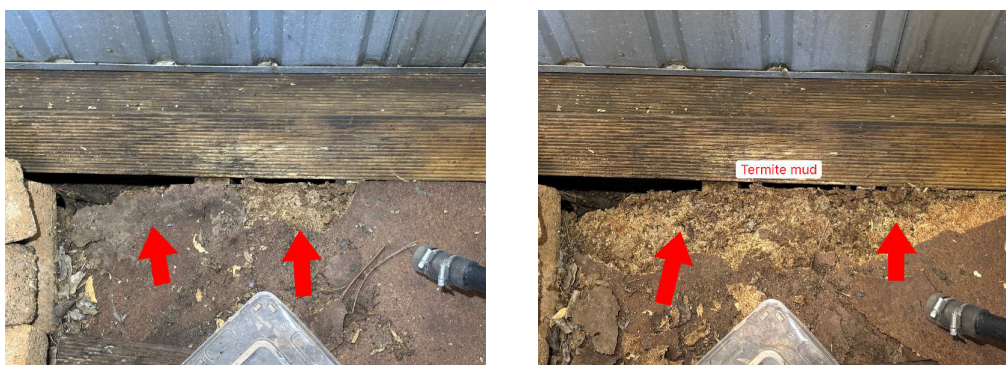
Evidence of termite damage and activity was found to the shed floor in the back yard. Evidence of moisture damage was found in bedroom 3 on the wall that backs on to the shower.

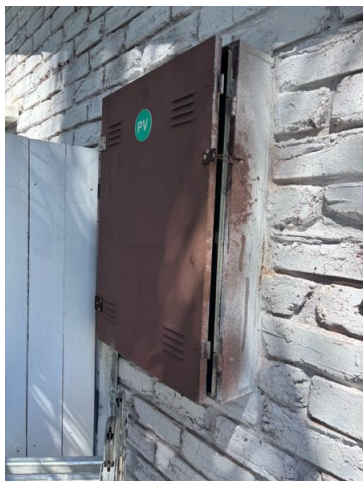
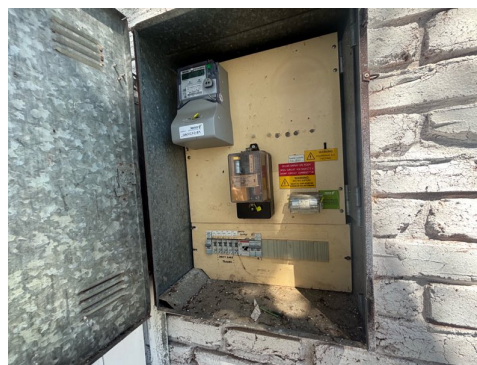
Finding 6.01

| Information: | At the time of the inspection, no evidence of a chemical termite management system was found. There is no durable notice in the meter box. |

At the time of inspection, it appeared as though no termite management system has been installed, with no evidence to suggest preventative works taking place.

The application of a post-construction chemical termite barrier is highly recommended for all properties, particularly if live termite activity has been found on the site previously.

The client may consider gaining further advice from a pest controller as to the costs and procedures involved with this application. It is recommended that obtaining such advice be a short-term priority.

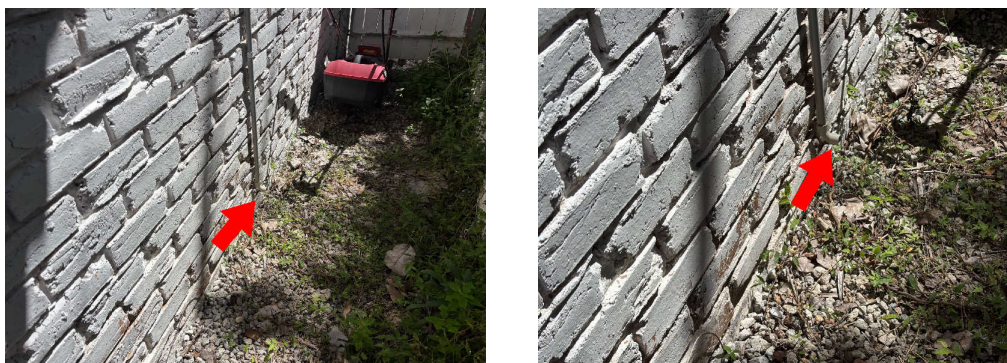
Finding 6.02

Finding: Air conditioner - Disconnected overflow

Information: At the time of the inspection, it was noted that the air conditioner drain overflow to the unit on the side of the dwelling was not connected to the storm water drainage and as a result are draining next to the foundations of the dwelling.

Air conditioning overflows that are not connected to the storm water drainage and are draining near the foundation can create excessive moisture in the surrounding area.

Such leaking creates an environment which is conducive to an array of defects, including water damage to associated building elements and the attraction of termite or timber pest infestation.

It is highly recommended that a licensed plumber be appointed to connect the A/C overflow in order to prevent such an environment from being created. These minor works should be carried out as soon as possible.

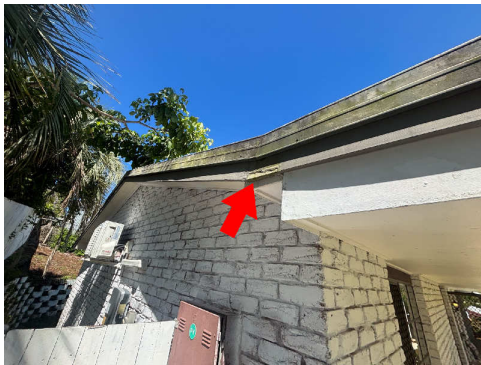
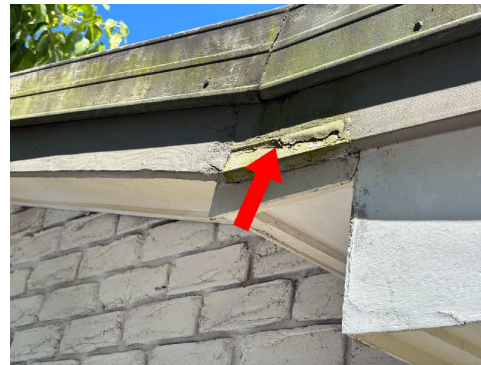
Finding 7.01

Finding: Wood rot - timber fascia board

Information: At the time of the inspection, it was noted that there was evidence of wood rot to a section of the timber fascia board. This may be due to the age of the timber building elements and general weathering.

This building element shows evidence of wood rot. Wood rot, also known as Fungal Decay, occurs when timbers and other cellulose building materials are exposed to damp conditions on an ongoing basis.

Early intervention and regular maintenance, particularly of exterior timbers, will prolong the useful life of these building elements. Prior to any works being performed, the cause of the moisture that has created the visible wood rot should be identified and addressed in a suitable manner. Replacement of affected timbers may then be a necessary step in protecting surrounding building elements from such deterioration.

A qualified carpenter or registered builder may also be required to replace affected building materials.

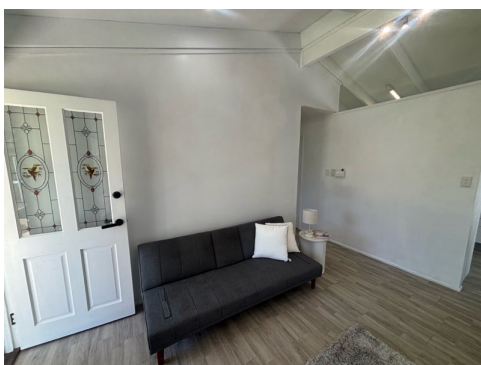
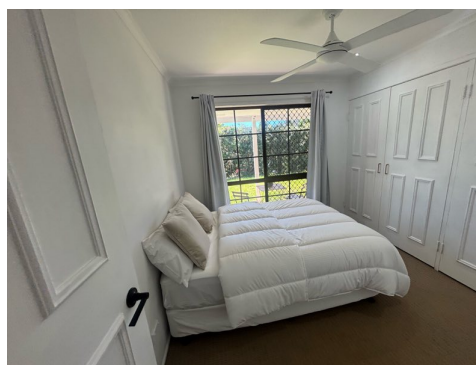
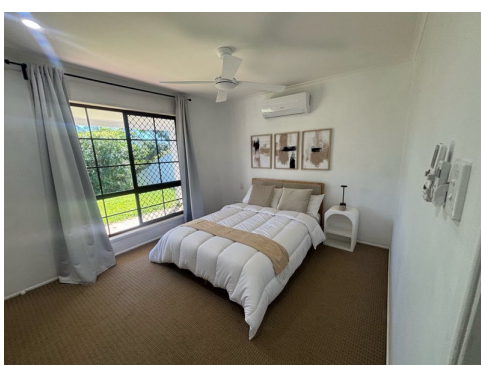
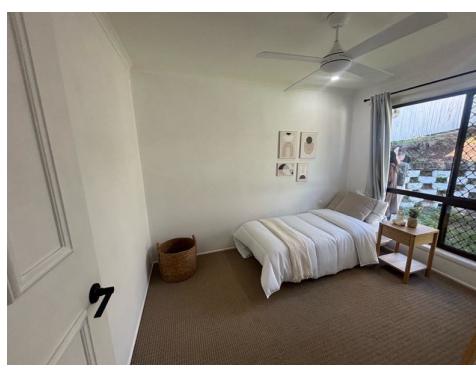
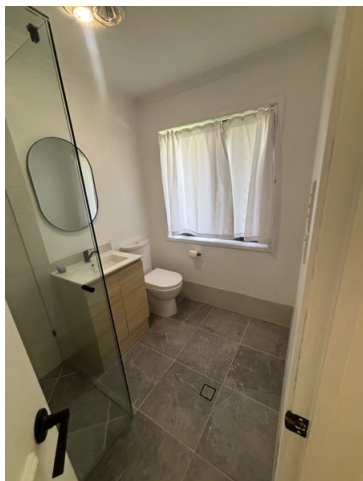
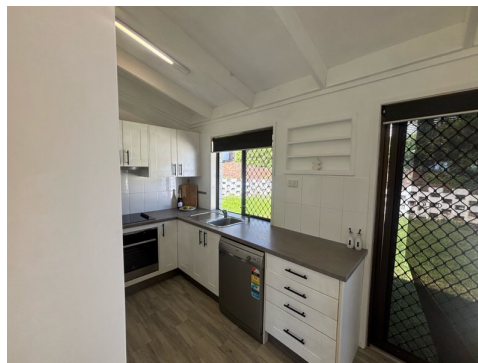
Finding: Obstructions and Limitations - Internal areas

Information: These photographs are an indication of the obstructions and limitations which impeded full inspection of the property of the internal areas at the time of inspection. These obstructions can hide an array of defects and should be removed to allow full inspection to be carried out. A re-inspection is recommended once the areas are made accessible.

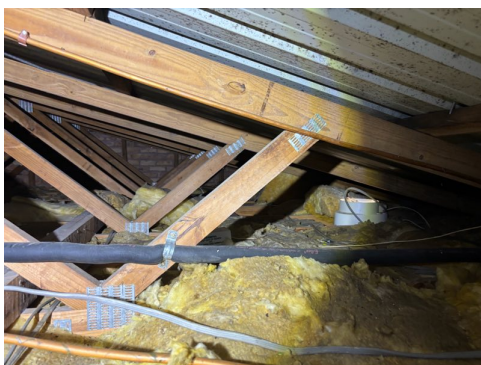
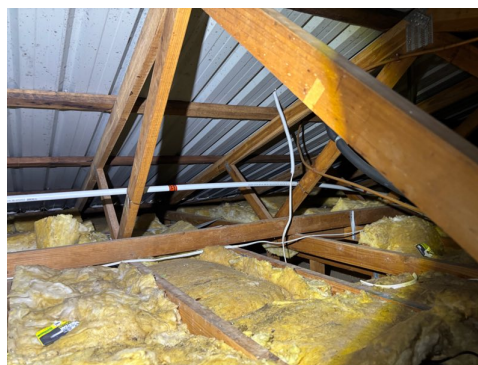
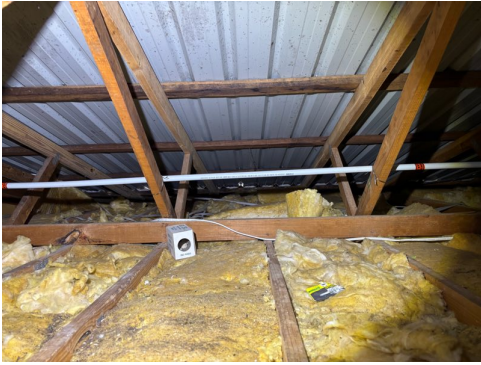
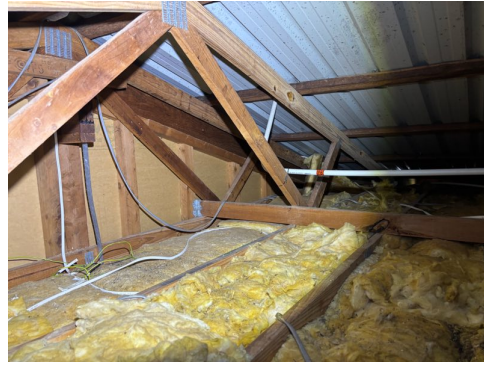
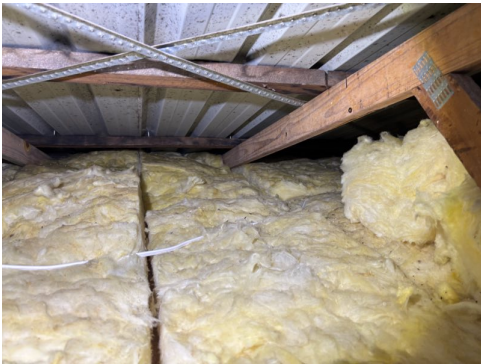
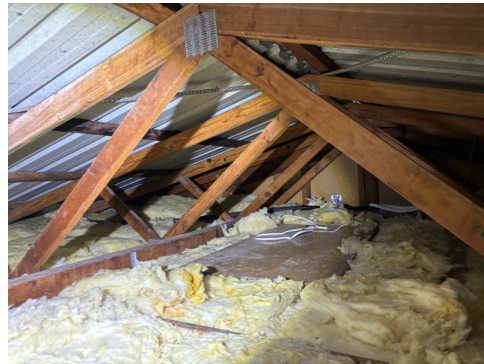
Finding: Obstructions and Limitations - Roof cavity

Information: These photographs are an indication of the obstructions and limitations which impeded full inspection of the property of the roof cavity at the time of inspection. These obstructions can hide an array of defects and should be removed to allow full inspection to be carried out. A re-inspection is recommended once the areas are made accessible.
