## Building and Timber Pest Inspection Report

Inspection Date: Fri, 13 Feb 2026

Property Address: 34 Catherine Cres, BLAXLAND, NSW, 2774,  
Australia

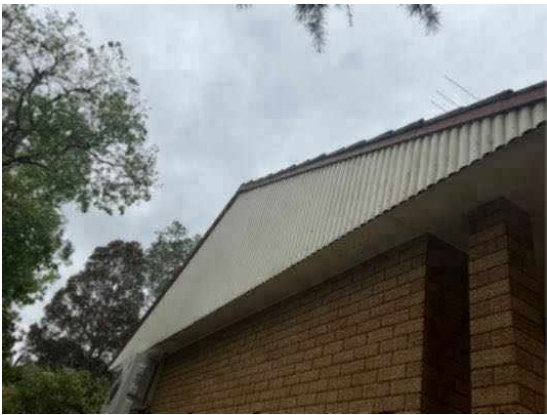
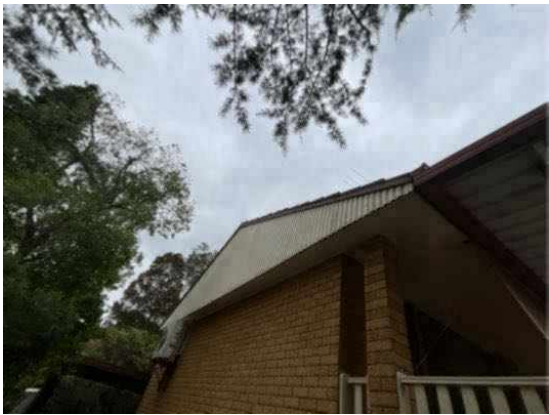
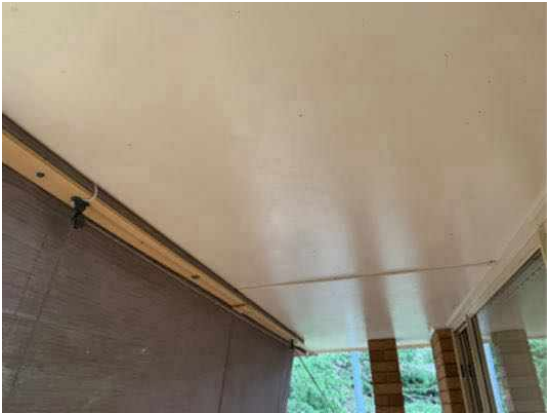
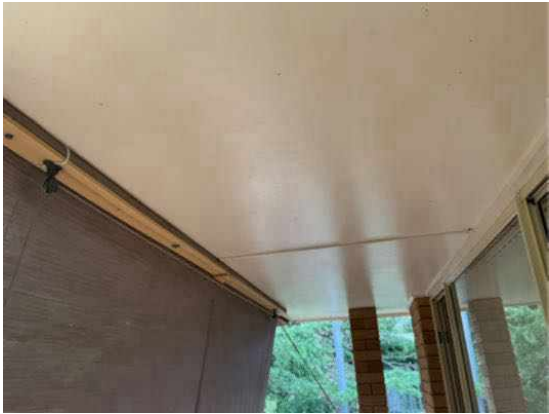
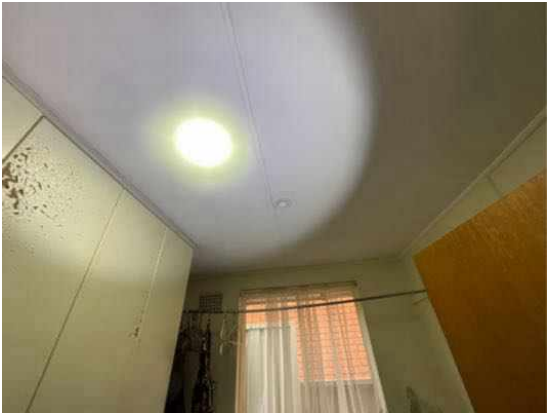
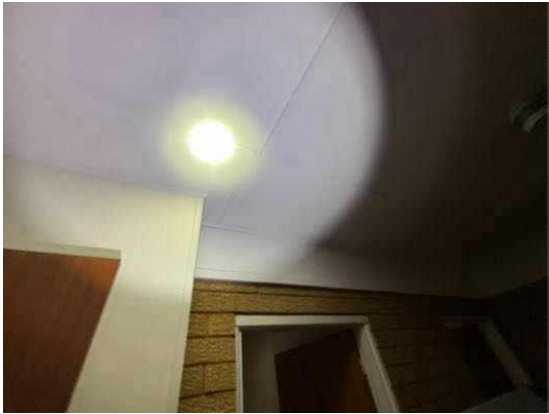
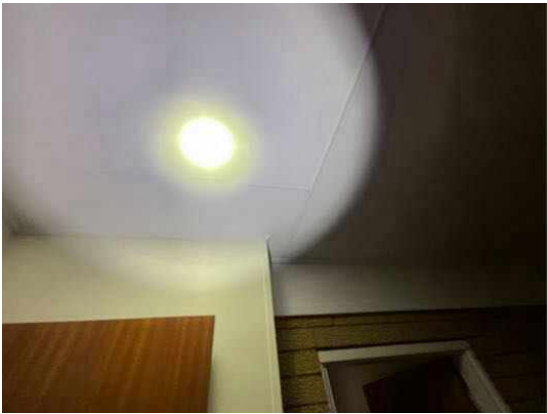
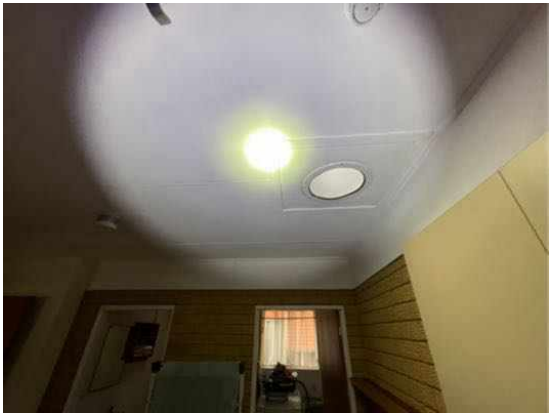
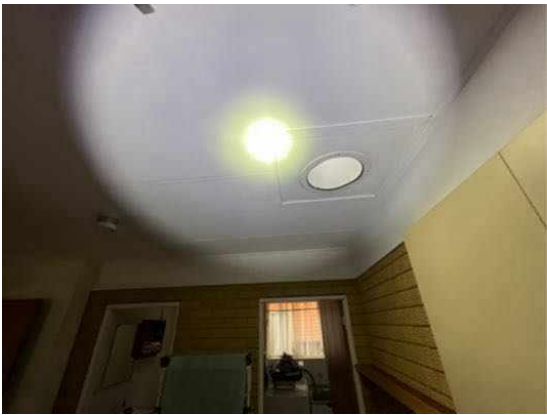
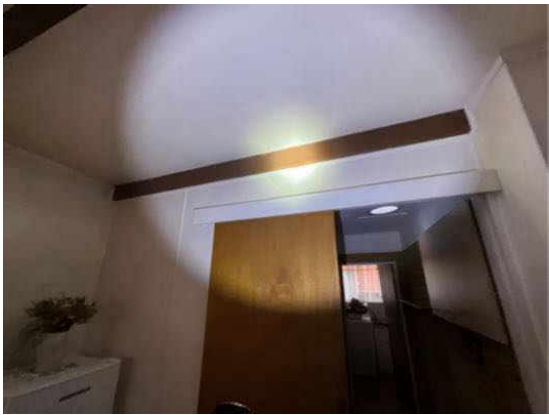
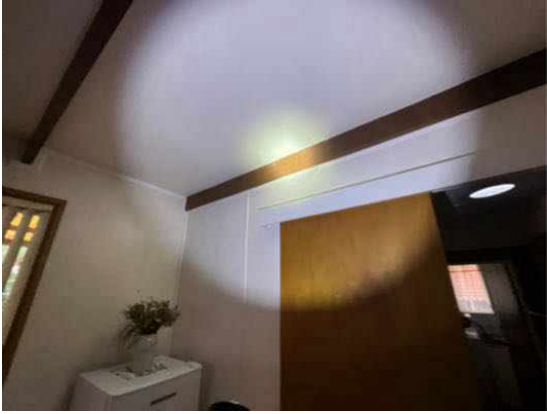
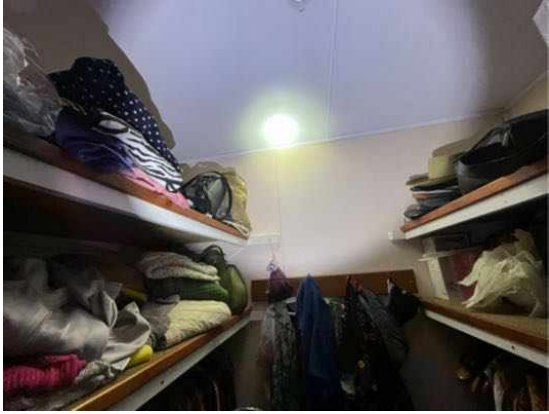
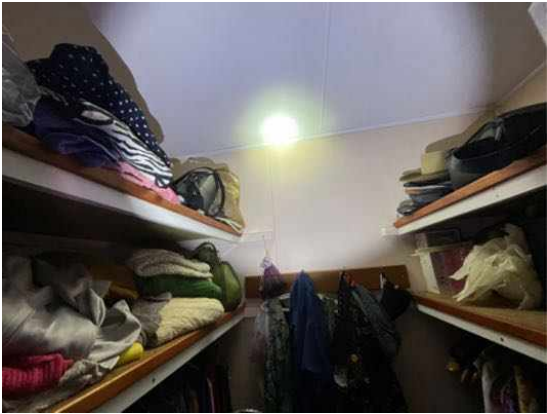
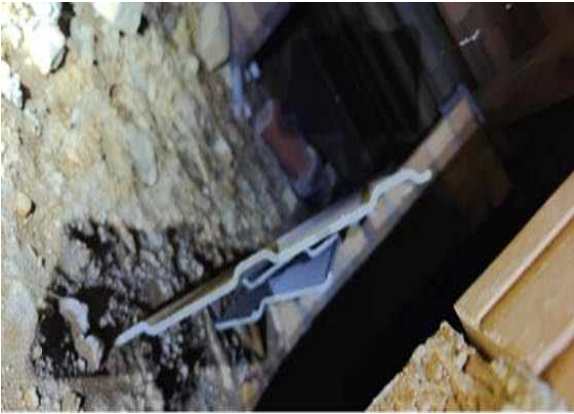
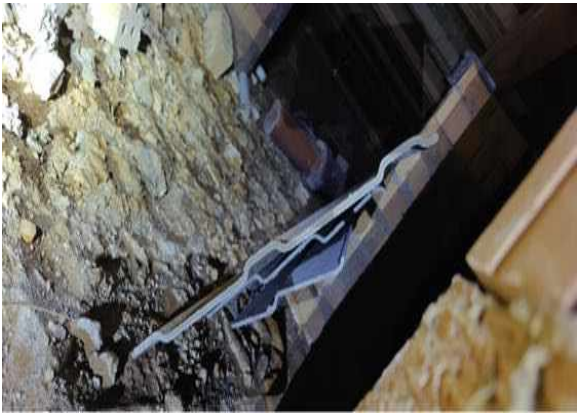
Building:	Main Building
Location:	All Areas
Finding:	Asbestos - Suspected ACM Identified on Site
Information:	Reporting on Asbestos is outside the Scope of this Report. This suspected defect is highlighted as a caution only. We suspect, based on our experience in the building industry, that there is a higher risk of the identified building element containing asbestos.

As Asbestos Reporting is outside the scope of this report, we advise that you consider a separate Asbestos Inspection and Condition Audit, which can include the taking of samples for definitive confirmation of the presence of Asbestos.

In the interim, the client is advised to act with caution, especially when considering any damage to building materials general wear and tear renovations extensions demolition and general maintenance activities due to the suspected presence of Asbestos.

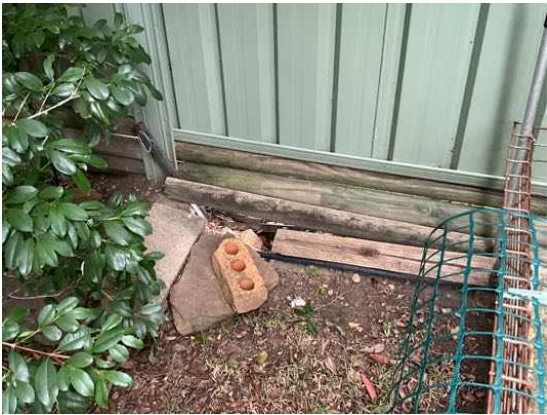
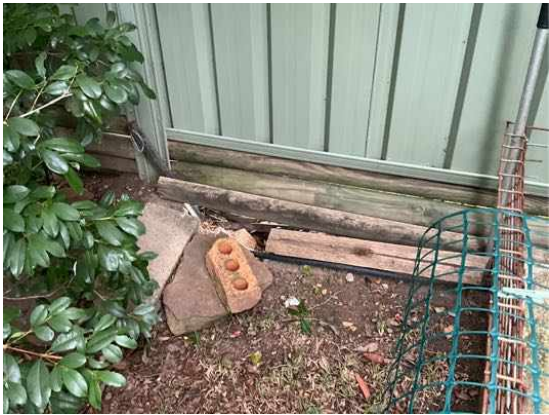
Building: Main Building  
 Location: All Areas  
 Finding: Detoriated fence  
 Information: The fence along the property boundary has deteriorated significantly, showing signs of rot, rust, and structural weakness. Several sections are leaning or have become detached, compromising the integrity of the fence and its ability to perform its intended function.

The deteriorated fence poses multiple risks:

1. **Safety Hazard:** The unstable fence may collapse, posing a risk of injury to residents, visitors, and passersby.
2. **Security Concern:** The compromised fence may allow unauthorized access to the property, increasing the risk of theft, vandalism, or trespassing.
3. **Property Damage:** Falling sections of the fence could damage nearby structures, plants, or other property features.
4. **Legal Liability:** If the fence were to fail and cause injury or damage to neighboring properties, the property owner may be held liable.

- **Licensed Fencing Contractor:** A professional fencing contractor should be hired to assess the extent of the damage and either repair or replace the deteriorated sections.
- **Handyman Services:** For minor repairs, a qualified handyman could be engaged to reinforce or repair specific sections of the fence.
- **Landscaper (if the fence is part of a larger garden feature):** If the fence is integrated into the landscape design, a landscaper with experience in fencing could be involved in the repair or replacement process.

It's important to ensure that whoever is hired is experienced and qualified to ensure the fence is restored to a safe and functional condition, compliant with local

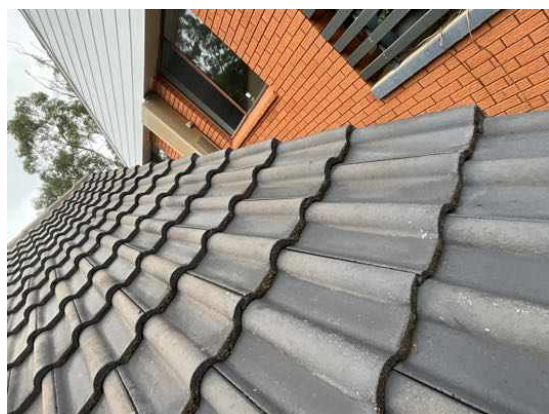
### Finding 3.02

Information: Inspection of the roof revealed widespread weathering to the tiled roof surface. The tiles show loss of surface finish, colour fading, and age-related deterioration typical of older roof coverings. Although no significant cracking was noted, weathering can lead to increased porosity, reduced water-shedding capability, and a higher risk of future cracking or displacement during adverse weather conditions.

A licensed roofer should be engaged to undertake a closer inspection, carry out routine maintenance, and replace any tiles that may be compromised. Ongoing monitoring is recommended due to the age and condition of the roof covering.

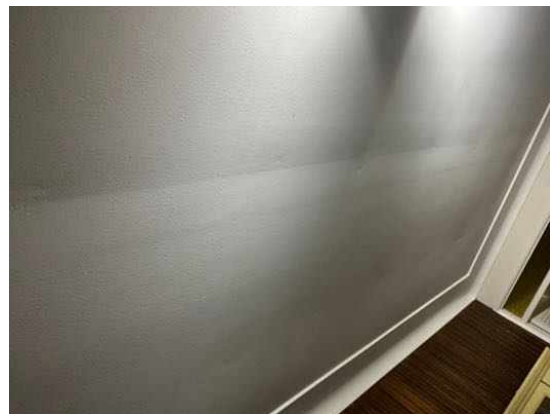
Finding 3.03

Risk: Sagging ceilings pose several risks, including potential collapse or detachment of ceiling materials, which can lead to property damage and serious injuries to occupants. Additionally, sagging ceilings may indicate underlying structural issues, such as water damage or compromised support beams, which could worsen over time if left unaddressed.

A qualified and licensed Builder or structural engineer should be consulted to assess the extent of the sagging and identify the underlying cause. Depending on the severity and cause, repairs may involve reinforcing support structures, addressing water damage, or replacing damaged ceiling materials to ensure safety and structural integrity.

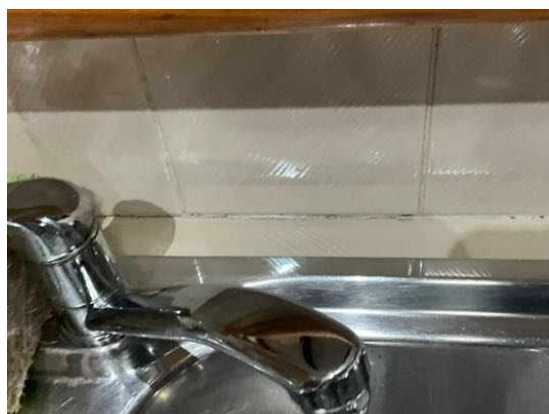
Finding 3.04

Building: Main Building  
 Location: Kitchen  
 Finding: Silicone Sealant - Deteriorated Around Basin  
 Information: The silicone seal around the basin has deteriorated, with visible gaps and discolouration noted along the edges.

Water penetration through the deteriorated seal may cause damage to surrounding surfaces, promote mould growth, and lead to deterioration of adjacent materials.

A licensed plumber or qualified handyman should remove the old sealant and reapply a sanitary-grade silicone to ensure watertight protection.

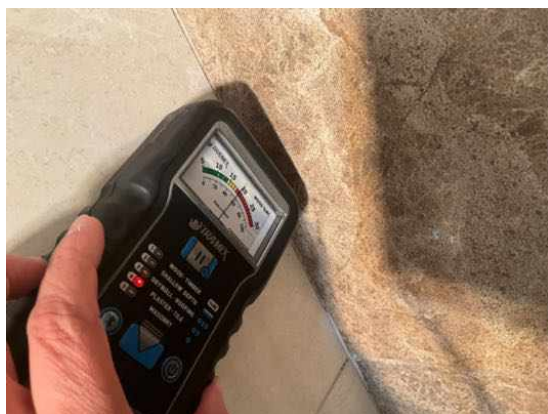
### Finding 3.05

Building: Main Building  
 Location: Bathroom  
 Finding: Shower - Damp  
 Information: Damp is evident to the lower 300mm of wall to the shower alcove. This defect is quite common, and is suspected to have been caused by moisture permeating through the

grouting in this area, which shows evidence of deterioration. Leaking pipes within the adjoining wall is also a possible cause.

Unmanaged damp in the shower recess is likely to facilitate the formation and development of mould and fungi growth, decaying associated building materials and compromising their structural integrity. It is important to address damp conditions, as the World Health Organisation notes that excess moisture leads - on almost all indoor materials - to growth of microbes such as moulds, fungi and bacteria, which subsequently emit spores and other matter into the indoor air. Exposure to these contaminants is associated with a wide range of respiratory and other health-related problems.

Consultation with a qualified plumber or bathroom specialist is advised immediately to identify the cause of damp and to perform remedial works as required. Where excessive mould growth is present, further inspection by a specialist environmental health inspector should also be considered.

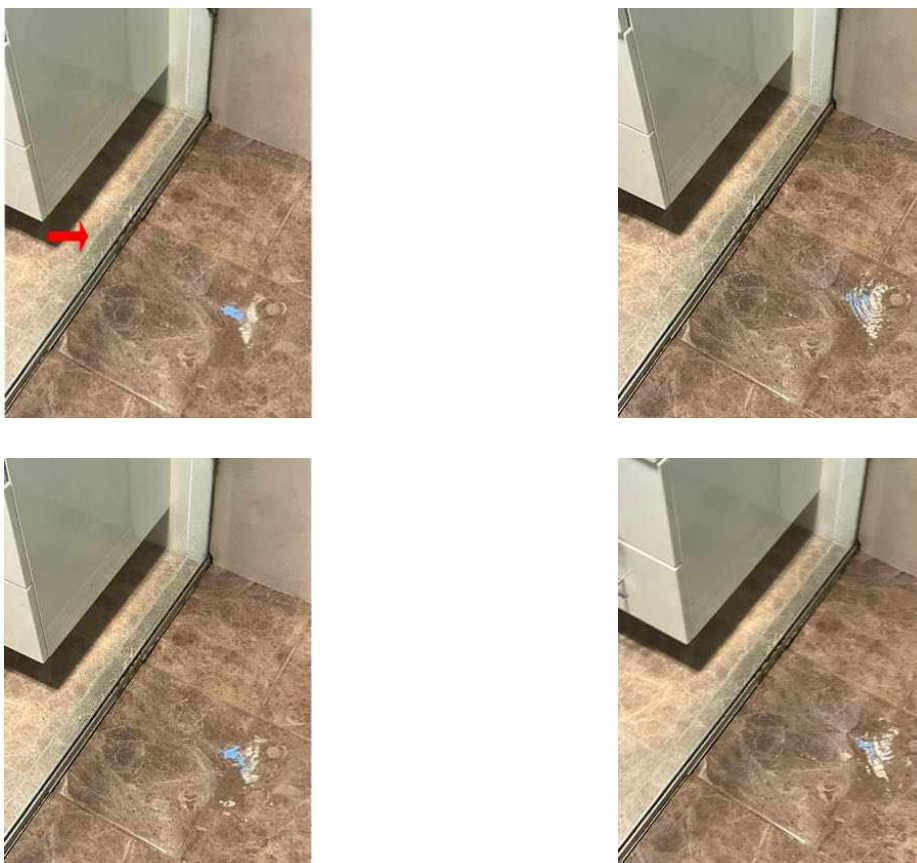
### Finding 3.06

Building:	Main Building
Location:	Bathroom
Finding:	Sealant and grouting - Missing or damaged
Information:	It was noted on inspection that sealant or grout is degraded to the tiled shower alcove and or other areas of the bathroom.

There appears to be excessive mould to the sealant and grout which will likely require scraping out and replacement.

Flexible and mould resistant materials should be applied to affected areas to prevent any subsequent water damage that is likely to occur. Regular maintenance and replacement of damage or missing or damaged sealant and grout is highly recommended to the wet areas, as this is a regular wear and tear defect. Sealant and grouting in areas that come into regular contact with water should be maintained for the long term care of your property.

A sealant specialist or tiling contractor should be appointed to complete these works as soon as possible

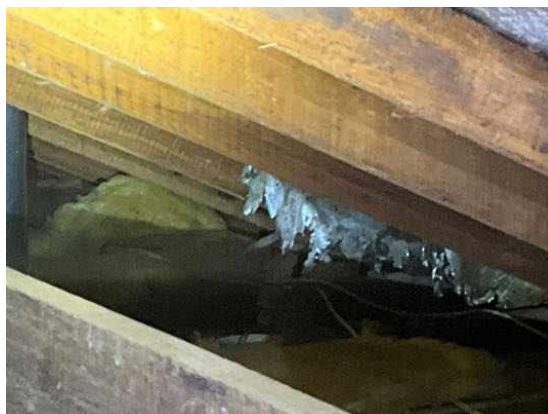
Building:	Main Building
Location:	Roof Void
Finding:	Exhaust fan not vented out
Information:	The exhaust fan located within the roof void is not appropriately ducted to the external atmosphere and is currently discharging moist air directly into the roof space. This is considered a defect under AS 4349.1, as it does not meet the minimum standard of residential building performance expected under normal residential building practices.

This condition may lead to excessive condensation within the roof void, increasing the risk of mould growth, deterioration of insulation, timber decay, and overall reduced durability of building elements. It may also result in poor indoor air quality, potentially affecting occupant health.

It is recommended that the exhaust fan be modified by a licensed HVAC contractor or qualified builder, ensuring it is properly ducted to discharge externally in accordance with manufacturer specifications, the National Construction Code (NCC), and applicable Australian Standards.

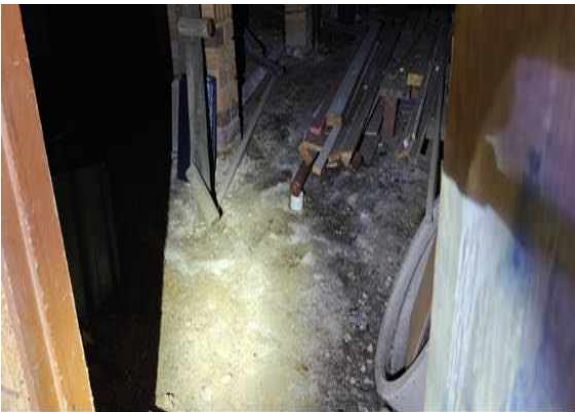
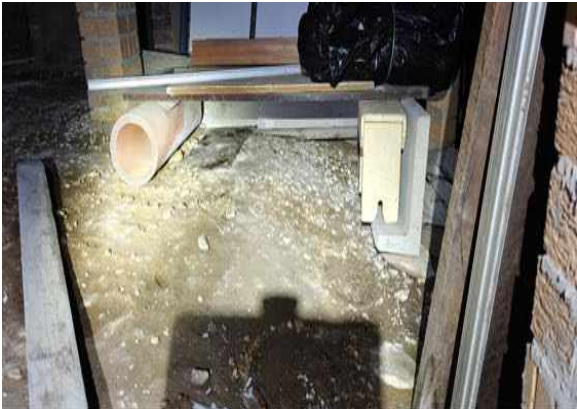
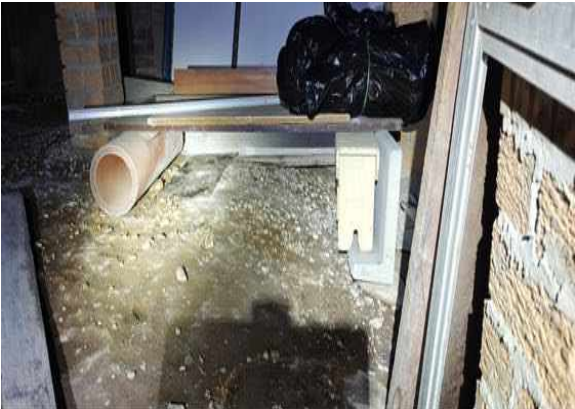
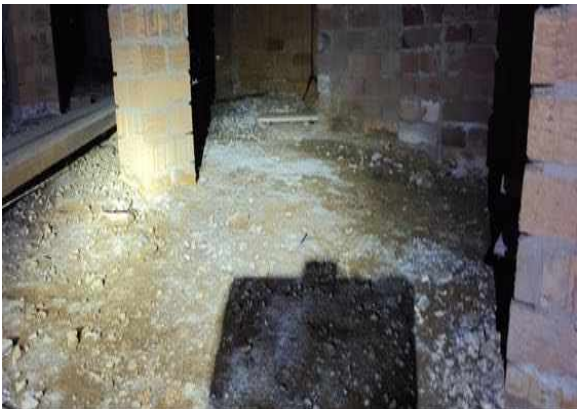
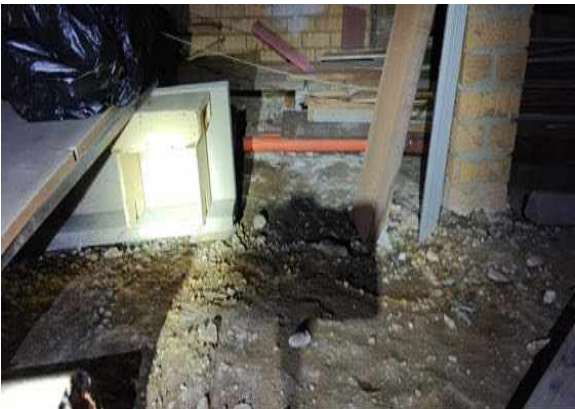
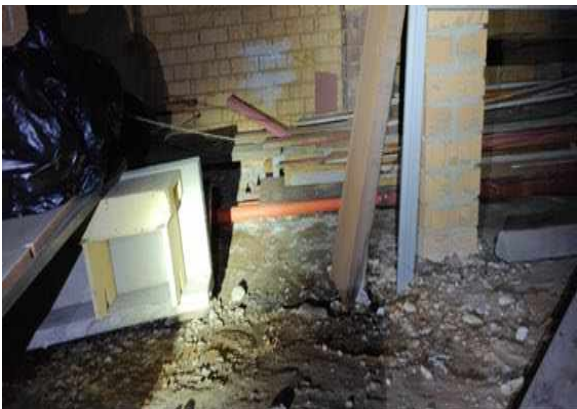
Building: Main Building  
 Location: Subfloor  
 Finding: Subfloor - Site drainage - Inadequate  
 Information: The site exhibits poor drainage under the subfloor, leading to several critical issues. Water accumulates and does not properly drain away from the subfloor area, creating a hazardous condition.

1. Frequent water pooling and stagnation under the subfloor.
2. Risk of subfloor structural damage due to prolonged moisture exposure.
3. Potential for mold and mildew growth, compromising indoor air quality and a potential of Termite attack.
4. Safety hazard for occupants due to slippery surfaces and potential electrical hazards.

The poor site drainage under the subfloor poses a significant safety risk to the occupants, as it can lead to structural damage and health hazards.

This issue requires immediate attention and rectification. A licensed and experienced plumber or licensed builder specialising in drainage and foundation work should be engaged to assess the problem and implement necessary drainage solutions, such as improved grading, installation of drainage systems, and moisture barrier enhancements. Regular maintenance and inspections should also be scheduled to prevent future occurrences. Water damage and secondary defects are likely to occur if left unmanaged.

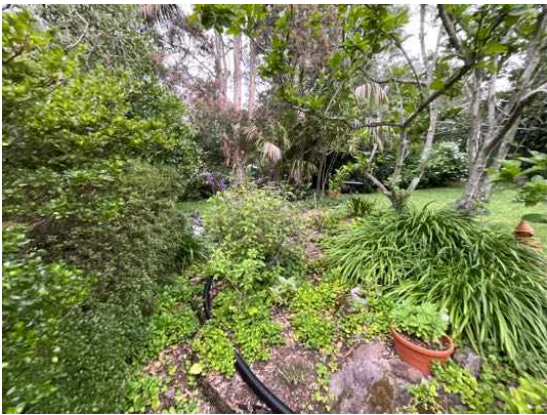
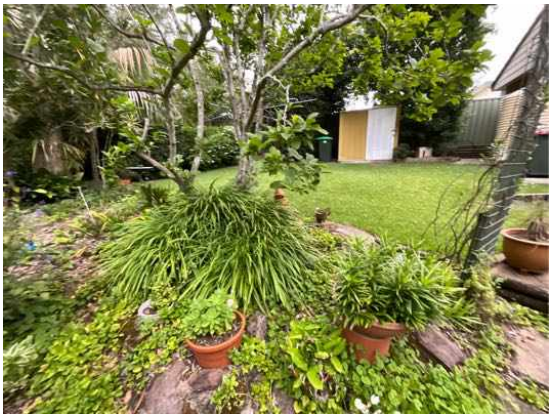
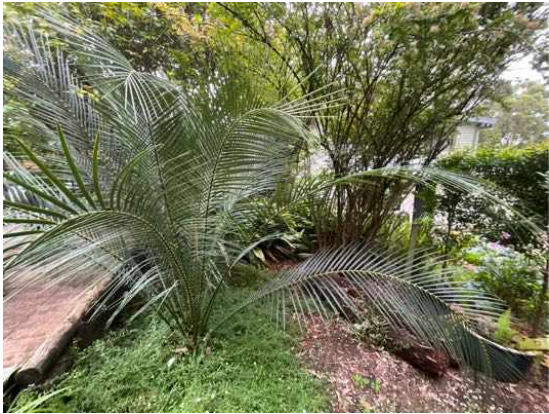
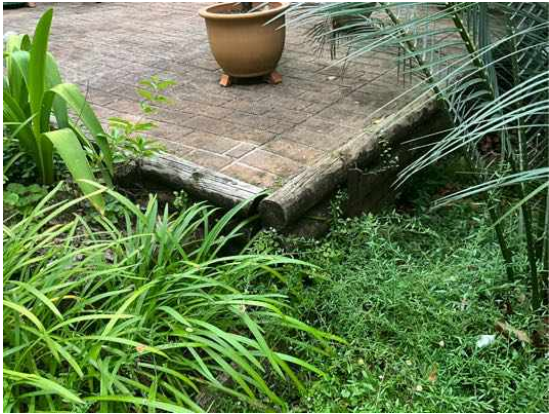
Building: Main Building  
Location: Exterior walls - right side  
Finding: No Evidence of Termite Management System - Durable notice / Legible Sticker  
Information: The application of a pre & post-construction chemical termite barrier is highly recommended for all properties. Such barriers are highly effective in preventing termite attack on any timber building elements throughout the property.

Client must seek further information from the vendor or real estate agent if the conditions of termite management systems were maintained.

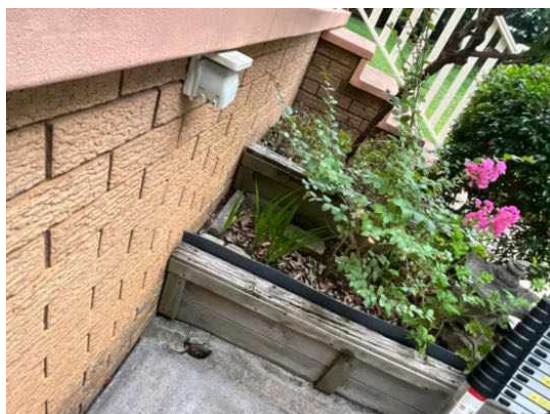
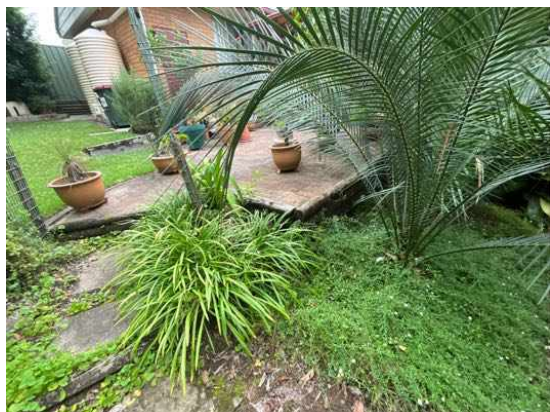
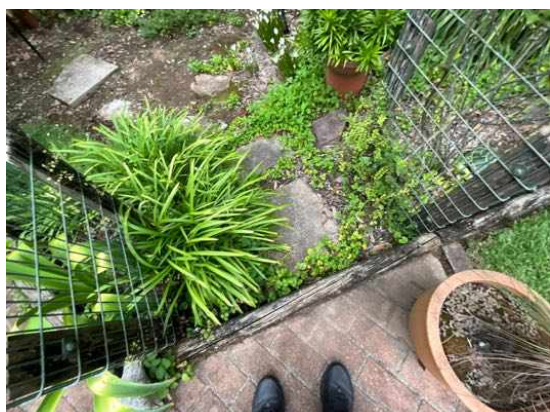
Finding 6.03

Building: Main Building  
Location: All Areas  
Finding: Timber on ground / conducive conditions to termite damage  
Information: Timber on the ground is indeed conducive to termite damage. Termites are known to thrive in moist environments, and wood in contact with soil or moisture is more susceptible to infestation.

To prevent this, it's important to keep timber elevated and away from direct ground contact. Regular inspections and proper termite control measures are also essential to protect your wooden structures from termite damage.

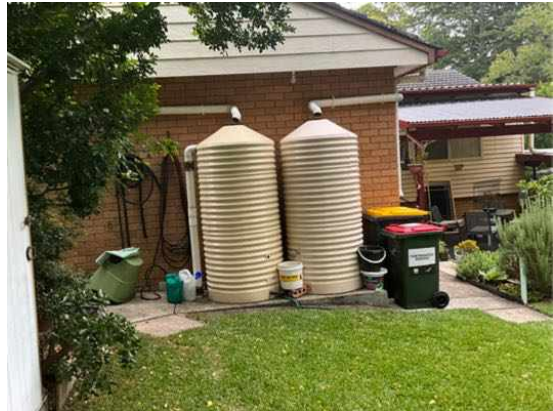
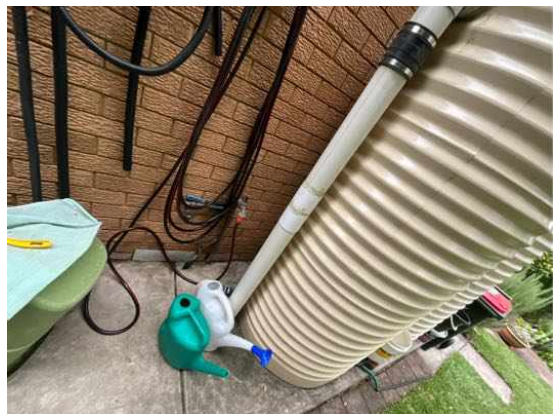
### Finding 6.04

Building: Main Building  
 Location: All Areas  
 Finding: Bridging or Obstruction Conducive environment for Termites  
 Information: Bridging of termite barriers occurs when termites bridge (usually by building a mud tunnel) a termite barrier or inspection zone or where termites have a passage, allowing them to bridge the barrier.

Recommended moving obstructions away from the external walls for further and future inspections.

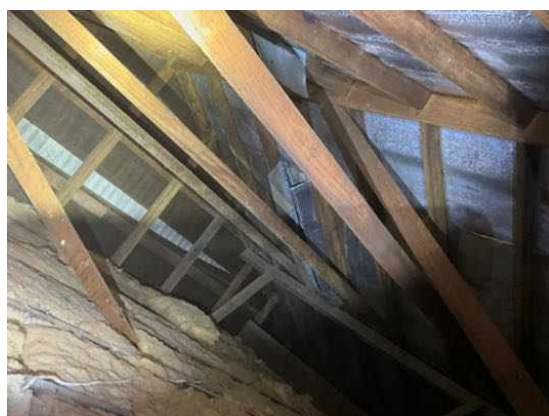
Building:	Main Building
Location:	Roof Void
Finding:	Roof void exhibits conspicuous signs of excessive moisture
Information:	The roof void exhibits conspicuous signs of excessive moisture, evident through water staining within the sarking material.

Risk in Terms of Timber Pest: The excessive moisture within the roof void poses a significant risk for timber pests such as termites, as it creates an ideal environment for infestation and proliferation. The damp conditions promote wood decay, making the structure susceptible to damage by these pests.

A qualified roofing contractor and a professional pest control service specialized in timber pest management should be engaged to rectify the issue. They can assess the extent of moisture damage, address any underlying structural issues, and implement effective solutions to mitigate the risk of timber pest infestation.

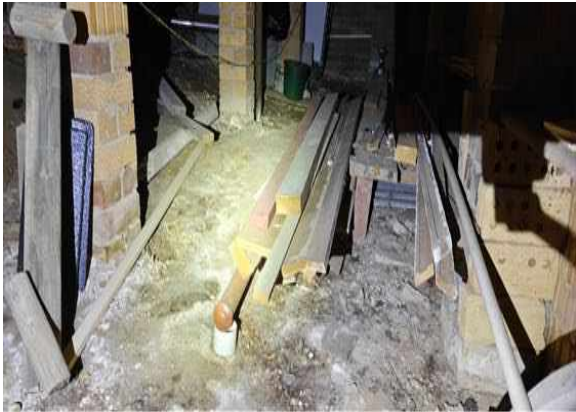
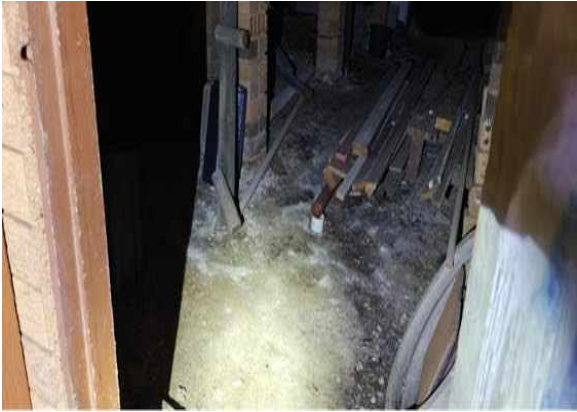
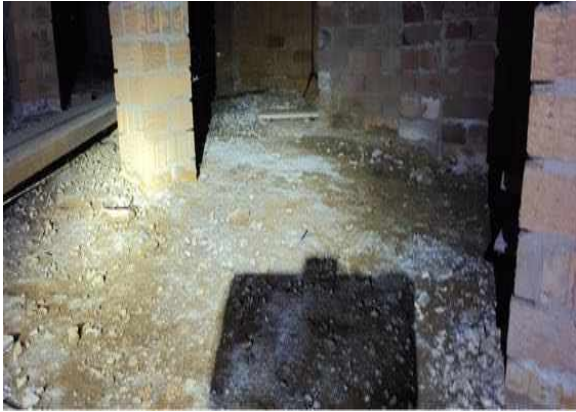
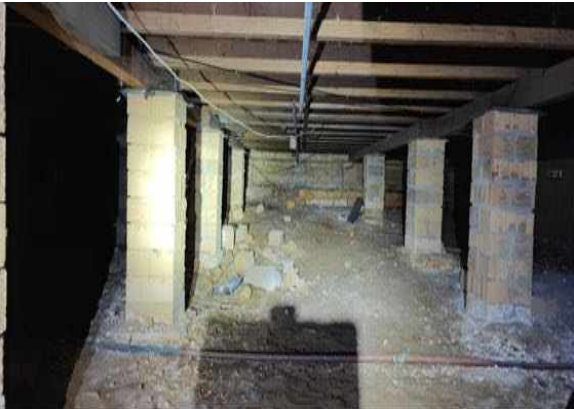
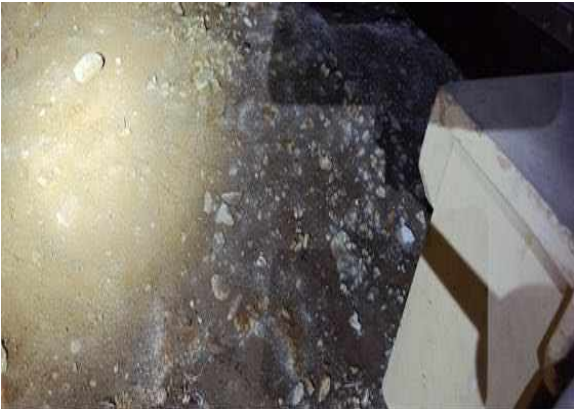
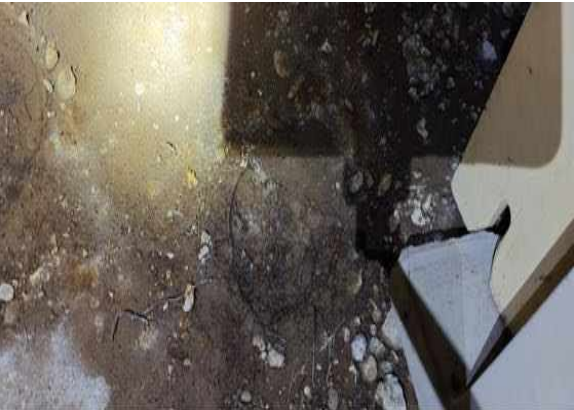
### Finding 6.08

Building:	Main Building
Location:	Subfloor
Finding:	Subfloor - poor ventilation, inadequate site drainage, water stains
Information:	The subfloor lacks adequate ventilation, suffers from inadequate site drainage, exhibits water stains, creating conducive conditions for timber pests such as termites.

Risk: The combination of poor ventilation, inadequate drainage, water stains significantly increases the risk of timber pest infestations. Termites are attracted to moist environments and can thrive in subfloors with high humidity levels and water damage. The lack of proper ventilation and drainage exacerbates moisture retention, providing an ideal habitat for timber pests to establish colonies and cause extensive damage to the subfloor structure. Additionally, water stains indicate previous or ongoing moisture issues, which further attract timber pests and contribute to the deterioration of timber materials.

A licensed pest control professional specializing in timber pest management should be consulted to assess the extent of the infestation and develop a comprehensive treatment plan. They can implement strategies to eliminate existing timber pests, such as termites and prevent future infestations by addressing underlying moisture issues. Additionally, a qualified plumber or builder may be needed to improve subfloor

ventilation, enhance site drainage, repair water-damaged areas. Regular inspections and maintenance are essential to ensure ongoing protection against timber pests and maintain the structural integrity of the subfloor.

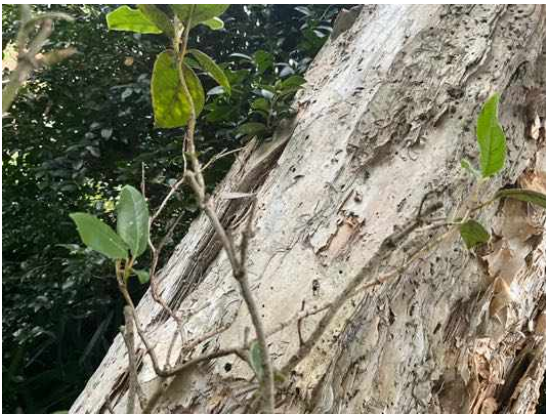
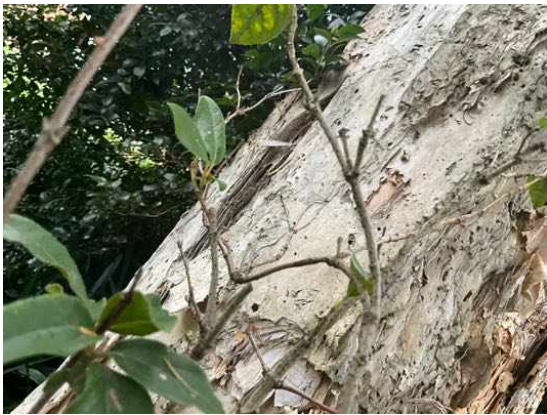
Building: Main Building  
 Location: Yard - Back  
 Finding: Wood Borer Activity - Trees  
 Information: Numerous small to medium-sized exit holes and surface tunnelling marks were noted along the trunk and branches of a dead standing tree. The pattern and shape of the damage are consistent with wood borer infestation. No live activity was observed at the time of inspection, though damage is clearly evident.

- The tree maybe structurally compromised and may pose a fall or safety hazard, especially during wind events.
- Proximity to structures or power lines may increase the risk of damage or injury.
- Although native borers are not typically a threat to treated structural timbers, their presence indicates decay and weakened wood that could attract secondary pests.

- Engage a qualified arborist to assess the structural integrity of the tree and arrange for safe removal if required.
- If the tree is within falling distance of a building, fence, or utility infrastructure, urgent removal is recommended.
- Regular site monitoring is advised for surrounding trees to detect any early signs of similar pest activity.

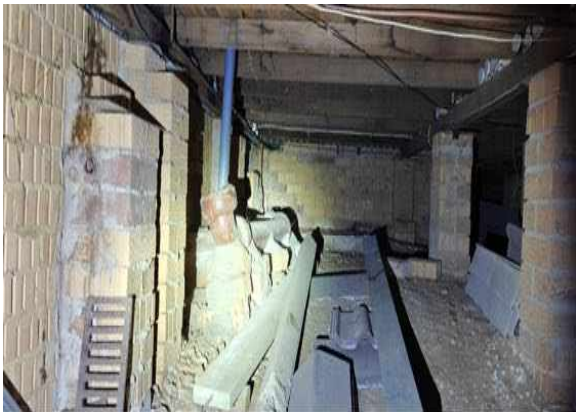
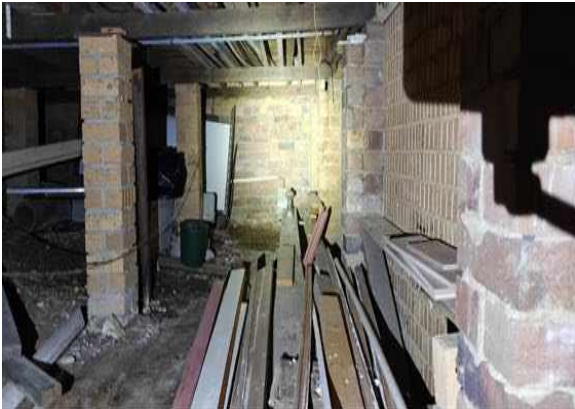
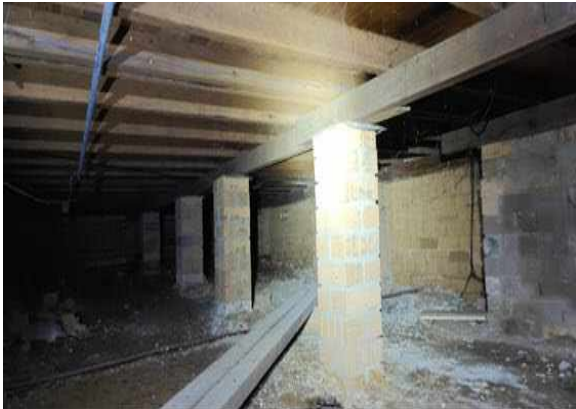
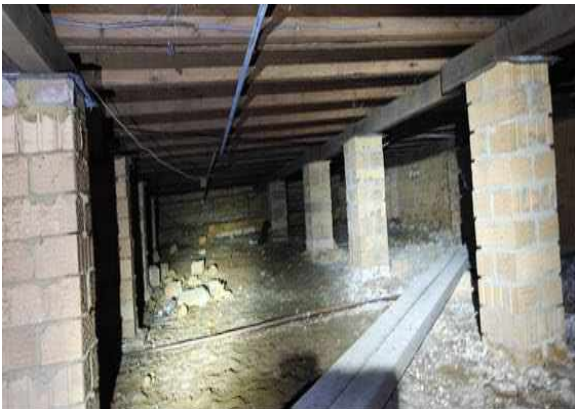
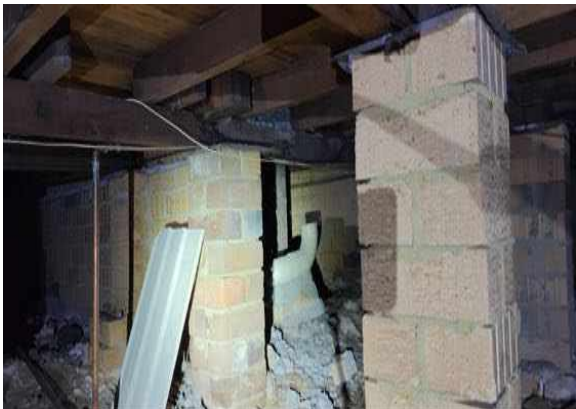
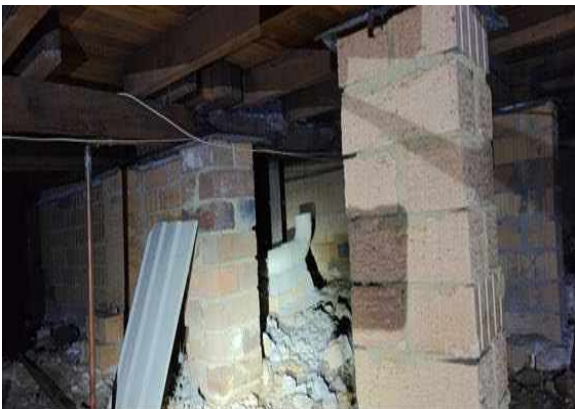
Building:	Main Building
Location:	All Areas
Finding:	Additional Photos - Obstructions and Limitations
Information:	These photographs are an indication of the obstructions and limitations which impeded full inspection of the property at the time of inspection. These obstructions can hide an array of defects and should be removed to allow full inspection to be carried out. A re-inspection is recommended once the areas are made accessible.
