Building Inspection Report

Inspection Date: Sat, 21 Feb 2026

Property Address: Unit 2/92 Roberts St, WEST FOOTSCRAY,
VIC, 3012, Australia

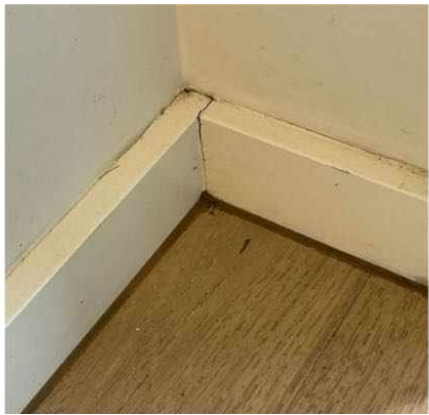
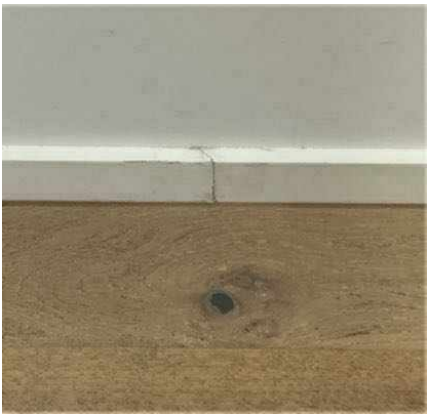
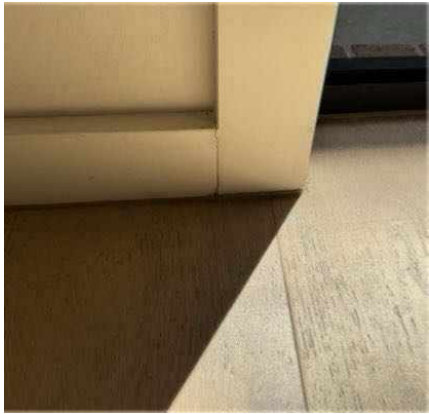
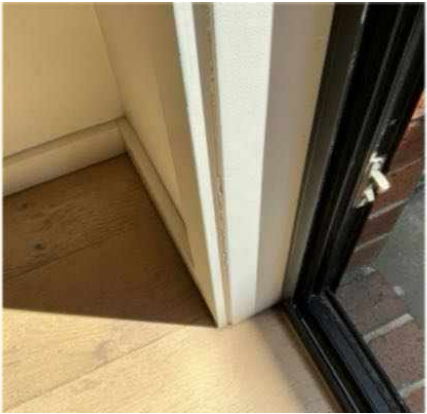
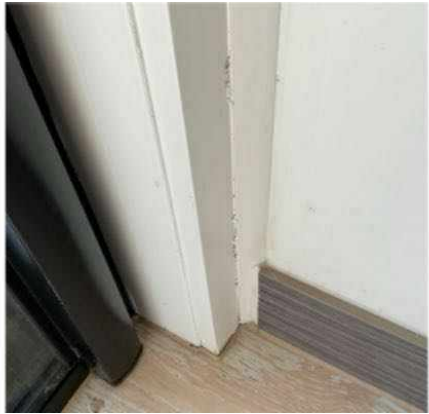
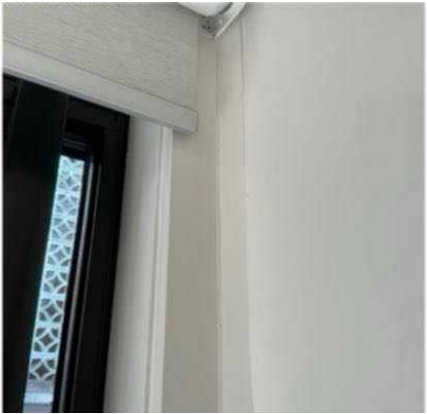
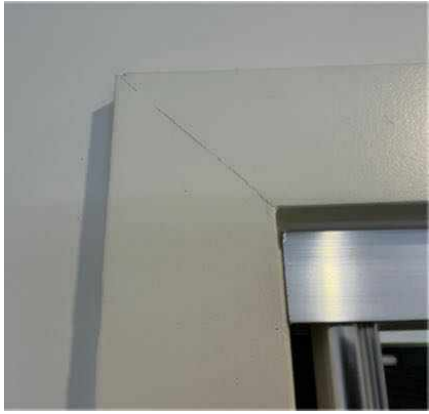
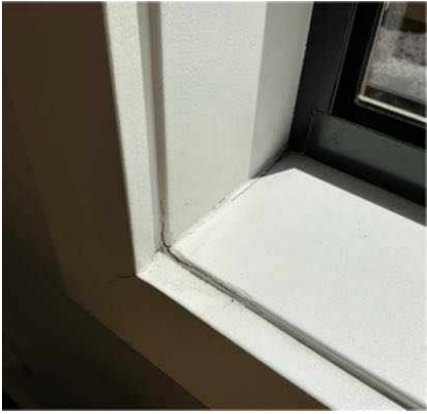
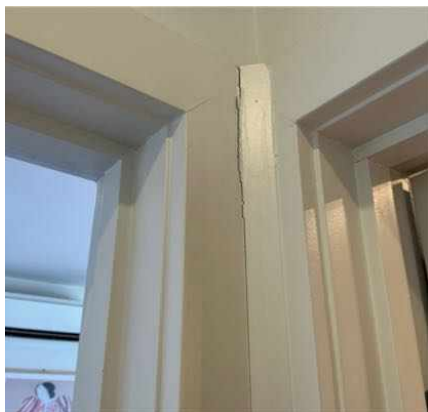
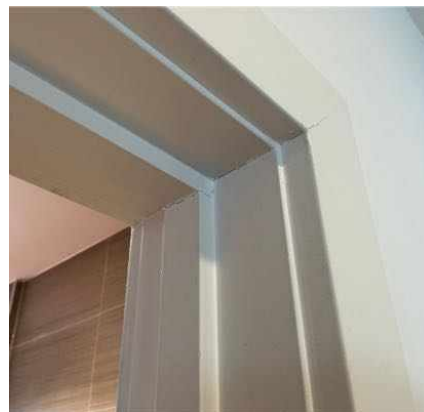
Defects 3.01

Building:	Main Building
Location:	All Internal Areas
Finding:	Cracking to Painted Architraves and Skirting Boards
Information:	Cracks were observed opening up in various sections of the painted architraves and skirting boards. These cracks may be associated with minor building movement, timber shrinkage, or inadequate surface preparation prior to painting.

- Aesthetic presentation is compromised by visible cracking.
- Potential ongoing movement may lead to further deterioration or require repeated maintenance.
- May indicate underlying workmanship or preparation issues.

This condition is not uncommon following recent painting, particularly in timber joinery, and is typically considered a maintenance item unless associated with significant structural movement.

- Engage a qualified painter or builder to assess the extent of cracking and undertake necessary repairs, which may include filling, sanding, and repainting affected areas.
- Monitor for any signs of worsening or recurring movement over time.

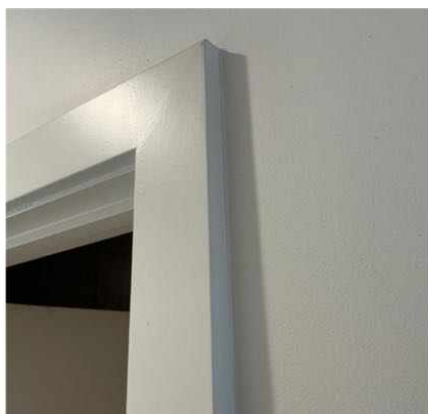
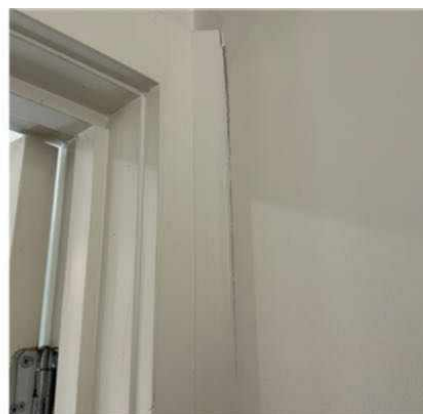
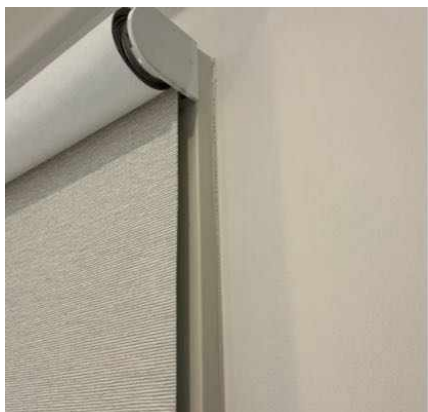
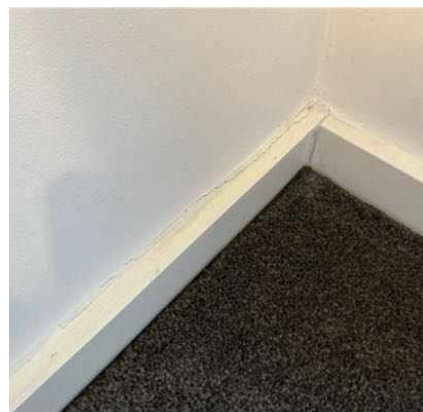
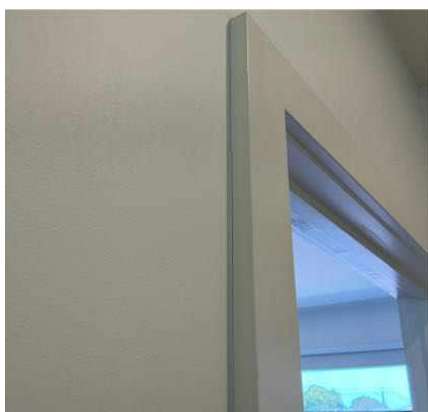
Defects 3.02

Building:	Main Building
Location:	All Internal Areas
Finding:	Cracking at Junctions Between Wall Linings and Timber Trims - PCI
Information:	Minor cracking was observed at junctions where wall linings meet architraves and skirting boards throughout the dwelling. These cracks are consistent with normal settlement and material shrinkage that can occur as the building stabilises within the initial occupancy period. However, visible gaps and paint fractures at these locations detract from the finish quality expected at handover and within the 90-day maintenance period.

- Guide to Standards and Tolerances 2023 – Section 13.03: Hairline cracking up to 1 mm at junctions between dissimilar materials is acceptable; cracking greater than this is considered a defect.
- NCC 2022, Volume Two – Clause 10.7.1: Linings and finishes must be installed to maintain an acceptable standard of appearance and performance.
- AS/NZS 2589:2017 – Gypsum Linings Application and Finishing: Requires joints and junctions to be finished to a smooth, even surface consistent with the specified finish level.

Rectification is required to fill, sand, and repaint affected junctions to restore a consistent and uniform finish throughout, ensuring the dwelling meets expected presentation and durability standards for new residential construction.

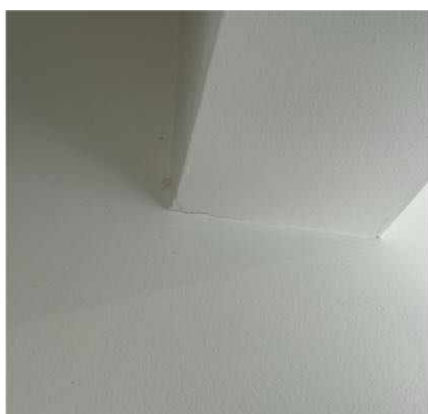
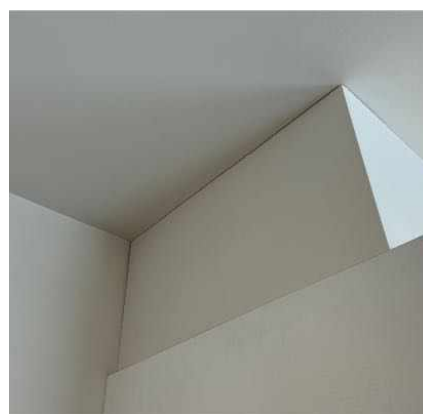
Defects 3.03

Building:	Main Building
Location:	All Internal Areas
Finding:	Cracking to Internal Wall Linings
Information:	Cracking was observed to internal wall linings during the inspection. These types of cracks are generally considered common and are typically the result of natural building movement, age-related wear, thermal expansion and contraction, or minor installation-related issues in plasterboard or supporting framing members.

The cracking noted is typical of minor building movement and does not currently present as structural. Regular monitoring and cosmetic repair will assist in preserving the internal presentation and allow early intervention if future issues arise.

- Engage a qualified plasterer to repair cracks and consider installing expansion joints if necessary to accommodate ongoing building movement.
- Arrange for repainting by a qualified painter following any plaster repairs.
- Monitor cracks over time for signs of progression (e.g. widening, lengthening, or new cracks forming).
- If deterioration continues or operational issues with doors/windows arise, seek further assessment from a building inspector or structural engineer.

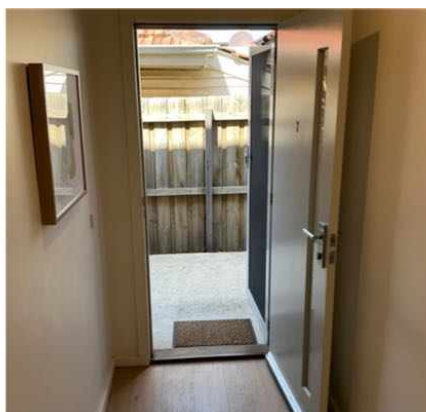
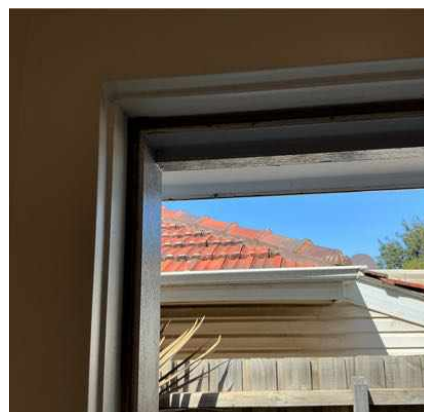
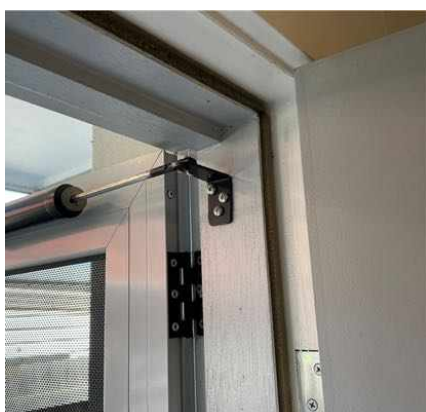
Defects 3.04

Building:	Main Building
Location:	Entry
Finding:	Deteriorated Door Seal
Information:	The door seal was observed to be significantly deteriorated and no longer provides an effective barrier against external elements. This type of defect typically occurs from prolonged exposure to weather or general wear and tear over time.

- Allows wind, dust, and moisture to enter the home

The damaged seal affects both comfort and energy efficiency. Timely replacement will restore the door's proper function and prevent further weather-related issues.

- Replace the deteriorated door seal with a suitable weather-resistant alternative
- Inspect the door and frame during replacement for any signs of damage or misalignment
- Consider periodic checks and maintenance of all external door seals to ensure ongoing performance

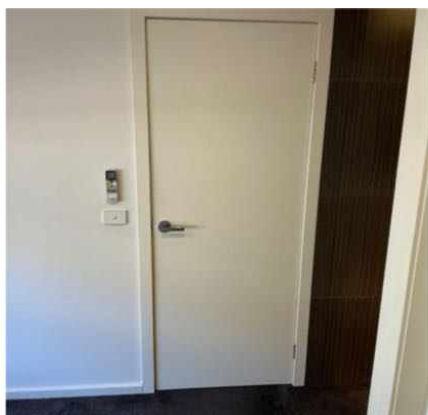
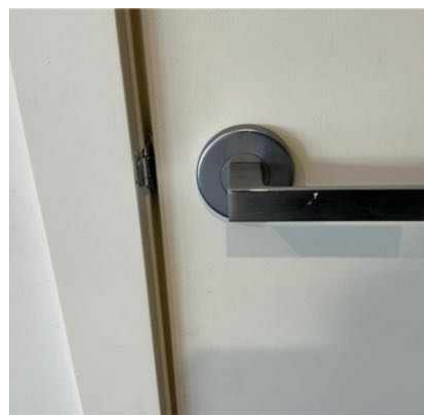
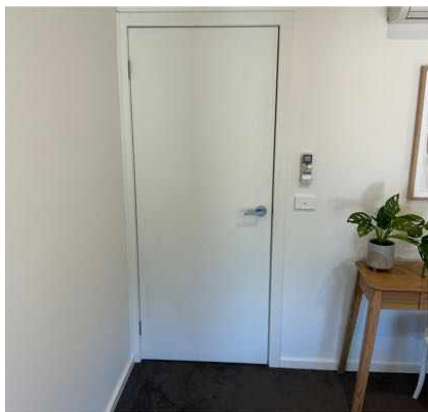
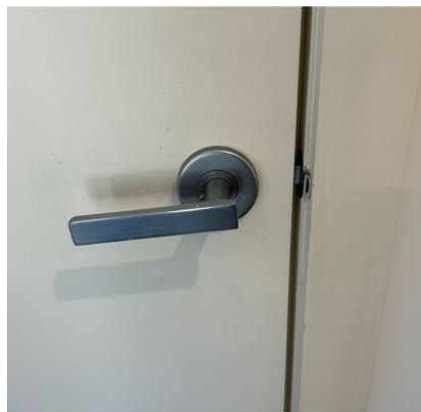
Defects 3.05

Building: Main Building
Location: Bedroom - Master, Bedroom 2
Finding: Door Does Not Latch Securely When Closed

Information: At the time of inspection, the door was observed to not latch firmly when closed. The latch did not consistently engage with the striker plate, resulting in noticeable movement and audible rattling within the frame during normal use. This condition is commonly associated with misalignment between the door latch and striker plate.

- A door that does not latch correctly may not remain closed as intended during normal use.
- Ongoing movement can lead to increased wear to the latch, striker plate, and surrounding door frame.
- Reduced latching performance may affect privacy and security.

In summary, the door does not latch securely and requires adjustment to restore proper function, reduce movement, and improve usability

- Have a qualified handyperson or carpenter assess the door alignment and hardware.
- Adjust or reposition the striker plate to ensure proper engagement of the latch.
- Confirm correct operation of the door following adjustment.

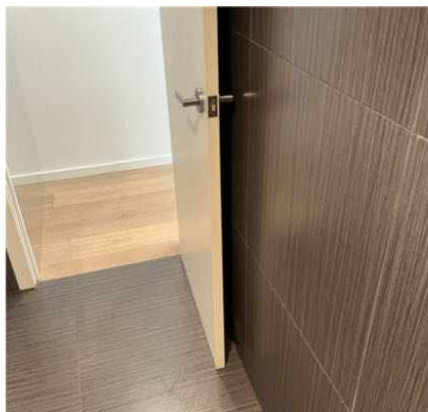
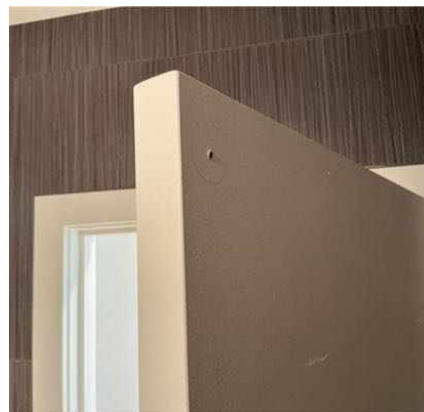
Defects 3.06

Building:	Main Building
Location:	Downstairs Bathroom
Finding:	Missing or Damaged Door Stops
Information:	One or more door stops were observed to be missing or damaged throughout the property. Door stops are an important protective component designed to prevent doors from swinging excessively and impacting walls, skirting boards, architraves, or adjacent fixtures.

- Increased risk of damage to walls, architraves, skirting boards, and door hardware due to uncontrolled door movement.
- Repeated contact may result in dents, chipped paint, or cracking to finishes.
- Accelerated wear to doors and frames, reducing their service life and appearance.

Restoring effective door stops is a simple preventative measure that will help protect finishes, improve durability, and maintain the overall condition of the dwelling.

- Engage a suitably qualified tradesperson or handyman to install or replace door stops where required.
- Ensure door stops are appropriate for the door configuration and swing direction (e.g. floor-mounted, wall-mounted, or hinge-pin types).
- Inspect and repair any associated surface damage caused by previous door impact.

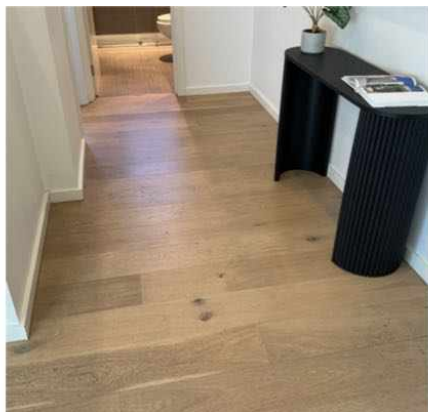
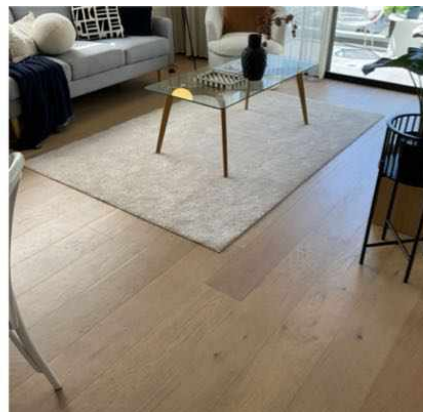
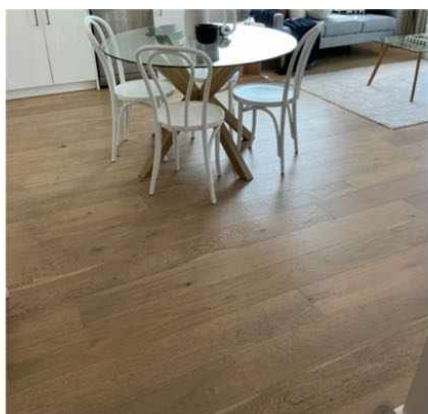
Defects 3.07

Building:	Main Building
Location:	Upstairs Floor
Finding:	Upper Storey – Audible Floor Squeaking
Information:	During the inspection, audible floor squeaking was noted in several locations to the upper storey level of the dwelling. This type of noise is commonly associated with minor movement within the upper floor framing system and may result from timber shrinkage or expansion, minor deflection of joists, loose floor sheeting fixings, or friction between structural members. No significant structural defects were identified at the time of inspection; however, the noise indicates movement within the floor system.

- May indicate minor movement or flexing within the upper floor joists or flooring substrate.
- Can become more pronounced over time if fixings loosen or timber movement continues.
- May result in ongoing nuisance noise and reduced amenity.
- In more advanced cases, could contribute to minor cracking to ceilings below or floor finish wear.

Floor squeaking to the upper level is not considered a major structural defect in isolation but reflects movement within the floor system. Ongoing monitoring is recommended, with further assessment if conditions deteriorate.

- Monitor the affected areas for any increase in noise, deflection, or associated cracking.
- Observe ceilings below the upper floor for signs of movement such as plaster cracking.
- If symptoms worsen, engage a registered builder to assess the upper floor framing and floor sheeting fixings.

- Rectification may include re-fixing flooring, installing additional fixings, or reinforcing framing where required.

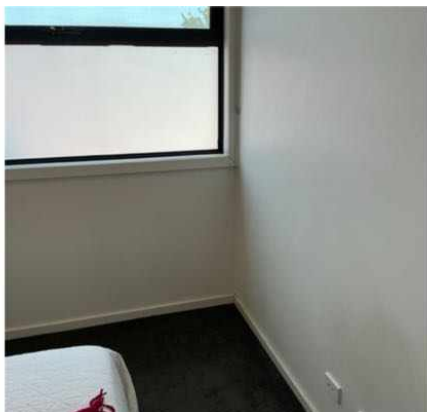
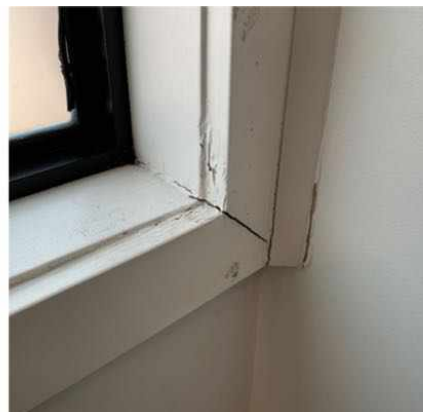
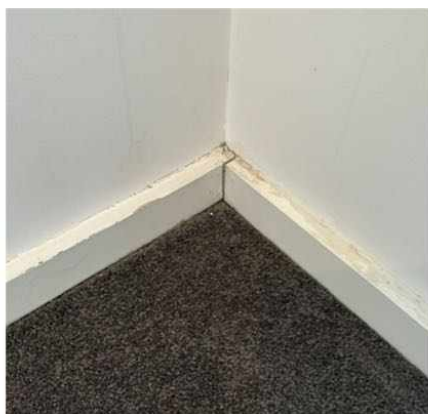
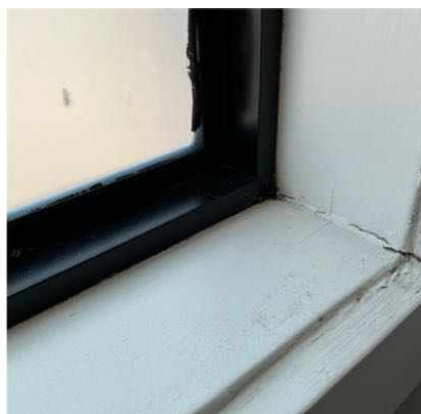
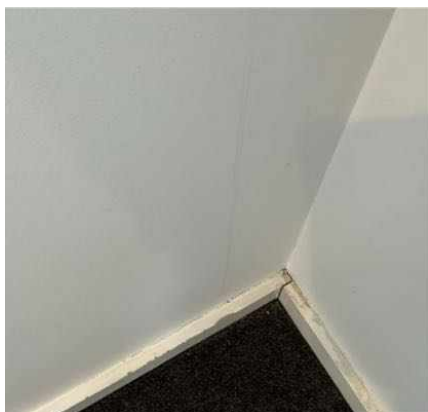
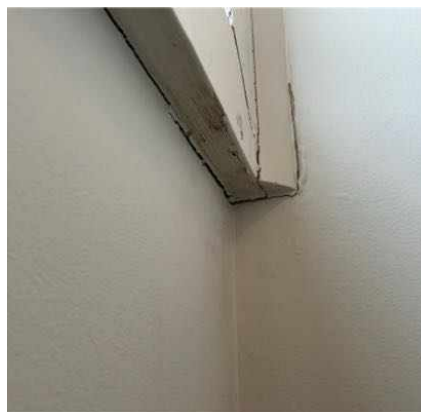
Defects 3.08

Building:	Main Building
Location:	Bedroom 3
Finding:	Bedroom 3 – Evidence of Moisture Ingress at Window
Information:	Evidence of past or present moisture ingress was observed to the bottom right-hand corner of the Bedroom 3 window. Water staining and a visible run mark were noted to the internal wall surface beneath the window, along with deterioration and paint damage to the adjacent skirting board. Localised cracking and separation were also visible at the window reveal junction.

The rubber glazing seal to the window frame appears damaged or deteriorated in sections, which may allow water penetration during rainfall. While active moisture was not confirmed at the time of inspection, the staining pattern indicates that water entry has occurred previously. The leak appears minor in nature; however, the age and extent of the issue cannot be determined without further investigation.

- Ongoing moisture ingress may result in progressive deterioration of internal linings and skirting boards.
- Potential concealed damage to framing or insulation around the window opening.
- Risk of mould development if moisture persists.
- Internal cosmetic damage and maintenance requirements.

The observed staining and material damage indicate water entry at the window junction, and further assessment and rectification are recommended to prevent ongoing deterioration.

- Have the window and glazing seals inspected by a qualified window installer or relevant tradesperson.
- Replace or repair damaged rubber seals as required.
- Check external flashings and sealant joints to ensure the window is adequately weatherproofed.
- Repair and repaint affected internal surfaces once the source of moisture has been rectified.

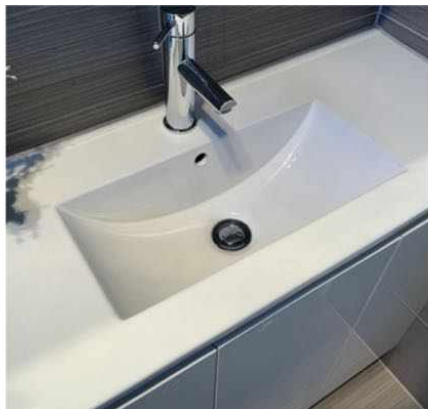
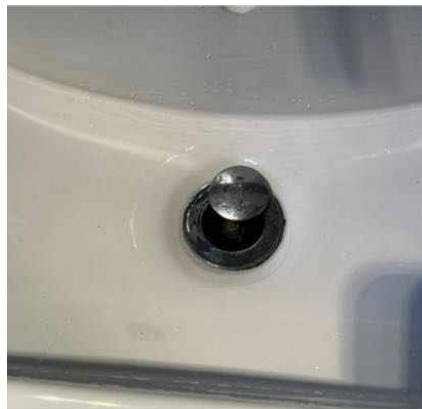
Defects 3.09

Building:	Main Building
Location:	Upstairs Bathroom
Finding:	Upstairs Bathroom – Damaged Basin Waste Plug
Information:	The basin waste plug to the upstairs bathroom vanity was found to be damaged and not functioning as intended. The pop-up mechanism appears loose and does not seat correctly within the waste fitting, preventing the basin from being effectively sealed to retain water.

While this is considered a minor defect, the fitting is not operating as designed and will require repair or replacement.

- Basin cannot be properly filled or sealed when required.
- Loose or damaged components may deteriorate further with continued use.
- May result in premature wear to the waste fitting assembly.

The basin waste plug is currently not functioning correctly and should be repaired or replaced to restore normal operation.

- Have the basin waste assembly inspected and repaired or replaced by a licensed plumber.

- Ensure the pop-up mechanism operates smoothly and seals correctly once rectified.

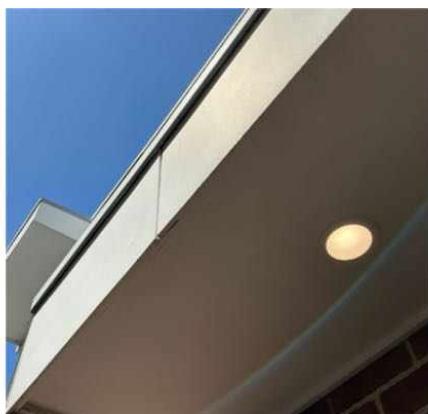
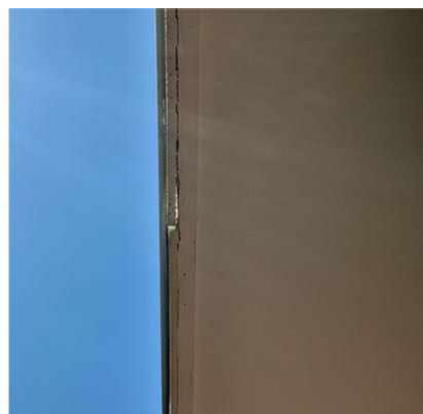
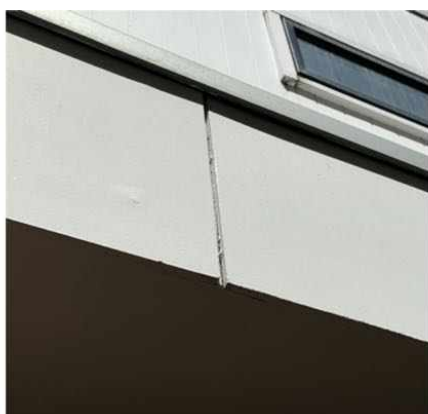
Defects 3.10

Building:	Main Building
Location:	Rear Yard Roof
Finding:	Rear Roof/Eaves Cladding – Joint Separation
Information:	A section of cladding to the rear roof/eaves area was observed to be separating at a vertical joint. A visible gap is present between adjoining panels, and minor deterioration is evident along the joint line and lower edge. The separation creates an opening that may permit moisture entry behind the cladding.

- Potential moisture ingress behind cladding.
- Accelerated deterioration of substrate materials.
- Risk of timber decay or corrosion of concealed fixings if prolonged exposure occurs.
- Ongoing expansion of the gap due to movement or weather exposure.

The separation of the cladding joint presents a potential pathway for water ingress and should be rectified to maintain the integrity and durability of the roof/eaves structure.

- Re-secure or realign the cladding panels as required.
- Seal joints appropriately to restore weather resistance.
- Monitor the area for any signs of internal staining or moisture-related damage.

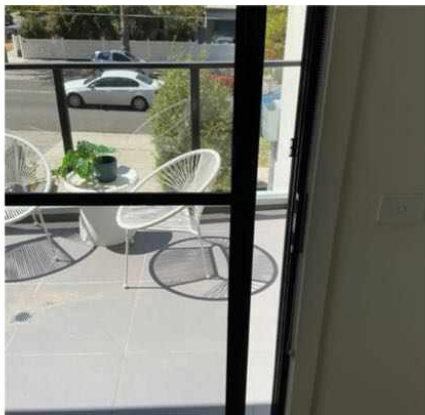
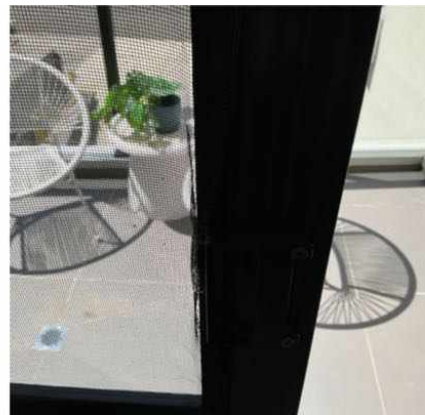
Defects 3.11

Building:	Main Building
Location:	Balcony
Finding:	Sliding Flyscreen Door – Torn Mesh at Handle
Information:	The mesh to the sliding flyscreen door has torn adjacent to the handle area. The damage appears consistent with wear from regular operation and handling, resulting in a split in the insect screen material.

The tear compromises the effectiveness of the flyscreen and detracts from the overall condition of the door.

The torn mesh is considered a minor defect but should be repaired to restore the functionality of the flyscreen door.

- Replace the damaged flyscreen mesh panel.
- Inspect the frame and handle area during repair to ensure there are no sharp edges contributing to premature wear.

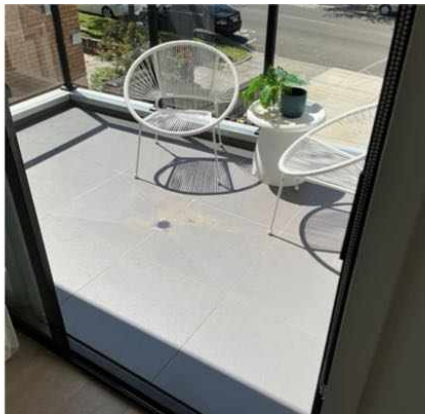
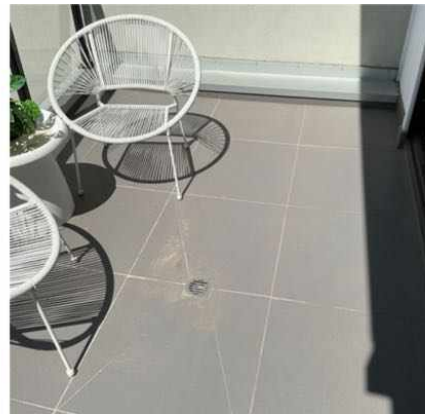
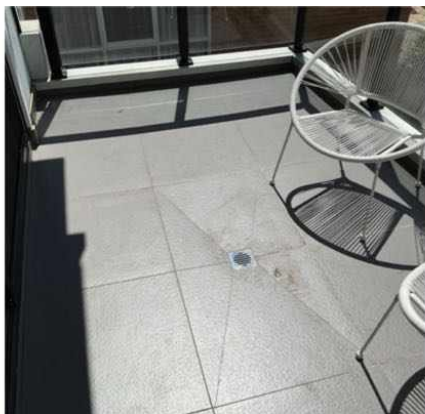
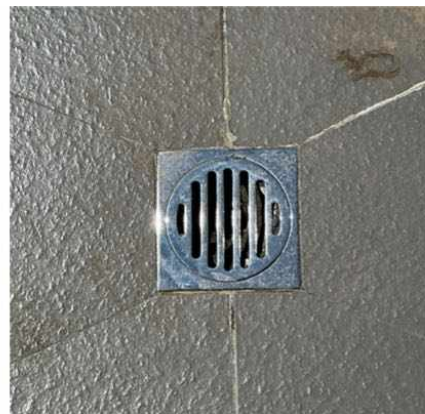
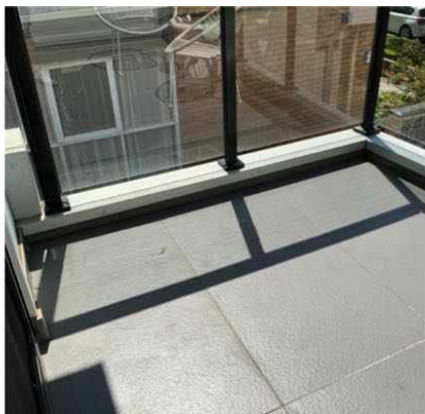
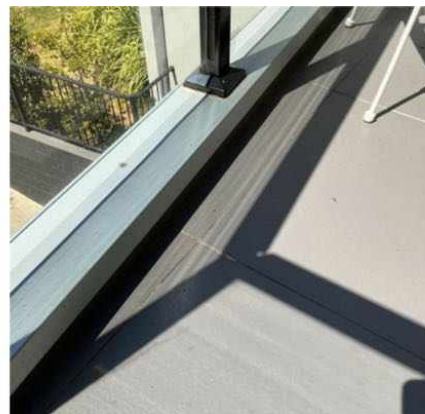
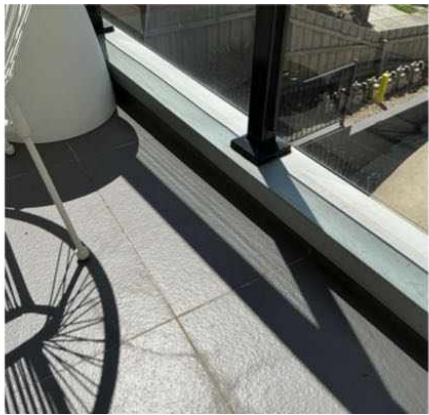
Building:	Main Building
Location:	Balcony
Finding:	Balconies not above habitable spaces
Information:	Balconies not located above habitable rooms are less likely to pose structural risks to interior living areas below; however, they still require proper construction and ongoing maintenance to prevent deterioration and secondary damage. In recent years, there has been an increase in waterproofed balcony failures, commonly associated with incorrectly installed membranes, inadequate falls, poor detailing at junctions, insufficient drainage provisions, material degradation, or substandard workmanship. The exact cause of balcony failure cannot be determined through a non-invasive inspection, as critical elements such as the waterproofing membrane and substrate are concealed beneath the finished surface.

It was also noted that no overflow provision has been installed to the balcony drainage system. In the event that the primary floor waste becomes blocked by debris, there is no secondary path for water discharge. This increases the risk of water ponding and potential overflow toward the dwelling, particularly at door thresholds and junctions. Even where the balcony is not located above a habitable room, uncontrolled overflow may result in water ingress to internal areas or deterioration of adjacent building elements.

Although balconies not located above habitable rooms may not directly impact internal ceilings, they can still cause external damage, compromise structural components, or affect adjoining walls and finishes if water is allowed to accumulate or track back toward the building.

Ongoing monitoring and appropriate drainage provisions are essential to reduce the risk of water overflow and potential damage to the dwelling.

4. Preventive Maintenance: Regularly clear the floor waste of debris and ensure surface finishes remain intact and free of cracking or deterioration.
