# Building and Timber Pest Inspection Report

Inspection Date: Mon, 9 Mar 2026

Property Address: 143 St Killian St, White Hills VIC 3550,  
Australia

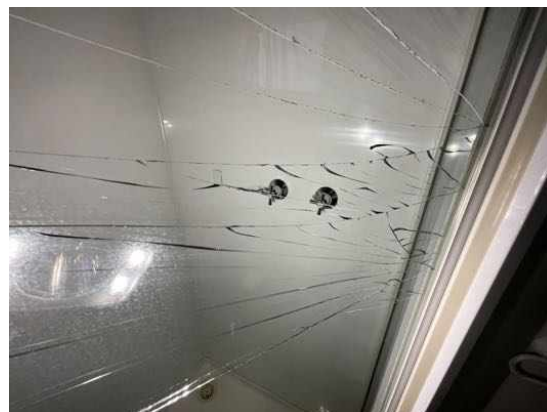
#### Finding 1.01

Building:	Building 1
Location:	Bathroom
Finding:	Shower screen - Cracked
Information:	Cracking was evident to the shower screen at the time of inspection, which is suspected to be due to accidental impact damage.

While the cracking appears to be minor, any further impact may lead to additional cracking and or shattering of the shower screen, creating a potential safety hazard in the area. Further damage would almost certainly necessitate replacement of the entire shower screen.

A qualified glazier is required to repair the shower screen as soon as possible. Please be advised that any persons coming into contact with the cracked shower screen should do so with due caution to avoid any personal injury that may ensue.

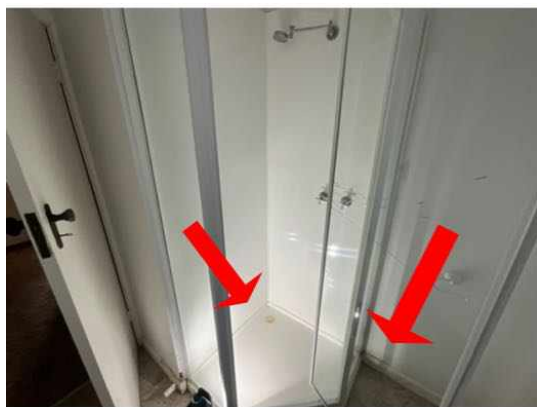
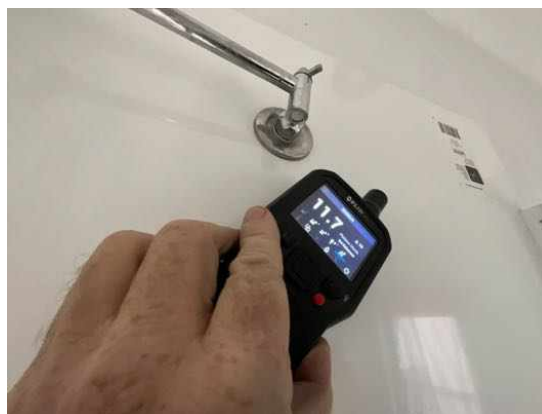
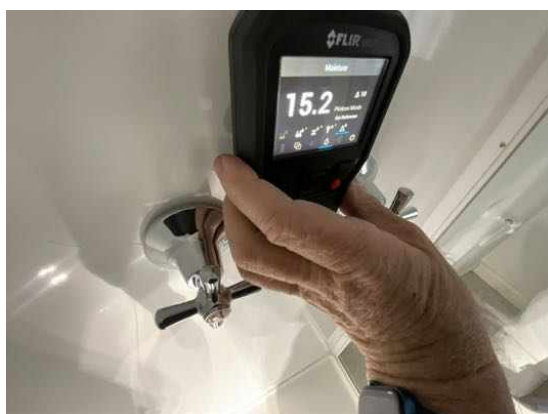
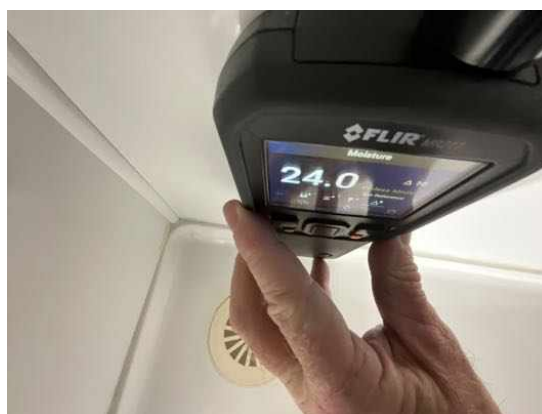
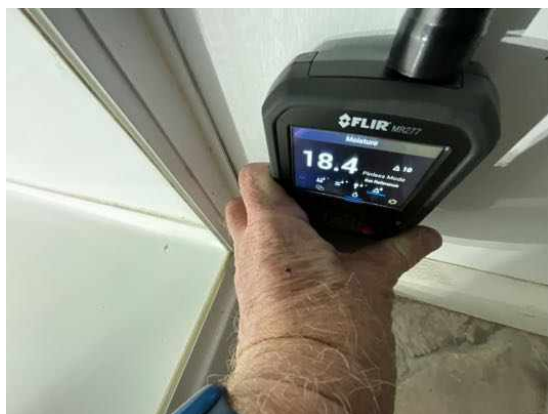
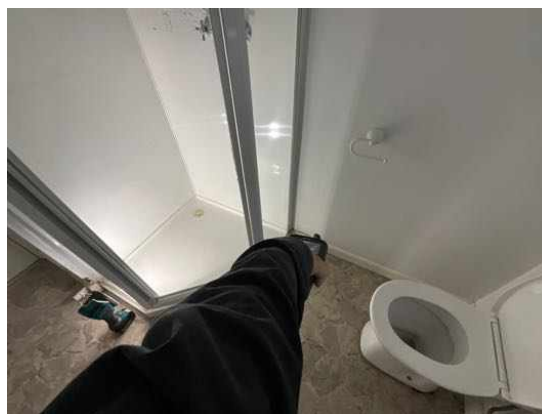
This defect is quite common, and is suspected to have been caused by moisture permeating or leaching through the grouting and perhaps gaps in the sealant prior to repair.

Damp (or structural damp) refers to the presence of unwanted moisture in the structure of a building, either as the result of intrusion from outside, or condensation from within the structure. In the shower area, internal water leaks or other sources of excessive moisture are generally the cause of damp.

Monitoring the area is advised and if any visual signs of excessive moisture appear (peeling paint, mould) then consultation with a qualified plumber or bathroom specialist would be advised to identify the cause of damp and to perform remedial works as required.

Always ensure that sealant and grout is in good condition to prevent any moisture issues occurring in the future.

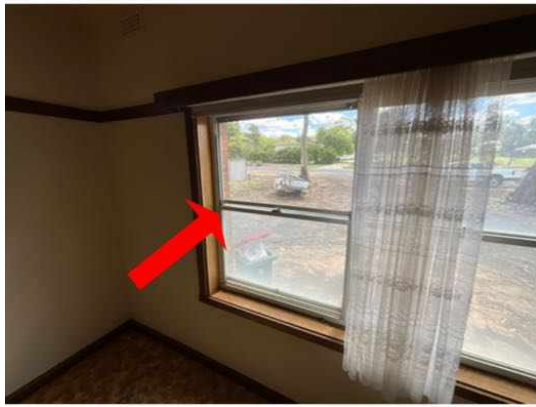
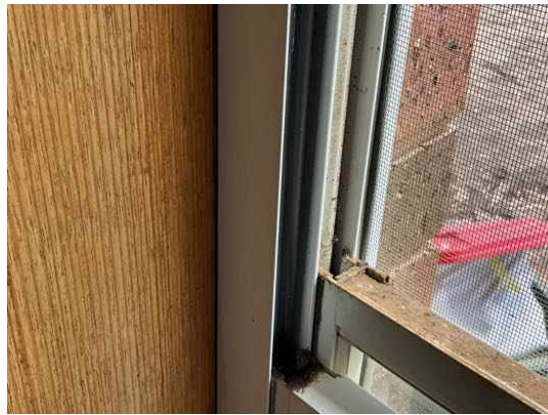
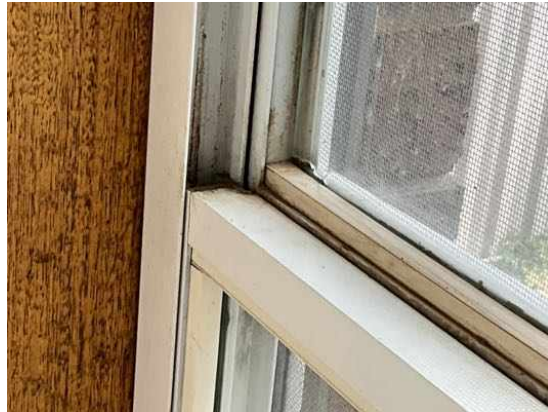
### Finding 3.02

Building:	Building 1
Location:	Bed 1
Finding:	Windows - Stiff to slide
Information:	Several windows throughout the property were jammed and difficult to operate at the time of the inspection. Windows provide ventilation to the adjoining area and should be at a fully operational level to ensure user comfort. Restricted function of the window may also pose as a potential safety hazard if required for emergency egress from the building.

Generally, factors such as general age of the building element and a lack of maintenance are the usual causes for this type of defect.

Replacement of window hardware or frame may be required, as well as minor repairs and cleaning. A registered builder or general handy person will be required to repair the affected windows.

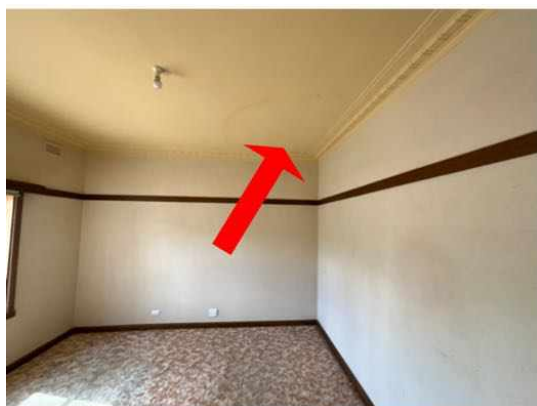
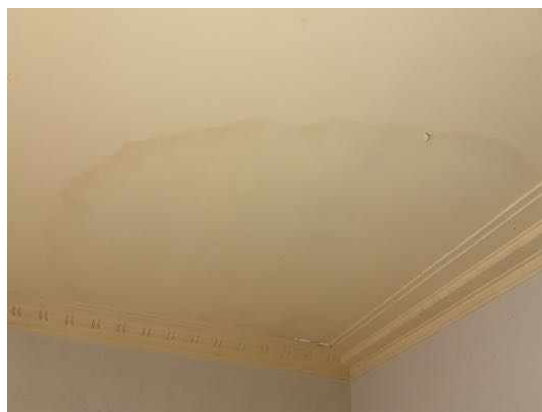
### Finding 3.03

Building:	Building 1
Location:	Bed 1
Finding:	Ceiling - Water stained
Information:	Water staining to ceiling linings in this area was evident at the time of inspection. Water staining indicates that surfaces have been exposed to excessive moisture over time. The minerals and other elements in the water lead to staining, which may graduate to corrosion and deterioration if left unmanaged.

While mostly an appearance defect, water staining can be indicative of more serious defects, which may be currently concealed by interior ceilings.

Where water staining is active, a licensed plumber must be consulted to identify the cause of the staining and to provide advice on any reparation works that may be required. Replacement of any damaged structures is advised.

Conversely, where water staining is old and inactive, affected building materials may be repaired or replaced at client discretion.

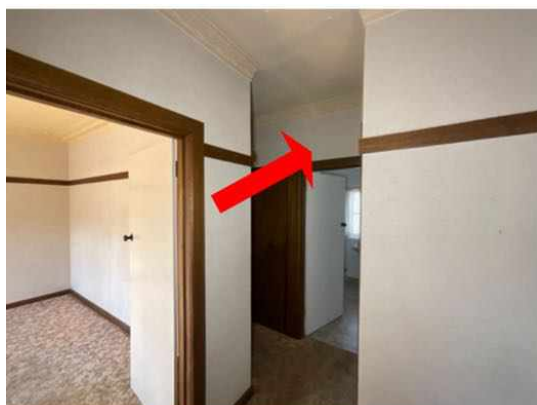
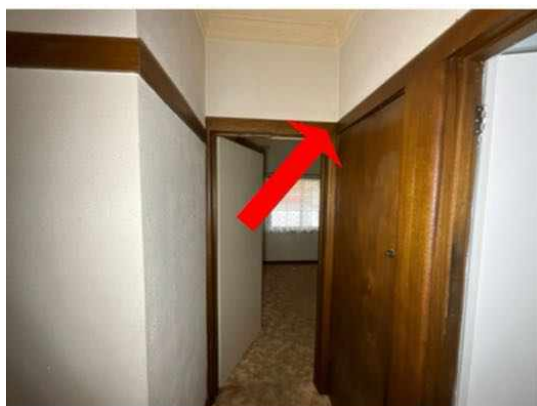
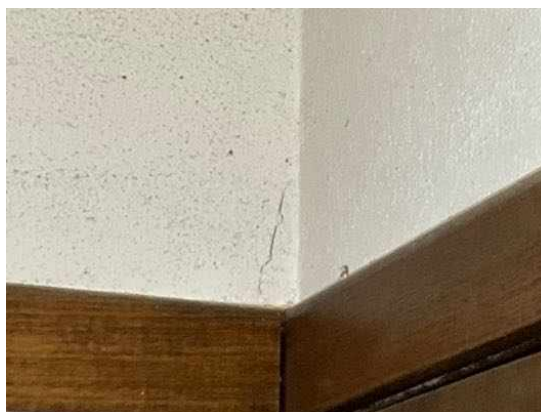
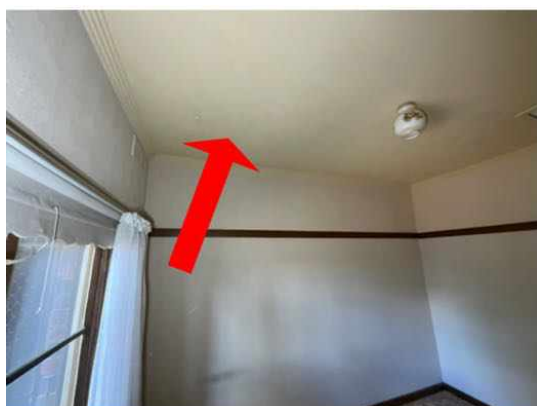
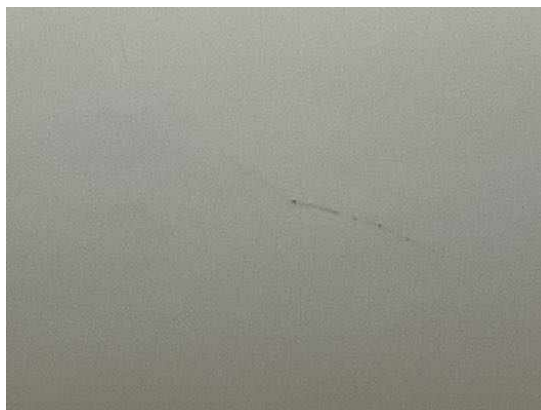
### Finding 3.04

Building:	Building 1
Location:	Hall, bed 3
Finding:	Cracking - Damage Category 2 - Noticeable (up to 5mm)
Information:	Noticeable cracks are a common occurrence as a result of many primary defects. Such causes may include age, general wear and tear, expected building movement, general expansion/contraction of building materials in different weather conditions, and/or minor failings in the installation or application of building materials.

Noticeable cracks may result in minor sticking or jamming of associated doors and windows, which require easement. However, noticeable cracks are easily filled and repaired. A plasterer can be consulted to install an expansion joint at this point to allow for this movement during different weather conditions.

Monitoring of all cracking should be conducted frequently. Always contact a building inspector should cracks widen, lengthen, or become more numerous. Additionally, your building inspector should also be contacted if associated building elements such as doors and windows become more difficult to operate over time.

Relevant tradespeople, such as carpenters, painters and plasterers, should be appointed to perform remedial works, as deemed necessary.

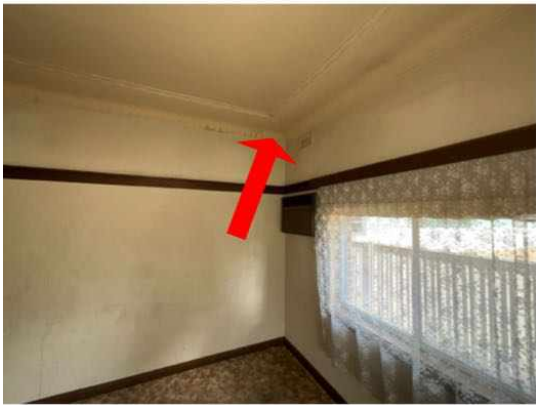
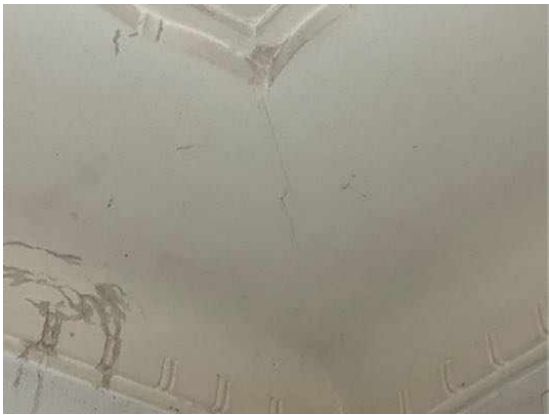
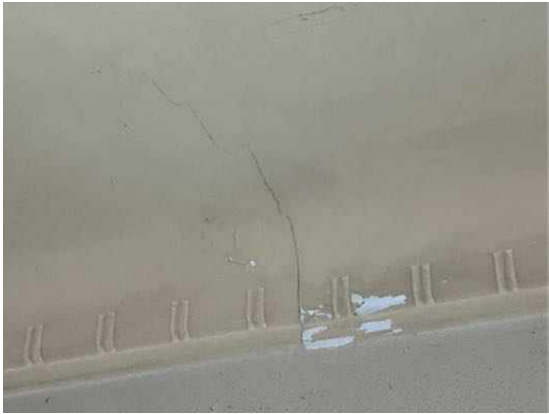
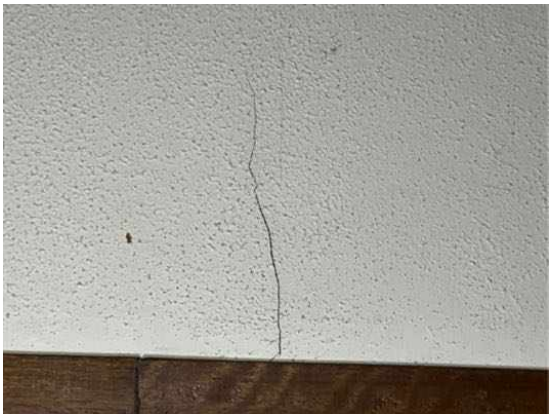
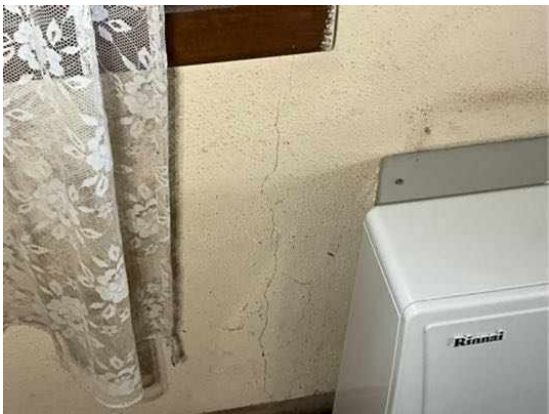
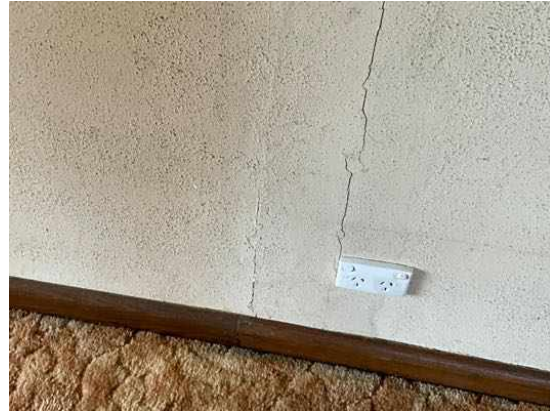
### Finding 3.05

Building:	Building 1
Location:	Living Room
Finding:	Cracking - Damage Category 1 - Fine (up to 1mm)
Information:	Although fine cracks are quite noticeable, they are often only considered to be an appearance defect, and usually do not indicate any structural damage. Generally, the cause of a fine crack is indicative of a separation between building materials and finishes (e.g. paint, plaster, etc.) along joins.

Cracking of this nature can generally be repaired with minor sanding, filling and/or repainting. Such works should be performed by a qualified painter or a general handyman.

Monitoring of all cracking should be conducted frequently. Always contact a building inspector should cracks widen, lengthen, or become more numerous.

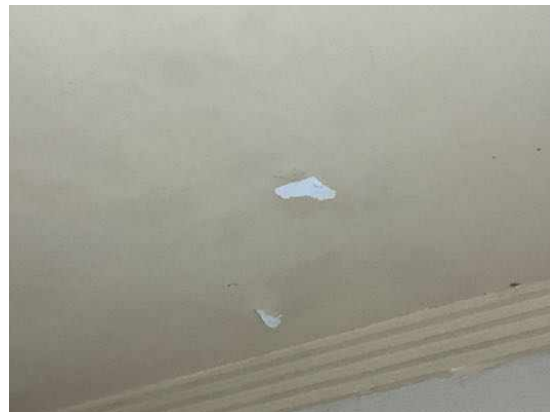
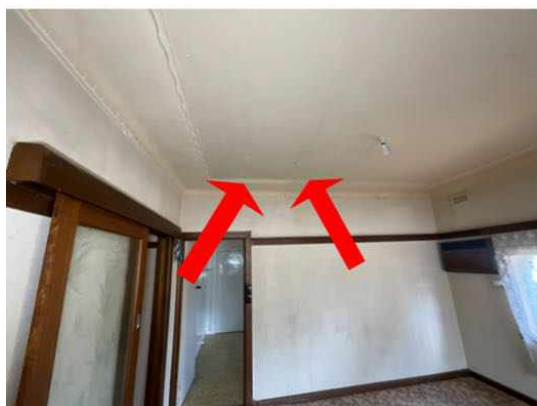
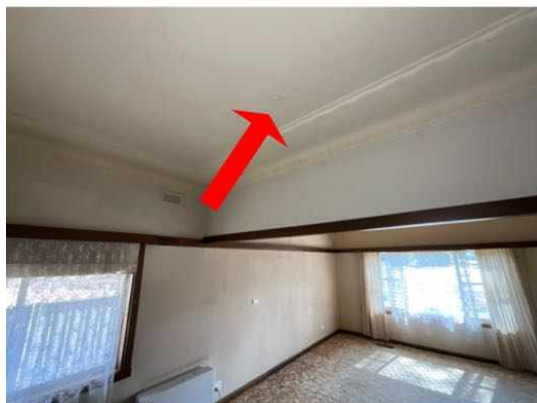
### Finding 3.06

Building: Building 1  
 Location: Bed 2, living room  
 Finding: Paint- Flaking  
 Information: Sections of paint in this area was found to have deteriorated. Paint flaking is generally an indication of excessive moisture in the area, that is currently hidden by the painted surface.

The presence of excessive moisture can have major implications on associated building elements if left unattended. While only seemingly minor at this stage, the damage cannot be determined due to the paint obstructing any further inspection of the damage.

A qualified Painter should be contacted at the Owner's discretion to re-paint the area.

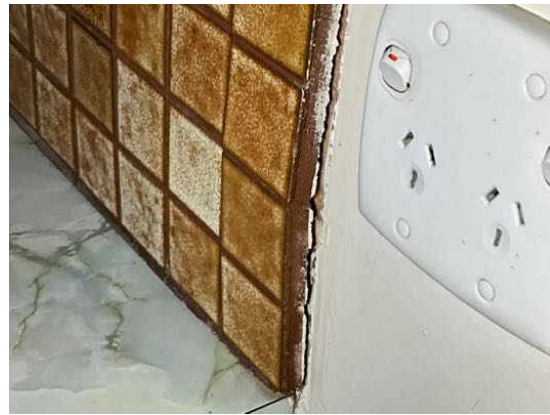
### Finding 3.07

Building:	Building 1
Location:	Kitchen
Finding:	Tiles - Drummy
Information:	Drummy tiled areas were identified at the time of inspection. The term 'drummy' refers to tiles that have become detached from their fixing, despite otherwise being in relatively good condition. Such defects are generally caused by physical or moisture damage to the area. Drummy tiled areas may also be a direct result of poor workmanship during the construction process.

Tiled areas may swell and shrink with changes in air humidity if the area has sustained moisture damage. Any exposure to moisture is capable of causing tiled areas to become drummy and/or cracked over a prolonged period of time. Drummy tiled areas generally require removal and replacement of affected tiles, with adequate sealant and grouting.

Specialist trades are available for these types of services. A registered builder may be required to undertake works if damage is extensive or if secondary building defects have resulted. Otherwise, it is advised that a tiling contractor be appointed to perform works as necessary. Immediate action is recommended to ensure that no further damage is sustained in the affected area.

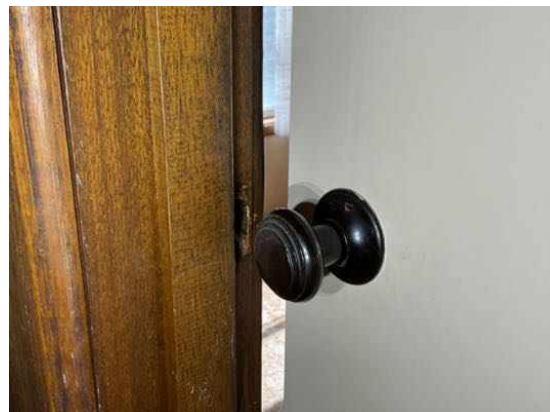
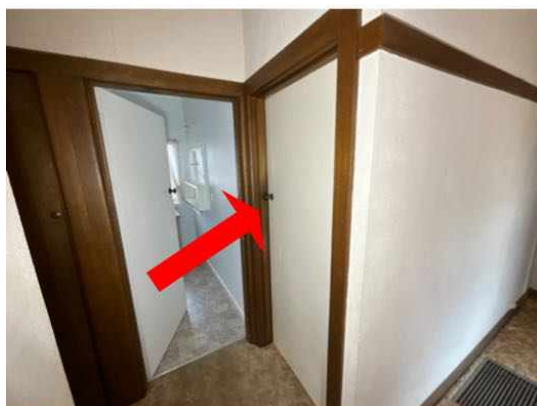
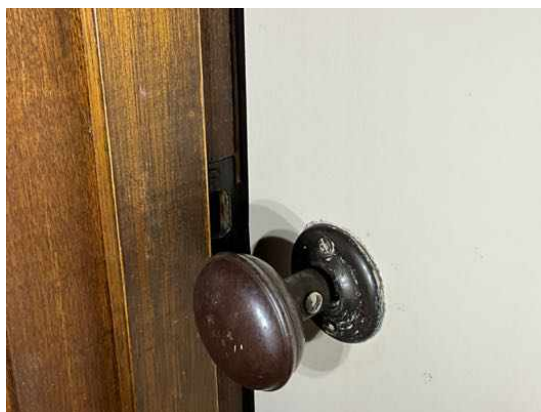
### Finding 3.08

Building: Building 1  
 Location: Bedroom 1,3  
 Finding: Door - Striker plate misaligned  
 Information: The striker plate to this door appears to have become misaligned and has consequently resulted in the door's operation being compromised.

This is a common defect and is expected in a property of this age, whether being due to substandard installation or general deterioration of the door hardware.

Readjustment of the striker plate is recommended at client discretion. Works such as these can be completed by a general handyman or qualified carpenter.

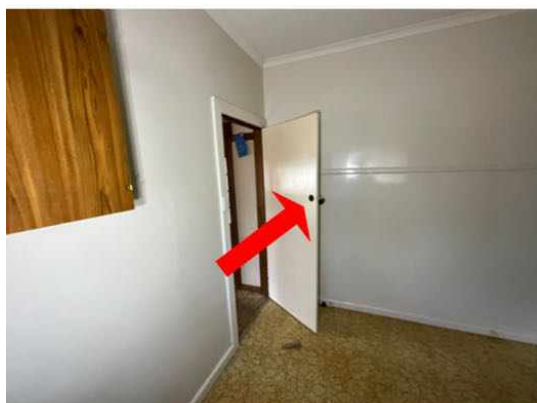
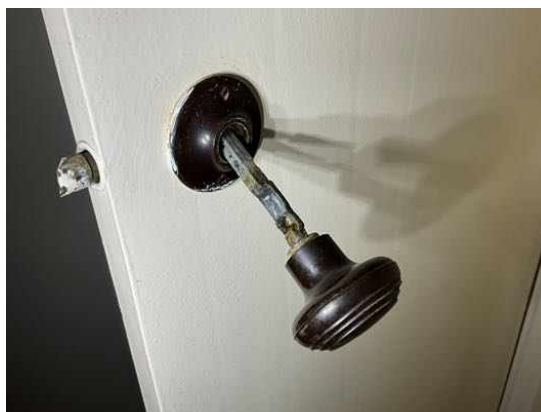
### Finding 3.09

Building: Building 1  
 Location: Kitchen  
 Finding: Door handle- Poor operation  
 Information: The door handle/ catch in this area was found to be faulty during the visual inspection. This is most probably because of a lack of maintenance or wear and tear over time.

A general Handy person or lock specialist should be contacted to make needed repairs at the discretion of the owner and restore full function.

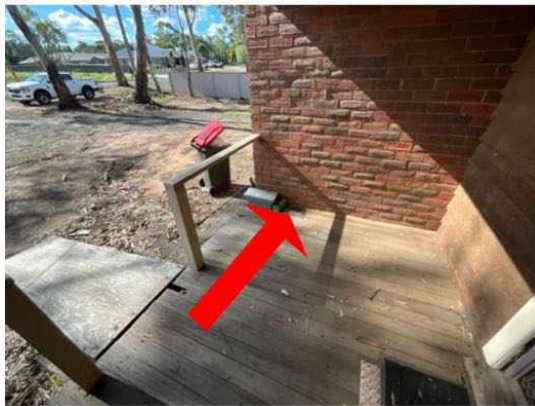
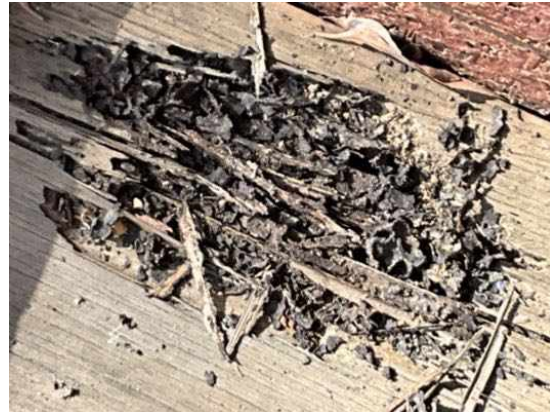
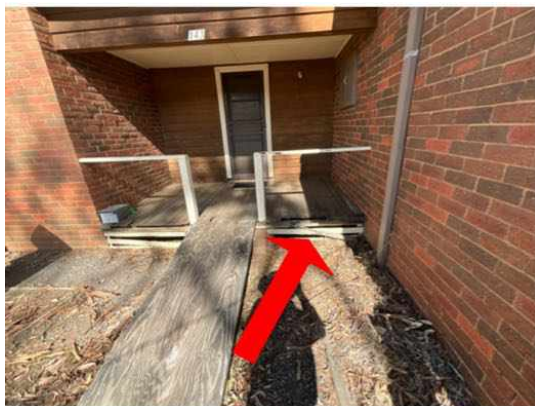
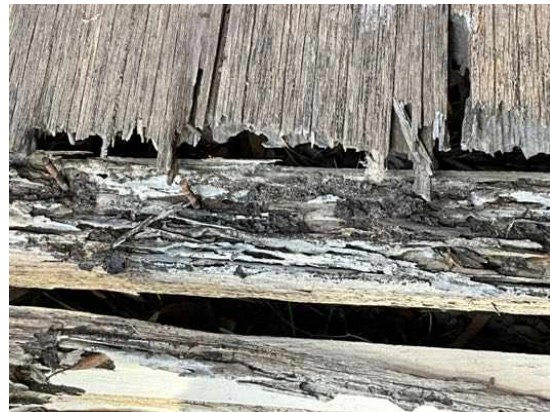
Building: Building 1  
 Location: Verandah > Front  
 Finding: Evidence of termite damage - minor

Information: Despite no live termite or timber pest activity being indicated, previous termite damage was found to have affected this area. This damage is considered to be inactive and is minor in nature.

It is advised that the area be visually inspected frequently to ensure that the condition of affected building materials does not worsen. At the time of inspection, damage is not structural and is only considered to be superficial.

A building contractor may be appointed to provide a further invasive inspection if further damage is evident.

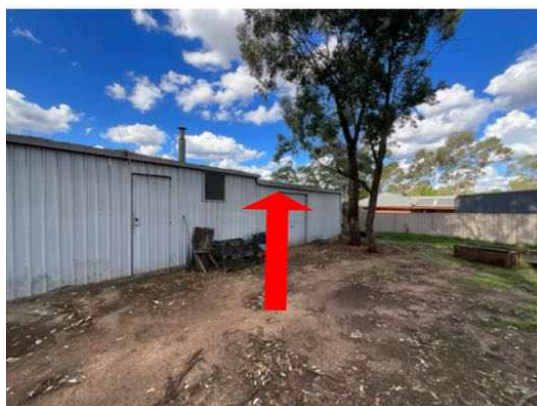
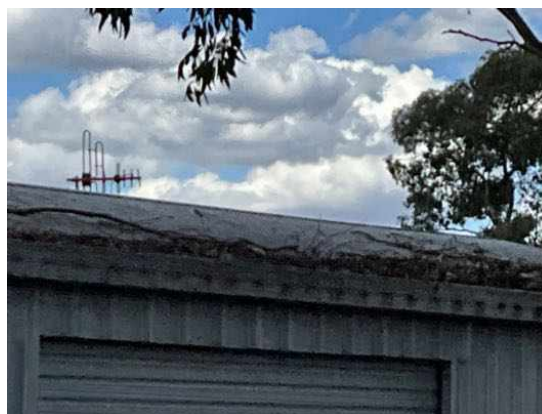
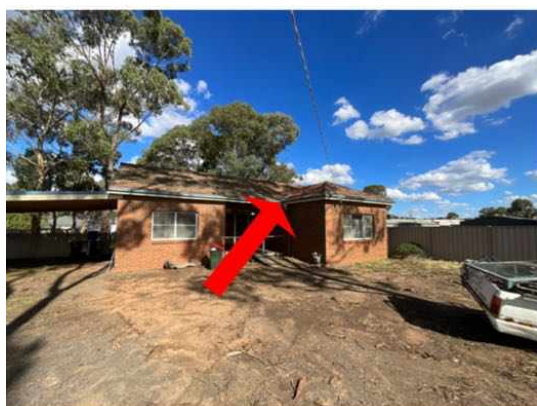
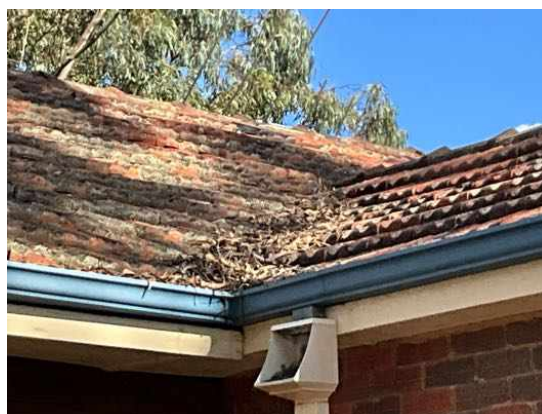
### Finding 6.01

Blocked gutters are likely to lead to high levels of moisture in the affected areas. Such moisture will not only cause rust and decay of the associated building materials, but can also provide conditions that are conducive to termite and timber pest activity. Blockages in gutters should therefore be removed immediately to ensure dry conditions are maintained.

Consult a Licensed Plumber for further specific advice on remedial works that may be required. In the interim, it is highly advised that blocked gutters be removed by the homeowner or a general handyperson as a matter of urgency.

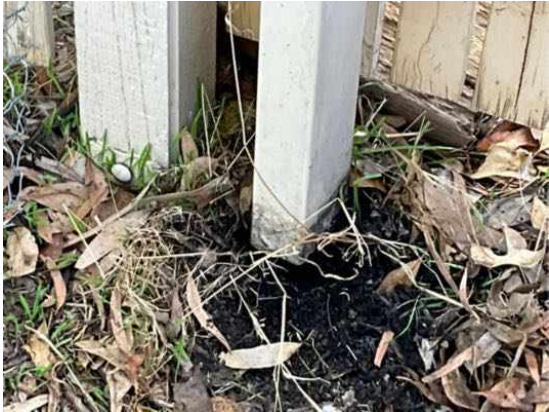
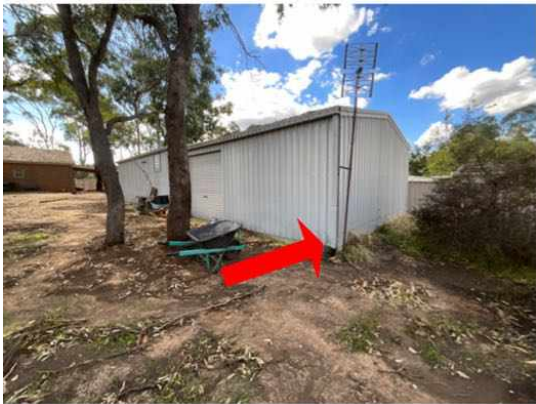
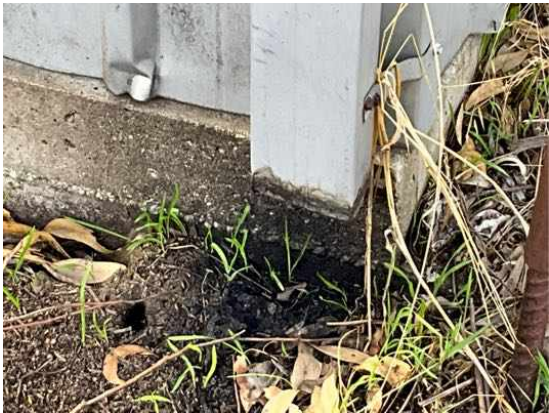
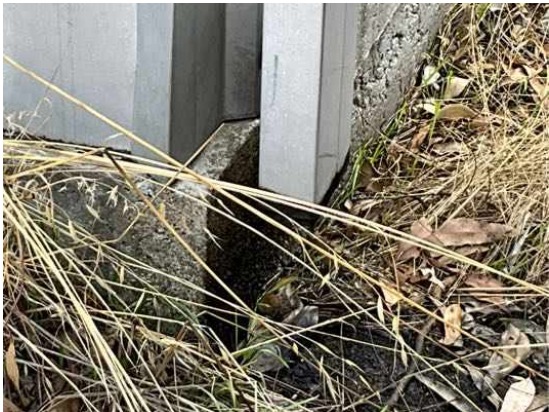
## Finding 6.02

Building:	Building 1
Location:	Carport, garage
Finding:	Stormwater drain - Not connected
Information:	The roof plumbing is not adequately connected to stormwater drainage on the site. This disconnection negatively impacts the functional capacity of the roof plumbing.

Where roof plumbing doesn't drain adequately, the area at the base perimeter can become excessively damp, potentially creating an environment that is susceptible to rust and corrosion of surrounding building elements, as well as attracting termites and other pests.

It is highly recommended that a plumber be appointed to further inspect the area and to install adequate drainage equipment where necessary.

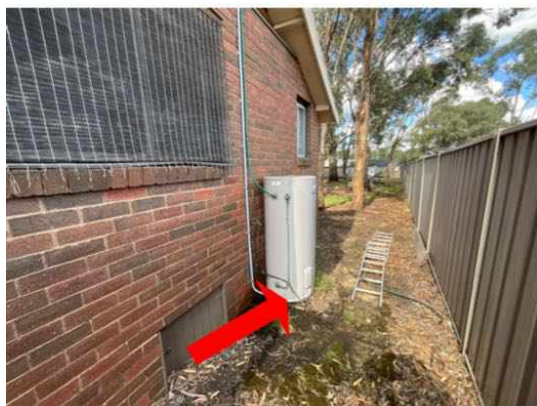
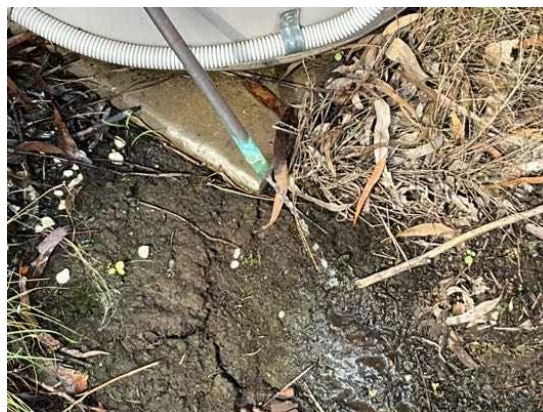
**Finding 6.03**

Building: Building 1  
Location: Yard - Side  
Finding: HWS Overflow - Not Connected  
Information: The Hot Water System (HWS) overflow was found to be disconnected from storm water drainage and is creating excessive moisture in the surrounding area.

These damp conditions can lead to secondary defects such as rot, rust or corrosion

of associated building elements, the formation of fungal decay, or even the creation of potential slip hazards. When coupled with poor site drainage, pooling of water may also attract termite activity to this area.

It is highly recommended that a licensed plumber be appointed to connect the HWS overflow in order to prevent such an environment from being created. These minor works should be carried out as soon as possible.

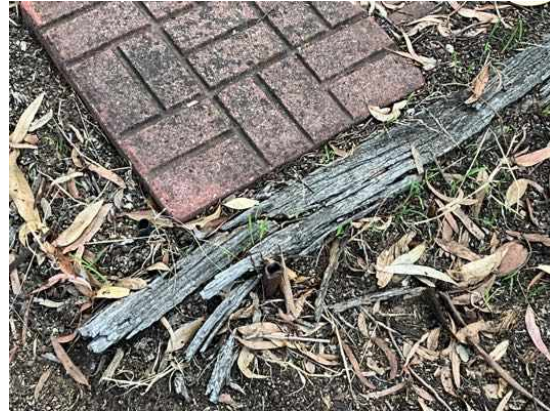
#### Finding 6.04

Building:	Building 1
Location:	Yard - Back
Finding:	Untreated or non-durable timbers in a hazardous environment
Information:	To reduce the risk of timber pest attack it is essential that timber used in a hazardous environment (e.g. in direct contact with the ground or frequently exposed to damp conditions) is of sufficient durability and/or is adequately preservative treated.

Untreated timbers in direct contact with the ground are likely to develop severe wood rot and/or fungal decay if left unattended creating attraction for subterranean termites to infest the timbers from surrounding areas.

If untreated or non-durable timbers are found to be in a hazardous environment it is highly advised that replacement of these building elements be performed as soon as possible to aid the protection of the property against termite / timber pest attack.

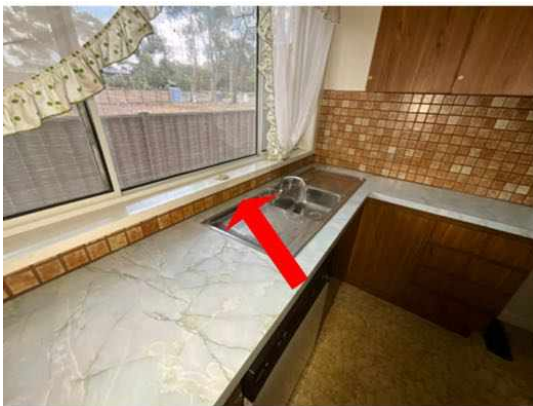
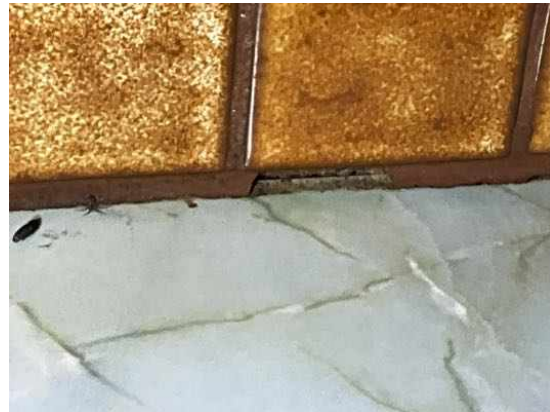
### Finding 6.05

Building: Building 1  
 Location: Kitchen  
 Finding: Inadequate sealant or Grout  
 Information: This area has a lack of effective Sealant or Grout. This is allowing the ingress of water to the structure inside the wall.

The presence of water encourages Termite attack, Mould and Fungal Decay.

A Tiler or General Handy person must be contacted as soon as possible to effect repairs and prevent further deterioration.

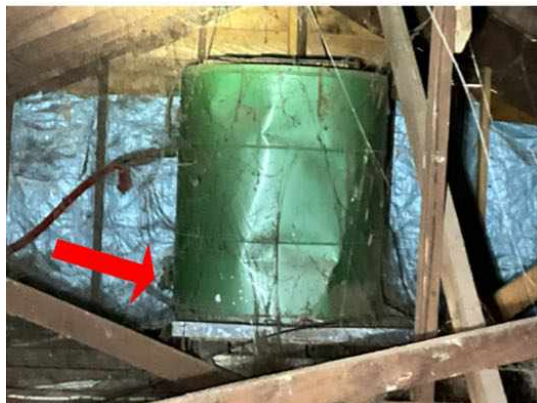
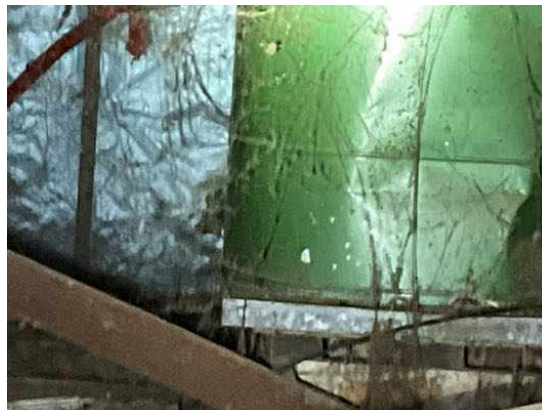
### Finding 6.06

Building: Building 1  
 Location: Roof Void  
 Finding: Gravity-Fed HWS - Disconnected  
 Information: It was noted at the time of inspection that a disconnected gravity-fed hot water system (HWS) remains in this area.

Despite this plumbing structure being unused, it is likely to be storing residual water, and is therefore susceptible to rust and corrosion. If allowed to continue, rust and corrosion is likely to lead to damage to adjoining building elements, and may also

make the area susceptible to termite or timber pest activity.

While it is a costly exercise to remove the disused gravity-fed HWS, it is advisable in the short-term future to prevent any further damage to the area. Further consultation with a licensed plumber is required to gain further advice on removal of the structure.

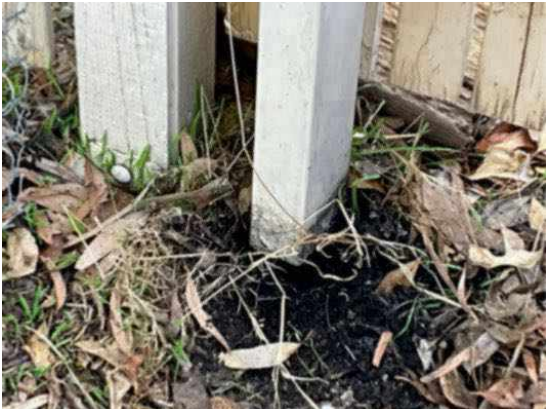
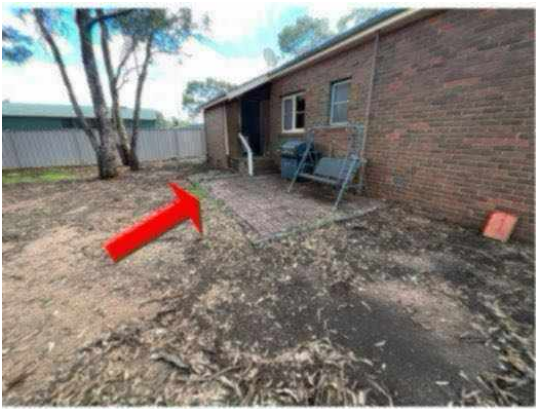
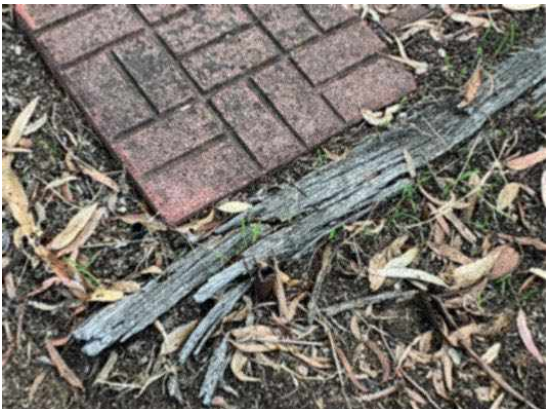
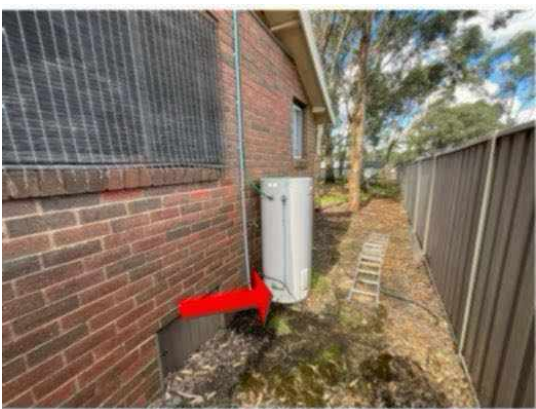
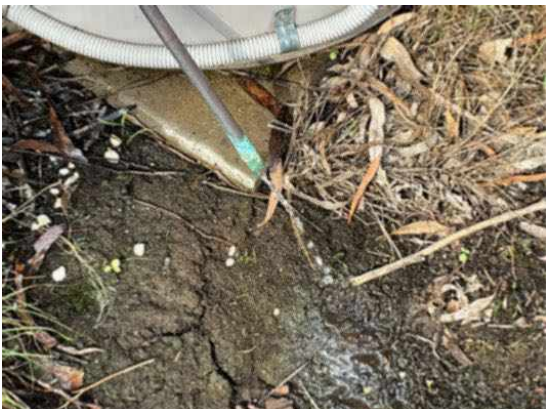
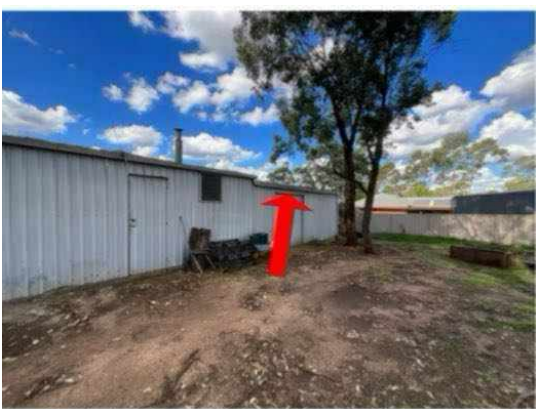
### Finding 6.07

Building:	Building 1
Location:	All External Areas
Finding:	Termite Management System - no evidence of a chemical installation
Information:	The application of a post-construction chemical termite barrier is highly recommended for all properties, particularly if live termite activity has been found on the site previously. Such barriers are highly effective in preventing termite attack on any timber building elements throughout the property.

A durable notice should be placed in the switchboard unit to indicate current termite barriers. At the time of inspection, it appeared as though no termite management system has been installed, with no evidence to suggest preventative works taking place.

The client may consider gaining further advice from a pest controller as to the costs and procedures involved with this application. It is recommended that obtaining such advice be a short-term priority.

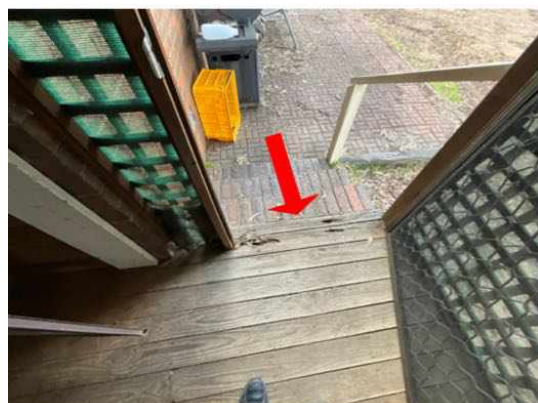
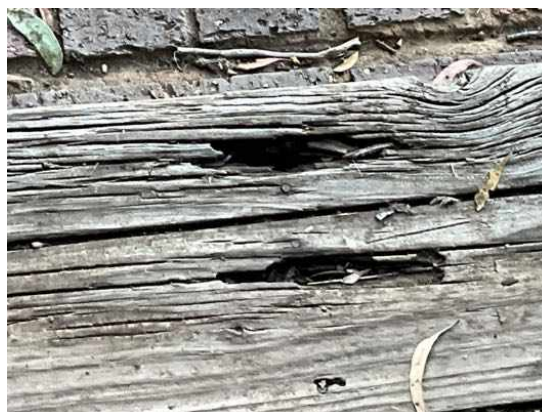
### Finding 7.01

Building:	Building 1
Location:	Laundry area, carport
Finding:	Fungal decay - present (localised)
Information:	Fungal decay also known as wood decay or wood rot generally refers to the deterioration of timber elements when in contact with excessive levels of moisture for a prolonged period of time.

The development of fungal decay is accelerated by temperatures in the range of 5degreeC to 40degreeC as well as the presence of oxygen. Generally fungal decay develops on timber elements that are in use in an external environment which are exposed to rain penetration.

In this case although the affected timber element is in a decaying state the extent of any visible damage appears to be localised to a specific area and is yet to spread to other parts of the building element or affect adjoining structures. The fungal decay is therefore likely to be of a relatively superficial nature with minimal impact on the structural integrity or tensile strength of the timber element.

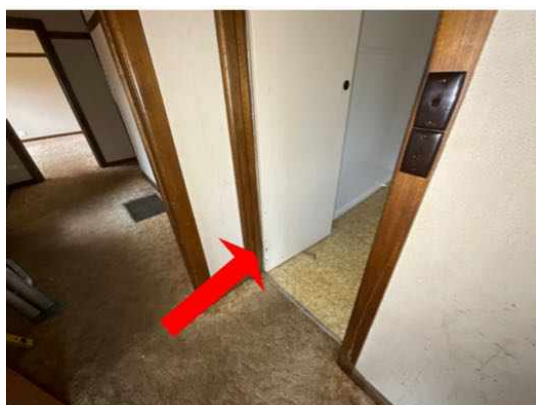
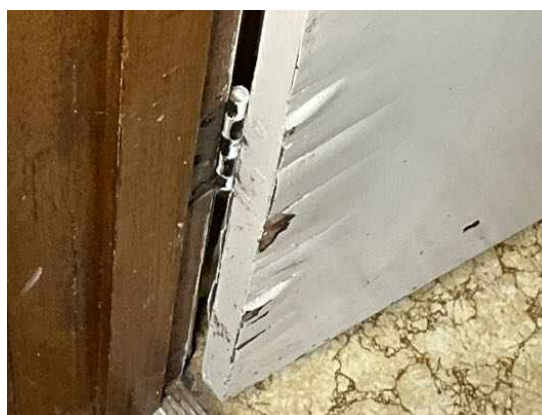
Building:	Building 1
Location:	Kitchen
Finding:	Delamination of timbers
Information:	Delamination is one means by which composite materials (e.g. layered timber composites) may fail over time. In laminated materials, repeated cyclic stresses may lead to the formation of mini-structures of separate layers, with significant loss of mechanical toughness. Water penetration or the presence of excessive moisture also generally contributes to delamination.

Where building materials have become delaminated, they lose their structural strength, and are likely to have a variety of appearance and serviceability defects as a result.

Delamination of timbers may be repaired where the area affected is minor and/or easily accessible, by gluing and screwing layers back together. However, this is an interim repair, and where delamination has occurred, the client should plan for the replacement of affected timbers sooner than would otherwise be expected.

All timber structures affected by delamination should be replaced as soon as possible to avoid any further damage. Repair and replacement estimates should be sought from a registered builder or qualified carpenter.

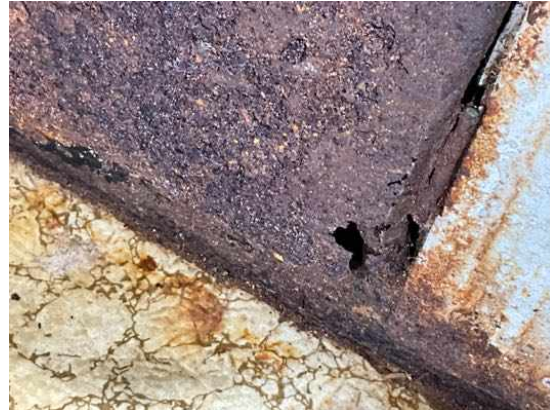
Building:	Building 1
Location:	Laundry
Finding:	Rust- metal component
Information:	The metal element in this area is rusted. This will further deteriorate if not addressed.

Appropriate trades should be contacted at the discretion of the client, to restore the area to improve utility.

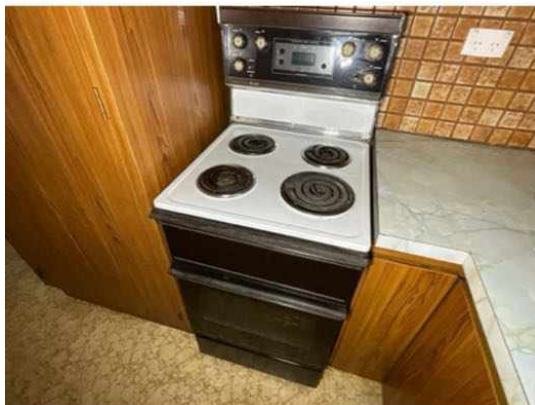
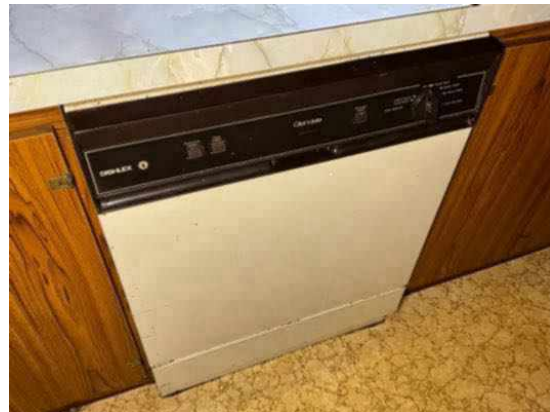
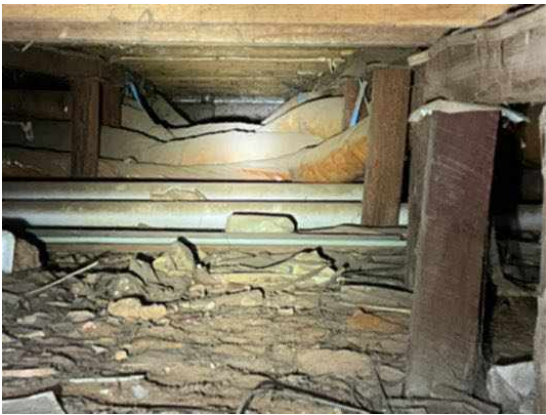
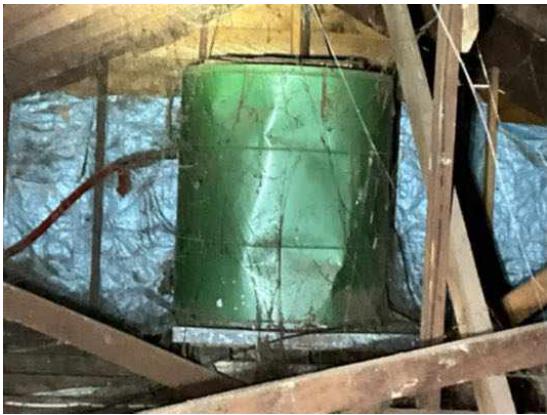
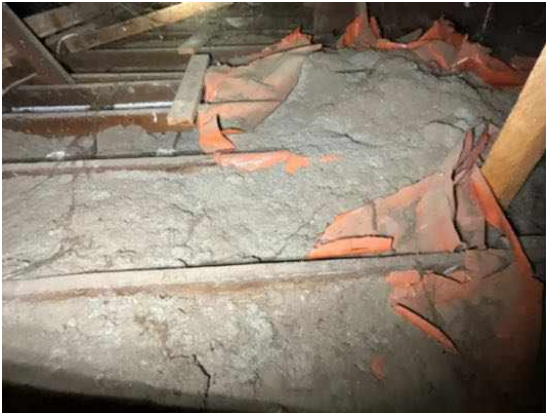
Building: Building 1  
Location: All Areas  
Finding: Additional Photos - Obstructions and Limitations  
Information: These photographs are an indication of the obstructions and limitations which impeded full inspection of the property at the time of inspection. These obstructions can hide an array of defects and should be removed to allow full inspection to be carried out. A re-inspection is recommended once the areas are made accessible.
