## Building Inspection Report

Inspection Date: Thu, 5 Mar 2026

Property Address: 6 Bellevue Ave, Old Reynella SA 5161,  
Australia

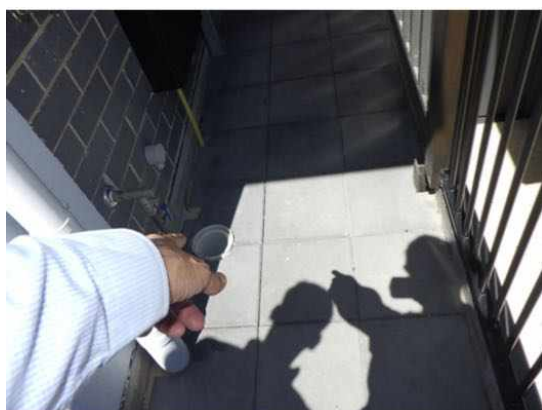
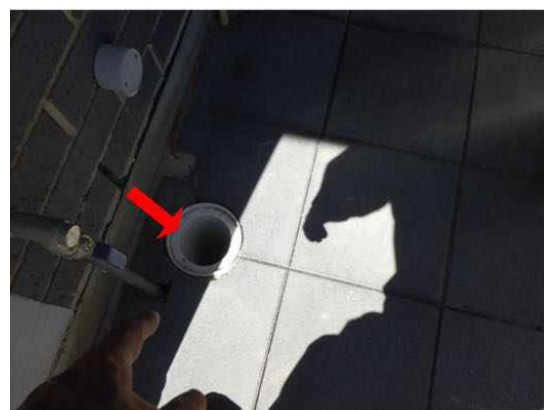
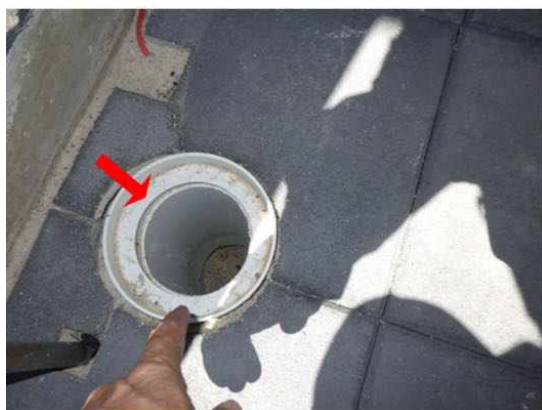
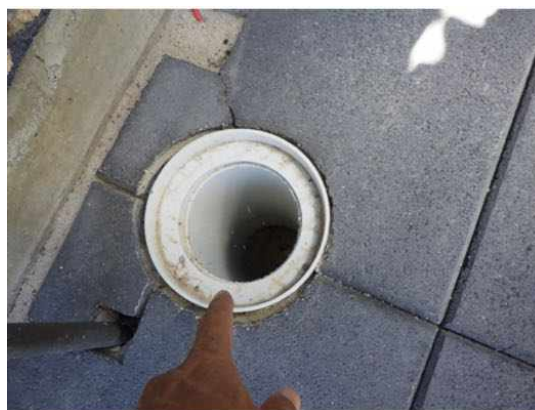
#### Defects 2.01

Building: Building 1  
Location: All External Areas  
Finding: Stormwater Drainage – Plumbing Pipe Not Covered  
Information: At the time of inspection, it was observed that the stormwater drainage plumbing pipe near the electrical and gas meter box was not properly covered or sealed. Unprotected stormwater pipes may allow the entry of debris, soil, pests, or other foreign materials, which can lead to blockages and reduced efficiency of the stormwater drainage system over time.

In addition, the exposed pipework in close proximity to service meter boxes may increase the likelihood of accidental damage if left unprotected.

This condition is considered a defect and maintenance concern that requires attention.

It is recommended that a suitably qualified and licensed plumber or relevant tradesperson be engaged as soon as practicable to properly cover and seal the stormwater pipe in accordance with relevant plumbing standards and accepted building practices. Rectification works should be undertaken to prevent potential blockages, damage, and the development of secondary defects.

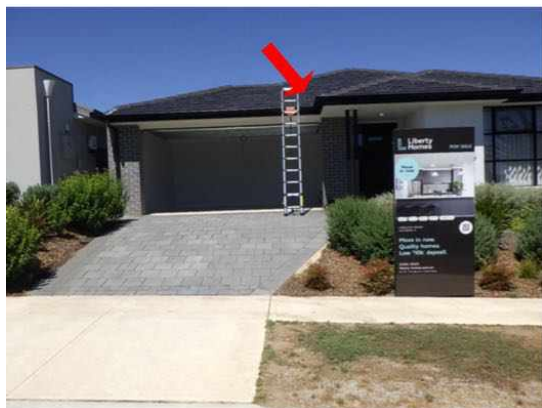
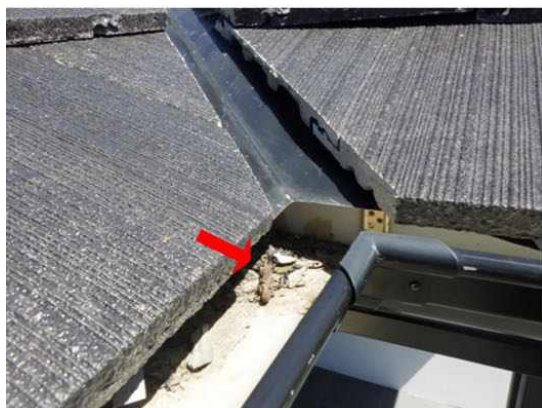
### Defects 3.01

Building:	Building 1
Location:	All External Areas
Finding:	Gutters - Blocked
Information:	At the time of inspection it was noticed that gutters were blocked in few sections around the property. Gutters have to be cleaned in regular intervals.

Roof plumbing structures, such as guttering and downpipes, should be free of all debris to prevent blockages. Blockages of the guttering and downpipes will lead to pooling and accumulated water overflows, which is likely to subsequently flood eaves and exterior walls.

Blocked gutters are likely to lead to high levels of moisture in the affected areas. Such moisture will not only cause rust and decay of the associated building materials, but can also provide conditions that are conducive to termite and timber pest activity. Blockages in gutters should therefore be removed immediately to ensure dry conditions are maintained.

Consult a Licensed Plumber for further specific advice on remedial works that may be required. In the interim, it is highly advised that blocked gutters be removed by the homeowner or a general handyperson as a matter of urgency.

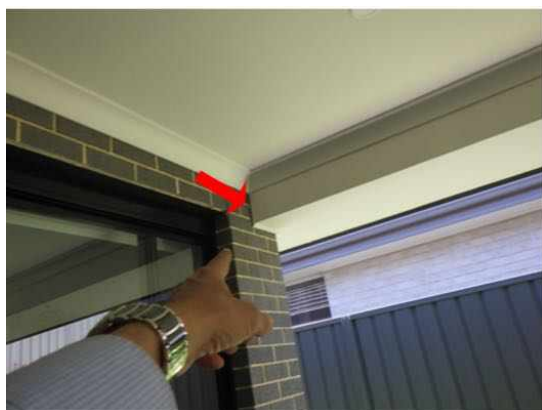
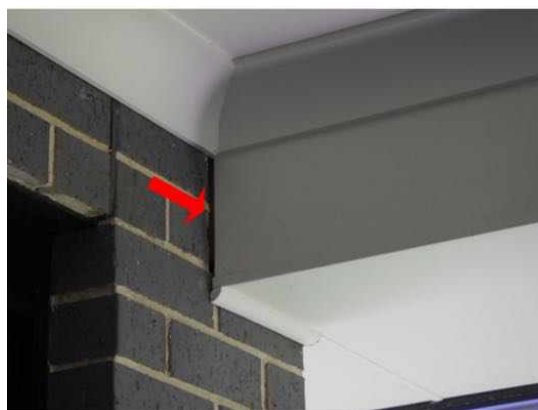
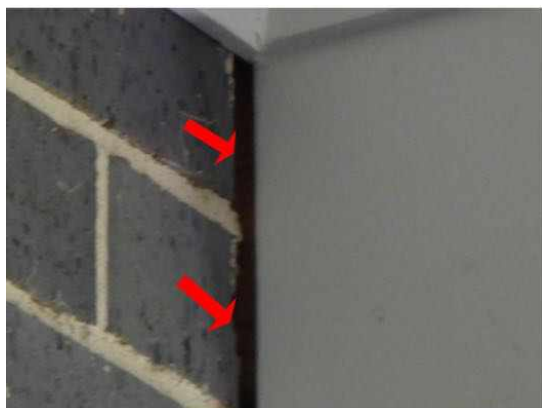
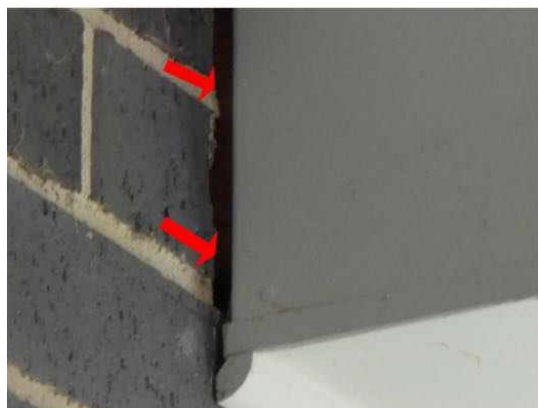
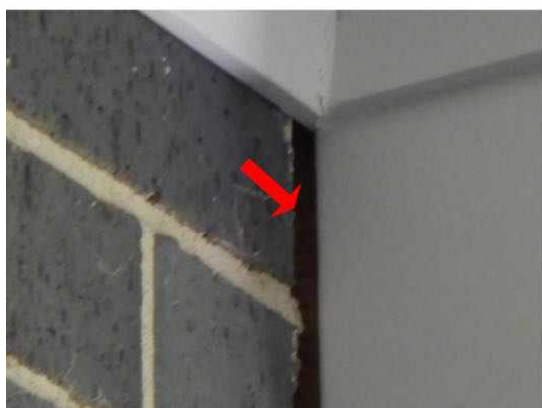
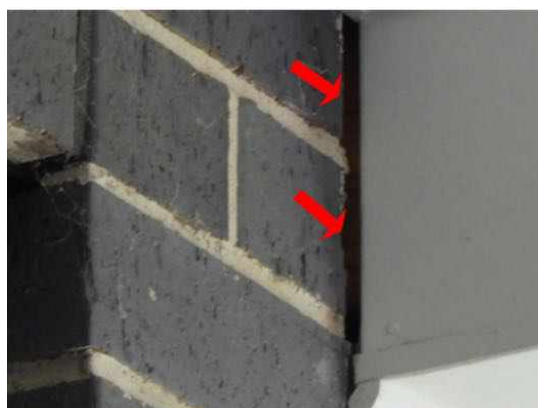
### Defects 3.02

Building:	Building 1
Location:	All External Areas
Finding:	Alfresco Area - External Walls & Timber Beam - Significant Gaps Observed
Information:	At the time of inspection, it was noted that significant gaps are present between the external wall cladding and timber beam in this alfresco area. These gaps indicate poor detailing, movement, deterioration of materials, or inadequate installation and sealing.

Such conditions may arise due to age-related degradation, environmental exposure, or physical damage. If left unrectified, these gaps may allow water and air ingress, potentially leading to secondary defects, including moisture damage, deterioration of adjacent building elements, and reduced thermal and weatherproof performance.

Repair and/or replacement of the affected components is recommended to reinstate the integrity and performance of the building envelope. All building elements play an essential role in the operation and overall performance of the structure, and defects of this nature may adversely impact durability and habitability.

It is advised that a suitably qualified and licensed tradesperson be engaged to assess and rectify the affected areas to prevent further deterioration or consequential damage.

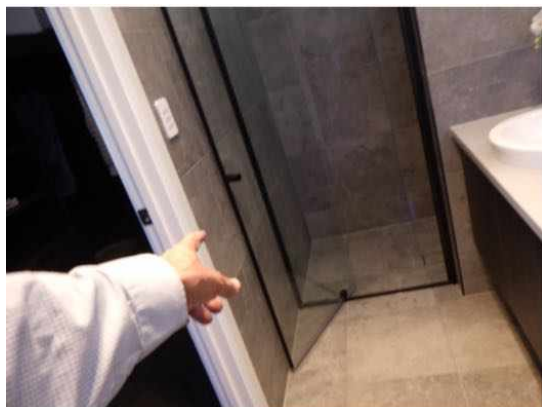
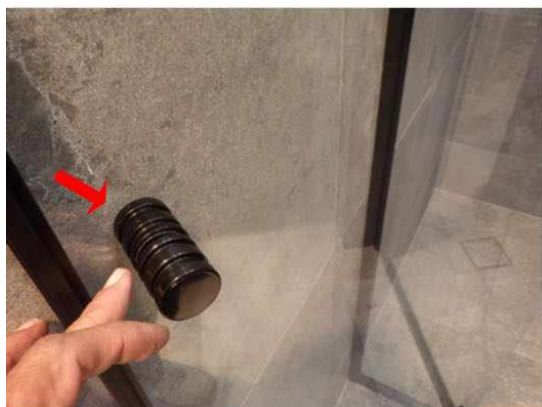
### Defects 3.03

Building:	Building 1
Location:	Bathroom - Ensuite
Finding:	Shower screen touching - Internal wall tiles during standard operation
Information:	At the time of inspection it was noticed that shower screen door is touching the internal wall tiles and creating a potential safety hazard in the bathroom -ensuite area during standard operation and creating a potential safety hazard for the persons coming contact in this area.

It advised that builder should take appropriate measures to avoid/ reduce the impact of shower screen hitting during door operations.

A qualified glazier is required to repair the shower screen as soon as possible. Please be advised that any persons coming into contact with the shower screen should do so with due caution to avoid any personal injury that may ensue.

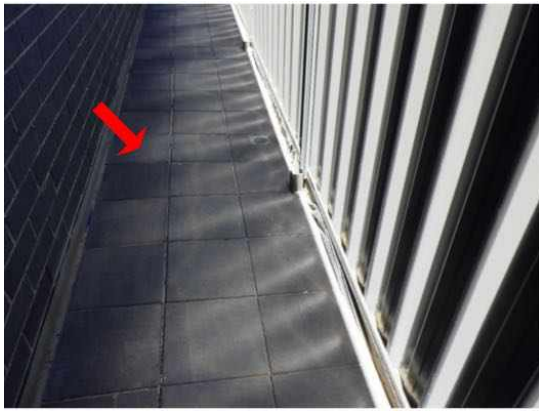
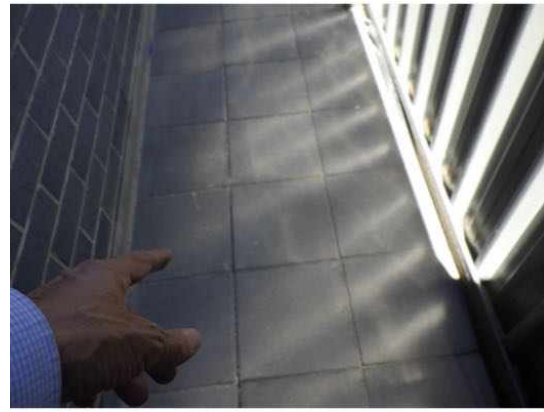
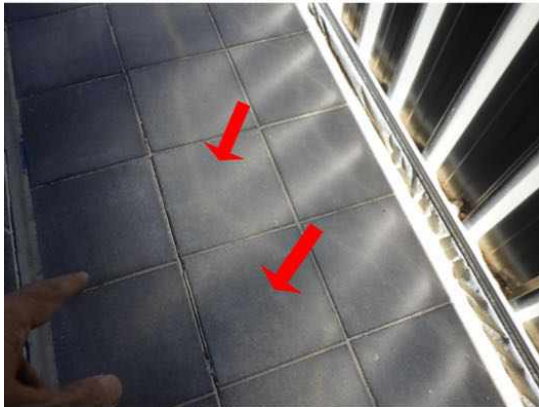
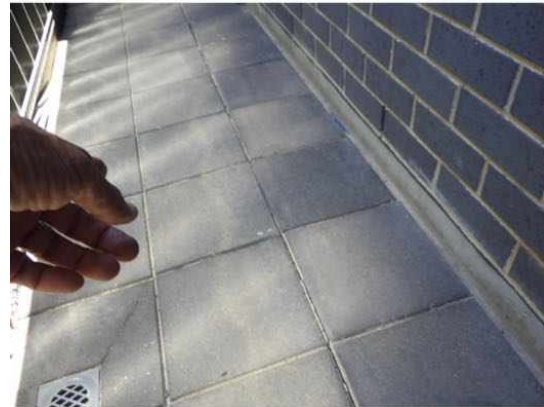
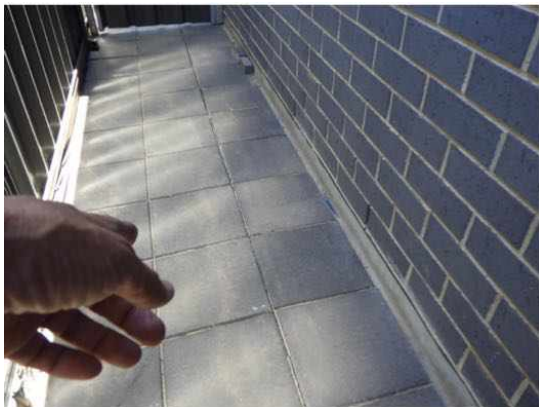
### Defects 3.04

Building:	Building 1
Location:	All External Areas
Finding:	Paving - Uneven
Information:	Sections of the external paved area are uneven, creating a potential trip hazard. It appears as though the area has been subject to rough installation, or that paving sections have lifted due to movements in the foundation of the property.

Where paving creates a trip hazard, personal injury may ensue if due caution is not taken by all persons within this area.

Re-paving of the area is required as soon as possible to remedy this situation. Further consultation with a specialist concreter is advised.

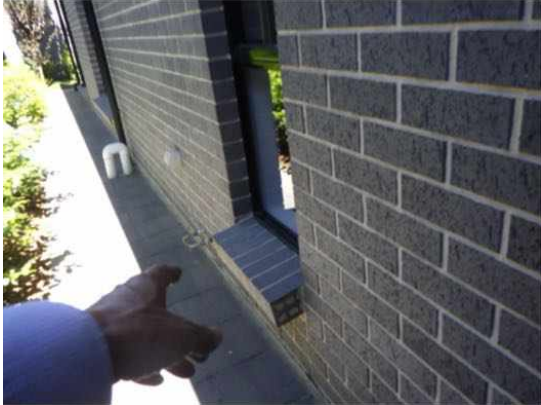
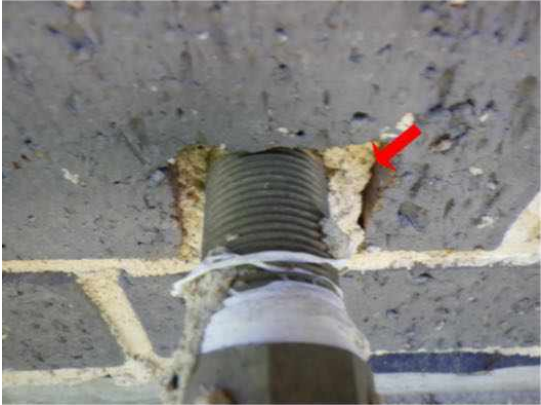
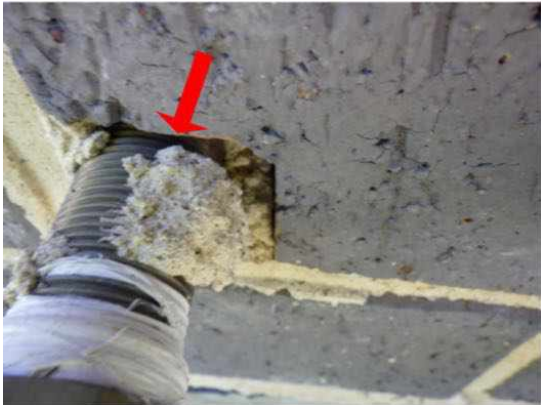
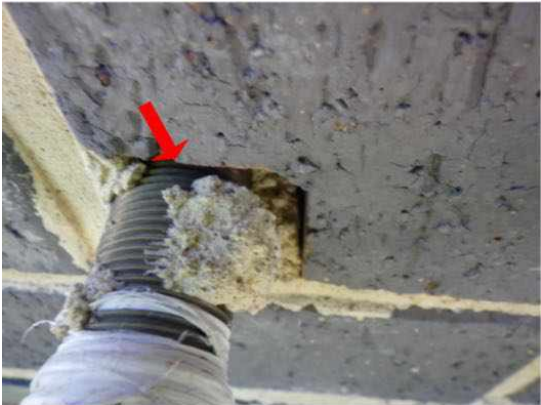
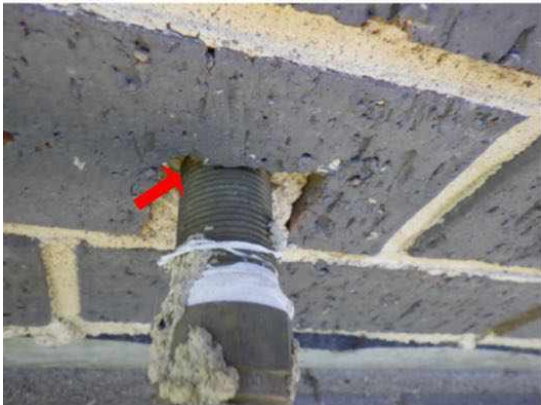
### Defects 3.05

Building:	Building 1
Location:	All External Areas
Finding:	External walls - Holes
Information:	Significant holes were identified around pipe penetrations in this wall section. It is suspected that the installation of this pipework was completed to a substandard level of workmanship or is incomplete.

Gaps and holes around pipework makes the area susceptible to insect and vermin ingress, as well as allowing water penetration to the cavity wall. As such, associated building elements are likely to deteriorate at an accelerated rate, and major implications are expected if holes around the pipework are left unmanaged.

All excessive holes, gaps or cracks should be adequately filled by a suitable sealant or trimmings as soon as possible to prevent any further damage. Such works may be conducted by a general handyperson or licensed plumber.

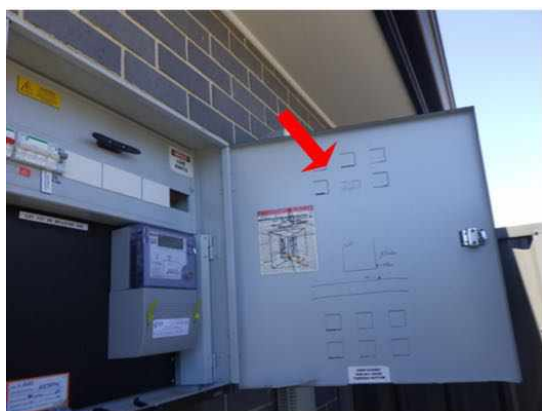
Building: Building 1  
 Location: All External Areas >  
 Finding: Termite Management System - No evidence of a chemical installation  
 Information: The application of a post-construction chemical termite barrier is highly recommended for all properties, particularly if live termite activity has been found on the site previously. Such barriers are highly effective in preventing termite attack on any timber building elements throughout the property.

A durable notice should be placed in the switchboard unit to indicate current termite barriers. At the time of inspection, it appeared as though no termite management system has been installed, with no evidence to suggest preventative works taking place.

The client may consider gaining further advice from a pest controller as to the costs and procedures involved with this application. It is recommended that obtaining such advice be a short-term priority.

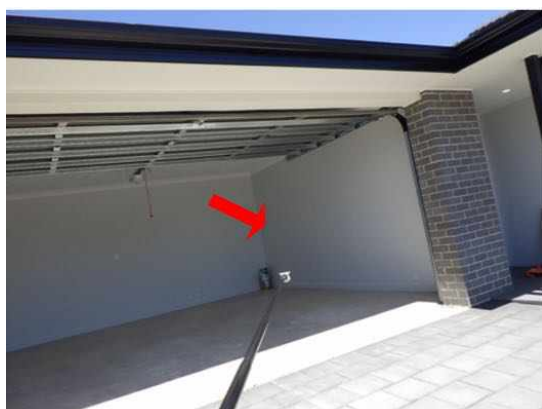
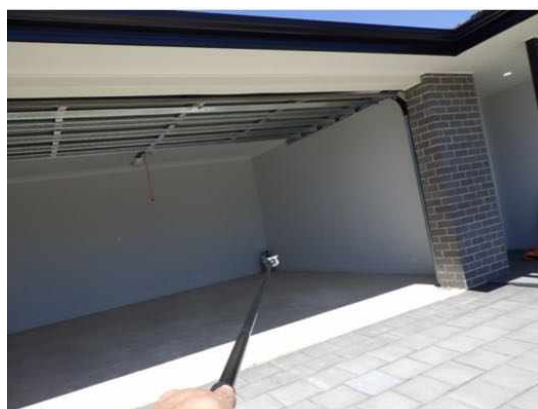
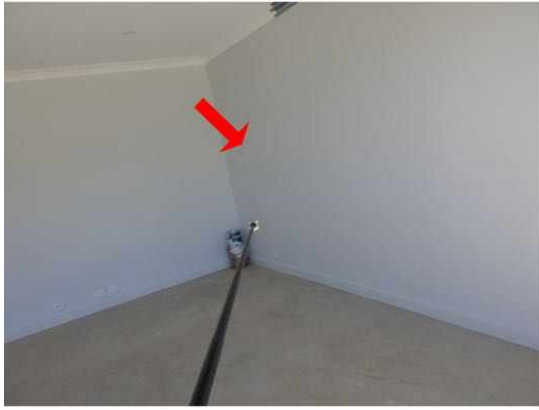
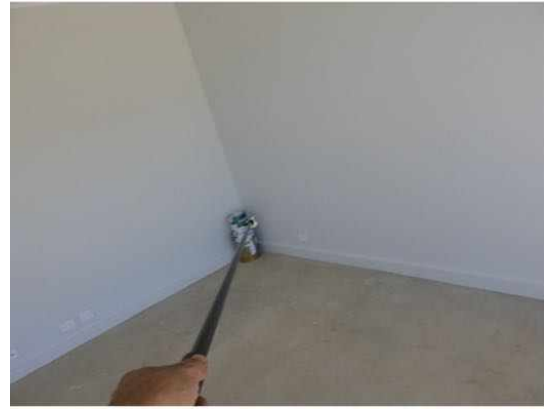
Building: Building 1  
 Location: All Internal Areas  
 Finding: Garage – Internal Access Doorway Restriction  
 Information: At the time of inspection, it was observed that access through the internal doorway between the garage and the house was restricted when entering the dwelling from the garage area. The doorway clearance appears limited, which may affect safe and convenient access between these areas.

It is recommended that clarification be obtained regarding the design and intended use of this access point to ensure it complies with relevant building requirements and provides safe access for occupants.

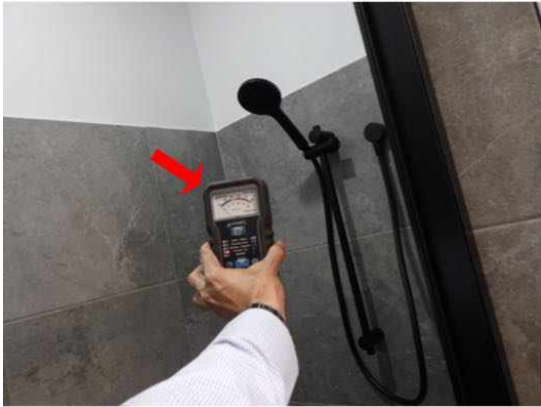
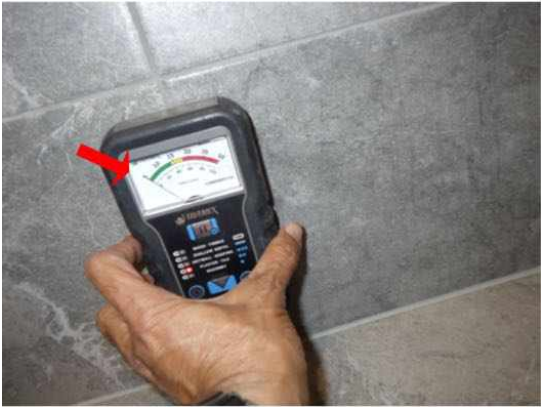
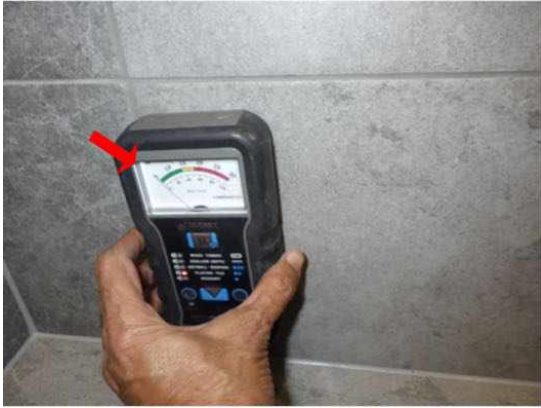
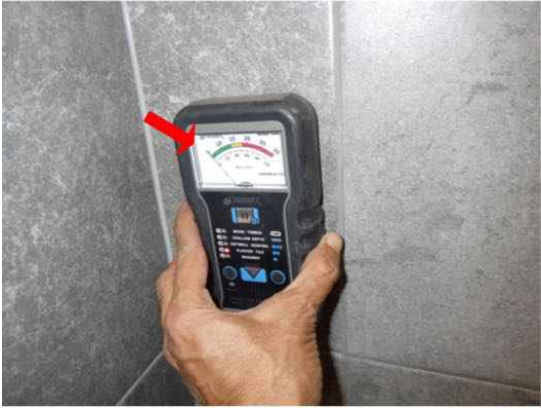
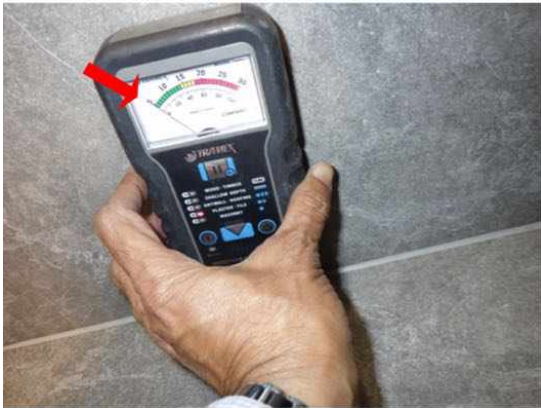
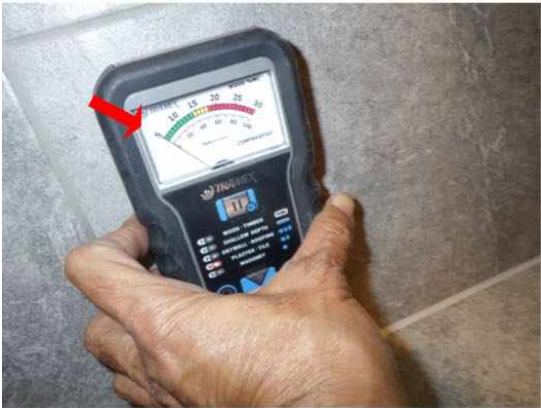
Building: Building 1  
Location: Bathroom-Ensuite  
Finding: Shower Alcove - No Damp  
Information: At the time of inspection it was noticed that damp is not evident to the shower alcove.

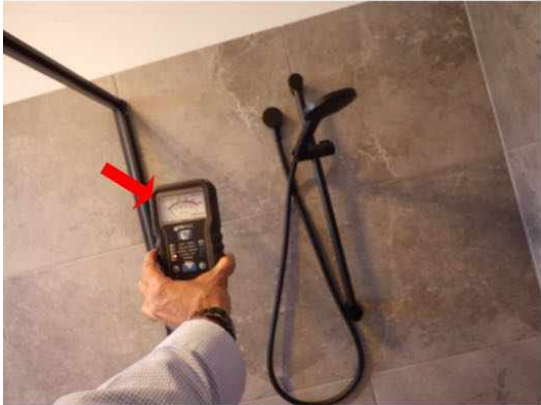
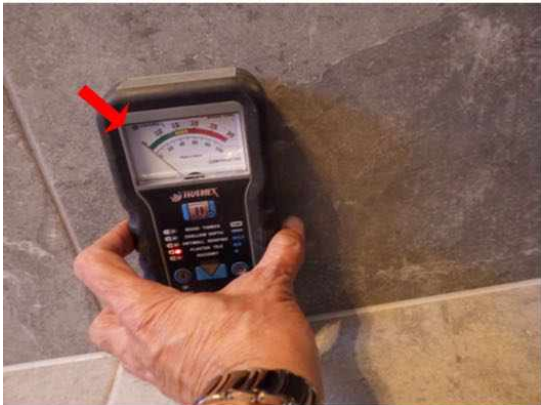
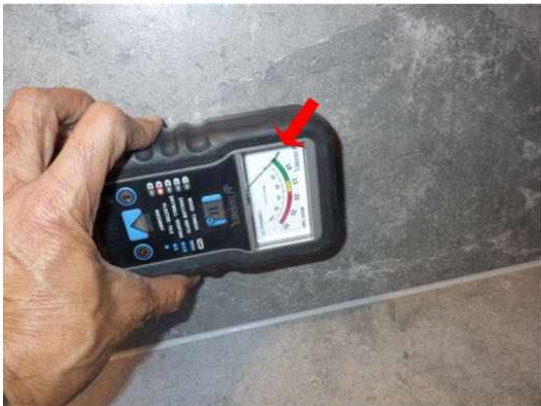
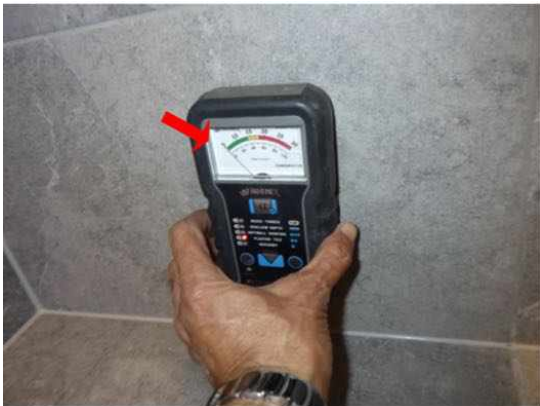
Building: Building 1  
 Location: Bathroom 2  
 Finding: Shower Alcove - No Damp  
 Information: At the time of inspection it was noticed that damp is not evident to the shower alcove.

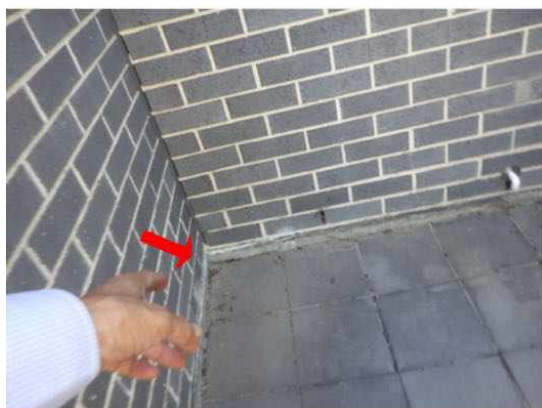
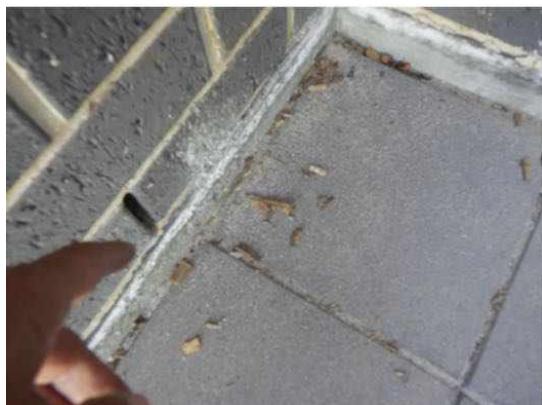
Building: Building 1  
 Location: All External Areas  
 Finding: Slab edge concrete - Efflorescence  
 Information: At the time of inspection it was noticed that efflorescence appears to be effecting the slab edge concrete in few sections around the property.

Efflorescence appears to be affecting the concrete in this area. Efflorescence typically occurs when excess salts within the concrete or cement mortar is leached to the surface due to water transfer. Slab concrete - Efflorescence

Generally, soluble salt deposits can be removed by dry brushing with a stiff-bristled brush. Repeated dry brushing is an ideal treatment for eliminating this forming of efflorescence. A cleaning contractor or general handyperson may be appointed to perform these works at the discretion of the client.
