Building and Timber Pest Inspection Report

Inspection Date: Fri, 6 Feb 2026

Property Address: 39 Glory Way, Shepparton VIC 3630,
Australia

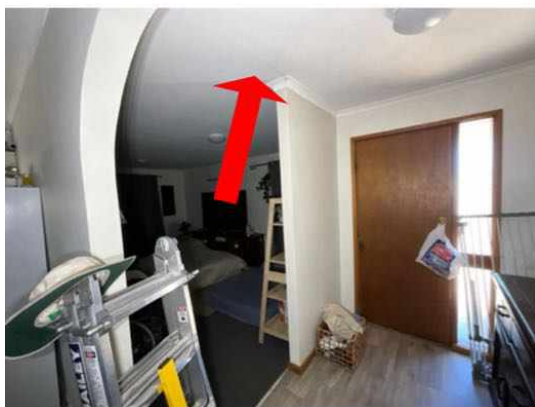
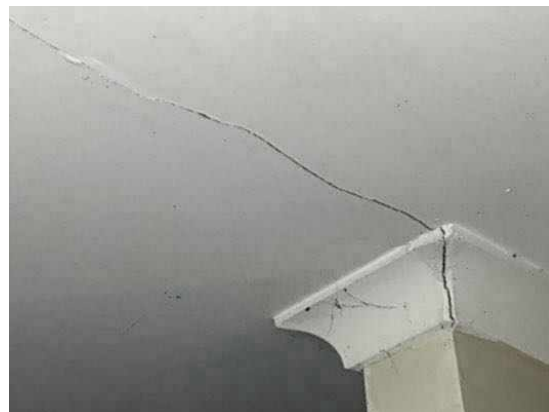
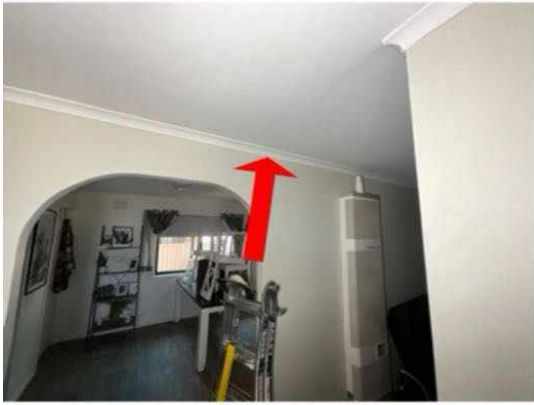
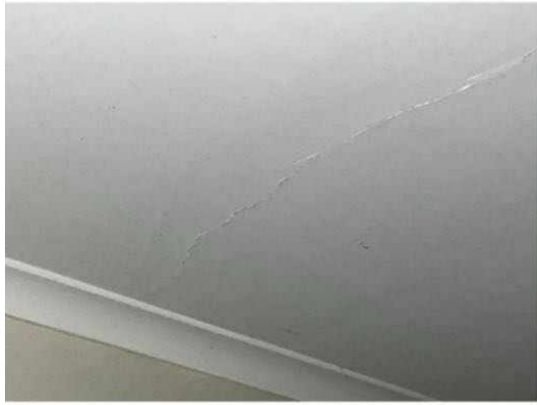
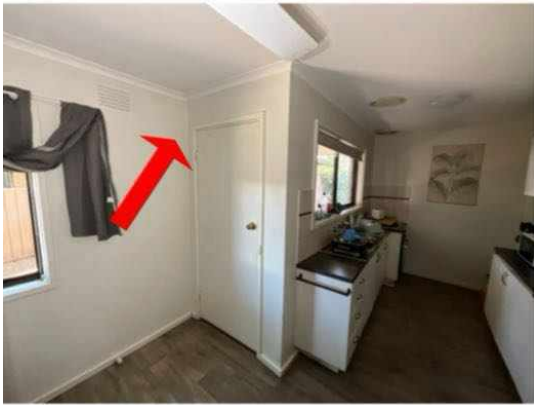
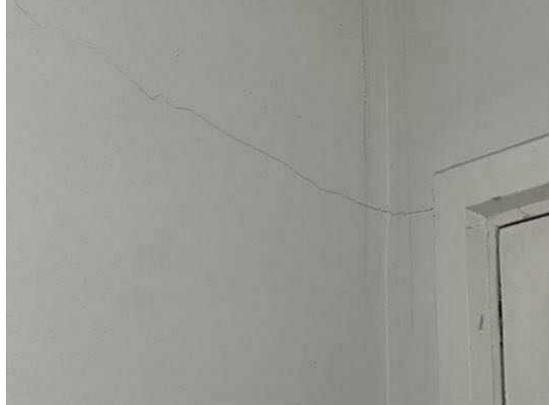
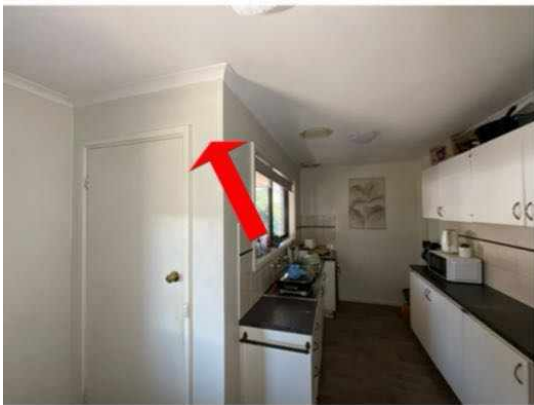
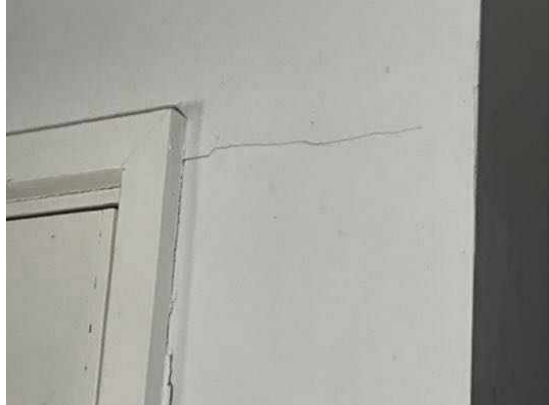
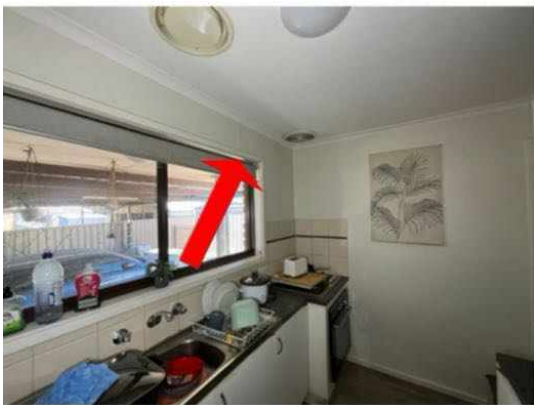
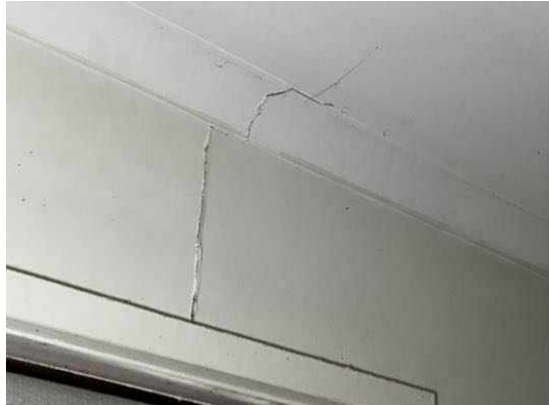
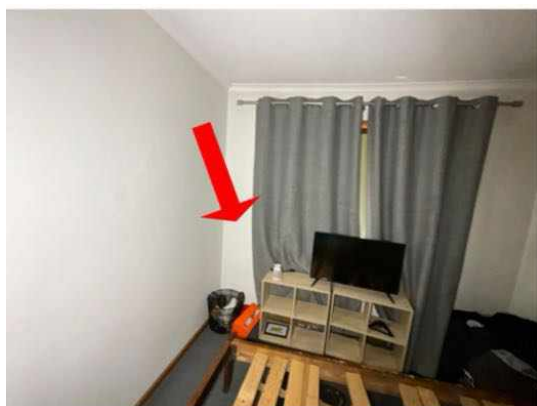
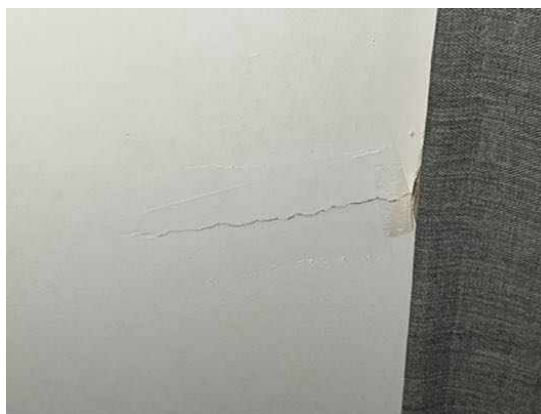
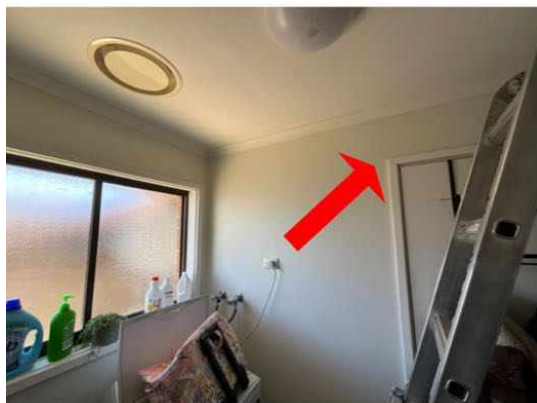
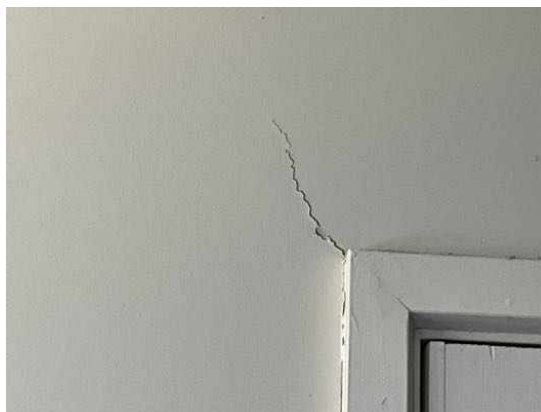
Finding 3.01

Building: Building 1
Location: Living Room, kitchen, bed 2, laundry,
Finding: Cracking - Damage Category 1 - Fine (up to 1mm)
Information: Although fine cracks are quite noticeable, they are often only considered to be an appearance defect, and usually do not indicate any structural damage. Generally, the cause of a fine crack is indicative of a separation between building materials and finishes (e.g. paint, plaster, etc.) along joins.

Cracking of this nature can generally be repaired with minor sanding, filling and/or repainting. Such works should be performed by a qualified painter or a general handyman.

Monitoring of all cracking should be conducted frequently. Always contact a building inspector should cracks widen, lengthen, or become more numerous.

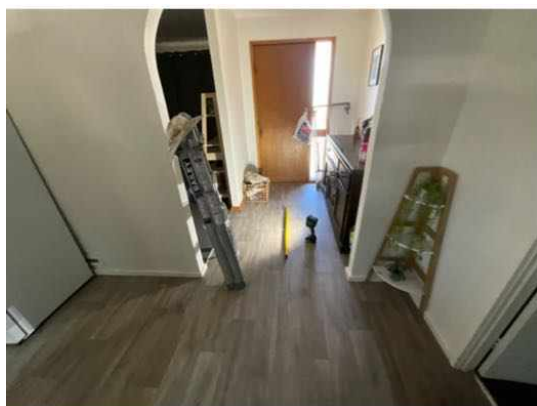
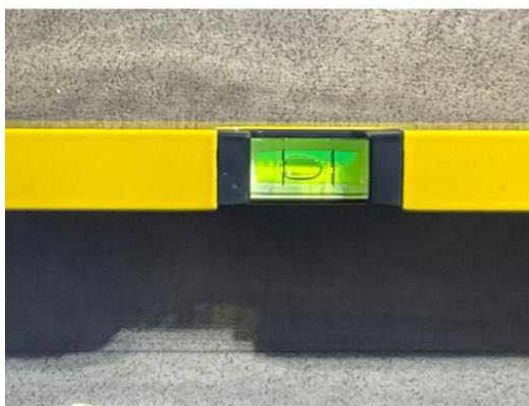
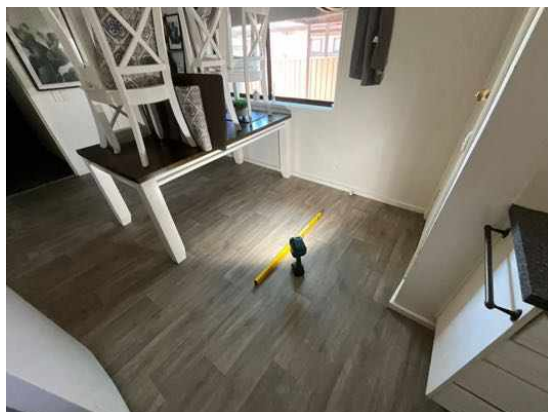
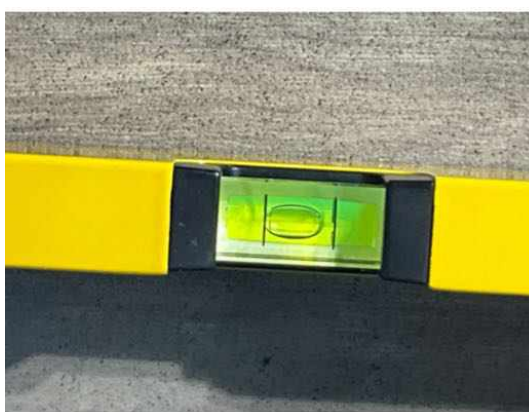
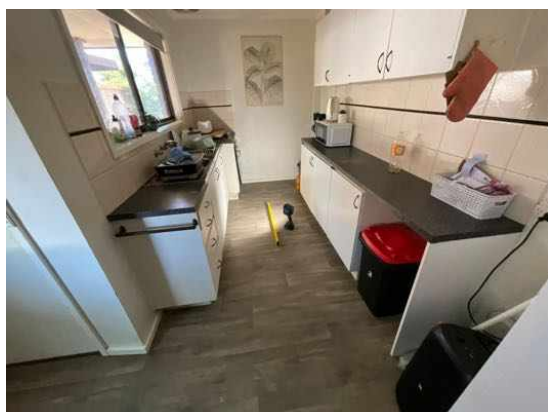
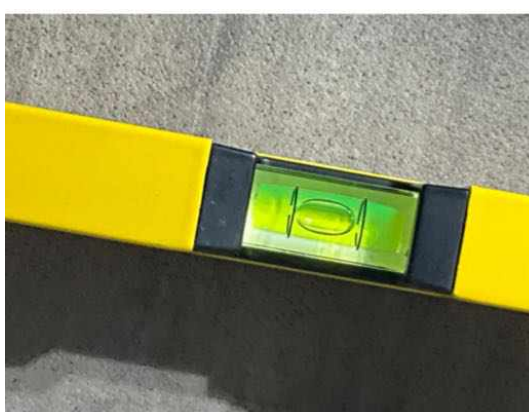
Finding 3.02

Building:	Building 1
Location:	All Internal Areas
Finding:	Flooring - slightly uneven
Information:	The internal flooring in this area is out of level and uneven. Uneven flooring is likely to indicate minor defects such as expected movement of the foundations of the property, but may also indicate subsidence of the associated subfloor stumps.

It is advised that the flooring be closely monitored to identify any further movement. Where flooring remains relatively unchanged for an extended period of time (i.e. several months), it is likely that this defect has been caused by expected movement of the foundations of the property.

However, where flooring is increasingly uneven, potentially invasive inspection of the subfloor structures and stumps in this area is required. In this case, works to repair are likely to be required, and would be carried out by a registered builder specialising in re-stumping.

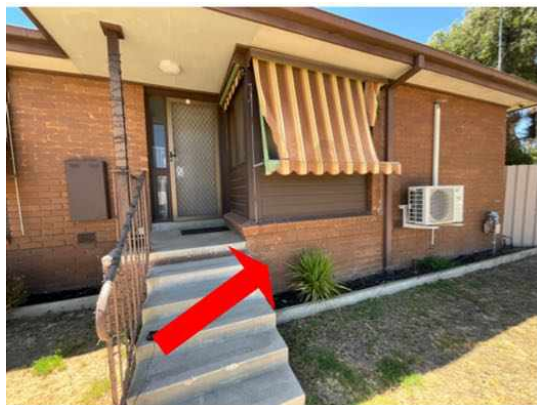
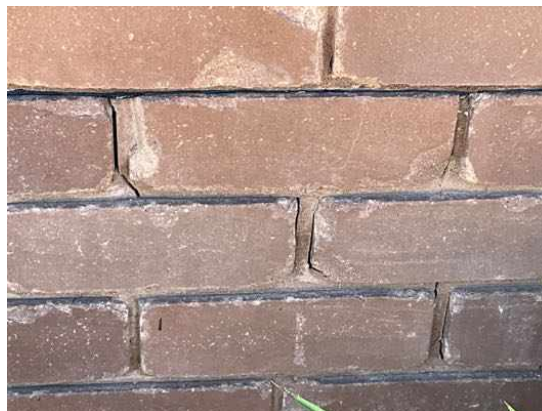
Finding 3.03

Building: Building 1
 Location: Entry area
 Finding: Brickwork- Step cracking
 Information: Step cracking was identified to the brickwork in this area at the time of inspection. Step cracking, which is similar to other forms of cracking, has a variety of possible causes. However, the most common is the subsidence of adjacent footings.

Step cracking is a relatively common defect, and is most likely to occur adjacent to windows, doors and other openings. Mortar failure in the gaps between affected bricks indicates the stresses and tensions affecting the wall.

Minor step cracking can be used as a warning sign to address factors causing stress to the wall, which can include the effect of surrounding trees, water leaks, soil erosion, or even the presence of reactive soils in the surrounding area.

If cracks increase in size or number contact a Licensed builder immediately to make all needed repairs.

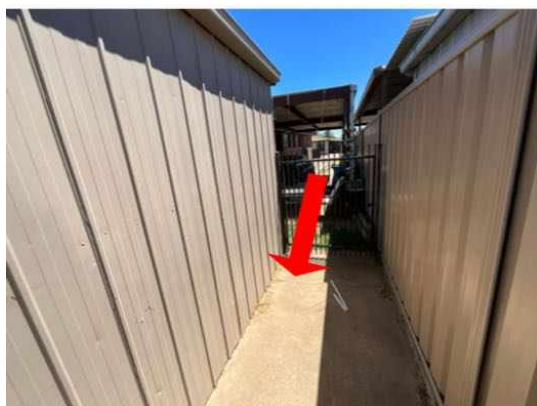
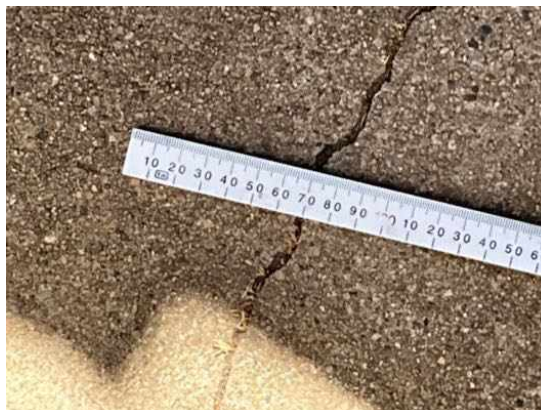
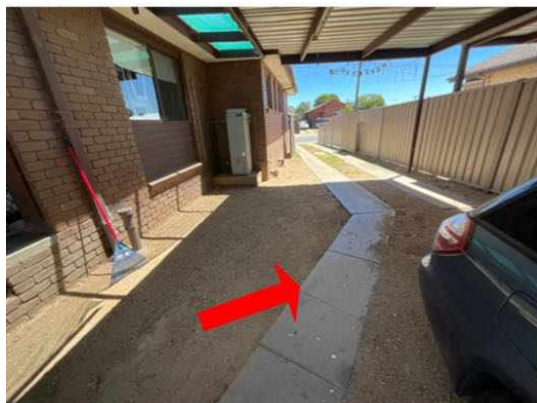
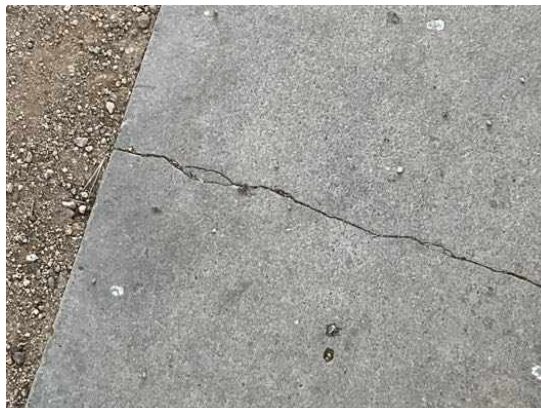
Finding 3.04

Building:	Building 1
Location:	Yard - Back, carport
Finding:	Cracking - External Concrete Paving Damage Category 1 - Fine (less than 2mm)
Information:	Fine cracks were identified in external concrete paving. Although fine cracks are quite noticeable, they are often only considered to be an appearance defect, and usually do not indicate any structural damage. To be considered a Category 1 or fine crack, the crack is found to be less than 2mm in width.

Generally the cause of a hairline crack in existing concrete paving such as driveways and pathways is indicative of the expansion and contraction of the concrete. Such causes are generally due to environmental factors, such as moisture levels, weather conditions, root systems of nearby trees or the soil types on which they are laid.

Fine cracks may also be due to poor original installation of the concrete. Factors such as poor compaction of the sub surface and/or inadequate reinforcing of the slab may create cracking and other secondary defects.

Monitoring of all cracking should be conducted frequently. Always contact a building inspector should cracks widen, lengthen, or become more numerous.

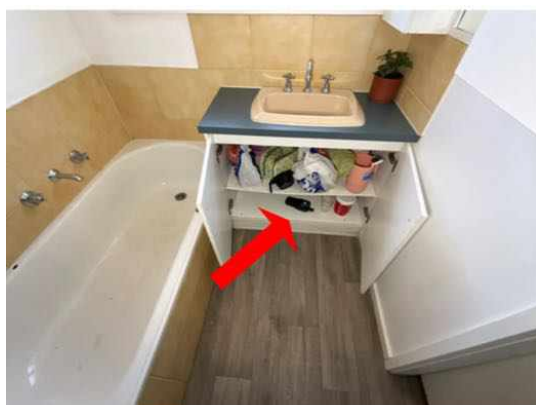
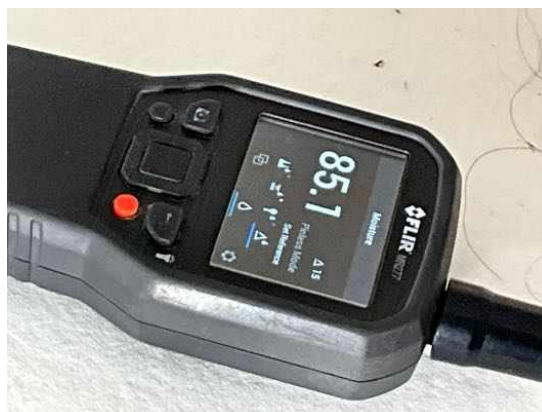
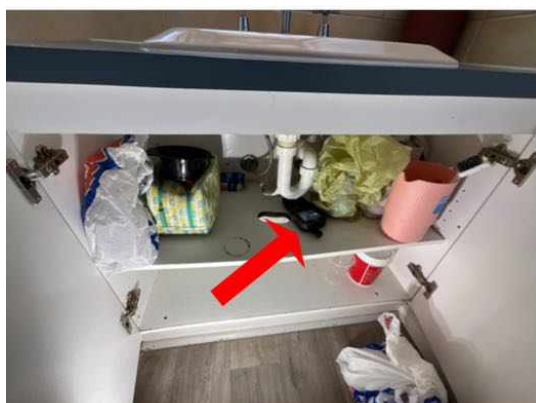
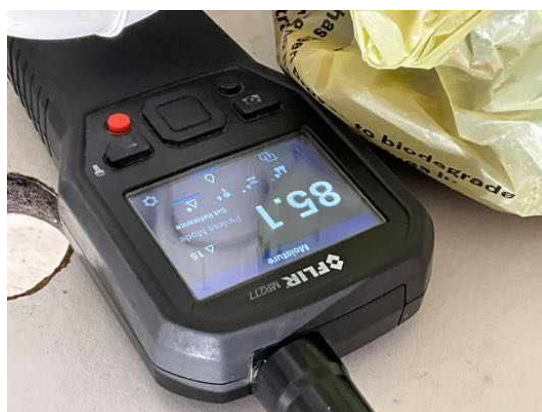
Finding 6.01

Building:	Building 1
Location:	Bathroom
Finding:	Excessive moisture- identified
Information:	Excessive moisture can attract termites and produce conditions that promote fungal growth and wood decay.

In this case, it appears that leaking washing machine connections over time have caused moisture levels to be excessive.

Replacement of MDF board is at the discretion of the client.

A Licensed plumber may be needed to identify the cause of the excessive moisture. Works to remove affected building elements may then be necessary and should be performed by an appropriate tradesperson.

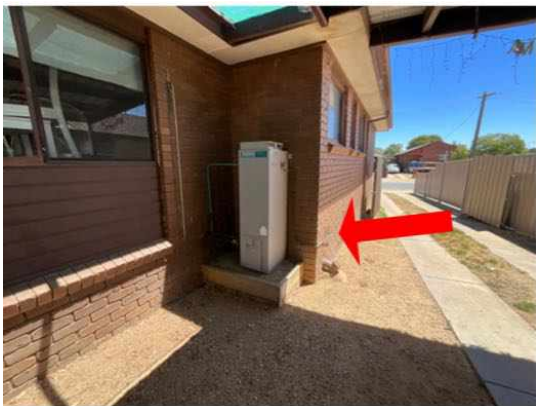
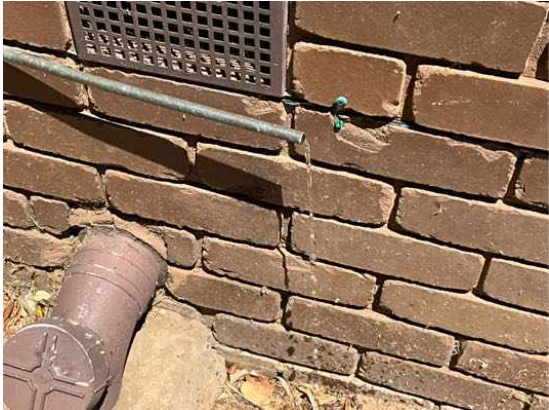
Finding 6.02

Building:	Building 1
Location:	Driveway
Finding:	HWS Overflow - Not Connected
Information:	The Hot Water System (HWS) overflow was found to be disconnected from storm water drainage and is creating excessive moisture in the surrounding area.

These damp conditions can lead to secondary defects such as rot, rust or corrosion of associated building elements, the formation of fungal decay, or even the creation of potential slip hazards. When coupled with poor site drainage, pooling of water may also attract termite activity to this area.

It is highly recommended that a licensed plumber be appointed to connect the HWS overflow in order to prevent such an environment from being created. These minor

works should be carried out as soon as possible.

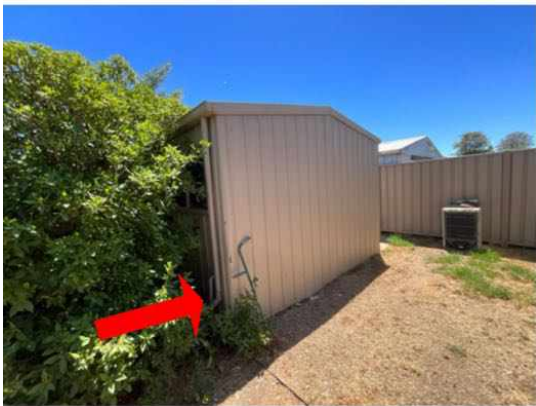
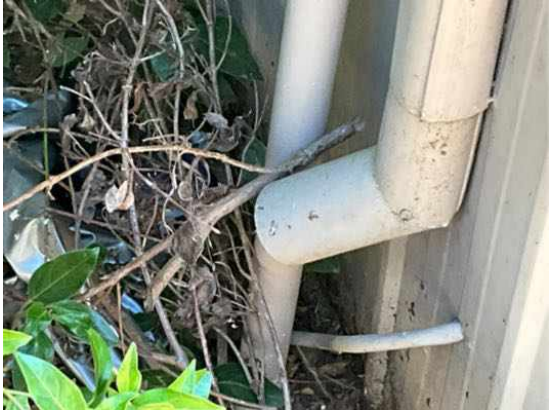
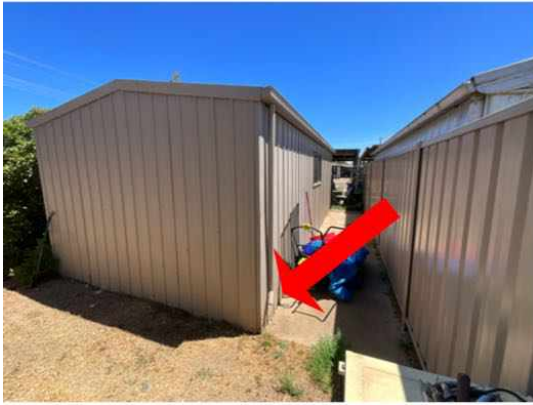
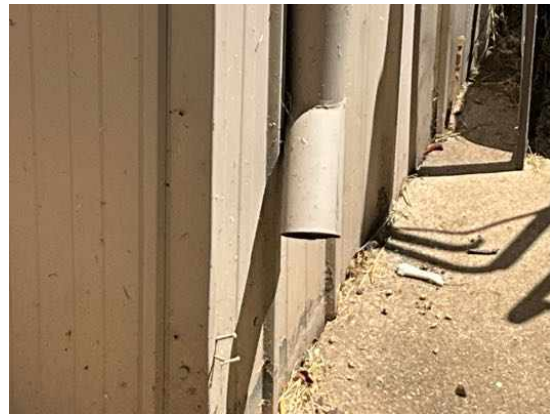
Finding 6.03

Building: Building 1
Location: Garage
Finding: Stormwater drain - Not connected
Information: The roof plumbing is not adequately connected to stormwater drainage on the site. This disconnection negatively impacts the functional capacity of the roof plumbing.

Where roof plumbing doesn't drain adequately, the area at the base perimeter can become excessively damp, potentially creating an environment that is susceptible to rust and corrosion of surrounding building elements, as well as attracting termites and other pests.

It is highly recommended that a plumber be appointed to further inspect the area and to install adequate drainage equipment where necessary.

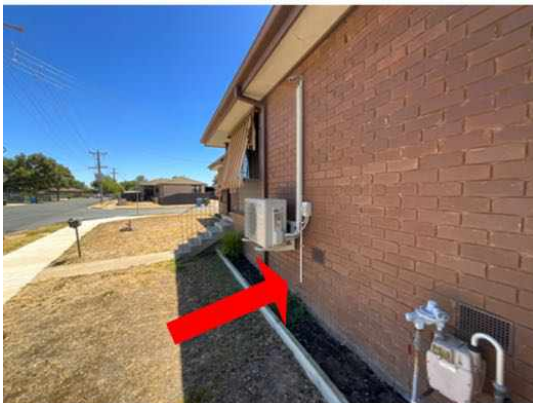
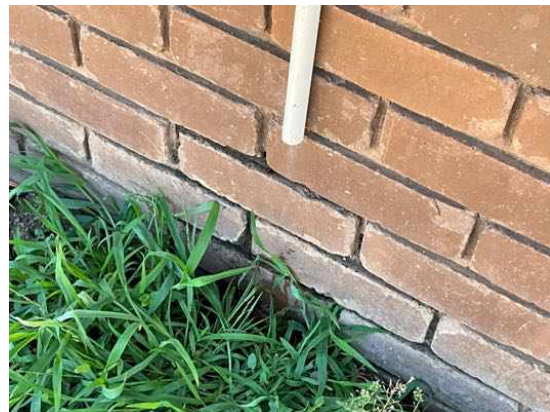
Finding 6.04

Building:	Building 1
Location:	Front wall
Finding:	Air conditioner - Disconnected overflow
Information:	The Air Conditioner (A/C) overflow was found to be disconnected from storm water drainage and is creating excessive moisture in the surrounding area.

Such leaking creates an environment which is conducive to an array of defects, including water damage to associated building elements and the attraction of termite or timber pest infestation.

It is highly recommended that a licensed plumber be appointed to connect the A/C overflow in order to prevent such an environment from being created. These minor works should be carried out as soon as possible.

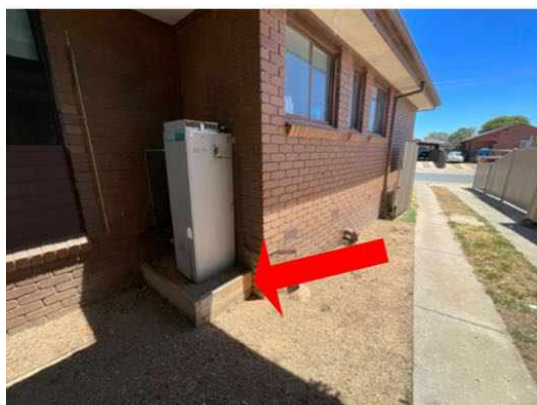
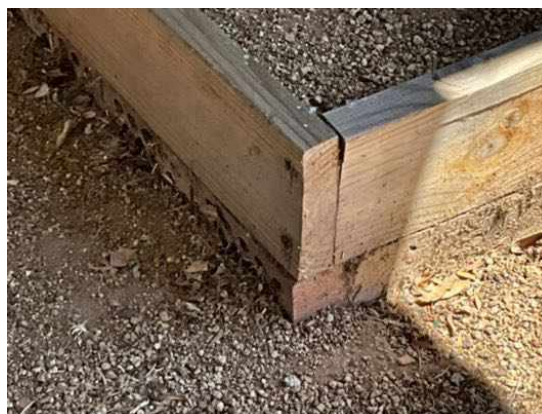
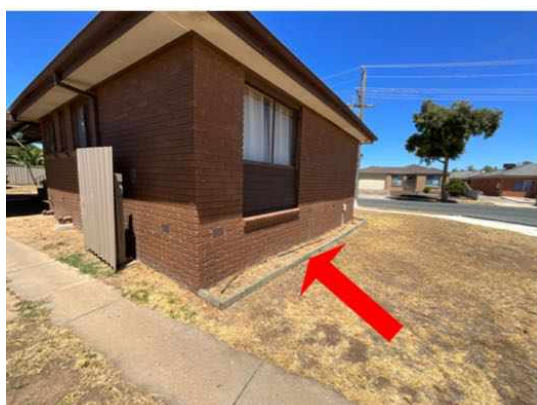
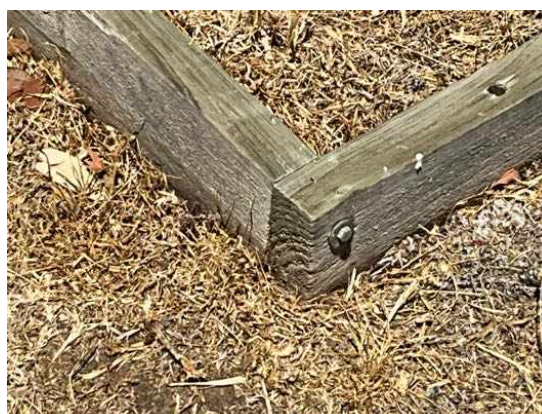
Finding 6.05

Building:	Building 1
Location:	Carport, yard- front
Finding:	Untreated or non-durable timbers in a hazardous environment
Information:	To reduce the risk of timber pest attack it is essential that timber used in a hazardous environment (e.g. in direct contact with the ground or frequently exposed to damp

conditions) is of sufficient durability and/or is adequately preservative treated.

Untreated timbers in direct contact with the ground are likely to develop severe wood rot and/or fungal decay if left unattended creating attraction for subterranean termites to infest the timbers from surrounding areas.

If untreated or non-durable timbers are found to be in a hazardous environment it is highly advised that replacement of these building elements be performed as soon as possible to aid the protection of the property against termite / timber pest attack.

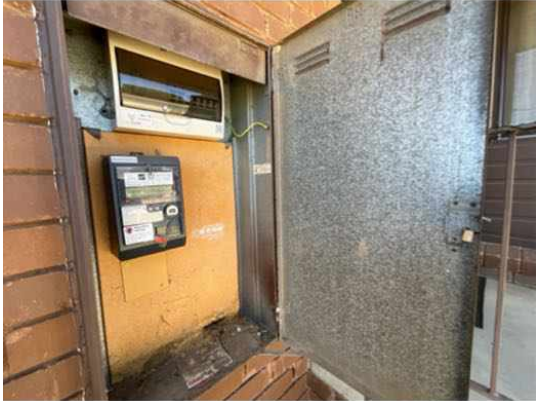
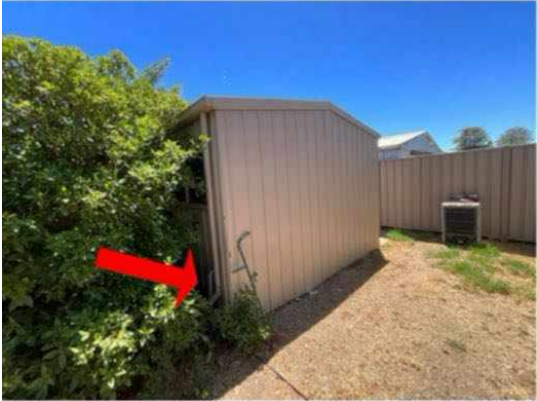
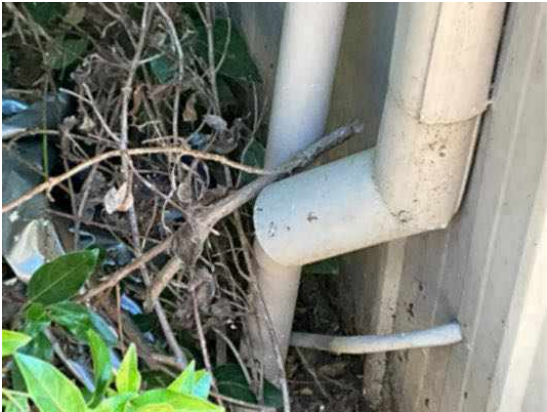
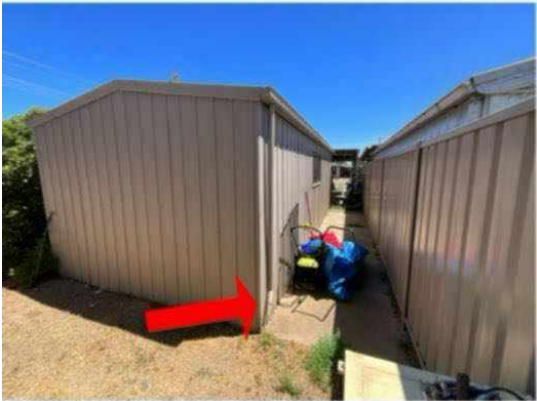
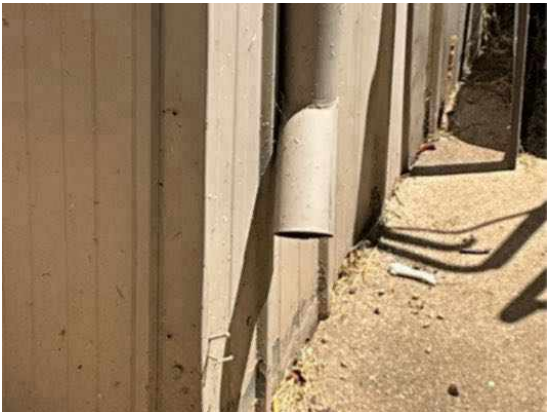
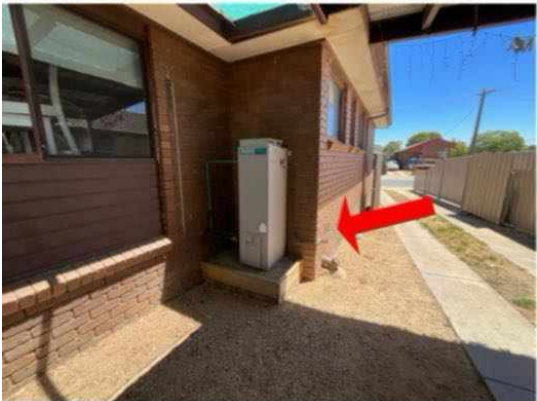
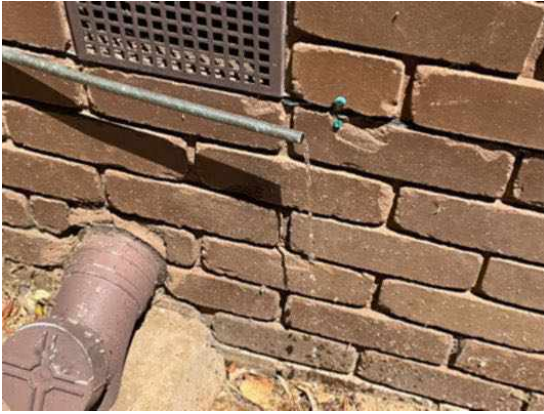
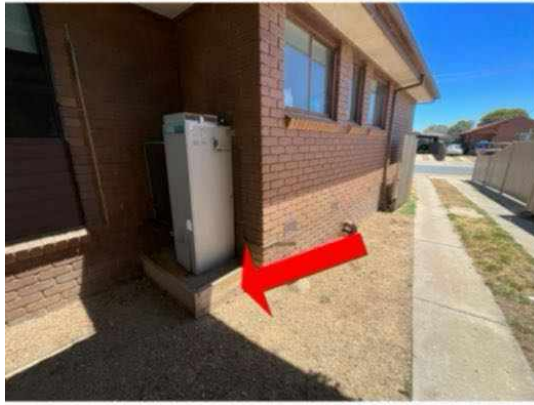
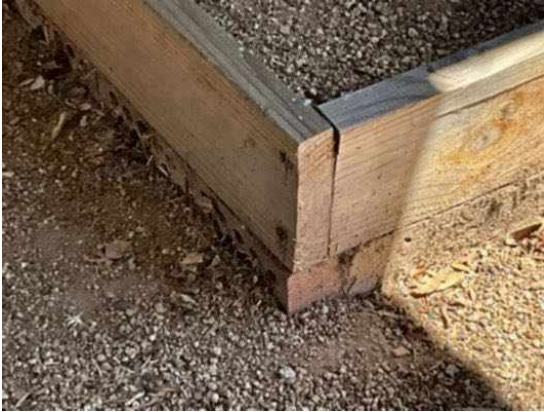
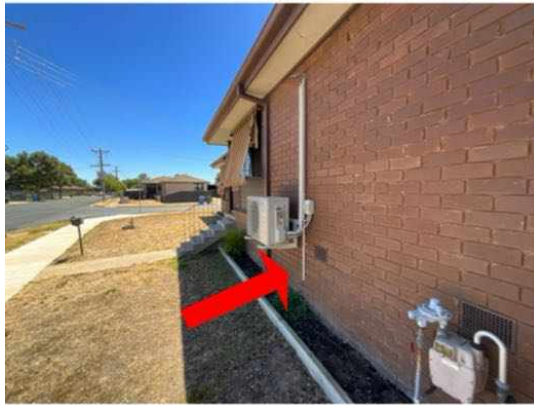
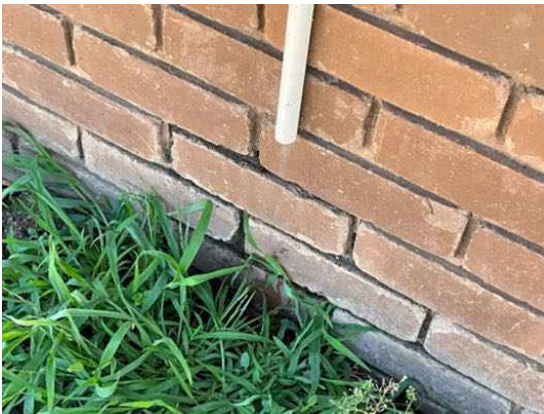
Finding 6.06

Building:	Building 1
Location:	All External Areas
Finding:	Termite Management System - no evidence of a chemical installation
Information:	The application of a post-construction chemical termite barrier is highly recommended for all properties, particularly if live termite activity has been found on the site previously. Such barriers are highly effective in preventing termite attack on any timber building elements throughout the property.

A durable notice should be placed in the switchboard unit to indicate current termite barriers. At the time of inspection, it appeared as though no termite management system has been installed, with no evidence to suggest preventative works taking place.

The client may consider gaining further advice from a pest controller as to the costs and procedures involved with this application. It is recommended that obtaining such advice be a short-term priority.

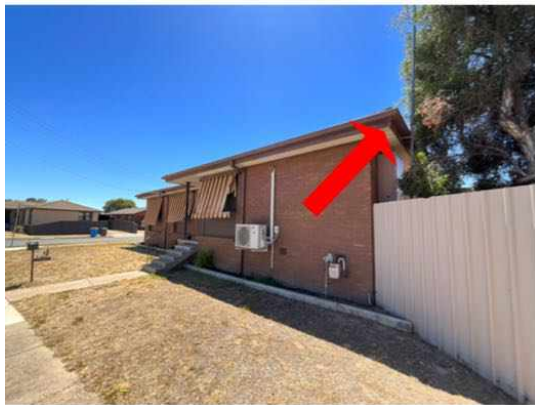
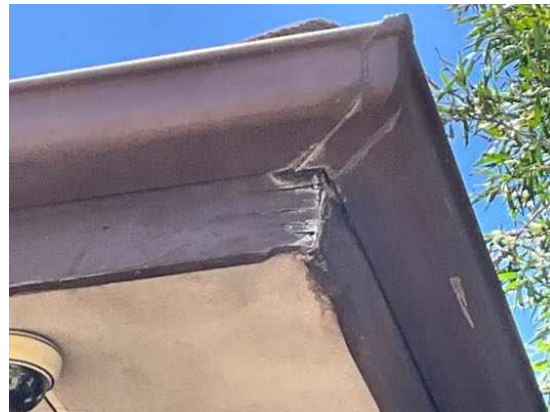
Finding 7.01

Building:	Building 1
Location:	Eaves
Finding:	Fungal decay - present (localised)
Information:	Fungal decay also known as wood decay or wood rot generally refers to the deterioration of timber elements when in contact with excessive levels of moisture for a prolonged period of time.

In this case although the affected timber element is in a decaying state the extent of any visible damage appears to be localised to a specific area and is yet to spread to other parts of the building element or affect adjoining structures. The fungal decay is therefore likely to be of a relatively superficial nature with minimal impact on the structural integrity or tensile strength of the timber element.

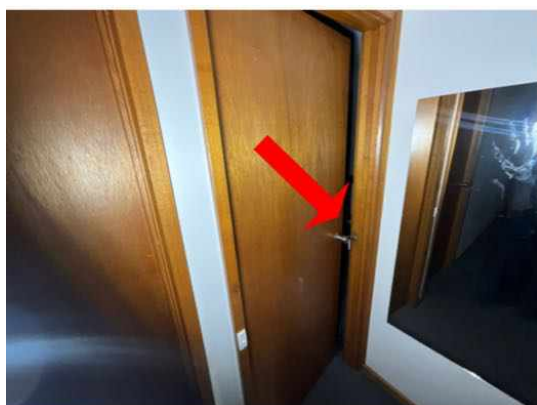
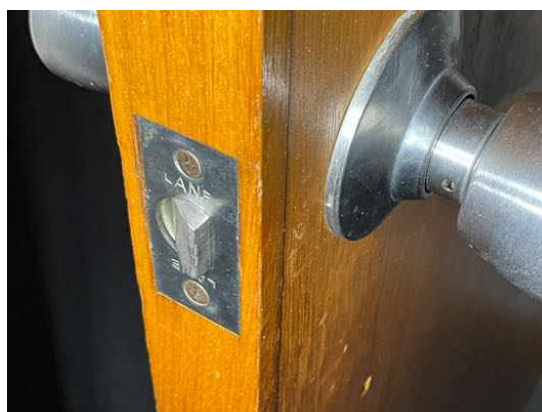
Building: Building 1
 Location: Bedroom 2
 Finding: Door handle- Not latching
 Information: It was noted that the door in this area was not latching during operation at the time of inspection.

It is suspected that this defect has occurred due to minor issues with the associated hinges. Such damage is identified as general wear and tear, which is expected for building elements of this age.

A qualified carpenter or general handyperson may be appointed to perform rectification works as necessary, at client discretion.

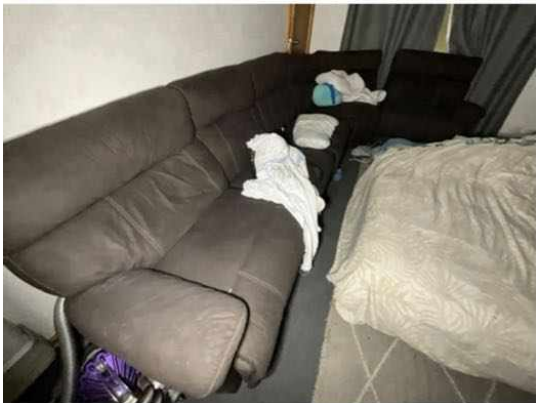
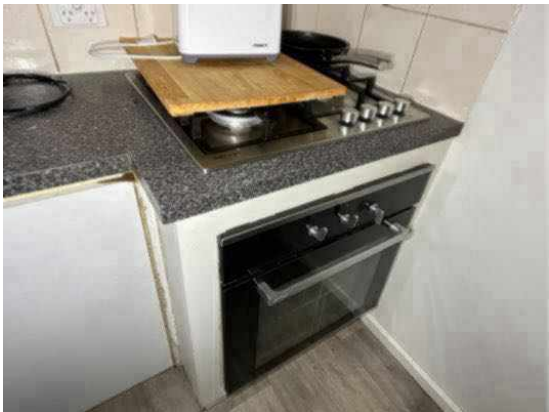
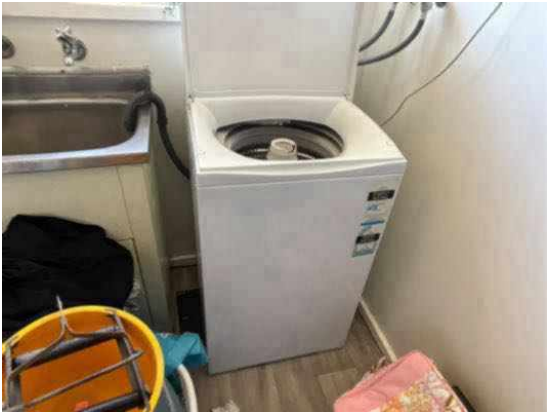
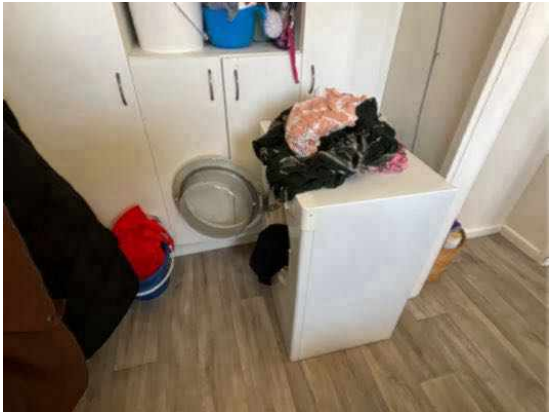
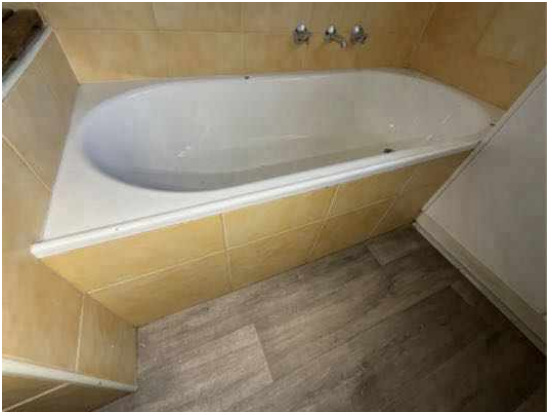
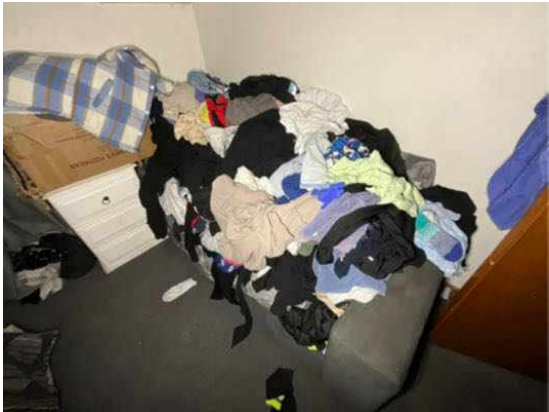
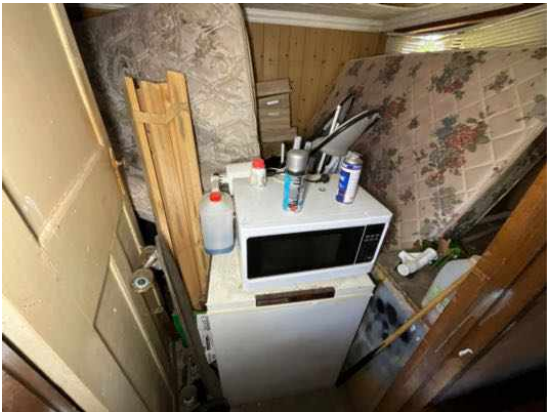
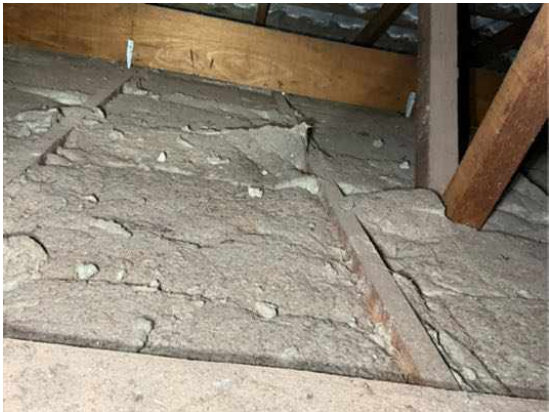
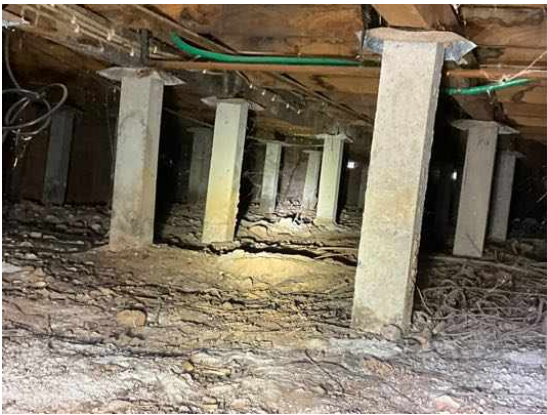
Building: Building 1
 Location: All Areas
 Finding: Additional Photos - Obstructions and Limitations
 Information: These photographs are an indication of the obstructions and limitations which impeded full inspection of the property at the time of inspection. These obstructions can hide an array of defects and should be removed to allow full inspection to be carried out. A re-inspection is recommended once the areas are made accessible.
