Building and Timber Pest Inspection Report

Inspection Date: Wed, 21 Jan 2026

Property Address: 29A Woolshed Dr, Hamilton SA 5373,
Australia

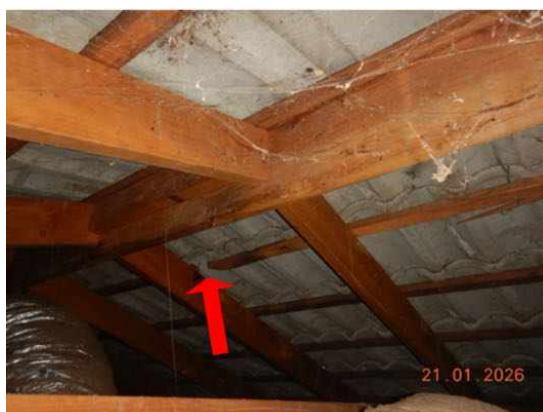
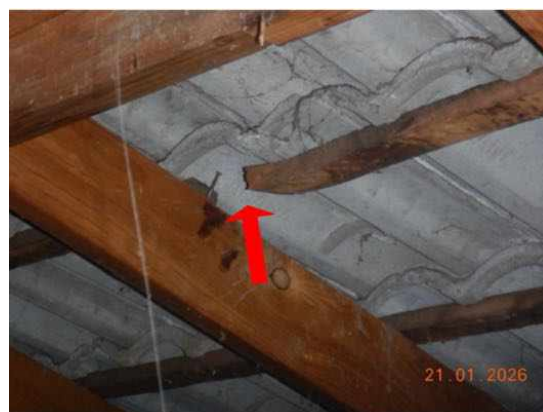
Finding 3.01

Building: Main Building
 Location: Roof Void
 Finding: Broken/deteriorated tile battens
 Information: At the time of the inspection, it was observed that sections of the roof tile battens were broken and/or showing signs of deterioration. This condition may reduce the support and fixing capacity for the roof tiles, increasing the risk of tile displacement, water ingress, and further deterioration of the roof structure.

The issue may be associated with age-related degradation, moisture exposure, or general movement within the roof structure and is not consistent with good building practice.

A licensed builder or roofing contractor should be appointed for further assessment and rectification.

Repair tile batten in roof void

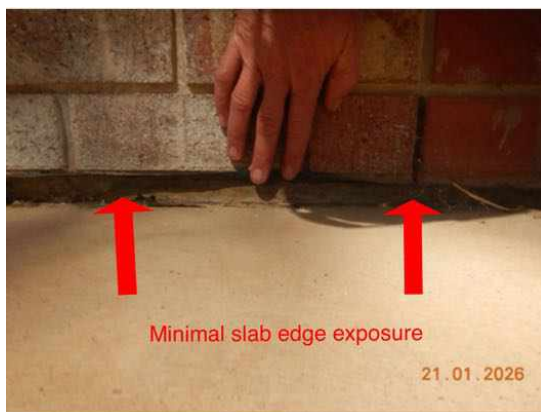
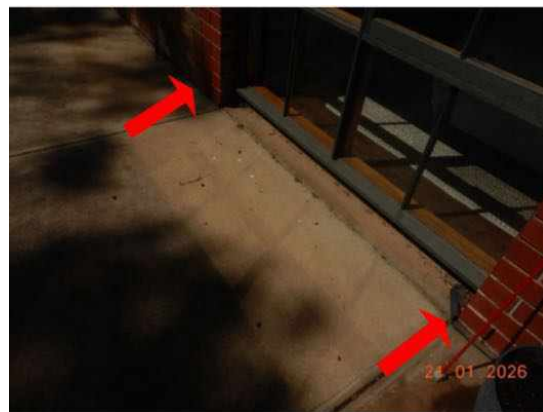
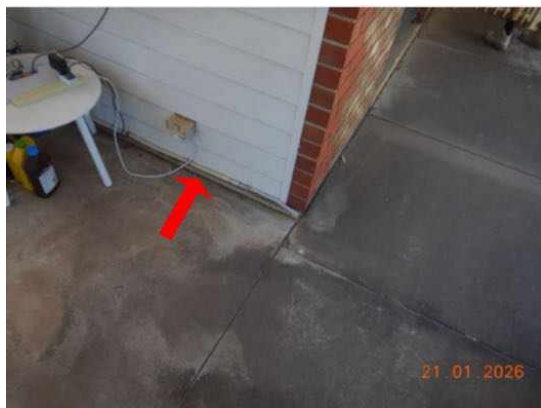
Finding 3.02

Building: Main Building
 Location: All External Areas >
 Finding: Slab Edge - Exposure

Information: It can be seen that at the time of inspection multiple areas throughout the slab edge of the dwelling failed to adhere to the minimum requirements of 75MM exposure.

If the slab edge is not properly exposed there is a high risk of termite attack. Sometimes, in order to determine the type of slab, a suitably qualified person such as an architect or builder may be required to consult the construction plans.

Where the slab edge cannot be properly inspected, it is highly recommended that termite or timber pest inspections be carried out every 6-12 months to aid protection of the property against infestation.

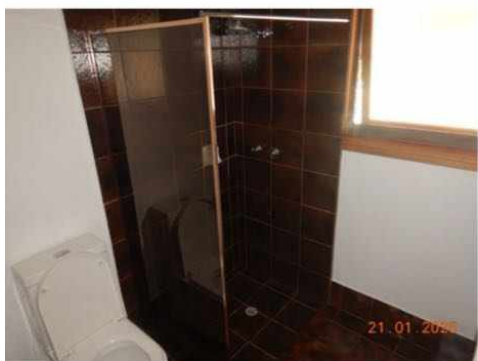
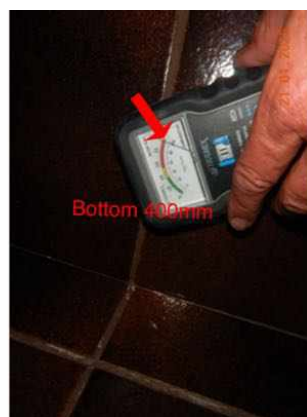
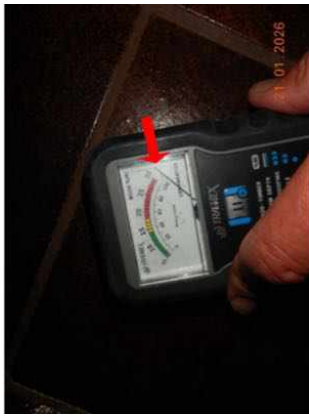
Finding 3.03

Location: Bathroom

Finding: Shower damp - Monitor

Information: Damp was evident to the lower 400mm of wall to the shower alcove. There is no high reading around the taps nor are there high readings transferring to the other side of the

wall. Sealant and grout appears in acceptable condition throughout the alcove at present.

This defect is quite common, and is suspected to have been caused by moisture permeating or leaching through the grouting and perhaps gaps in the sealant prior to repair.

Monitoring the area is advised and if any visual signs of excessive moisture appear (peeling paint, mould) then consultation with a qualified plumber or bathroom specialist would be advised to identify the cause of damp and to perform remedial works as required.

Always ensure that sealant and grout is in good condition to prevent any moisture issues occurring in the future.

Monitor bathroom moisture

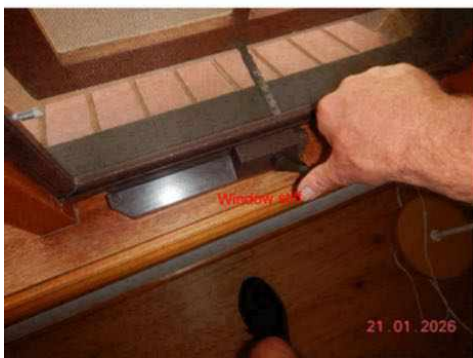
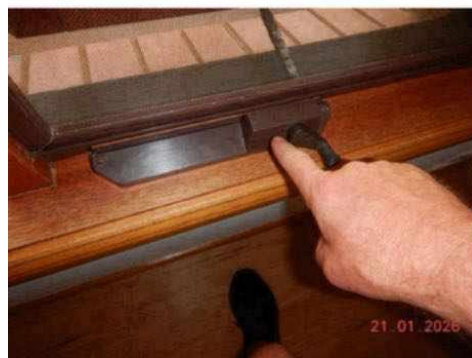
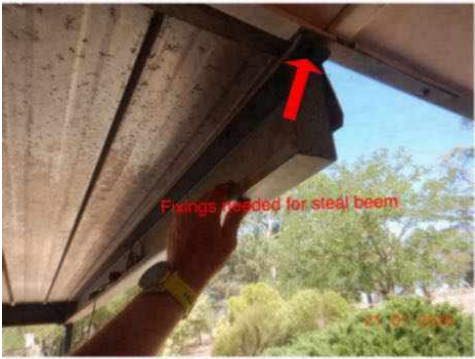
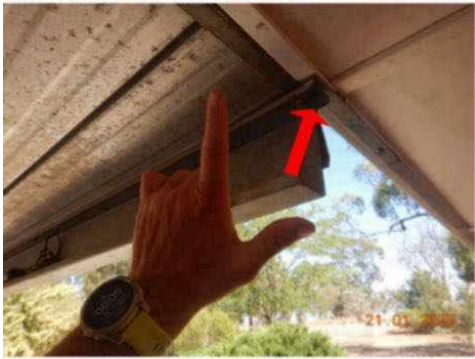
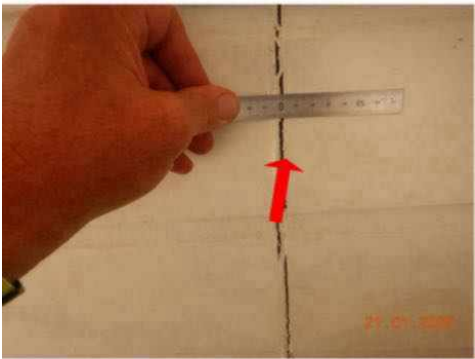
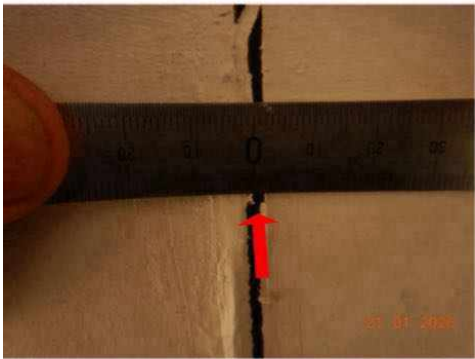
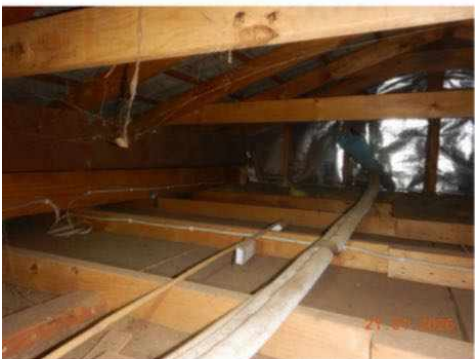
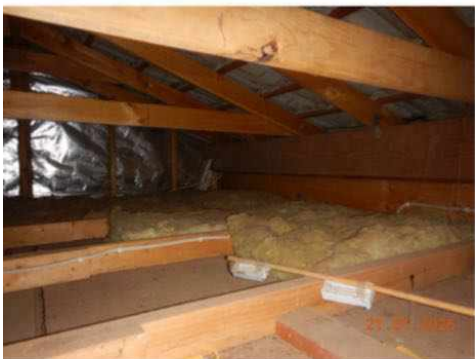
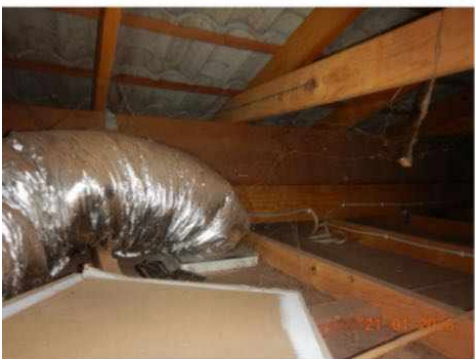
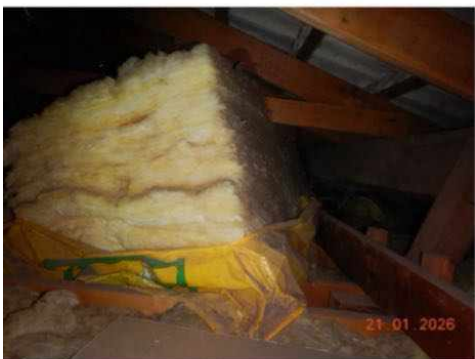
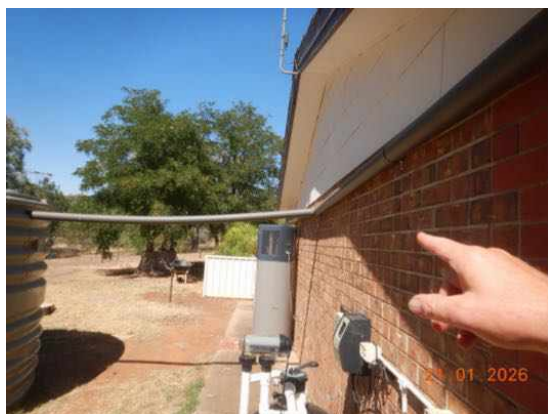
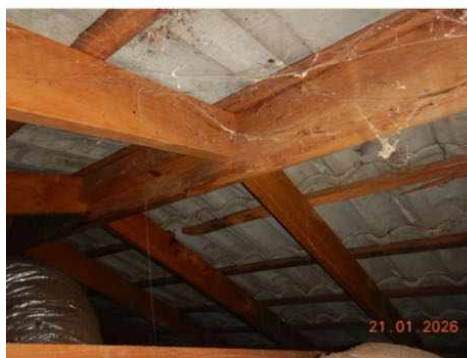
Finding 3.04

Building:	Main Building
Location:	All Areas
Finding:	Minor defects present
Information:	There were a multitude of minor defects throughout the dwelling in which presented as primarily cosmetic issues, these were

- Minor cracking underneath carport
- Unfixed steel beam underneath back pergola
- Window stiff whilst functioning in study
- Sections of ceiling not insulated (spare bags of insulation in ceiling).
- Stormwater pipe to tank unsupported

A qualified tradesperson should review the affected areas and undertake routine maintenance or repairs as required to address the minor defects.

Secure steel beam under rear pergola

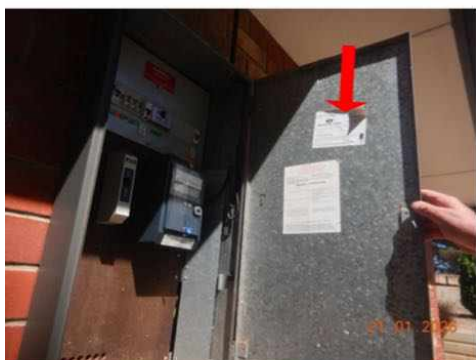
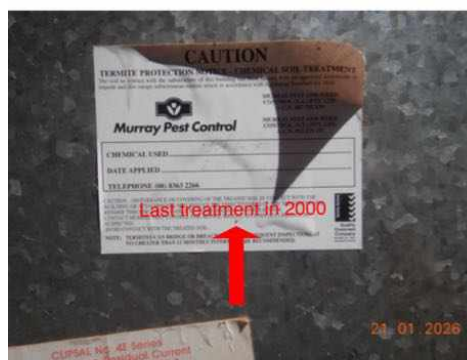
Finding 6.01

Building:	Main Building
Location:	All Areas
Finding:	Termite treatment required
Information:	At the time of the inspection, it was observed that while evidence of a previous termite treatment notice/sticker was present, the treatment appears to be due for renewal and is no longer current. The absence of an up-to-date termite management system increases the risk of termite infestation and potential concealed damage to the building's timber elements.

A licensed pest controller should assess the property and update or renew the termite treatment as required.

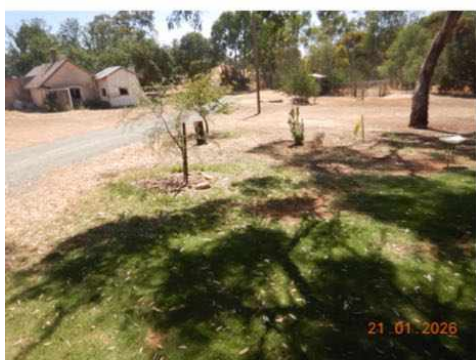
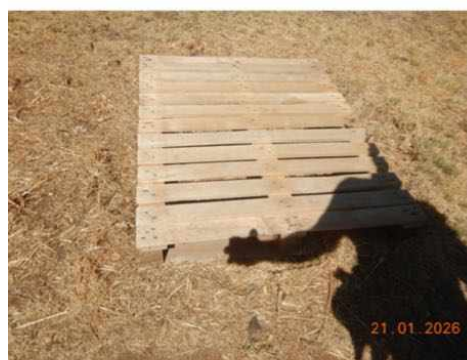
Finding 6.02

Building:	Main Building
Location:	Yard
Finding:	Untreated or non-durable timbers in a hazardous environment
Information:	To reduce the risk of timber pest attack it is essential that timber used in a hazardous environment (e.g. in direct contact with the ground or frequently exposed to damp conditions) is of sufficient durability and/or is adequately preservative treated.

Untreated timbers in direct contact with the ground are likely to develop severe wood rot and/or fungal decay if left unattended creating attraction for subterranean termites to infest the timbers from surrounding areas.

If untreated or non-durable timbers are found to be in a hazardous environment it is highly advised that replacement of these building elements be performed as soon as possible to aid the protection of the property against termite / timber pest attack.
