Building and Timber Pest Inspection Report

Inspection Date: Fri, 13 Feb 2026

Property Address: 4/103 Beatrice St, Taringa QLD 4068,
Australia

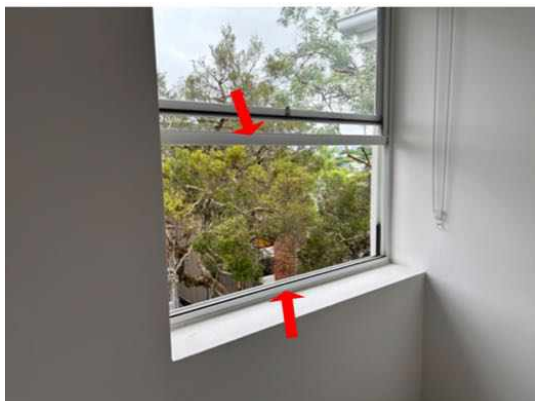
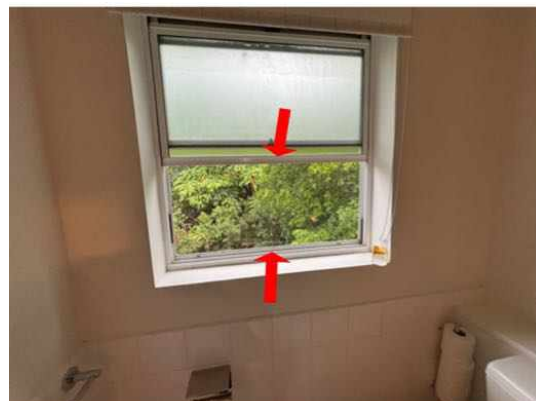
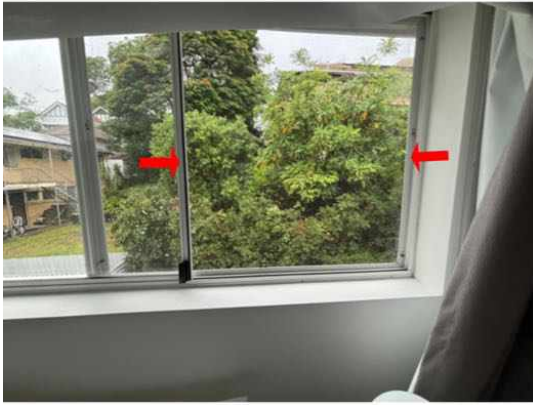
Finding 1.01

Building: Main Building
Location: All Internal Areas
Finding: Bedroom 1, 2 and family bathroom - windows open more than 125mm
Information: At the time of the inspection, it was noted that the windows in bedrooms 1, 2 and the family bathroom were not restricted to prevent them from opening more than 125mm. These windows could be opened to their full width. Permanent screens were not fitted to either window, only removable fly screen covered the openings.

The Australian Building Codes Board (ACCB) altered the Building Code of Australia (BCA) in 2013. The new requirements relate to childcare centres, bedrooms within buildings two stories or more, and bedrooms within single story buildings on steep sloping blocks where the fall to the ground is greater than 2m.

Existing buildings within Strata Schemes and Early Childhood Centres must fit an appropriate device to windows by March 2018 to prevent them opening more than 125mm (representing the size of a young child's head) or a robust screen to resist an outward force of 250 N (~25kg).

The client should engage a building maintenance professional to fit restrictors or permanent screens to the windows in bedrooms 1, 2 and the family bathroom. This must be done as a matter of urgency.

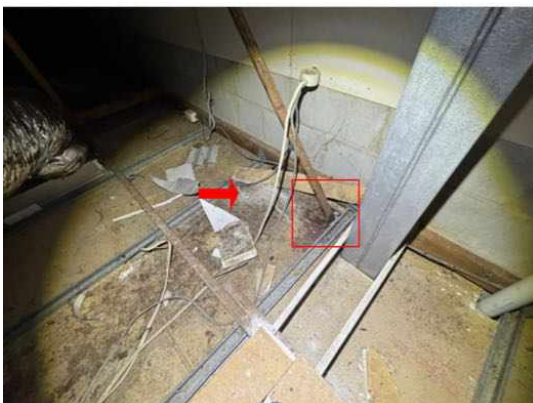
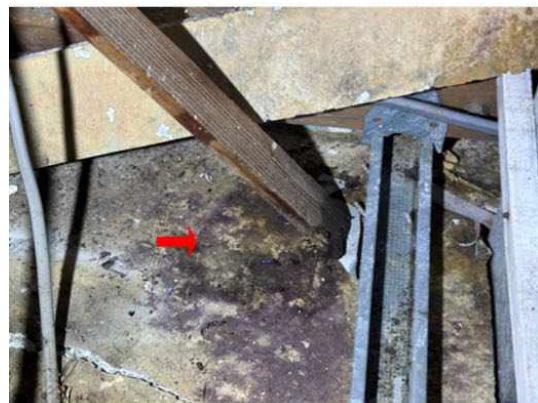
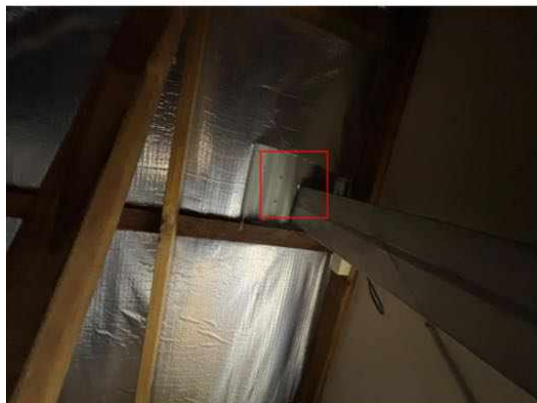
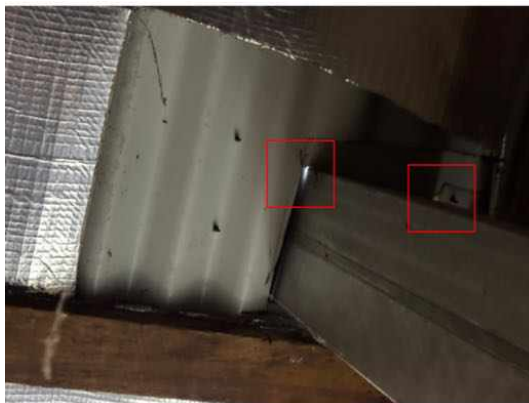
Finding 2.01

Building:	Main Building
Location:	Roof Exterior
Finding:	Roof covering - active leak
Information:	At the time of the inspection, it was noted that there was an active water leak from the metal roofing covering. Moisture could be seen on the top of the ceiling lining.

Light can be seen on either side of the roof penetration. These could be the potential ingress points for moisture. Due to the height of the roof void, this could not be confirmed. It is understood that the roof covering has recently been replaced. Access to the roof was not possible due to the height and rain on the day of the inspection.

The body corporate should be informed of the active water leak to allow them to have the roof inspected by the roofing contractor who carried out the work. This should be done as a matter of urgency.

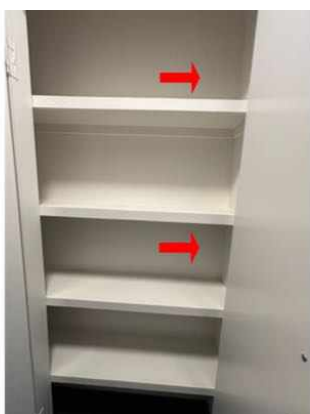
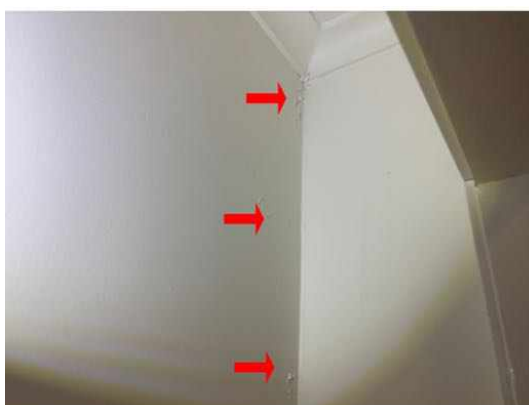
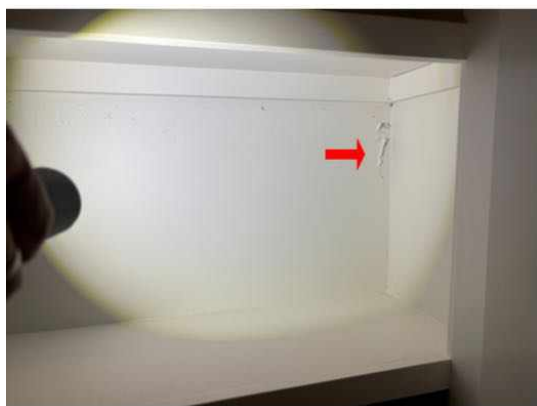
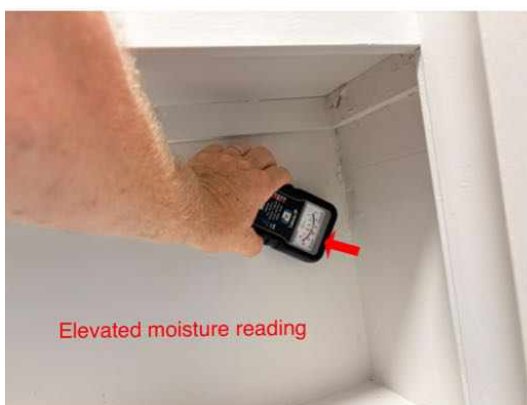
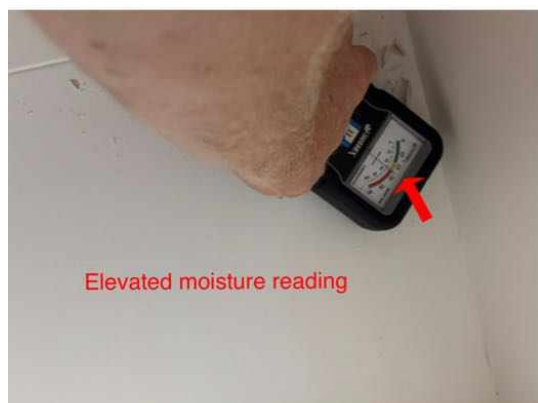
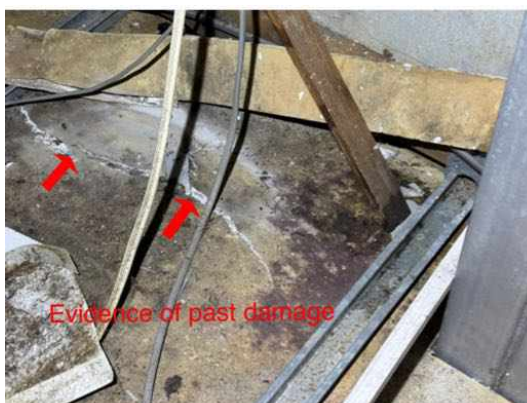
Finding 3.01

Building: Main Building

Location: Hall cupboard

Finding: Hall cupboard - moisture damage

Information: At the time of the inspection, it was noted that there was evidence of moisture damage in the right hand corner of the hall cupboard at the top of the stairs. Elevated moisture readings were recorded in this area. It was found that past damage has occurred to the ceiling lining directly above the hall cupboard. As previously mentioned, there is an active water leak from the roof above this area.

A roofing contractor needs to address the leak from the roof. This should be a body corporate issue and needs to be addressed as a matter of urgency.

After the active leak is repaired, a painting contractor could be engaged to carry out the necessary repairs to the inside of the cupboard. This can be done at the clients discretion.

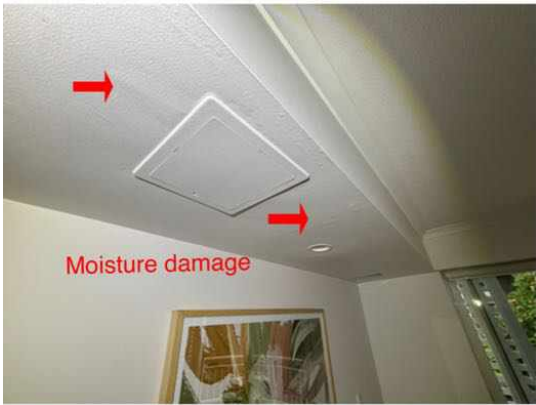
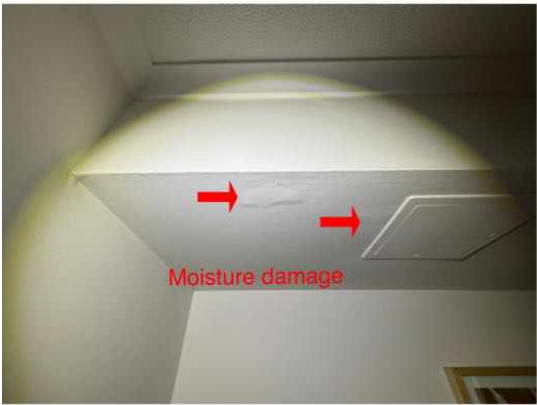
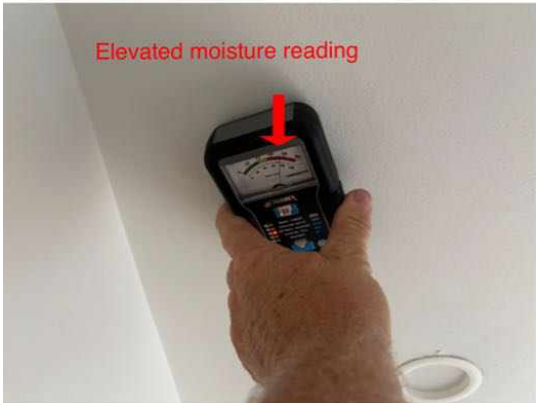
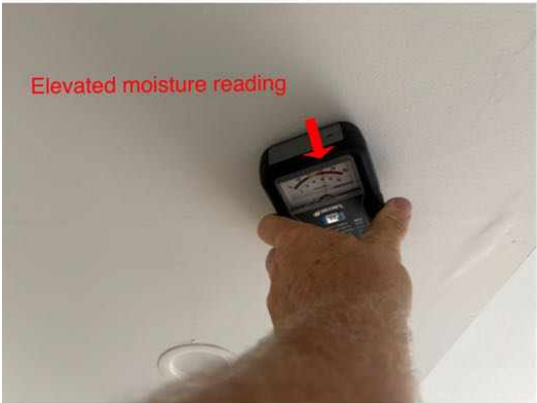
Finding 3.02

Building:	Main Building
Location:	Lounge
Finding:	Lounge - moisture damage to bulkhead
Information:	At the time of the inspection, it was noted that there was evidence of moisture damage to the bulkhead in the lounge. The bulkhead is for the underfloor plumbing for the ensuite. Elevated moisture readings were recorded in this area. The source of the moisture could not be determined. The evidence suggests that there is no active leak at this time.

If left unaddressed, this may become a major defect.

A licensed plumber should be engaged to use the access points in the bulkhead to determine the source of the moisture and to confirm that there is no active leak. This should be done as a matter of urgency.

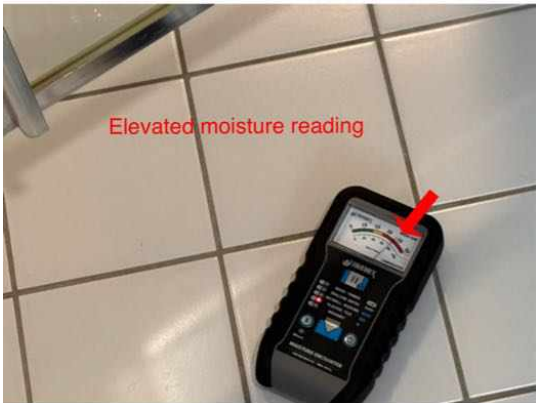
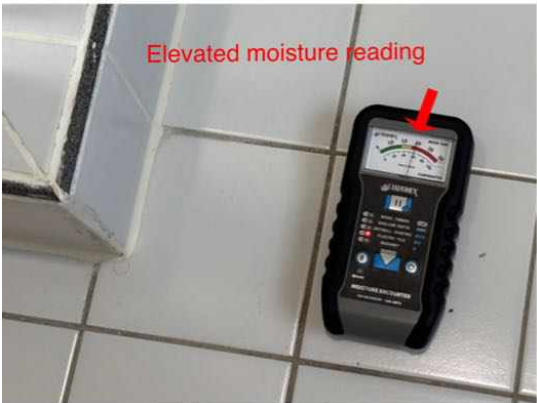
Finding 3.03

Building: Main Building
 Location: Ensuite
 Finding: Ensuite - elevated moisture readings
 Information: At the time of the inspection, it was noted that there were elevated moisture readings recorded on the floor directly outside of the shower in the ensuite. The rest of the floor in the ensuite, outside of the shower, had normal moisture readings.

As a preventative measure, it is recommended that bathroom specialist be engaged to replace the grout and seal the wall and floor tiles in the shower cubicle in the ensuite. This should be done as a short term priority.

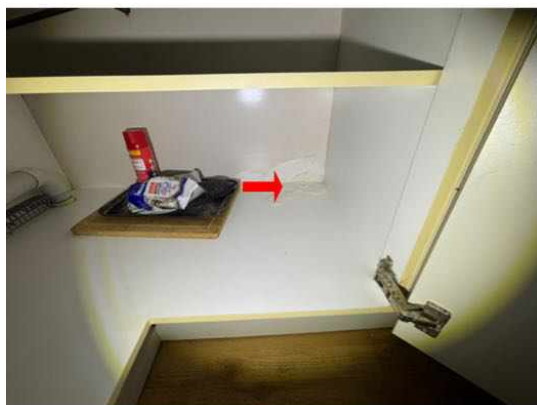
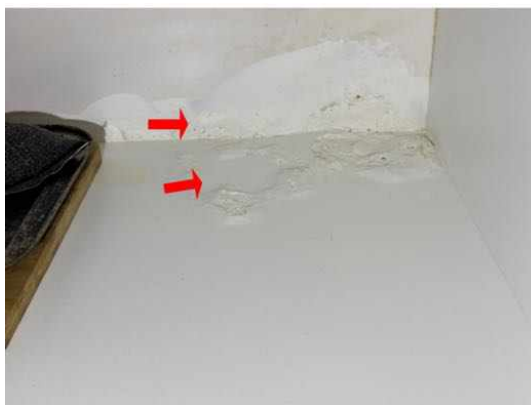
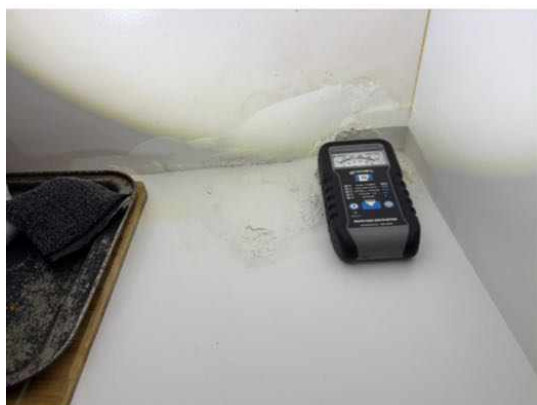
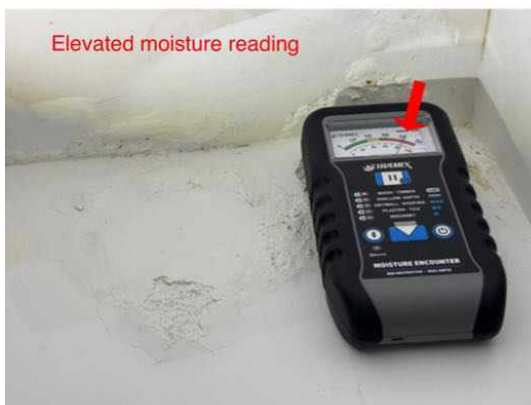
Finding 3.04

Building: Main Building
Location: Kitchen
Finding: Kitchen - moisture damage to cabinetry
Information: At the time of the inspection, it was noted that there was evidence of moisture damage to the sink cabinet in the kitchen. The source of this moisture damage could not be determined. Elevated moisture readings were recorded in this area. This does not appear to be an active leak at this time.

The client should monitor the area for any change in appearance which could suggest a leak.

A building maintenance professional or kitchen specialist could be engaged to carry out the necessary repairs to the cabinet. This can be done at the clients discretion.

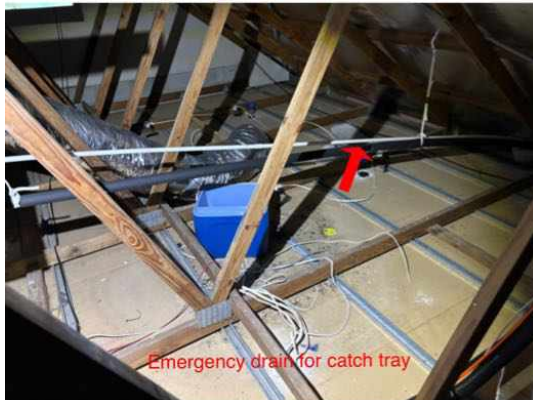
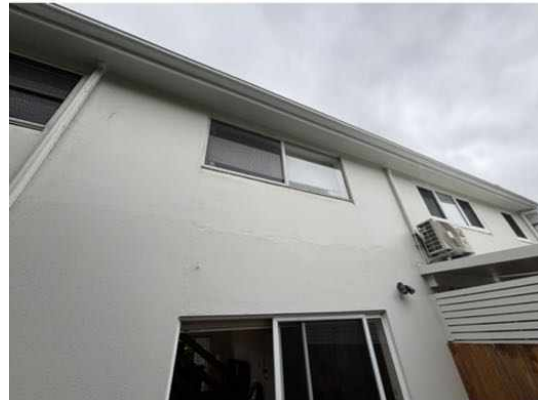
Finding 3.05

Building: Main Building
Location: Roof Void
Finding: Ducted air conditioner - emergency drain
Information: At the time of the inspection, it was noted that the emergency drain for the roof void air conditioning unit was not visible in the fascia below the gutter.

The emergency drain will have moisture coming out of it if the catch tray under the unit starts to fill up with water. Water in the catch tray suggests an issue with the unit or that the unit requires servicing. The emergency drain needs to be visible to be effective.

The client should request that the vendor have the company responsible for the installation come and assess the work to ensure that it has been done correctly. This should be done as a matter of urgency.

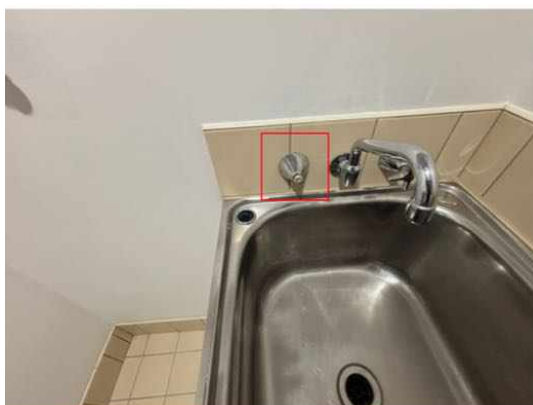
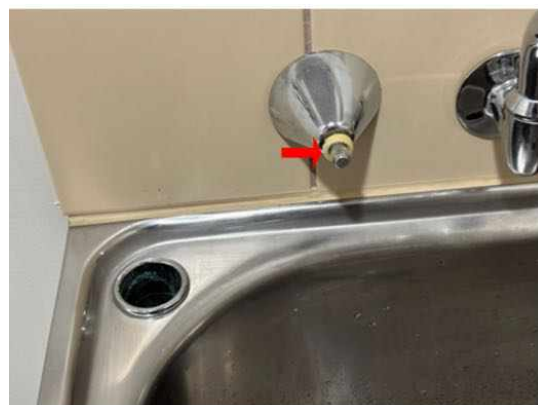
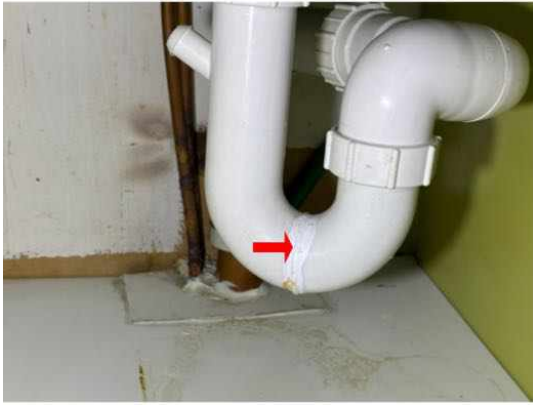
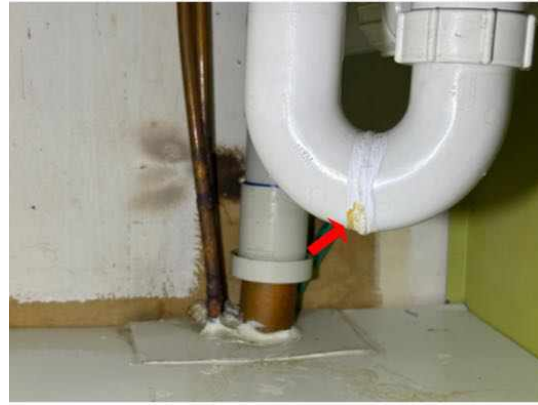
Finding 3.06

Building:	Main Building
Location:	Laundry
Finding:	Laundry - tub defects
Information:	At the time of the inspection, it was noted that there were defects associated with the laundry tub. The hot tap handle is not secure and comes away in your hand when operated. There is thread tape wrapped around the trap under the tub. This is not normal use for thread tape. A stain on the tape indicates a leak, the tub drain was not leaking when checked.

A licensed plumber should be engaged to carry out these repairs. This can be done at the clients discretion.

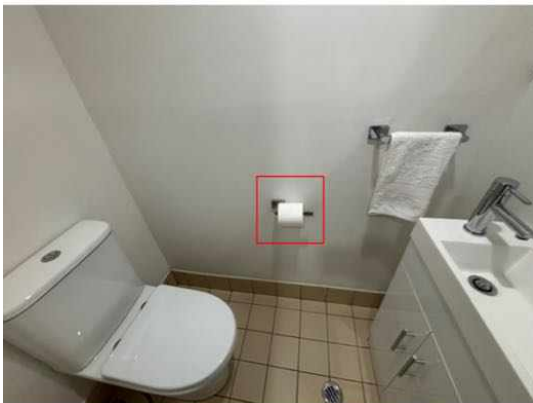
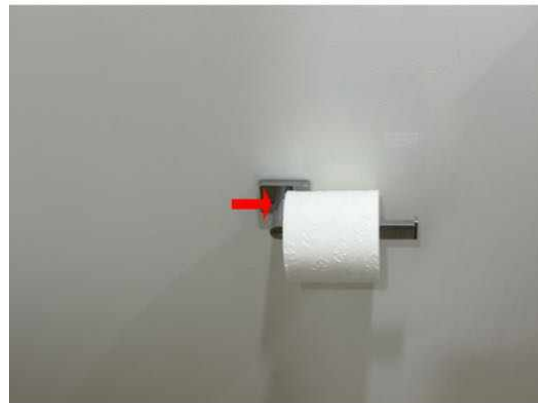
Finding 3.07

Building:	Main Building
Location:	Downstairs toilet
Finding:	Downstairs toilet - toilet roll holder loose
Information:	At the time of the inspection, it was noted that the toilet roll holder in the downstairs toilet was loose. While not a major operational defect, function can deteriorate if the problem is left unmanaged.

It is advised that the homeowner performs remedial works to re-attach the toilet roll holder to its original fixing. A building maintenance professional may be required to perform these works. This can be done at the clients discretion.

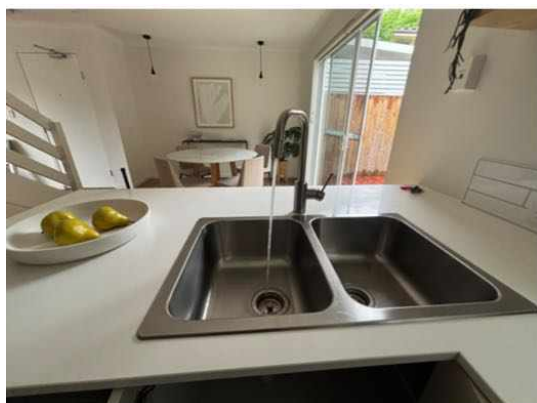
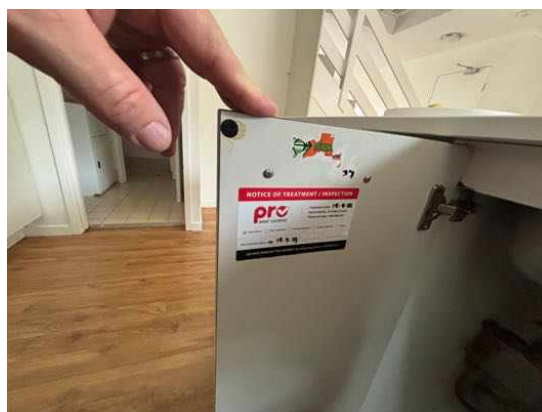
Finding 6.01

Building:	Main Building
Location:	All External Areas
Finding:	Termite Management System - no evidence of a chemical installation
Information:	At the time of the inspection, no evidence of a chemical termite management system was found. There is no durable notice in the kitchen sink cabinet.

The application of a post-construction chemical termite barrier is highly recommended for all properties, particularly if live termite activity has been found on the site previously. Such barriers are highly effective in preventing termite attack on any timber building elements throughout the property.

A durable notice should be placed in the switchboard unit or kitchen sink cabinet to indicate current termite barriers. At the time of inspection, it appeared as though no termite management system has been installed, with no evidence to suggest preventative works taking place.

The client should enquire of the body corporate as to the nature of the termite management plan for the complex and the individual units. Also, are annual termite inspections being carried out and up to date.

The client may consider gaining further advice from a pest controller as to the costs and procedures involved with this application. It is recommended that obtaining such advice be a short-term priority.

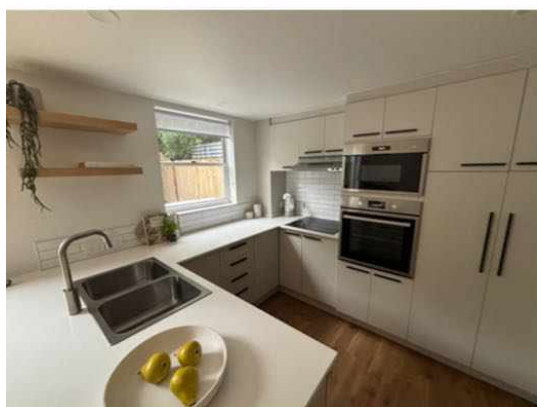
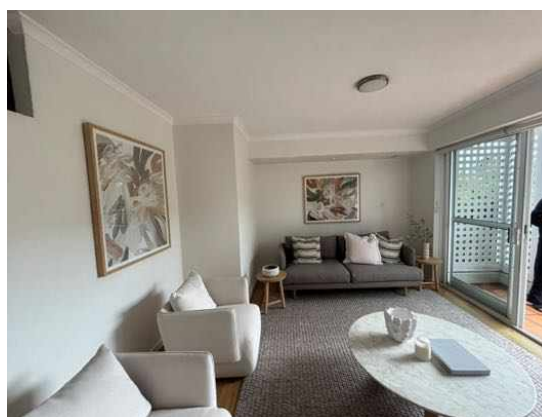
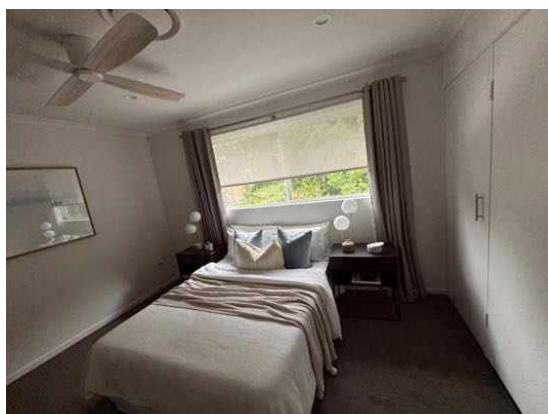
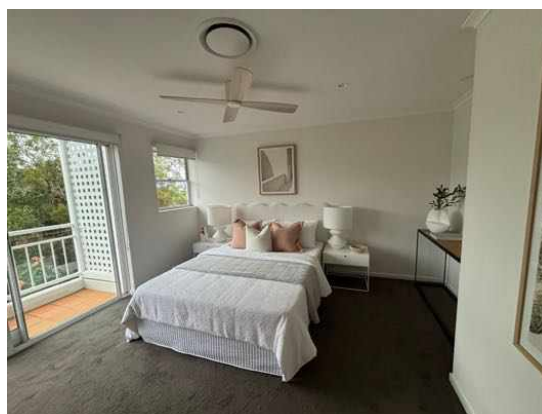
Building:	Main Building
Location:	All Internal Areas
Finding:	Obstructions and Limitations - Internal areas
Information:	These photographs are an indication of the obstructions and limitations which impeded full inspection of the property of the internal areas at the time of inspection. These obstructions can hide an array of defects and should be removed to allow full inspection to be carried out. A re-inspection is recommended once the areas are made accessible.

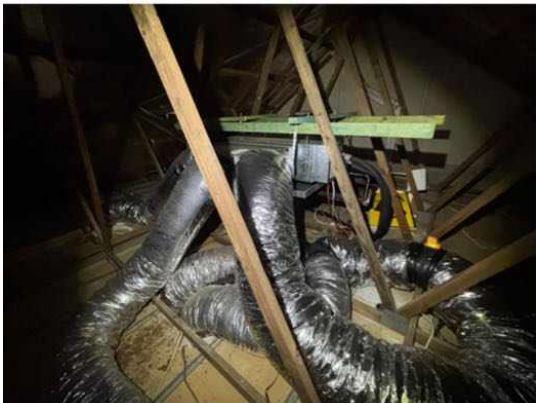
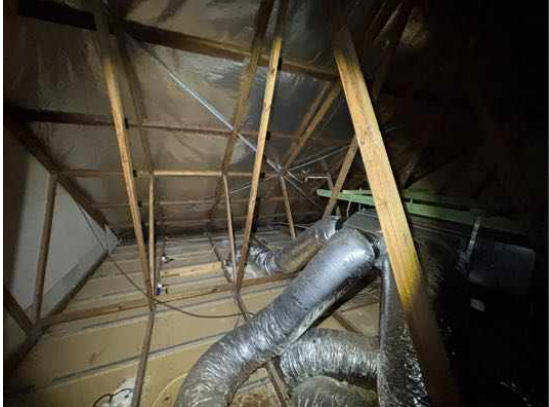
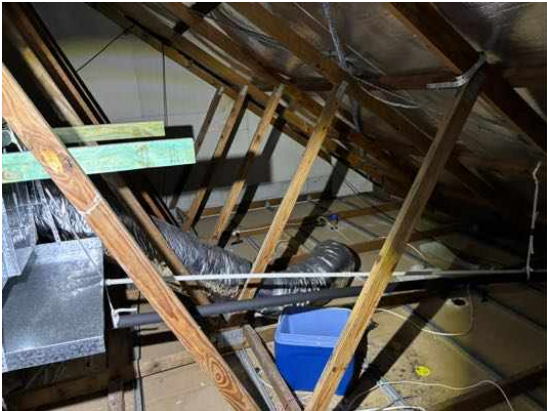
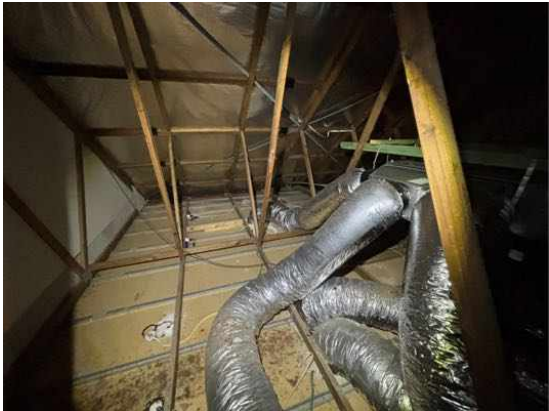
Building:	Main Building
Location:	Roof Void
Finding:	Obstructions and Limitations - Roof cavity
Information:	These photographs are an indication of the obstructions and limitations which impeded full inspection of the property of the roof cavity

at the time of inspection. These obstructions can hide an array of defects and should be removed to allow full inspection to be carried out. A re-inspection is recommended once the areas are made accessible.
