# Building and Timber Pest Inspection Report

Inspection Date: Mon, 23 Feb 2026

Property Address: 5/123 Anderson Rd, Albion VIC 3020,  
Australia

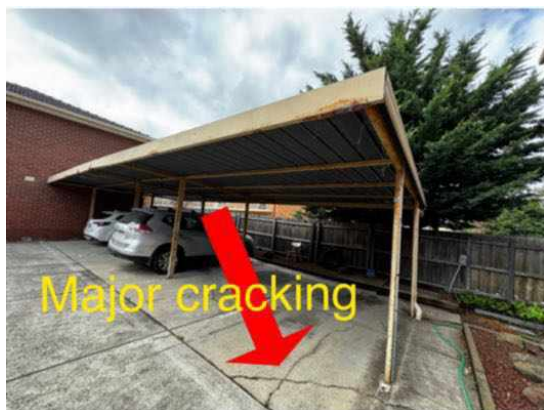
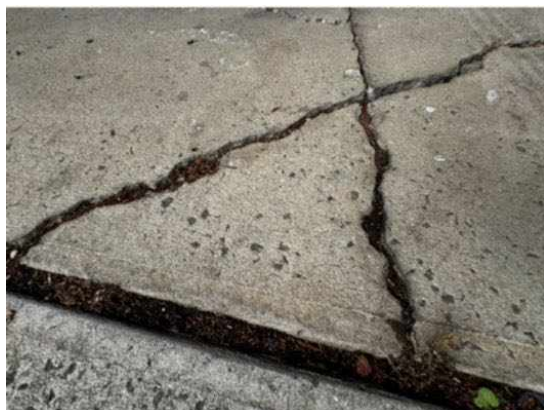
Building: Carport  
Location: Carport Area > Centre Left  
Finding: Carport Structure – Severe Corrosion and Concrete Deterioration  
Information: The carport structure above the parking provision for Unit 5 was observed to be in poor condition at the time of inspection. The steel framing elements were heavily corroded, with sections of steel visibly deteriorated. The extent of corrosion suggests prolonged exposure to moisture and lack of maintenance, which may have compromised the structural integrity of the affected members.

The concrete slab beneath the carport area was also found to be severely cracked. The cracks were significant in width and depth, with certain sections of concrete visibly separated from adjoining areas. This level of cracking indicates structural movement and/or long-term deterioration of the slab.

In accordance with AS 4349.1–2007, common property areas such as shared carports are generally outside the scope of a standard pre-purchase inspection of an individual unit. These observations are therefore provided for your information only and were not subject to detailed structural assessment. However, given the structural nature of the defect, it was decided to categorise as a Major Defect to draw attention to the issue.

It is recommended that the body corporate or managing authority engage a qualified structural engineer or licensed builder to assess the condition of the carport structure and concrete slab to determine structural adequacy and required remedial works.

Further assessment recommended in the short term due to potential structural and safety concerns.

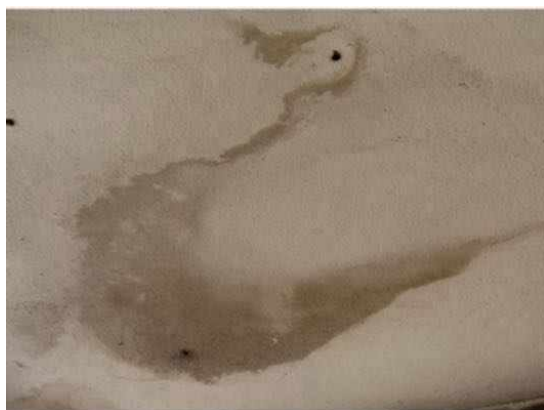
## Finding 2.02

Building:	Main Building
Location:	Entry eaves > Front
Finding:	Moisture Damage to Eave Lining – Suspected Roof Leak (Liability to Be Confirmed)
Information:	The eave lining directly in front of the entry door to Unit 5 was observed to have significant moisture damage, with visible timber decay and deterioration to associated timber elements. The condition is consistent with prolonged water exposure.

Moisture testing undertaken with a moisture meter returned very high moisture readings within the affected eave lining, confirming the presence of excessive moisture at the time of inspection. It is suspected that the source of moisture may be related to damaged or displaced roof tiles above the affected eave area. However, the upper-level roof areas were not accessible at the time of inspection due to safety constraints, and no direct confirmation of the source of water ingress could be made.

The eave area directly in front of Unit 5 entry will need to be clarified with the body corporate management to determine responsibility for repair. It is currently unclear whether this area constitutes common property or forms part of the landlord's responsibility, given that the roof in question sits directly above the subject unit.

In the absence of formal confirmation from the body corporate, this issue has been assumed to be a landlord-related responsibility and has therefore been classified as a major defect until verification confirms otherwise.

It is recommended that the landlord and/or body corporate management clarify ownership and maintenance responsibility for the affected eave and roof section. A qualified roofing contractor should be engaged to inspect the roof above for damaged or displaced tiles and rectify the source of water ingress. Damaged eave linings and decayed timber elements should be repaired or replaced once the source of moisture has been addressed.

Further investigation and rectification recommended in the short term due to active high moisture readings and risk of ongoing deterioration.

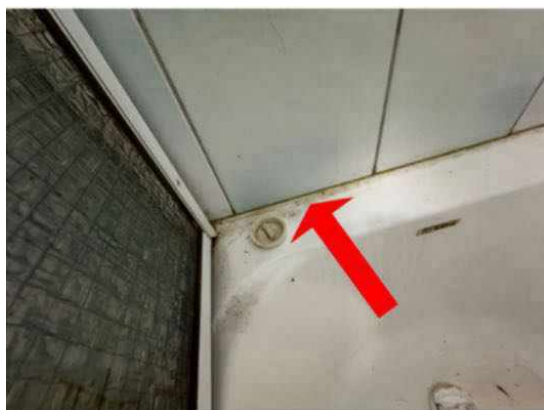
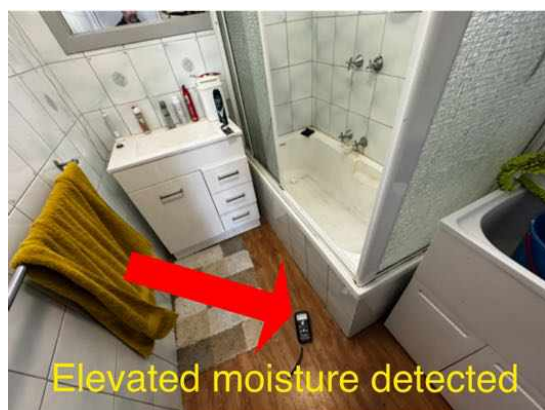
### Finding 2.03

**Building:** Main Building  
**Location:** Bathroom > Rear  
**Finding:** Bathroom Defects – Potential Water Ingress and Elevated Moisture  
**Information:** During the inspection of the bathroom area, a visible gap was observed around the shower plumbing penetration point. This gap presents a potential point of water ingress into the wall cavity, particularly during normal shower use. If left unsealed, moisture may enter concealed areas and contribute to timber decay, mould growth, and structural deterioration over time.

Elevated moisture readings were also detected to the bathroom floor area when tested with a moisture meter. The elevated readings are likely related to water ingress associated with the unsealed plumbing penetration around the shower wall tile. Moisture migration into concealed areas can lead to deterioration of adjacent building elements, including wall framing, floor substrates, and finishes. For this reason, concealed moisture damage is considered high risk.

The bathtub was observed to be aged and in deteriorated condition, consistent with the suspected age of the building. Visible dirt and grime build-up were noted to the tile surfaces and at the junctions between the shower screen, wall tiles, and bathtub. These junction points may have deteriorated or missing sealant, further increasing the risk of moisture penetration into concealed areas.

It is recommended that the plumbing penetration be properly sealed with suitable waterproof sealant to prevent further water ingress. The elevated moisture levels to the bathroom floor should be further investigated to determine the full extent of moisture migration. All junctions within the shower and bath area should be inspected and re-sealed where required. The condition of the bathtub should be assessed to determine whether repair, re-surfacing, or replacement is necessary.

Further invasive investigation may be required if moisture levels persist or increase.

Immediate. Rectification and further investigation recommended due to elevated moisture readings and risk of concealed structural damage.

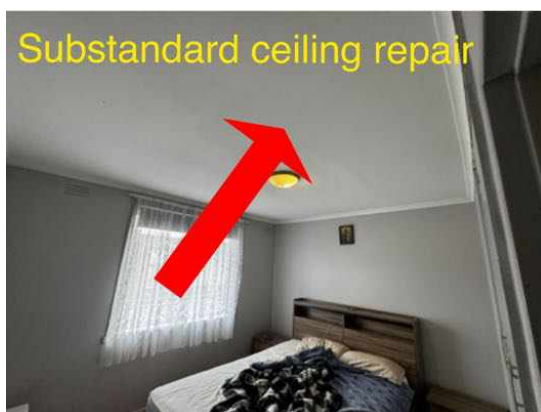
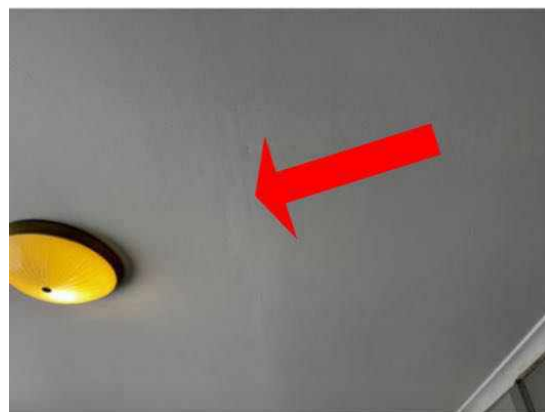
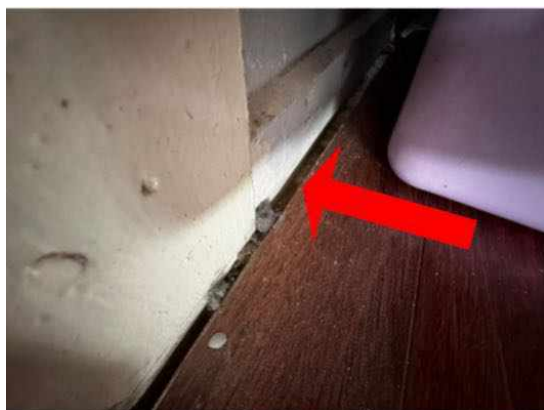
### Finding 3.01

Building:	Main Building
Location:	All Areas > All Areas
Finding:	Interior Finishes – Substandard Repairs and Suspected Historical Moisture Damage
Information:	Several internal defects were observed during the inspection. These included substandard plaster repairs to ceilings and walls, evidence of previous ceiling damage with inconsistent patching, and a large ceiling crack near the kitchen area. Flooring installation was noted to be of poor finish in certain areas, particularly around door jambs. Painting defects were evident throughout, including light switches and door hinges painted over.

Evidence of suspected past moisture damage was observed to the entry door area, which appeared to have been concealed with paint. Moisture testing was undertaken to affected areas using a moisture meter, and no elevated moisture levels were detected at the time of inspection. No active water leaks were identified during the inspection.

However, it is important to note that the inspection was carried out during a prolonged dry period and at the peak of summer conditions. The absence of detectable moisture at the time of inspection does not rule out the possibility of intermittent or seasonal

roof leaks. Any previous moisture may have dried out due to weather conditions. Given the evidence of past damage and repairs, the risk of potential moisture-related issues is considered high.

It is recommended that the large ceiling crack and substandard plaster repairs be further assessed and rectified by a qualified tradesperson. The entry door area and ceiling near the kitchen should be closely monitored, particularly during and after significant rainfall events, to determine whether moisture ingress reoccurs. If further moisture staining or damage is identified, a licensed roofing contractor should be engaged to inspect the roof covering and associated flashings.

Monitoring recommended in the immediate term, with rectification of cosmetic defects in the short to medium term. Further investigation required promptly if moisture ingress reoccurs.

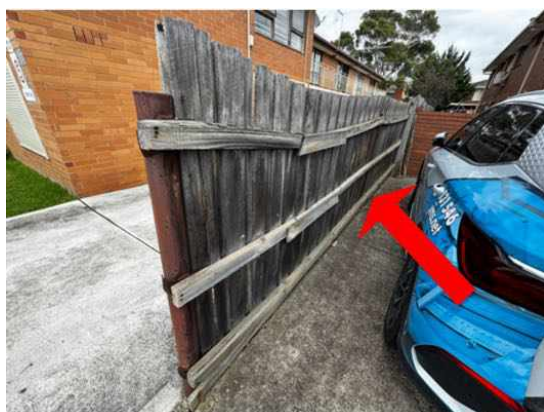
Building: Main Building  
 Location: Yard - side > Centre Left  
 Finding: Inground timber contact (TP)  
 Information: At the time of inspection, in-ground timber contact was observed to the side yard, including timber garden edging, and fence posts, all in direct contact with the ground. These timber elements are positioned within the soil zone and in close proximity to the building and associated structures.

In accordance with AS 3660.2, conditions that facilitate termite access or provide a direct food source are recognised as increasing the risk of termite activity to existing

buildings. Timber elements in direct contact with the ground are particularly vulnerable, as they can attract subterranean termites and support concealed foraging activity, potentially allowing termite colonies to establish and migrate toward nearby structures without early detection.

As a result, the presence of in-ground timber elements is considered to increase the risk of termite activity to the property. It is recommended that a licensed termite management or pest control contractor be engaged to assess these conditions and provide advice on appropriate risk mitigation measures, which may include removal or replacement of timber elements with non-susceptible materials, isolation of timber from soil contact, and integration of suitable termite management measures to suit the existing site conditions.

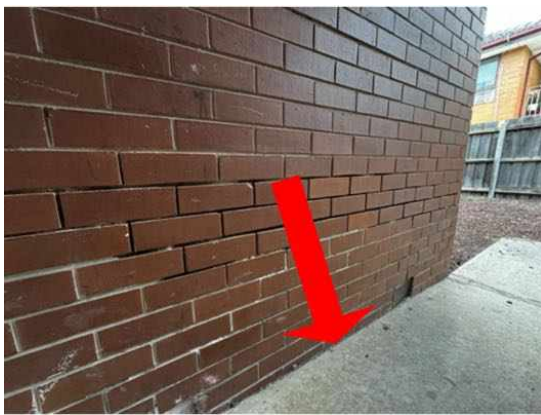
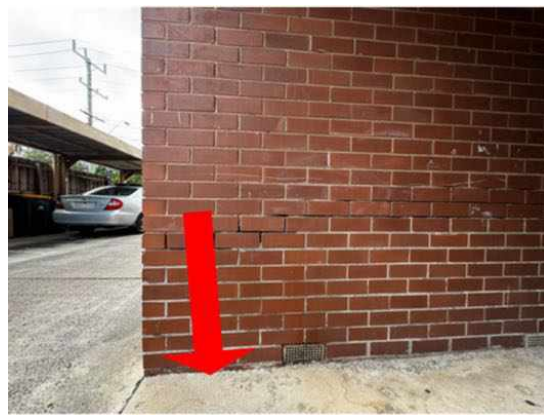
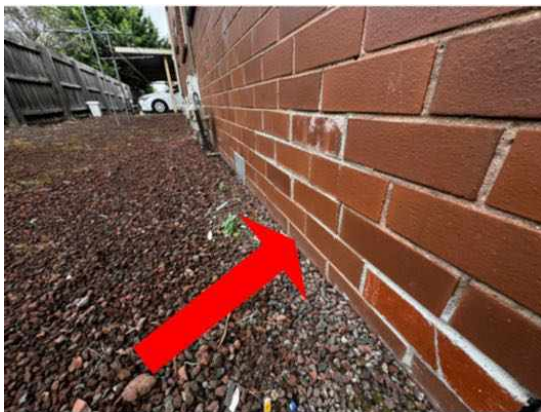
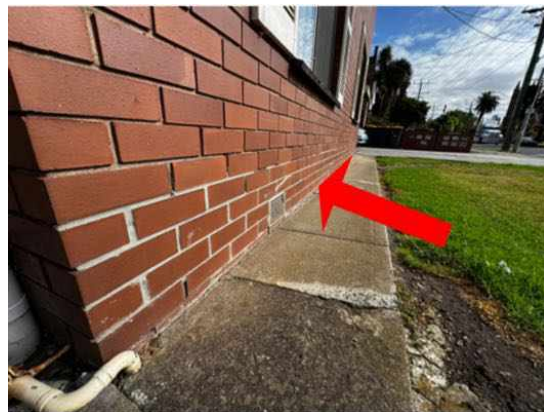
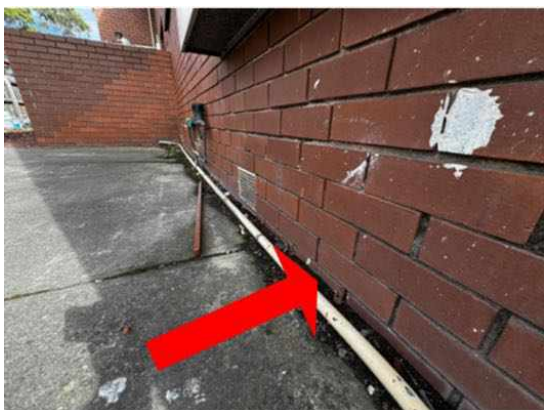
### Finding 6.02

Building:	Main Building
Location:	All Areas > All Areas
Finding:	Slab edge - concealed (TP)
Information:	At the time of inspection, the slab edge to most areas of the building was observed to be concealed behind concrete paving, and landscaping. This condition restricts clear visibility of the slab perimeter and limits the ability to visually inspect critical inspection zones intended for the early detection of termite activity.

Where slab edges and inspection zones are concealed, concealed termite entry paths may develop without early warning. In accordance with AS 3660.2, existing buildings are required to maintain conditions that allow for effective inspection and management of termite risk, noting that obstructions such as paving, paths, or landscaping can compromise the effectiveness of termite management measures. Where inspection zones are obstructed, the likelihood of undetected termite activity is increased.

As a result, the current configuration is considered to increase the risk of concealed termite entry to the building. It is recommended that a licensed termite management or pest control contractor be engaged to assess the extent of the concealed slab edges and provide advice on rectification options, which may include modifying paving or landscaping to reinstate suitable inspection access and integrating appropriate termite management measures to suit the existing conditions.

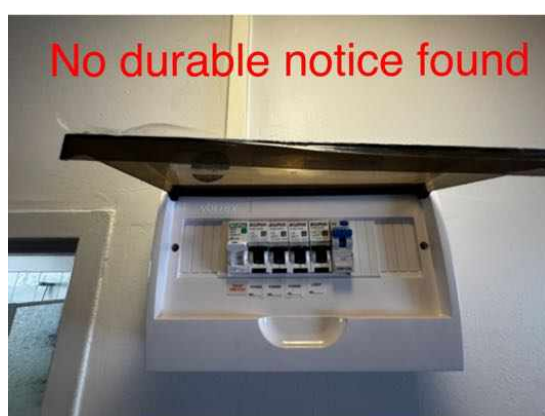
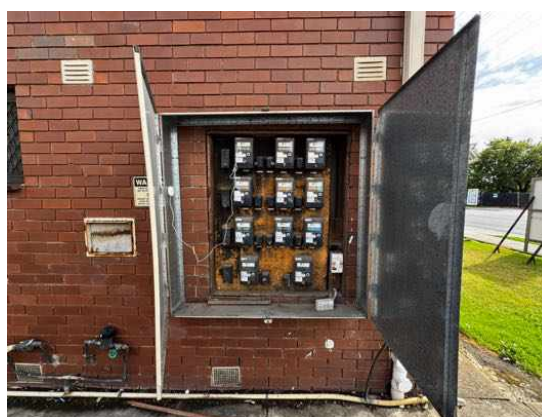
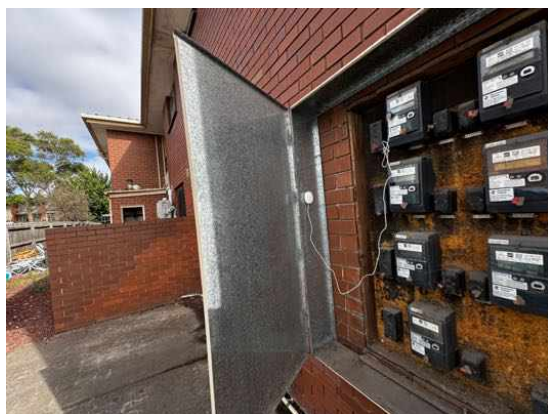
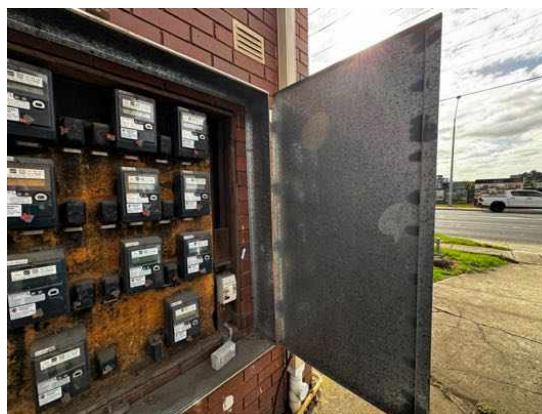
Building:	Main Building
Location:	Meter Box > Front Left
Finding:	Termite management system - no evidence of chemical installation (TP)
Information:	At the time of inspection, there was no visible evidence to suggest that a chemical termite management system has been installed or remains effective. In addition, no durable notice was observed within the electrical switchboard to identify the presence, type, or date of any termite protection measures.

For this reason, the installation of a post-construction chemical termite management system is highly recommended to reduce the risk of termite activity. A durable notice should also be installed within the electrical switchboard to clearly identify the treatment provided and support ongoing inspection and maintenance.

Engagement of a licensed termite management or pest control contractor is recommended as a matter of priority to assess the site conditions, consider local termite risk, and determine the most appropriate treatment method and procedures for this property.

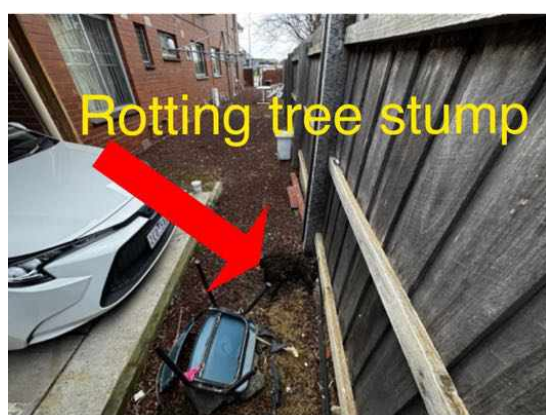
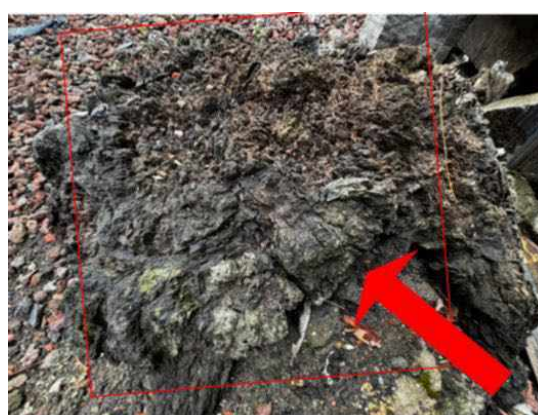
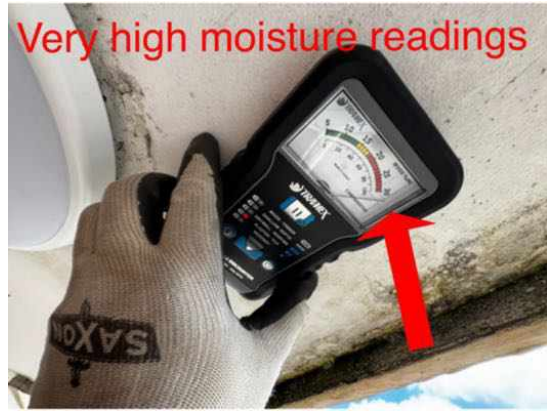
Building:	Main Building
Location:	Balcony, side yard > Centre Left, Level 1
Finding:	Timber decay & rot - Conducive conditions (TP)
Information:	During the inspection, several conducive conditions for termite and timber pest activity were observed in the common area adjacent to the unit. Timber decay and rot were identified in the side yard of the building. A rotting dead tree stump was present in the side yard, and loose timber elements in this area showed visible signs of fungal decay.

In addition, the eave lining directly in front of the unit entrance was observed to be visibly moisture damaged. Timber elements to the eave exhibited signs of timber decay and rot. Moisture testing undertaken in this area returned very high moisture readings, confirming the presence of excessive moisture. Prolonged moisture exposure significantly increases the likelihood of timber deterioration and creates conducive conditions for termite and timber pest activity.

These conditions represent elevated risk areas for potential termite and timber pest infestation, particularly given the suspected age of the building and the presence of decaying timber materials in close proximity to the structure.

It is recommended that all decayed timber materials, including the dead tree stump and loose timber debris, be removed from the side yard. The moisture-damaged eave lining and affected timber elements should be further investigated and repaired or replaced as required. The source of moisture contributing to the elevated readings should be identified and rectified. Ongoing monitoring for termite and timber pest activity is advised.

Rectification recommended in the short term due to high moisture levels and increased risk of termite and timber pest activity.
