# Building and Timber Pest Inspection Report

Inspection Date: Thu, 8 Jan 2026

Property Address: 2 Warrener St, Nerang QLD 4211, Australia

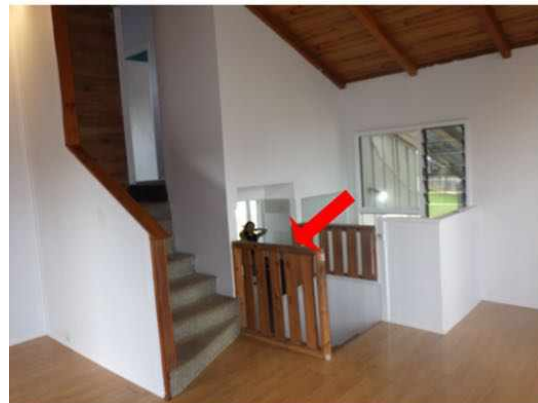
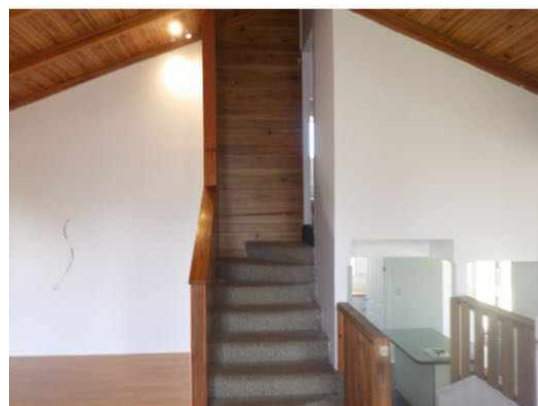
Building:	Main Building
Location:	Stairs - Internal > Existing
Finding:	Balustrade - Suspected Non-Compliance
Information:	The internal stair balustrade was measured and found to be (.905m high) less than the present building regulation requirement of 1000mm high.

A registered builder should be contacted to discuss possible rectification solutions.

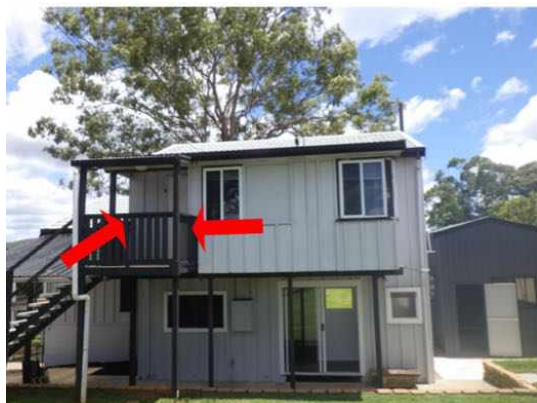
#### Finding 1.02

Building: Main Building  
 Location: Balcony > Existing  
 Finding: Balustrade - Suspected Non-Compliance  
 Information: The balcony area balustrade was measured and found to be (.950mm high) less than the present building regulation requirement of 1000mm high.

This defect creates a potential safety hazard and should be rectified to ensure the safety of the area and to meet present building standards and regulations.

A registered builder should be contacted to discuss possible rectification solutions.

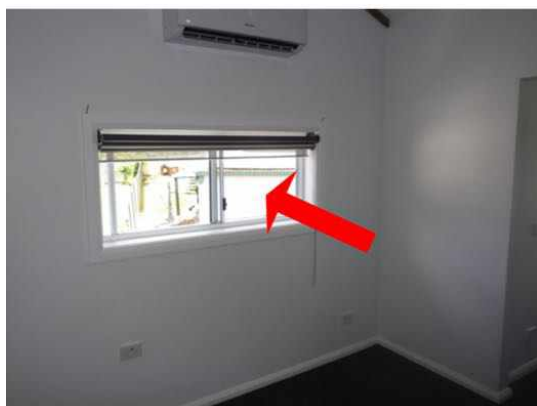
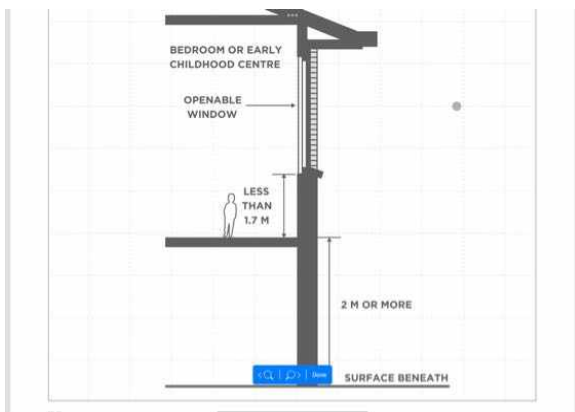
### Finding 1.03

Building: Main Building  
 Location: Bedroom 3 > Existing  
 Finding: Window safety  
 Information: It was noted that the windows of the upper level bedroom 3 are less than 1.7m from the floor and have a fall greater than 2m on the exterior from the sill and as such are required to only open upto 125mm or have security grills fitted.

This is noted as a safety concern and this regulation may not have been in place at the time of construction.

Windows are defective if they do not comply with provision 3.9.2.5 of Volume 2 of the BCA that requires that a window opening must have protection if the floor below the window in a bedroom is 2 m or more above the ground surface beneath.

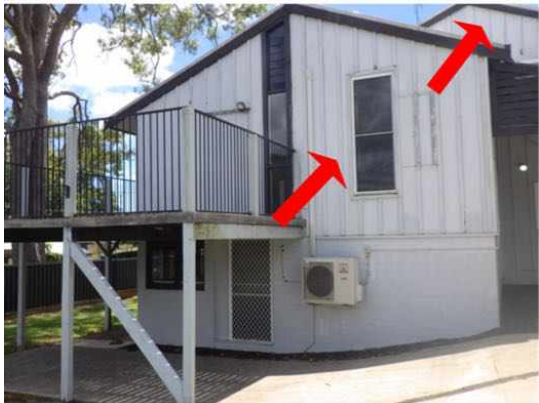
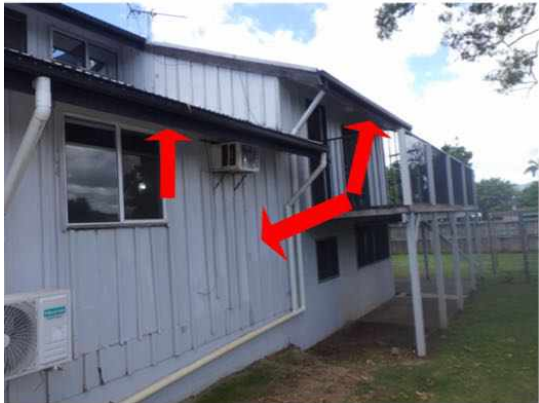
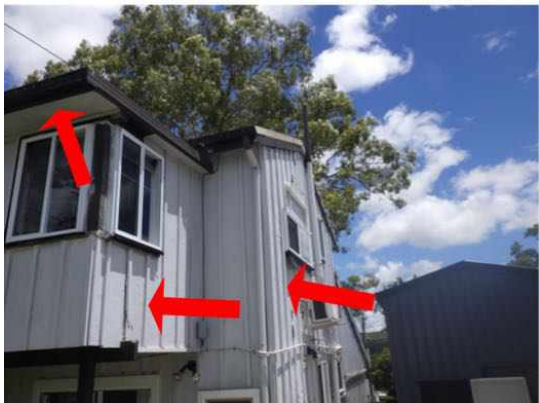
Reporting on Asbestos is outside the Scope of this Report. This suspected defect is highlighted as a caution only. We suspect, based on our experience in the building industry, that there is a higher risk of the identified building elements containing asbestos.

As Asbestos Reporting is outside the scope of this report, we advise that you consider a separate Asbestos Inspection and Condition Audit, which can include the taking of samples for definitive confirmation of the presence of Asbestos.

In the interim, the client is advised to act with caution, especially when considering any damage to building materials general wear and tear renovations extensions demolition and general maintenance activities due to the suspected presence of Asbestos.

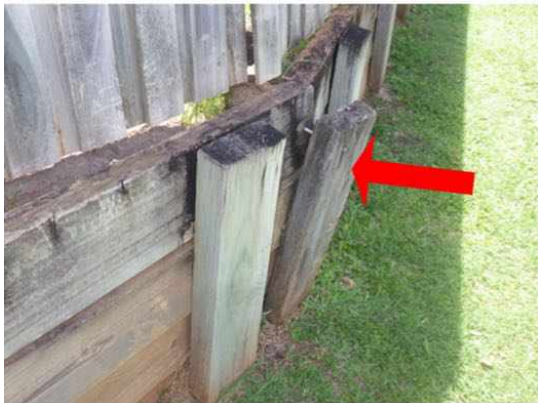
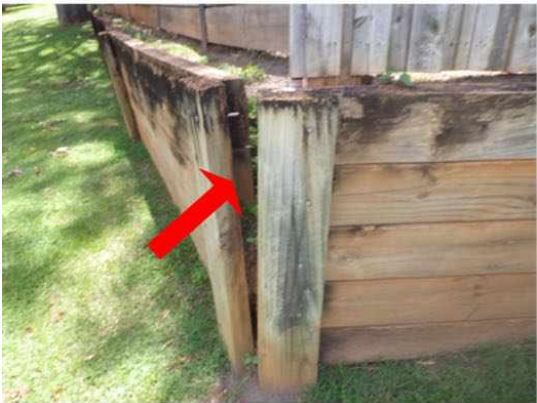
Building: Main Building  
Location: Yard - Side > Existing  
Finding: Retaining wall - Deteriorated  
Information:

The timber retaining wall to the front left side of the property was found to be deteriorated at the time of inspection. Generally, deteriorated retaining walls are caused by poor material use or continuous exposure to weather conditions. However, deteriorated retaining walls may also be a result of substandard construction, poor site drainage or unmanaged stormwater flows.

If left unmanaged, the retaining wall may become a safety hazard. Where retaining walls further rot and decay, an environment is created that is conducive to termite and pest infestation.

A landscaper or retaining wall installer could be appointed to repair the wall, at the discretion of the client.

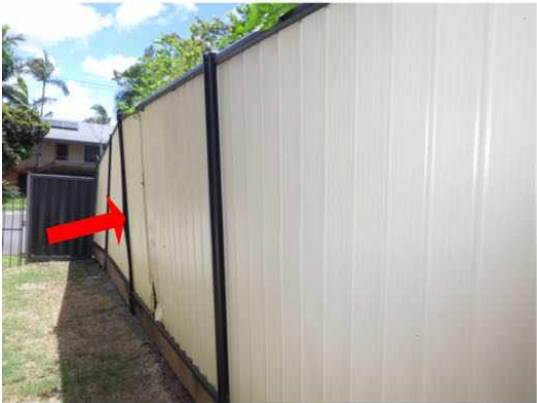
**Finding 3.03**

Building: Main Building  
Location: Yard - Side > Existing  
Finding: Fencing - Deteriorated  
Information:

It was noted at the time of inspection that sections of the metal fencing to the right side of the property showed signs of impact damage and/or have deteriorated. Typically fencing deteriorates due to age and or wear, rot and or rust which is generally expected for a structure of this age, due to prolonged exposure to weather conditions. Sometimes inadequate installation or maintenance can be to blame.

It is suspected that repair of several elements of the fencing may be required.

A licensed fencing contractor could be appointed to provide further advice and perform rectification works as necessary.

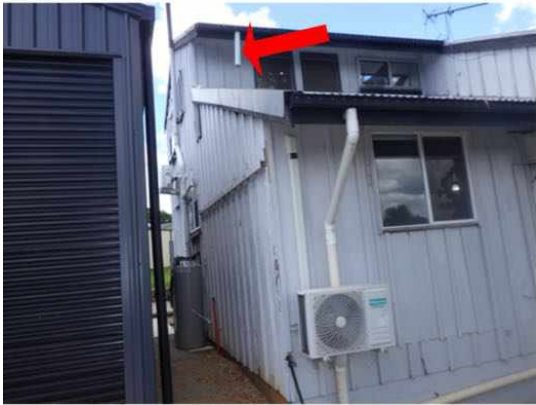
### Finding 3.05

Building:	Main Building
Location:	Roof Exterior > Rear Right
Finding:	Downpipe spreaders - Insufficient
Information:	The down pipe from the upper roof catchment area is not adequately installed onto the lower roof, the current installation allows for discharge water in a concentrated area which may cause roof leaks into the underlying areas, Downpipe spreaders which are not installed correctly are likely to result in excessively damp conditions against the exterior wall surfaces of the building.

A registered roofing plumber could be engaged to inspect the area and advise on relevant works required.

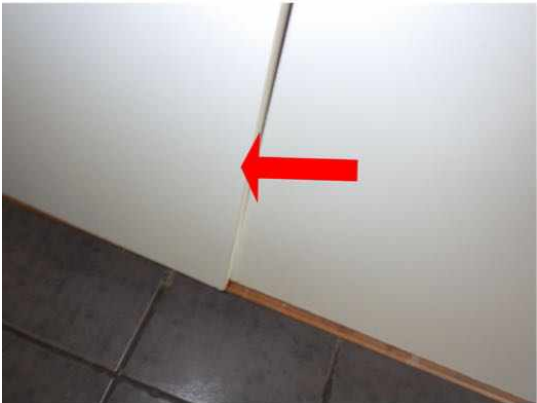
**Finding 3.06**

Building: Main Building  
 Location: Kitchen > Existing  
 Finding: Cabinetry - Deterioration  
 Information: At the time of inspection the kitchen cabinetry showed signs of deterioration (as per example photos). The level of damage appears consistent with exposure to moisture, previous alterations or general wear and tear.

A qualified cabinet maker or general handyman could be engaged to undertake repair works at the clients discretion.

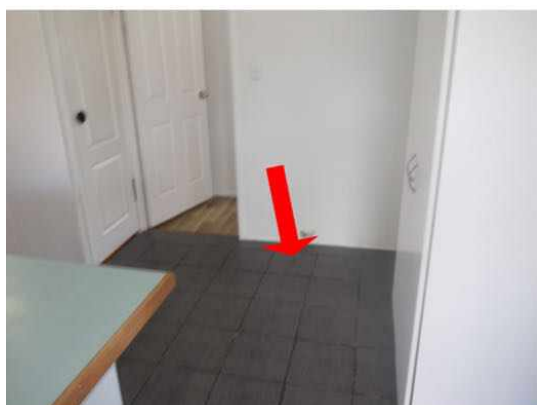
**Finding 3.07**

Building: Main Building  
Location: Kitchen > Rear Right  
Finding: Tiles - Chipped  
Information: Chipped tiles to the kitchen floor area were identified at the time of inspection (as per example photos). Chipped tiles are generally caused by impact.

A tiling contractor could be appointed to perform repair works at the clients discretion.

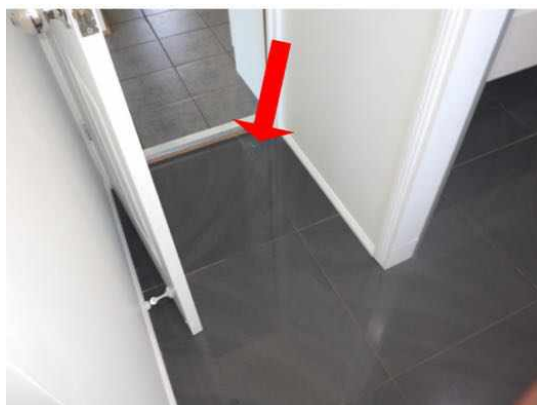
**Finding 3.08**

Building: Main Building  
 Location: Laundry > Front  
 Finding: Tile - Cracked  
 Information: Cracked tiles to the laundry floor area was identified at the time of inspection. Such defects are generally caused by impact. Cracked or broken tiled areas may also be a direct result of poor workmanship during the construction process.

A tiling contractor could be appointed to perform repair works at the clients discretion.

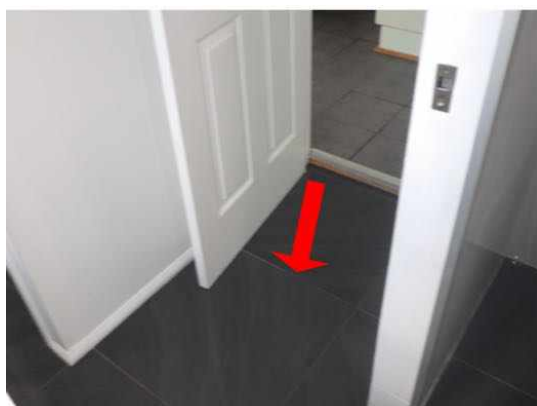
### Finding 3.09

Building: Main Building  
 Location: Laundry > Front  
 Finding: Grout - Missing  
 Information: Grout is missing from a section of floor tiles in the laundry area. Grout is used to protect gaps and crevices in building materials to ensure that they are water-tight and prevent water penetration to the associated structures.

Where grout is missing, a tiling contractor or general handyman should be appointed to apply grout and re-apply any silicone where necessary.

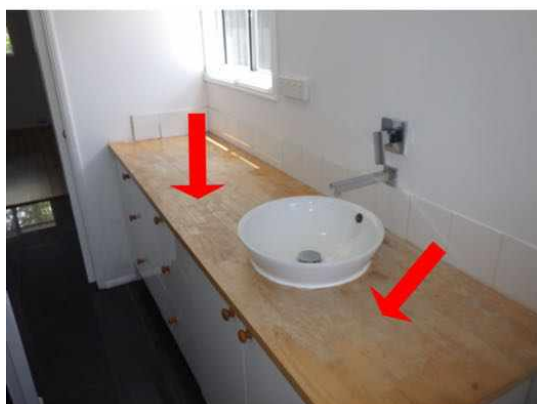
Building:	Main Building
Location:	Laundry > Centre
Finding:	Painted surface - Deteriorated
Information:	At the time of inspection the protective coating or sealer to the timber bench top in the laundry area was found to have deteriorated. Deteriorated internal paint or sealer is generally an indication of a lack of maintenance, excessive moisture or poor workmanship.

It is advised that a qualified painter is engaged to re-apply a protective coating to the affected timber top.

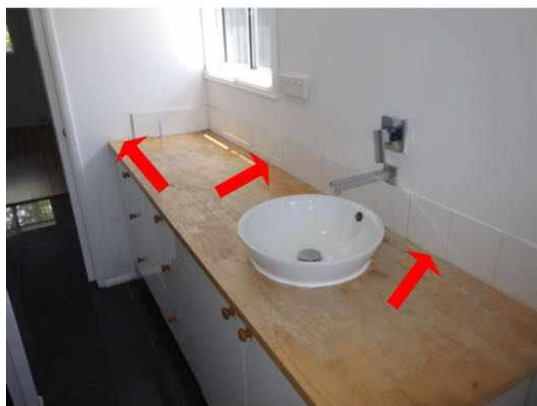
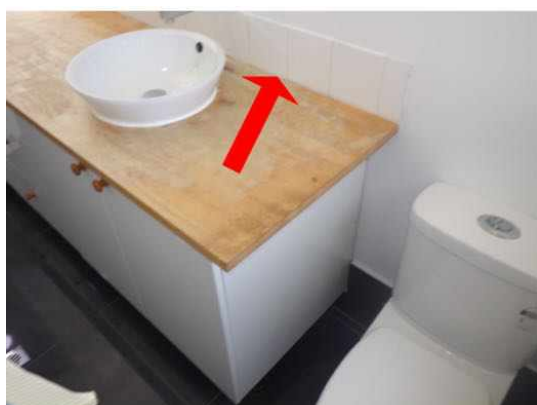
### Finding 3.12

Building: Main Building  
 Location: Laundry > Rear Left  
 Finding: Tiles - Missing  
 Information: It was noted on inspection that wall tiles and sealant are missing from the laundry bench tiled splash back. It is important this area is tiled and sealed to prevent moisture or liquids penetrating the generally unsealed edges. Tiles and sealant also prevents vermin from accessing and or nesting in these areas.

A tiling contractor should be appointed to complete these works as soon as possible.

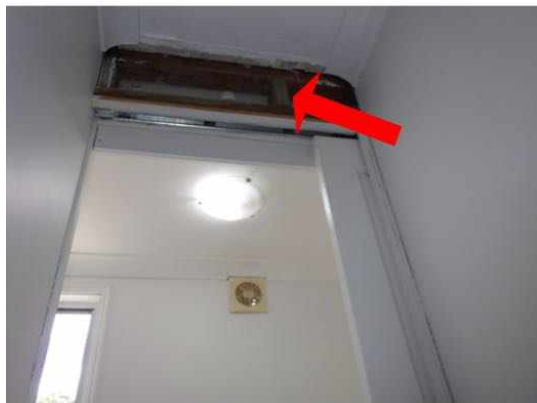
### Finding 3.13

Building: Main Building  
 Location: Laundry > Centre Right  
 Finding: Incomplete works.  
 Information: At the time of inspection it appeared there were areas of incomplete renovation work to wall and ceiling linings in the laundry area.

A general handyman could be engaged to complete the work, at the clients discretion.

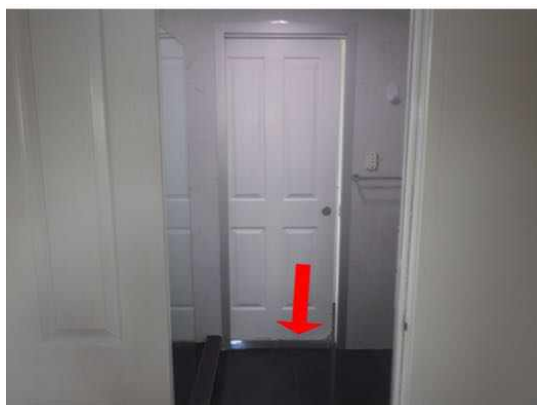
### Finding 3.14

Building:	Main Building
Location:	Bathroom > Front
Finding:	Damaged Door
Information:	The door leading into the bathroom has suffered damage to the bottom edge.

Damage occurs generally when the building materials have aged and decayed, but in this instance the damage appears to be the result of exposure to moisture, possibly from the bottom and/or top edges of the door not being sealed with a suitable paint or sealant at the time of construction.

A qualified carpenter or general handyman could be appointed to repair/replace the door at the clients discretion.

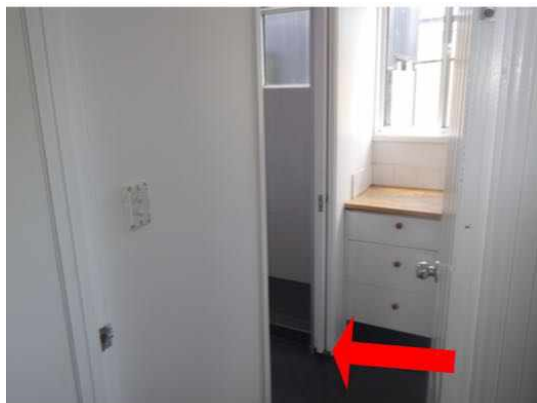
### Finding 3.15

Building:	Main Building
Location:	Bathroom > Front
Finding:	Door Guide
Information:	It was noted that the door guides to the bathroom area sliding door were missing at the time of inspection.

This is noted as a minor defect that you need to be aware of.

A licensed carpenter or general handyman could be engaged to adjust or replace the door guides at the clients discretion.

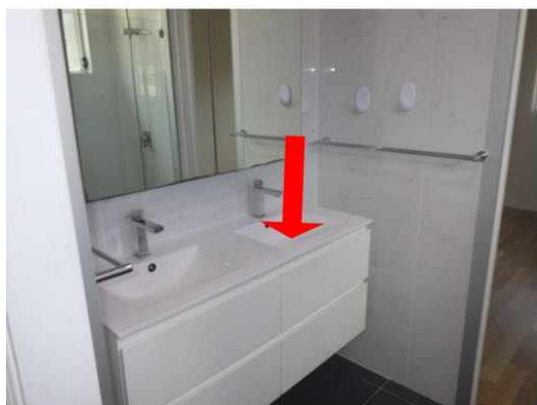
### Finding 3.16

Building: Main Building  
 Location: Bathroom > Centre Left  
 Finding: Basin - Pop up waste stiff.  
 Information: The right side basin pop up waste was broken or stiff to operate at the time of inspection. It is advised that maintenance is carried out on the waste so as it functions as intended.

A handyman could be appointed to perform any remedial works where required.

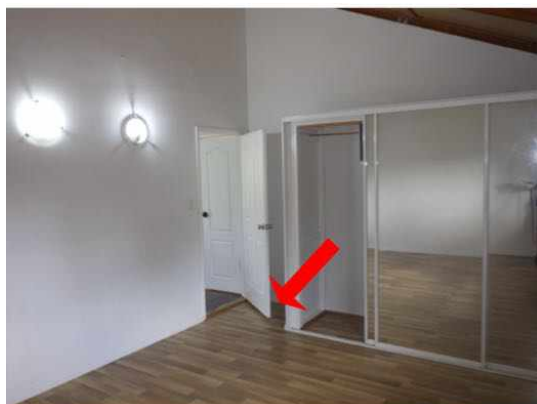
### Finding 3.17

Building: Main Building  
 Location: Bedroom 1 > Front  
 Finding: Door stop - Missing  
 Information: The bedroom 1 door stop is missing or is inadequate to stop the door handle from damaging the wall.

Re-installation or replacement of the door stop is advised to prevent any subsequent damage to the wall linings or associated structures.

A general handyman may be appointed to perform these works at client discretion.

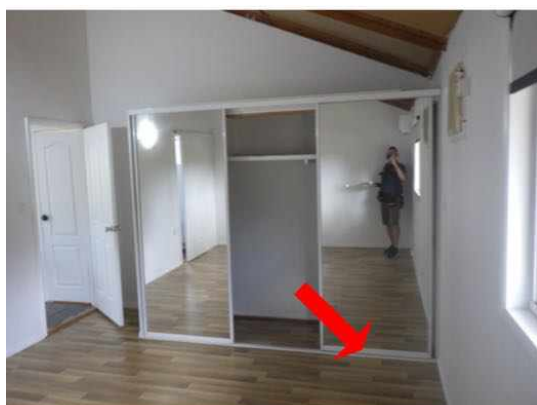
### Finding 3.18

Building:	Main Building
Location:	Bedroom 1 > Centre Left
Finding:	Robe Doors
Information:	The sliding robe doors in bedroom 1 were difficult to operate at the time of inspection. The door wheels or rollers may be deteriorated or misaligned with the door track system.

Repair of the robe doors is advised. A sliding robe door installer or general handyman may be appointed to perform these works at client discretion.

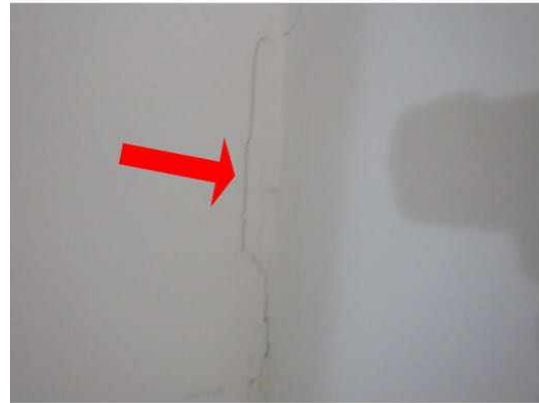
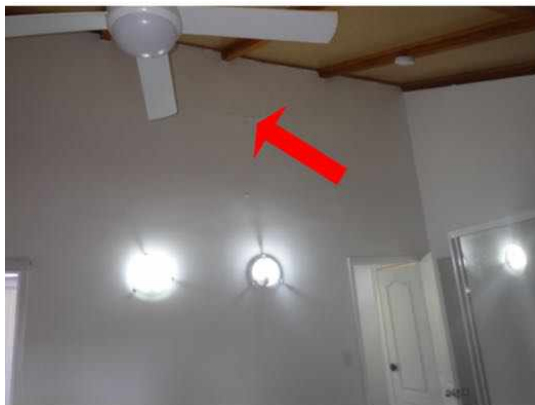
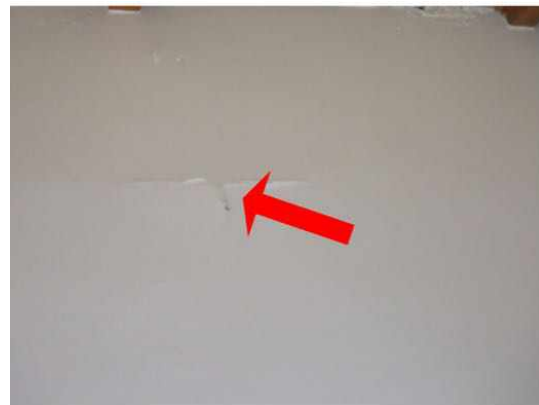
### Finding 3.19

Building:	Main Building
Location:	Bedroom 1 > Existing
Finding:	Damaged - Wall
Information:	There is damage to areas of the wall linings in bedroom 1 (as per example photos).

The damage appears minor in nature and generally is only ever an appearance defect. While such damage may be noticeable in some cases, it is quite common and does not indicate any structural damage.

Damage of this nature can generally be repaired with minor filling, sanding and/or repainting. Such works should be performed by a qualified painter or a general handyman.

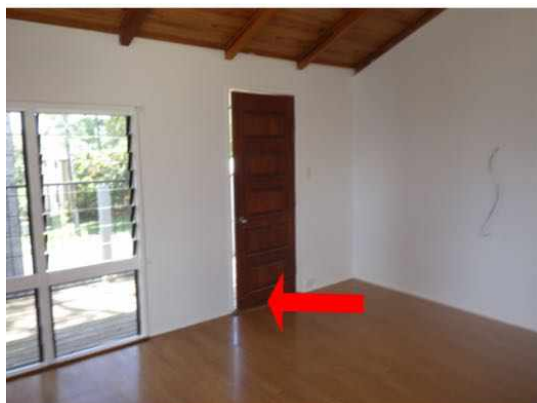
### Finding 3.21

Building:	Main Building
Location:	Living Room > Rear Right
Finding:	Door - Binding/Jamming
Information:	Binding and/or jamming of the living room door on the door sill was evident during standard operation. This defect inhibits the functionality of affected door as well as creating potential for secondary defects to associated building elements, such as damage to the door framing.

A door that binds to the associated door frame or sill may have several causes, such as poor installation of the door or deteriorated hinges.

A qualified carpenter or general handyperson could be appointed to perform minor rectification works at client discretion.

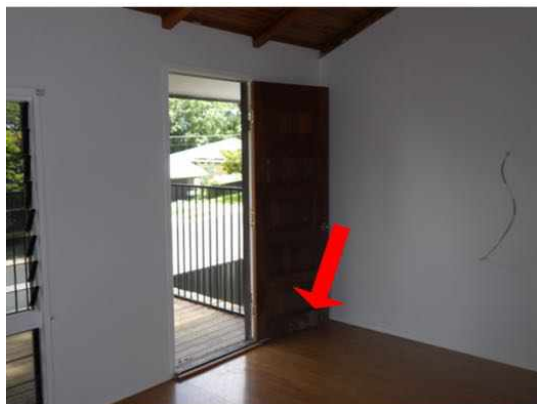
### Finding 3.22

Building:	Main Building
Location:	Living Room > Rear Right
Finding:	Timber paint deterioration.
Information:	The paint or protective coating to the living room timber exterior door has deteriorated. The deterioration appears consistent with general wear and tear along

with continual exposure to weather conditions.

A qualified painter could be engaged to undertake maintenance work on the exposed timber door surface at the clients discretion.

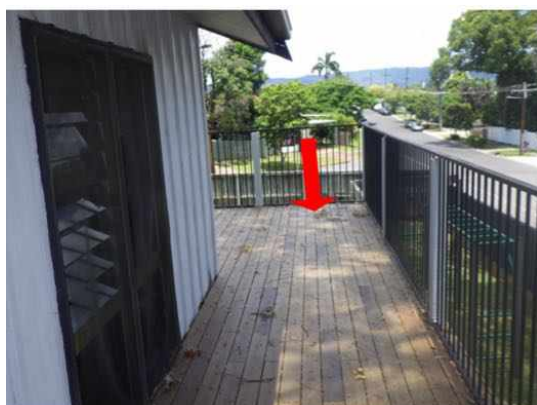
### Finding 3.23

Building: Main Building  
 Location: Deck > Existing  
 Finding: Decking - Deteriorated  
 Information:

It was noted at the time of inspection that a section of the timber decking showed signs of deterioration. Typically decking deteriorates due to age and or wear, which is generally expected for a structure of this age, due to prolonged exposure to weather conditions. Sometimes inadequate installation or maintenance can be to blame.

If left unattended, it is likely that further damage will occur. It is suspected that repair of several elements of the decking may be required.

A licensed builder or carpenter could be appointed to provide further advice and perform rectification works as necessary.

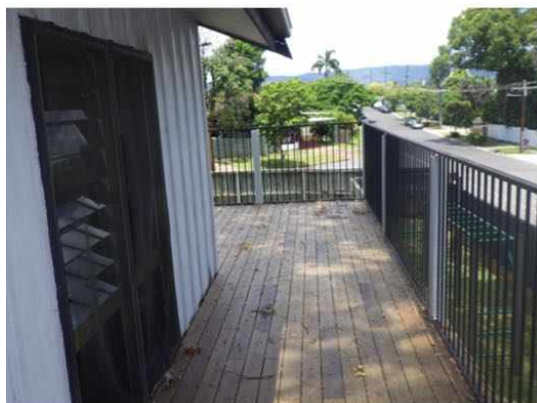
### Finding 3.24

External decking timbers that are frequently exposed to harsh weather conditions require adequate protection in order to maintain their condition. Where timbers have not been painted or treated adequately, general deterioration is likely to occur at an accelerated rate.

Adequate treatment of the balcony area decking timbers will be required by a painting contractor or general handyman.

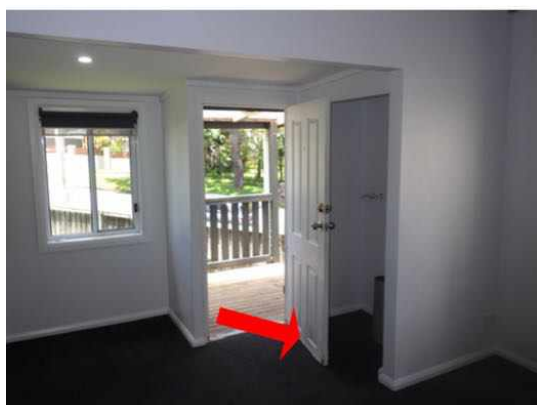
### Finding 3.26

NOTE - The door appears to be an internal grade door and not suitable for external use.

A qualified carpenter or general handyman could be appointed to replace the door at the clients discretion.

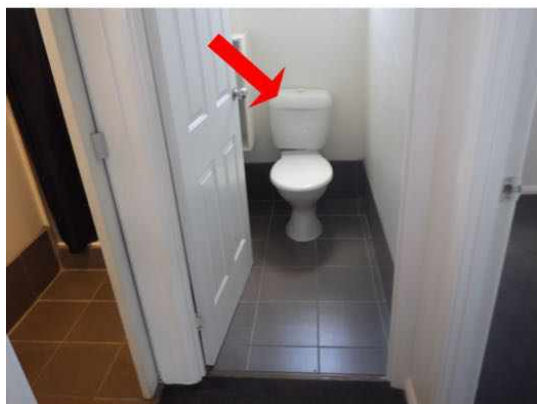
### Finding 3.29

Building: Main Building  
 Location: Toilet (WC) > Centre

Finding: Cistern not level  
 Information: At the time of inspection the WC toilet cistern had been installed off level.  
 A qualified plumber could be engaged to undertake repair work on the toilet cistern.

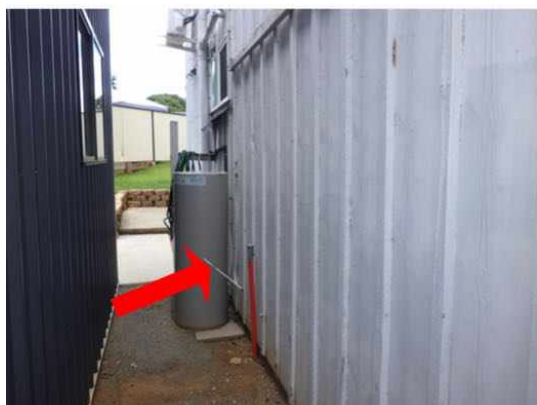
Building:	Main Building
Location:	Exterior walls - right side > Centre
Finding:	Overflow - Not plumbed for drainage
Information:	The hot water system overflow is not plumbed or connected to suitable drainage, which can result in the surrounding area becoming excessively damp. These damp conditions can lead to secondary defects such as rot, rust or corrosion of associated building elements, the formation of fungal decay, or even the creation of potential slip hazards. When coupled with poor site drainage, pooling of water may also attract termite activity to this area. It is highly recommended that a qualified plumber be appointed to install adequate drainage to the overflow. These works will ensure that the area remains dry and free of any secondary defects.
