Building and Timber Pest Inspection Report

Inspection Date: Tue, 27 Jan 2026

Property Address: 7/32 Shoalhaven Heads Rd, Shoalhaven Heads NSW 2535, Australia

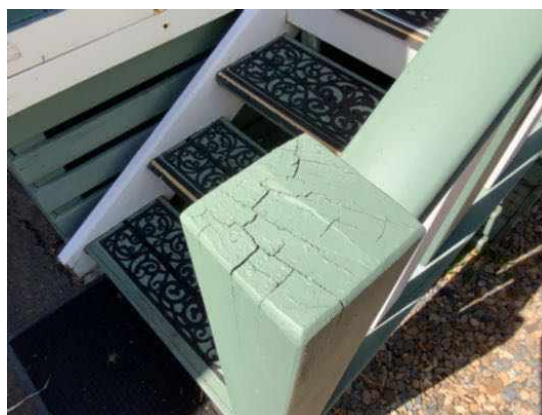
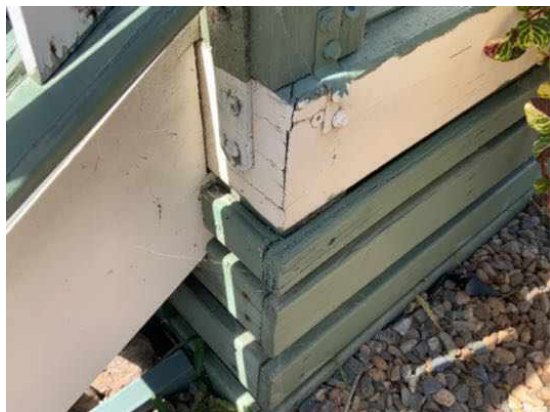
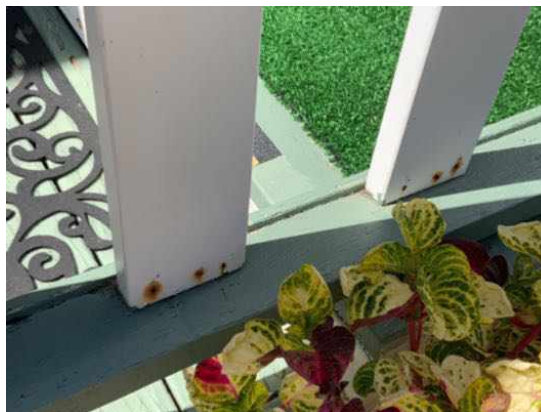
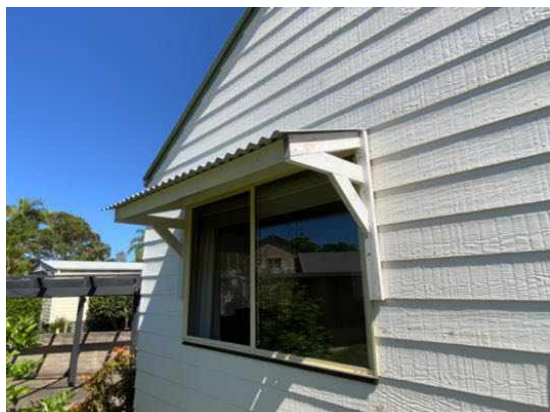
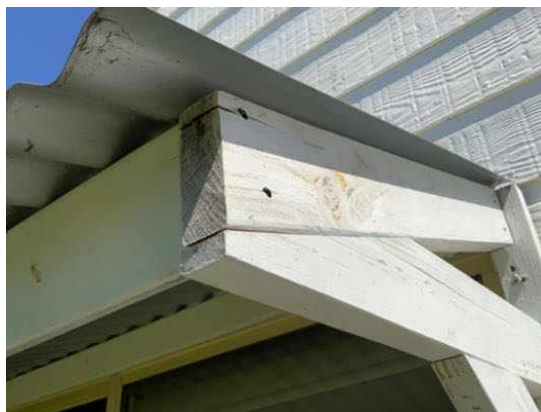
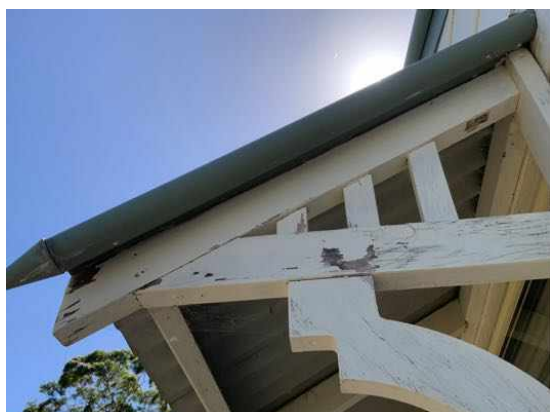
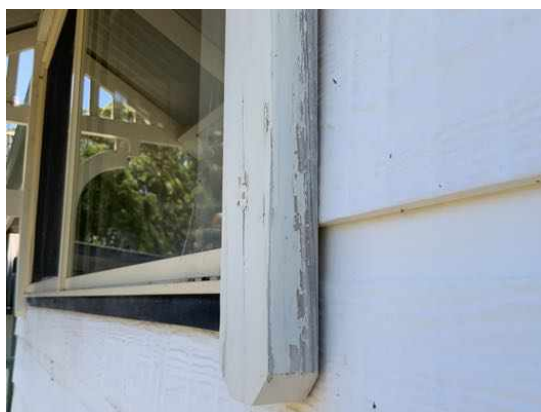
Building:	Main Building
Location:	All Areas
Finding:	External paint to timbers - deteriorated
Information:	Much of the external paintwork including but not limited to external timbers and trims have been neglected and require attention to prepare and re-paint.

Whilst incomplete or missing paint finish is generally an appearance defect, it can also lead to the development of secondary building defects over time. Incomplete areas of paint finish expose the area to moisture, potentially accelerating the deterioration of underlying building materials.

Degraded paint finishes should be sanded back, filled, leveled and painted, as applicable. Where inadequate or missing paint protection has led to the deterioration of the associated building element, repair and/or replacement of this building element may be required.

A painting contractor should be appointed as soon as possible to perform necessary works to aid the appearance of the affected area and to ensure the area is protected against further deterioration. Alternatively, the homeowner following manufacturer instructions may perform these works.

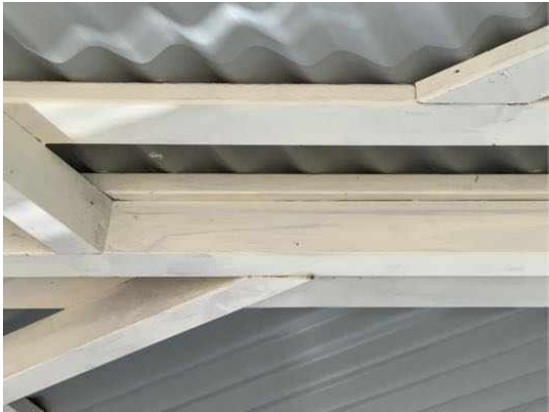
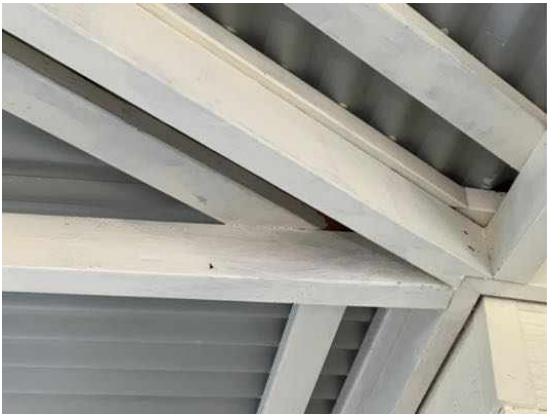
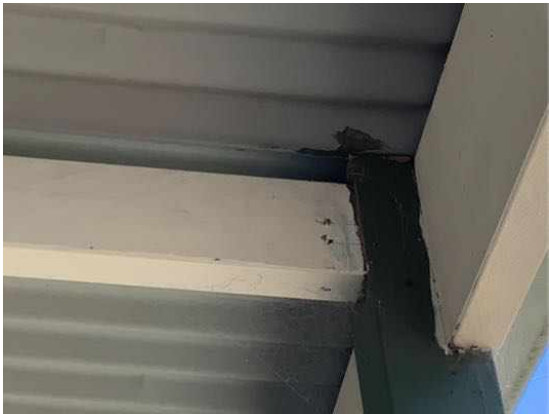
Finding 3.03

Building:	Main Building
Location:	All Areas
Finding:	Paint finish - Incomplete (a 2nd coat of paint is required)
Information:	The paint finish in this area was identified as being incomplete at the time of inspection.

Whilst incomplete or missing paint finish is generally an appearance defect, it can also lead to the development of secondary building defects over time. Incomplete areas of paint finish expose the area to moisture, potentially accelerating the deterioration of underlying building materials.

Incomplete paint finishes should be sanded back, filled, leveled and painted, as applicable. Where inadequate or missing paint protection has led to the deterioration of the associated building element, repair and/or replacement of this building element may be required.

A painting contractor should be appointed as soon as possible to perform necessary works to aid the appearance of the affected area and to ensure the area is protected against further deterioration. Alternatively, the homeowner following manufacturer instructions may perform these works.

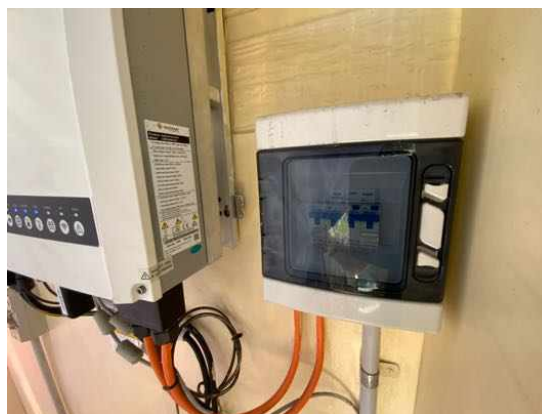
Building:	Main Building
Location:	All Areas
Finding:	Termite Management System - no evidence of a chemical installation
Information:	The application of a post-construction chemical termite barrier is highly recommended for all properties, particularly if live termite activity has been found on the site previously. Such barriers are highly effective in preventing termite attack on any timber building elements throughout the property.

A durable notice should be placed in the switchboard unit to indicate current termite barriers. At the time of inspection, it appeared as though no termite management system has been installed, with no evidence to suggest preventative works taking place.

The client may consider gaining further advice from a pest controller as to the costs and procedures involved with this application. It is recommended that obtaining such advice be a short-term priority.

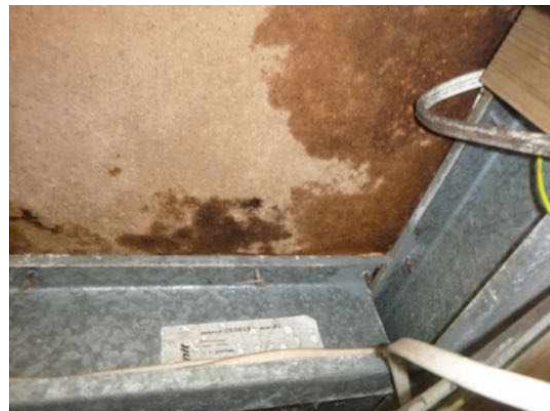
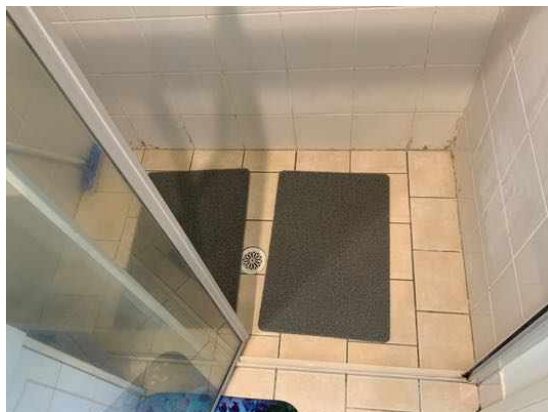
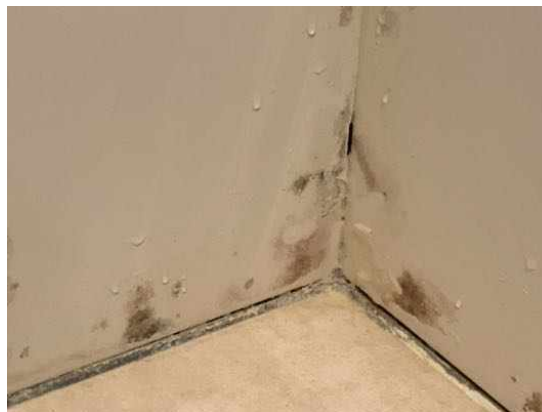
Excessive moisture is generally caused by deteriorated inadequate or missing roof drainage, leaking plumbing pipes or fixtures, poorly plumbed HWS overflows or condenser units and poor site drainage.

It is highly recommended that all plumbing and drainage fixtures and fittings be maintained regularly in order to prevent excessive moisture being present in the external / internal property.

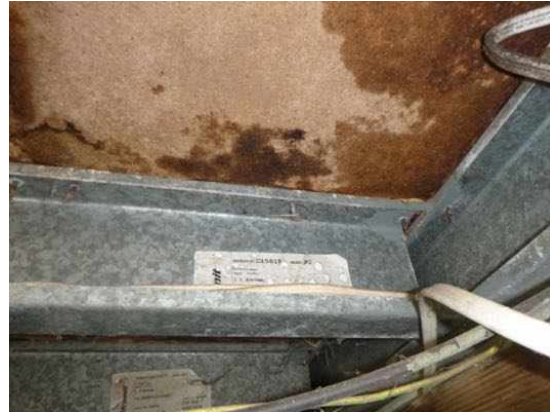
In this case although the affected timber element is in a decaying state the extent of

any visible damage appears to be localised to a specific area and is yet to spread to other parts of the building element or affect adjoining structures. The fungal decay is therefore likely to be of a relatively superficial nature with minimal impact on the structural integrity or tensile strength of the timber element.

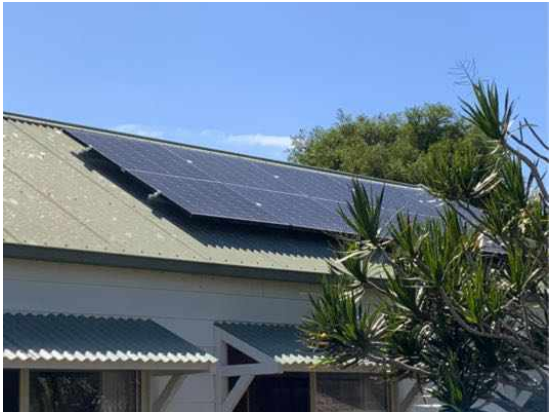
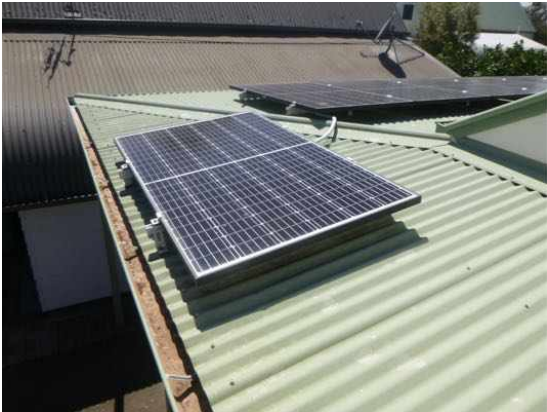
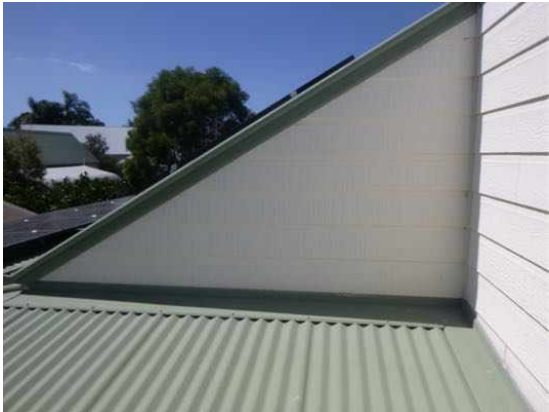
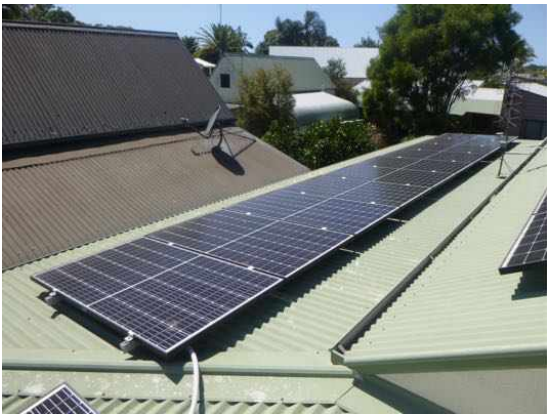
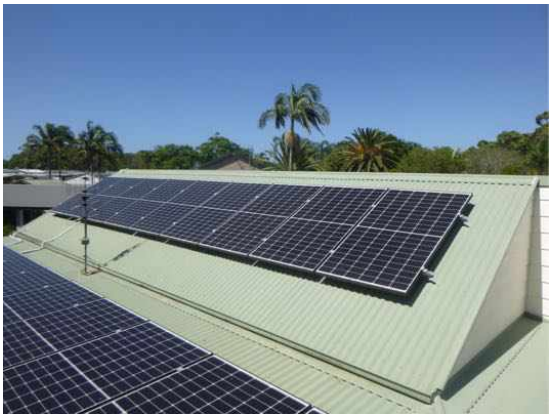
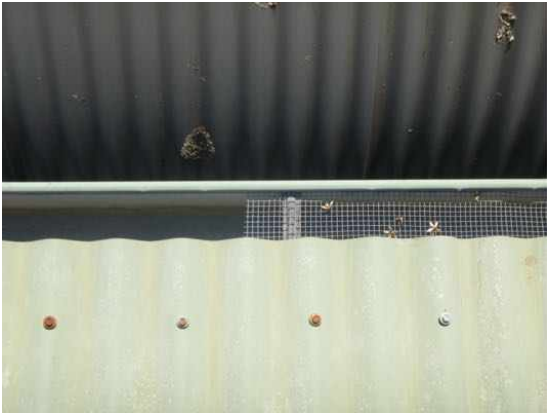
Building: Main Building
Location: Roof Exterior
Finding: Additional Photos - Obstructions and Limitations
Information: These photographs are an indication of the obstructions and limitations which impeded full inspection of the property at the time of inspection. These obstructions can hide an array of defects and should be removed to allow full inspection to be carried out. A re-inspection is recommended once the areas are made accessible.

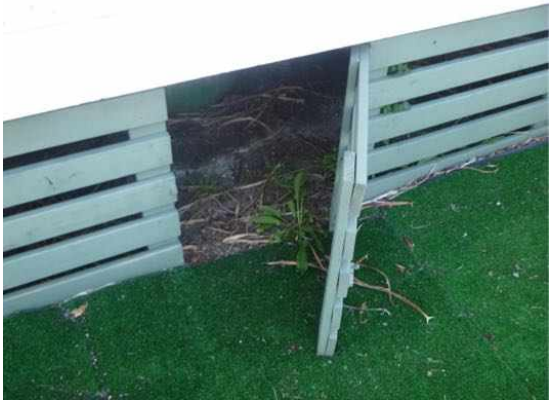
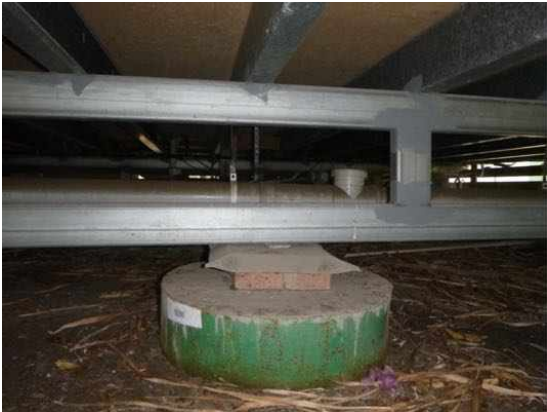
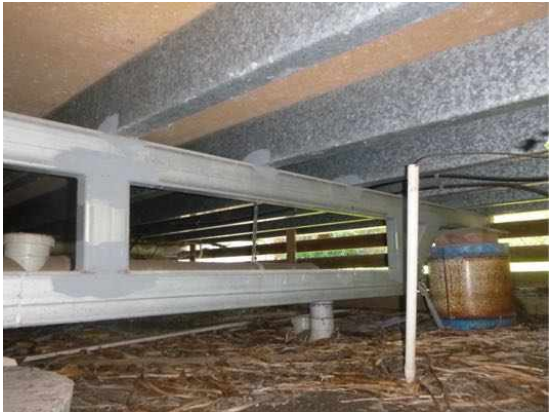
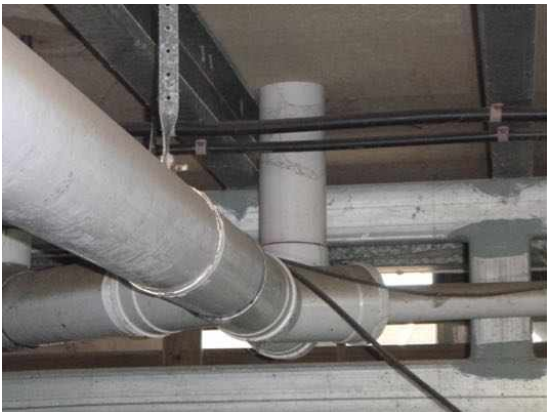
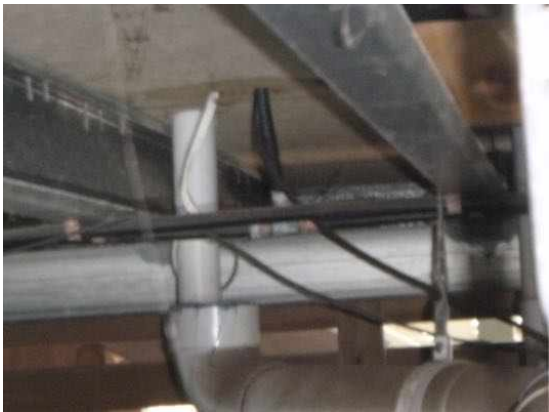
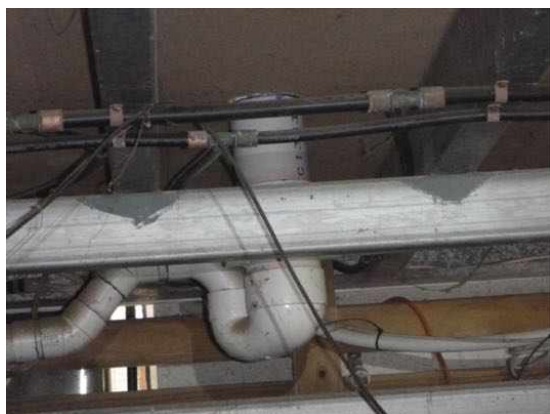
Building: Main Building
Location: Subfloor
Finding: Additional Photos - Obstructions and Limitations
Information: These photographs are an indication of the obstructions and limitations which impeded full inspection of the property at the time of inspection. These obstructions can hide an array of defects and should be removed to allow full inspection to be carried out. A re-inspection is recommended once the areas are made accessible.

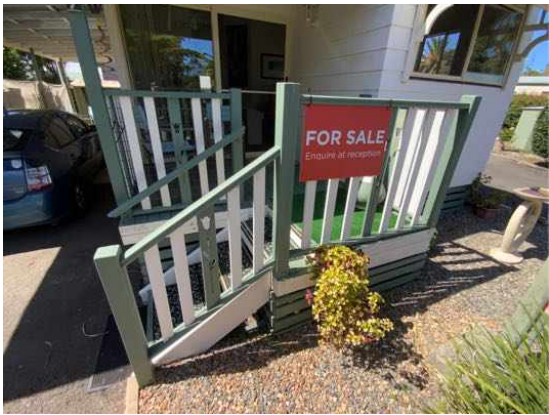
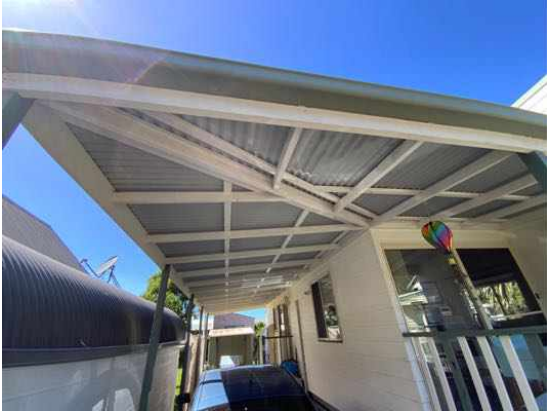
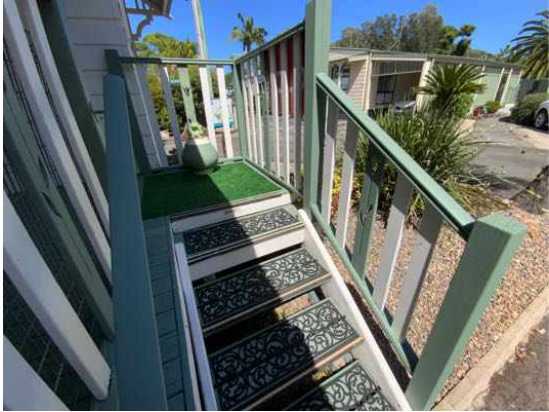
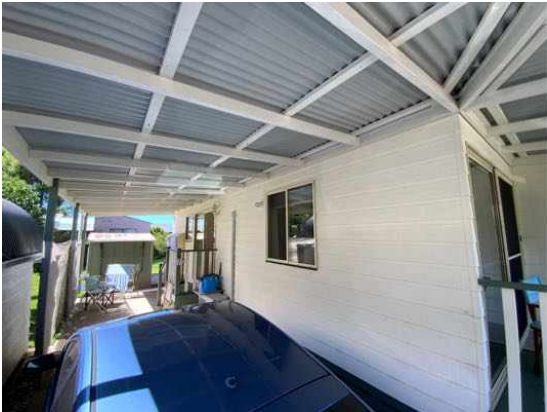
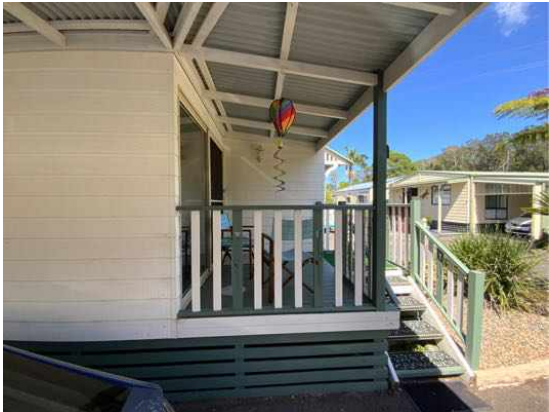
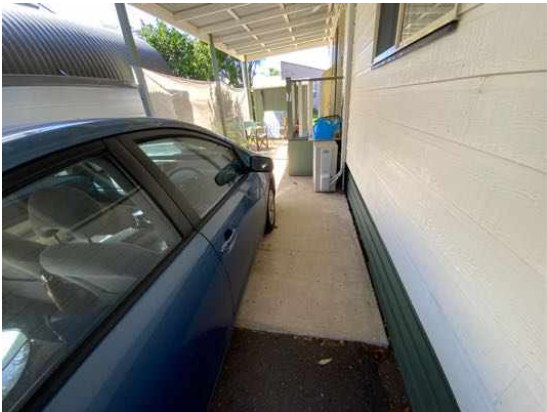
Building:	Main Building
Location:	All Areas
Finding:	Additional Photos - Obstructions and Limitations
Information:	These photographs are an indication of the obstructions and limitations which impeded full inspection of the property at the time of inspection. These obstructions can hide an array of defects and should be removed to allow full inspection to be carried out. A re-inspection is recommended once the areas are made accessible.

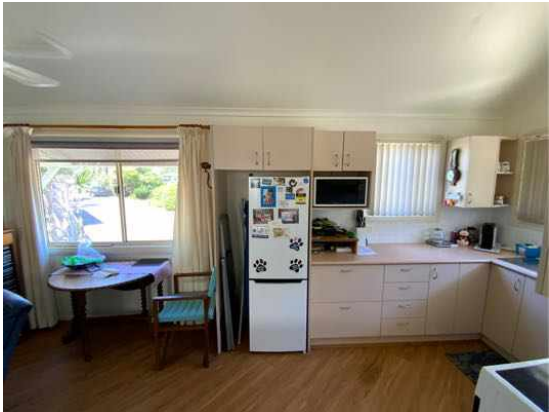
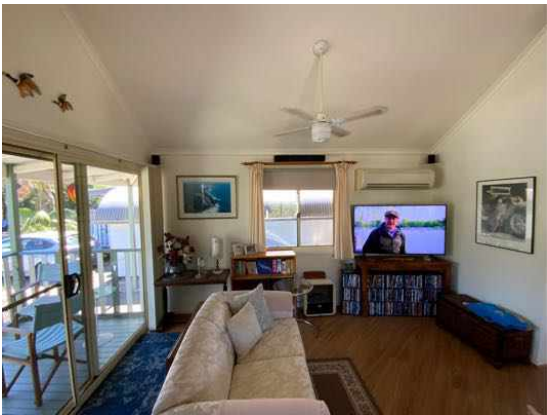
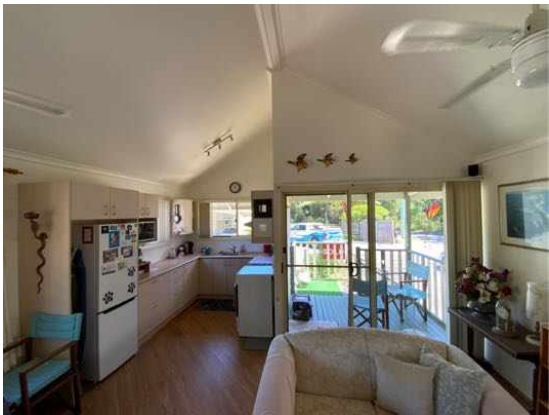
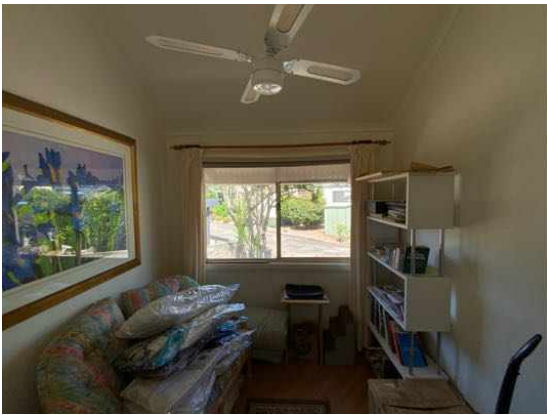
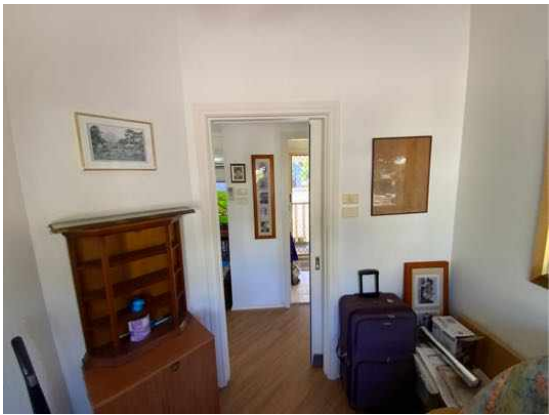
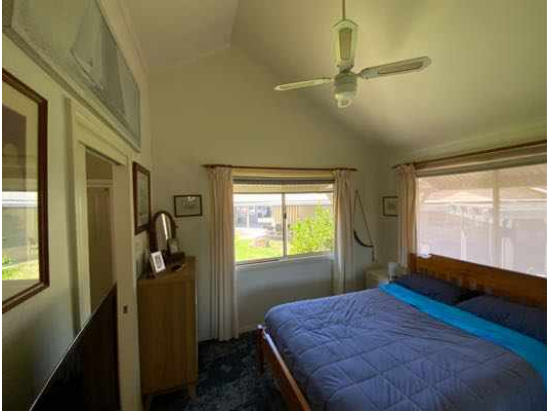
Building: Main Building
Location: All Areas
Finding: Additional Photos - Obstructions and Limitations
Information: These photographs are an indication of the obstructions and limitations which impeded full inspection of the property at the time of inspection. These obstructions can hide an array of defects and should be removed to allow full inspection to be carried out. A re-inspection is recommended once the areas are made accessible.
