# Building and Timber Pest Inspection Report

Inspection Date: Wed, 4 Feb 2026

Property Address: 30 Cornelius Place, Regentville NSW 2745

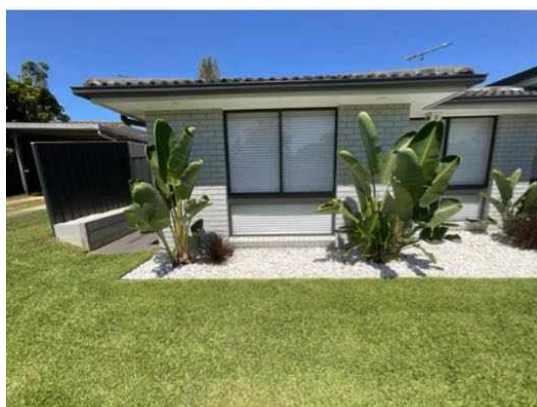
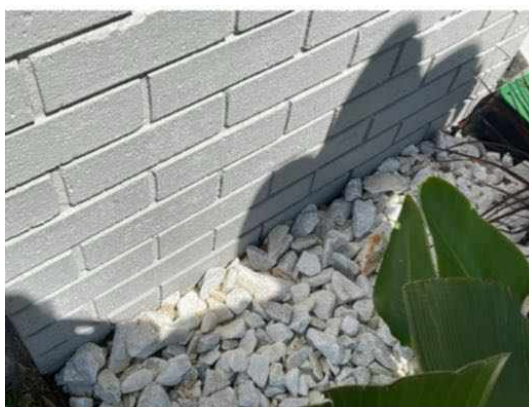
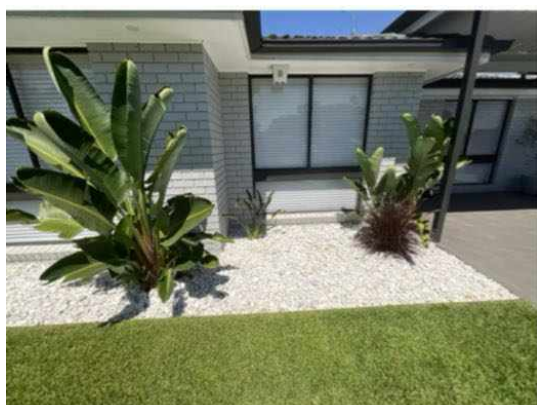
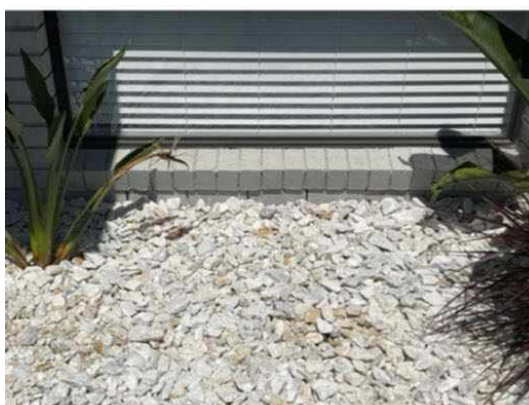
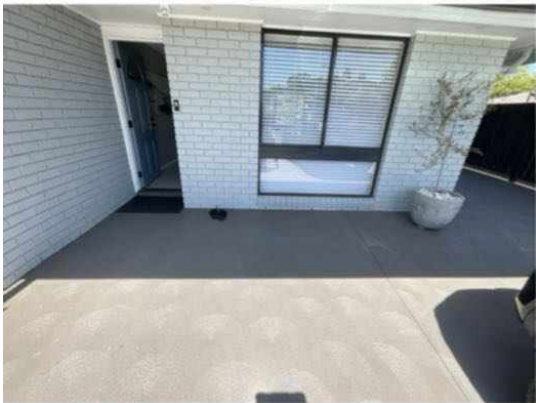
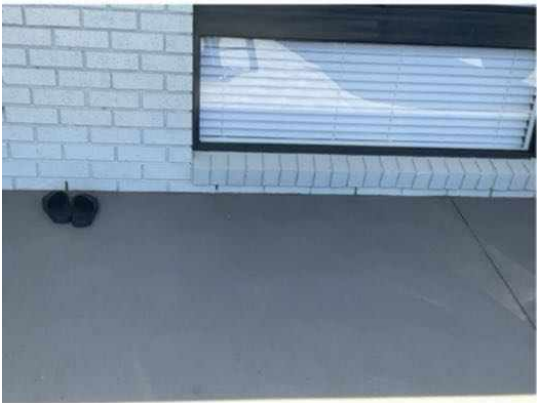
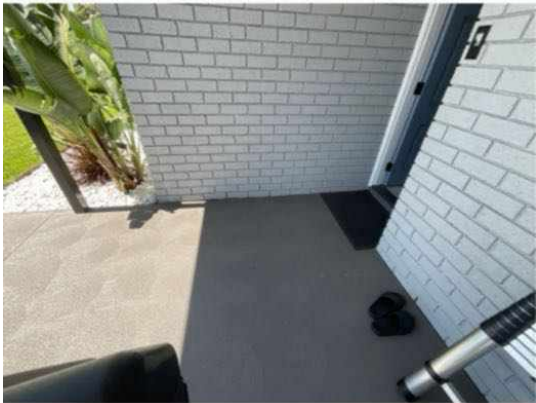
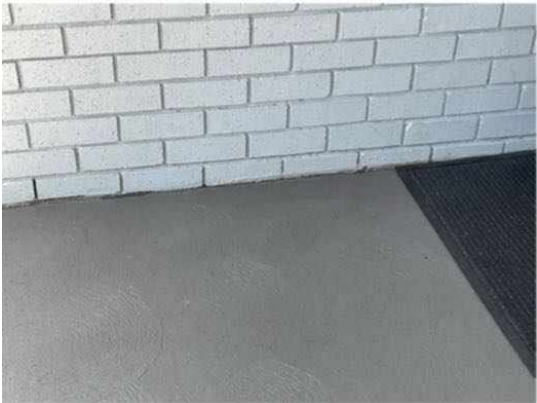
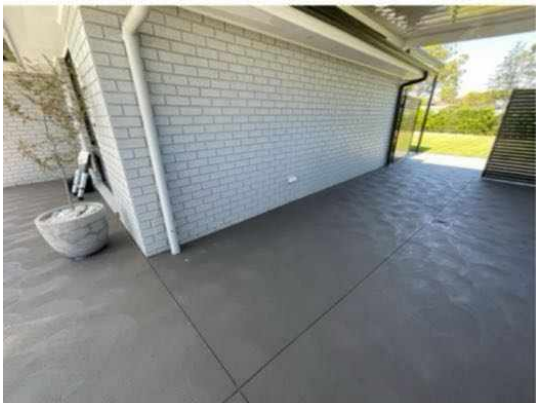
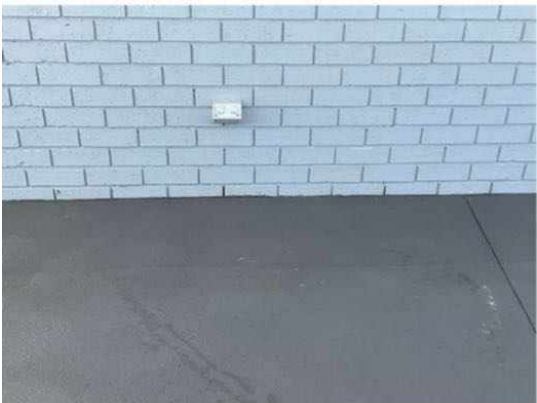
The damp-proof course (DPC) was observed to be partially below adjacent ground or paving levels in some areas of the property.

DPCs are installed as an impervious barrier within masonry walls or piers to prevent rising moisture from migrating into the building. When ground levels or paving are built up above the DPC, moisture can enter the brickwork and rise through the structure.

- Rising damp, leading to brick fretting, mortar deterioration, and staining
- Moisture build-up within the wall cavity, potentially causing mould growth
- Deterioration of internal timber building elements such as frames, wall plates, and flooring
- Increased risk of termite attraction, as termites are drawn to damp, concealed environments
- Reduced lifespan of structural materials and possible hidden internal damage

- Lower external ground levels or landscaping to restore required clearance between finished surfaces and the DPC
- Regular monitoring advised at a minimum.

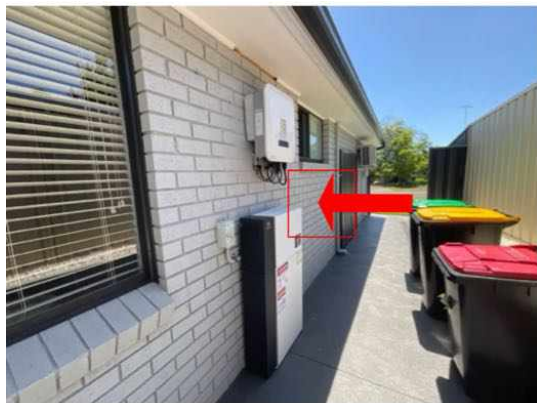
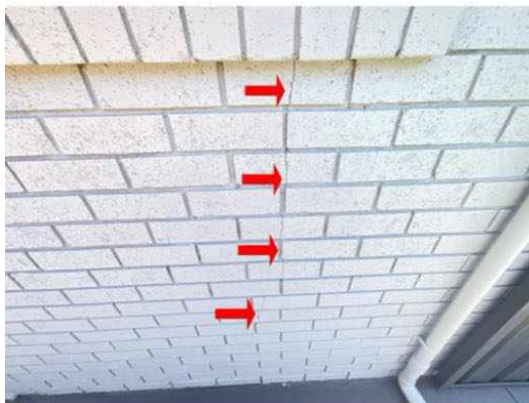
Finding 3.02

Building: Main Building  
Location: Exterior walls - left side  
Finding: Brickwork - Cracking.  
Information: Observation:

Cracking was noted in the external brickwork and appeared to be minor to moderate at the time of inspection.

Vertical cracking may indicate thermal movement, while other patterns could suggest more localised stress within the wall.

- Cracks of this nature may progress or widen if underlying movement continues
- Recent landscaping (paving) suggests moisture issues may have been resolved.
- Moisture ingress may also occur through open cracks, leading to deterioration of internal elements if not addressed

- Although cracking appears moderate and non-structural at this stage, it is recommended that the area be monitored.
- For a more detailed assessment, consultation with a qualified Structural Engineer is advised to determine if movement is ongoing and whether any remedial action is necessary

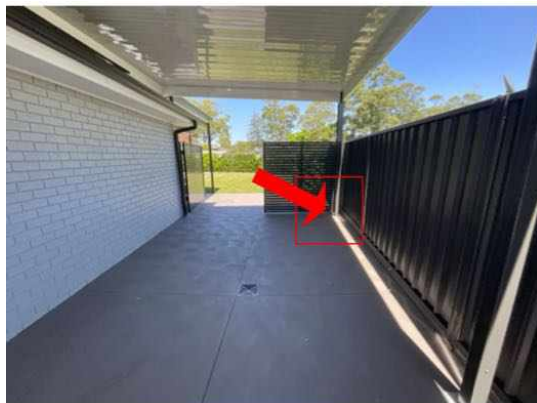
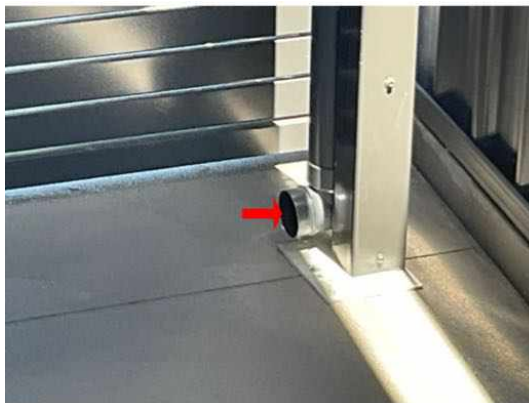
### Finding 3.03

Building:	Carport
Location:	Roof Exterior
Finding:	Downpipe - Unconnected. (Minor)
Information:	Observation:

A section of roof plumbing was found where the downpipe is not connected to the stormwater drainage system.

Excessive moisture from uncontrolled roof runoff can create conditions that promote termite activity and timber decay.

It is advised that a licensed plumber be engaged to:

- Inspect the affected roof plumbing area, and
- Connect the downpipe to a compliant stormwater drainage system, or alternatively, install appropriate drainage measures to manage water flow and mitigate potential property damage or pest risks.

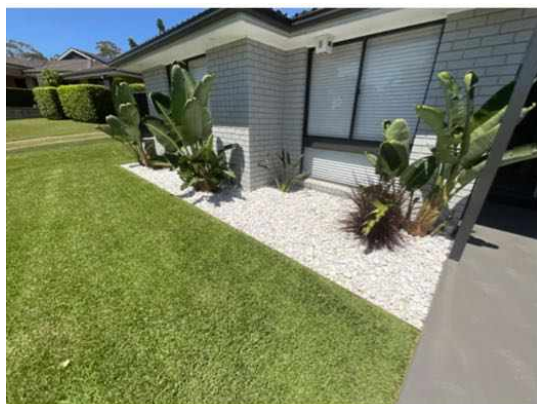
Garden beds were observed directly against the perimeter of the building. This condition can result in water pooling or retention during rainfall or from regular watering/hosing, which may lead to moisture ingress beneath the structure.

- Persistent moisture buildup around the base of the building creates an environment that is conducive to termite activity and timber decay.
- Plants and vegetation close to or in contact with external walls can provide shade and cover, further increasing the likelihood of termite infestation.
- Garden beds may also conceal weep holes, slab edges, or termite barriers, reducing visibility during inspections and allowing for undetected termite entry.

It is strongly recommended that garden beds be removed or relocated away from the

building perimeter. Maintaining a clear inspection zone around the structure helps reduce moisture retention and improves visibility during regular pest inspections. This preventative measure significantly lowers the risk of termite ingress and related structural damage.

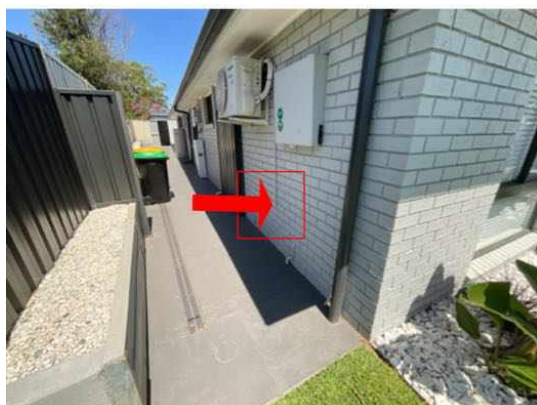
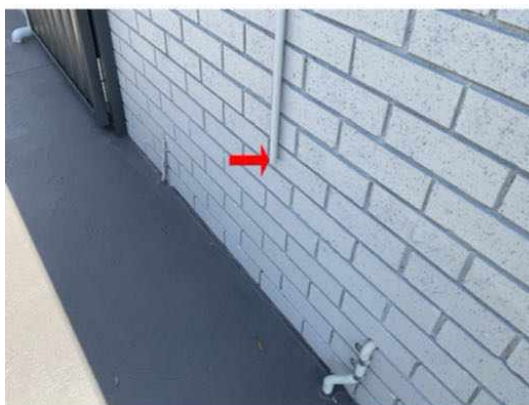
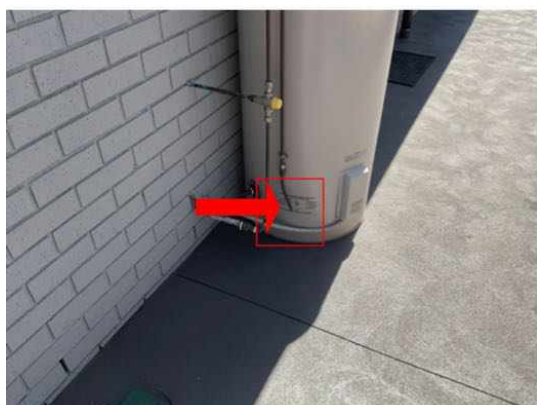
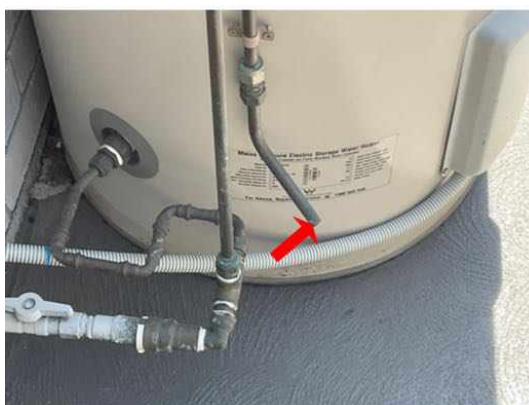
### Finding 6.02

Building:	Main Building
Location:	All External Areas
Finding:	Overflow Management – Risk of Termite Activity..
Information:	Observation: Water Pooling from HWS and Air Conditioning Overflows

Water discharge from the Hot Water System (HWS) pressure relief valve and air conditioning unit overflows was observed discharging close to the base of the structure, contributing to water pooling around the building perimeter.

Persistent moisture near the foundation or subfloor area significantly increases the likelihood of termite activity. Termites are highly attracted to damp environments, and stagnant water near structural elements provides ideal conditions for foraging and infestation.

- **Moisture Conducive to Infestation:** Termites require moisture for survival, and pooled water can soften timber materials, making them more accessible.
- **Structural Risk:** Prolonged dampness may also contribute to timber decay, further increasing vulnerability.

It is highly recommended that all overflows from the HWS and air conditioning units be

redirected away from the building, preferably via fixed drainage or extension piping, to prevent water accumulation near the structure.

These minor corrective works should be undertaken promptly to minimise the risk of both termite ingress and potential structural damage due to ongoing moisture exposure.

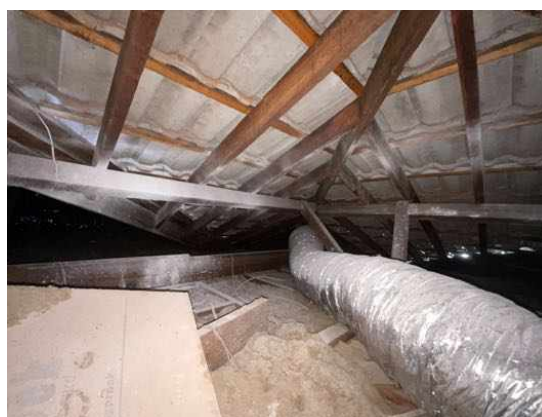
Building: Main Building  
 Location: Roof Void  
 Finding: Roof Void – Limited Accessibility..

Installation of an additional manhole is recommended to facilitate a re-inspection and enable a more thorough assessment of the roof void in the future. This will help ensure that all structural elements and concealed areas are properly evaluated.

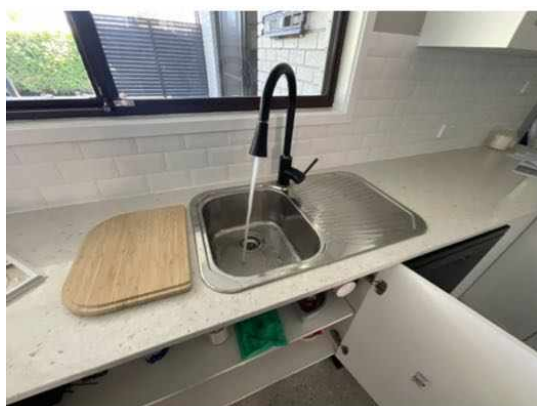
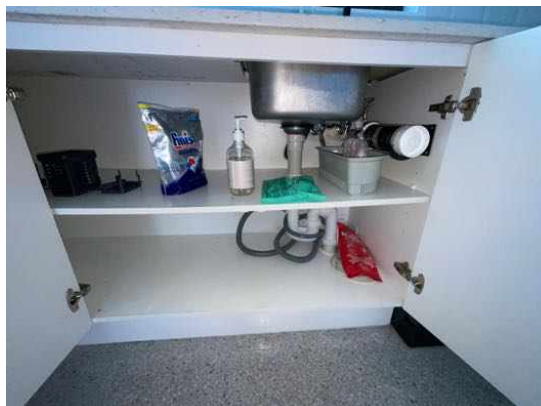
Building: Main Building  
 Location: Kitchen  
 Finding: Kitchen Sink – Overall Condition & Recommendations.  
 Information: Observations:

- Further monitoring and testing are recommended once the tap(s) are in constant use, to identify any drainage issues or signs of slow leaks not evident during the limited inspection.
- For long-term property care, it is advised that sealant and grouting in water-exposed areas be regularly inspected and maintained.

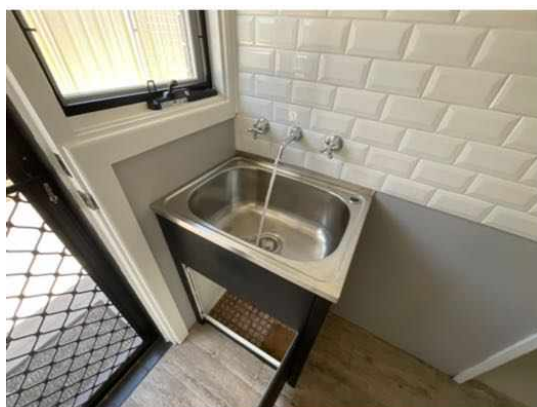
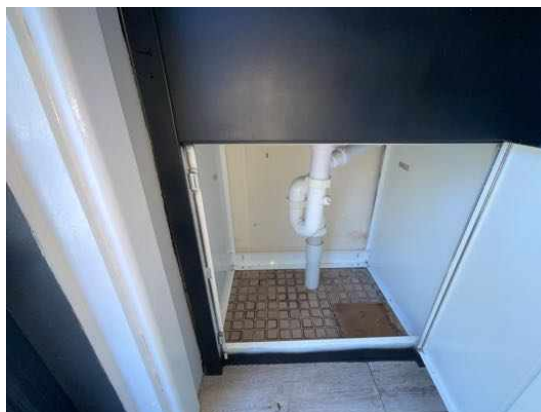
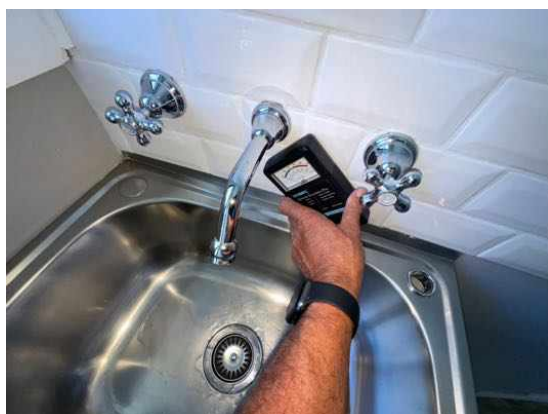
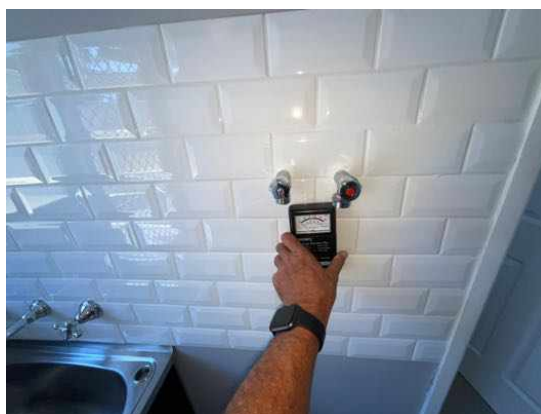
Building: Main Building  
 Location: Laundry  
 Finding: Laundry - Taps/Plumbing/Drainage.  
 Information: Observation: Laundry Tub – Taps, Plumbing, and Cabinetry

- Further monitoring or testing is recommended once the taps are placed into regular use, to ensure no leaks develop over time and that the drainage system continues to perform adequately.
- Sealant and grouting in wet areas should be maintained as part of the long-term care and upkeep of the property.
