Building and Timber Pest Inspection Report

Inspection Date: Tue, 17 Feb 2026

Property Address: 42 Tallwood Avenue, Glenmore Park NSW
2745

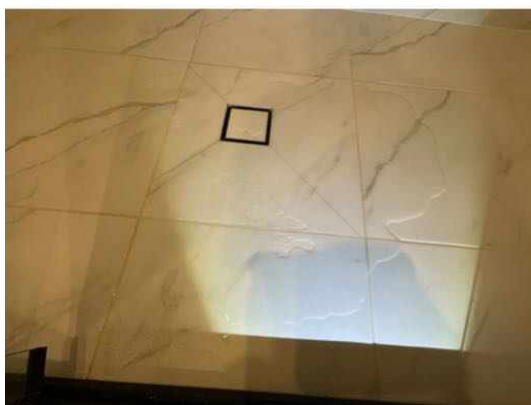
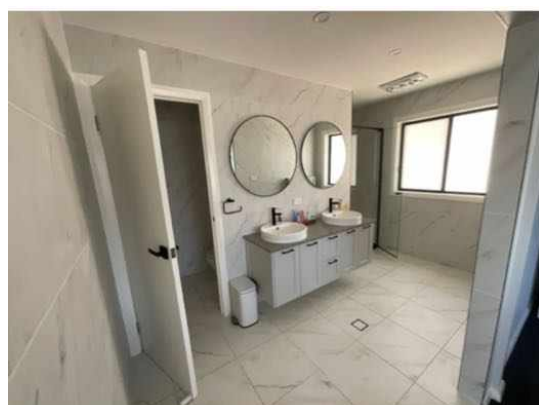
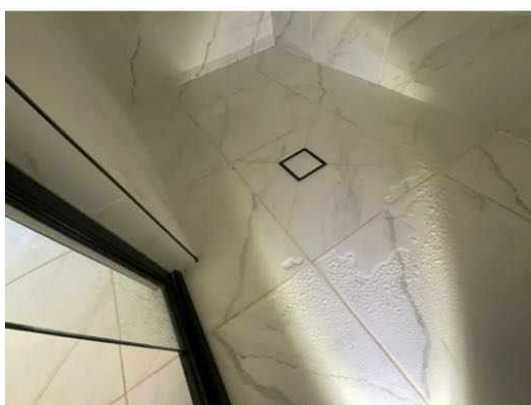
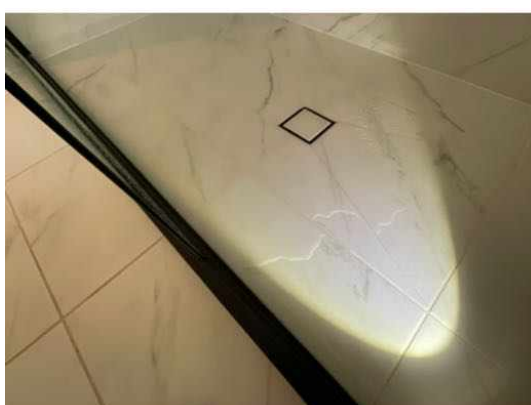
Building:	Main Building
Location:	Ensuite, Bathroom & Powder Room
Finding:	Minor Defect – Inadequate Fall to Shower Floor Waste.
Information:	Observation:

Minor water pooling was observed around the shower floor waste at the time of inspection. This condition appears to be due to insufficient fall in the shower floor tiling, resulting in incomplete drainage following use. The shower recess appeared dry prior to testing.

Although the extent of pooling is currently minor, the condition is considered unsatisfactory in accordance with accepted tiling and wet area installation standards. Prolonged water retention may contribute to:

- Localised slip hazards
- Mould and mildew development
- Premature deterioration of grout joints and flexible sealants
- Increased risk of moisture migration over time

Under the National Construction Code (NCC 2019 – SA 3.1 Performance Requirements for Wet Areas), bathroom floors must be installed to prevent the accumulation of water that may create unhealthy or hazardous conditions.

Rectification may involve regrading and retiling sections of the shower base to achieve adequate fall toward the floor waste. While not considered urgent at the time of inspection, corrective works are recommended to improve drainage performance and

reduce the risk of longer-term moisture-related deterioration.

Alternatively, the area may be monitored over time to determine whether the water fully dissipates after normal use. Should monitoring confirm that the area dries adequately and no ongoing issues develop, rectification may not be required. Any decision to proceed with remedial works remains at the Client's discretion.

If rectification is elected, a licensed tiler or bathroom renovation specialist should be engaged to assess and carry out the necessary works.

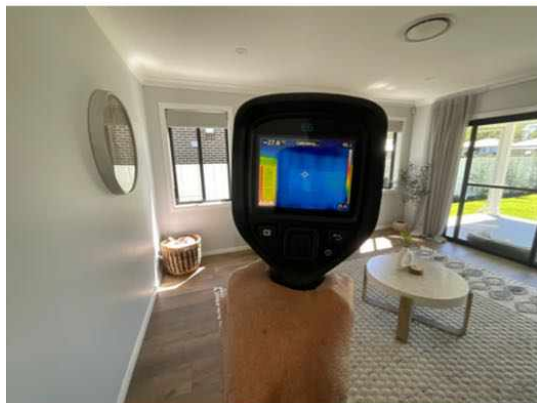
Termites release heat in the form of carbon dioxide and build mud tubes with high moisture content, which can create irregular heat patterns on surfaces such as walls, ceilings, and floors.

At the time of the inspection, no abnormalities indicating live termite activity were observed. However, it's important to note that various factors—such as obstructions, ambient temperature, and wall material/thickness—can impact the accuracy of thermal readings. In cases where surfaces are visually restricted or obstructed, a comprehensive thermal scan may not always be feasible.

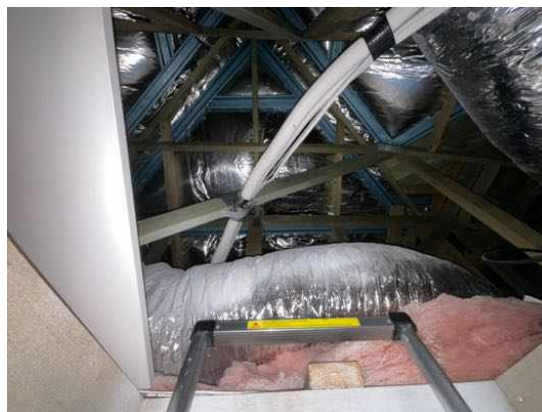
A full inspection of the roof space is not achievable unless all obstructions—including insulation and restricted access points—are removed, and full, safe access is provided. Termite activity or timber pest damage may go undetected in concealed or inaccessible areas.

Installation of an additional manhole is recommended to facilitate a re-inspection and enable a more thorough assessment of the roof void in the future. This will help ensure that all structural elements and concealed areas are properly evaluated.

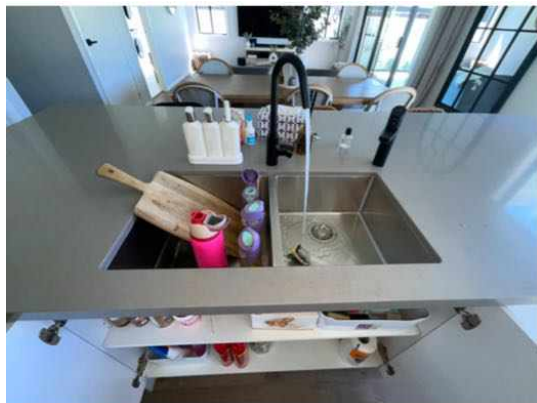
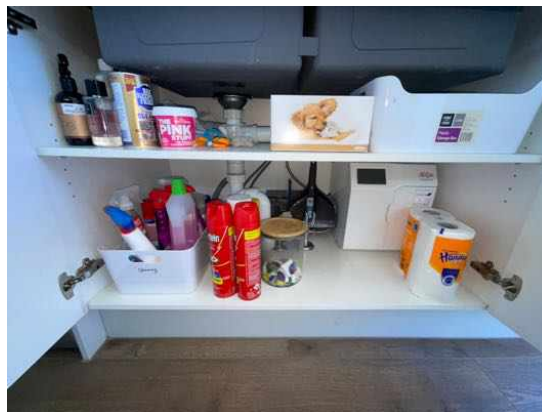
Building: Main Building
Location: Kitchen
Finding: Kitchen Sink – Overall Condition & Recommendations.
Information: Observations:

- The kitchen sink tap(s) were water tested at the time of inspection, with no evidence of leaks or blockages observed in the visible plumbing or drainage.
- No significant water damage was observed to the cabinetry/unit
- Stored items under the sink obstructed access, limiting a full inspection of the plumbing and internal cabinetry.

- Further monitoring and testing are recommended once the tap(s) are in constant use, to identify any drainage issues or signs of slow leaks not evident during the limited inspection.
- It is recommended that the stored items beneath the sink be removed to allow for a full re-inspection of the plumbing and cabinetry, ensuring no concealed defects are present.

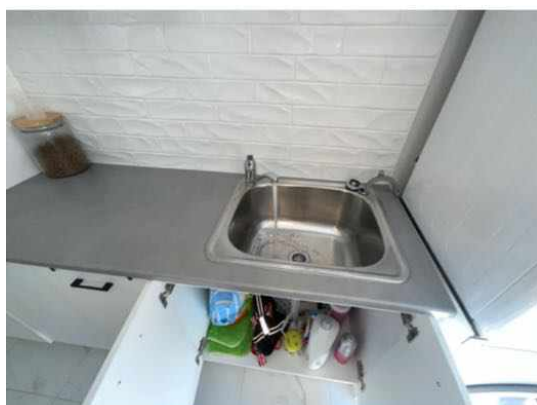
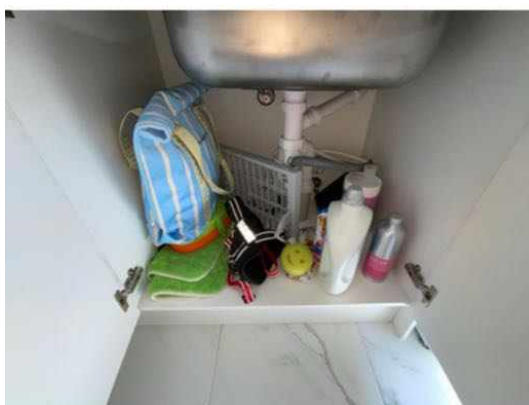
Building: Main Building
 Location: Laundry
 Finding: Laundry - Taps/Plumbing/Drainage.
 Information: Observation: Laundry Tub – Taps, Plumbing, and Cabinetry

- Further monitoring or testing is recommended once the taps are placed into regular use, to ensure no leaks develop over time and that the drainage system continues to perform adequately.
- Sealant and grouting in wet areas should be maintained as part of the long-term care and upkeep of the property.

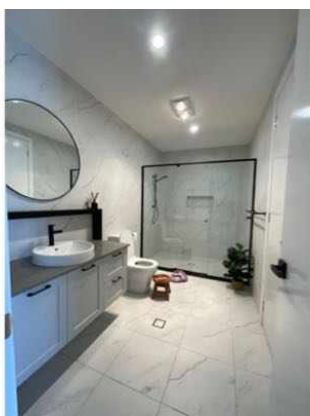
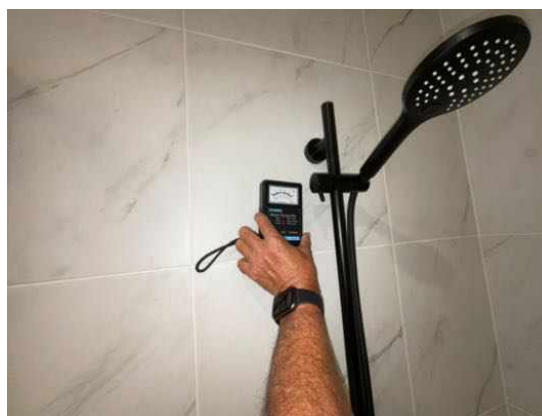
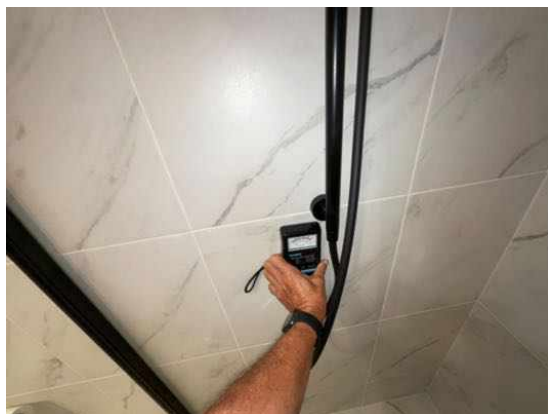
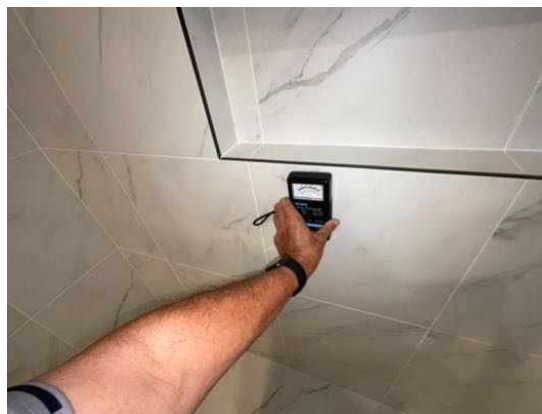
Building: Main Building
Location: Powder Room
Finding: Wet Areas - Bathroom(s) - Overall Condition & Recommendations.
Information: Overall Condition & Recommendations

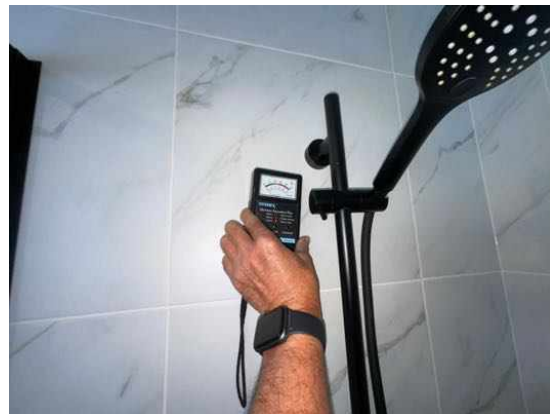
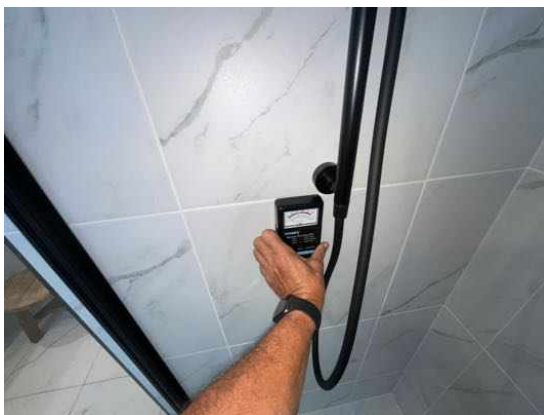
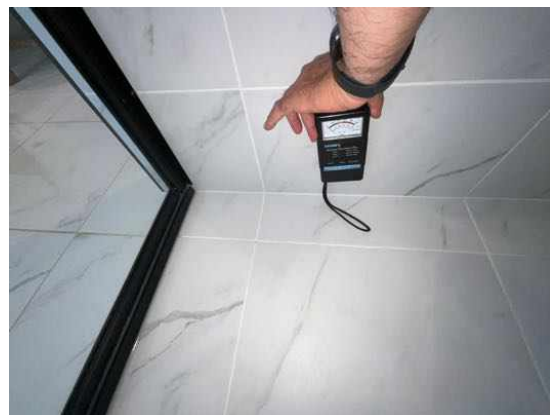
Building: Main Building
Location: Bathroom
Finding: Wet Areas - Bathroom(s) - Overall Condition & Recommendations.
Information: Overall Condition & Recommendations

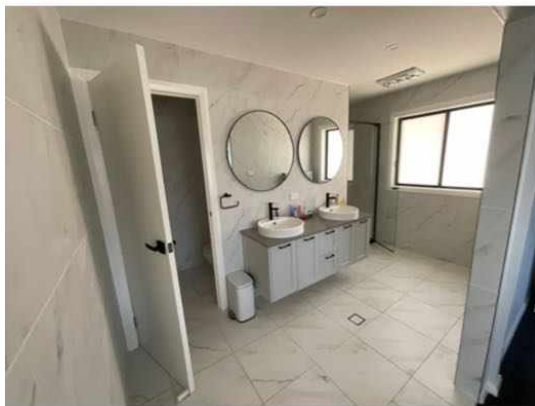
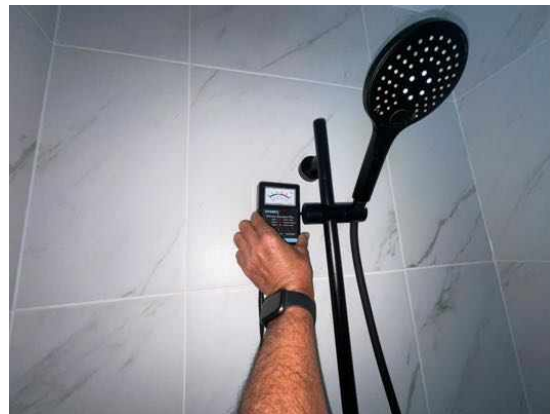
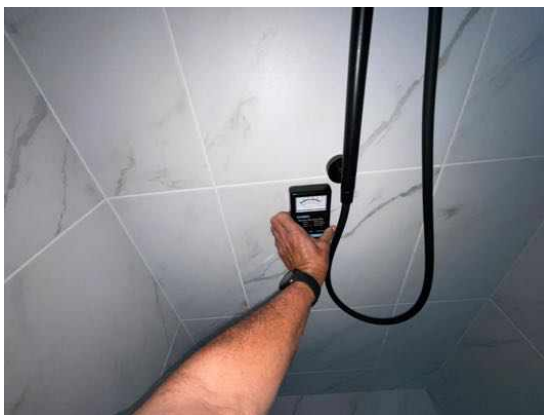
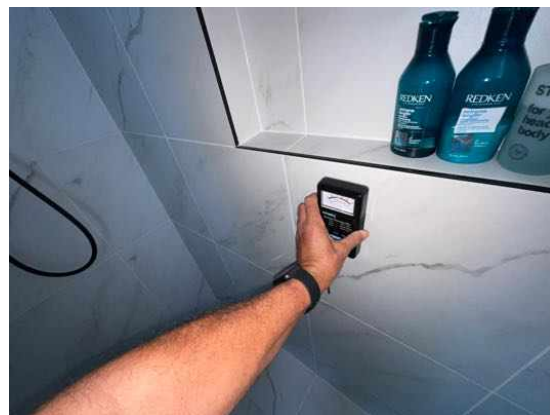
Building: Main Building
Location: Ensuite
Finding: Wet Areas - Bathroom(s) - Overall Condition & Recommendations.
Information: Overall Condition & Recommendations

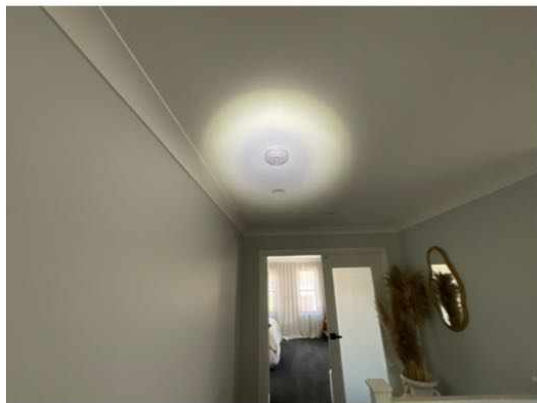
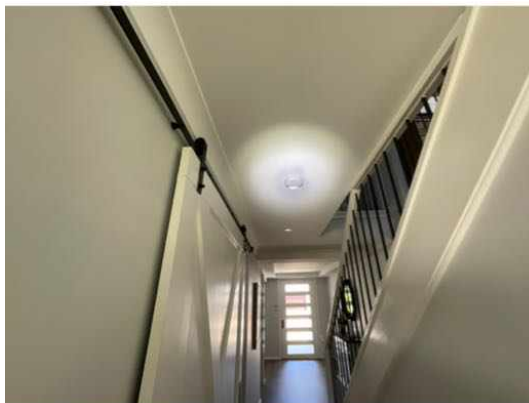
Building:	Main Building
Location:	All Areas
Finding:	Smoke Detectors / Alarms.
Information:	Reporting on the presence, type, location, or compliance of smoke detectors or alarms, including hard-wired smoke detection systems and their legislative requirements, is outside the scope of this inspection report.

- All smoke detectors be tested monthly by the homeowner.
- All systems comply with the requirements of AS 3786 and any applicable state-based legislation.
