Building and Timber Pest Inspection Report

Inspection Date: Mon, 23 Mar 2026

Property Address: 1/89 Green St, Ivanhoe, VIC, 3079, Australia

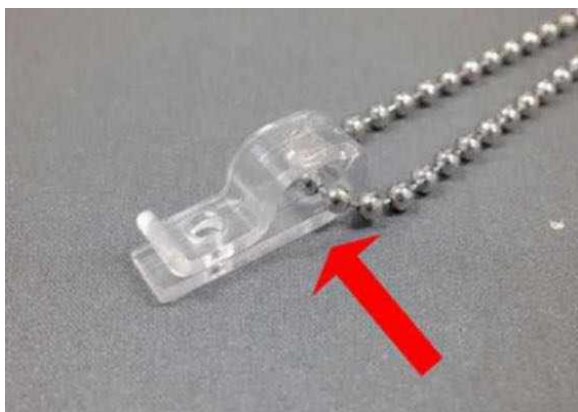
Building:	Main Building
Location:	Master Bedroom/ Lounge
Finding:	Curtain & Blind - Safety Cord
Information:	Looped curtain and blind cords pose a significant strangulation hazard for children as they can place the loop over their head and/or get tangled in the loose cords.

Check all the rooms in your house for any blinds or curtains with long cords that are either loose or looped. This includes any cords that are within children's reach at floor level or near furniture they can climb on.

Secure any loose or looped cords with cleats or tension devices – these can be purchased from your local curtain and blind retailer or hardware store. Do not put furniture such as cots, beds, highchairs, playpens, couches, chairs, tables or bookshelves near a window where children can reach the blind or curtain cord.

It is recommended that this defect be resolved immediately to avoid harm to occupants.

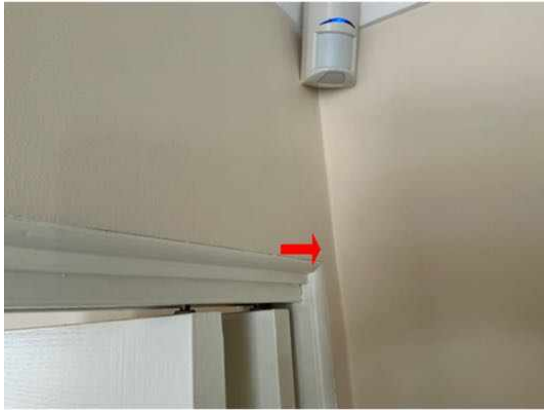
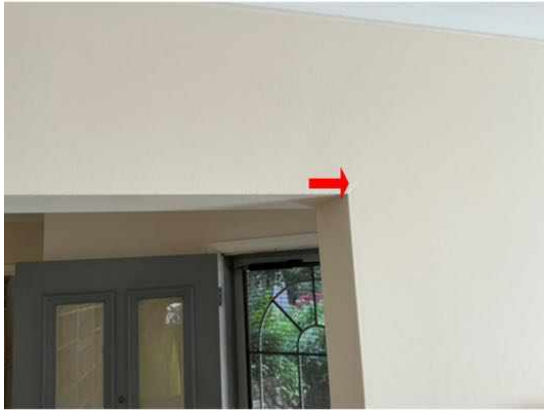
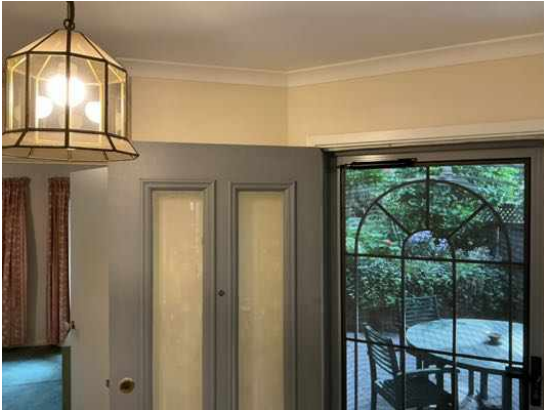
Building:	Main Building
Location:	All Areas
Finding:	Cracking - Damage Category 1 - Fine (up to 1mm)
Information:	Although fine cracks are quite noticeable, they are often only considered to be an appearance defect, and usually do not indicate any structural damage. Generally, the cause of a fine crack is indicative of a separation between building materials and finishes (e.g. paint, plaster, etc.) along joints.

In this instance client have indicate that these cracks become visible after roof leaks. However the leaks have been repaired, and hence no change in terms of sizes.

Cracking of this nature can generally be repaired with minor sanding, filling and/or repainting. Such works should be performed by a qualified Painter or a general Handyman.

Monitoring of all cracking should be conducted frequently. Always contact a Building Inspector should cracks widen, lengthen, or become more numerous.

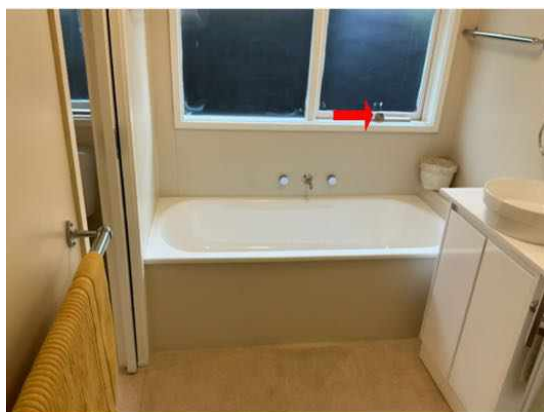
Finding 3.02

Building:	Main Building
Location:	Bathroom/Main
Finding:	Window - Missing handle
Information:	The handle to the window was missing at the time of the inspection. Absence of the handle limits the operation of the window and may pose as a safety risk.

Replacement of the handle should be conducted as soon as possible. A general handy person or qualified carpenter should be appointed to perform these works to improve the operational state of the affected window and improve the safety of the internal area.

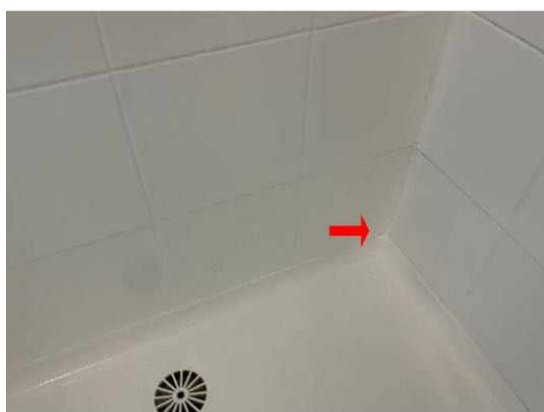
Finding 3.03

Building:	Main Building
Location:	Bathroom/Master
Finding:	Sealant and grouting - Missing or damaged
Information:	It was noted on inspection that sealant or grout is degraded to the tiled shower alcove and or other areas of the bathroom . A flexible sealant is required to allow for expected expansion and contraction, while keeping the joint water tight and protective of all associated building materials.

The lack of sealant between tiles can cause water damp to the wall behind it.

Regular maintenance and replacement of damage or missing or damaged sealant and grout is highly recommended to the wet areas, as this is a regular wear and tear defect. Sealant and grouting in areas that come into regular contact with water should be maintained for the long term care of your property.

Consultation with a sealant specialist is advised immediately to perform remedial works as required.

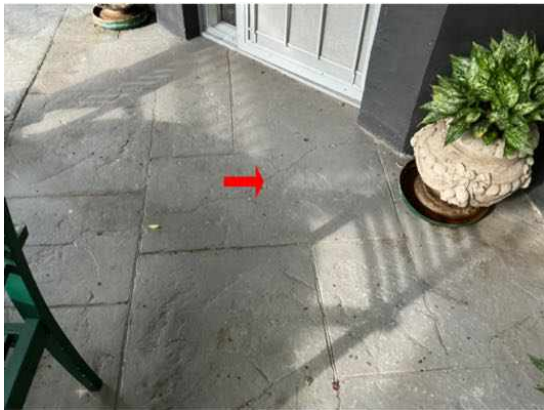
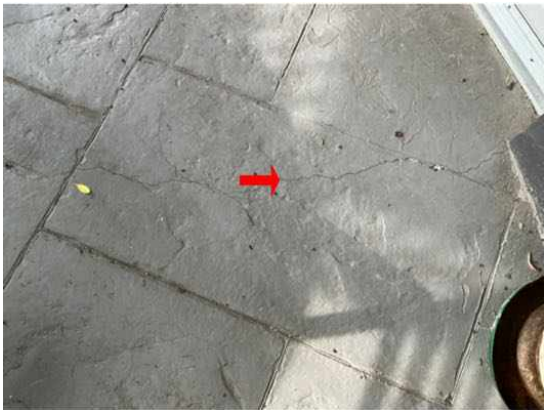
Building: Out Building
Location: Front Yard
Finding: Crack in pavement
Information: Crack in the pavement has noted and it is To be considered Category 2, the approximate width of the crack is less than 2.0mm, or a change in offset of less than 15mm when a 3m straight edge is placed over the defect.

Category 2 cracks to pavement should be monitored for a period of 12 months. At the end of the monitoring period, cracks rated greater than Category 2 are considered defects that require rectification.

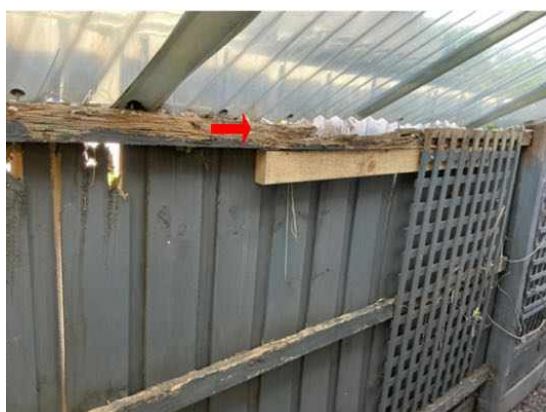
Finding 3.06

Building: Main Building
Location: Fencing
Finding: Fencing - Deteriorated
Information:

It was noted at the time of inspection that sections of the fencing throughout the property have deteriorated. Typically fencing deteriorates due to age and or wear, rot and or rust which is generally expected for a structure of this age, due to prolonged exposure to weather conditions. Sometimes inadequate installation or maintenance can be to blame.

If left unattended, it is likely that further damage will occur. It is suspected that repair of

several elements of the fencing may be required however replacement may be a consideration of the client also.

A licensed fencing contractor should be appointed to provide further advice and perform rectification works as necessary.

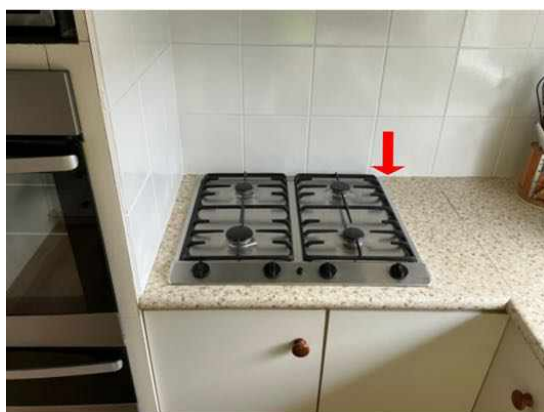
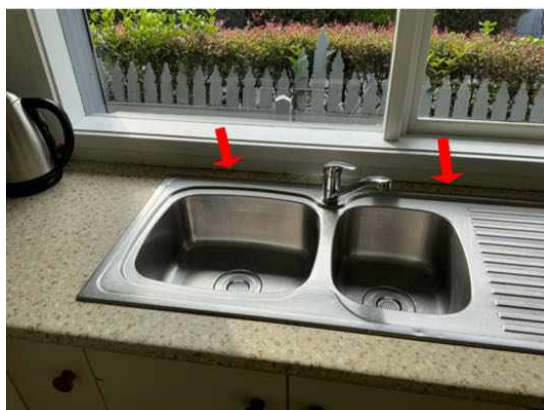
Finding 3.07

Building:	Main Building
Location:	Kitchen
Finding:	Sealant- Missing
Information:	The lack of sealant between wall and bench top can cause water damp to the wall behind it.

Consultation with a sealant specialist is advised immediately to perform remedial works as required.

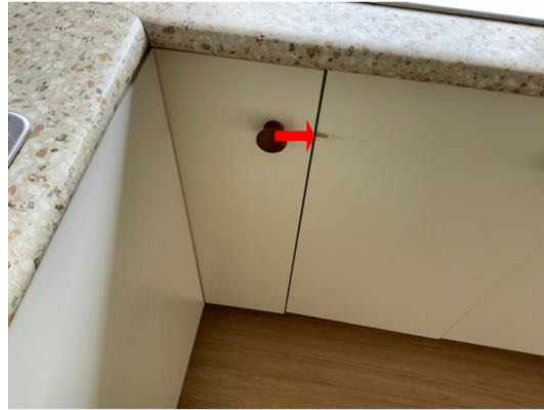
Finding 3.08

Building:	Main Building
Location:	Kitchen
Finding:	Door - Damaged
Information:	The door was found to be damaged at the time of inspection.

Damage of this type occurs generally when the building materials have aged and decayed, but may be indicative of impact damage (accidental or deliberate).

Repair and/or replacement of the door is advised to improve the operational state of the associated door.

A qualified carpenter should be appointed to repair/replace the door at the client's discretion.

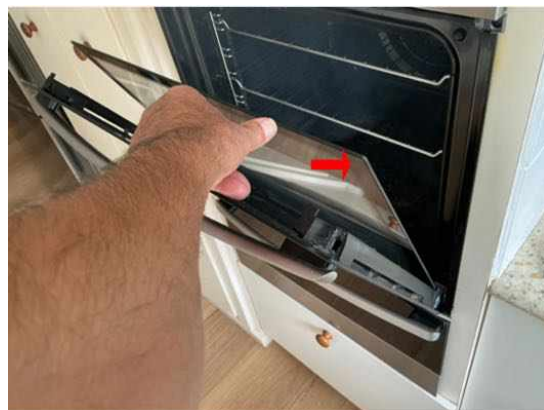
Finding 3.09

Finding: Oven Glass Door - Loose

Information: The Glass to the oven was found to be loose at the time of inspection. Loose glass occurs generally when the oven have aged and decayed, but may be indicative of impact damage (accidental or deliberate).

Repair and/or replacement of the loose glass is advised to improve the operational state of the associated door.

A general handyman or glazier should be appointed to repair/replace the door glass at the client's discretion.

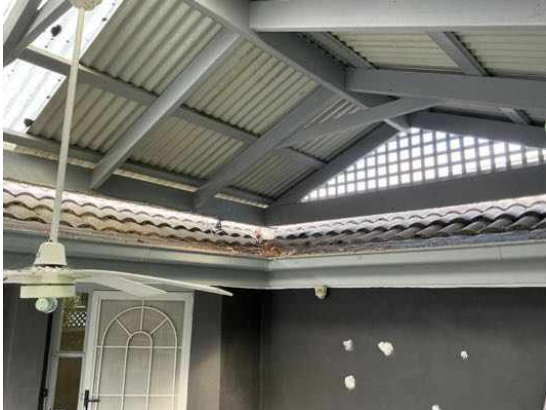
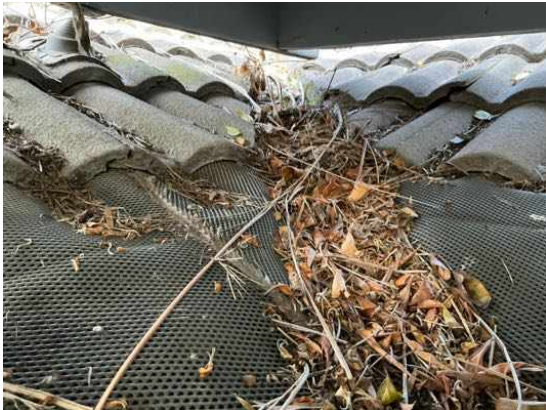
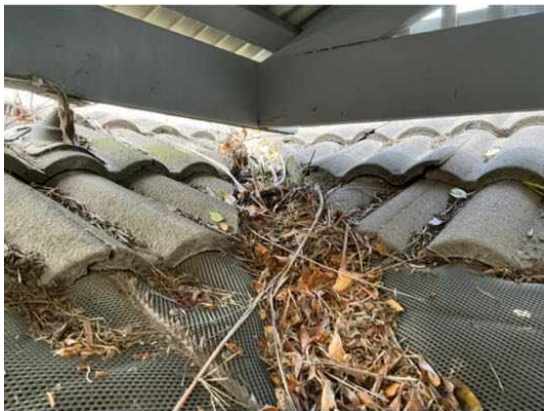
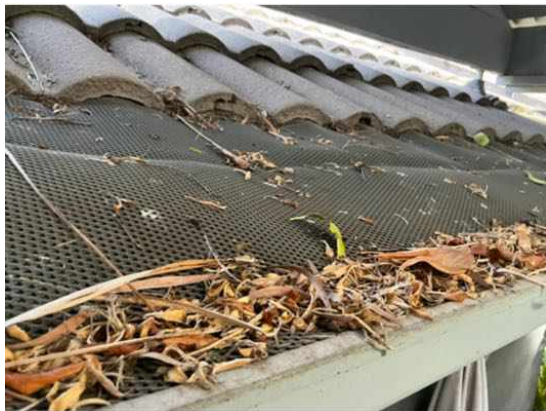
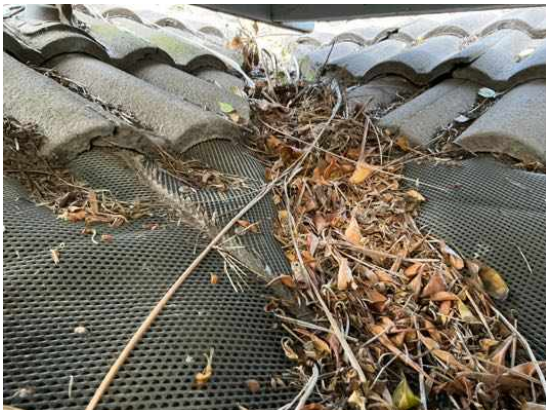
Blocked gutters are likely to lead to high levels of moisture in the affected areas. Such moisture will not only cause rust and decay of the associated building materials, but can also provide conditions that are conducive to termite and timber pest activity. Blockages in gutters should therefore be removed immediately to ensure dry conditions are maintained.

Consult a Licensed Plumber for further specific advice on remedial works that may be required. In the interim, it is highly advised that blocked gutters be removed by the homeowner or a general handyperson as a matter of urgency.

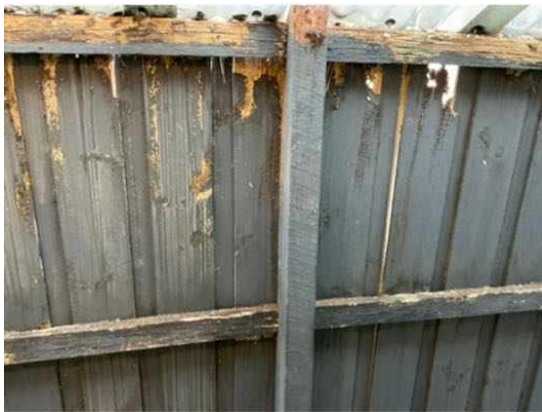
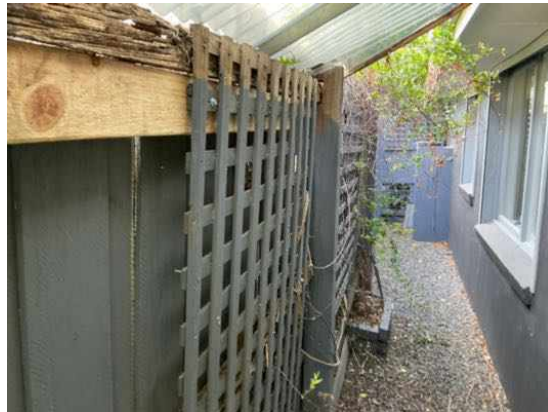
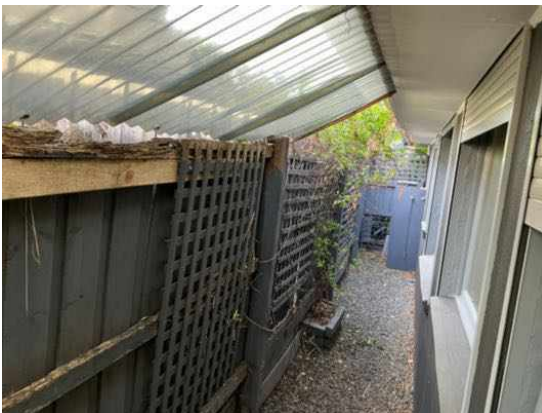
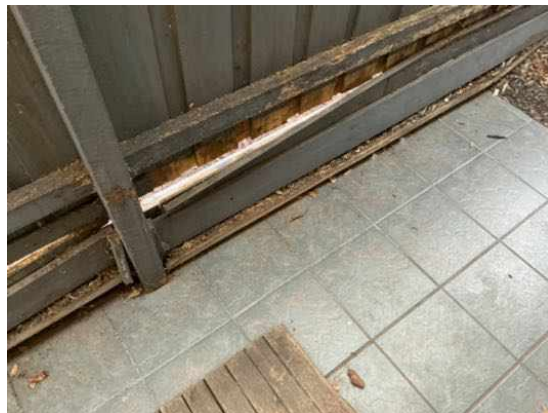
Finding 7.01

Building:	Main Building
Location:	All Areas
Finding:	Fencing - Wood rot
Information:	Wood rot was found to be affecting the fencing in this area, evidenced by the presence of mould on the surface in some areas. Wood rot, also known as Fungal Decay, occurs when timbers and other cellulose building materials are exposed to damp conditions on an ongoing basis.

It is likely that this wood rot has developed as a result of faults in the roof plumbing, creating excessive moisture in this areas. Frequent exposure to rain and other weather conditions also make fascias and barges susceptible to accelerated deterioration.

It is advised that a roof plumber be appointed to inspect all roof plumbing and subsequently identify the cause of the wood rot. Replacement of affected fascias and barges may then be a necessary step in protecting surrounding building elements from such deterioration.

A qualified plumber may be appointed to assess the cause of excessive moisture and to provide advice on any remedial works as required. A qualified carpenter or registered builder may also be required to replace affected building materials.
