Building and Timber Pest Inspection Report

Inspection Date: Thu, 29 Jan 2026

Property Address: 95 Brighton St, Riverstone NSW 2765,
Australia

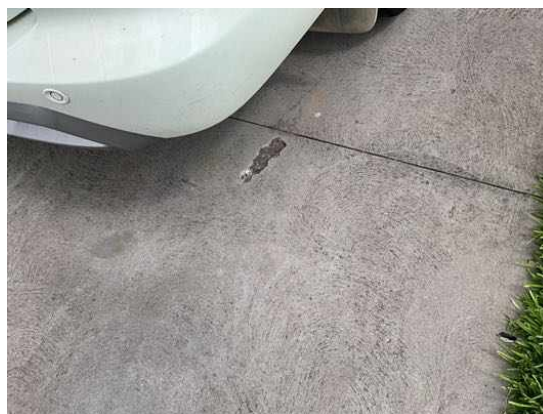
Finding 3.07

Building:	Main Building
Location:	Driveway
Finding:	Concrete damaged
Information:	The concrete pavement exhibits various forms of damage, including cracks, potholes, and spalling, compromising its integrity and smoothness.

Risk: Damaged concrete pavement poses several risks, including trip hazards, vehicle damage, and drainage issues. Cracks and potholes can cause pedestrians to trip and fall, leading to injuries, while vehicle damage may occur from driving over uneven surfaces. Additionally, poor drainage due to damaged pavement can result in water

accumulation, leading to erosion, flooding, and further deterioration of the pavement over time.

A professional concrete contractor or pavement repair company should be engaged to assess the extent of the damage and determine the appropriate repair method. Depending on the severity of the damage, repairs may involve patching, resurfacing, or replacing sections of the concrete pavement to restore functionality and safety. Additionally, measures may be taken to address underlying issues such as poor drainage to prevent future damage.

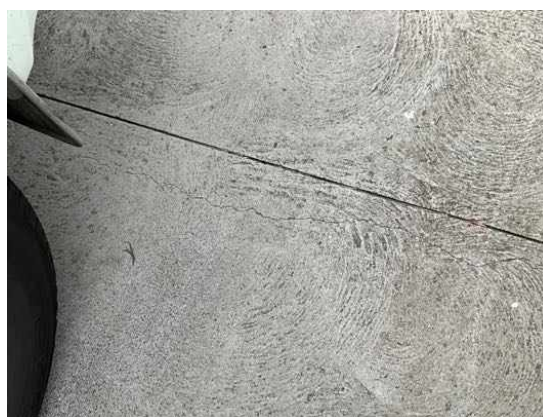
Finding 3.08

Building: Main Building
 Location: All Areas
 Finding: Crack in concrete slab - Category 0
 Information: A crack coded as Category 0 was identified in the slab. A Category 0 crack is described as a hairline crack, representing insignificant movement of slab from level.

The approximate width of the crack to be considered Category 0 is 0.3mm, or change in offset of less than 8mm when a 3m straight edge is placed over the defect.

No rectification is required at this time. However, all cracking should be monitored over a 12 month period to identify any further damage in the area.

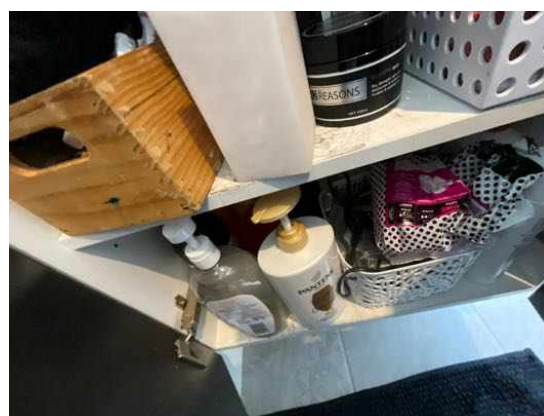
Finding 3.11

Building: Main Building
Location: Bathroom downstairs
Finding: Evidence of excessive moisture - Drywall
Information: Excessive moisture is present at the time of , indicating a potential water leakage issue within the wall.

The prolonged presence of moisture can lead to mold growth, deteriorate the structure, and create an environment conducive to health hazards. Additionally, it may compromise the adhesive holding the tiles, leading to their detachment.

A licensed plumber or a qualified contractor specializing in water damage remediation should investigate the source of the moisture, fix any leaks, and address the damage. Additionally, replacing affected tiles and ensuring proper waterproofing are crucial to preventing future issues.

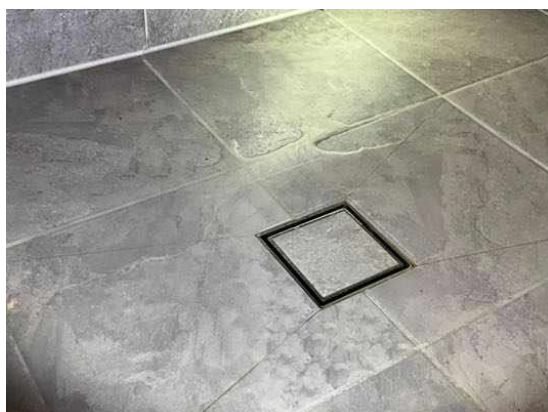
Finding 3.15

Building:	Main Building
Location:	Bathroom
Finding:	Shower - Damp
Information:	Damp is evident to the lower 300mm of wall to the shower alcove. This defect is quite common, and is suspected to have been caused by moisture permeating through the grouting in this area, which shows evidence of deterioration. Leaking pipes within the adjoining wall is also a possible cause.

Damp (or structural damp) refers to the presence of unwanted moisture in the structure of a building, either as the result of intrusion from outside, or condensation from within the structure. In the shower area, internal water leaks or other sources of excessive moisture are generally the cause of damp.

Unmanaged damp in the shower recess is likely to facilitate the formation and development of mould and fungi growth, decaying associated building materials and

compromising their structural integrity. It is important to address damp conditions, as the World Health Organisation notes that excess moisture leads - on almost all indoor materials - to growth of microbes such as moulds, fungi and bacteria, which subsequently emit spores and other matter into the indoor air. Exposure to these contaminants is associated with a wide range of respiratory and other health-related problems.

Consultation with a qualified plumber or bathroom specialist is advised immediately to identify the cause of damp and to perform remedial works as required. Where excessive mould growth is present, further inspection by a specialist environmental health inspector should also be considered.

Always ensure that sealant and grout is in good condition to prevent any moisture issues occurring in the future.

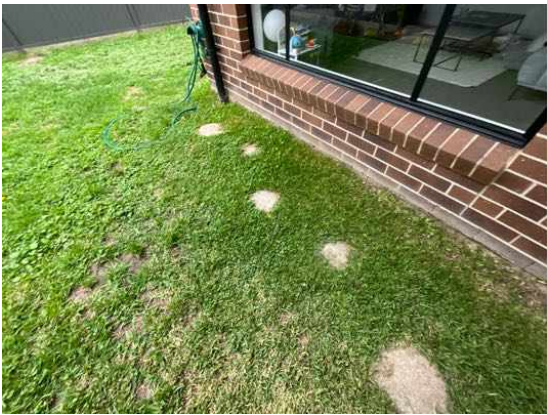
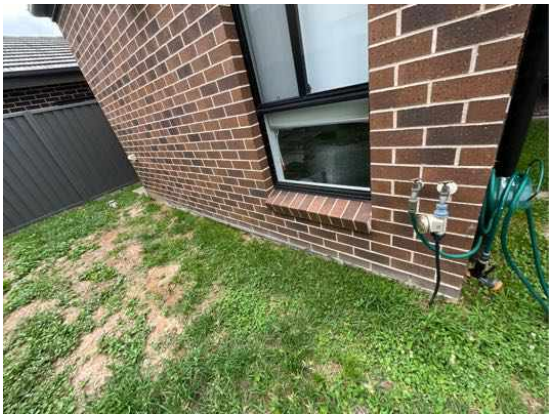
Finding 6.02

Building: Main Building
Location: All Areas
Finding: vegetation around a property can increase the risk of termite infestation
Information: The presence of vegetation around a property can increase the risk of termite infestation, as it provides a conducive environment for them. To address this, consider maintaining a clear space between the vegetation and your home. If you suspect a termite issue, it's advisable to consult with a licensed pest control professional for inspection and treatment.

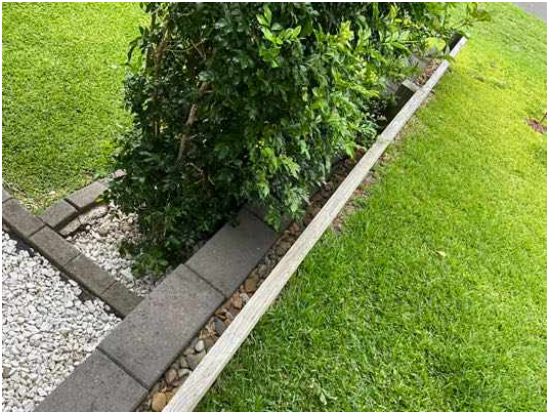
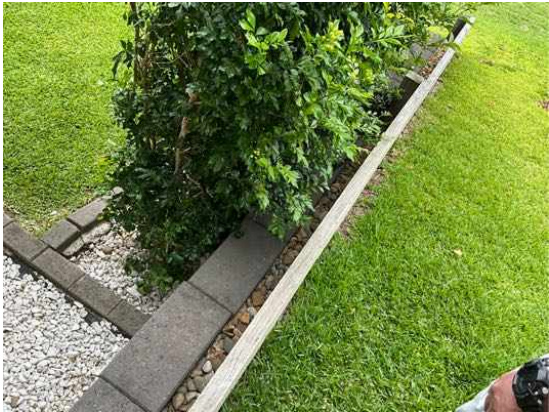
Finding 6.04

Building: Main Building
Location: All Areas
Finding: Bridging or Obstruction Conducive environment for Termites
Information: Bridging of termite barriers occurs when termites bridge (usually by building a mud tunnel) a termite barrier or inspection inspection zone or where termites have a passage, allowing them to bridge the barrier.

Recommended moving obstructions away from the external walls for further and future inspections.
