Building and Timber Pest Inspection Report

Inspection Date: Wed, 4 Feb 2026

Property Address: 16/2 Charles St, Parramatta NSW 2150,
Australia

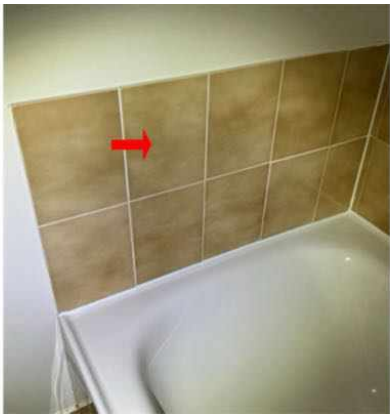
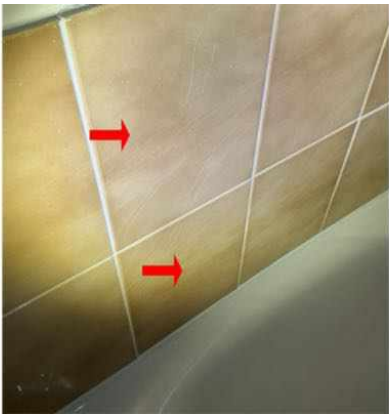
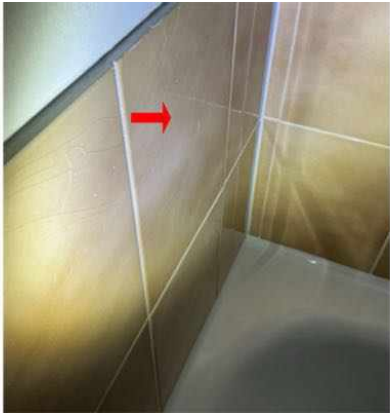
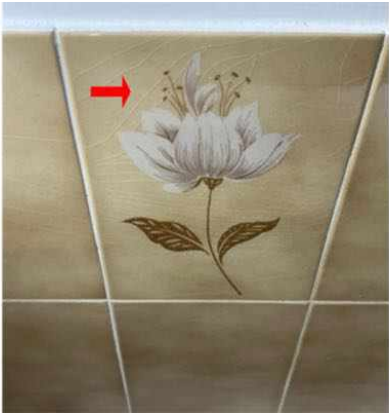
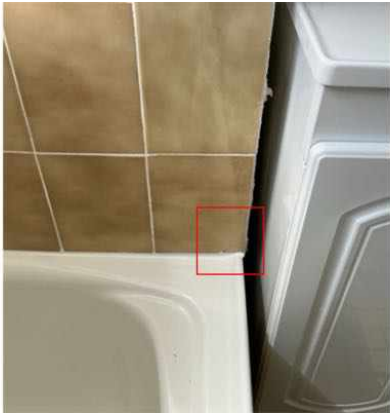
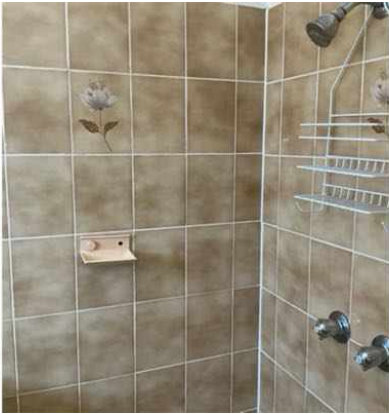
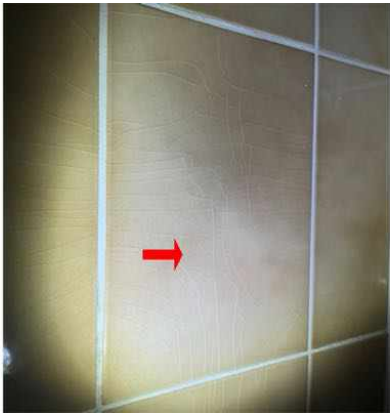
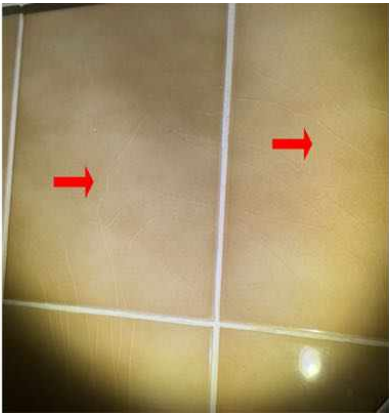
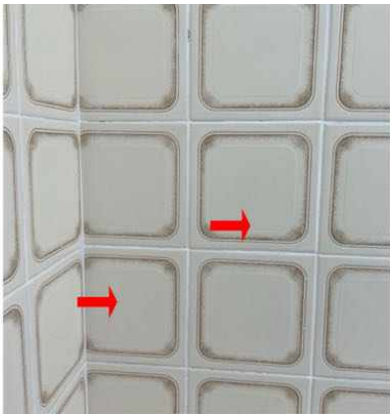
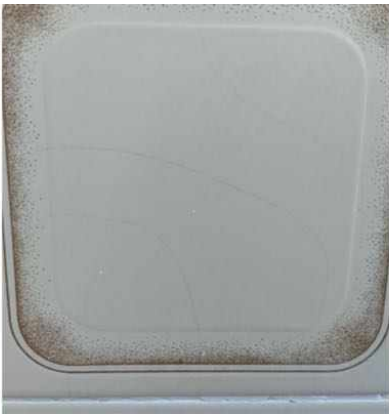
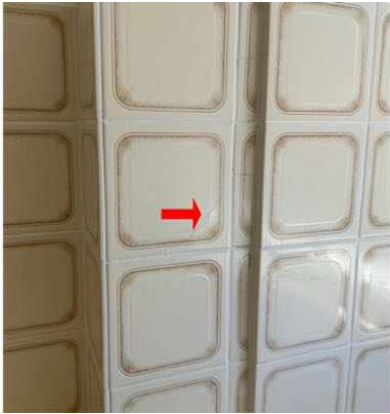
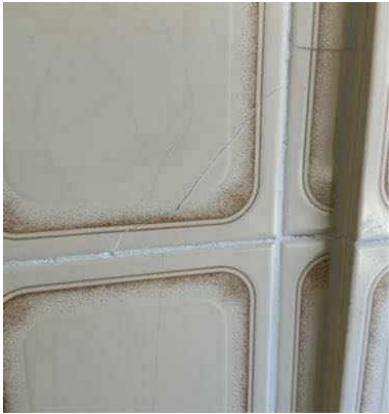
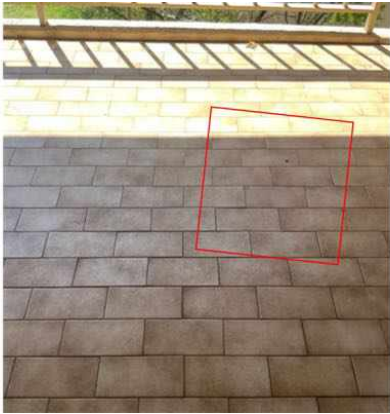
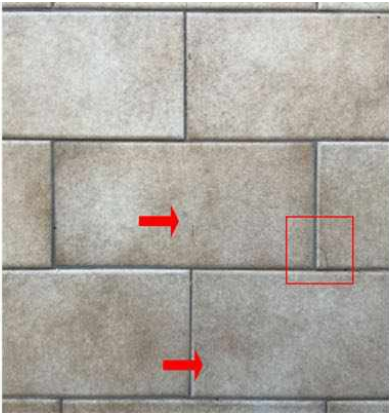
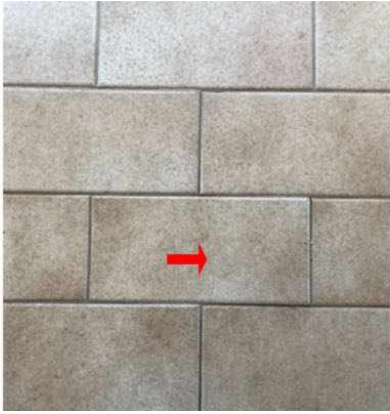
Building: Main Building
Location: Bathroom, kitchen , balcony
Finding: Tiles - Cracked or damaged (inc Hairline glaze cracking)
Information: Cracking was evident to the tiling in this area at the time of inspection. While the cracking appears to be minor, this area is frequently exposed to water, allowing potential for water penetration into adjoining sections of walls or flooring.

If left unmanaged, water penetration to these areas may lead to subsequent water damage, which is likely necessitate repair work to affected building elements.

A tiling contractor should be appointed to ensure that no further water damage occurs. The re-application of silicone and grouting throughout remaining tile work is also advised, to further protect the area against water penetration.

Where water penetration has led to water damage, appointment of a relevant tradesperson may be required to repair damaged building elements.

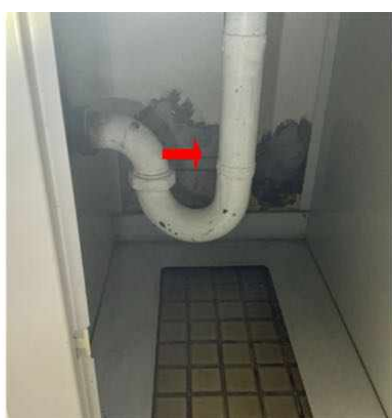
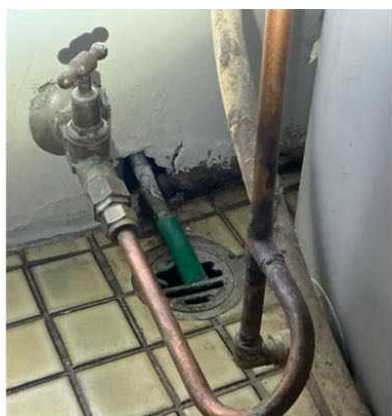
Finding 3.02

Building:	Main Building
Location:	Laundry
Finding:	Installation - substandard or incomplete (Incomplete repairs of possible moisture damage, incomplete finish)
Information:	The installation of this building element appears to have been completed to a substandard level of workmanship or is incomplete. Generally substandard repairs or installation are related to poor workmanship, the use of inappropriate materials, or a failure to complete installation to a suitable standard.

Where installation is substandard and/or incomplete, the client should contact the responsible trade to undertake rectification. Unfinished and substandard building works are likely to degrade more quickly and may create potential for secondary defects to associated building elements.

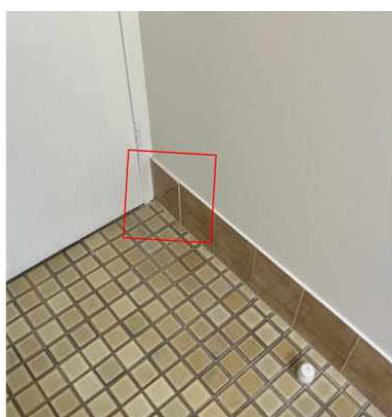
Finding 3.03

Building:	Main Building
Location:	Bathroom
Finding:	Tiles - Drummy
Information:	Drummy tiled areas were identified at the time of inspection. The term 'drummy' refers to tiles that have become detached from their fixing, despite otherwise being in relatively good condition. Such defects are generally caused by physical or moisture damage to the area. Drummy tiled areas may also be a direct result of poor

Tiled areas may swell and shrink with changes in air humidity if the area has sustained moisture damage. Any exposure to moisture is capable of causing tiled areas to become drummy and/or cracked over a prolonged period of time. Drummy tiled areas generally require removal and replacement of affected tiles, with adequate sealant and grouting.

Specialist trades are available for these types of services. A registered builder may be required to undertake works if damage is extensive or if secondary building defects have resulted. Otherwise, it is advised that a tiling contractor be appointed to perform works as necessary. Immediate action is recommended to ensure that no further damage is sustained in the affected area.

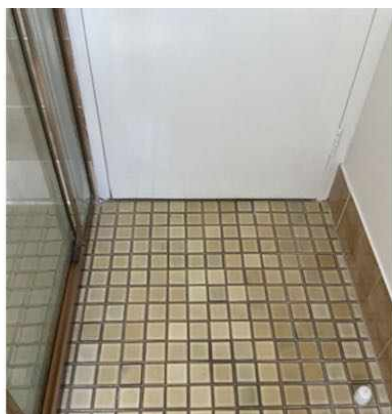
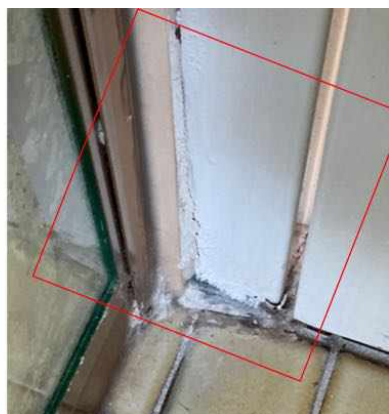
Building:	Main Building
Location:	Bathroom
Finding:	Wet-Area Door Jambs – Moisture Staining / Decay
Information:	Minor moisture staining and early signs of deterioration were observed at the base of the wet-area door jamb and architraves. This is commonly due to water splashing or moisture tracking from the bathroom floor into adjacent joinery. At the time of inspection, the condition appears superficial and non-structural, consistent with general wear typical of wet-area use.

It is recommended that the door junctions be resealed with a suitable moisture-resistant sealant and that ventilation and drainage within the bathroom be maintained to reduce further dampness. Where timber swelling or decay has progressed, localised repair or replacement using moisture-resistant materials (H3-treated or equivalent) should be undertaken.

For information only — further inspection by a licensed carpenter or waterproofing contractor is recommended to confirm the extent of deterioration and verify whether remedial sealing or minor replacement works are warranted.

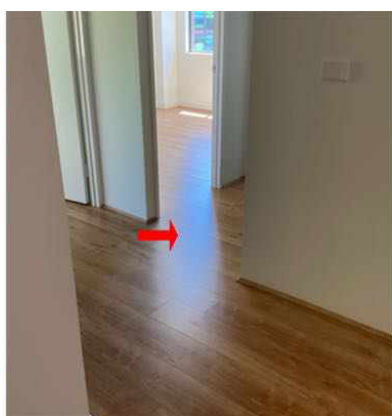
Finding 3.06

Building:	Main Building
Location:	All Internal Areas
Finding:	Flooring - Uneven
Information:	The internal flooring in this area is out of level and uneven. Uneven flooring is likely to indicate minor defects such as expected movement of the foundations of the property, but may also indicate subsidence of the associated subfloor stumps.

It is advised that the flooring be closely monitored to identify any further movement. Where flooring remains relatively unchanged for an extended period of time (i.e. several months), it is likely that this defect has been caused by expected movement of the foundations of the property.

However, where flooring is uneven further, potentially invasive inspection of the subfloor structures and stumps in this area is required. In this case, works to repair are likely to be required, and would be carried out by a registered builder specialising in re-stumping.

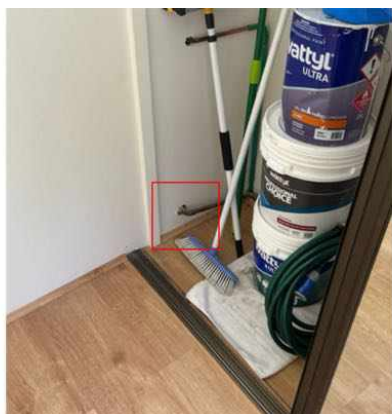
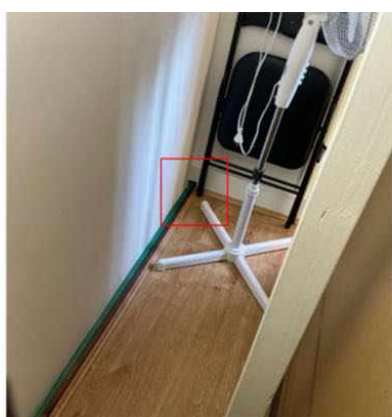
Works that have not been completed to a satisfactory level create potential for the development of building defects and may impede on the safety and integrity of the overall structure.

It is highly recommended that the relevant trades be appointed to complete these

works and ensure the safety of the area and the longevity of all associated building elements.

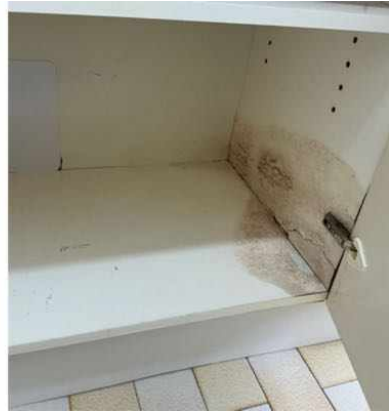
Finding 3.09

Building:	Main Building
Location:	Kitchen
Finding:	Building element - Damaged - Cabinet moisture damage
Information:	Breakage occurs generally when the building materials have either aged and decayed, or as a result of damage (accidental or deliberate).

Repair and/or replacement of broken elements is advised to ensure that additional secondary defects do not arise as a consequence. Such works are necessary, as all building elements play a key role in the operation and function of the overall structure and its performance.

A relevant tradesperson should be appointed to repair or replace the affected building element prior to any subsequent damage being caused.

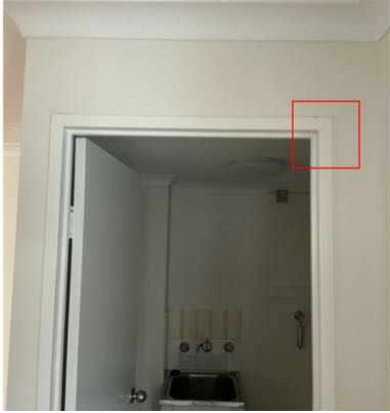
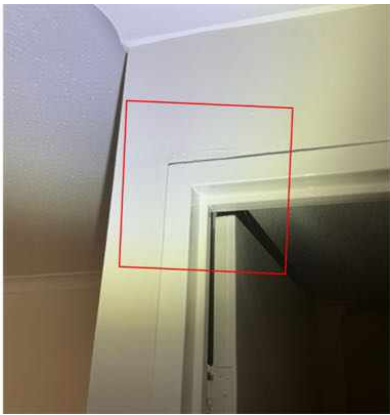
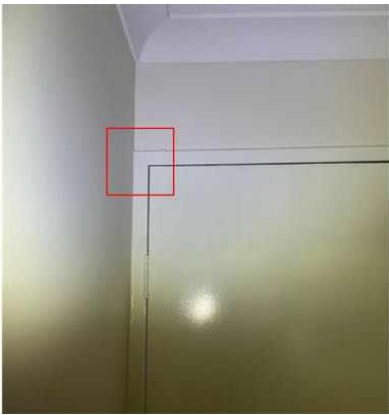
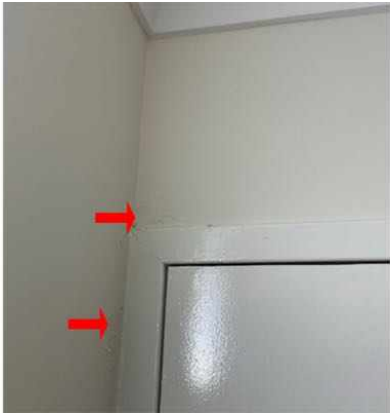
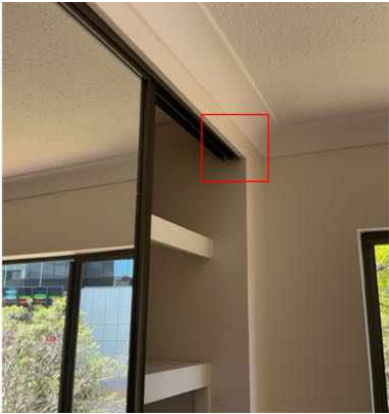
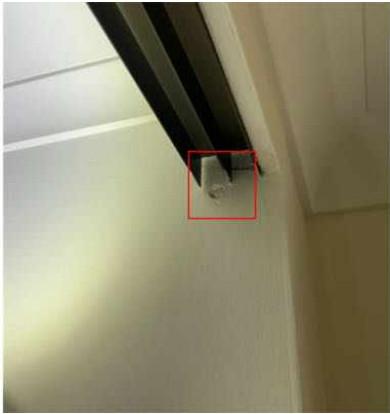
Finding 3.10

Building:	Main Building
Location:	All Internal Areas
Finding:	Paint finish and hairline cracking
Information:	The paint finish in this area was identified as being incomplete at the time of inspection including some hairline minor cracking.

Whilst incomplete or missing paint finish is generally an appearance defect, it can also lead to the development of secondary building defects over time. Incomplete areas of paint finish expose the area to moisture, potentially accelerating the deterioration of underlying building materials.

Incomplete paint finishes should be sanded back, filled, leveled and painted, as applicable. Where inadequate or missing paint protection has led to the deterioration of the associated building element, repair and/or replacement of this building element may be required.

A painting contractor should be appointed as soon as possible to perform necessary works to aid the appearance of the affected area and to ensure the area is protected against further deterioration. Alternatively, the homeowner following manufacturer instructions may perform these works.

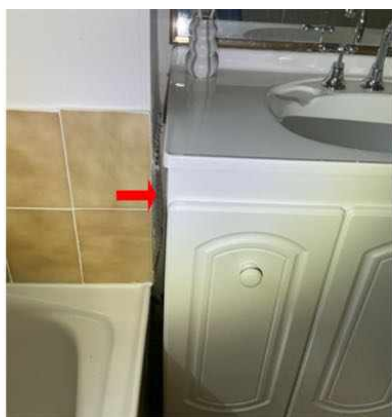
Finding 3.11

Building:	Main Building
Location:	Bathroom
Finding:	Installation - substandard or incomplete (Gap between vanity and wall)
Information:	The installation of this building element appears to have been completed to a substandard level of workmanship or is incomplete. Generally substandard repairs or installation are related to poor workmanship, the use of inappropriate materials, or a failure to complete installation to a suitable standard.

Where installation is substandard and/or incomplete, the client should contact the responsible trade to undertake rectification. Unfinished and substandard building works are likely to degrade more quickly and may create potential for secondary

defects to associated building elements.

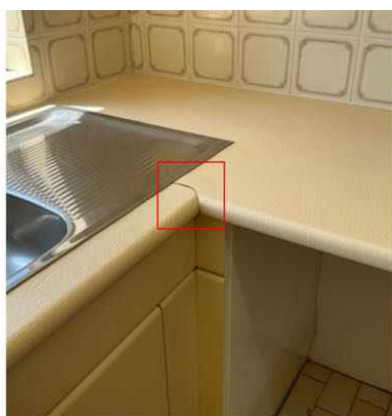
Finding 3.12

Building:	Main Building
Location:	Kitchen
Finding:	Building element - Damaged - benchtop minor crack
Information:	Breakage occurs generally when the building materials have either aged and decayed, or as a result of damage (accidental or deliberate).

Repair and/or replacement of broken elements is advised to ensure that additional secondary defects do not arise as a consequence. Such works are necessary, as all building elements play a key role in the operation and function of the overall structure and its performance.

A relevant tradesperson should be appointed to repair or replace the affected building element prior to any subsequent damage being caused.

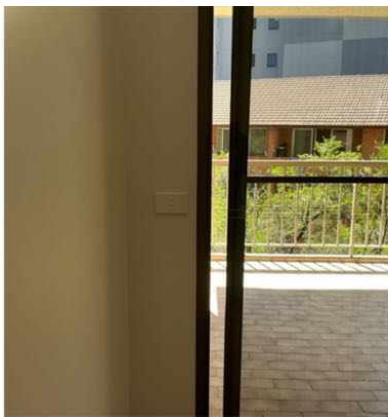
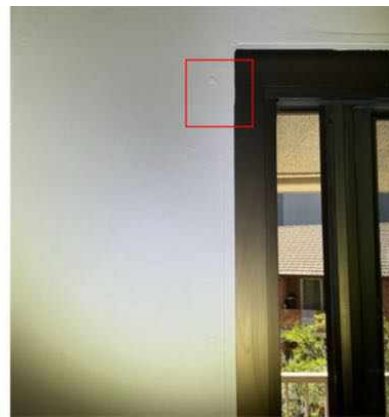
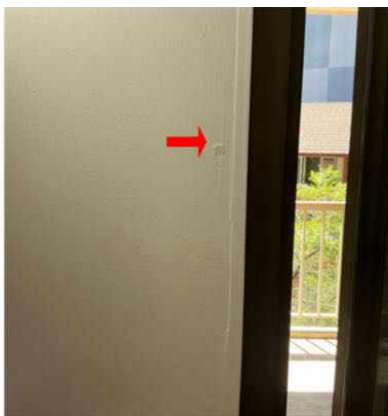
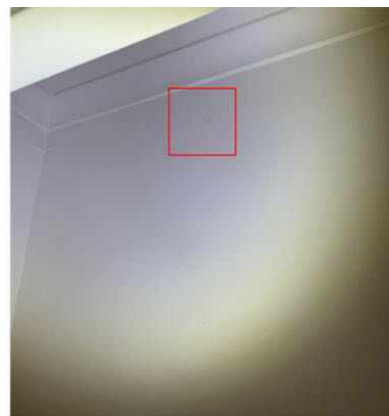
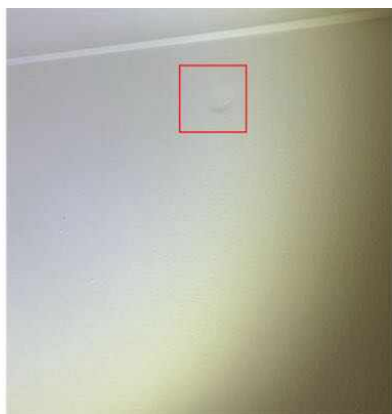
Finding 3.13

Building:	Main Building
Location:	All Internal Areas
Finding:	Wall nails - Popping to some areas

Numerous popped nails were identified in the wall sheets at the time of inspection. Nails and screws are held by the friction between them and the surface that they are applied to. Over time, the nails and screws can back out, which is often a result of general ageing and deterioration of the building structure.

If left unmanaged, the wall sheets may become loose and unstable, increasing the rate of deterioration of the wall sheeting and creating potential for the development of secondary defects.

Re-fastening of popped nails will help to maintain the stability of the internal walls and associated building elements. Such minor works will also help to improve the appearance of the affected area and secure the wall sheets. These works should be performed by a qualified carpenter or plasterer at client discretion.

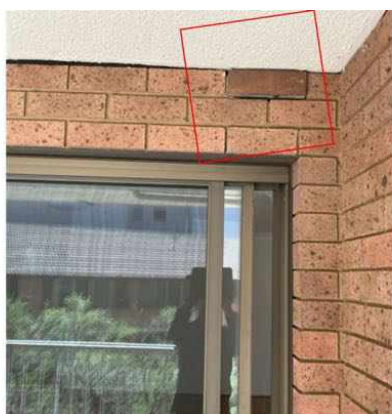
Finding 3.14

Building:	Main Building
Location:	Balcony
Finding:	Brickwork - Deteriorated mortar and loose brick
Information:	Mortar, or 'bedding', is the material which fills joins and intersections between bricks in masonry walls and structures. Sections of mortar in this brickwork were identified as having deteriorated, which is generally expected for a property of this age and condition.

Mortar may deteriorate as a result of age of building materials, minor movement of bricks, or frequent exposure to weathering. Mortar should be replaced to ensure that bricks remain in their intended location and to prevent gaps, which would allow water or moisture ingress and secondary damage as a result.

Mortar deterioration can be addressed by a bricklayer where areas of deterioration are localised and easily accessible. Alternatively, appointment of a registered builder is advised, to repoint large areas of decaying mortar. Where secondary structural defects have become evident, consultation with a structural engineer may be required.

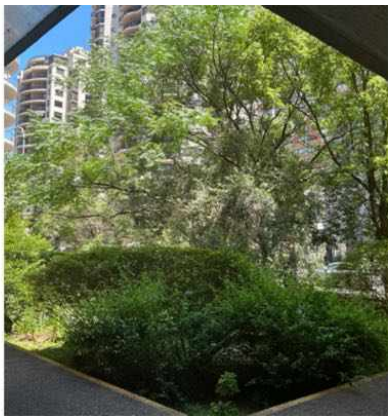
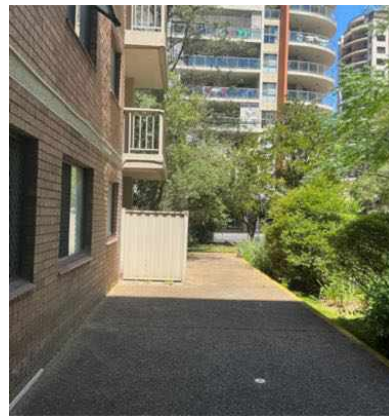
Finding 6.01

Building:	Main Building
Location:	All External Areas
Finding:	Trees within 50m
Information:	Trees within 50m of the property can be conducive to termite activity. It is recommended an invasive inspection of all trees with 50m to the property be carried out by a qualified pest control expert.

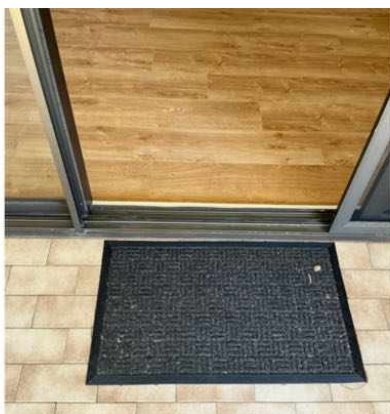
Building:	Main Building
Location:	Balcony
Finding:	Balcony Floor Level Differential
Information:	The balcony finished surface appears to be close to, or at the same level as, the internal floor. Standard construction practice requires a step-down of approximately 50 mm unless a fully engineered threshold drainage system is provided. No such drainage features were visible during inspection. This configuration increases the risk of water ingress, and confirmation of the balcony waterproofing detail through strata/building management is recommended.

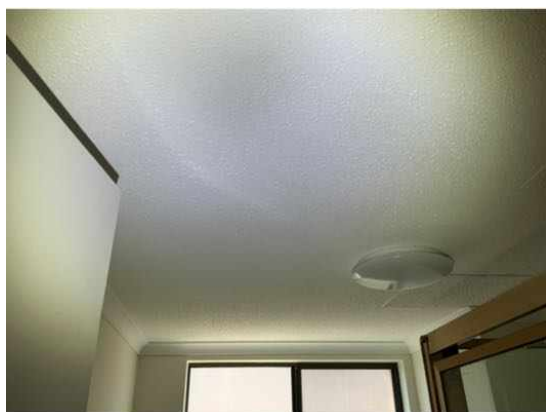
Building: Main Building
 Location: Bathroom
 Finding: Building element - Missing - No ventilation fan
 Information: Although some building elements may seem irrelevant or unnecessary, all building elements play a key role in the operation and function of the overall structure and its performance.

Replacement of any missing building element should be conducted as soon as possible to ensure that no damage or functional issues occur to associated building materials.

The appropriate tradesperson should be appointed as soon as possible to replace the missing building element.
