Building and Timber Pest Inspection Report

Inspection Date: Fri, 23 Jan 2026

Property Address: 299 Dwyer Rd, Leppington NSW 2179,
Australia

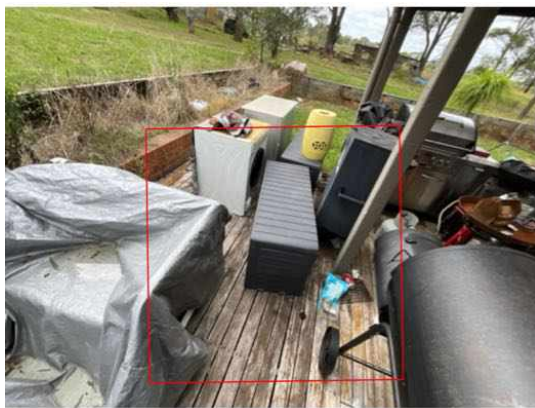
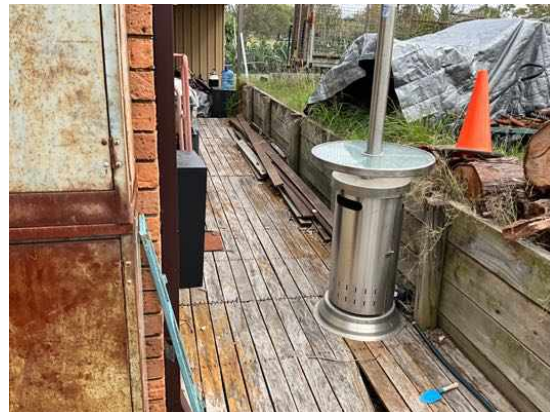
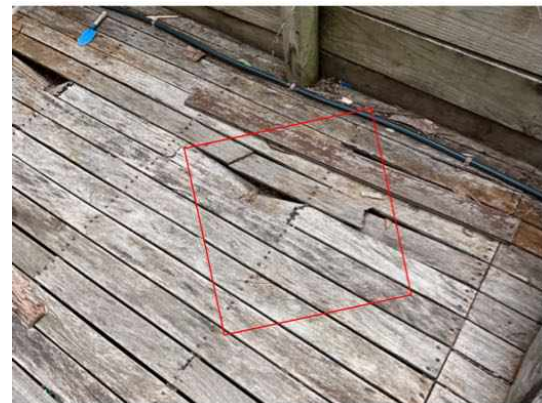
Building:	Main Building
Location:	Deck
Finding:	Flooring - Uneven
Information:	The internal flooring in this area is out of level and uneven, suspected to have been caused as a result of severe timber rot.

This creates a trip and fall hazard and severe injuries maybe caused if not addressed urgently. A licensed carpenter must be appointed immediately for rectifications.

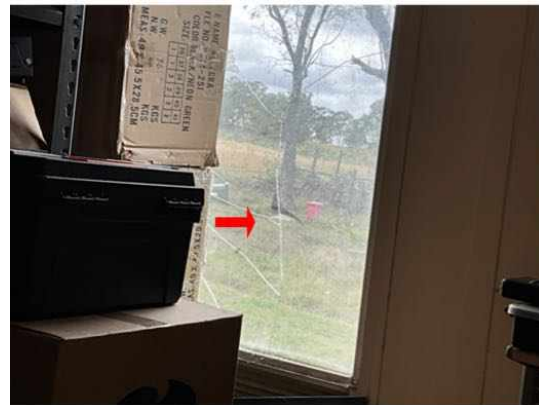
Finding 1.02

Building:	Main Building
Location:	Outbounding storage
Finding:	Window/glass - Cracked/broken
Information:	Cracks and or breakage was identified in this area at the time of inspection. Cracking or breakage is generally the result of impact damage, and is likely to develop further

The likelihood of this window pane further cracking and shattering is increased exponentially, providing a safety hazard in the area. The cracked window also impairs the weather tightness of the building, creating potential for minor water leaks.

A licensed glazier is required to repair the window as soon as possible. Depending on the extent of the cracking, replacement of the window may be required. Please be advised that any persons coming into contact with the cracked window should do so with due caution to avoid any personal injury that may ensue.

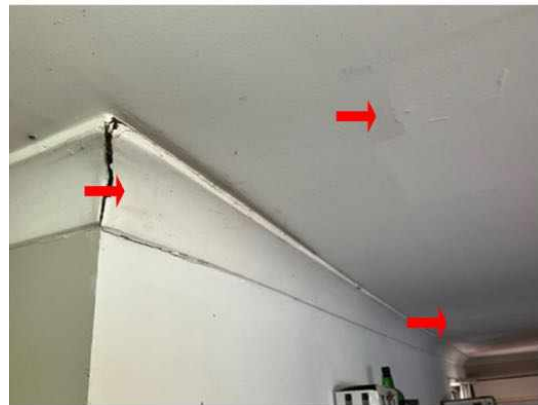
Building:	Main Building
Location:	Dining Room
Finding:	Ceiling - Water damaged
Information:	Water damage to the ceiling lining is generally an indication of excessive moisture being present in the roof void, usually via a leak to the roof covering.

Where water damage is evident to the ceiling, the primary requirement is to identify and rectify the source of the leak. A roof restoration specialist should be appointed as soon as possible to identify the leak and perform rectification works as necessary, ensuring the water damage is restricted.

Once the leak is repaired, consultation with relevant tradespeople, including plasterers and painters, is advised. Rectification works may include replacement of ceiling lining or minor repainting, depending on the extent of the damage.

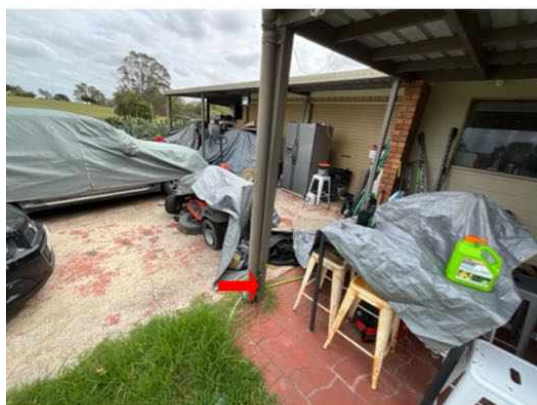
Building:	Main Building
Location:	Front awning
Finding:	Wood rot/decay
Information:	This building element shows evidence of severe wood rot. Wood rot, also known as Fungal Decay, occurs when timbers and other cellulose building materials are exposed to damp conditions on an ongoing basis. This could be the result of exposure to weathering over a prolonged period of time, or the attraction of excessive moisture from other abutting building materials.

Replacement of affected timbers is a necessary step in protecting surrounding building elements from such deterioration. A licensed carpenter is required to replace affected building materials.

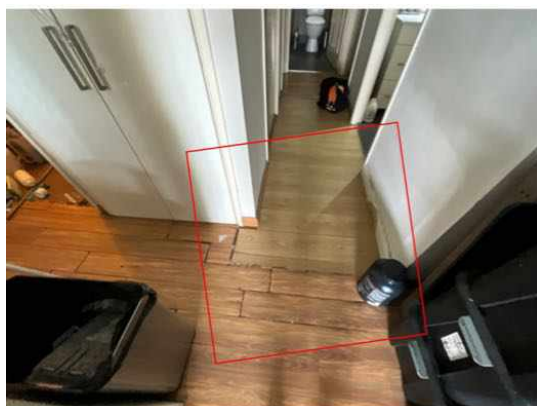
Finding 3.01

Building:	Main Building
Location:	Outside bathroom
Finding:	Water Damage

Information: Water damage is generally an indication of excessive moisture being present, usually via a leak.

Where water damage is evident, the primary requirement is to identify and rectify the source of the leak. A licensed plumber should be appointed as soon as possible to identify the leak and perform rectification works as necessary, ensuring the water damage is restricted.

Once the leak is repaired, consultation with relevant tradespeople, including carpenters, plasterers and painters, is advised.

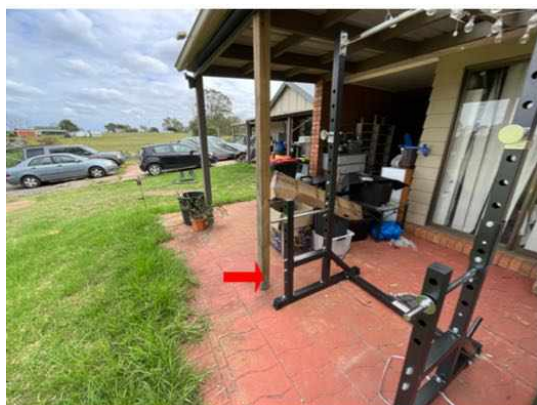
Finding 3.02

Finding: Fitting or fixture - Loose

Information: The fitting in this area is loose and requires adjustment to tighten.

If left unmanaged, the fitting may further deteriorate, causing potential for the development of other minor secondary defects.

A licensed carpenter should be appointed to perform these rectification works at discretion of the client.

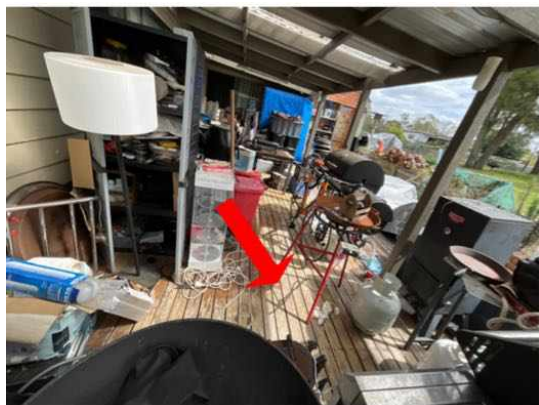
Information: External timbers that are frequently exposed to harsh weather conditions require adequate protection in order to maintain their condition. Where timbers have not been

painted or treated adequately, general deterioration is likely to occur at an accelerated rate.

If left unattended, replacement of these timbers is likely to be necessary in the short-term future. Adequate treatment of these timbers is required as soon as possible by a painting contractor or general handyman.

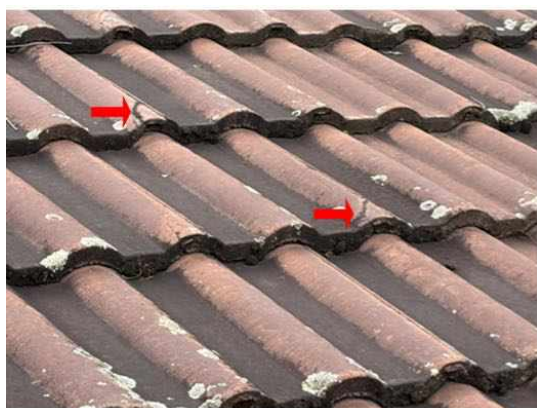
Upon inspection of the exterior roofing, the majority of roof tiles were considered to be in a fair condition. While weathering of the tiles is consistent with the age of the property, maintenance works are required.

Where left unmanaged, deteriorating roof tiles are likely to lead to a number of secondary defects, including minor water leaks and weather exposure to internal roofing structures.

Consultation with a licensed roofing contractor is highly advised to gain advice on cost of remedial works that may be required in the short to medium term. Remedial works are likely to increase the longevity of the exterior roofing structure.

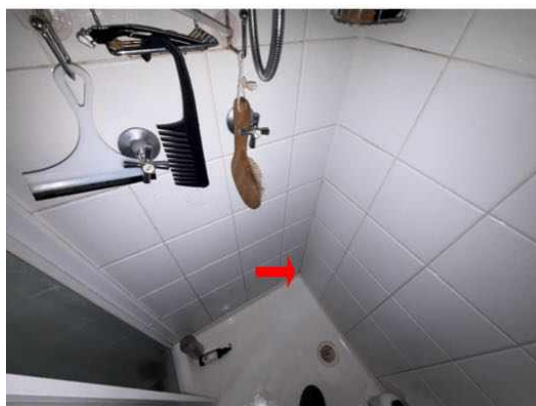
If left unmanaged, water penetration to these areas may lead to subsequent water damage, which is likely necessitate repair work to affected building elements.

A bathroom specialist should be appointed to determine the integrity of the bathroom waterproofing membrane. If the membrane was found to be intact then relatively minor works to replace the cracked tiles should be carried out to ensure no further damage occurs. The re-application of silicone and grouting throughout remaining tile work is also advised, to further protect the area against water penetration.

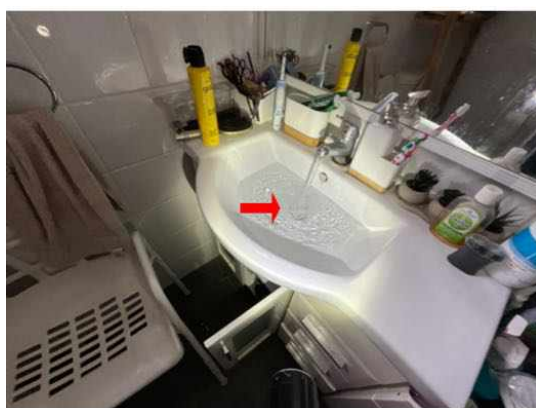
The sink/basin drain appeared to be partially blocked at the time of inspection. Blockages here are usually caused by hair and other debris. If left unmanaged, a lack of general maintenance may lead to the development of more significant defects, such as water damage to surrounding building materials.

A licensed plumber should be appointed to remove the blockage at the client discretion.

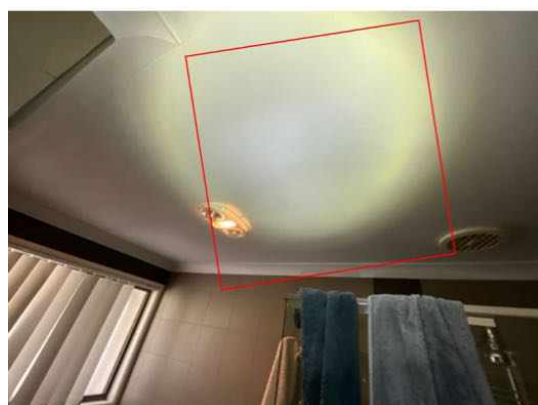
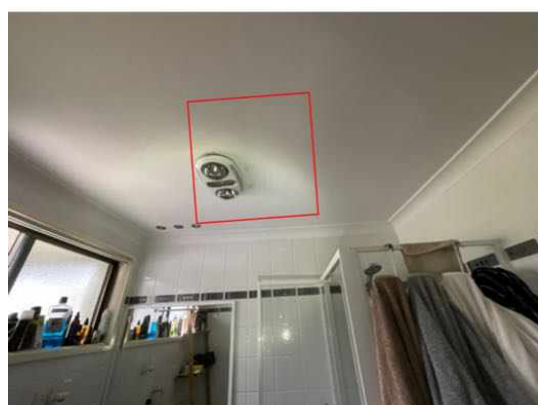
Inadequate surface preparation can also cause these failures, especially when paint is applied to bare wood or a very porous surface without first applying a primer.

A qualified painter should be appointed to rectify the problem.

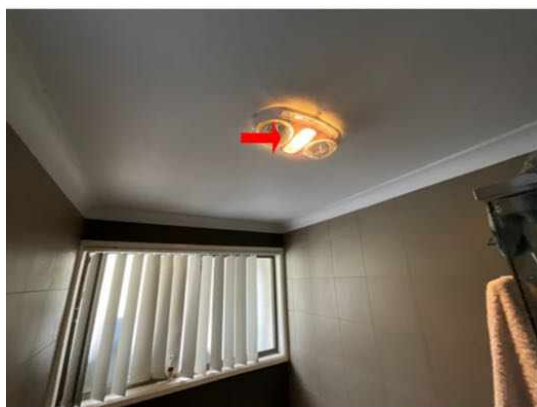
Finding 3.19

Building: Main Building
Location: Bathroom
Finding: Exhaust fan - Not operating

Where no secondary damage has developed, the Homeowner may undertake minor cleaning of the area and consider replacement of the exhaust fan. Alternatively, consultation with a Licensed Electrician is required to check for any secondary or concealed damage and consider repair or replacement.

Please be advised that a cabinet maker or qualified carpenter may also be required if water damage has occurred and that an additional specialist mould inspection may be required if severe mould has resulted.

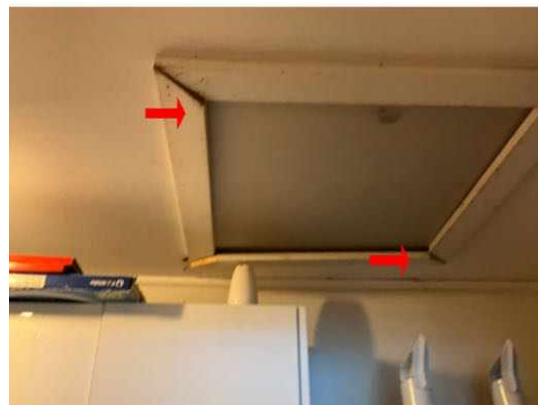
Beading is important in weatherproofing the surrounding building elements and preventing pest ingress. Furthermore, beading works to protect the joins of building materials, which are more susceptible to deterioration and decay.

Repair or replacement of the beading is advised to ensure the protection and longevity of any associated building elements. Such works may be performed by a general handyperson or qualified carpenter.

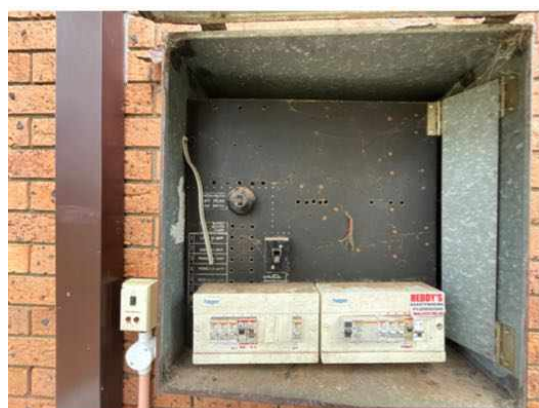
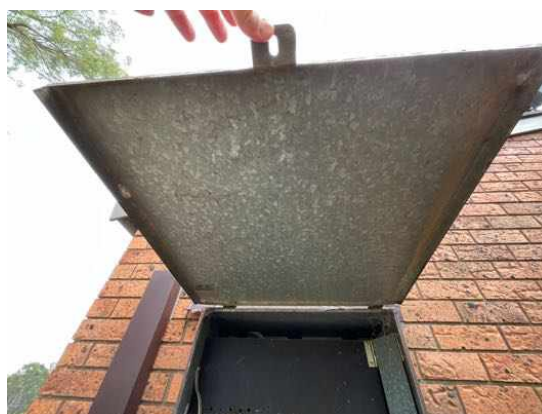
A durable notice should be placed in the switchboard unit to indicate current termite barriers. At the time of inspection, it appeared as though no termite management system has been installed, with no evidence to suggest preventative works taking place.

The client may consider gaining further advice from a pest controller as to the costs and procedures involved with this application. It is recommended that obtaining such advice be a short-term priority.

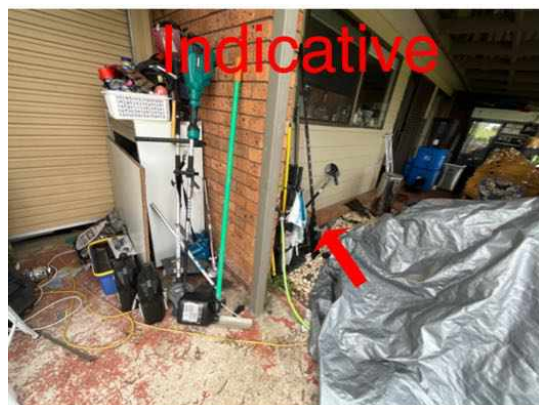
Information: Slab Edge Exposure: Where external concrete slab edges are not exposed there is a high risk of concealed termite entry. In some buildings built since July 1995 the edge of the slab forms part of the termite shield system. In these buildings an inspection zone of at least 75mm should be maintained to permit detection of termite entry. The concrete edge should not be concealed by render, tiles, cladding, flashings, adjoining structures, paving, soil, turf or landscaping etc. Where this is the case you should arrange to have the slab edge exposed for inspection. Concealed termite entry may already be taking place but could not be detected at the time of the inspection. This may have resulted in concealed timber damage. Does the slab edge inspection zone fully comply?

Not able to comment. A very high proportion of termite attacks are over the edge of both Infill and other concrete slabs types. Covering the edge of a concrete slab makes concealed termite entry easy. Infill slab type construction has an even higher risk of concealed termite ingress as the slab edge is concealed due to the construction design and cannot be exposed. The type of slab may only be determined by assessment of the construction plans by a qualified person e.g. Builder, Architect. Construction Plans may be obtainable by your local Council or Builder. Termite activity and or damage may be present in concealed timbers of the building. We strongly recommend frequent regular inspections in accordance with AS 3660.2. Where the slab edge is not fully exposed or the slab is an infill slab or the slab type cannot be determined then we strongly recommend inspections every 3 to 6 months in accordance with AS 3660.2 or AS 4349.3.

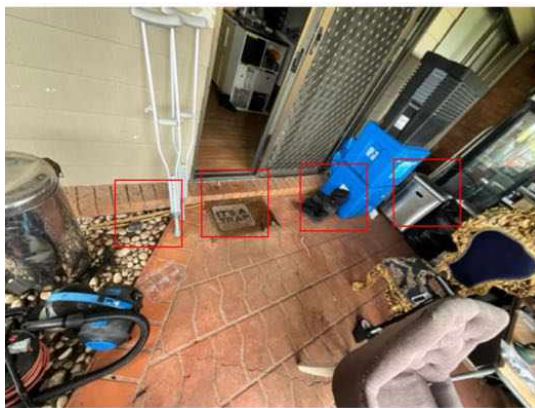
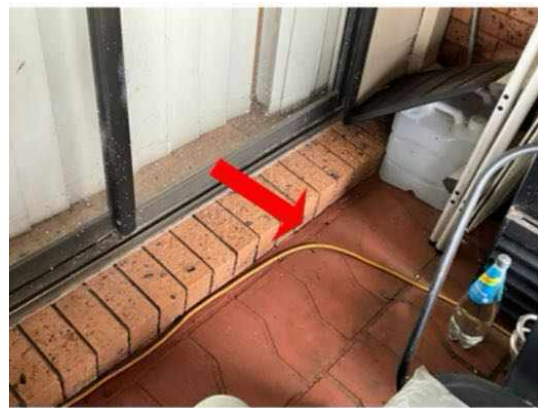
Finding 6.04

Building: Main Building
Location: Multiple areas
Finding: Bridging or breaching of termite barriers - damp course level
Information: Bridging is the spanning of a termite barrier or inspection zone so that subterranean termites are provided with passage over or around that barrier.

Such conditions attract termites into these damp areas which is likely to lead to infestation if left untreated.

While retrospective fitting of DPC is considered to be impractical works are required in order to prevent the extraction of moisture from the external environment into exterior brickwork or wall materials. Landscaping or re-paving of external grounds may be considered by the client. Regular annual inspections are strongly advised.

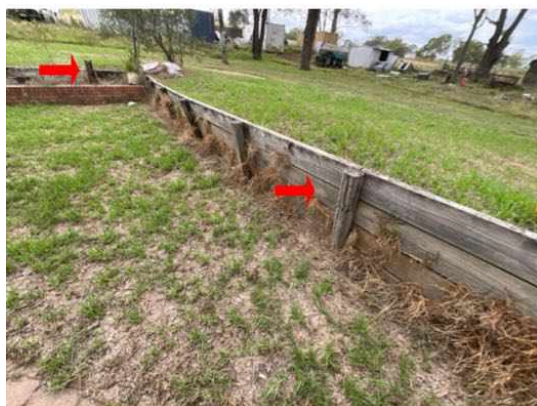
Finding 6.09

Building:	Main Building
Location:	Fencing & Landscaping
Finding:	Building materials in direct ground contact - conducive to termites
Information:	Where timber elements are in direct contact with the ground and consequently moisture or dampness they become conducive to termite activity. Whether timber is used as a building element part of a fencing structure or stored as an unused item they can provide an environment that is attractive to termite infestation.

The removal of any such materials that may be conducive to termite activity should be removed as soon as possible to minimise the risk of termite attack.

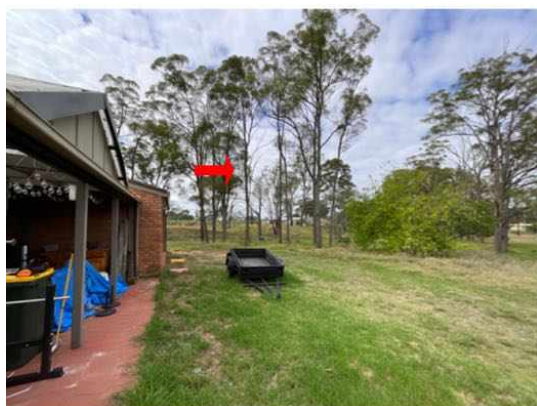
Information: Home and or building is situated in a high risk area for termite activity, due to close proximity to surrounding bushland.
