Building and Timber Pest Inspection Report

Inspection Date: Tue, 3 Mar 2026

Property Address: 1/130 Lake Entrance Rd, Oak Flats NSW
2529, Australia

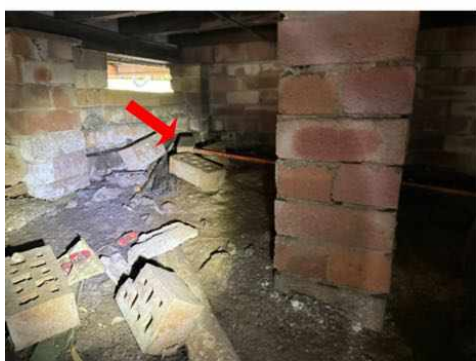
Building: Building 1
 Location: Rear wall/yard areas
 Finding: Site drainage - Inadequate
 Information: The site drainage in the rear of the property was found to be inadequate at the time of inspection, creating water damage to associated building elements.

Rainwater is entering the subfloor and combined with the water leak, has created mould, rising damp, pooling water and possibly the reason for the leaning pier.

In NSW, a major defect is a defect that can cause further damage which applies here.

It is important that water does not lie against the base of walls; surrounding paths and ground levels should be sloped to drain water away from walls. Downpipes should not discharge stormwater onto lower walls or plinths. Stormwater should be carried away by large, regularly cleaned drains. Ground levels may need to be lowered to expose a buried DPC.

Where site drainage is inadequate here, installation of an Agricultural (Aggie) Drain is required. A qualified plumber should be appointed to further inspect the property and perform any remedial works as necessary. Secondary defects are likely to occur if left unmanaged.

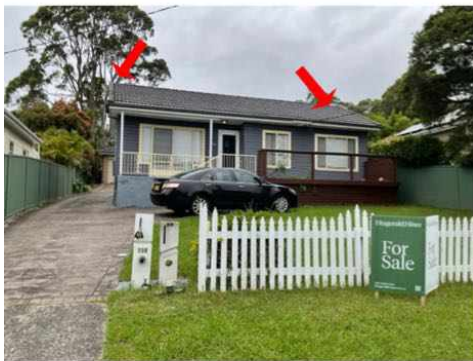
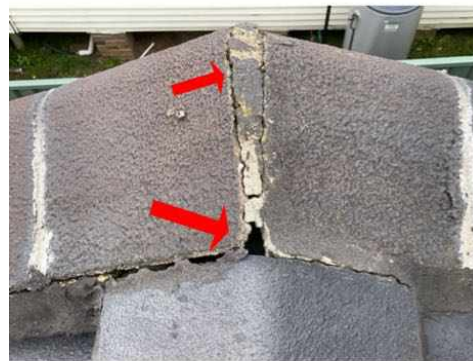
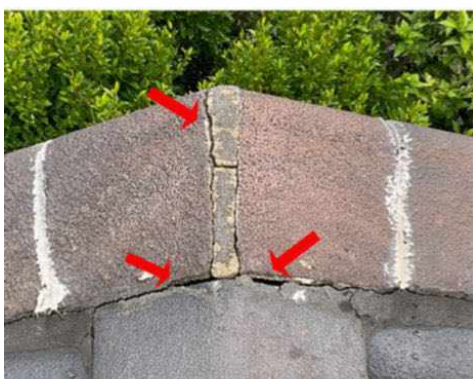
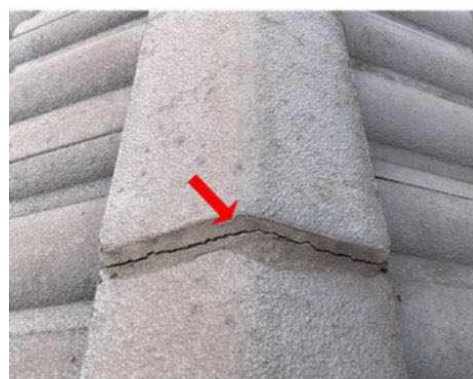
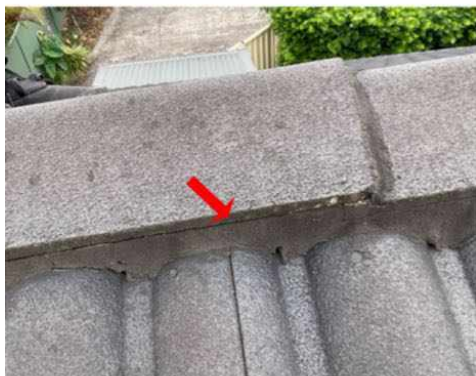
Finding 2.02

Information: Upon inspection of the exterior roofing, the majority of the roof areas were considered to be in a fair condition. While weathering of these pictured areas is consistent with the age of the property, maintenance works are required. The large gaps in the left and right ridge mortar need urgent attention (pictures 1-3) to stop rain entering the roof. The other photos are more minor cracking damage.

Re-sealing and replacing small areas of gaps must be undertaken to help preserve and extend the life span of these roofing areas. Where left unmanaged, deteriorating roofing materials are likely to lead to a number of secondary defects, including water leaks and weather exposure to internal roofing structures.

Consultation with a roofing contractor is highly advised to gain advice on cost of remedial works that may be required in the short to medium term.

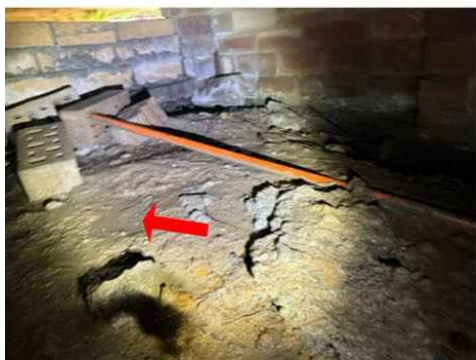
Finding 3.01

Building:	Building 1
Location:	Subfloor
Finding:	Foundations - adjacent water pooling
Information:	Water pooling near foundations and footings is a serious concern with the potential to adversely impact on the longevity of the dwelling. This house requires rear drainage and immediate repair if the water leak to stop water pooling and foundation movement.

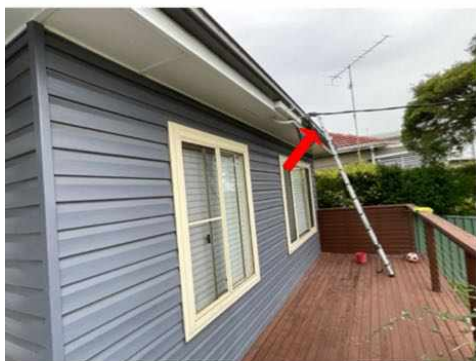
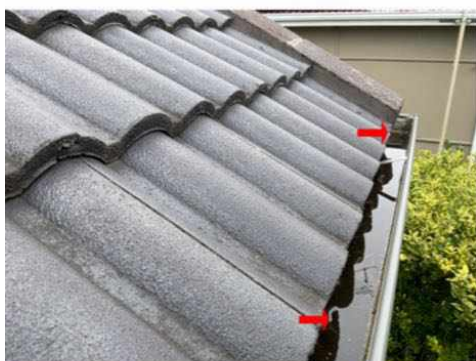
Finding 3.02

Building:	Building 1
Location:	Pictured front right gutter
Finding:	Gutter - Insufficient fall
Information:	There is an insufficient fall in the front gutter, which means that the angle of this gutter is inadequate for rainwater to drain away. This will result in pooling of water in the area, creating the potential for water damage to nearby areas. This is likely to lead to further defects if not repaired. Adjustment by a roofing contractor is required as soon as possible to prevent any damage to this area.

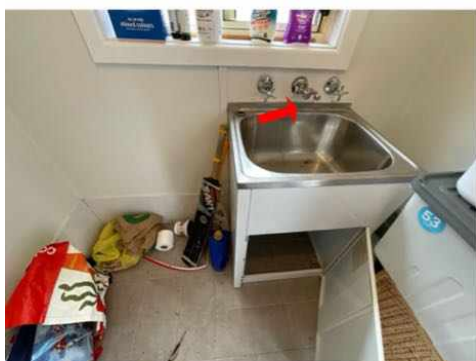
Finding 3.04

Building:	Building 1
Location:	Laundry
Finding:	Taps not working
Information:	The tap in this area appears to have not been installed correctly. This middle tap is working with cold water. The two outside laundry tub taps were not working at the time of the inspection. A qualified plumber should be appointed to re-fix these plumbing fittings.

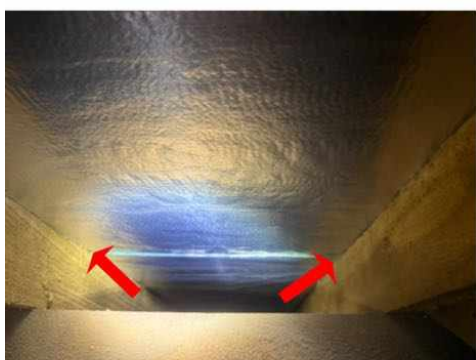
Finding 3.05

Building:	Building 1
Location:	Some Roof cavity areas
Finding:	Chemical delignification identified
Information:	Minor chemical delignification also known as wood defibration was found in the rafters and refers to the chemical breakdown of timber building elements. This breakdown of the Lignin deteriorates the wood impacting on the structural integrity and tensile strength of the affected building element.

Chemical delignification is most common near marine environments due to the high levels of salt in the air however this deterioration may also occur in other areas where timber elements are frequently exposed to damaging gases chemicals etc.

Where timber building elements have minor deterioration, these areas should be monitored and repair and / or replacement may be required in the future if the damage continues. The likely cause of the defibration should also be investigated and dealt with accordingly.

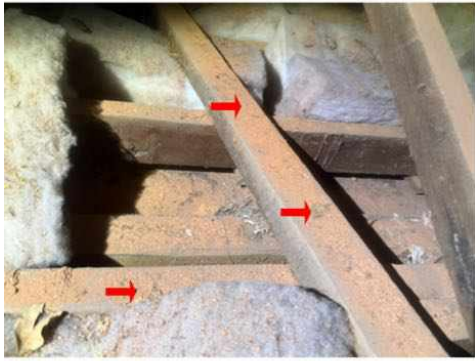
Finding 3.06

Building:	Building 1
Location:	All Roof cavity areas
Finding:	Roof tile deterioration - Fretting
Information:	Fretting has been observed in the roof void evidenced by dust from the tiles settling on the insulation. This condition indicates premature deterioration of the tiles, which may be caused by poor-quality or unsuitable tiles, excessive moisture exposure, inadequate sealing, or general wear over time. This appears to be very minor at the time of the inspection.

This should be checked every 2 years and if the tile fretting worsens, a qualified tiler or building contractor should be engaged to assess the affected areas and carry out appropriate remedial works, which may include sealing, surface treatment, or replacement of the deteriorated tiles, and investigation of any underlying moisture issues.

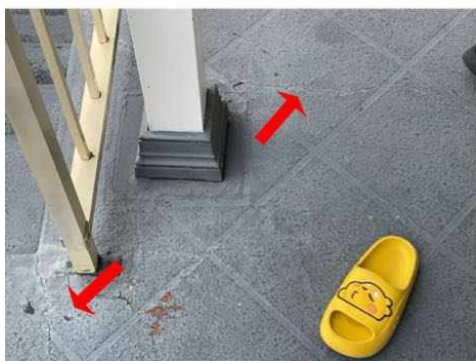
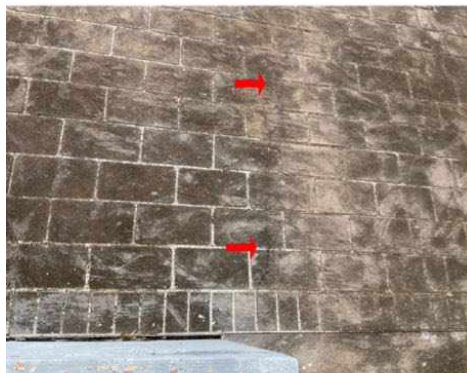
Finding 3.08

Building:	Building 1
Location:	Balcony/ driveway
Finding:	Crack in concrete slabs - Category 1
Information:	Cracks coded as Category 1 was identified in these pictured slabs. A Category 1 crack is described as a fine but noticeable crack, with the slab at an otherwise reasonable level. To be considered Category 1, the approximate width of the crack is less than 1.0mm, or a less than 10mm change in offset when a 3m straight edge is placed over the defect.

Category 1 cracks should be monitored for a period of 12 months. At the end of the monitoring period, identified cracks that are rated greater than Category 2 are considered defects, and require rectification.

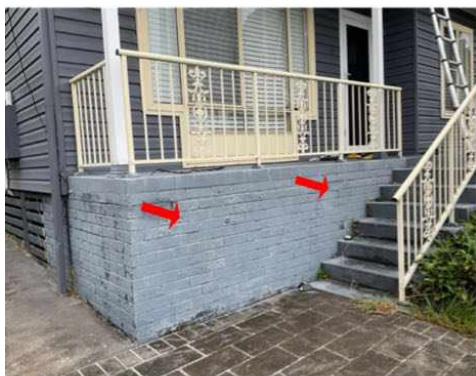
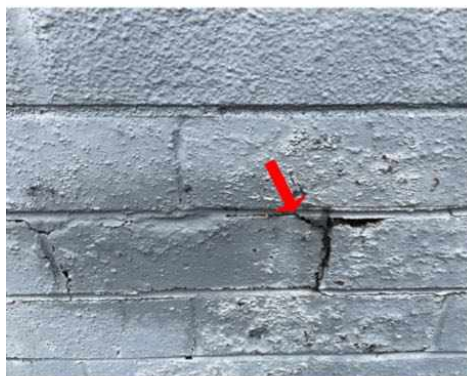
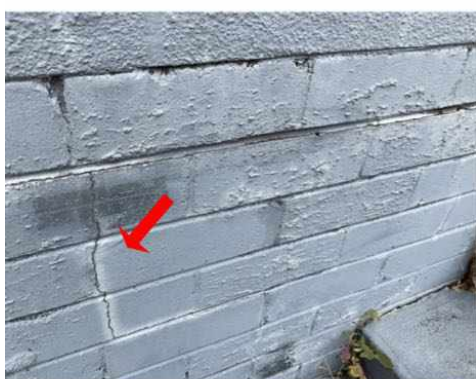
Finding 3.09

Building:	Building 1
Location:	Exterior front wall
Finding:	Step cracking to brickwork (minor under 1mm)
Information:	Step cracking was identified to the brickwork in this area at the time of inspection. Step cracking, which is similar to other forms of cracking, has a variety of possible causes. However, the most common is the subsidence of adjacent footings.

Step cracking is a relatively common defect, and is most likely to occur adjacent to windows, doors and other openings. Mortar failure in the gaps between affected bricks indicates the stresses and tensions affecting the wall.

Where step cracking is extensive or severe, the client is advised to consult a structural engineer. This minor step cracking can be used as a warning sign to address factors causing stress to the wall, which can include the effect of surrounding trees, water leaks, soil erosion, or even the presence of reactive soils in the surrounding area.

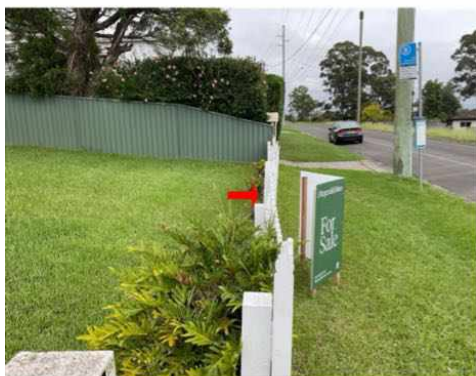
Building: Building 1
 Location: Front fence areas
 Finding: Fences damaged - leaning
 Information: Evidence of damage to the pictured fences was identified at the time of the inspection. The likely cause of this fence leaning is not enough concrete used in the post footings.

If left unmanaged this fence may deteriorate further. It is suggest a fencing contractor be engaged for rectification when convenient.

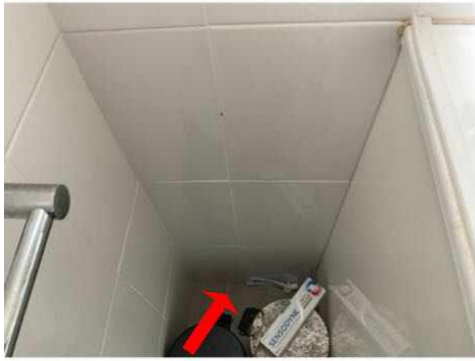
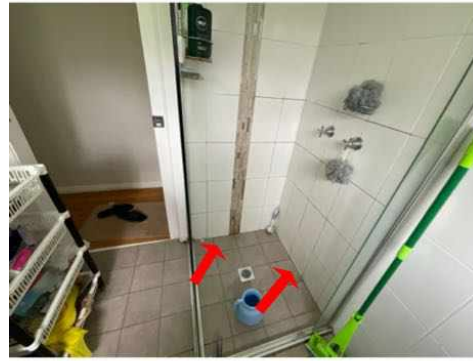
Finding 3.13

Building: Building 1
 Location: Bathroom
 Finding: Sealant and grouting - Missing or damaged
 Information: It was noted on inspection that sealant or grout is degraded to these pictured wet areas.

Different materials and floor areas move at different rates, generally causing cracking to grout or sealant at this point. A flexible sealant is required to allow for expected expansion and contraction, while keeping the joint water tight and protective of all associated building materials.

Flexible and mould resistant materials should be applied to affected areas to prevent any subsequent water damage that is likely to occur. Regular maintenance and replacement of damage or missing or damaged sealant and grout is highly recommended to the wet areas, as this is a regular wear and tear defect. Sealant and grouting in areas that come into regular contact with water should be maintained for the long term care of your property.

A sealant specialist or tiling contractor should be appointed to complete these works as soon as possible

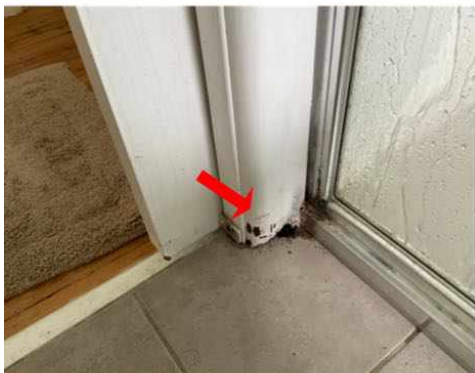
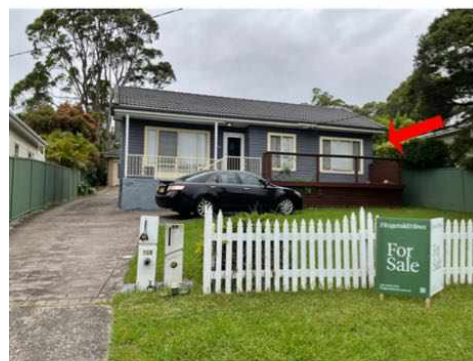
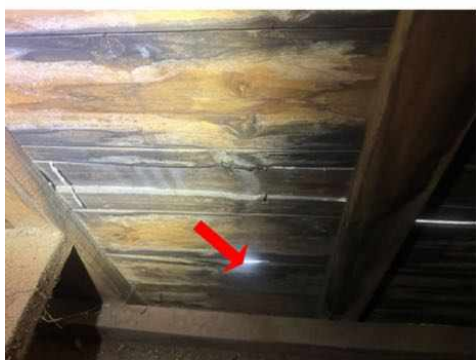
Finding 3.14

Building:	Building 1
Location:	Pictured right wall and bathroom
Finding:	Wood rot
Information:	The building shows evidence of wood rot. Wood rot, also known as Fungal Decay, occurs when timbers and other cellulose building materials are exposed to damp conditions on an ongoing basis. This could be the result of exposure to weathering over a prolonged period of time, or the attraction of excessive moisture from other abutting building materials.

Early intervention and regular maintenance, particularly of exterior timbers, will prolong the useful life of these building elements. Prior to any works being performed, the cause of the moisture that has created the visible wood rot should be identified and addressed in a suitable manner. Replacement of affected timbers may then be a necessary step in protecting surrounding building elements from such deterioration.

A qualified carpenter or registered builder may also be required to replace affected building materials.

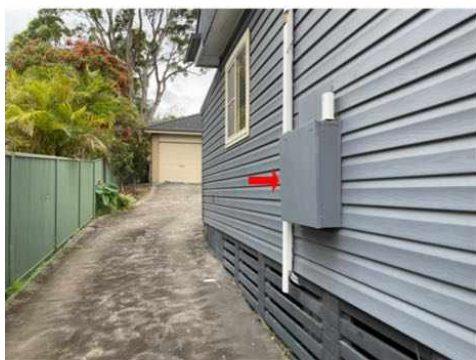
Building:	Building 1
Location:	Meter Box
Finding:	Termite Management System - no evidence of a chemical installation
Information:	The application of a post-construction chemical termite barrier is highly recommended for all properties. Such barriers are highly effective in preventing termite attack on any timber building elements throughout the property.

to suggest preventative works taking place since the property was built.

The client may consider gaining further advice from a pest controller as to the costs and procedures involved with a 'chemical' application. It is recommended that obtaining such advice be a short-term priority.

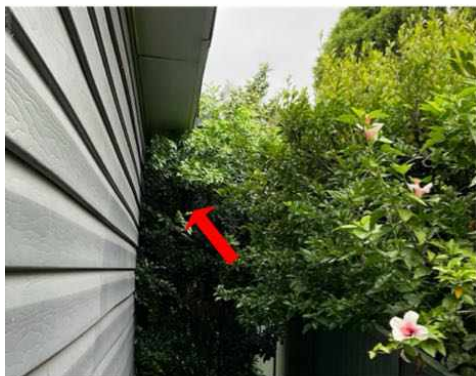
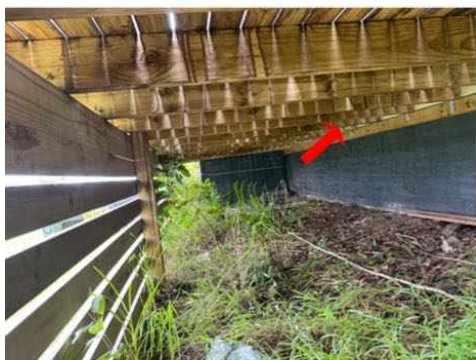
Finding 6.02

Building:	Building 1
Location:	Yard - front
Finding:	Bridging - Vegetation and decking
Information:	Where vegetation and decking obstructs inspection of building elements, also known as bridging as it provides a bridging point for the access of termites, full inspection can not be achieved. Consequently moisture or dampness may be present and the areas becomes conducive to termite activity. Plants and decks against or very close to buildings provide cover, shade and can provide an environment that is attractive to termite infestation.

The removal of any such stored building or plant materials that may be conducive to termite activity should be carried out as soon as possible and arrange re inspection to minimize the risk of termite attack.

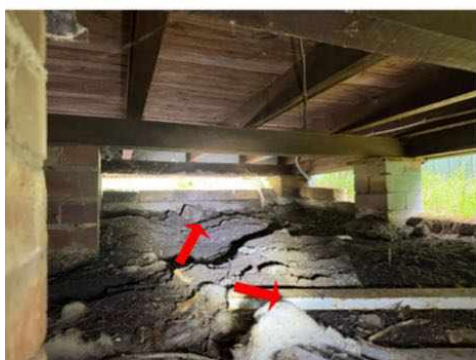
Finding 6.03

Building:	Building 1
Location:	Subfloor
Finding:	Timber in contact with the ground
Information:	Any timbers in direct ground contact provide opportunity for concealed termite entry and are likely to be subject to premature rot and decay as the soil retains moisture or damp conditions against the timbers.

Removal of all waste timber that is in direct contact with ground is highly advised. This timber is promoting mould and wood rot and is very attractive to termites.

Frequent pest inspections are advised to readily identify any termite activity in these areas.

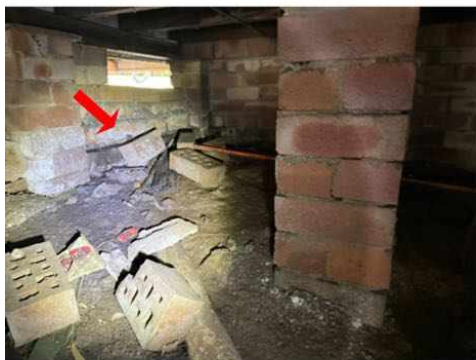
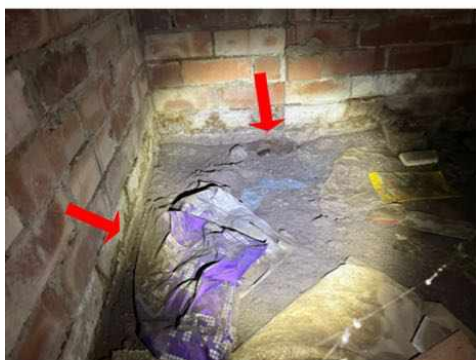
Rising damp is generally managed by the installation of a damp proof course during construction. A Damp Proof Course (DPC) is an impermeable barrier at the base of the wall above ground level. However, many 19th Century buildings have no damp course installed, or the materials have failed. The DPC may have been omitted as a

consequence of poor workmanship, or it may have been bridged where materials built up against the side of the house allow moisture ingress above the DPC level.

The first step in addressing rising damp is to diagnose the cause. The identified cause should be addressed first before addressing the appearance and other defects which have resulted from the rising damp. If the original cause is not resolved, further cases of damp are likely to ensue, resulting in secondary defects.

Consultation with a qualified plumber is advised immediately to identify the cause of the damp and perform remedial works as required.

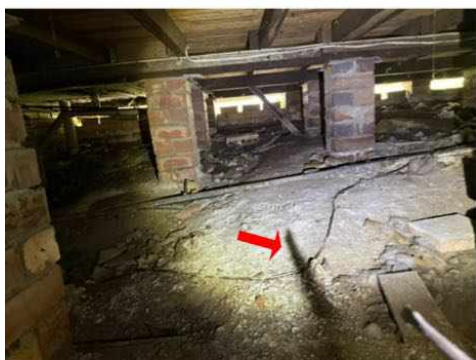
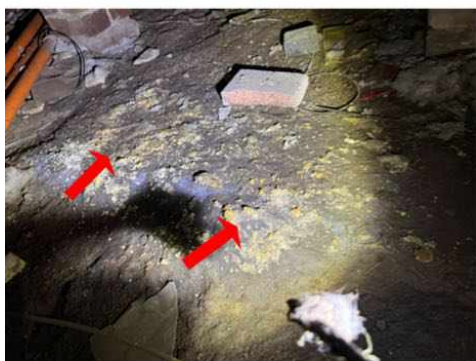
Finding 6.06

Building:	Building 1
Location:	Subfloor
Finding:	Mould - Present in subfloor
Information:	Where evidence of mould growth was noted, there may be environmental, biological or health issues associated with the report. A specialist inspection by a suitably qualified environmental health inspector is warranted, where mould is extensive or where any

Subfloor mould is generally caused by moisture ingress, lack of external drainage, lack of adequate ventilation and subfloor debris present. These issues need rectification

Generally, the client is advised to ensure that the general environment is free of moisture and humidity to aid in the prevention of mould formation and development.

to stop mould development. Any mould found during the inspection should be cleaned immediately by a cleaning contractor or the homeowner as applicable.

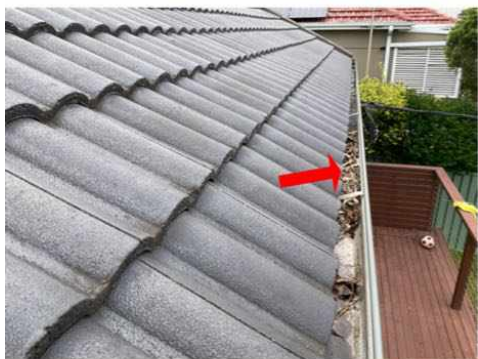
Finding 6.07

Building:	Building 1
Location:	Roof exterior
Finding:	Gutters - Full and blocked
Information:	The guttering on around the roof was found to be blocked at the time of the inspection. Roof plumbing structures, such as guttering and downpipes, should be free of all debris to prevent blockages. Blockages of the guttering and downpipes will lead to pooling and accumulated water overflows, which is likely to subsequently flood eaves and exterior walls.

Blocked gutters are likely to lead to high levels of moisture in the affected areas. Such moisture will not only cause rust and decay of the associated building materials, but

can also provide conditions that are conducive to termite and timber pest activity. Blockages in gutters should therefore be removed immediately to ensure dry conditions are maintained.

It is highly advised that gutters be cleaned by the homeowner or a general handyman as a matter of urgency.

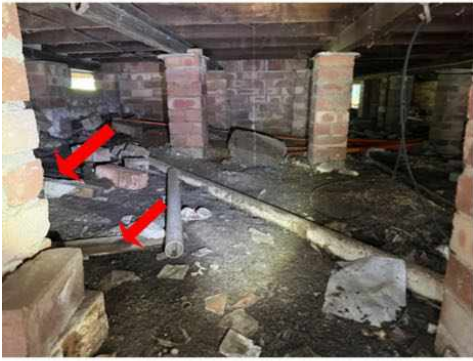
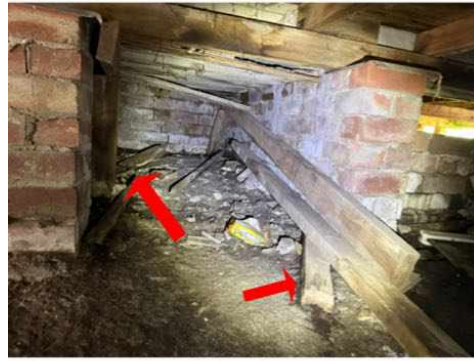
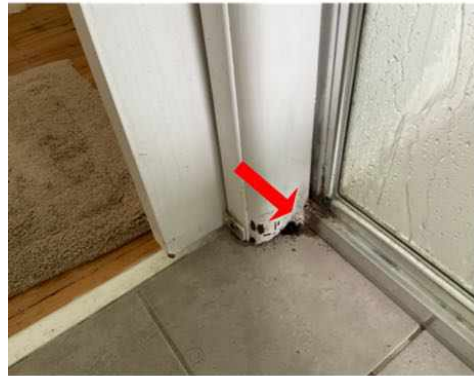
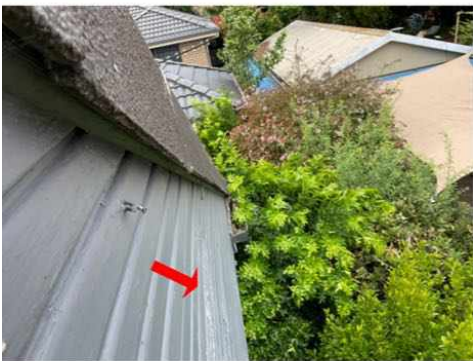
Finding 7.01

Building:	Building 1
Location:	Verandah
Finding:	Fungal decay - present (localised)
Information:	Fungal decay also known as wood decay or wood rot generally refers to the deterioration of timber elements when in contact with excessive levels of moisture for a prolonged period of time.

The development of fungal decay is accelerated by temperatures from 5degreeC to 40degreeC as well as the presence of oxygen. Generally fungal decay develops on timber elements that are in use in an external environment which are exposed to rain penetration.

In this case, the affected timber element is in a decaying state and will need replacement by a carpenter or licensed builder.

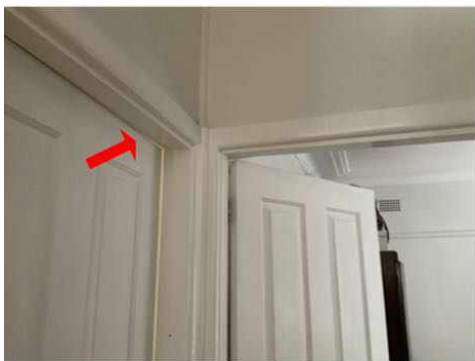
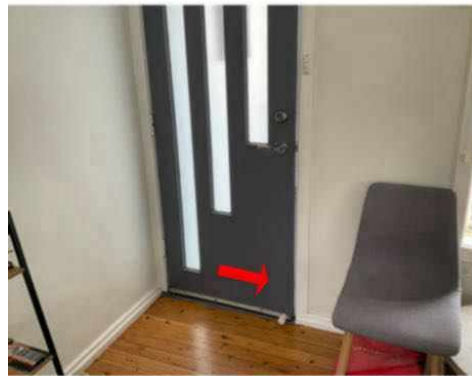
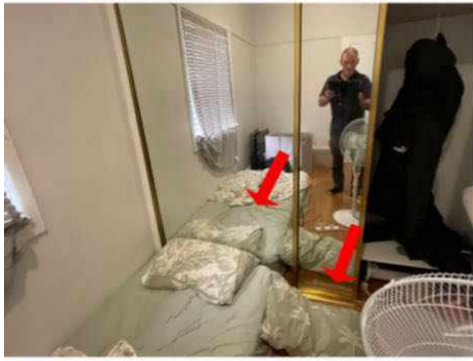
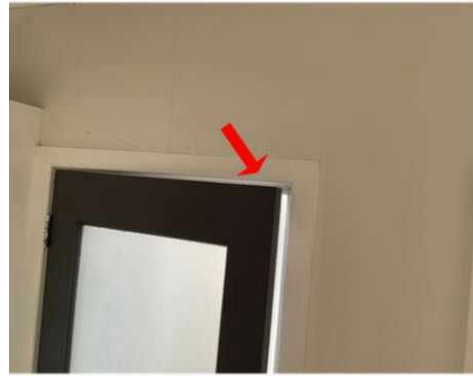
Building:	Building 1
Location:	Many doors
Finding:	Doors - Binding/jamming
Information:	Binding and/or jamming of these 3 doors is evident during standard operation. This defect inhibits the functionality of the affected doors making them hard to use as well as creating potential for secondary defects to associated building elements, such as damage to the floor covering or the adjoining door jamb.

For minor causes, a qualified carpenter or general handyperson should be appointed to perform minor rectification works at client discretion.

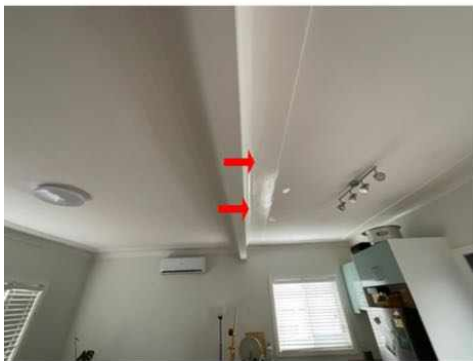
Building: Building 1
 Location: Kitchen
 Finding: Ceiling repairs evident - pictures for your information
 Information:

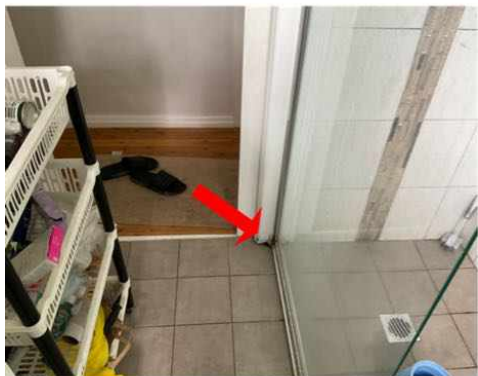
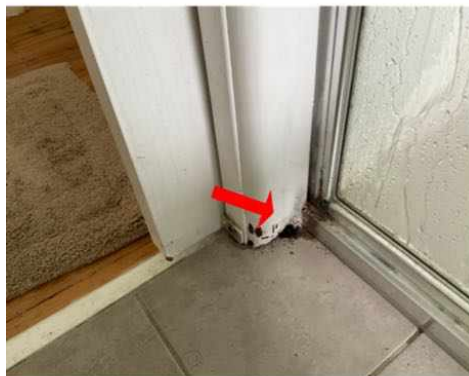
Building: Building 1
 Location: Bathroom architrave
 Finding: Waterproofing membranes - Information Only
 Information: Internal Water Proofing Membranes, are crucial in preventing water ingress into the property is important to know that the Membrane System used is to Australian Standards and has been installed correctly.

evident to any adjacent walls or ceilings below a licensed builder or waterproofing specialist is recommended to investigate further.

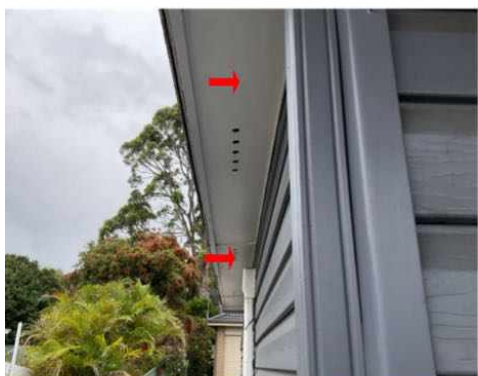
Building:	Building 1
Location:	Roof exterior
Finding:	Asbestos - Suspected ACM Identified on Site
Information:	Reporting on Asbestos is outside the Scope of this Report. This suspected defect is highlighted as a caution only. We suspect, based on our experience in the building industry, that there is a higher risk of the identified building element containing asbestos.

In the interim, the client is advised to act with caution, especially when considering any damage to building materials general wear and tear renovations extensions demolition and general maintenance activities due to the suspected presence of Asbestos.
