Building and Timber Pest Inspection Report

Inspection Date: Tue, 27 Jan 2026

Property Address: 87 Hastings St, The Ponds NSW 2769,
Australia

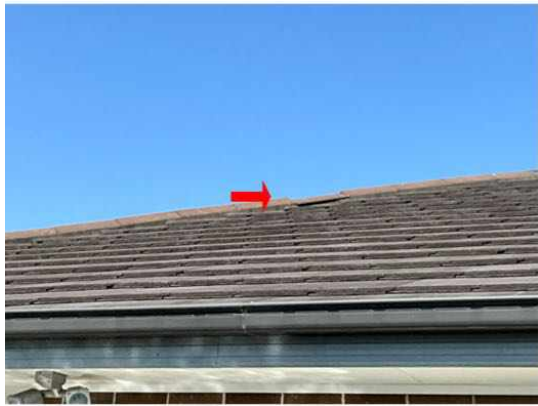
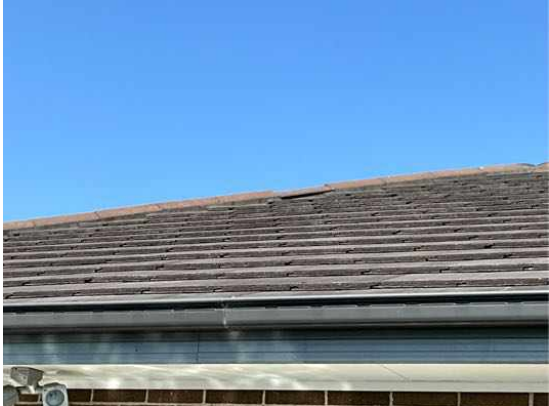
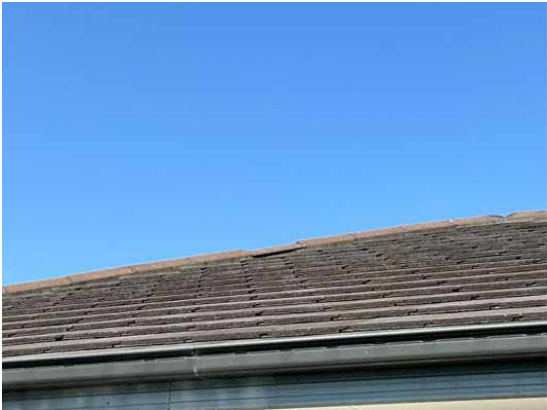
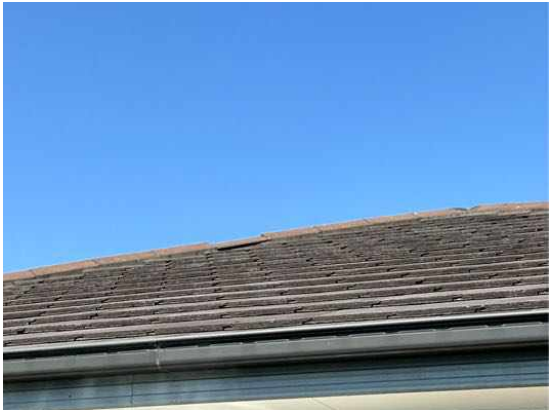
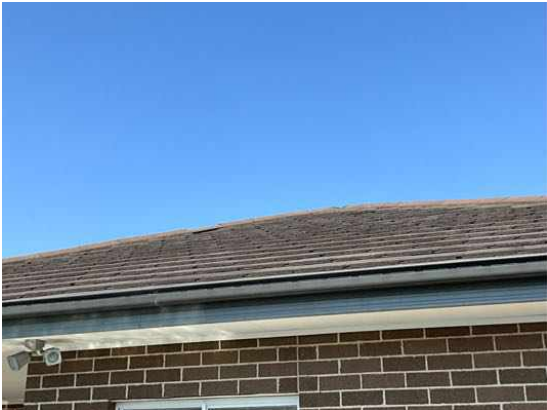
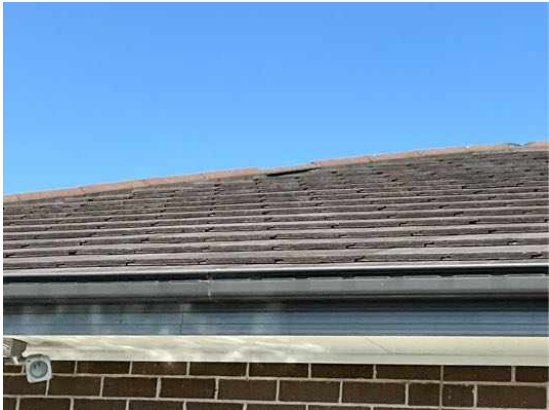
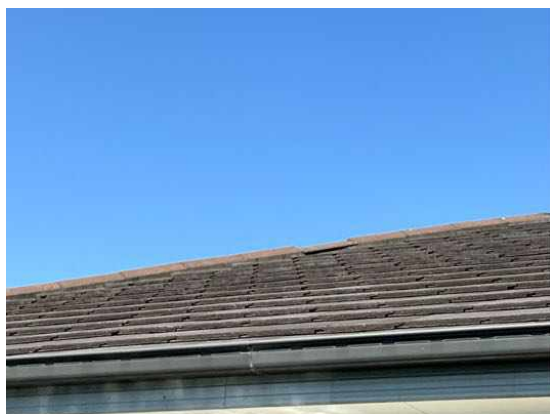
tiles show loss of surface finish, colour fading, and age-related deterioration typical of older roof coverings, weathering can lead to increased porosity, reduced water-shedding capability, and a higher risk of future cracking or displacement during adverse weather conditions.

A licensed roofer should be engaged to undertake a closer inspection, carry out routine maintenance, and replace any tiles that may be compromised. Ongoing monitoring is recommended due to the age and condition of the roof covering.

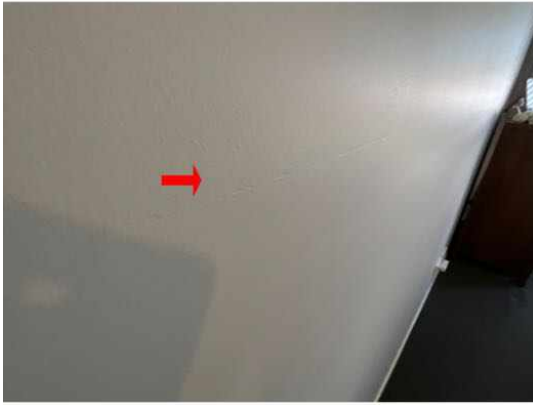
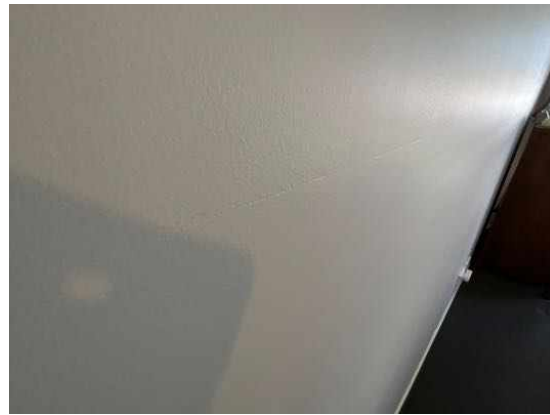
Finding 3.02

Building:	Main Building
Location:	Bedroom - Master
Finding:	Paint surface - Scratches
Information:	Scratches have been identified on the paint surface, detracting from the overall appearance and quality of the painted surface.

1. Aesthetic Degradation: Scratches mar the appearance of the painted surface, diminishing its visual appeal and potentially lowering property value.
2. Corrosion Vulnerability: Exposed areas of bare metal due to scratched paint are susceptible to corrosion, leading to structural damage and compromised durability.
3. Environmental Hazards: Scratched paint can release hazardous chemicals into the environment, posing risks to both human health and the ecosystem.

A qualified painter should address the issue promptly to repair the scratched paint. Depending on the severity of the scratches, repair options may include sanding, priming, and repainting the affected area to restore the integrity and appearance of the paint surface.

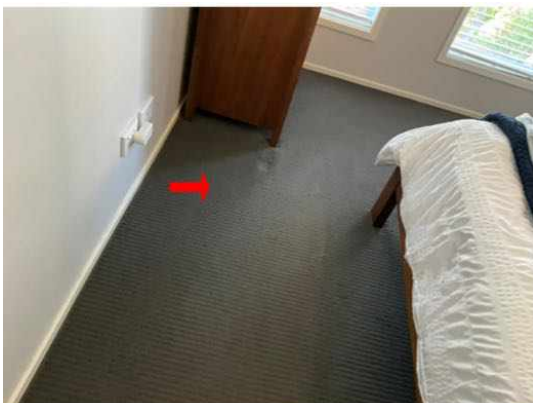
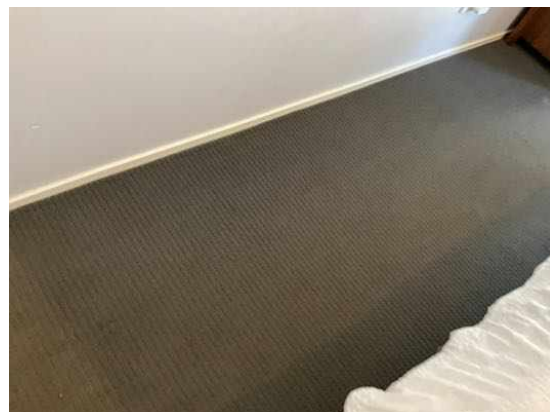
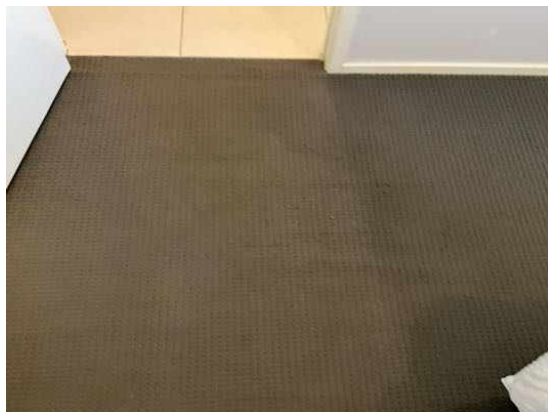
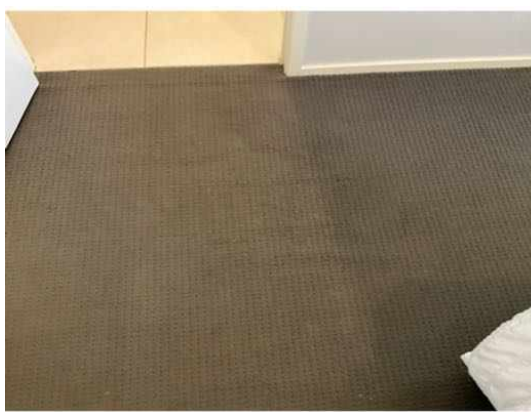
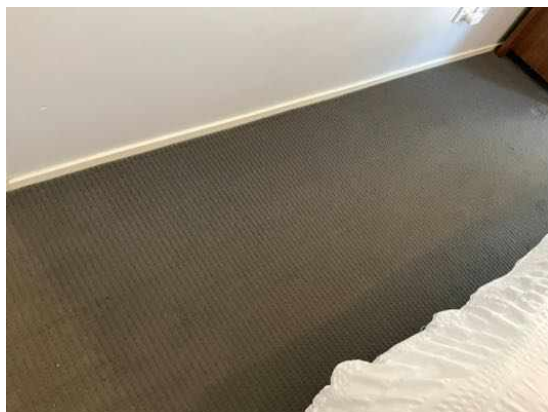
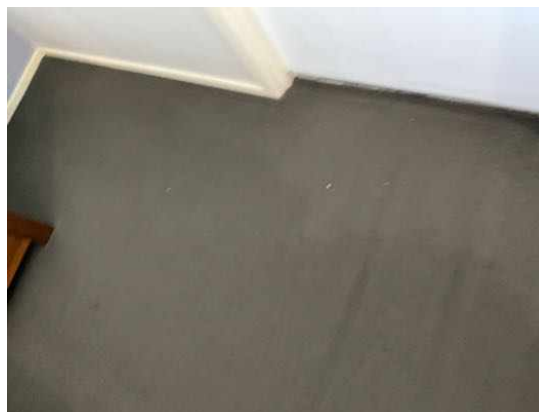
Finding 3.03

Building:	Main Building
Location:	All Areas
Finding:	carpet exhibits visible signs of aging
Information:	Carpets are exhibiting visible signs of aging, including fraying edges, faded colors, and flattened fibers, diminishing their aesthetic appeal and functional quality.

The risk associated with aging carpets includes diminished appearance, decreased comfort, potential tripping hazards due to frayed edges, and a negative impact on indoor air quality if fibers begin to degrade and release particles into the air.

Professional carpet cleaning and restoration services can address issues such as deep cleaning to rejuvenate colors, repairing frayed edges, and restoring fibers. Additionally, replacing the carpets entirely may be necessary in severe cases of aging or damage beyond repair.

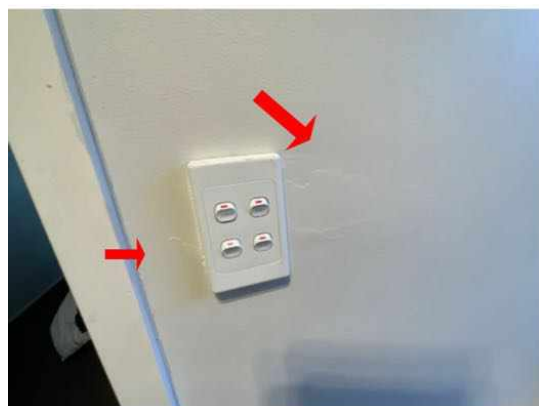
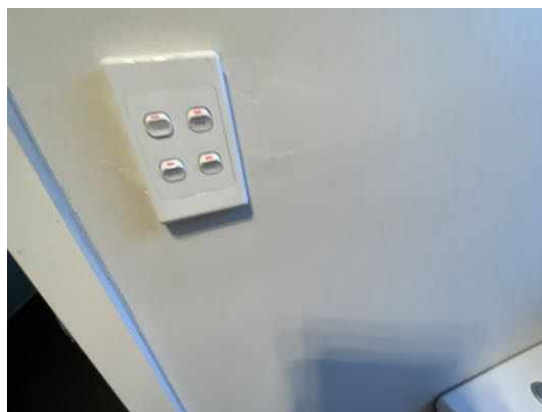
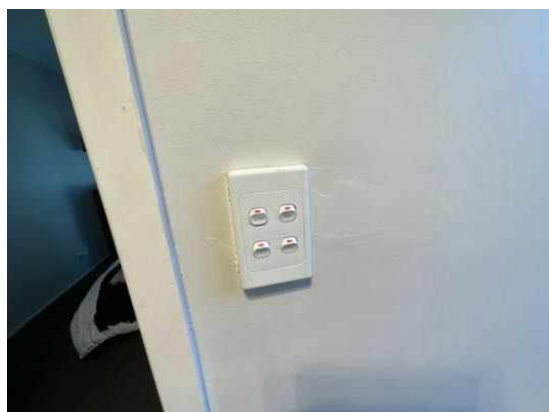
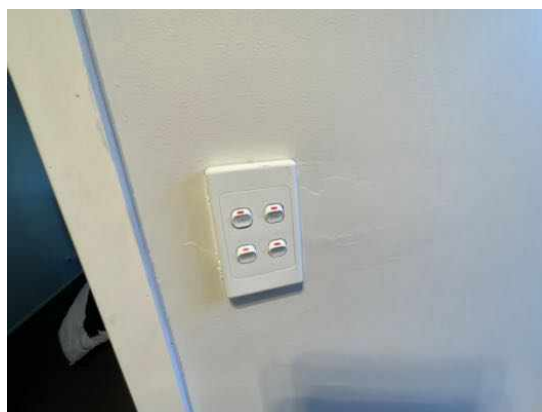
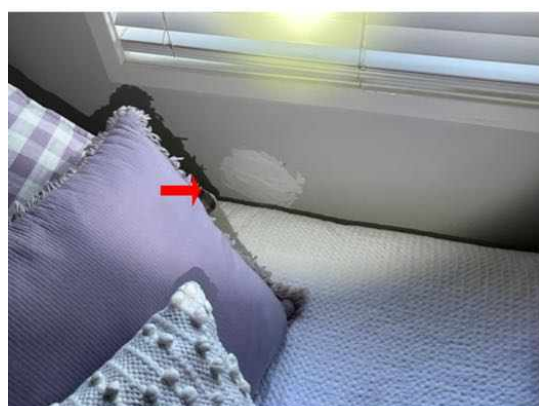
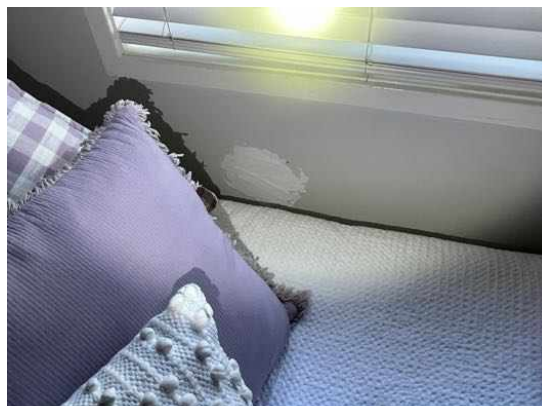
Finding 3.04

Building:	Main Building
Location:	Ensuite - Master
Finding:	Poor workmanship
Information:	The structure exhibits signs of poor workmanship, evident in various aspects of construction and finishing.

Risk: Poor workmanship poses a range of risks, including compromised structural integrity, potential safety hazards, and a decreased lifespan of the structure. It may also lead to aesthetic and functional issues.

Resolution: A qualified contractor or construction professional should be consulted to assess and address the poor workmanship. They can implement corrective measures to ensure structural soundness, safety, and overall quality of the construction.

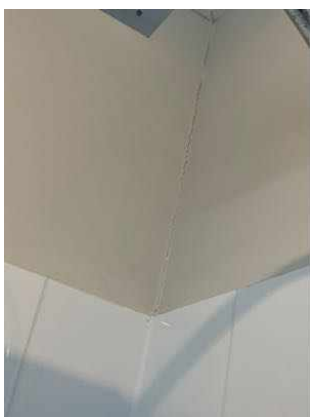
Finding: Gyprock - Crack (Fine)
 Information: Fine cracks have appeared in the gyprock , suggesting potential issues with settling or structural movement.

The fine cracks in the gyprock ceiling pose a risk of further widening, compromising the aesthetic appeal of the space, and potentially indicating underlying structural problems.

A skilled plasterer or a contractor specializing in drywall repairs should assess the extent of the cracks and address them promptly. Identifying and fixing the root cause of the issue, whether related to settling or structural concerns, is essential to prevent further damage and maintain the integrity of the ceiling.

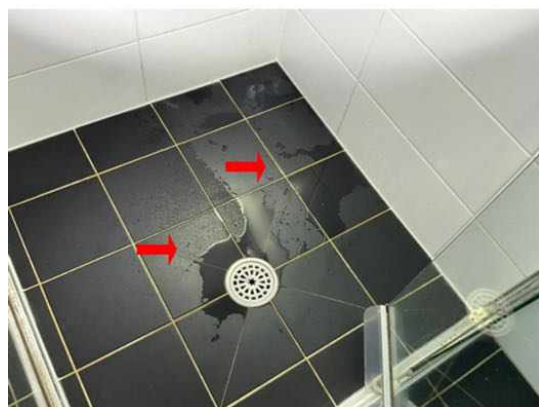
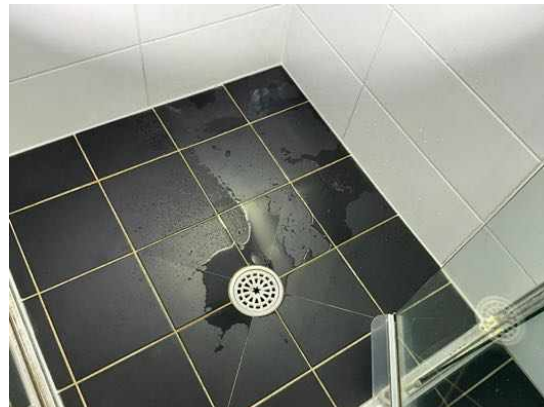
Building:	Main Building
Location:	Bathroom
Finding:	Shower base - Water pooling
Information:	Evidence of water pooling around the floor waste in the shower recess was noticed at the time of inspection. It is suspected that this excessive moisture is attributed to insufficient fall in the shower floor tiles.

This pooling is minor overall but is still considered unsatisfactory, as standard tiling practices would not permit this situation to occur. Pooling water around floor wastes can create a slip hazard in extreme cases and create conditions that are conducive to mould growth over time. Where left unmanaged, the degradation of sealant and grouting is also likely to occur, possibly necessitating further repair works.

Remedial works may involve some sections of tiling and flooring repair and replacement. A tiling contractor or bathroom specialist should be appointed to provide further advice on reparation options and to perform works as necessary.

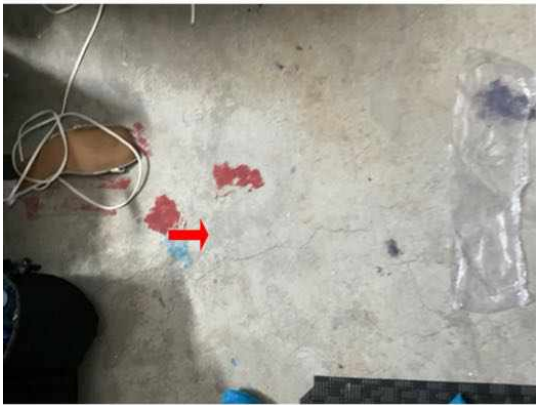
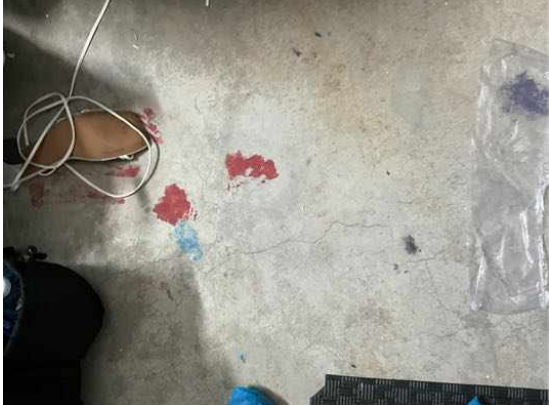
Finding: Crack in concrete slab - Category 0

Information: A crack coded as Category 0 was identified in the slab. A Category 0 crack is described as a hairline crack, representing insignificant movement of slab from level.

The approximate width of the crack to be considered Category 0 is 0.3mm, or change in offset of less than 8mm when a 3m straight edge is placed over the defect.

No rectification is required at this time. However, all cracking should be monitored over a 12 month period to identify any further damage in the area.

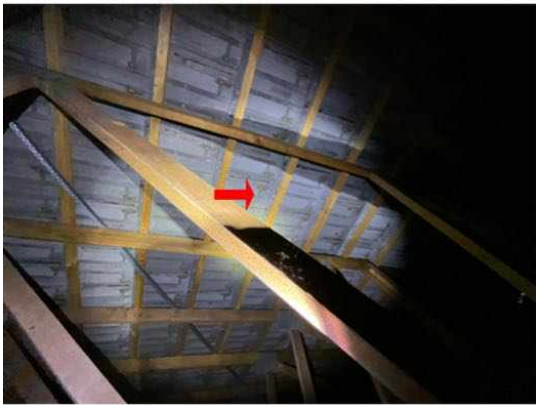
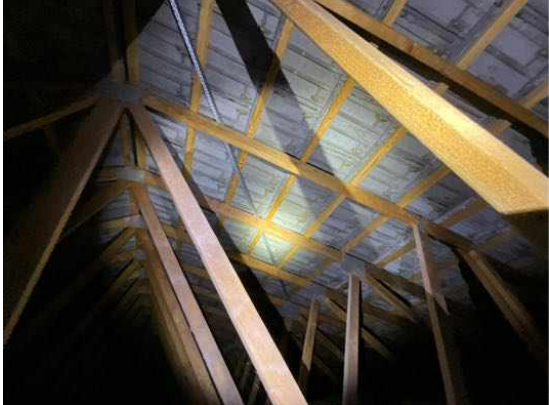
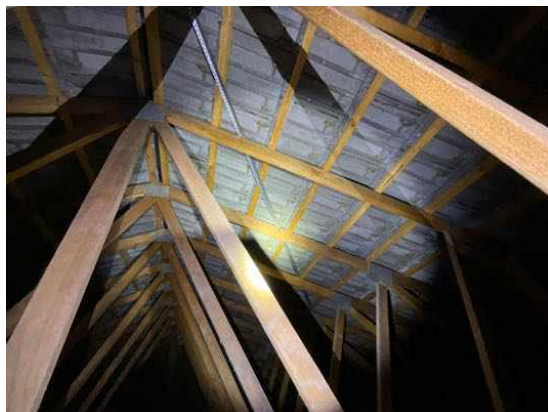
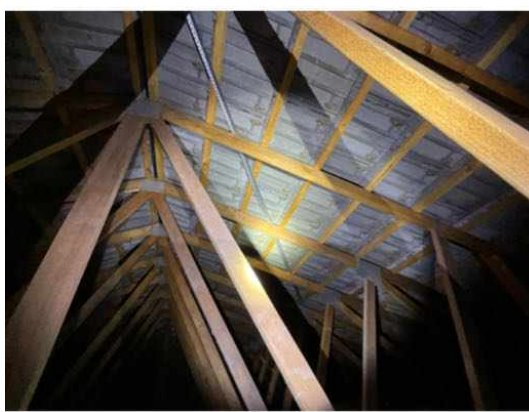
Finding 3.11

Building: Main Building
Location: Roof Void
Finding: Sarking - Missing
Information: Sarking is missing under the roof sheeting. Sarking acts as an insulator that helps with noise reduction and protects against water penetration. Sarking plays a key role in the operation and function of the overall roofing structure and its performance.

Although not a requirement at the time of construction, replacement of any missing building element is advisable (although this can be quite expensive to do after the time of construction). Where sarking is missing, regular inspections of the roof tiles for cracking and potential moisture penetration is required.

Sarking may be retrospectively fitted by a registered builder at the discretion of the client.

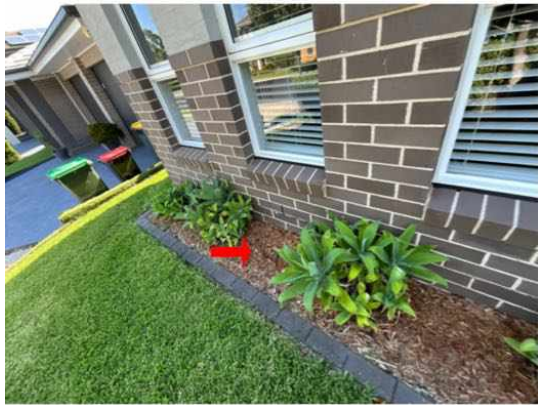
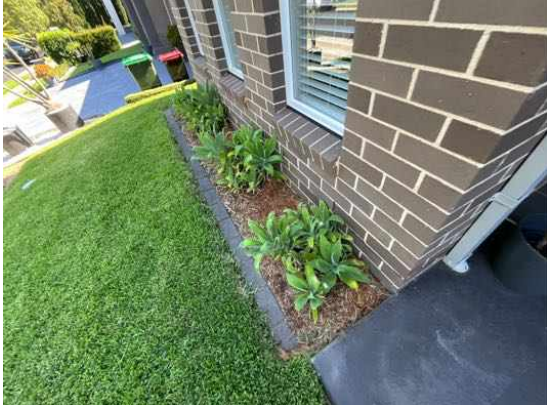
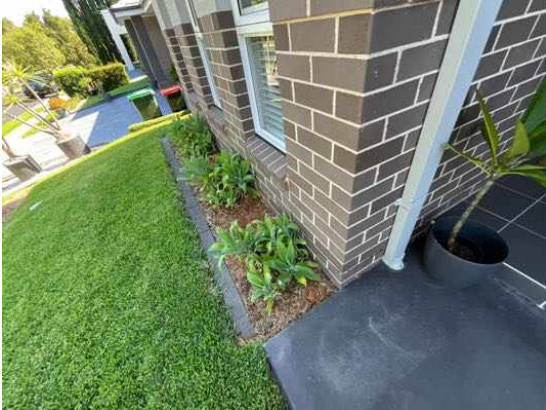
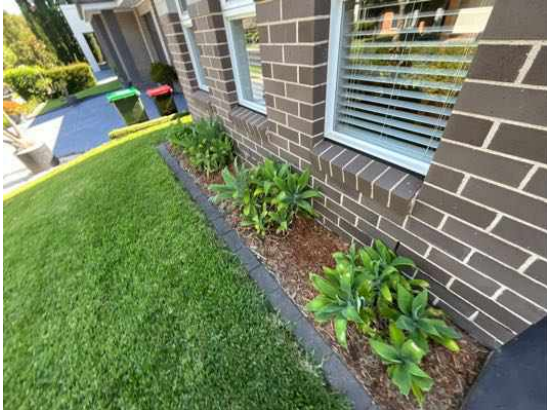
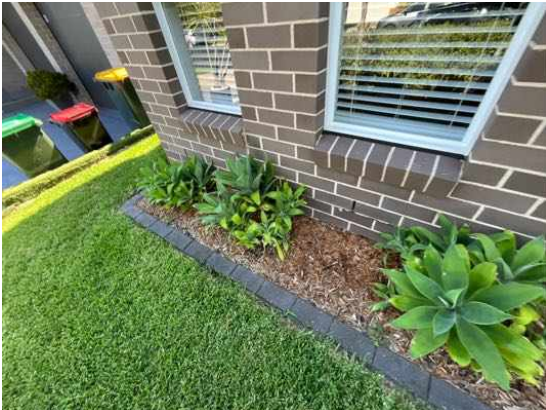
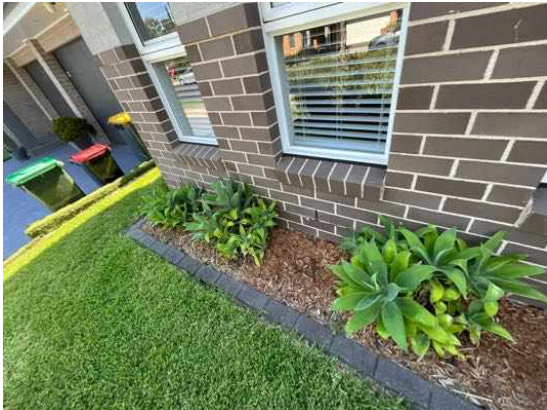
If the slab edge is not properly exposed there is a high risk of termite attack. Sometimes, in order to determine the type of slab, a suitably qualified person such as an architect or builder may be required to consult the construction plans.

Where the slab edge cannot be properly inspected, it is highly recommended that termite or timber pest inspections be carried out every 6-12 months to aid protection of the property against infestation.

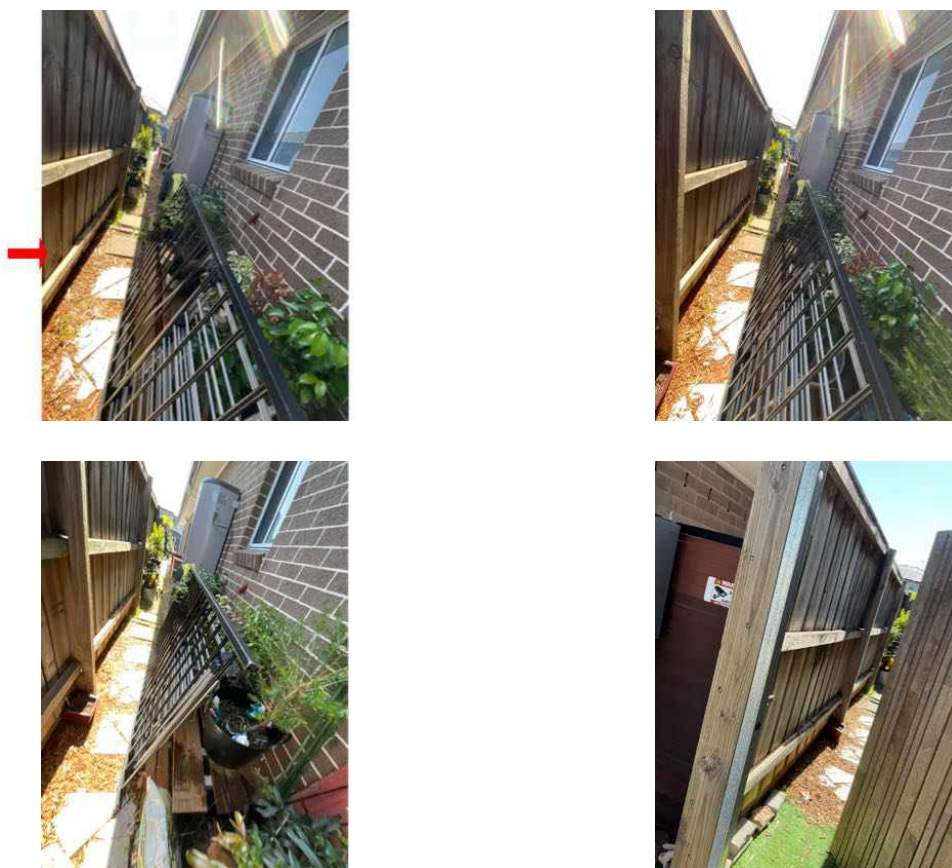
Finding 6.04

Building:	Main Building
Location:	All Areas
Finding:	Timber on ground / conducive conditions to termite damage
Information:	Timber on the ground is indeed conducive to termite damage. Termites are known to thrive in moist environments, and wood in contact with soil or moisture is more susceptible to infestation.

To prevent this, it's important to keep timber elevated and away from direct ground contact. Regular inspections and proper termite control measures are also essential to protect your wooden structures from termite damage.
