# Building and Timber Pest Inspection Report

Inspection Date: Fri, 30 Jan 2026

Property Address: 8002B Vista Dr, Benowa QLD 4217,  
Australia

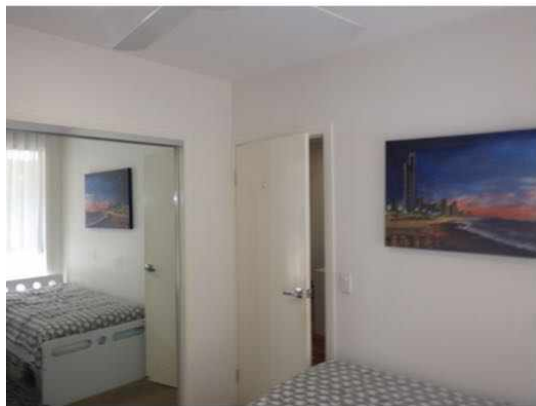
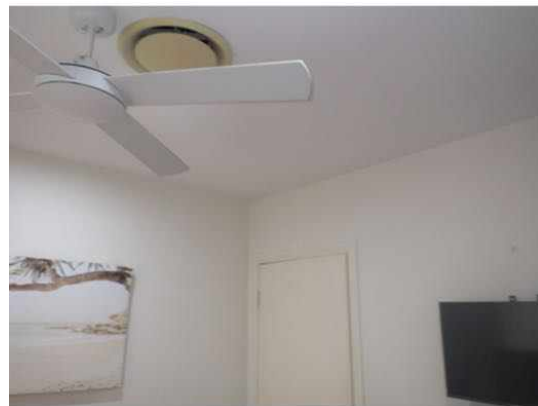
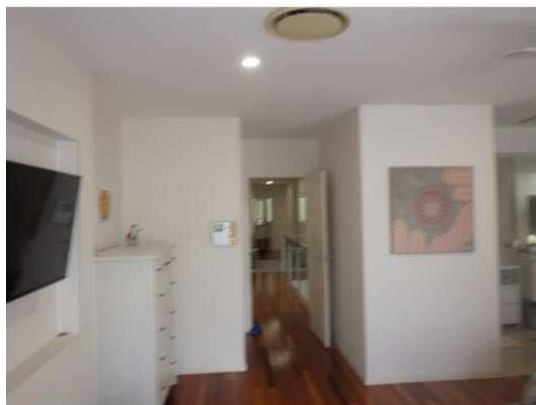
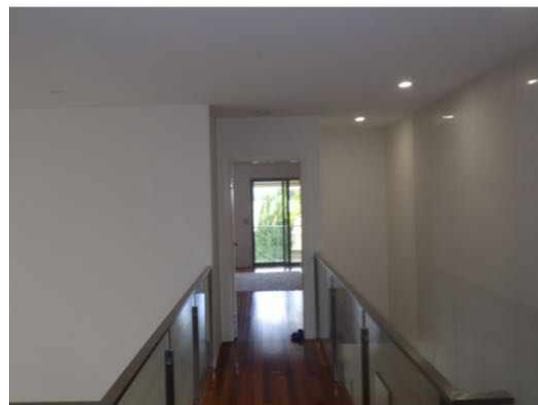
Building:	Main Building
Location:	Internal Areas > Existing
Finding:	Smoke Detectors and Alarms
Information:	At the time of inspection it was noted there was no interconnected photoelectric smoke detectors installed in the hallways or any of the bedrooms.

Please note that this defect is highlighted as a caution only. We suspect, based on our experience in the building industry, that the absence of smoke detectors, or their poor condition, should be addressed as a matter of urgency to improve occupant safety.

A qualified electrician should be engaged to install photoelectric smoke detectors and provide certification documentation to confirm smoke detector types, locations and compliance.

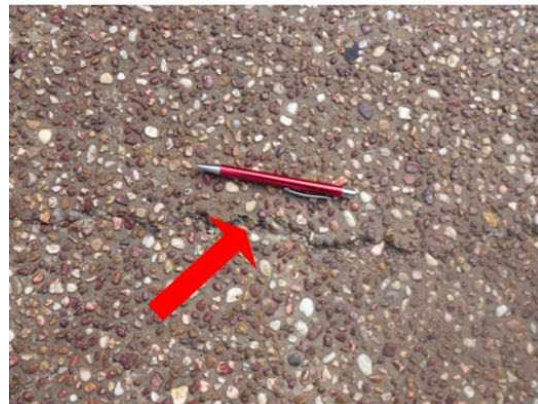
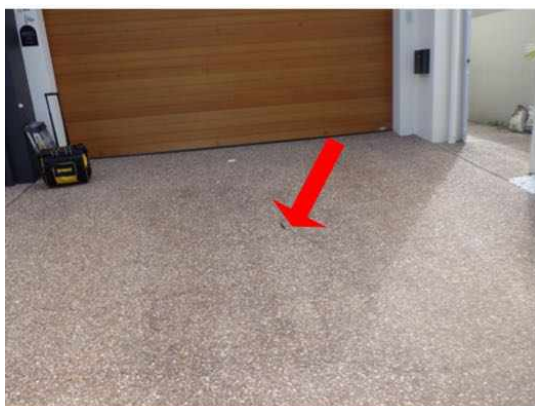
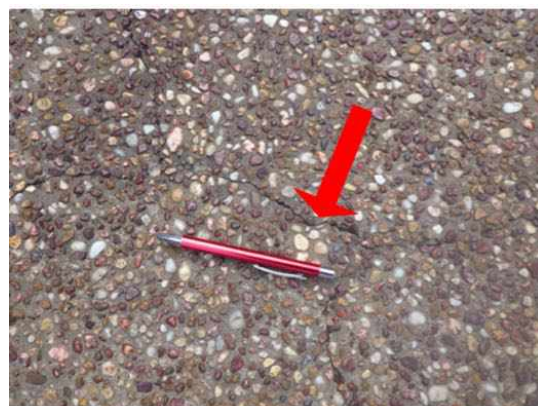
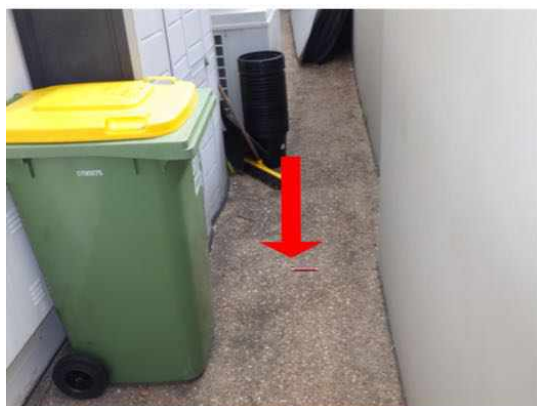
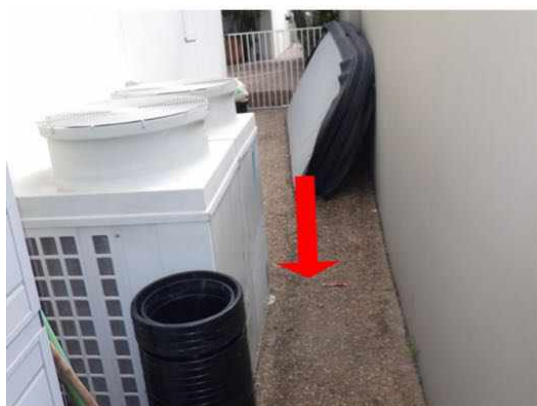
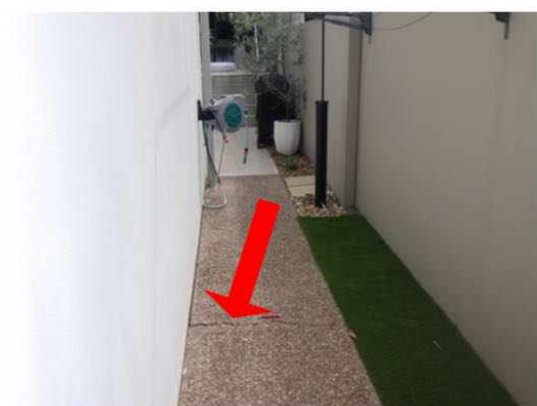
Building: Main Building  
Location: Driveway > Ground Level  
Finding: Cracking in concrete slab - Category 1  
Information: Cracking coded as Category 1 was identified in the driveway and footpaths concrete slabs. A Category 1 crack is described as a fine but noticeable crack, with the slab at an otherwise reasonable level.

To be considered Category 1, the approximate width of the crack is less than 1.0mm, or a less than 10mm change in offset when a 3m straight edge is placed over the defect.

Category 1 cracks should be monitored for a period of 12 months. At the end of the monitoring period, identified cracks that are rated greater than Category 2 are considered defects, and require rectification.

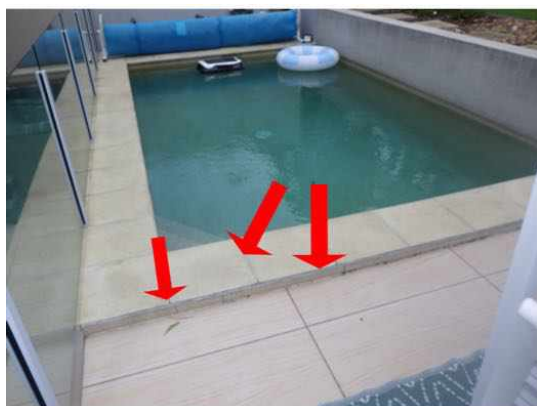
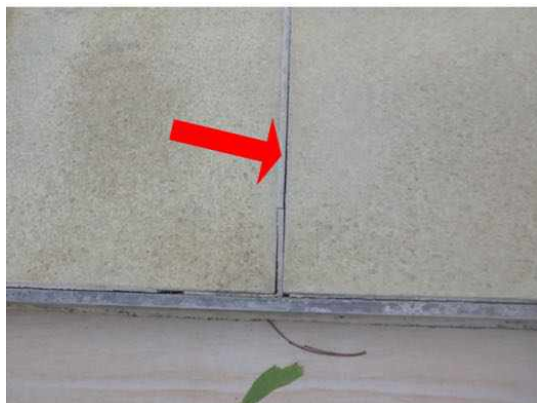
### Finding 3.02

Building:	Main Building
Location:	Pool Area > Front Left
Finding:	Sealant and grouting
Information:	It was noted on inspection that sealant or grout has deteriorated to the pool area coping tiles on the front left side. Grout is used to protect gaps and crevices in building materials to ensure that they are water-tight and prevent water penetration to associated structures.

A sealant specialist or tiling contractor should be appointed to complete repair work.

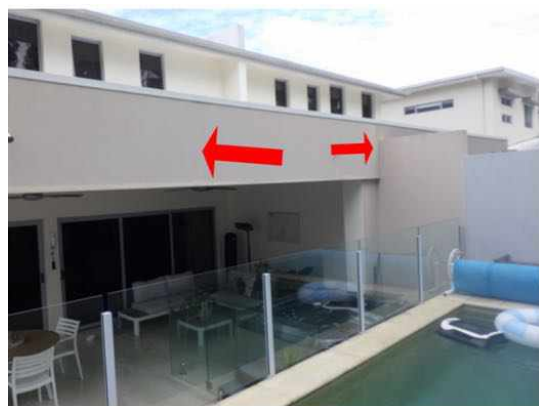
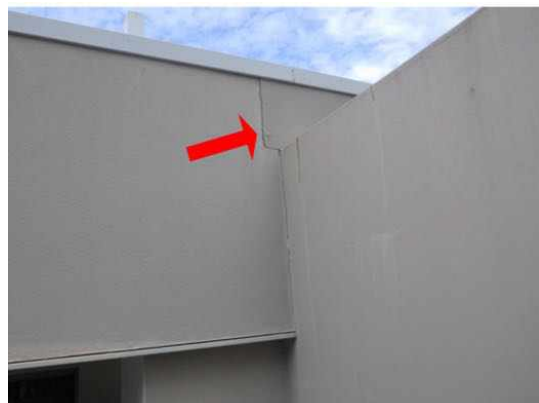
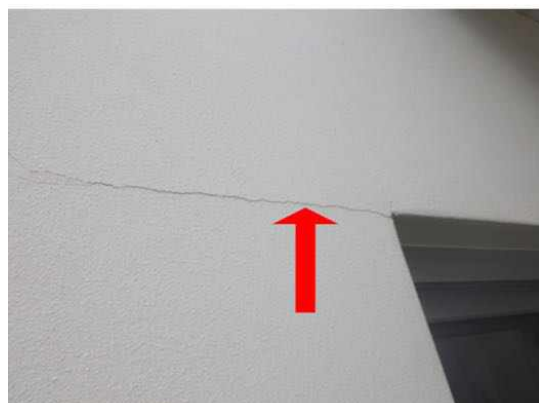
### Finding 3.03

Building:	Main Building
Location:	Exterior walls - rear > Rear
Finding:	Cracking - Walls
Information:	There is minor cracking to areas of the exterior wall cladding or render at the rear of the building (as per example photos). The cracking appears to be concentrated at the vertical joints of the wall sheeting and is generally minor in nature. It is assumed the cracking is the result of normal building movement or substandard workmanship at the time of construction.

A licensed solid plasterer or qualified painter could be consulted regarding rectification options.

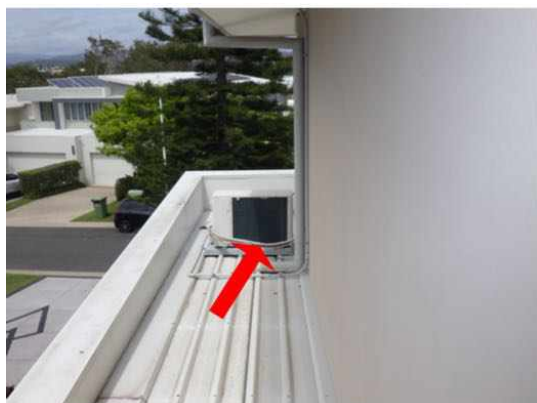
### Finding 3.04

Building:	Main Building
Location:	Exterior walls - right side > Centre Right
Finding:	Pipework - Insulation deteriorated
Information:	At the time of inspection sections of the air conditioning unit pipe work insulation showed evidence of damage and deterioration. It is suspected that this deterioration has developed as a result of excessive exposure to weather, including UV exposure in daylight. Deteriorated insulation reduces the effectiveness of the material in helping to maintain the desired temperature and work most efficiently.

If left in an exposed position, it is likely that the deterioration will continue and worsen over time, potentially resulting in secondary building defects as well as a further loss in

insulating properties.

Some areas of replacement of pipe insulation is likely to be required. Further preventative measures to remove or protect the material from future exposure are also advisable. Consultation with a licensed air conditioning installer is advised to gain quotes for the repair and/or replacement of deteriorated insulation.

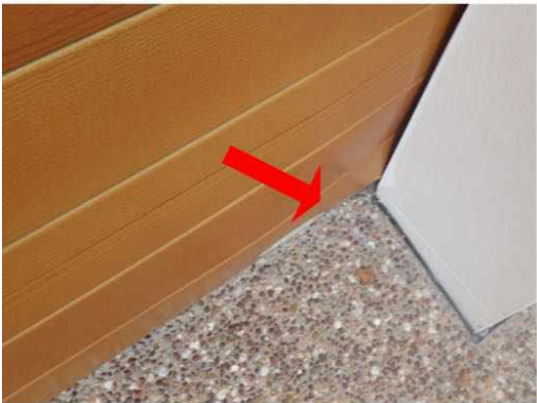
### Finding 3.05

Building:	Main Building
Location:	Garage > Front Right
Finding:	Garage door - dent
Information:	The garage door has a minor dent likely to have resulted from impact damage be it accidental or deliberate impact at sometime.

Repair and/or replacement of the garage door panel would improve the condition of the garage door but certainly not an urgent item

A qualified sectional door installer or supplier could be engaged to check out the operation and overall condition of the door to determine if repair is an option otherwise replacement of the bottom panel may need to be considered.

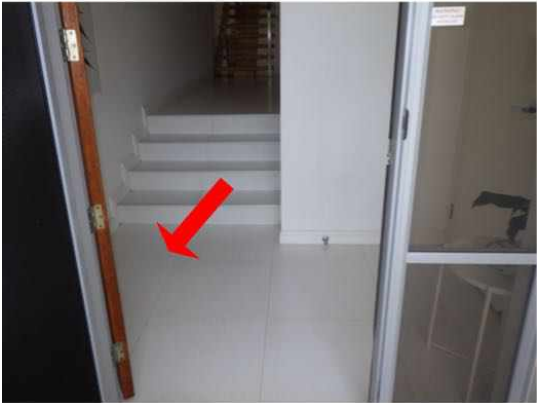
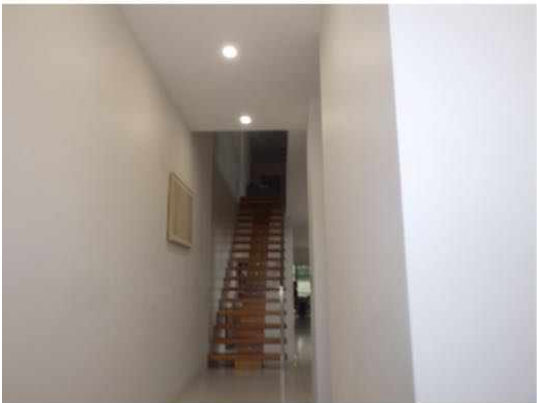
**Finding 3.06**

Building: Main Building  
Location: Entry > Centre Left  
Finding: Tile - Drummy  
Information:

A drummy tile to the entry area floor was identified at the time of inspection. The term 'drummy' refers to tiles that have become detached from their fixing, despite otherwise being in relatively good condition. Such defects are generally caused by physical or moisture damage to the area. Drummy tiled areas may also be a direct result of poor workmanship during the construction process.

A tiling contractor could be appointed to undertake repair works if necessary.

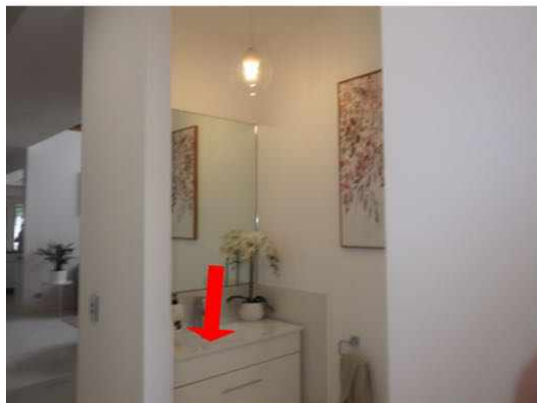
### Finding 3.07

Building:	Main Building
Location:	Powder Room > Centre
Finding:	Basin - Pop up waste stiff.
Information:	The powder room basin pop up waste was stiff to operate at the time of inspection. It is advised that maintenance is carried out on the waste so as it functions as intended.  A handyman could be appointed to perform any remedial works where required.

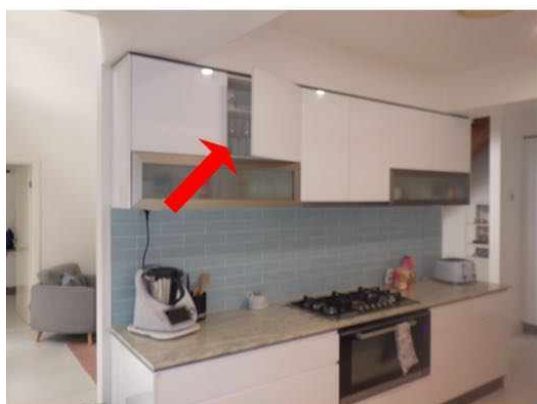
### Finding 3.08

Building:	Main Building
Location:	Kitchen > Centre Left
Finding:	Magnetic Catch
Information:	At the time of inspection the magnetic push catch to the left side overhead cupboard door was missing.  A general handyman could be engaged to replace the magnetic push catch at the clients discretion.

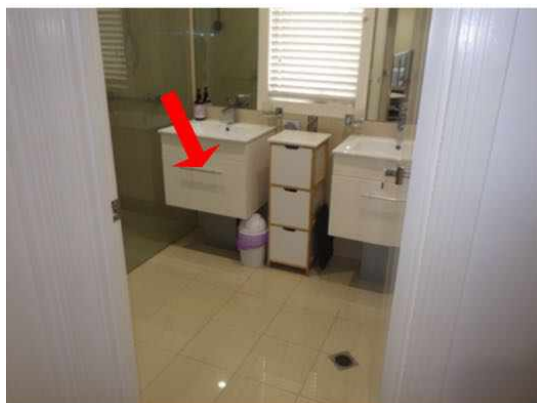
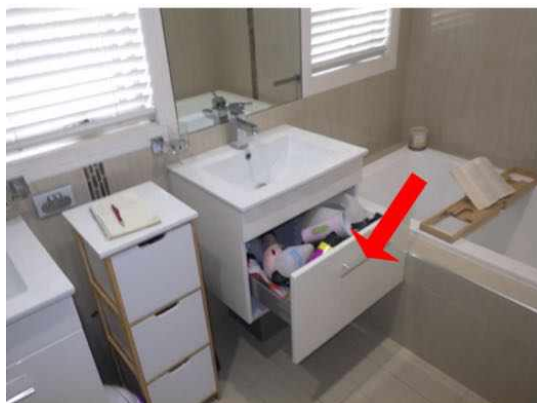
### Finding 3.09

Building: Main Building  
 Location: Bathroom > Centre  
 Finding: Handles - Loose  
 Information: The bathroom cabinetry drawer handles were found to be loose at the time of inspection. Breakage occurs generally when the building materials have aged and decayed.

Repair of the loose drawer handles is advised to improve the operational state of the cabinetry.

A general handyman could be appointed to re-tighten the drawer handles at the client's discretion.

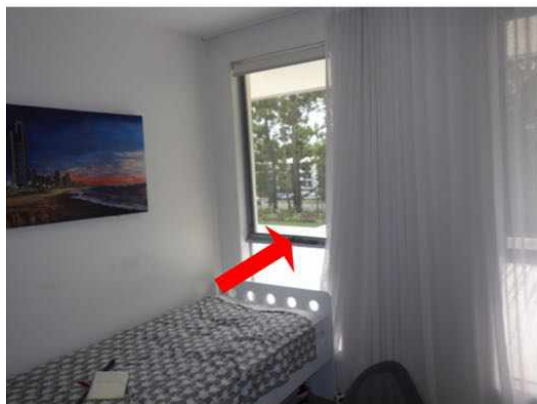
### Finding 3.10

Building: Main Building  
 Location: Bedroom 3 > Centre Left  
 Finding: Window - Broken handle  
 Information: The window winder handle to the bedroom 3 left side awning window was found to be broken or not functioning normally at the time of inspection. Breakage occurs generally when the building materials have aged and decayed.

Repair of the broken window winder handle is advised to improve the operational state

of the associated window.

An aluminium window service agent could be appointed to repair/replace the window winder handle at the client's discretion.

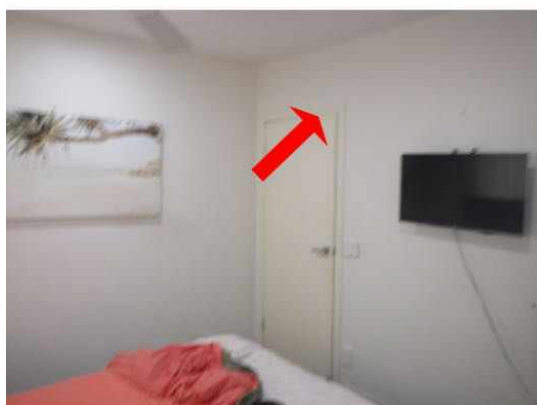
### Finding 3.11

Building: Main Building  
 Location: Bedroom 2 > Front  
 Finding: Door - Binding/Jamming  
 Information: Binding and/or jamming of the bedroom 2 door on the top of door frame was evident during standard operation. This defect inhibits the functionality of affected door as well as creating potential for secondary defects to associated building elements, such as damage to the door framing.

A door that binds to the associated door frame may have several causes, such as poor installation of the door or deteriorated hinges.

A qualified carpenter or general handyperson could be appointed to perform minor rectification works at client discretion.

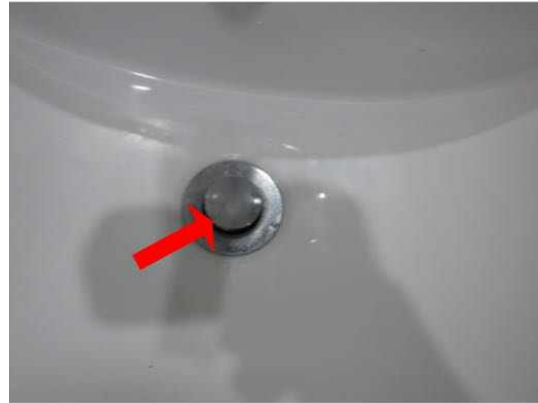
### Finding 3.12

Building: Main Building  
 Location: Ensuite - Bed 2 > Front Left  
 Finding: Basin - Pop up waste stiff.  
 Information: The bedroom 2 ensuite basin pop up waste was stiff to operate at the time of inspection. It is advised that maintenance is carried out on the waste so as it functions as intended.

A handyman could be appointed to perform any remedial works where required.

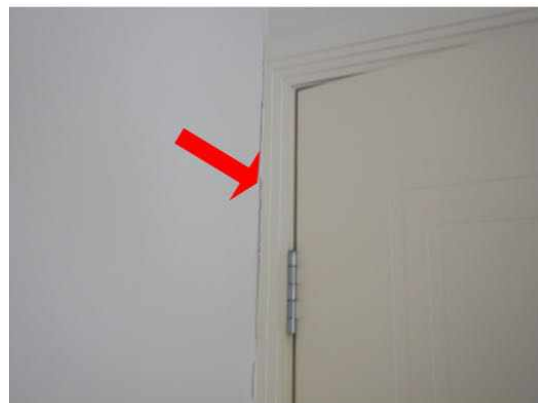
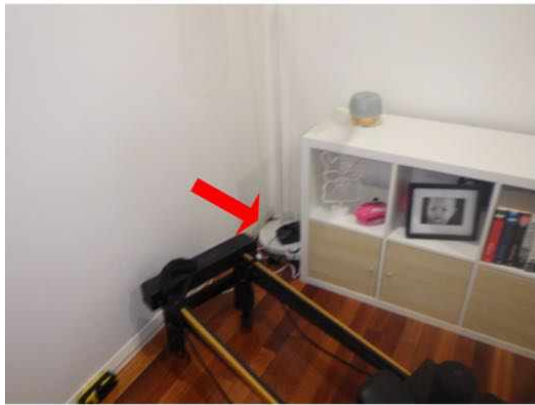
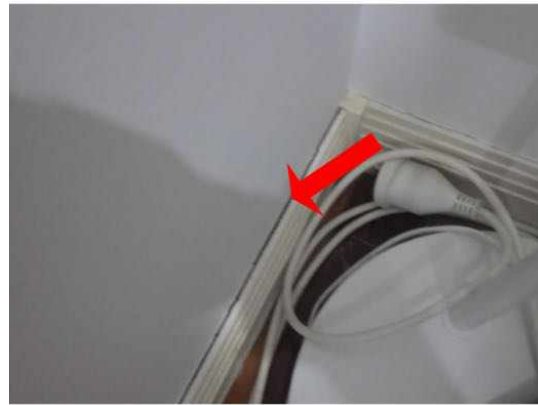
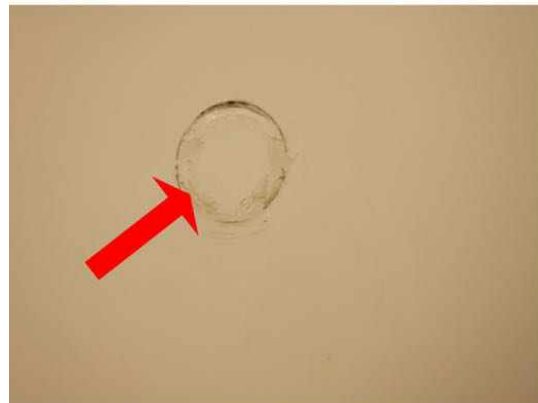
### Finding 3.13

Building: Main Building  
 Location: Internal Areas > Existing  
 Finding: Wear and Tear  
 Information: At the time of inspection the building interior showed signs of minor cracking and/or scuffing to walls, ceilings and timber trims (as per example photos).

The level of damage appears consistent with general deterioration and/or wear and tear.

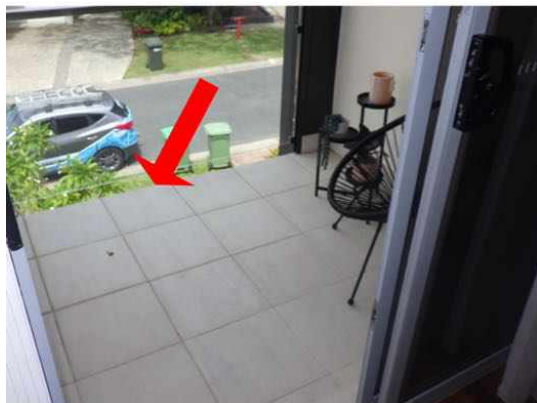
### Finding 3.14

Finding: Tile - Cracked

Information: A cracked tile to the main bedroom balcony floor area was identified at the time of inspection. Such defects are generally caused by impact. Cracked or broken tiled areas may also be a direct result of poor workmanship during the construction process.

A tiling contractor could be appointed to perform repair works at the clients discretion.

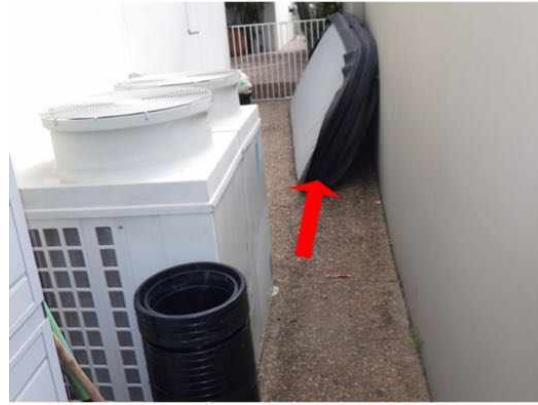
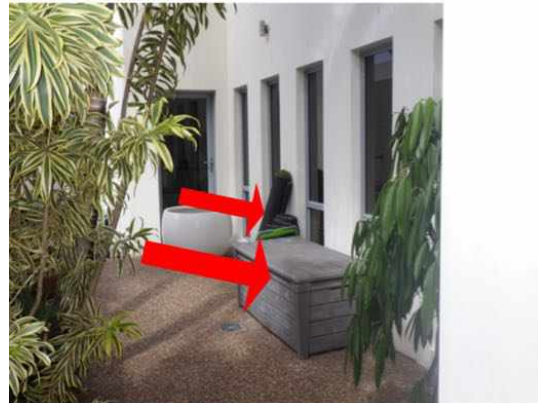
The storing of items around the exterior of the property increases the risk of termite activity being present.

It is highly recommended that any stored items be immediately moved away from external wall areas in which they may conceal or attract any termite / timber pest attack. Minimisation of risk / prevention of termite attack is far more adequate than dealing with the presence of termite activity.

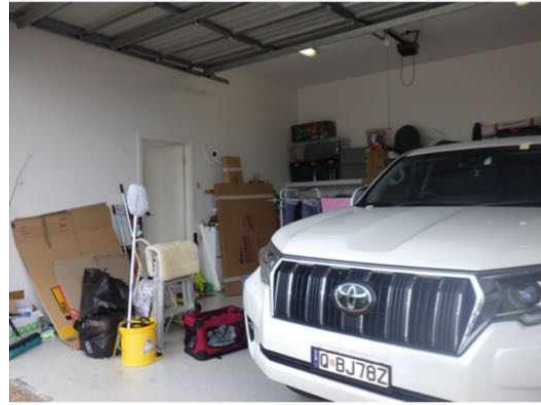
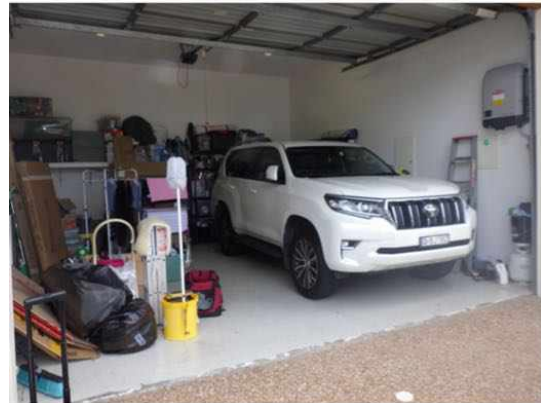
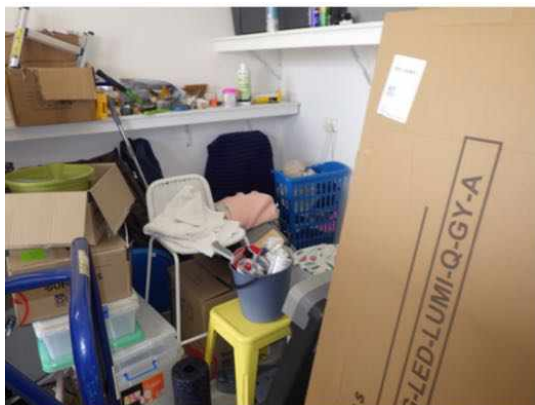
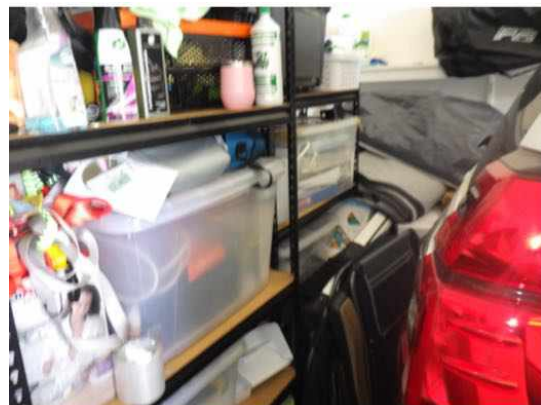
### Finding 6.02

These stored items severely limit full inspection of the area and may conceal timber termite pest and or vermin activity.

It is highly recommended the items are removed to allow for complete inspection of the area.
