# Building and Timber Pest Inspection Report

Inspection Date: Wed, 21 Jan 2026

Property Address: 9/12 Edward St, Caboolture QLD 4510,  
Australia

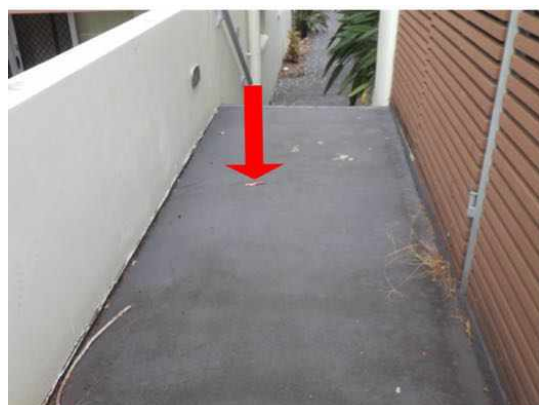
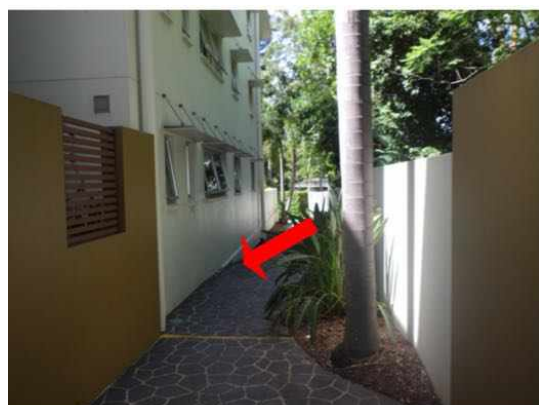
Finding 3.02

Building: Main Building  
 Location: Footpath > Ground Level  
 Finding: Cracking in concrete slab - Category 1  
 Information: Cracking and or movement coded as Category 1 - 2 was identified in the footpaths concrete slabs (as per example photos). A Category 1 crack is described as a fine but noticeable crack, with the slab at an otherwise reasonable level.

To be considered Category 1, the approximate width of the crack is less than 1.0mm, or a less than 10mm change in offset when a 3m straight edge is placed over the defect.

Category 1 cracks should be monitored for a period of 12 months. At the end of the monitoring period, identified cracks that are rated greater than Category 2 are considered defects, and require rectification.

Note - External area maintenance is generally the responsibility of the buildings body corporate managers.

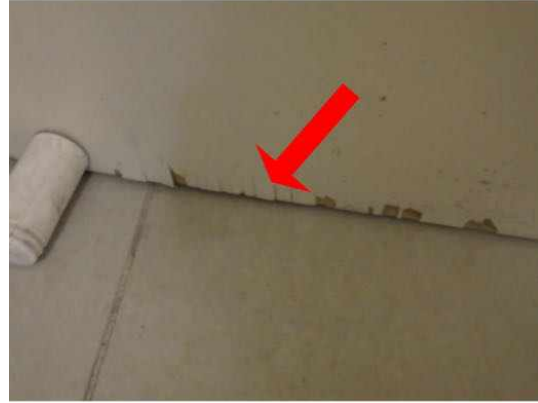
**Finding 3.03**

Building: Main Building  
 Location: Entry > Front  
 Finding: Damaged Door

Information: The entry door has suffered minor damage to the bottom edge.

Damage occurs generally when the building materials have aged and decayed, but may be the result of exposure to moisture.

A qualified painter or general handyman could be appointed to repair the door at the clients discretion.

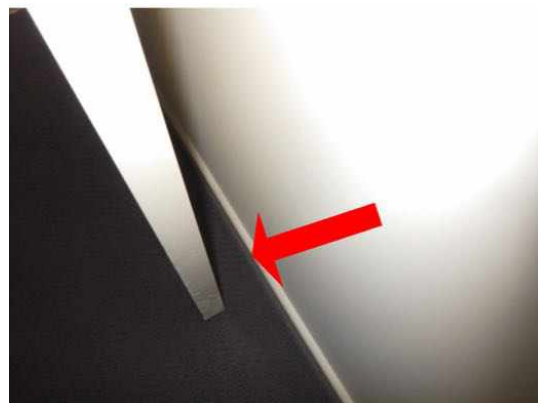
### Finding 3.04

Finding: Door stop - Missing

Information: The bedroom 2 door stop is missing or is inadequate to stop the door handle from damaging the wall.

Re-installation or replacement of the door stop is advised to prevent any subsequent damage to the wall linings or associated structures.

A general handyman may be appointed to perform these works at client discretion.

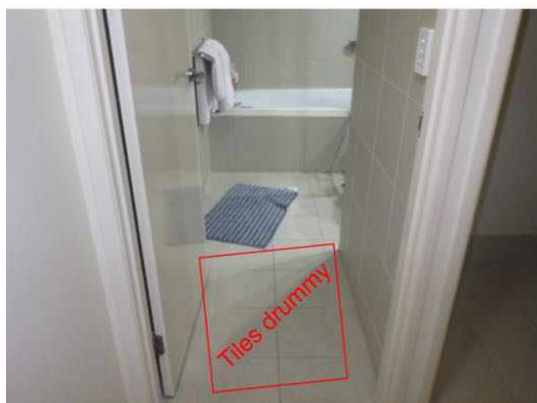
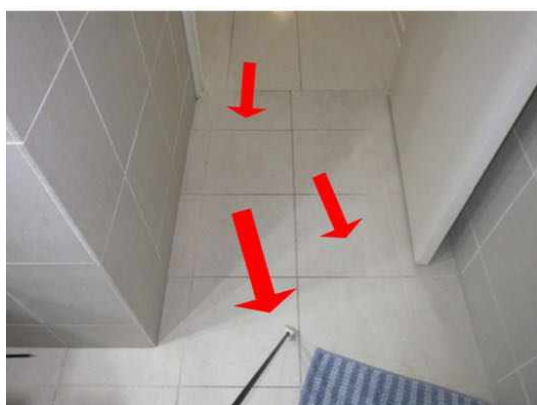
### Finding 3.05

Location: Bathroom > Front  
 Finding: Tiles - Drummy  
 Information: Drummy tiled areas were identified in the bathroom area floor at the time of inspection. The term 'drummy' refers to tiles that despite being in relatively good condition have a hollow sound when tapped on and may be inclined to crack from heavy impact whether accidental or deliberate. Drummy tiled areas may be a direct result of poor workmanship during the construction process.

A tiling contractor could be appointed to perform works if necessary.

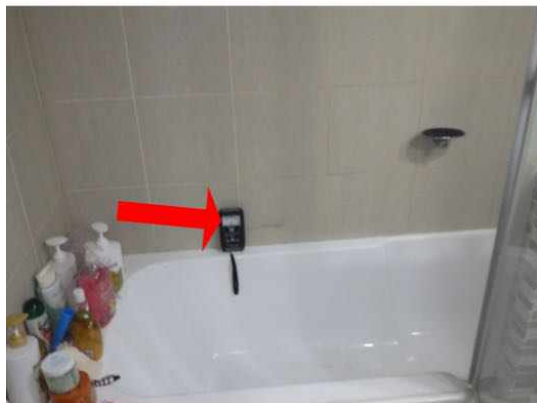
### Finding 3.06

Building: Main Building  
 Location: Bathroom > Rear Right  
 Finding: Shower - Monitor  
 Information: Mid range - elevated moisture level readings were recorded to the lower 200mm of wall to the bathroom shower alcove at the time of inspection. There was no elevated moisture level readings around the tap area, and no elevated readings transferring to the other side of the wall in the areas where moisture readings were able to be obtained. Both sealant and grout appear in good condition at present.

This defect is quite common, and is suspected to have been caused by moisture permeating or leaching through the grouting and perhaps gaps in the sealant.

Monitoring the area is advised and if any visual signs of excessive moisture appear (peeling paint, mould) then consultation with a qualified plumber or bathroom specialist would be advised to identify the cause of damp and to perform remedial works as required.

Always ensure that sealant and grout is in good condition to prevent any moisture issues occurring in the future.

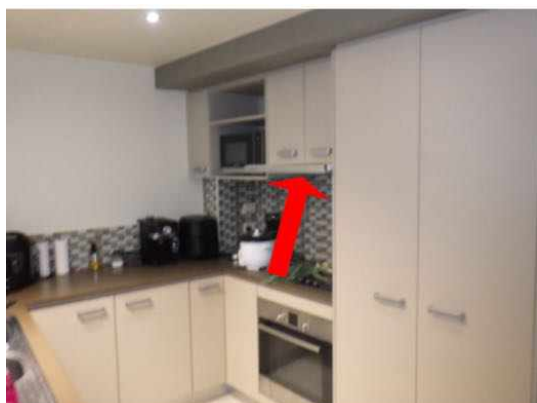
### Finding 3.07

Building:	Main Building
Location:	Kitchen > Centre Right
Finding:	Rangehood - Light
Information:	The range hood light was not working at the time of inspection. It is advised to replace the bulb first - if still not functioning, a licensed electrician could be appointed to repair or replace the range hood to restore it to a fully operational state.

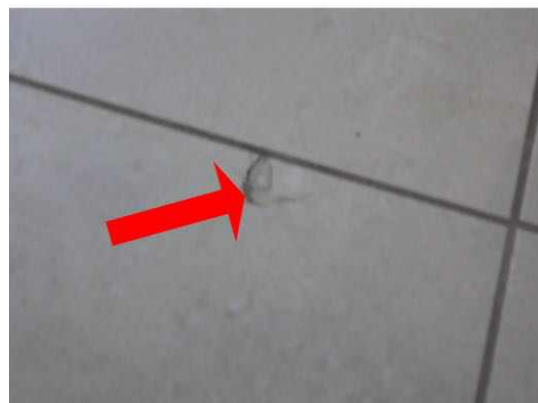
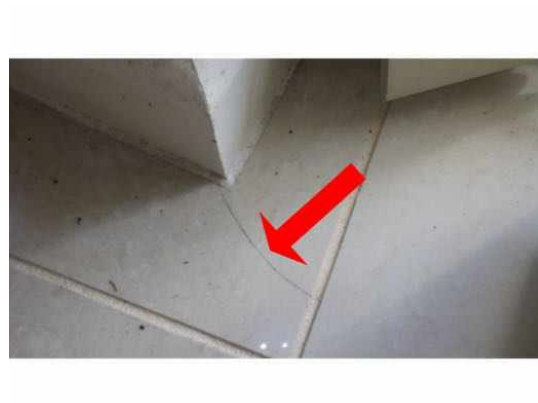
### Finding 3.09

Finding: Tiles - Chipped/ Cracked

Information: Chipped and cracked tiles to the living/dining room floor area were identified at the time of inspection. Cracks and/or chipped tiles are generally caused by impact.

A tiling contractor could be appointed to perform repair works at the clients discretion.

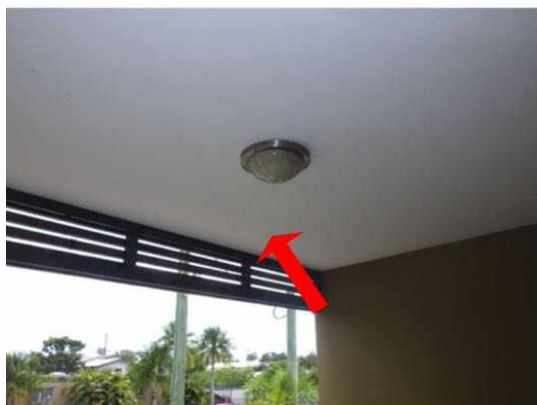
### Finding 3.10

Building: Main Building  
 Location: Balcony > Centre  
 Finding: Painted surface - Bubbling  
 Information: A small section of paint to the front balcony ceiling area was found to have bubbled and deteriorated.

A licensed painter or general handyman could be engaged to undertake repair works at the clients discretion.

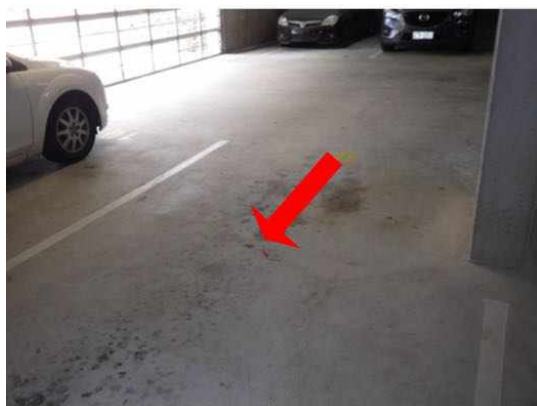
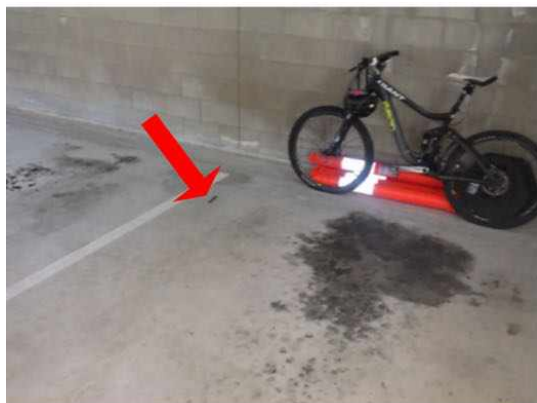
### Finding 3.11

Building: Main Building  
 Location: Carpark > Ground Level  
 Finding: Cracking in concrete slab - Category 1  
 Information: Cracking coded as Category 1 was identified in the carpark/parking space concrete slab. A Category 1 crack is described as a fine but noticeable crack, with the slab at an otherwise reasonable level.

To be considered Category 1, the approximate width of the crack is less than 1.0mm, or a less than 10mm change in offset when a 3m straight edge is placed over the defect.

Category 1 cracks should be monitored for a period of 12 months. At the end of the monitoring period, identified cracks that are rated greater than Category 2 are considered defects, and require rectification.

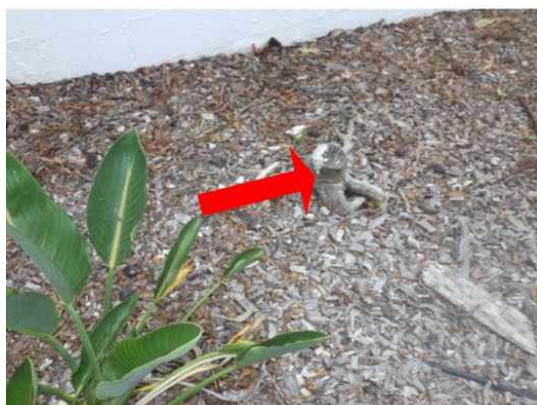
### Finding 6.01

Building:	Main Building
Location:	Yard - Back > Ground Level
Finding:	In ground - Tree Stump
Information:	At the time of inspection there was tree stumps in garden areas to the rear of the property.

Any timbers in direct ground contact provide opportunity for concealed termite activity and are likely to be subject to premature rot and decay as the soil retains moisture or damp conditions against the timbers.

Removal of any untreated timber or tree stumps which are in direct contact with

external ground is recommended. Frequent pest inspections are advised to readily identify any termite activity in these areas.

Note - Garden area maintenance or tree stump removal is most likely the responsibility of the buildings body corporate managers.
