Building Inspection Report

Inspection Date: Thu, 12 Mar 2026

Property Address: 22 Crozier Terrace, Oaklands Park SA 5046,
Australia

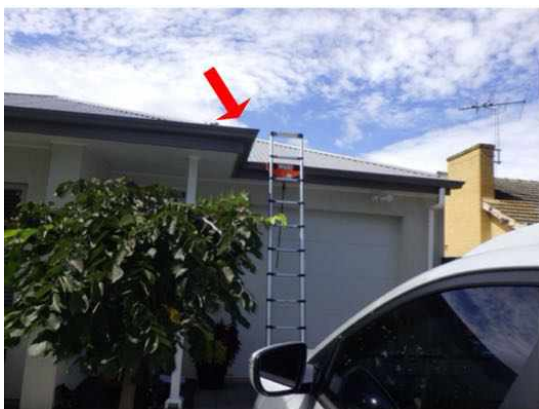
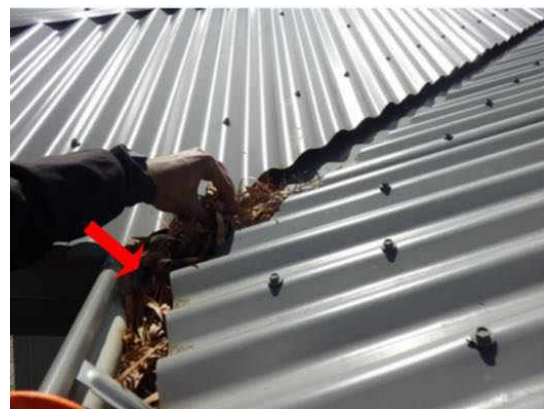
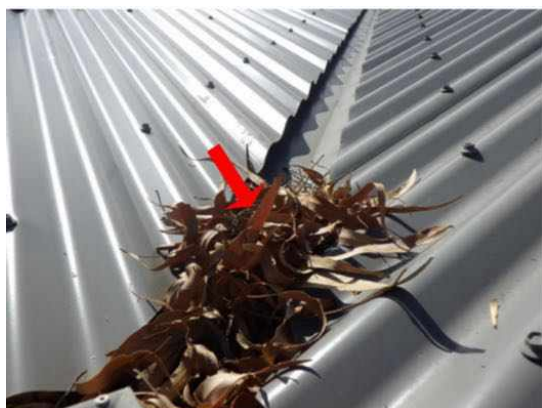
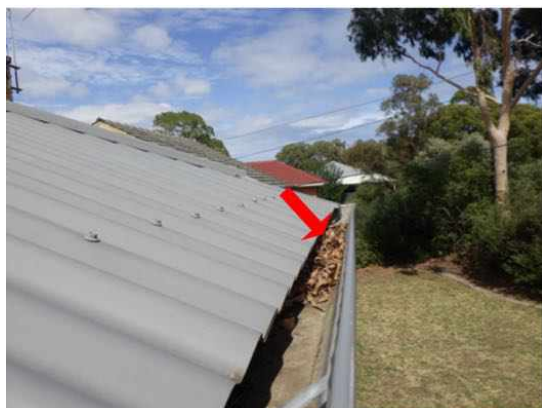
Defects 2.01

Building: Building 1
Location: All External Areas
Finding: Gutters - Blocked
Information: At the time of inspection it was noticed that gutters were blocked in few sections around the property. Gutters have to be cleaned in regular intervals.

Roof plumbing structures, such as guttering and downpipes, should be free of all debris to prevent blockages. Blockages of the guttering and downpipes will lead to pooling and accumulated water overflows, which is likely to subsequently flood eaves and exterior walls.

Blocked gutters are likely to lead to high levels of moisture in the affected areas. Such moisture will not only cause rust and decay of the associated building materials, but can also provide conditions that are conducive to termite and timber pest activity. Blockages in gutters should therefore be removed immediately to ensure dry conditions are maintained.

Consult a Licensed Plumber for further specific advice on remedial works that may be required. In the interim, it is highly advised that blocked gutters be removed by the homeowner or a general handyperson as a matter of urgency.

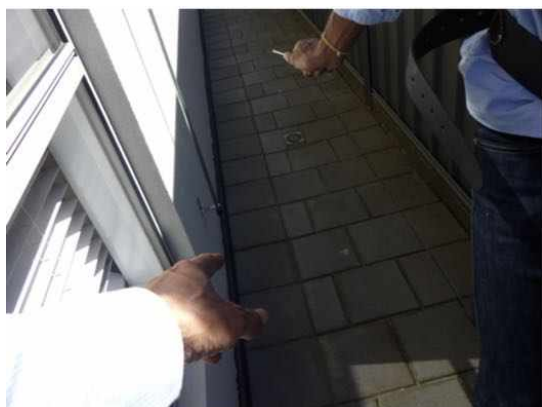
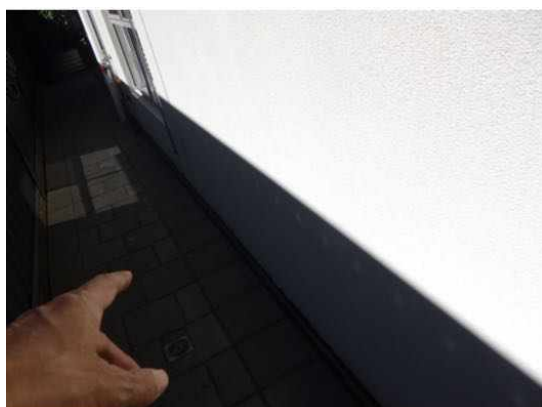
Defects 3.01

Building:	Building 1
Location:	All External Areas
Finding:	Slab Edge - Exposure compromised
Information:	At the time of inspection it was noticed that damp course member has been popping upwards from the external paving in few sections around property and result of that slab edge exposure has been compromised. It's advised to cut the extra popping upwards damp course.

An inspection zone of at least 75mm in relation to the exposed slab edge, between the bottom brick and the perimeter pavement, is required. This inspection zone should be maintained in order to force termites into the open where they can be detected more readily during regular inspections. The slab edge should not be concealed by anything that may prevent inspection of the area, including render, landscaping, soil, turf, paving, concrete cladding or other structures.

If the slab edge is not properly exposed there is a high risk of termite attack. Sometimes, in order to determine the type of slab, a suitably qualified person such as an architect or builder may be required to consult the construction plans.

Where the slab edge cannot be properly inspected, it is highly recommended that termite or timber pest inspections be carried out every 6-12 months to aid protection of the property against infestation.

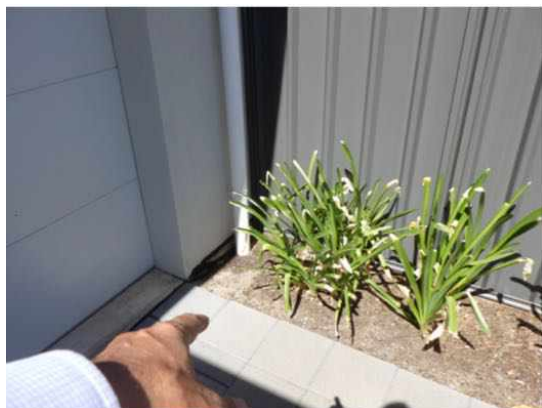
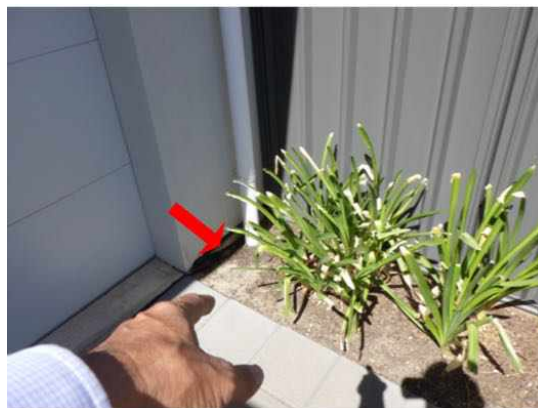
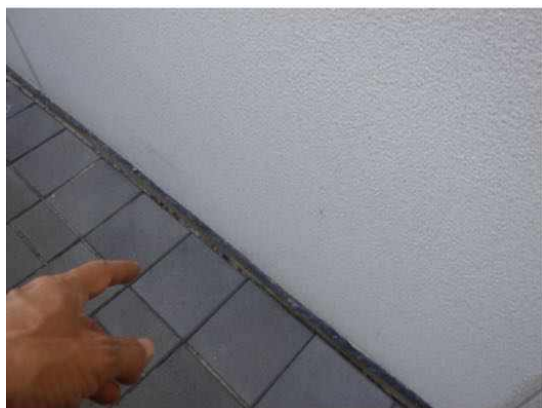
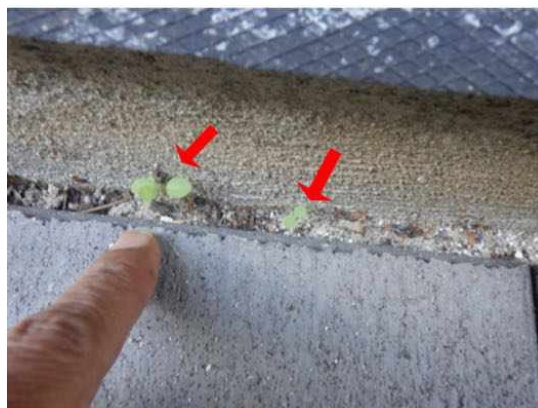
Defects 3.02

Building:	Building 1
Location:	All External Areas
Finding:	Bridging - Vegetation
Information:	Where vegetation obstructs inspection of building elements, also known as bridging as it provides a bridging point for the access of termites, full inspection can not be achieved. Consequently moisture or dampness may be present and the areas becomes conducive to termite activity. Plants against or very close to buildings provide cover, shade and can provide an environment that is attractive to termite infestation.

The removal and replanting of species that do not provide "cover" or cutting back of existing vegetation will assist greatly in preventing Bridging from occurring.

The removal of any such materials that may be conducive to termite activity should be carried out as soon as possible and arrange re inspection to minimize the risk of termite attack.

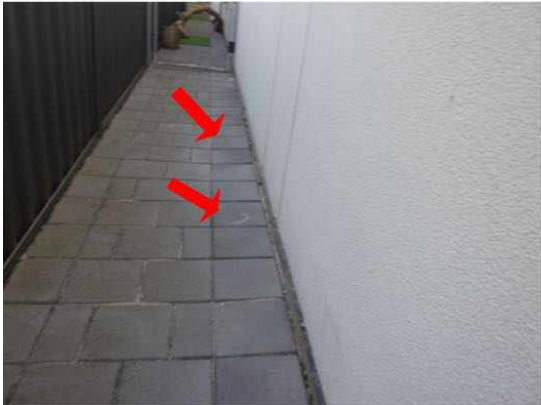
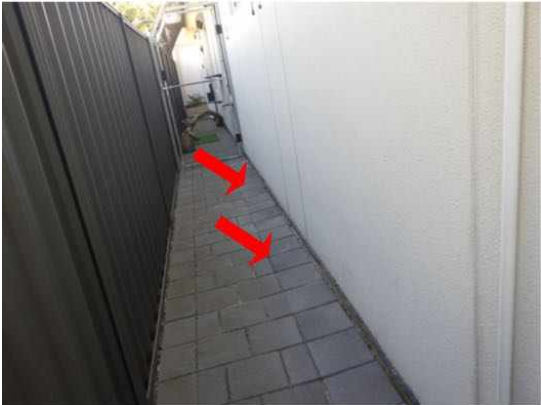
Defects 3.03

Building:	Building 1
Location:	All External Areas
Finding:	Paving - Uneven
Information:	Sections of the external paved area are uneven, creating a potential trip hazard. It appears as though the area has been subject to rough installation, or that paving sections have lifted due to movements in the foundation of the property.

Where paving creates a trip hazard, personal injury may ensue if due caution is not taken by all persons within this area.

Re-paving of the area is required as soon as possible to remedy this situation. Further consultation with a specialist concreter is advised.

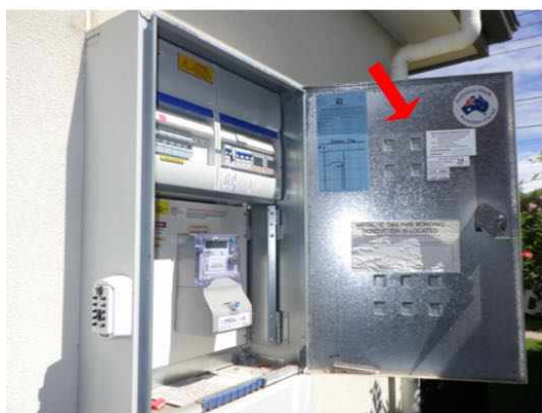
Building: Building 1
 Location: All External Areas >
 Finding: Termite Management System - No evidence of a chemical installation
 Information: The application of a post-construction chemical termite barrier is highly recommended for all properties, particularly if live termite activity has been found on the site previously. Such barriers are highly effective in preventing termite attack on any timber building elements throughout the property.

A durable notice should be placed in the switchboard unit to indicate current termite barriers. At the time of inspection, it appeared as though no termite management system has been installed, with no evidence to suggest preventative works taking place.

The client may consider gaining further advice from a pest controller as to the costs and procedures involved with this application. It is recommended that obtaining such advice be a short-term priority.

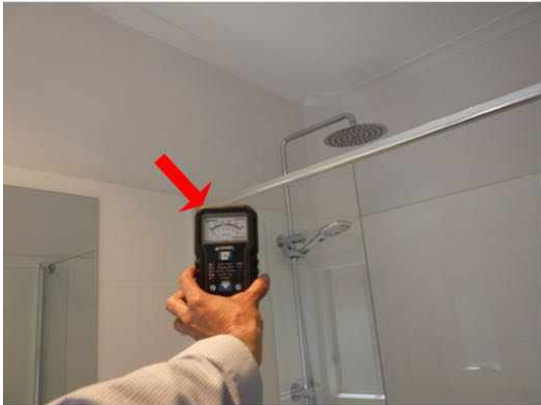
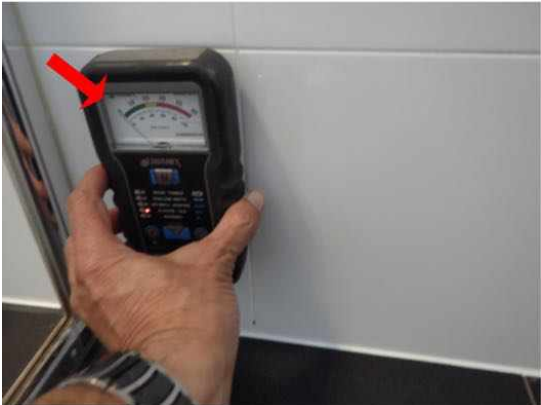
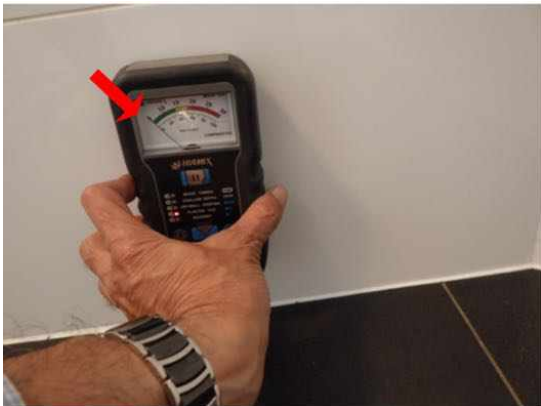
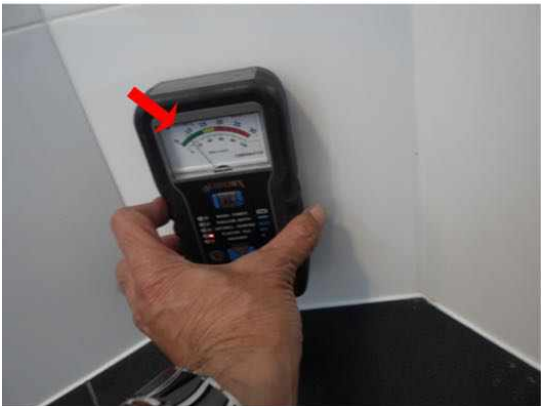
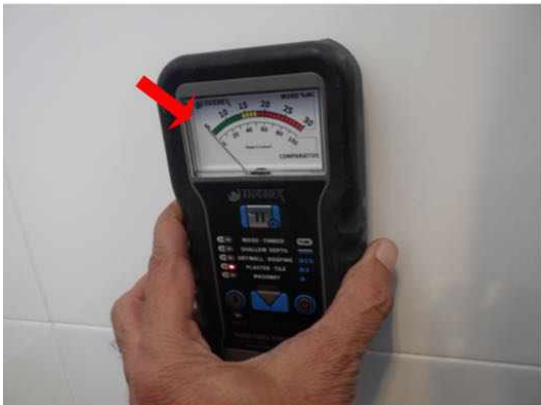
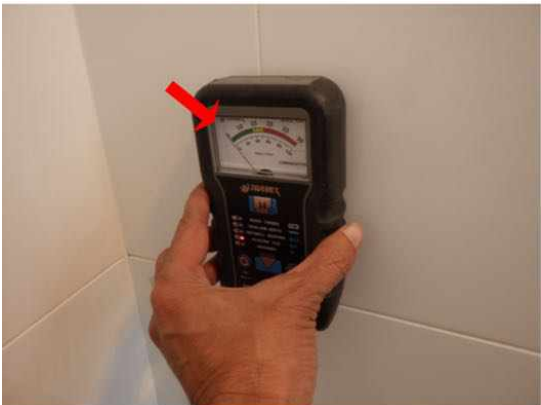
Building: Building 1
 Location: Bathroom-Ensuite
 Finding: Shower Alcove - No Damp
 Information: At the time of inspection it was noticed that damp is not evident to the shower alcove.

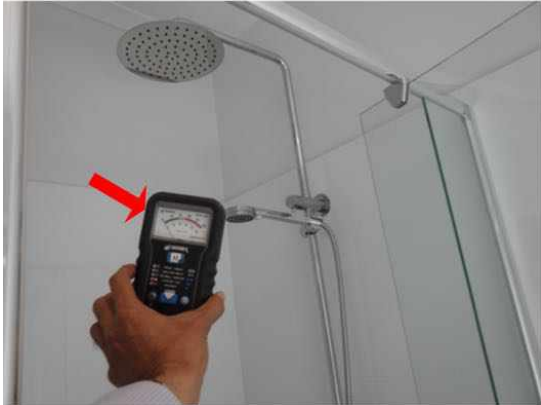
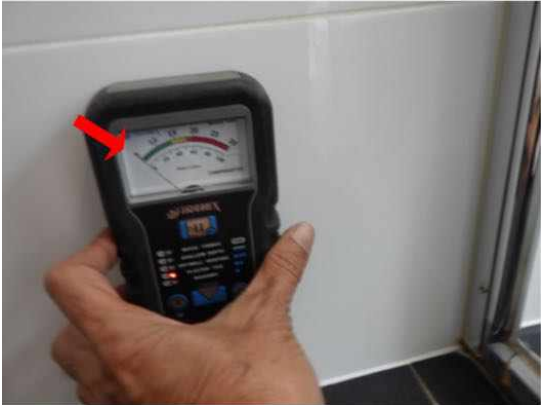
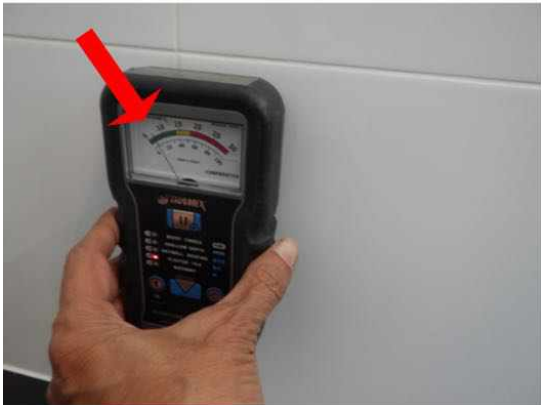
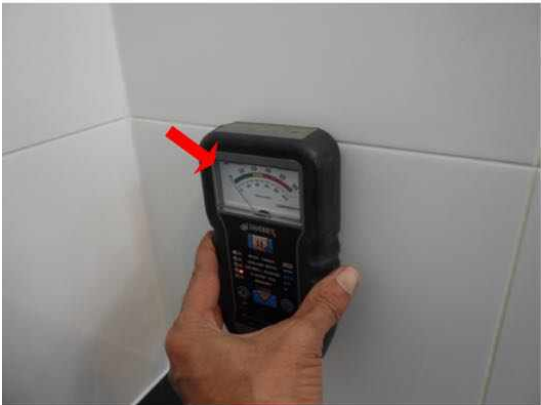
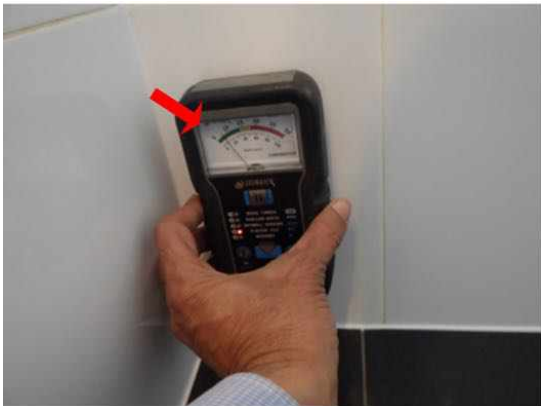
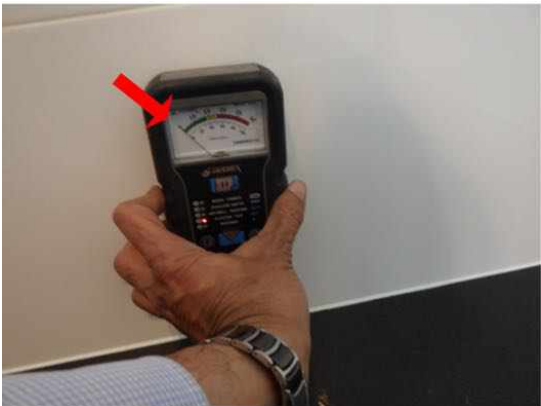
Building: Building 1
 Location: Bathroom 2
 Finding: Shower Alcove - No Damp
 Information: At the time of inspection it was noticed that damp is not evident to the shower alcove.

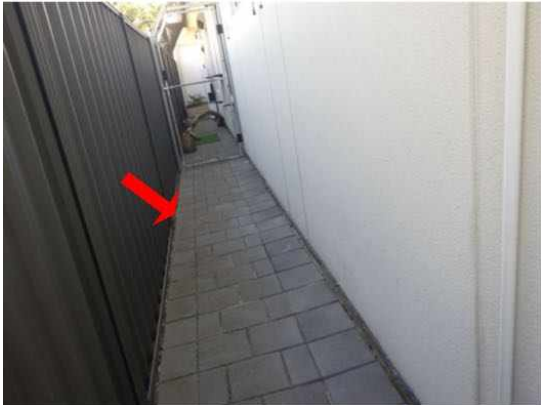
Building: Building 1
 Location: All External Areas
 Finding: Water pooling - against property
 Information: Water appears to be pooling against the house. It is suspected that this is a result of poor site drainage but may also be due to excessive moisture from an unidentified source.

Where water is pooling against the house water damage to the external wall cladding is imminent.

Such water pooling also increases the risk of termite activity and the development of fungal decay in the area.

Consult a Licensed Plumber regarding the cost of potential site drainage rectification works.

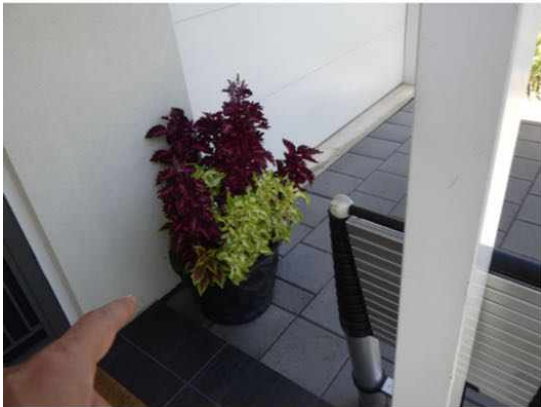
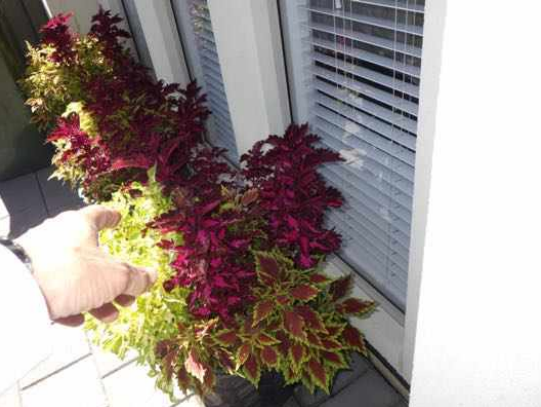
Building: Building 1
Location: All Areas
Finding: Additional Photos - Obstructions and Limitations
Information: These photographs are an indication of the obstructions and limitations which impeded full inspection of the property at the time of inspection. These obstructions can hide an array of defects and should be removed to allow full inspection to be carried out. A re-inspection is recommended once the areas are made accessible.
