Building and Timber Pest Inspection Report

Inspection Date: Fri, 27 Mar 2026

Property Address: 3/159 Northern Rd, Heidelberg Heights VIC
3081, Australia

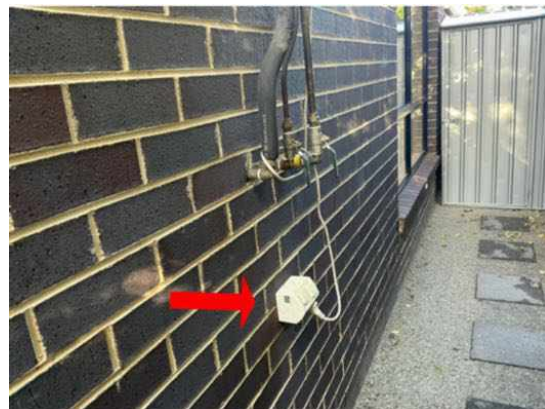
Building:	Main Building
Location:	Exterior walls - right side
Finding:	External power point not sealed
Information:	It was observed that the external power point to external wall was not adequately sealed from moisture ingress.(AS 3000)

All external power points are to be sealed (generally at the top) to prevent moisture ingress to the fitting.

Moisture inside a fitting can cause earth leakage, power cut out and could cause injury to persons

A licensed electrician should review immediately or alternatively the builder should review as part of his ongoing warranty obligation

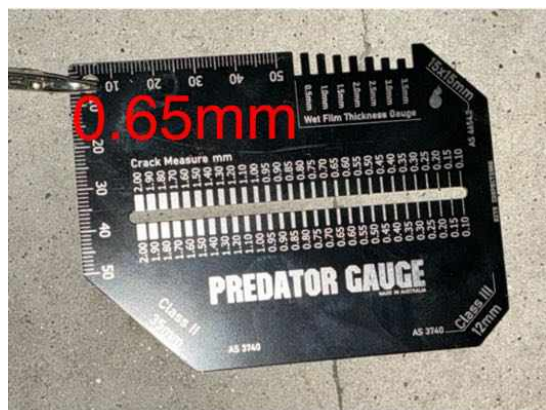
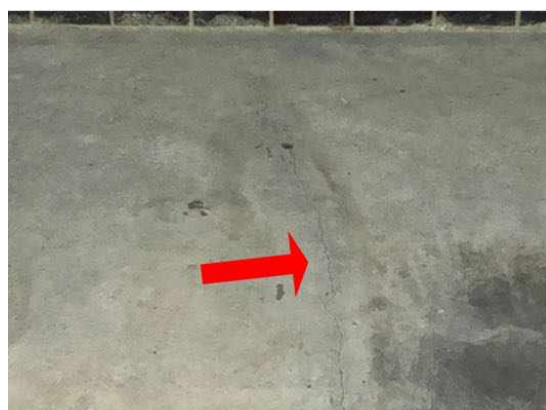
Building:	Main Building
Location:	Garage
Finding:	Crack in concrete slab - Category 1
Information:	A crack coded as Category 1 was identified in the slab. A Category 1 crack is

described as a fine but noticeable crack, with the slab at an otherwise reasonable level.

To be considered Category 1, the approximate width of the crack is less than 1.0mm, or a less than 10mm change in offset when a 3m straight edge is placed over the defect.

Category 1 cracks should be monitored for a period of 12 months. At the end of the monitoring period, identified cracks that are rated greater than Category 2 are considered defects, and require rectification.

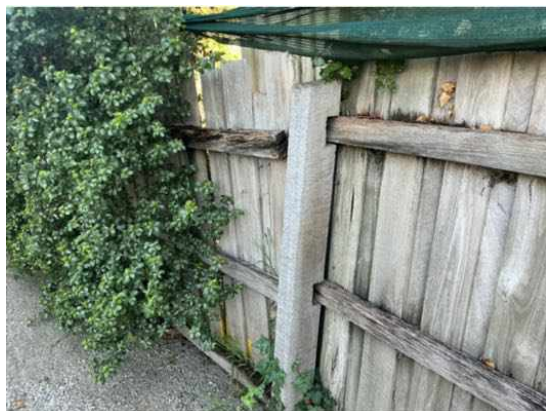
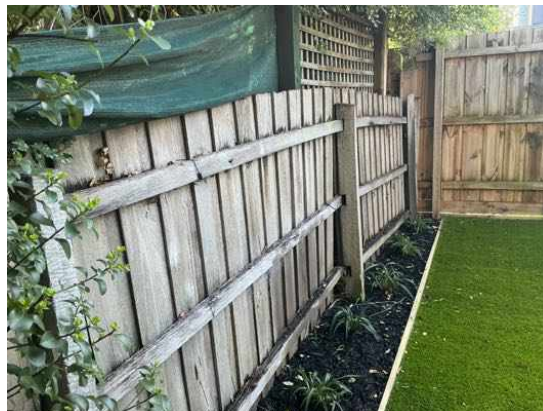
Finding 3.02

Finding: Fencing - Deteriorated

Information: It was noted at the time of inspection that sections of the fencing throughout the property have deteriorated. Typically fencing deteriorates due to age and or wear, rot and or rust which is generally expected for a structure of this age, due to prolonged exposure to weather conditions. Sometimes inadequate installation or maintenance can be to blame.

If left unattended, it is likely that further damage will occur. It is suspected that repair of

several elements of the fencing may be required however replacement may be a consideration of the client also.

A licensed fencing contractor should be appointed to provide further advice and perform rectification works as necessary.

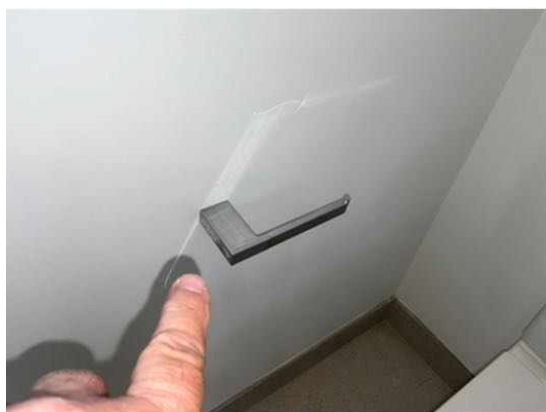
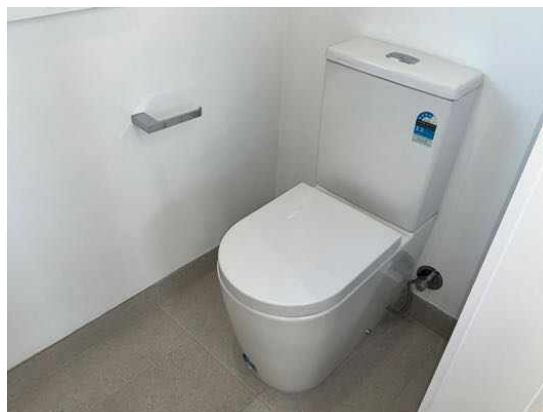
Finding 3.03

Building: Main Building
 Location: Bathroom
 Finding: Toilet roll holder - Loose
 Information: The toilet roll holder was found to be loose at the time of inspection. While not a major operational defect, function can deteriorate if the problem is left unmanaged.

It is advised that the homeowner performs remedial works to re-attach the toilet roll holder to its original fixing. A general handyperson may be required to perform these works.

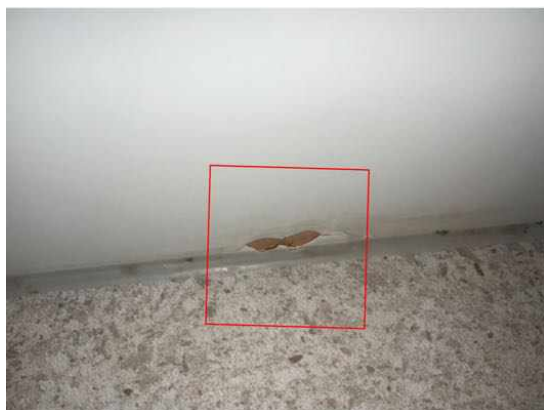
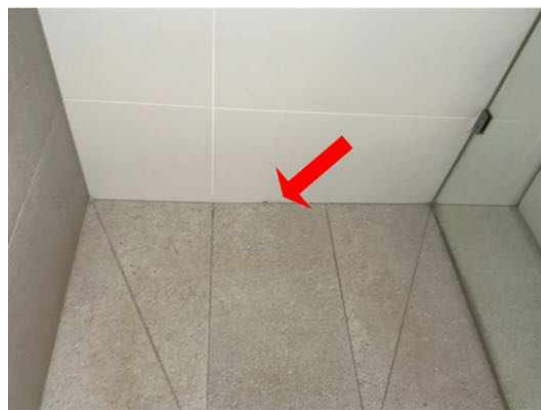
Finding: Tile chipped / damaged

Information: A chipped tile was evident to the tiling in the ground floor shower at the time of inspection. While the cracking appears to be minor, this area is frequently exposed to water, allowing potential for water penetration into adjoining sections of walls or flooring.

If left unmanaged, water penetration to these areas may lead to subsequent water damage, which is likely necessitate repair work to affected building elements

A tiling contractor should be appointed to ensure that no further water damage occurs. The re-application of silicone and grouting throughout remaining tile work is also advised, to further protect the area against water penetration.

Where water penetration has led to water damage, appointment of a relevant tradesperson may be required to repair damaged building elements.

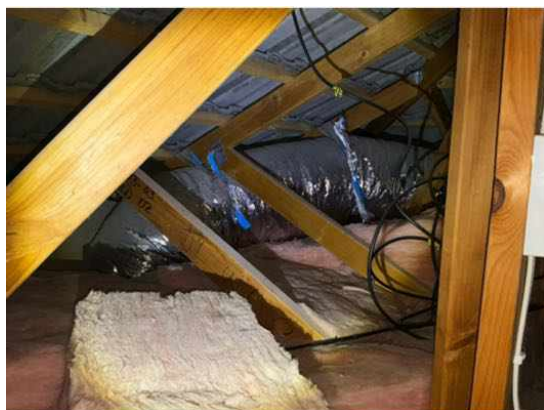
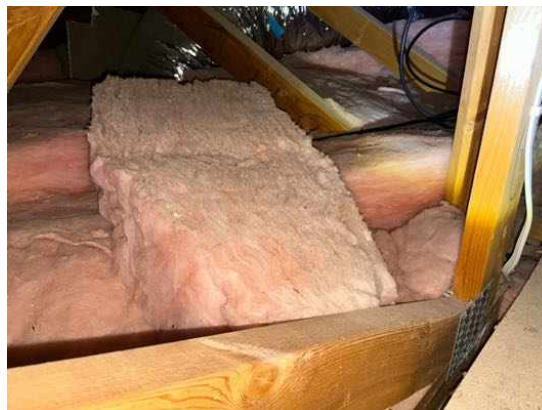
Finding 3.06

Building:	Main Building
Location:	Roof Void
Finding:	Insulation - Missing-disturbed
Information:	Upon inspection of the roof void it was noted that insulation is not present or disturbed.

Where insulation is absent, the area does not meet current Australian Standards. Installation of adequate insulation is required and should be conducted as soon as possible.

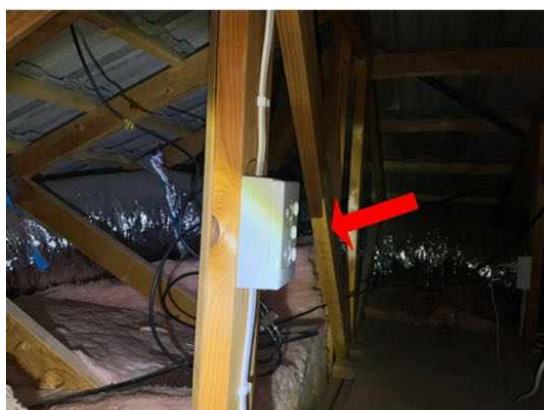
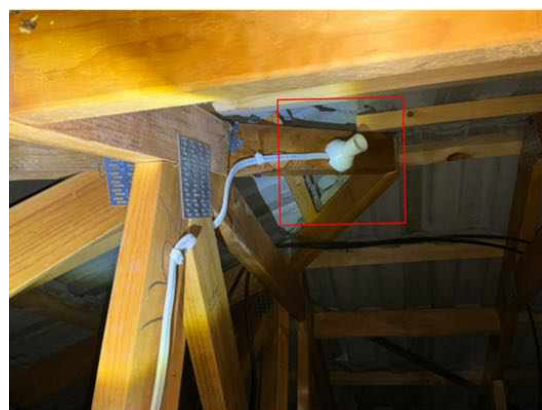
Finding 3.07

Building:	Main Building
Location:	Roof Void
Finding:	Roof void light not working
Information:	It was observed at the time of the inspection that the light to the roof void was missing a globe and not working. The light is required to be provided as per AS3500 for the servicing of heating and cooling appliances.

It is noted that the building is approximately three years old and this item should be covered under the builders statutory warranty

The globe should be replaced and the operation checked by a licensed electrician.

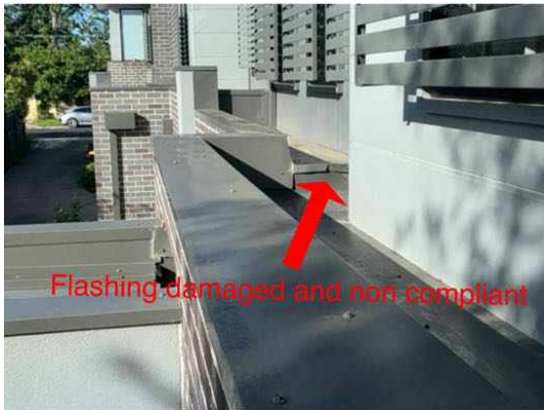
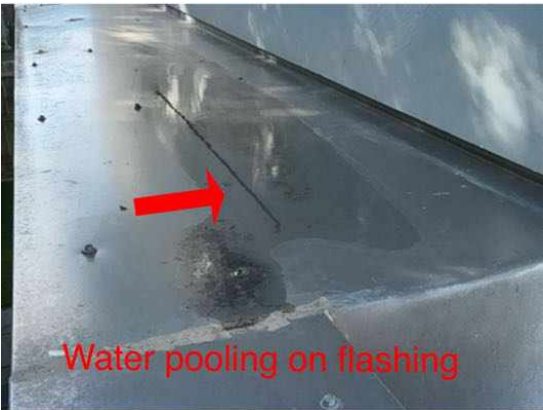
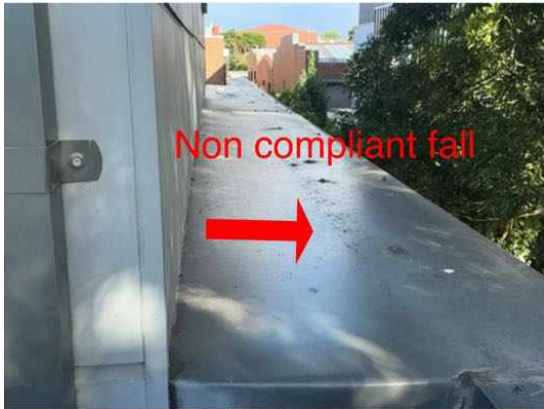
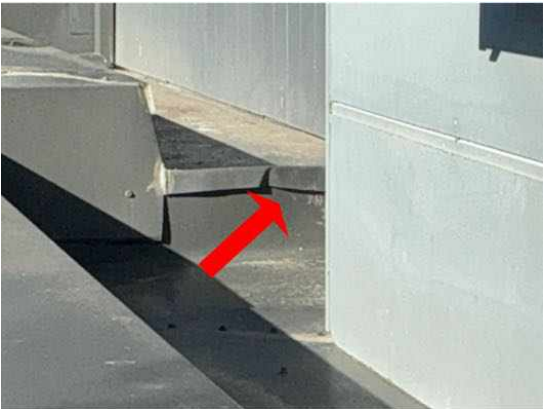
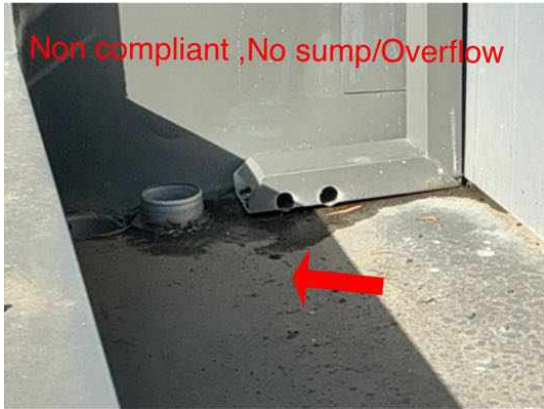
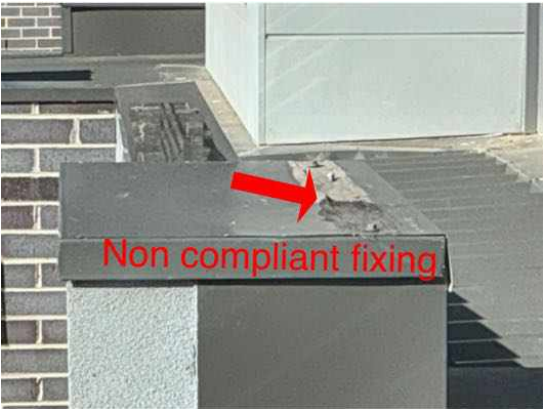
Finding 3.08

Building:	Main Building
Location:	Roof Exterior
Finding:	Roof plumbing poor works/non-compliance
Information:	Although this is not a new home compliance inspection and is outside the scope of works. It was however noted at the time of the inspection that several areas of the roof plumbing was demonstrating poor workmanship and or non-compliance. It is noted that the building is three years old and therefore is a builders statutory warranty issue.

It is noted that no leaking was found at the time of the inspection

A licensed roof plumber should review as soon as possible or alternatively the builder should rework as part of his warranty obligations.

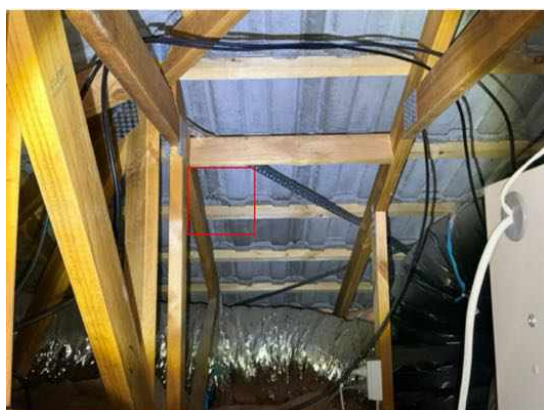
Information: The silicone repair work performed to the roofing tile appears to have been completed to an unsatisfactory standard. Excess silicone was evident in many sections of the tiled area providing a blemish on the appearance as well as detracting from the drainage of the area.

While weather-tight the excess silicone should be removed in order to increase roof drainage and to prevent accelerated deterioration of the roof tiles

It is noted that this repair was made at the time of construction and the builder should rework as part of his warranty obligations

. A roofing contractor or general handyman may be appointed to perform these works at client discretion.

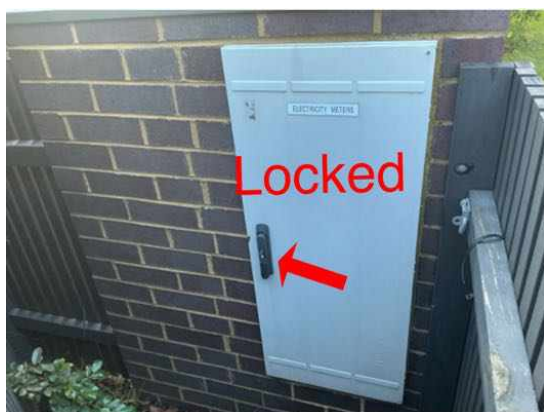
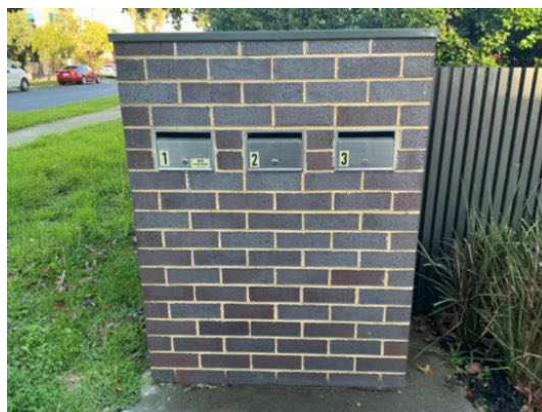
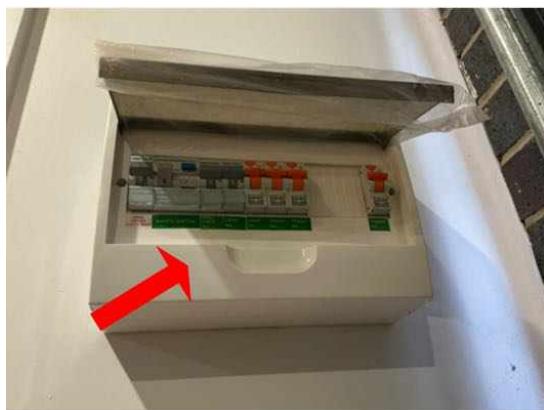
Building:	Main Building
Location:	Meter Box
Finding:	Termite Management System - no evidence of a chemical installation
Information:	The application of a post-construction chemical termite barrier is highly recommended for all properties, particularly if live termite activity has been found on the site previously. Such barriers are highly effective in preventing termite attack on any timber building elements throughout the property.

A durable notice should be placed in the switchboard unit to indicate current termite barriers. At the time of inspection, it appeared as though no termite management system has been installed, with no evidence to suggest preventative works taking place.

The client may consider gaining further advice from a pest controller as to the costs and procedures involved with this application. It is recommended that obtaining such advice be a short-term priority.

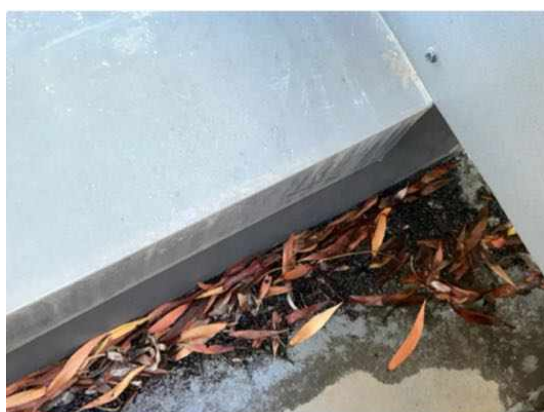
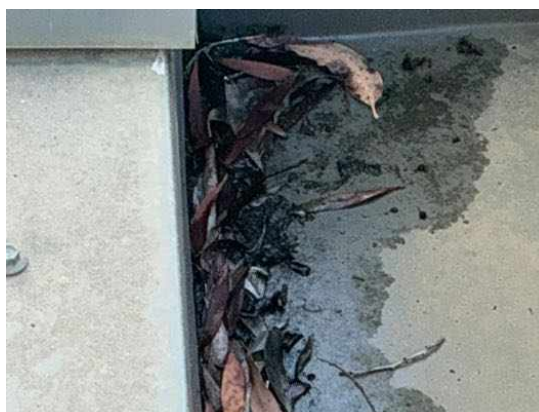
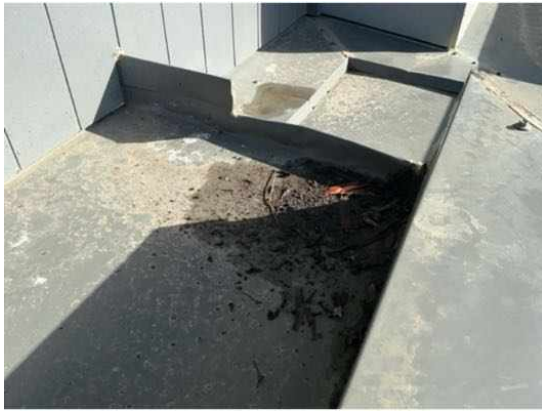
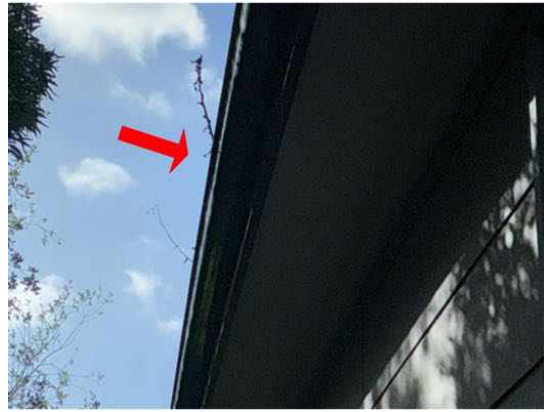
Finding 6.02

Building:	Main Building
Location:	Roof Exterior
Finding:	Gutters - Blocked
Information:	Roof plumbing structures, such as guttering and downpipes, should be free of all debris to prevent blockages. Blockages of the guttering and downpipes will lead to pooling and accumulated water overflows, which is likely to subsequently flood eaves and exterior walls.

Blocked gutters are likely to lead to high levels of moisture in the affected areas. Such moisture will not only cause rust and decay of the associated building materials, but can also provide conditions that are conducive to termite and timber pest activity. Blockages in gutters should therefore be removed immediately to ensure dry conditions are maintained.

Consult a Licensed Plumber for further specific advice on remedial works that may be required. In the interim, it is highly advised that blocked gutters be removed by the homeowner or a general handyperson as a matter of urgency.

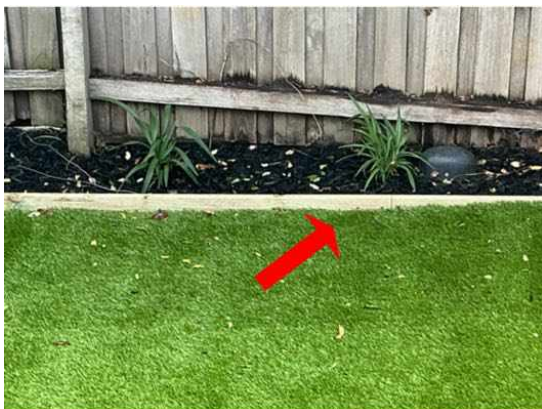
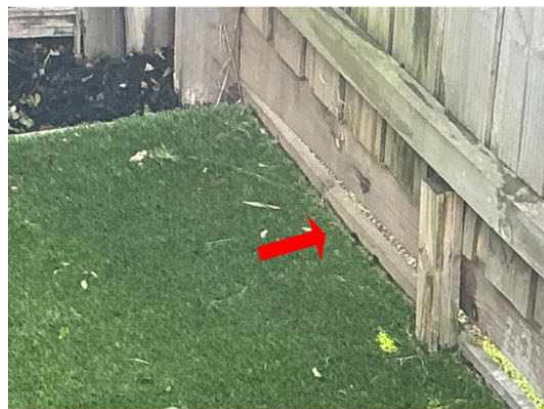
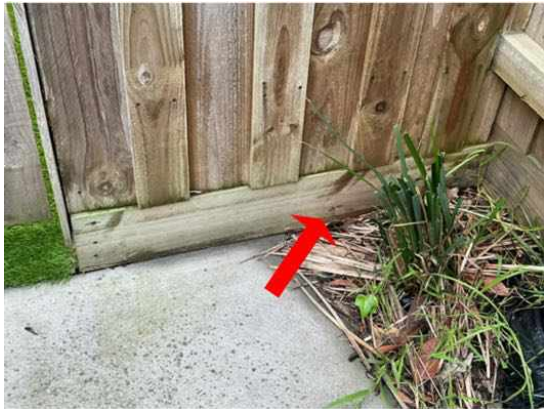
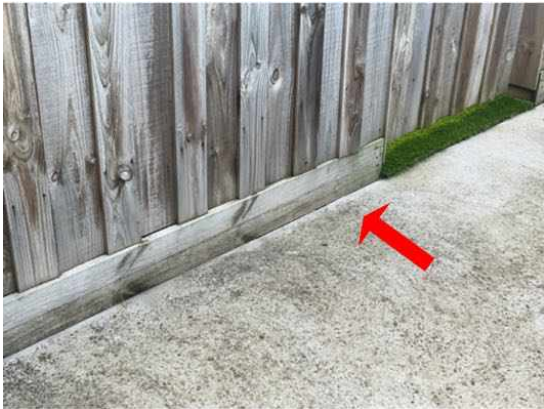
Finding 6.03

Building:	Main Building
Location:	All External Areas
Finding:	Untreated or non-durable timbers in a hazardous environment
Information:	To reduce the risk of timber pest attack it is essential that timber used in a hazardous environment (e.g. in direct contact with the ground or frequently exposed to damp conditions) is of sufficient durability and/or is adequately preservative treated.

Untreated timbers in direct contact with the ground are likely to develop severe wood rot and/or fungal decay if left unattended creating attraction for subterranean termites to infest the timbers from surrounding areas.

If untreated or non-durable timbers are found to be in a hazardous environment it is highly advised that replacement of these building elements be performed as soon as possible to aid the protection of the property against termite / timber pest attack.

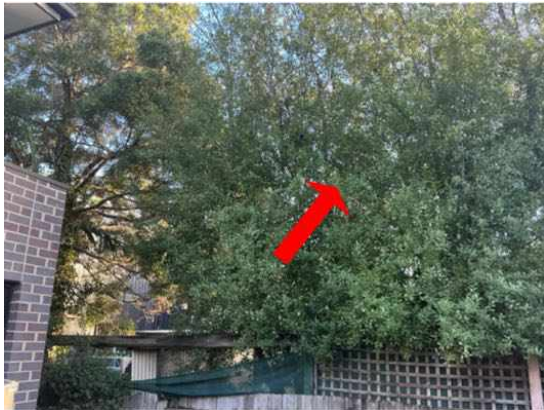
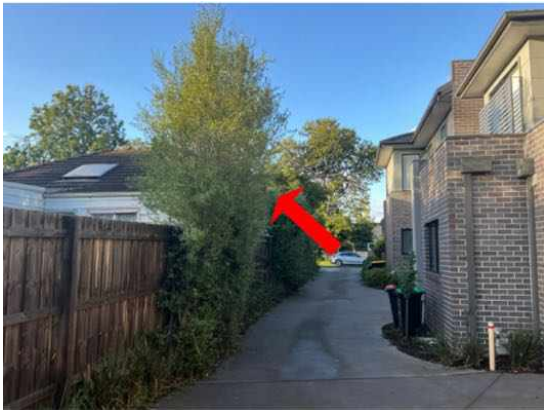
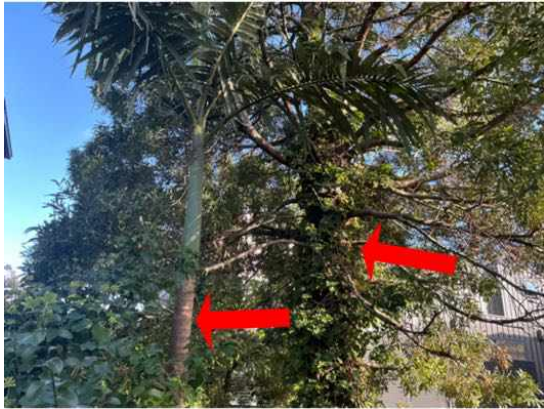
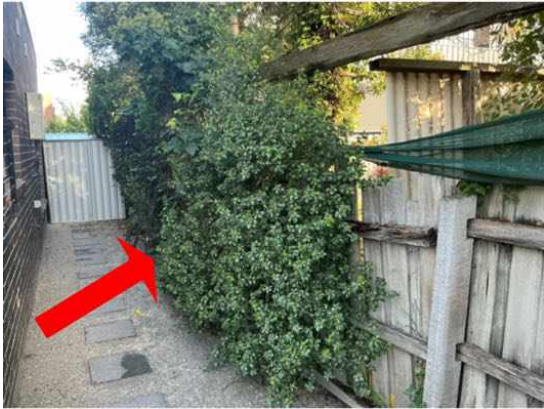
Finding 6.04

Building: Main Building
 Location: All External Areas
 Finding: Trees/large/termite
 Information: It was observed that there were several large trees next to or nearby the building.

The trees have the potential to provide conducive conditions for termite infestation

It is recommended that periodic 12 monthly inspections by a registered pest control contractor be undertaken and further reinstatement of outdated termite barriers as soon as possible.

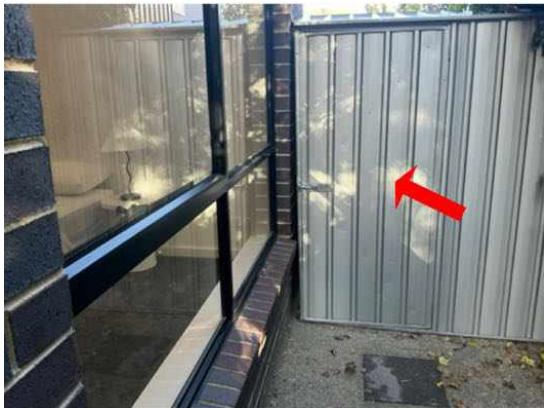
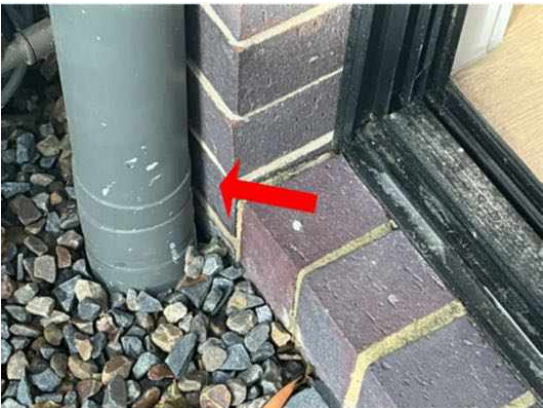
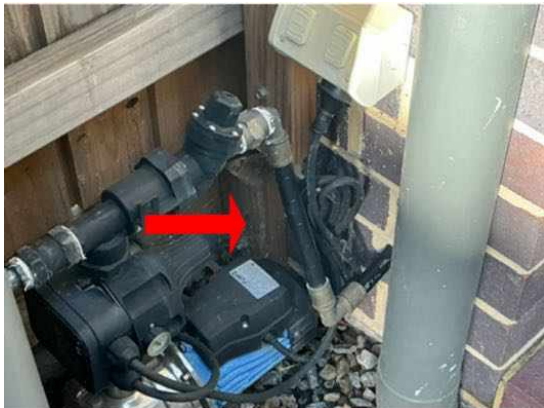
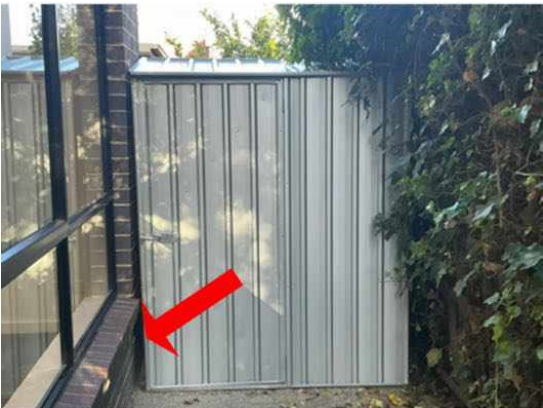
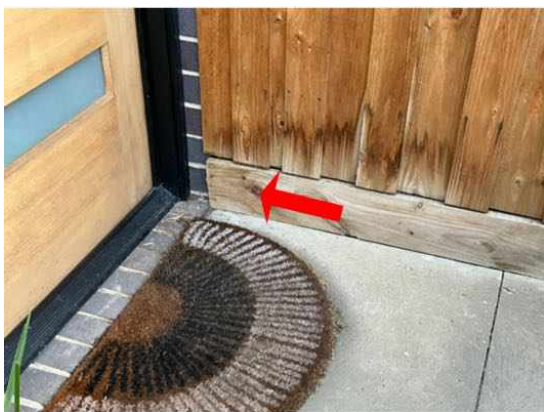
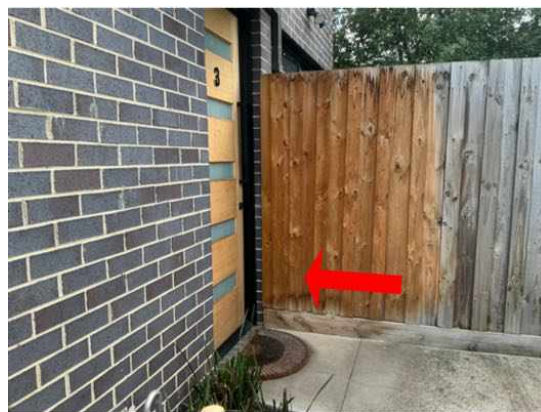
Finding 6.05

Building: Main Building
Location: All External Areas
Finding: Bridging or breaching of termite barriers - adjacent internal flooring
Information: Bridging is the spanning of a termite barrier or inspection zone so that subterranean termites are provided with passage over or around that barrier.

It is important for internal flooring to be raised above adjacent external ground levels. Where external ground levels are above internal flooring water pooling and subsequent internal flooding is likely to occur which may attract termite activity to the internal area.

It is highly advised that a landscaper or paver be appointed to lower external grounds that are raised above adjacent internal flooring. Alternatively if external grounds and internal flooring is level installation of a raised door sill may be appropriate in preventing any water pooling in the area.

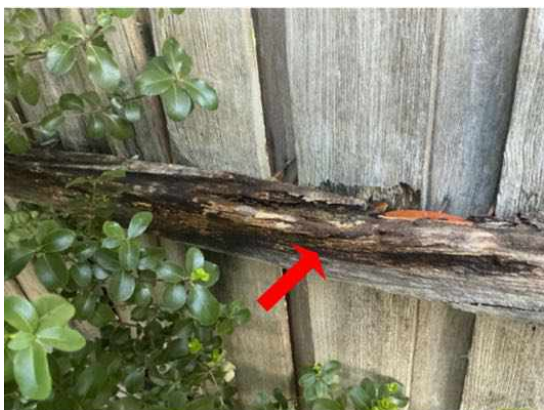
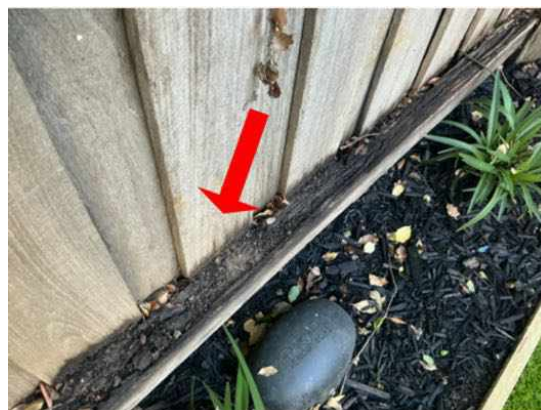
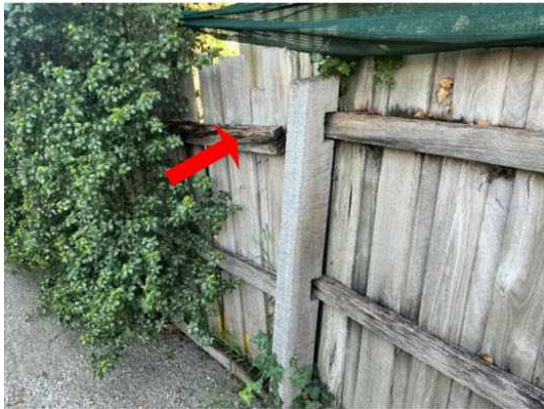
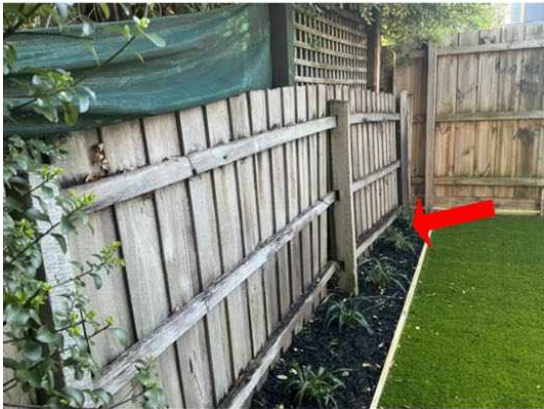
Finding 7.01

Building:	Main Building
Location:	Yard - Side
Finding:	Fungal decay - present (localised) RHS Fence
Information:	Fungal decay also known as wood decay or wood rot generally refers to the deterioration of timber elements when in contact with excessive levels of moisture for a prolonged period of time.

The development of fungal decay is accelerated by temperatures in the range of 5degreeC to 40degreeC as well as the presence of oxygen. Generally fungal decay develops on timber elements that are in use in an external environment which are exposed to rain penetration.

In this case although the affected timber element is in a decaying state the extent of any visible damage appears to be localised to a specific area and is yet to spread to other parts of the building element or affect adjoining structures. The fungal decay is therefore likely to be of a relatively superficial nature with minimal impact on the structural integrity or tensile strength of the timber element.

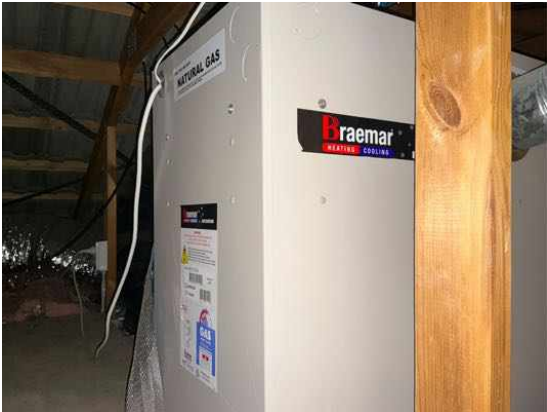
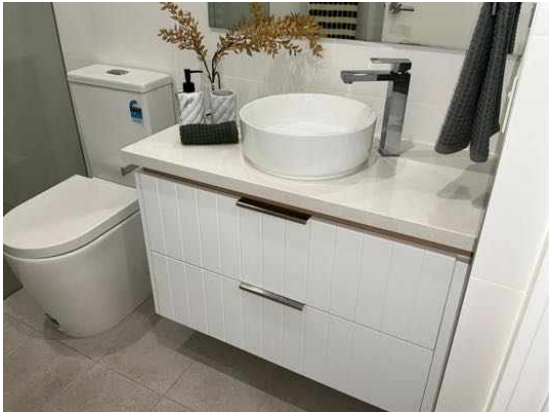
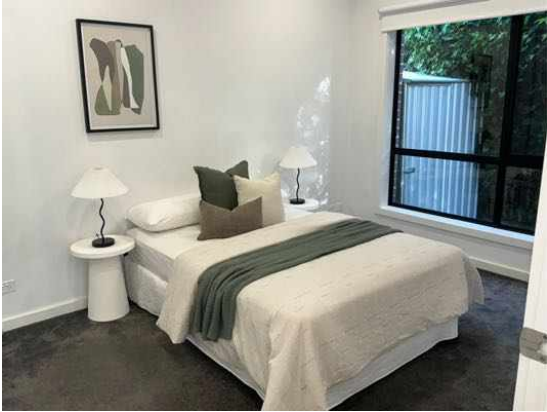
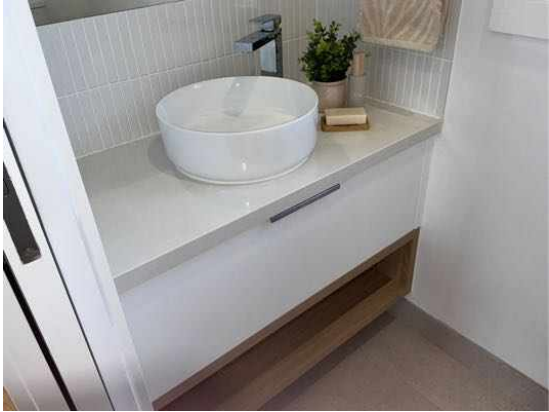
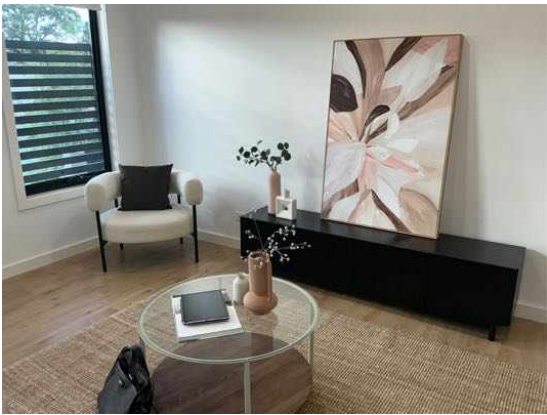
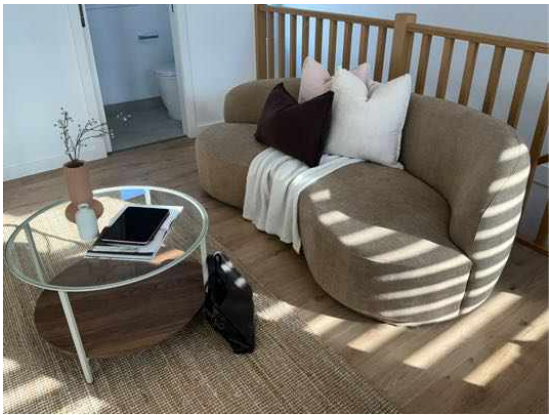
Building: Main Building
Location: All Areas
Finding: Additional Photos - Obstructions and Limitations
Information: These photographs are an indication of the obstructions and limitations which impeded full inspection of the property at the time of inspection. These obstructions can hide an array of defects and should be removed to allow full inspection to be carried out. A re-inspection is recommended once the areas are made accessible.
