Building and Timber Pest Inspection Report

Inspection Date: Tue, 10 Feb 2026

Property Address: 48 Carlisle St, Ethelton SA 5015, Australia

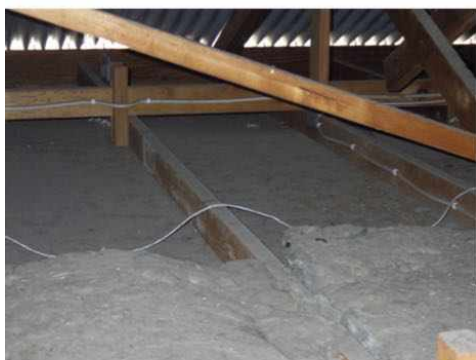
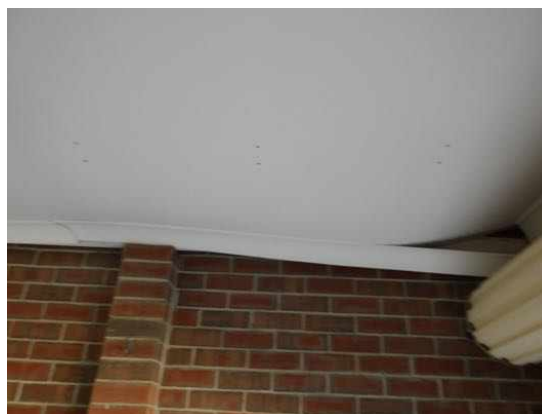
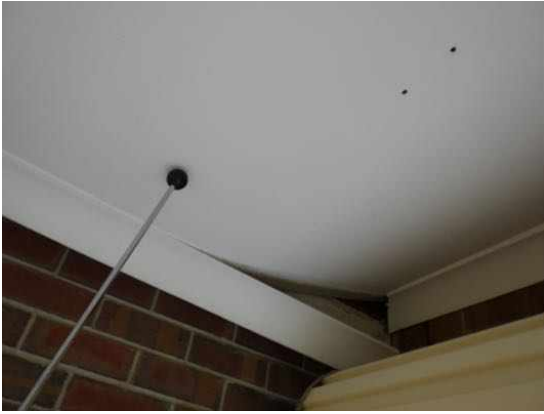
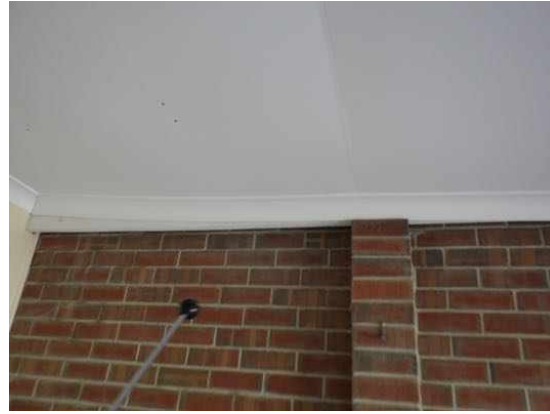
Finding 1.01

Building:	Building 1
Location:	Carport
Finding:	Ceiling sagging - garage
Information:	Sections of the ceiling were found to have major sagging to the garage ceiling at the time of inspection.

Sagging to the fixed ceiling structure generally indicates that the building materials have swollen, due to contact with water, or that fixings (e.g. nails or glue) have become loose and require reattachment.

This is a very common defect in carports due to their lack of insulation and or their susceptibility to moisture. Condensation builds up in the roof and rests on the plasterboard softening it somewhat which makes it more likely to sag and release from its fixing points.

Replacement of the ceiling will likely be required and should be carried out by licensed builders, plasterers and painters in the short term otherwise total collapse will be imminent.

Insulating the area is also highly recommended.

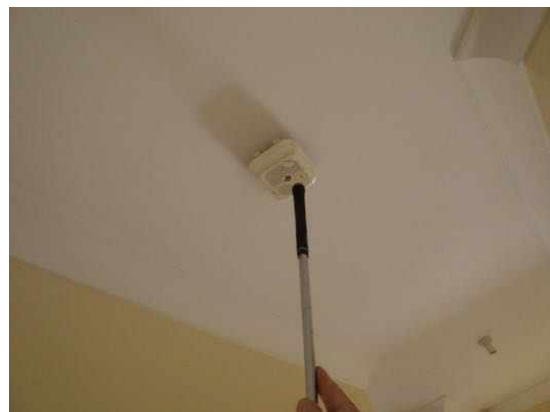
Finding 1.02

Building:	Building 1
Location:	All External Areas
Finding:	Smoke Detectors and Alarms
Information:	Reporting on Smoke Detectors or Alarms, including hard wired smoke detection systems and their legislative requirements, is outside the Scope of this Report.

Please note that this defect is highlighted as a caution only. We suspect, based on our experience in the building industry, that the absence of smoke detectors, or their poor condition, should be addressed as a matter of urgency to improve occupant safety.

Always ensure sufficient working and suitable smoke detectors are installed prior to occupying any building. Additionally, it is advised that all smoke detectors be tested by the homeowner on a monthly basis.

Please refer to AS3786 and state based legislation, which may also apply.

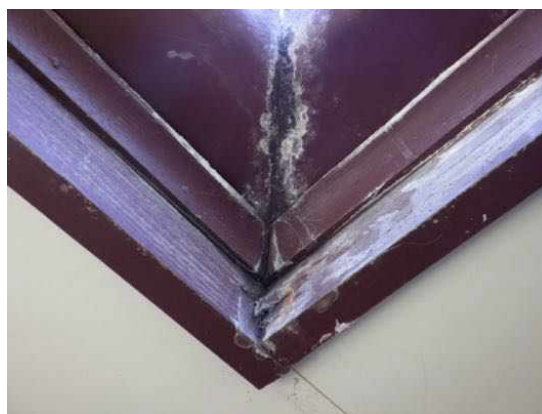
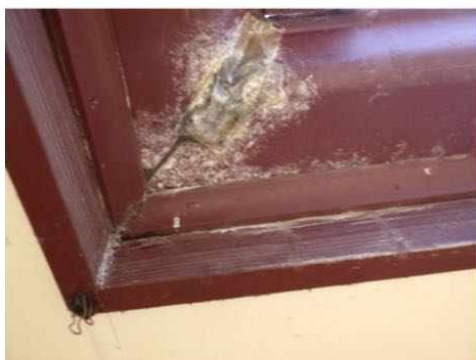
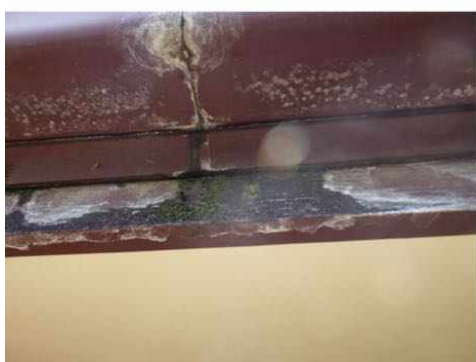
Finding 2.01

Building:	Building 1
Location:	Roof Exterior
Finding:	Roof plumbing - Rusted or corroded
Information:	The roof plumbing has areas of rust and corrosion. It is suspected that this has been caused by blockages, resulting in pooling or standing water, that have prematurely rusted elements of the roof plumbing.

Rusted roof plumbing will generally develop holes and leaks that can affect other building elements with poor drainage of storm water.

Poorly drained roof areas will also lead to damp conditions surrounding the base perimeter of the building which, if left unmanaged, can lead to a range of secondary building defects.

Repair and/or replacement of rusted roof plumbing is highly required in order to reinstate the roof drainage system to a fully operational level.

To further maintain these areas, gutters should be cleaned frequently, allowing the avoidance of any partial blockages.

A licensed plumber or specialist roof restoration company should be appointed to undertake these works. It is advised that such works be completed as soon as possible to prevent any further damage and deterioration.

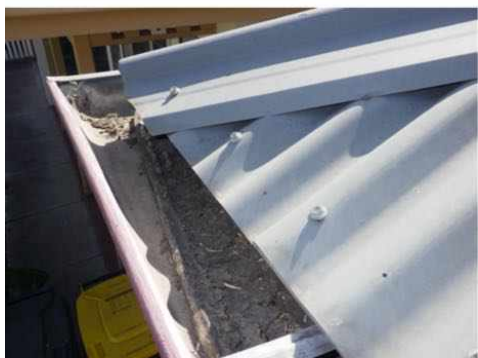
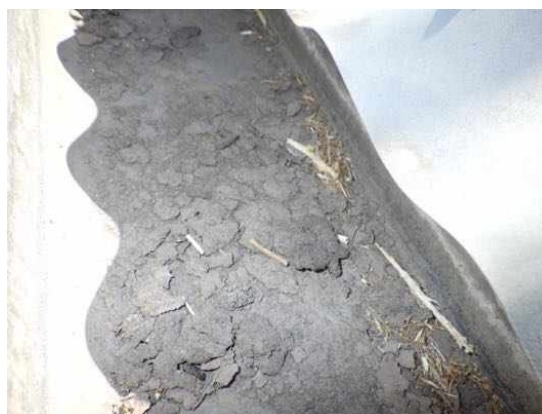
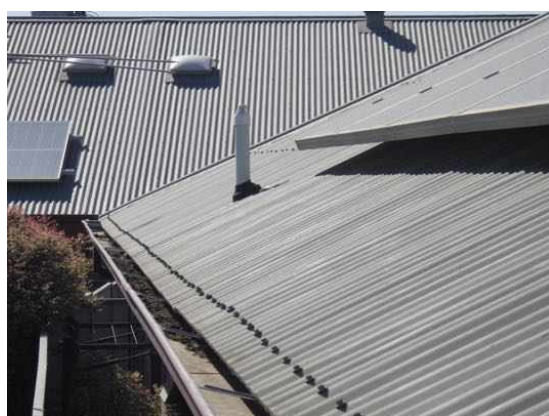
Finding 3.01

Blocked gutters are likely to lead to high levels of moisture in the affected areas. Such moisture will not only cause rust and decay of the associated building materials, but can also provide conditions that are conducive to termite and timber pest activity. Blockages in gutters should therefore be removed immediately to ensure dry conditions are maintained.

Consult a Licensed Plumber for further specific advice on remedial works that may be required. In the interim, it is highly advised that blocked gutters be removed by the homeowner or a general handyperson as a matter of urgency.

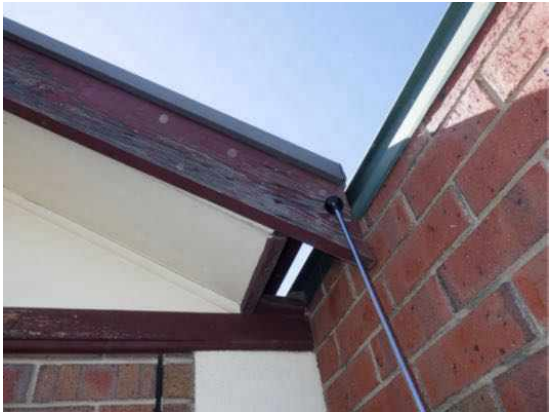
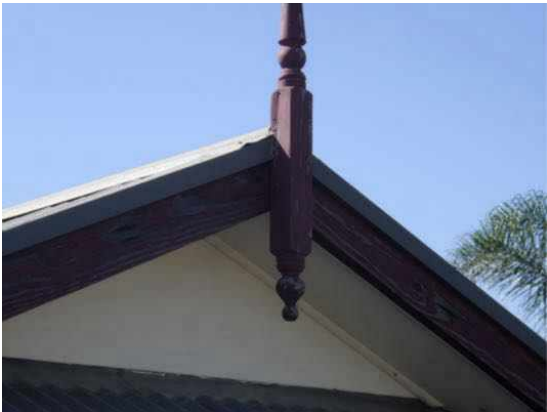
Finding 3.02

Building:	Building 1
Location:	All External Areas
Finding:	External painting deteriorated
Information:	Much of the external paintwork including but not limited to exterior fascia timbers, and other elements, have been neglected and require attention to prepare and re-paint.

Whilst incomplete or missing paint finish is generally an appearance defect, it can also lead to the development of secondary building defects over time. Incomplete areas of paint finish expose the area to moisture, potentially accelerating the deterioration of underlying building materials.

Degraded paint finishes should be sanded back, filled, leveled and painted, as applicable. Rust to steel beams should be ground out and treated.

A painting contractor should be appointed as soon as possible to perform necessary works to aid the appearance of the affected area and to ensure the area is protected against further deterioration. Alternatively, the homeowner following manufacturer instructions may perform these works.

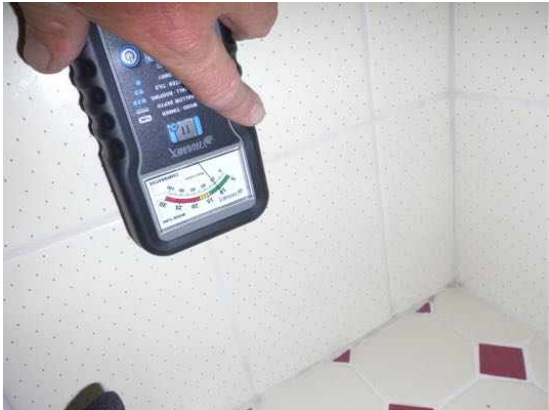
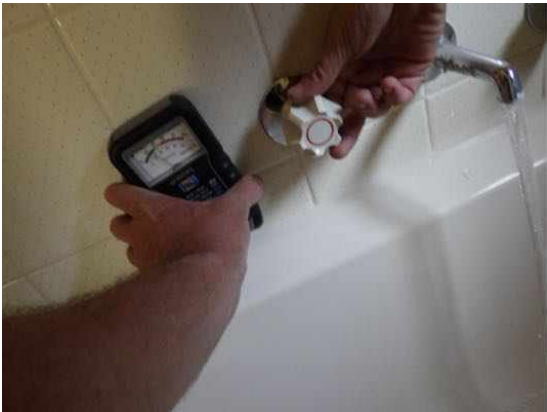
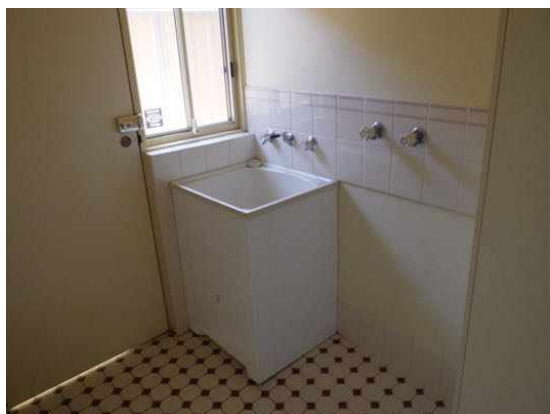
Finding 3.03

Building: Building 1
Location: Bathroom
Finding: Tiles - Drummy sealant and grout ok.
Information: Drummy tiles were identified to approximately 15% of the wall and floor tiles to the wet areas at the time of inspection.

The term 'drummy' refers to tiles that have become detached from their fixing, despite otherwise being in relatively good condition, or sometimes they get laid onto dust during the building process and never really form a good bond. Such defects are generally caused by physical or moisture damage to the area or poor workmanship during the building process.

As no damage to tiles or grout was evident at the time of inspection further monitoring is recommended and should deterioration to the tiles become evident a licensed tiling contractor should be appointed to required repairs at the discretion of the client.

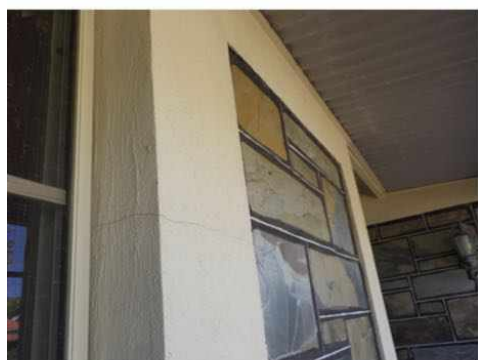
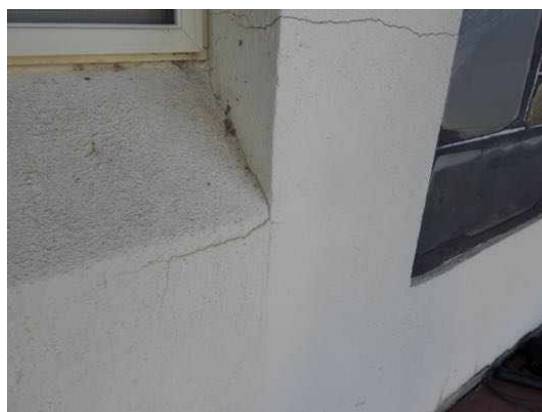
Finding 3.04

Building: Building 1
 Location: All External Areas
 Finding: Render - Cracking
 Information: There were several cracks evident to the render around the property at the time of inspection likely due to general expansion and contraction and or general old age. Most cracks were found to be less than 1 mm wide.

Moisture can penetrate the cracks and as such regular maintenance is required in these older properties.

A licensed painting contractor can be appointed to repair minor cracking and repaint the walls.

Always contact a building inspector should cracks widen lengthen or become more numerous.

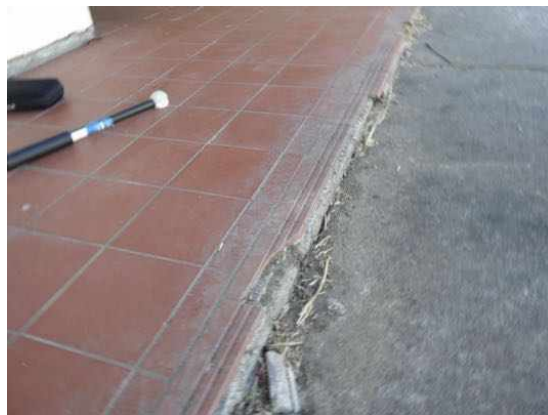
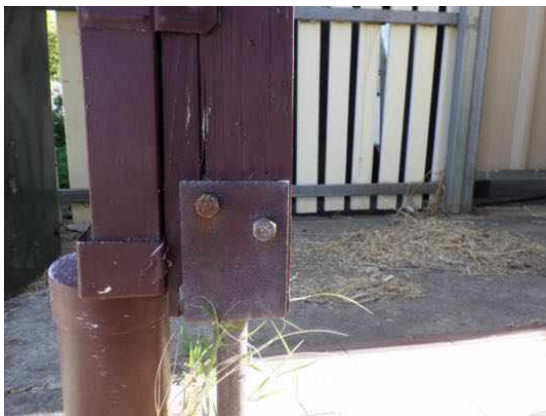
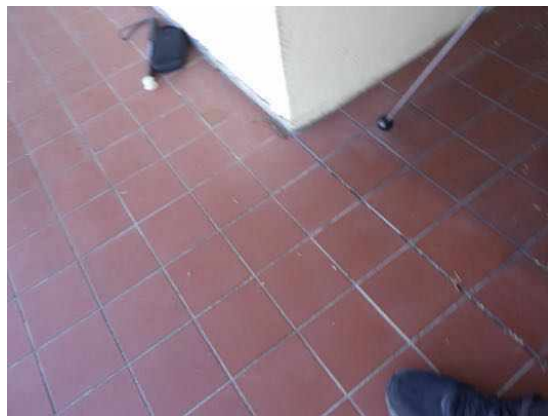
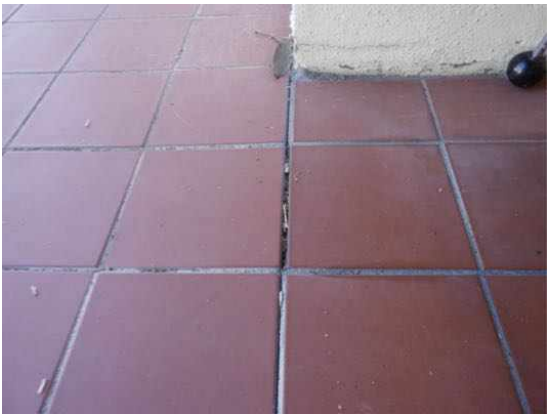
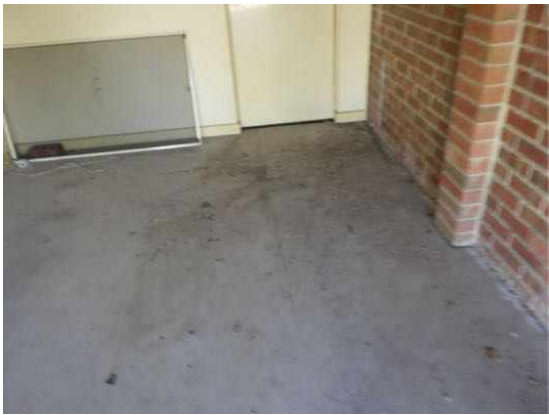
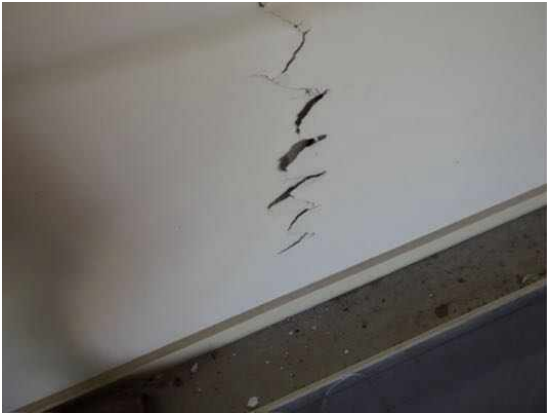
Finding 3.05

Building: Building 1
 Location: All Areas
 Finding: Minor defects present
 Information: There were several age and maintenance related defects evident to the dwelling at the

time of inspection. These defects include but are not limited to

- Damage to front porch tiling
- Damage to front porch post
- Physical Damage to garage wall
- Bed 1 door not striking
- Carpet deteriorated throughout.

Appropriate licensed trades people could be appointed to make repairs at the discretion of the client.

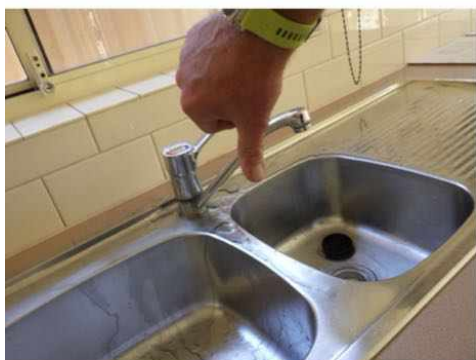
Finding 3.06

Building: Building 1
Location: Roof Void
Finding: Plumbing issues.
Information: All plumbing should to be maintained in good order.

However Issues noted by the inspector include but are not limited to

- Leak to bath spout
- Leaking to kitchen mixer
- Loose toilet pan

It is highly recommended that the client makes contact with a licensed plumber to make required investigations and adjustments prior to any further secondary defects being created.

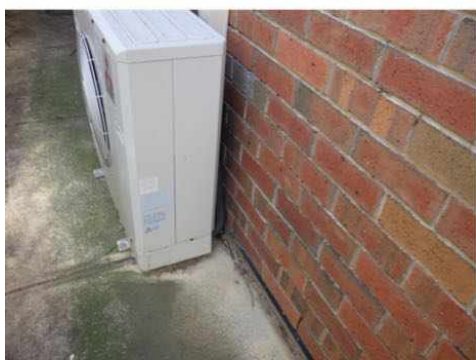
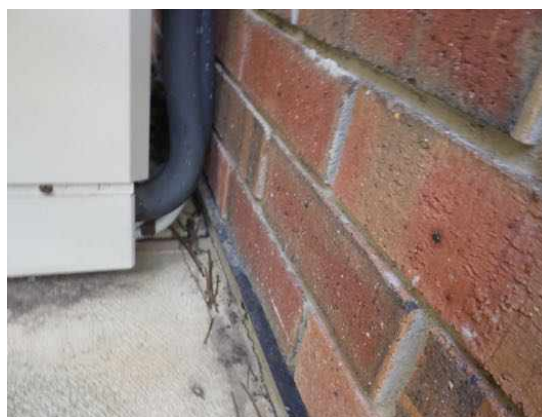
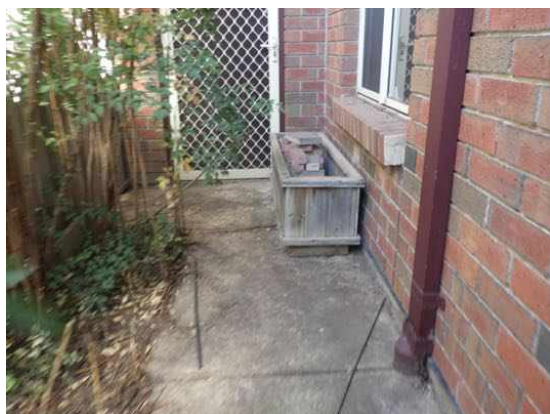
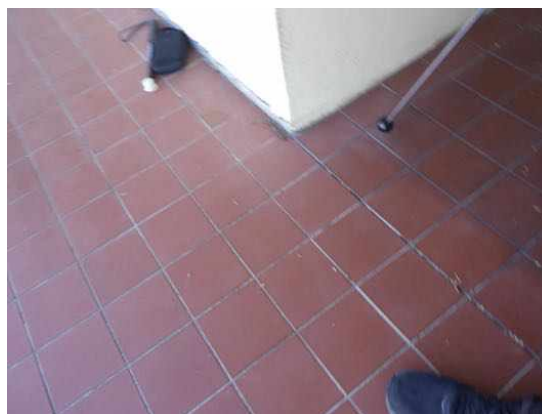
If the slab edge is not properly exposed there is a high risk of concealed termite attack which your inspector will likely not be able to see. Sometimes, in order to determine the type of slab, a suitably qualified person such as an architect or builder may be required to consult construction plans.

Where the slab edge cannot be properly inspected, it is highly recommended that termite or timber pest inspections be carried out every 6-12 months to aid protection of the property against infestation and termite treatment advice is followed closely.

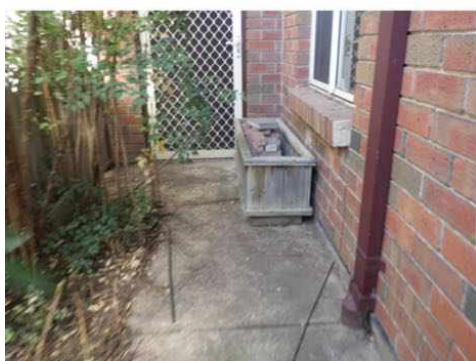
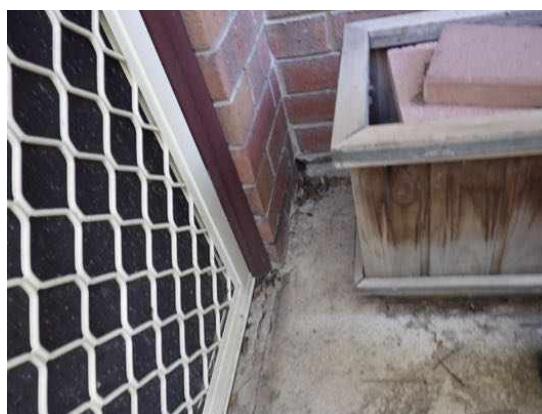
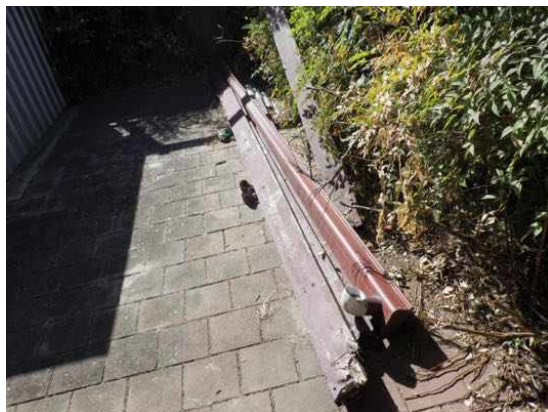
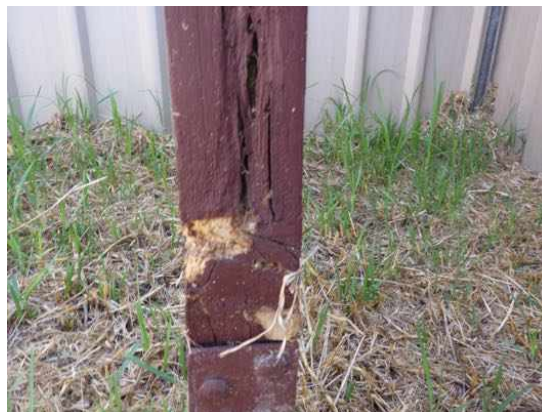
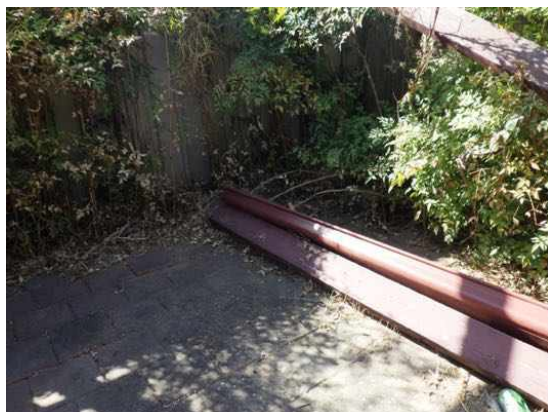
Finding 6.02

Building:	Building 1
Location:	All External Areas
Finding:	Untreated or non-durable timbers in a hazardous environment
Information:	To reduce the risk of timber pest attack it is essential that timber used in a hazardous environment (e.g. in direct contact with the ground or frequently exposed to damp conditions) is of sufficient durability and/or is adequately preservative treated. Additionally any timber lying around or timber stumps should be removed.

Untreated timbers in direct contact with the ground are likely to develop severe wood rot and/or fungal decay if left unattended creating attraction for subterranean termites to infest the timbers from surrounding areas.

If untreated or non-durable timbers are found to be in a hazardous environment it is highly advised that replacement of these building elements be performed as soon as possible to aid the protection of the property against termite / timber pest attack. Failing this close monitoring is recommended in an attempt to identify termite infestation at an early stage.

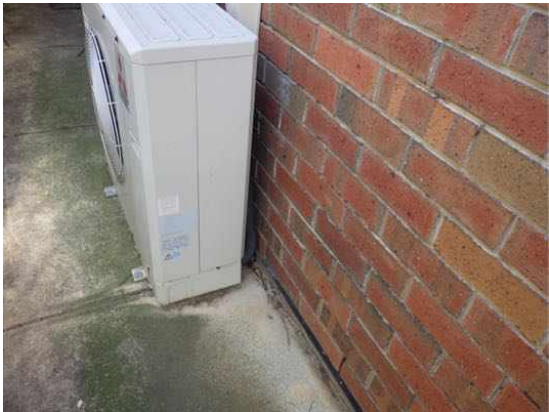
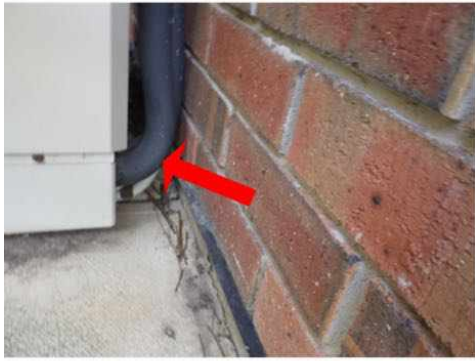
Building: Building 1
Location: Yard - Back
Finding: Air conditioner and or external tap - No drainage
Information: Moisture around the perimeter of the building should be minimised to ensure that the area is kept dry and stable which in turn reduces the risk of water damage and termite infestation.

There appears to be no drainage points set up to the air conditioning unit, and or the external tap. While this is not a legal requirement it is recommended to reduce the risk of moisture related issues and the creation of an environment conducive to termite activity.

It is recommended that a licensed plumber be appointed to set up drainage in order to prevent such an environment from being created.

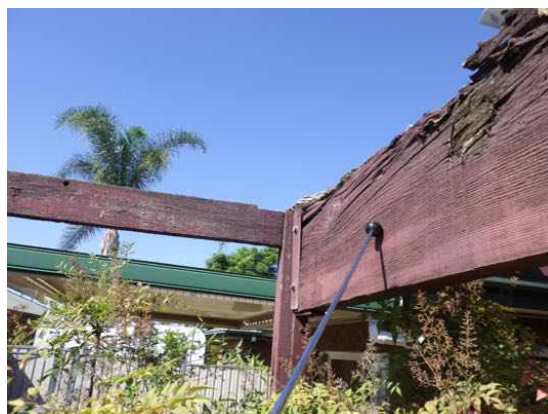
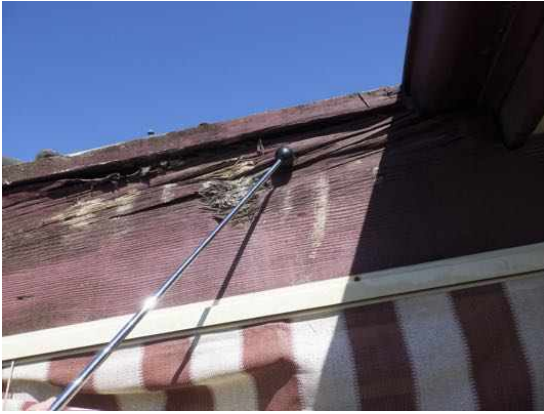
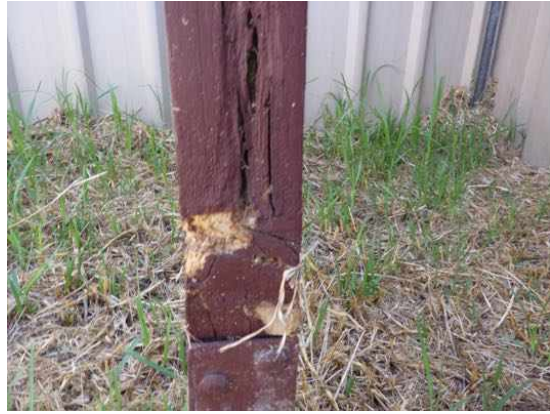
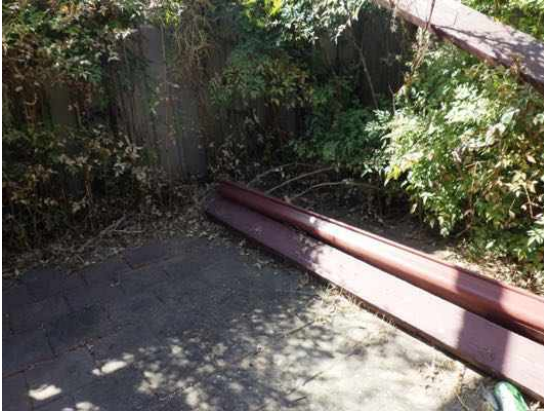
Finding 7.01

Building:	Building 1
Location:	Yard - Back
Finding:	Pergola - deteriorated
Information:	Age and general moisture associated deterioration was evident to the rear pergola at the time of inspection with rot evident to several sections and major damage to the structure.

It is likely that this damage has developed as a result of general old age, a lack of maintenance and protection from the elements.

Early intervention and regular maintenance will prolong the useful life of these building elements.

Replacement will likely be required and could be carried out by a licensed carpenter at the discretion of the client.
