Building and Timber Pest Inspection Report

Inspection Date: Thu, 15 Jan 2026

Property Address: 4/40 New Line Rd, West Pennant Hills NSW
2125, Australia

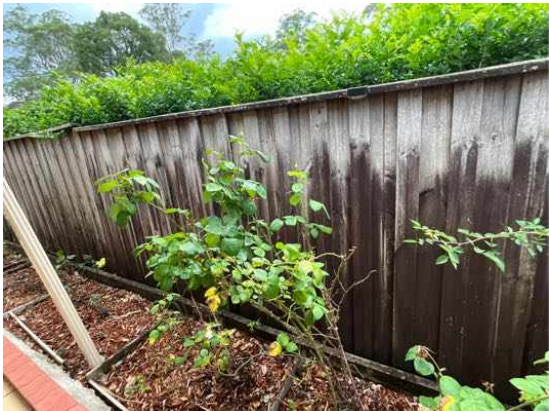
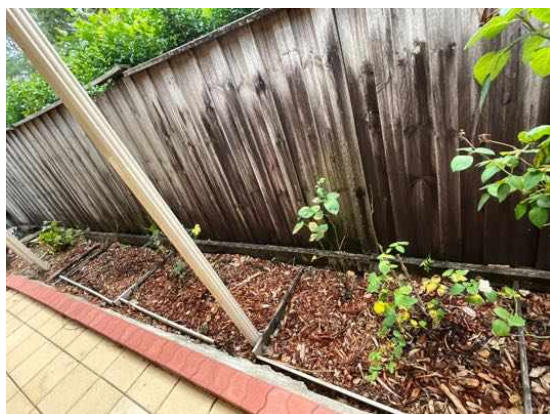
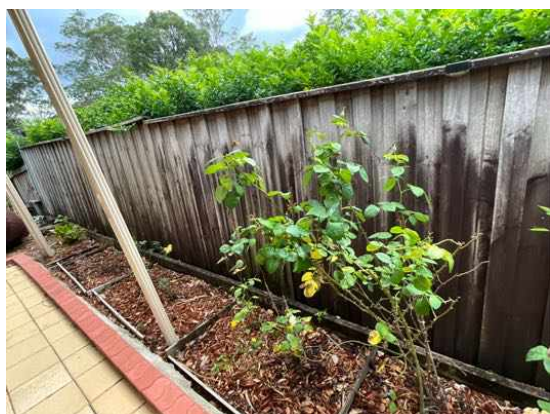
The leaning fence poses a risk of collapse, potential property damage, and a security breach, diminishing its effectiveness as a barrier.

A skilled fencing contractor or handyman is needed to assess and rectify the leaning fence. Timely repair is crucial to restore the fence's stability and prevent further damage or safety hazards.

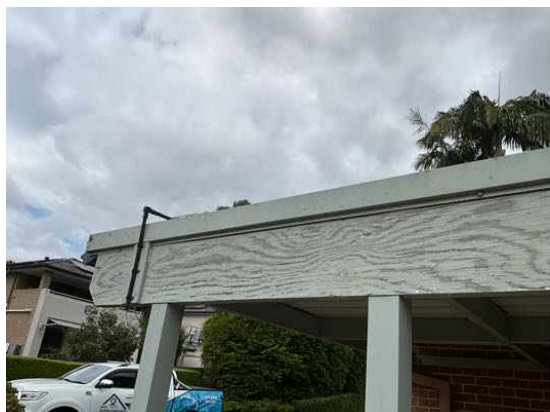
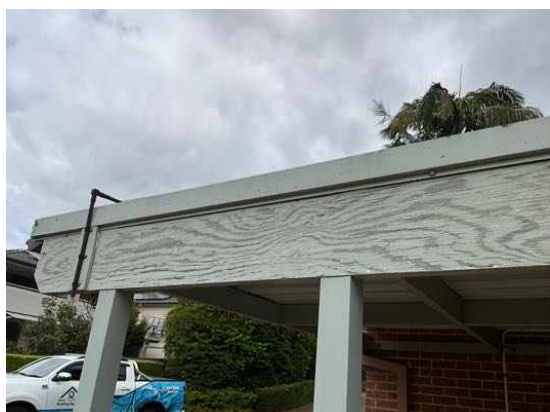
Finding 3.01

Building:	Main Building
Location:	All Areas
Finding:	Timber - exposed to weather
Information:	External timbers that are frequently exposed to harsh weather conditions require adequate protection in order to maintain their condition. Where timbers have not been painted or treated adequately, general deterioration is likely to occur at an accelerated rate.

If left unattended, replacement of these timbers is likely to be necessary in the short-term future. Adequate treatment of these timbers is required as soon as possible by a painting contractor or general handyman.

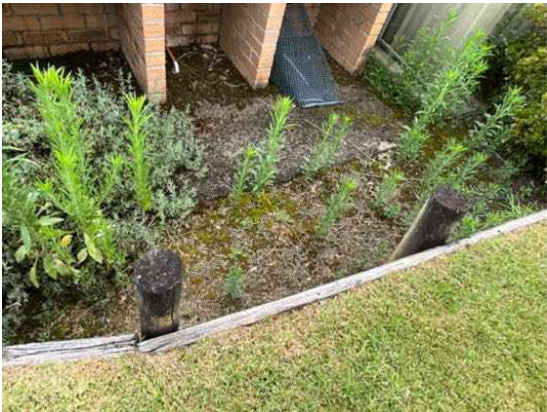
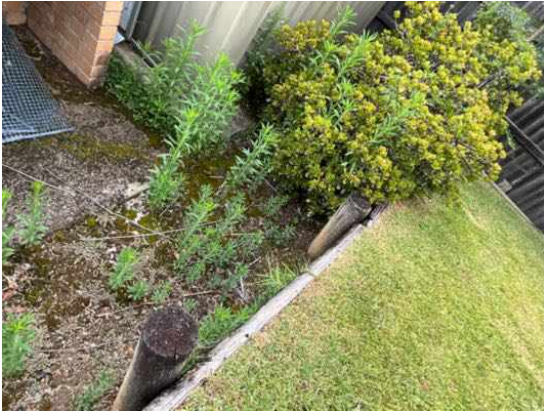
Finding 3.02

Finding: Retaining wall - Defective

Information: The retaining wall in this area was found to be defective at the time of inspection. Generally, defective retaining walls are caused by poor original design or material use. However, deteriorated retaining walls may also be a result of substandard construction, poor site drainage or unmanaged stormwater flows.

If left unmanaged, the retaining wall may become a safety hazard if it continues to destabilise. Where retaining walls further rot and decay, an environment is created that is conducive to termite and pest infestation.

Significant repair and replacement should be expected. Where retaining walls are considered structural walls, a structural engineer / surveyor should be consulted regarding required remedial works. Otherwise, a landscaper or retaining wall installer may be appointed to repair or replace the wall, at the discretion of the client.

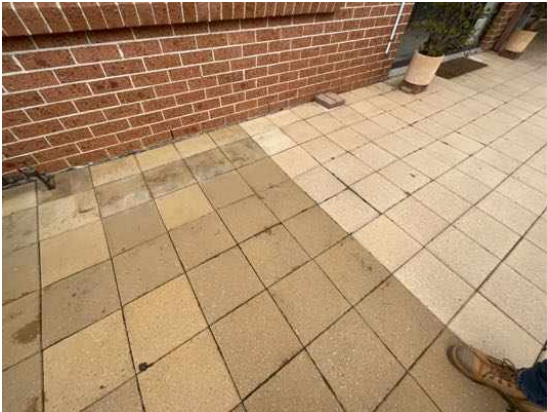
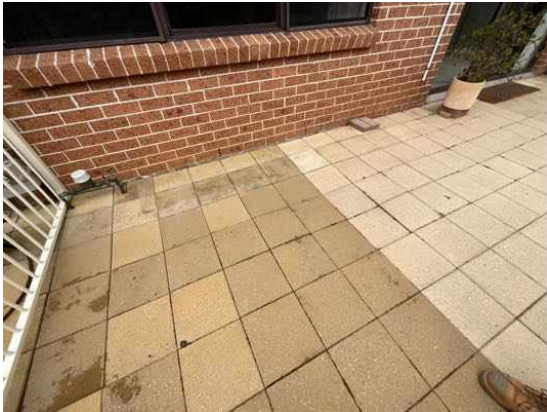
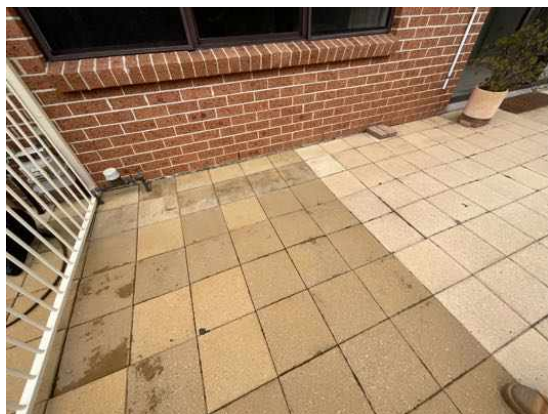
Building:	Main Building
Location:	Yard - Side
Finding:	Pavers uneven and displaced
Information:	Cracked, uneven, and displaced pavers were observed. Several pavers appear loose, misaligned, or deteriorated.

The uneven surface poses a significant trip hazard for pedestrians and may impact the usability of the driveway. Displacement and cracking can worsen over time due to vehicle traffic, poor subbase compaction, or water ingress. Wall cracking may lead to moisture entry or structural wear if left untreated.

- A qualified paving contractor should be engaged to lift, relevel, and relay the affected pavers with proper bedding and compaction.
- A licensed builder or bricklayer should repair and seal the masonry wall crack around the pipe to prevent further water ingress and deterioration.

- Drainage should also be checked to ensure water is not contributing to the issue.

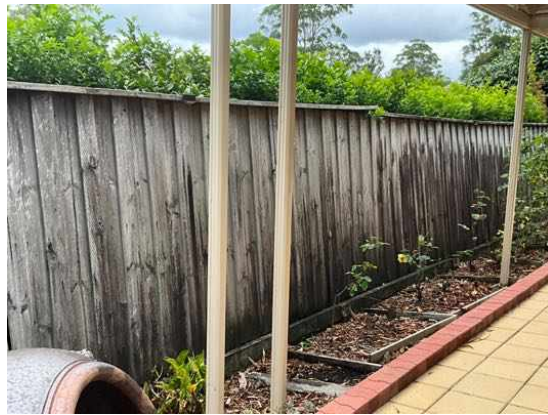
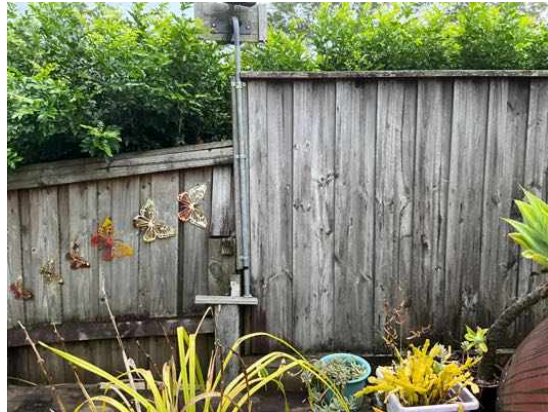
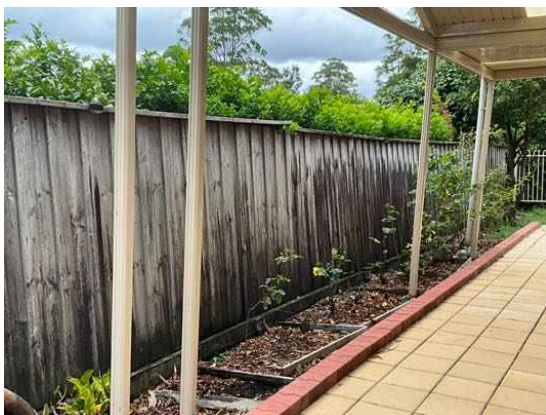
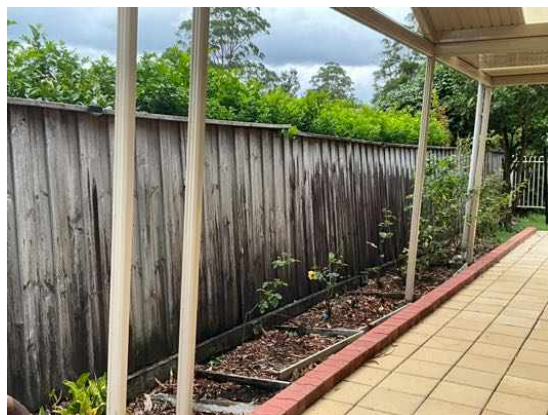
Information: The fence along the property boundary has deteriorated significantly, showing signs of rot, rust, and structural weakness. Several sections are leaning or have become detached, compromising the integrity of the fence and its ability to perform its intended function.

1. **Safety Hazard:** The unstable fence may collapse, posing a risk of injury to residents, visitors, and passersby.
2. **Security Concern:** The compromised fence may allow unauthorized access to the property, increasing the risk of theft, vandalism, or trespassing.
3. **Property Damage:** Falling sections of the fence could damage nearby structures, plants, or other property features.
4. **Legal Liability:** If the fence were to fail and cause injury or damage to neighboring properties, the property owner may be held liable.

- **Licensed Fencing Contractor:** A professional fencing contractor should be hired to assess the extent of the damage and either repair or replace the deteriorated sections.
- **Handyman Services:** For minor repairs, a qualified handyman could be engaged to reinforce or repair specific sections of the fence.
- **Landscaper (if the fence is part of a larger garden feature):** If the fence is integrated into the landscape design, a landscaper with experience in fencing could be involved in the repair or replacement process.

It's important to ensure that whoever is hired is experienced and qualified to ensure the fence is restored to a safe and functional condition, compliant with local regulations.

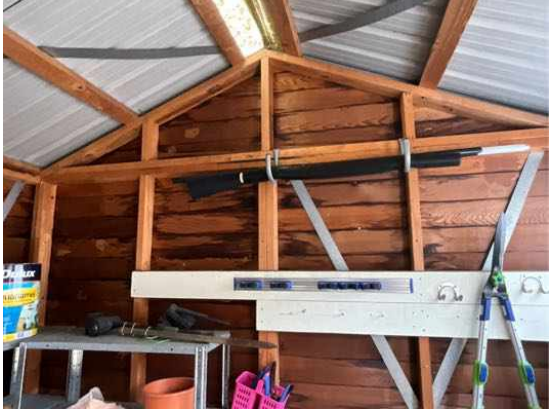
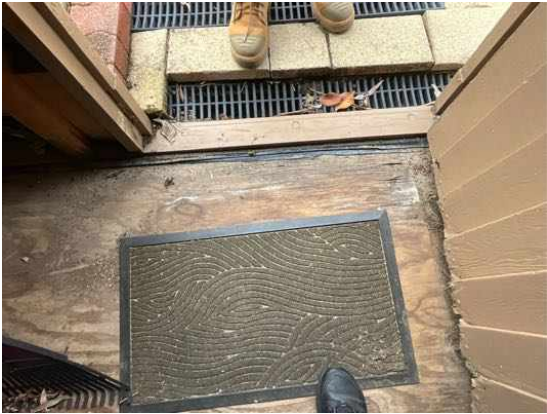
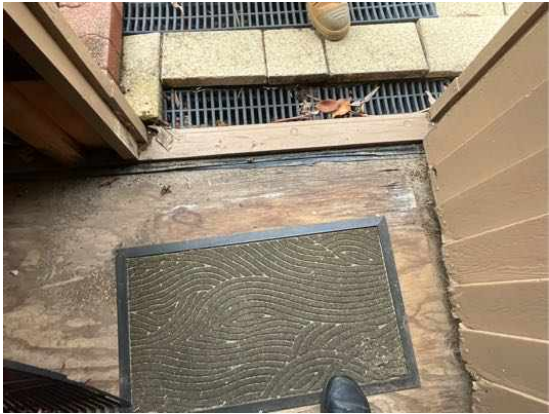
Finding 3.07

Building:	Main Building
Location:	Shed
Finding:	Shed - detached shed structure significant deterioration
Information:	The detached shed structure exhibits signs of significant deterioration, including weathered and rotting external cladding, uneven and damaged ceiling linings, and general structural instability. These conditions indicate the structure is not fit for safe use or occupation in its current state.
Risk:	
	High – Structural instability poses a safety hazard, with potential for partial collapse,

injury, or failure during adverse weather conditions.

Engage a licensed builder or structural engineer to conduct a full assessment of the shed's condition and advise on required repairs or reconstruction. Demolition and rebuild may be more cost-effective depending on the severity of structural issues.

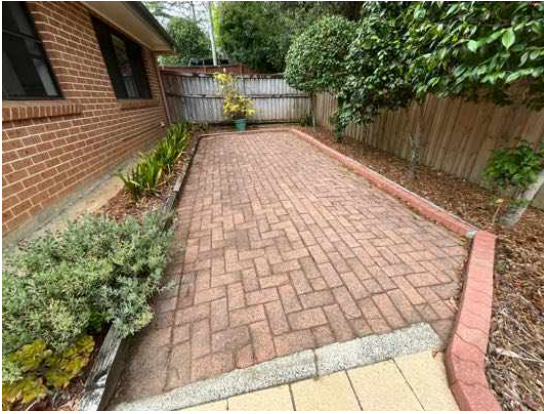
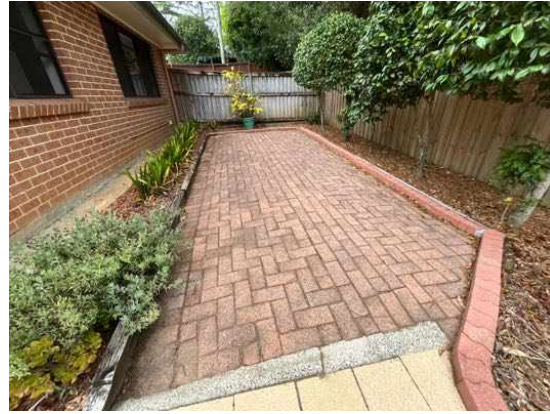
Finding 3.08

Surface water drainage is defective if it is not in accordance with the requirements of the Building Code of Australia.

Such water pooling also increases the risk of termite activity and the development of fungal decay in the area.

Consult a Licensed Plumber regarding the cost of potential site drainage rectification works.

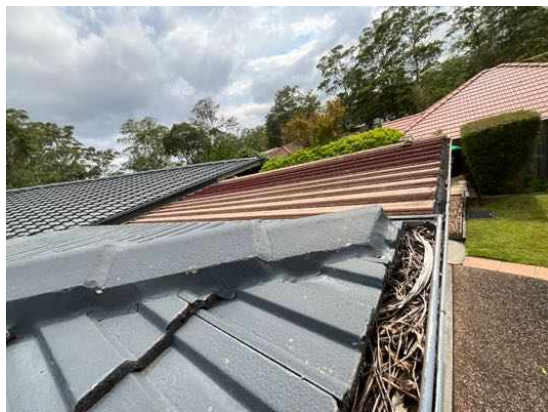
Finding 3.09

Building: Main Building
 Location: Roof Exterior
 Finding: Roof Weathered - metal roof sheeting
 Information: The roof sheeting shows visible weathering, surface oxidation, and deterioration of fastener washers. Some sheet overlaps appear uneven and may not provide adequate weatherproofing at joints near the dormer. The sealant and flashing junctions also show signs of age and deterioration.

Prolonged weather exposure and rusting can lead to corrosion, potential roof leaks, and reduced lifespan of the sheeting. Deteriorated fasteners may allow water ingress, particularly around joints and penetrations.

Engage a licensed roofing contractor to inspect and maintain the affected areas. Replace rusted screws and washers, resecure loose or uneven sheets, and apply protective roof coating or repainting as required. Check flashings and sealants to ensure watertightness.

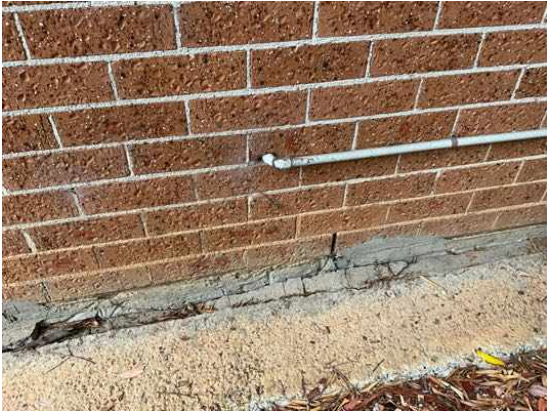
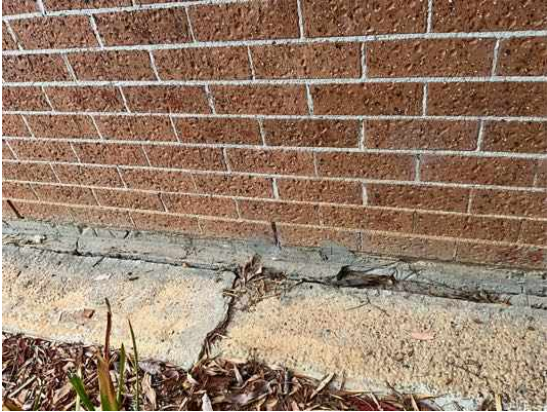
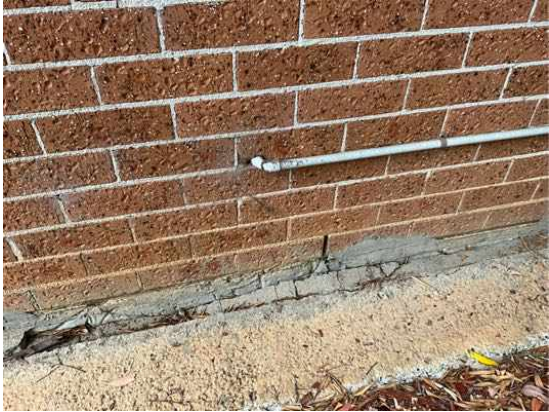
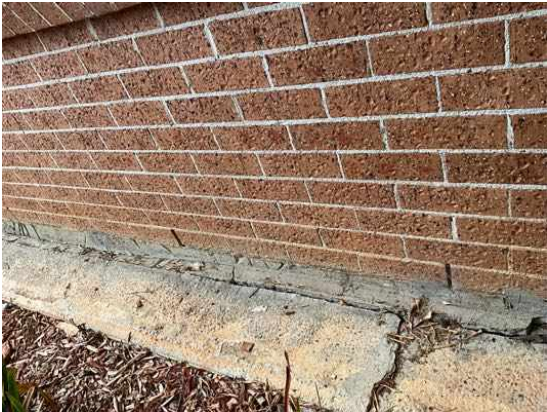
Building:	Main Building
Location:	Exterior walls - rear
Finding:	Mortar - damage and deterioration
Information:	The mortar joints in the brickwork and concrete structures, exhibit signs of damage and deterioration. The mortar has visibly cracked, crumbled, and eroded in sections, leading to weakened structural integrity of the affected areas.

If left unaddressed, the deterioration of mortar can allow moisture ingress, leading to potential water damage, mold growth, or further weakening of the wall's structure. Over time, this could lead to more significant structural issues such as cracking in the masonry or even partial collapse, presenting safety hazards.

A qualified bricklayer or masonry specialist should be engaged to perform repointing of the damaged mortar joints. The process involves removing the deteriorated mortar and replacing it with fresh mortar to restore the integrity of the structure. The affected concrete areas should also be repaired, possibly with a concrete repair specialist to ensure proper sealing and protection against further weathering and water infiltration.

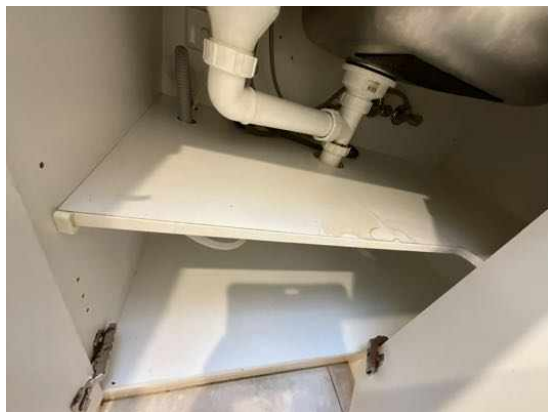
Building: Main Building
Location: Kitchen
Finding: Water Stains in Vanity
Information: "Water stains observed in the vanity area, compromising its appearance and potentially causing damage."

Continued water exposure may lead to material damage, mold growth, and diminished aesthetic appeal.

A licensed plumber or maintenance professional should assess and fix any leaks contributing to the water stains, while a cleaning or restoration service may be needed to address the visible stains and prevent further damage.

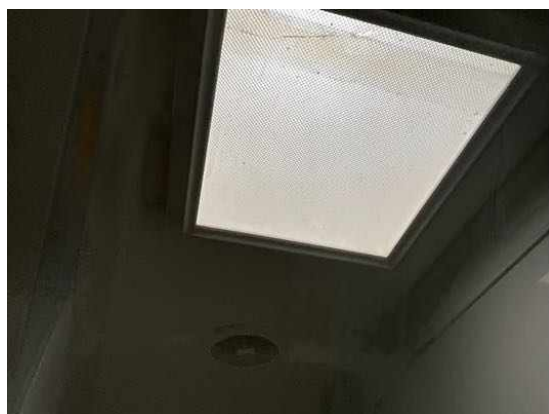
Finding: Skylight damaged

Information: Skylight or natural light diffuser in the roof space appears to be cracked..

- Water Ingress: A damaged or unsealed sunlit can allow rainwater to enter the roof cavity, causing damage to insulation, ceiling linings, or timber framing.
- Pest Entry: Gaps or cracks may provide access points for insects or rodents.
- Thermal Inefficiency: Unsealed areas can compromise insulation performance and contribute to energy loss.
- Structural Degradation: Ongoing water ingress can lead to rot, mould growth, or degradation of framing timbers over time.

- Roof Plumber or Licensed Roofing Contractor – To inspect the skylight , reseal or replace it as needed, and ensure proper waterproofing and flashing are in place in accordance with NCC and relevant Australian Standards.

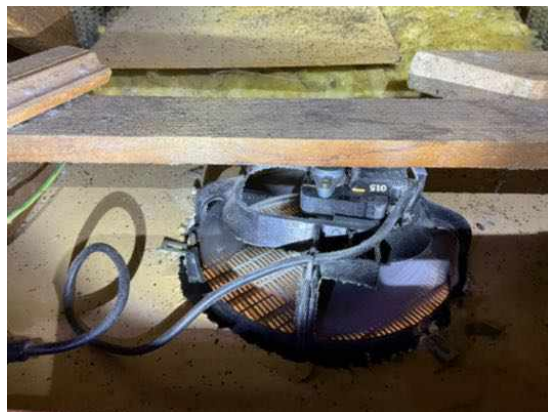
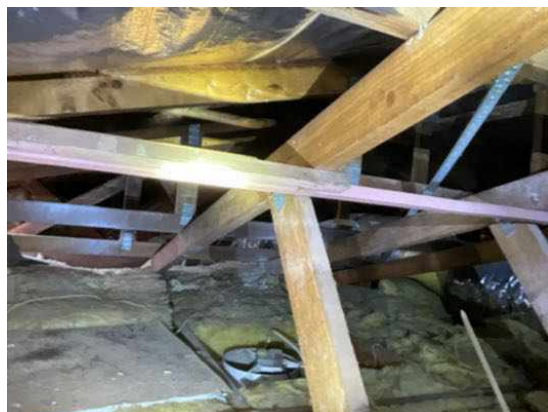
Finding 3.18

Building:	Main Building
Location:	Roof Void
Finding:	Exhaust fan not vented out

Information: The exhaust fan located within the roof void is not appropriately ducted to the external atmosphere and is currently discharging moist air directly into the roof space. This is considered a defect under AS 4349.1, as it does not meet the minimum standard of residential building performance expected under normal residential building practices.

This condition may lead to excessive condensation within the roof void, increasing the risk of mould growth, deterioration of insulation, timber decay, and overall reduced durability of building elements. It may also result in poor indoor air quality, potentially affecting occupant health.

It is recommended that the exhaust fan be modified by a licensed HVAC contractor or qualified builder, ensuring it is properly ducted to discharge externally in accordance with manufacturer specifications, the National Construction Code (NCC), and applicable Australian Standards.

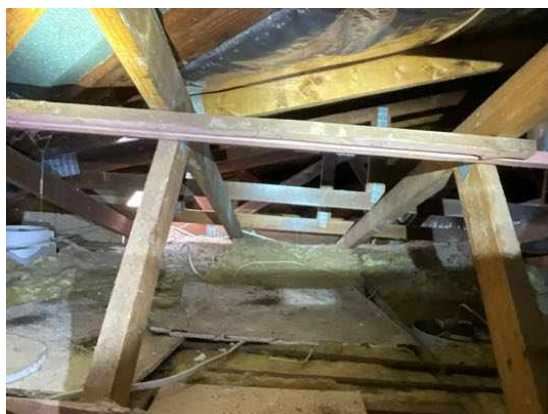
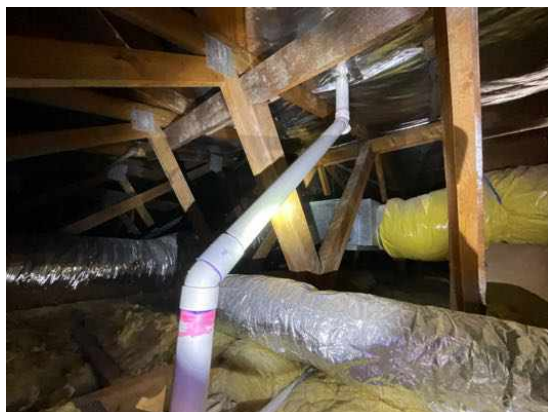
Finding 3.19

Information: Sections of insulation in the roof void have been poorly installed or moved from their original position and are covering down light fittings. While the down lights have been fitted with appropriate protective covers, the presence of this insulation creates a potential fire hazard.

Any insulation within the vicinity of down light fixtures should be moved and re-applied to more appropriate sections of the roof void, thus ensuring the area is fire-safe. An insulation contractor should be appointed as soon as possible to perform any necessary works as required.

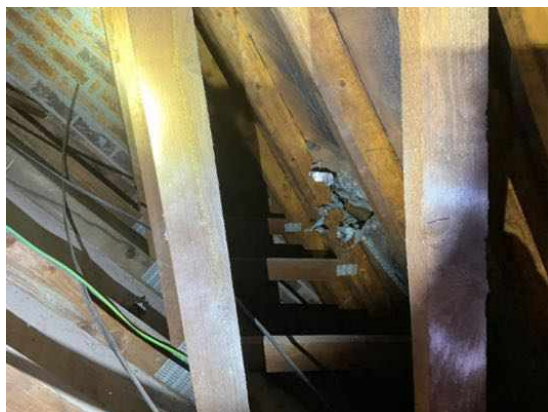
Finding 3.20

Building:	Main Building
Location:	Roof Void garage
Finding:	Sarking - Damaged
Information:	Sarking, a laminated aluminium foil applied to the interior of the roof covering, assists in insulating the property and acting as a vapour-barrier to the roof void and, subsequently, to the household.

Where sarking is damaged, both insulation and moisture protection of the property are inhibited. This creates a loss of energy and thus negatively impacts the energy efficiency of the property, allowing potential for moisture ingress from condensation or leaking roof tiles.

It is important to repair any holes or damaged sections of sarking to ensure that the building material is fully functional. A registered builder or qualified carpenter should be consulted to provide further advice on this defect and to perform rectification works at client discretion.

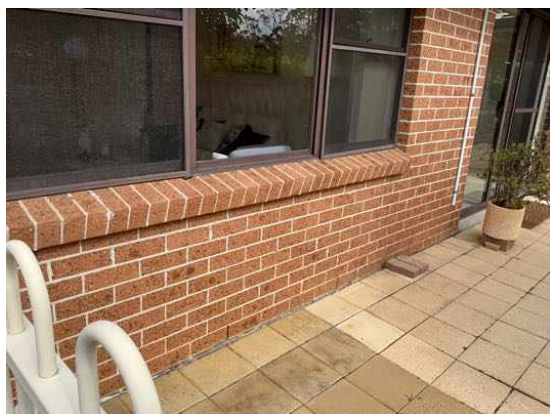
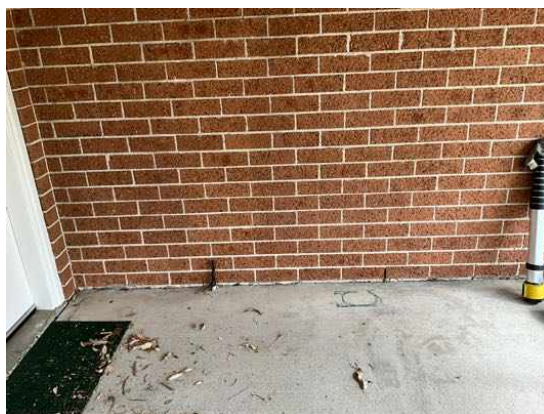
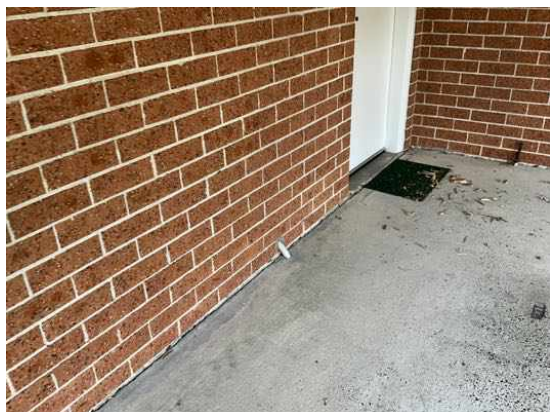
Building: Main Building
 Location: Garage
 Finding: No Evidence of Termite Management System - Durable notice / Legible Sticker
 Information: The application of a pre & post-construction chemical termite barrier is highly recommended for all properties. Such barriers are highly effective in preventing termite attack on any timber building elements throughout the property.

Where the slab edge cannot be properly inspected, it is highly recommended that termite or timber pest inspections be carried out every 6-12 months to aid protection of the property against infestation.

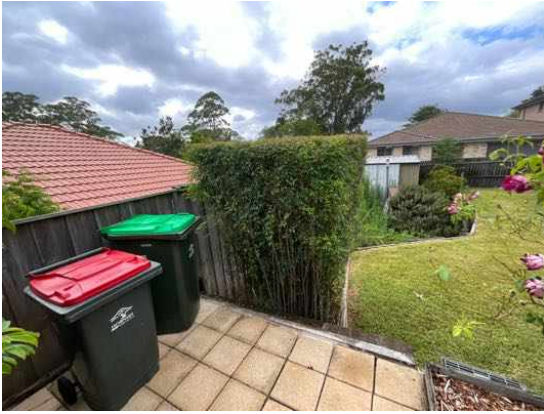
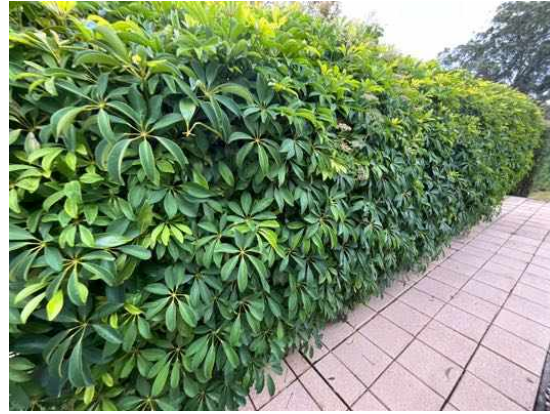
Finding 6.03

Building:	Main Building
Location:	All Areas
Finding:	Dense vegetation around a property can increase the risk of termite infestation
Information:	The presence of dense vegetation around a property can increase the risk of termite infestation, as it provides a conducive environment for them. To address this, consider maintaining a clear space between the vegetation and your home. If you suspect a termite issue, it's advisable to consult with a licensed pest control professional for inspection and treatment.

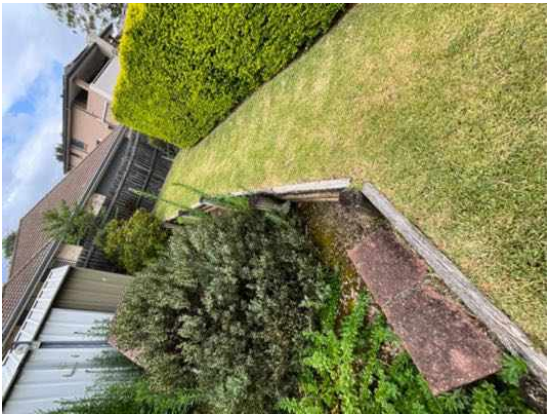
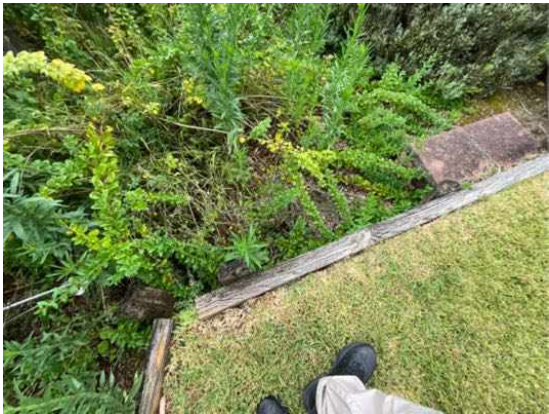
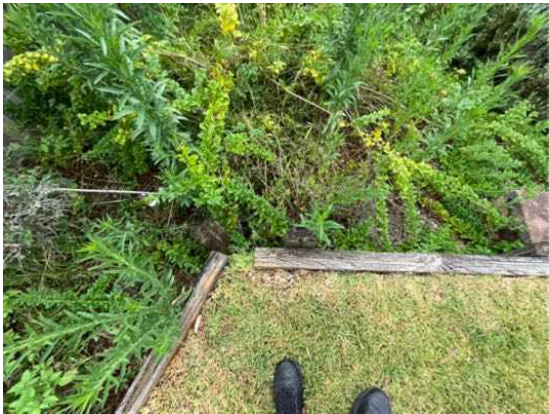
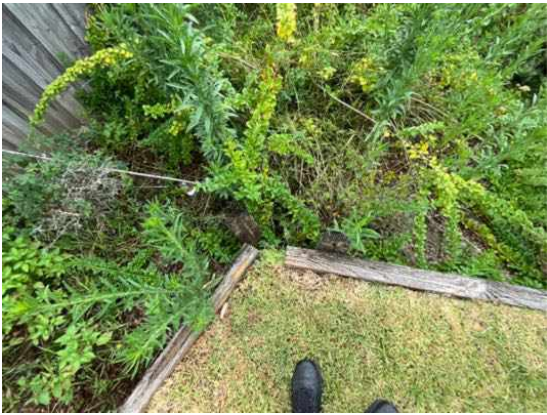
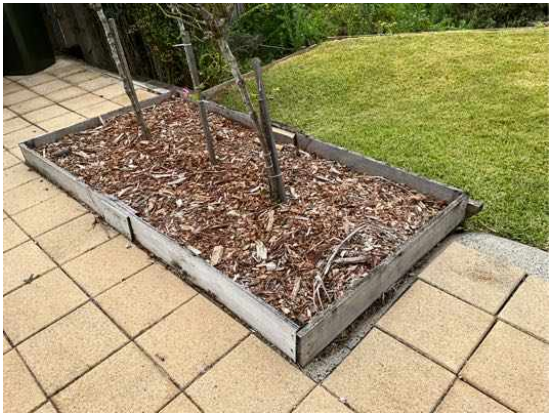
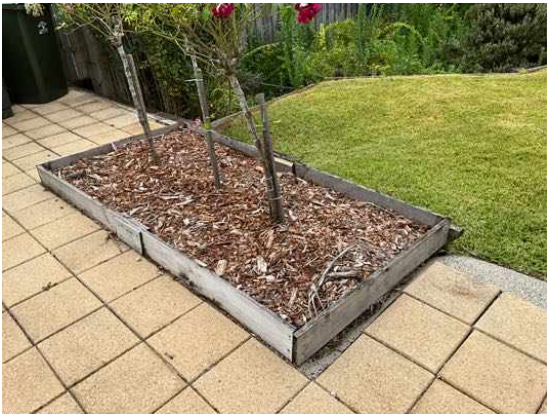
Finding 6.04

Building:	Main Building
Location:	All Areas
Finding:	Timber on ground / conducive conditions to termite damage
Information:	Timber on the ground is indeed conducive to termite damage. Termites are known to thrive in moist environments, and wood in contact with soil or moisture is more susceptible to infestation.

To prevent this, it's important to keep timber elevated and away from direct ground contact. Regular inspections and proper termite control measures are also essential to protect your wooden structures from termite damage.

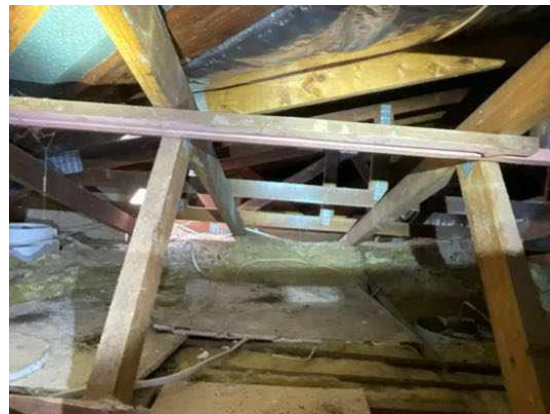
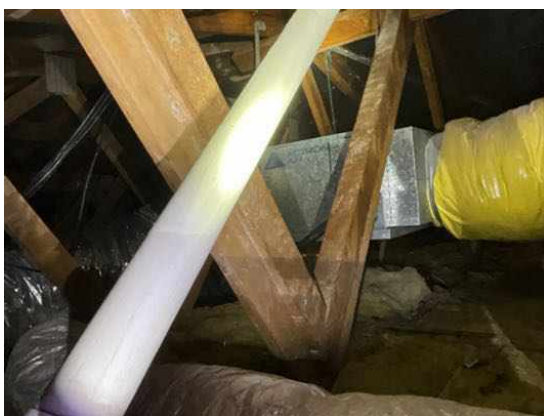
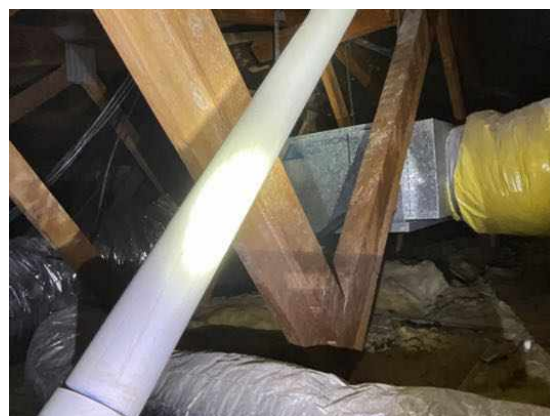
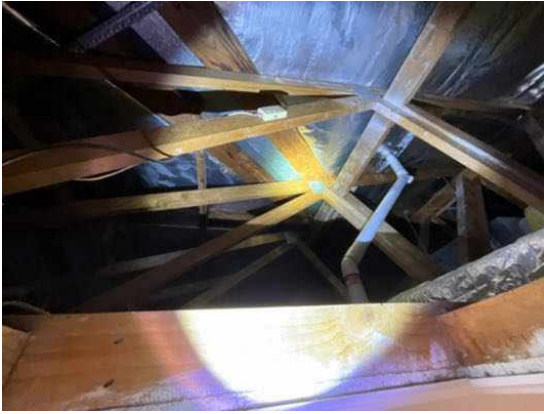
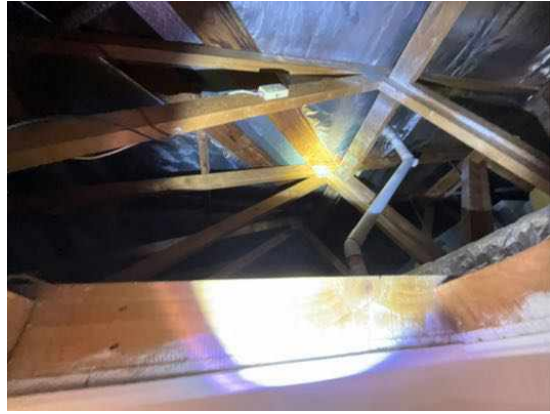
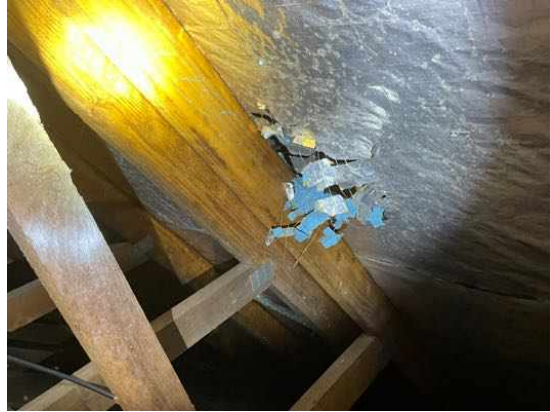
Risk in Terms of Timber Pest: The excessive moisture within the roof void poses a significant risk for timber pests such as termites, as it creates an ideal environment for infestation and proliferation. The damp conditions promote wood decay, making the structure susceptible to damage by these pests.

A qualified roofing contractor and a professional pest control service specialized in timber pest management should be engaged to rectify the issue. They can assess the extent of moisture damage, address any underlying structural issues, and implement effective solutions to mitigate the risk of timber pest infestation.
