Building and Timber Pest Inspection Report

Inspection Date: Thu, 26 Feb 2026

Property Address: 2/74 Linda St, Coburg VIC 3058, Australia

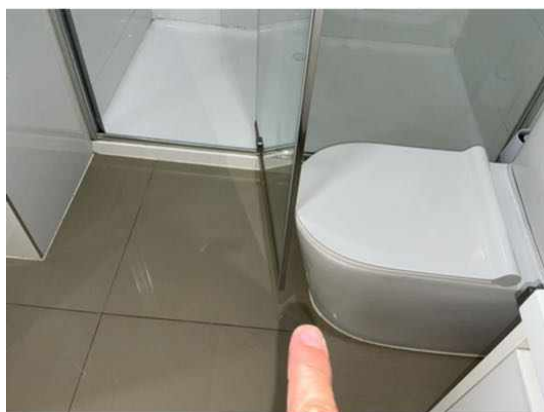
Finding 1.01

Building:	Main Building
Location:	Ensuite
Finding:	Shower screen door catching and binding
Information:	The shower screen door was found to be hitting the toilet when being opened. This would be considered a safety hazard as the glass could shatter if opened too hard. It is recommended that a shower screen installer or handyman attend to the shower screen door to adjust and fit a protective door cushion.

This should be done immediately

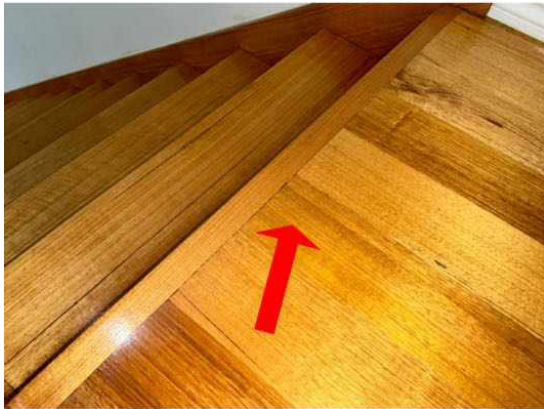
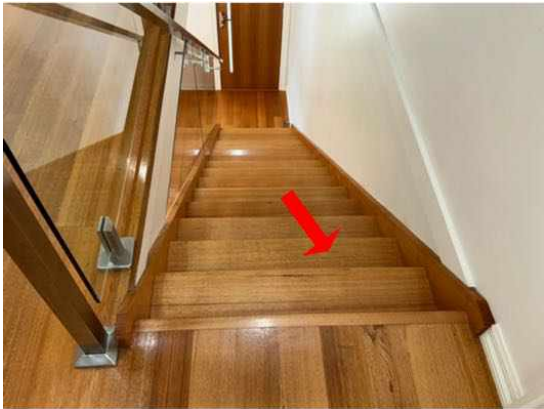
Finding 1.02

Building:	Main Building
Location:	Stairs - Internal
Finding:	Stairs slippery finish
Information:	It was observed that the polished timber stairs were finished in a coating that has no slip index rating and appears to be quite smooth

Polished timber stairs should be finished in an appropriate non-slip coating with a rough surface finish. Alternatively the stairs should be fitted with non-slip nosing to the treads or a non-slip tape to the stair treads

A general handyman or painting contractor should review as soon as possible.

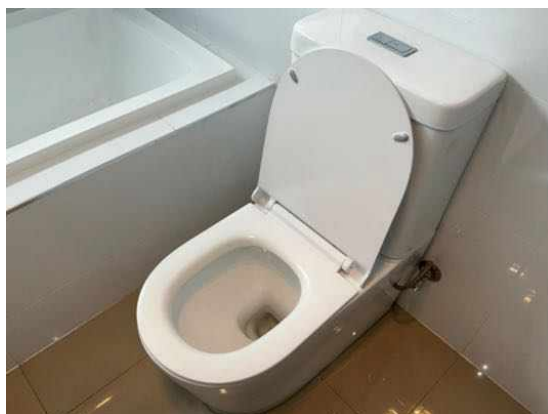
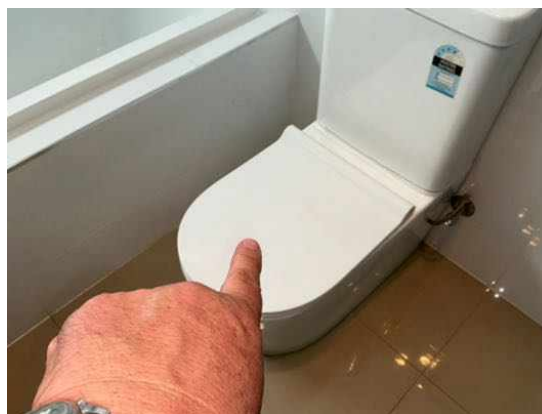
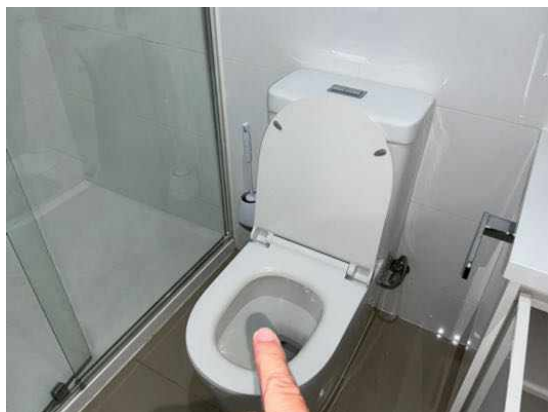
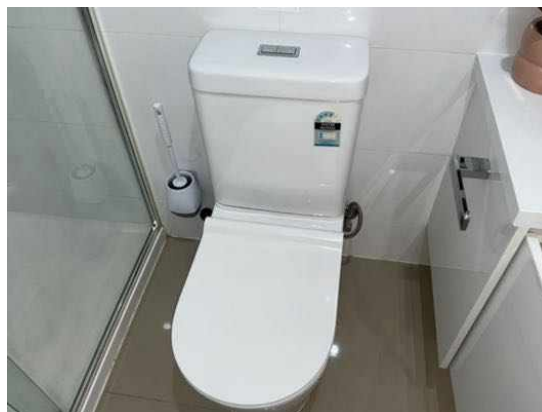
Finding 1.03

Building: Main Building
Location: All Bathrooms
Finding: Toilet seat loose
Information: It was observed that the toilet seats are loose and unstable.

Loose seats can cause fall injury to persons while in use and lead to serious injury

A licensed sanitary plumber should be engaged to review prior to use

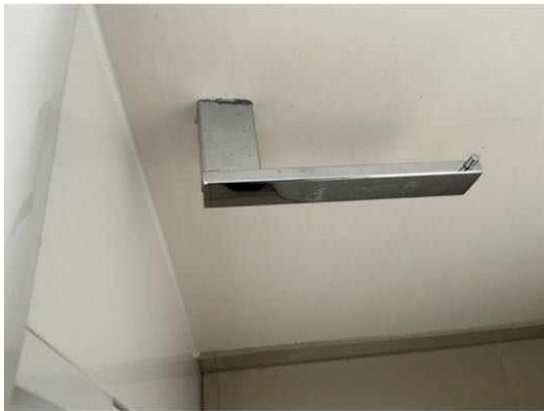
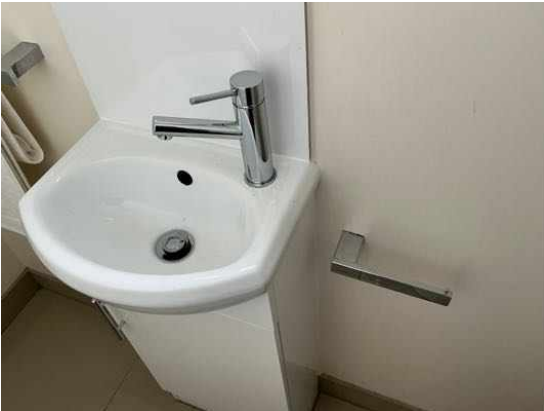
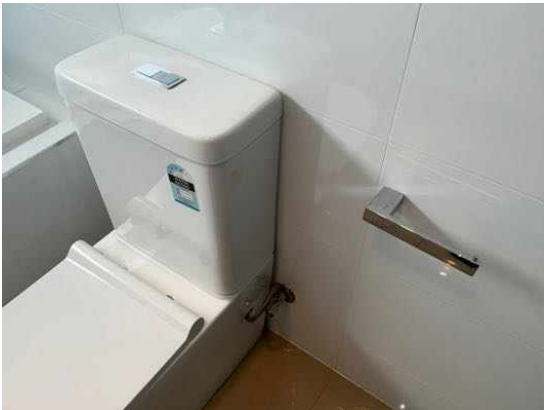
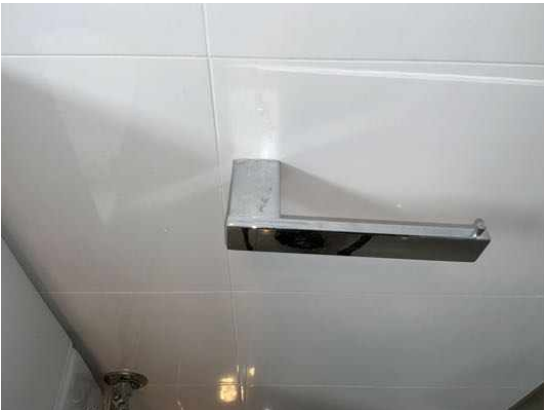
Building: Main Building
Location: All Bathrooms
Finding: Toilet roll holder - Loose
Information: The toilet roll holders were found to be loose at the time of inspection. While not a major operational defect, function can deteriorate if the problem is left unmanaged.

It is advised that the homeowner performs remedial works to re-attach the toilet roll holder to its original fixing. A general handyperson may be required to perform these works.

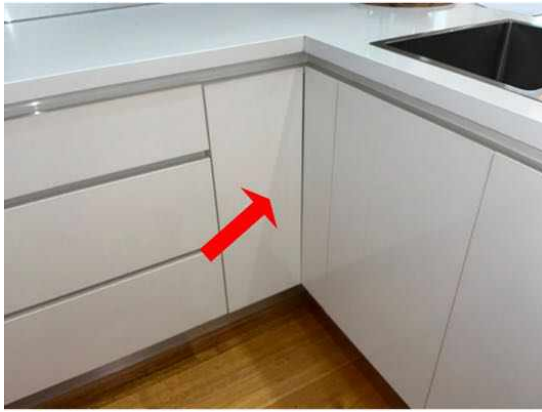
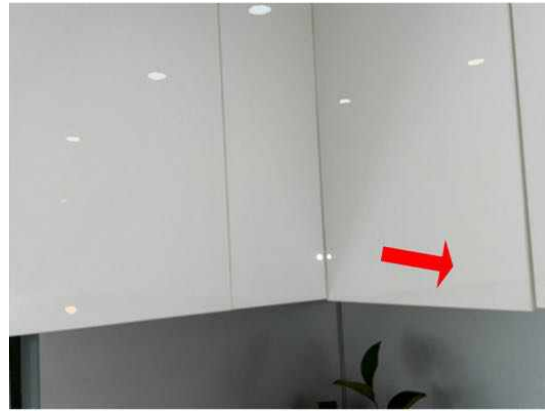
Finding 3.04

Building: Main Building
Location: Kitchen
Finding: Cabinet doors require adjustment
Information: It was noted that many cabinet doors to the kitchen had become loose overtime and has caused the doors to bind and become difficult to open.

Doors which catch and bind can damage laminated surfaces and allow water ingress into cabinetry elements. This can cause swelling of the chipboard substrate and premature deterioration of the structure of the cabinet.

A qualified cabinet maker should review at the owners discretion.

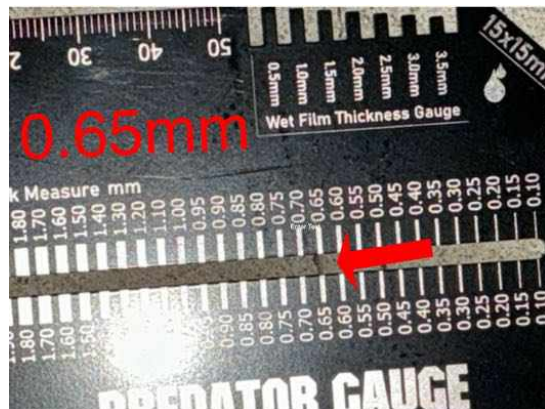
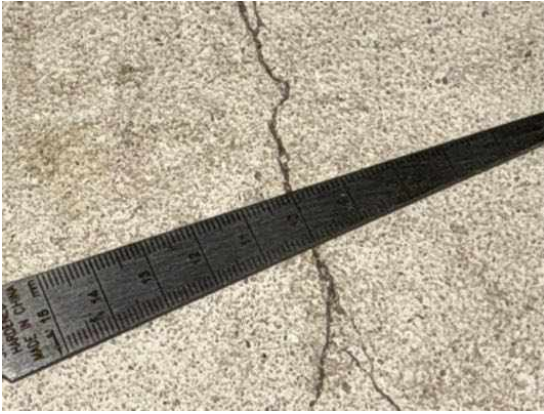
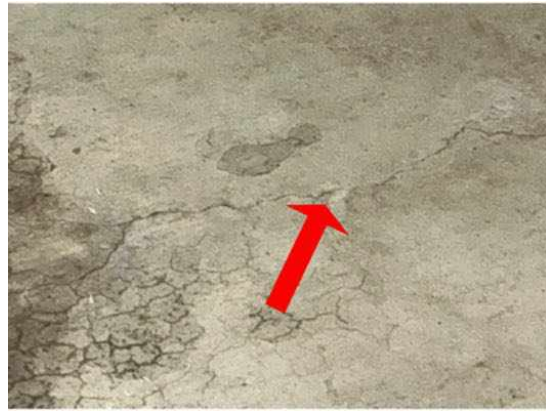
Finding 3.05

Building:	Main Building
Location:	Garage
Finding:	Cracking - Damage Category 1 - Fine (up to 1mm)
Information:	Although fine cracks are quite noticeable, they are often only considered to be an appearance defect, and usually do not indicate any structural damage. Generally, the cause of a fine crack is indicative of a separation between building materials and finishes (e.g. paint, plaster, etc.) along joins.

Cracking of this nature can generally be repaired with minor sanding, filling and/or repainting. Such works should be performed by a qualified painter or a general handyman.

Monitoring of all cracking should be conducted frequently. Always contact a building inspector should cracks widen, lengthen, or become more numerous.

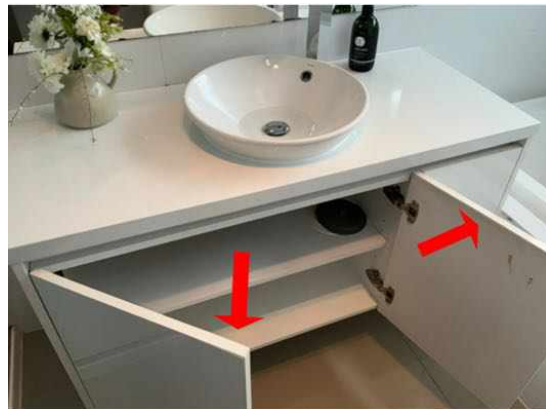
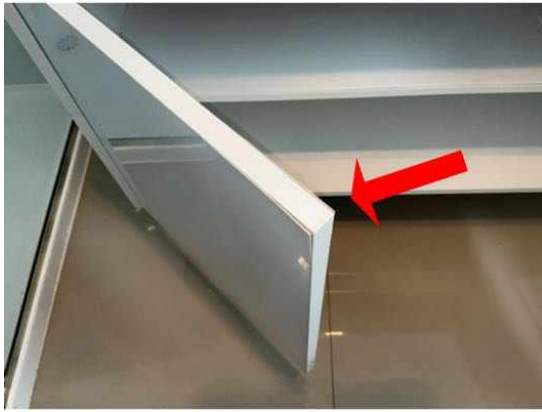
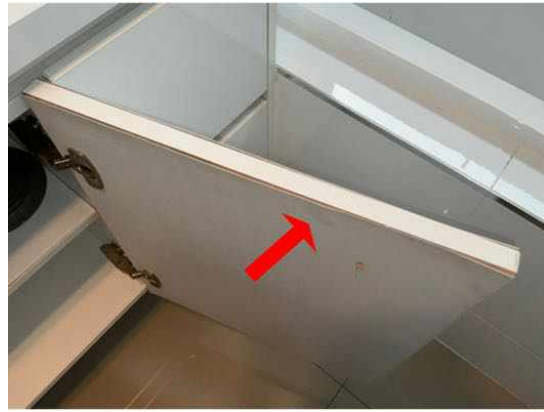
Finding 3.06

Building:	Main Building
Location:	Bathroom
Finding:	Malaine deteriorated
Information:	It was observed that the white malamine surface to the ensuite vanity cabinet doors was deteriorated and water damaged

The white melamine coating is required to prevent the ingress of moisture into the kitchen cabinets substrate. damaged Malaine on cabinets and is also an aesthetic defect which detracts from the overall appeal of the building.

A qualified cabinet maker should be engaged to review at their owners discretion

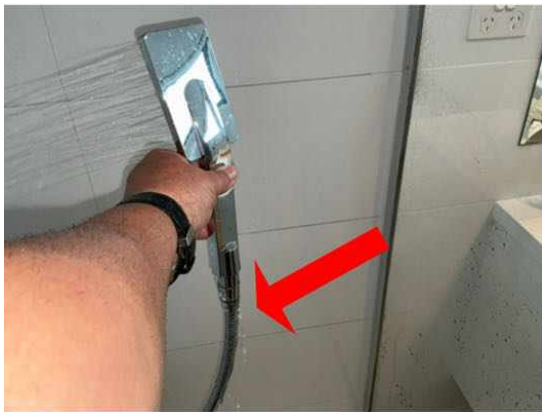
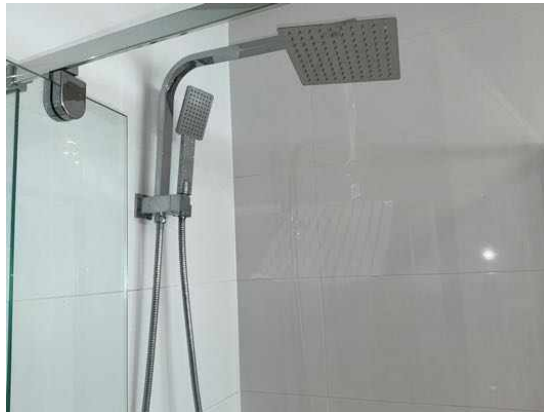
Finding 3.07

Building: Main Building
 Location: Ensuite
 Finding: Shower hose assembly damaged
 Information: It was observed at the time of the inspection that the shower house assembly was damaged and leaking.

This damage and deterioration can cause limited functionality and may provide uncontrolled moisture from the shower closet when in use.

A registered plumber should review as soon as possible

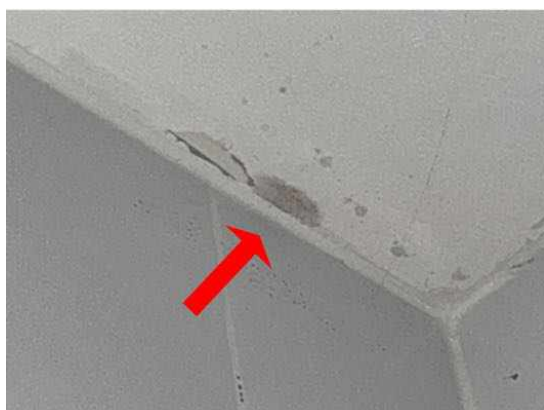
Finding: Water leak - Inactive

Information: Water leaks generally occur when a particular area of the property is not weather- or water-tight. While the damage in this area appears to be from an old inactive water leak, the area should be monitored frequently for the recurrence of any dampness.

Repair and / or replacement of previously affected building elements is at client discretion. Consider a further invasive inspection: removal of obstructions around the damaged area may reveal further damage which has been concealed. A more significant or major defect may be identified at this time.

Where recurrence of an active water leak is identified, a qualified plumber should be appointed immediately to rectify the leak and advise on any further preventative works as necessary.

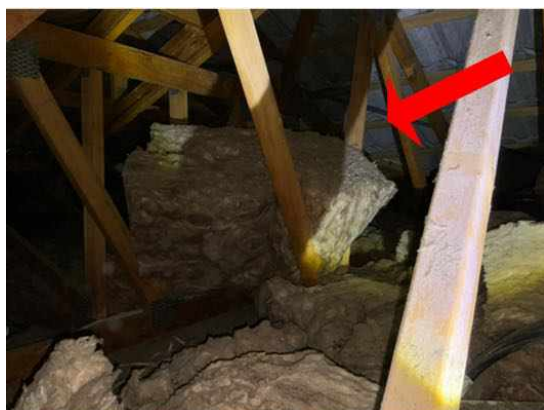
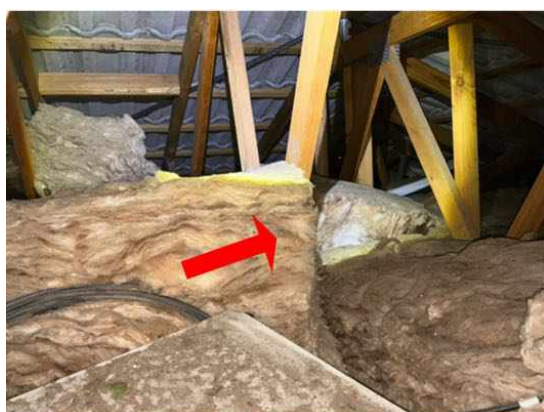
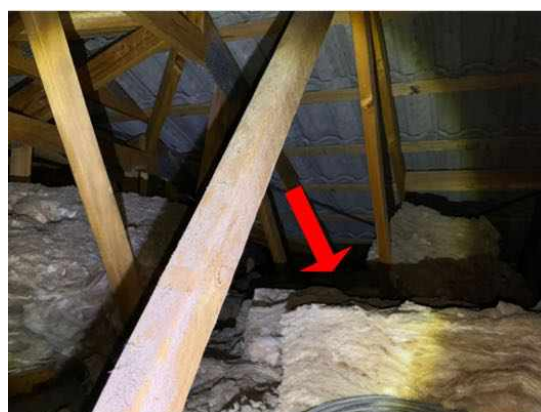
Building: Main Building
 Location: Roof Void
 Finding: Insulation - Missing-disturbed
 Information: Upon inspection of the roof void it was noted that insulation is not present or disturbed.

Insufficient insulation will result in a comparatively higher cost to heat and cool a property as there is a lack of Insulation (or uneven coverage of insulation) which works as a barrier to heat transfer. This helps to keep out unwanted heat in summer and preserves warmth inside your home in winter. It can also help soundproof your home from unwanted airborne noise transfer.

Where insulation is absent, the area does not meet current Australian Standards. Installation of adequate insulation is required and should be conducted as soon as possible.

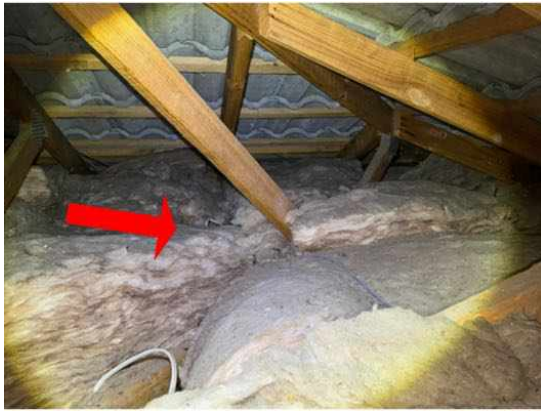
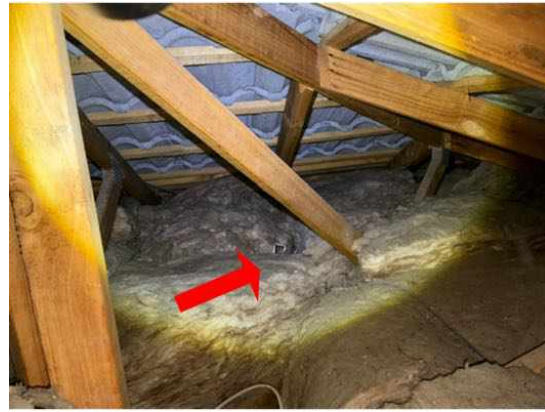
Finding 3.12

Building:	Main Building
Location:	Roof Void
Finding:	Insulation - Blocking fans
Information:	Upon inspection of the ceiling cavity, it was noted that sections of insulation were blocking the exhaust fans. It is suspected that the inappropriate placement of this insulation is a result of poor installation, or that the insulation has simply been removed from its original position.

Where exhaust fans are blocked, many secondary defects are likely to occur; particularly evaporative water staining to the ceiling in the affected room. The formation and development of mould growth is also a concern, which presents as a respiratory health hazard.

Any misplaced sections of insulation should be removed and returned to its original position. Where insulation is insul-fluff (blown-type), total replacement of insulation may be warranted. An insulation contractor should be consulted prior to any works being performed.

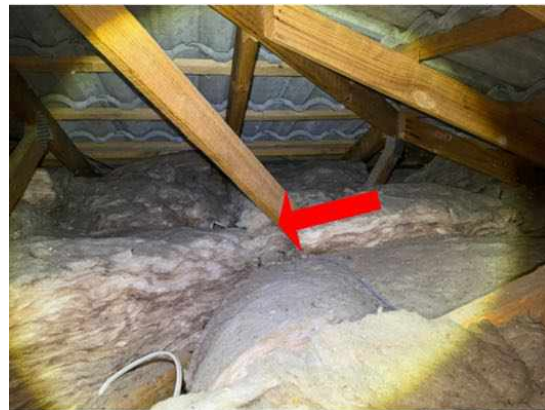
Finding 3.13

Building: Main Building
 Location: Roof Void
 Finding: Exhaust fan/fans not ducted
 Information: Exhaust fans should from the fan to the outside atmosphere. This is to prevent condensation, unwanted smells and the build up of moisture in the roof void.

A licenced plumber or licensed electrician should review as soon as possible.

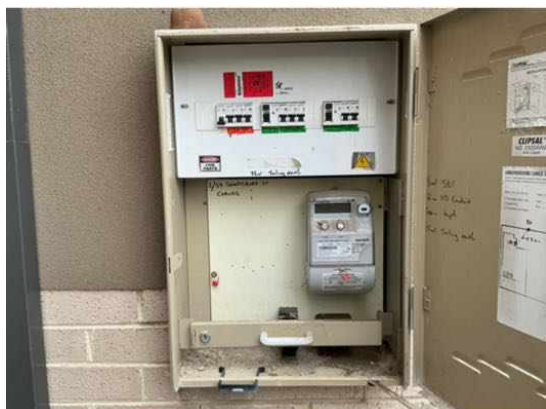
Building:	Main Building
Location:	Meter Box
Finding:	Termite Management System - no evidence of a chemical installation
Information:	The application of a post-construction chemical termite barrier is highly recommended for all properties, particularly if live termite activity has been found on the site previously. Such barriers are highly effective in preventing termite attack on any timber building elements throughout the property.

A durable notice should be placed in the switchboard unit to indicate current termite barriers. At the time of inspection, it appeared as though no termite management system has been installed, with no evidence to suggest preventative works taking place.

The client may consider gaining further advice from a pest controller as to the costs and procedures involved with this application. It is recommended that obtaining such advice be a short-term priority.

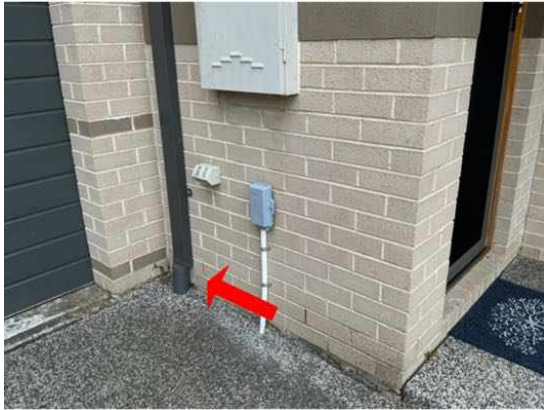
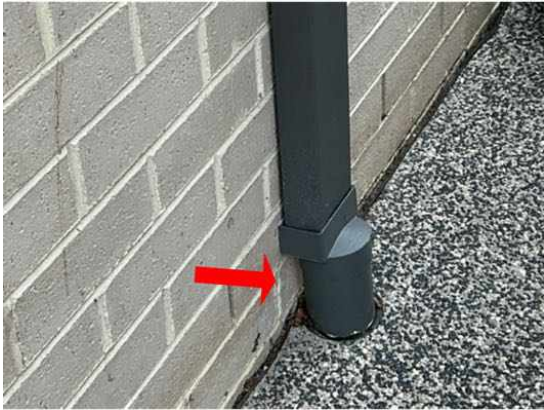
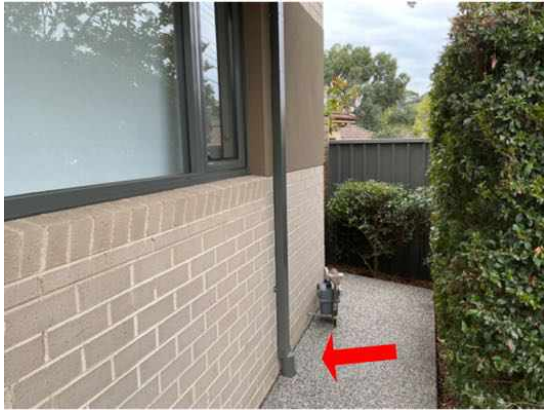
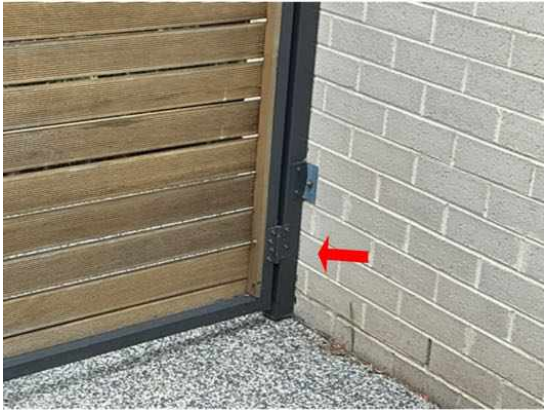
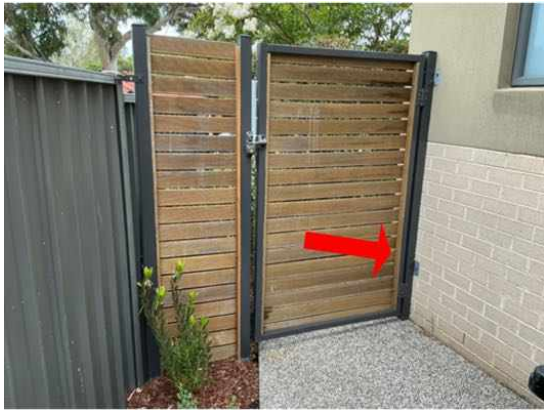
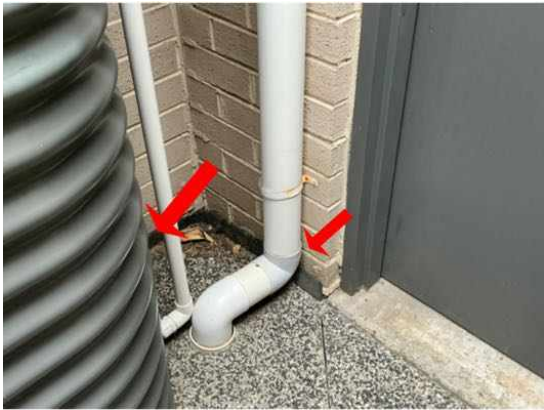
Finding 6.02

Building:	Main Building
Location:	All External Areas
Finding:	Bridging of termite barrier
Information:	Bridging of termite barriers occurs when termites bridge (usually by building a mud tunnel) a termite barrier or inspection zone or where termites have a passage allowing them to bridge the barrier.

Generally this takes the form of finished ground levels external paving or concrete being retrospectively installed above the damp course level the adjacent internal floor level or weep and ventilation holes.

Where bridging has occurred full inspection is prevented and termites may enter a property in a concealed or undetectable manner.

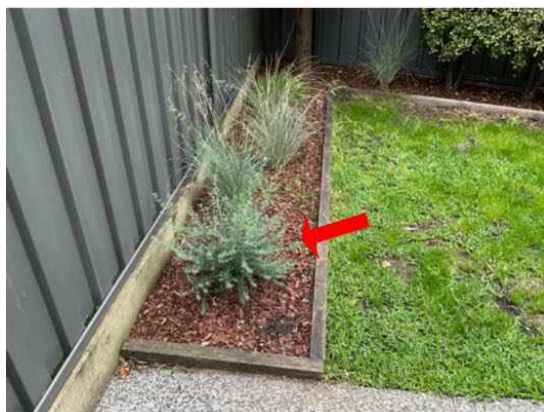
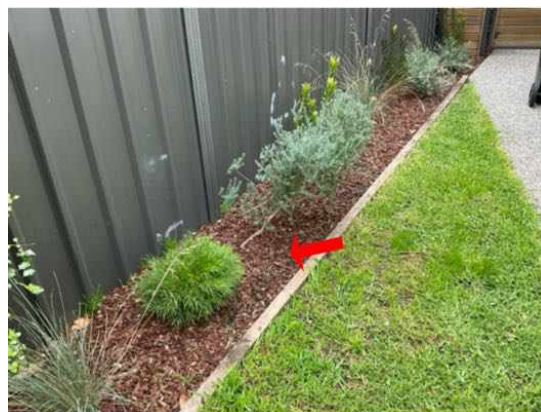
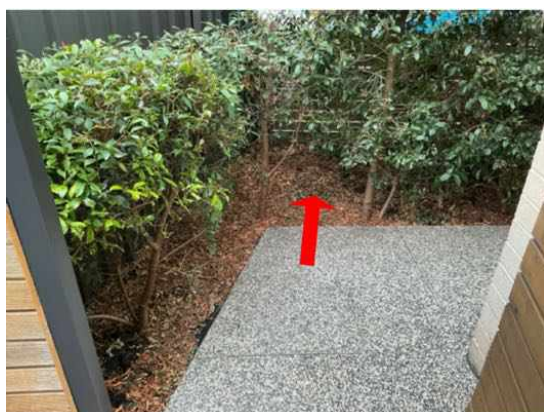
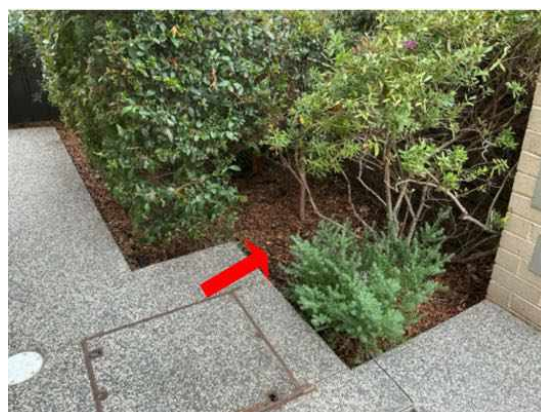
Finding 6.03

Building:	Main Building
Location:	All External Areas
Finding:	Garden Beds - Conditions Conducive to Termites
Information:	Garden beds were found to be evident in the garden area. These garden beds can include untreated timber, and with a combination of moisture from watering hosing can make conditions conducive to termite activity and termite ingress.

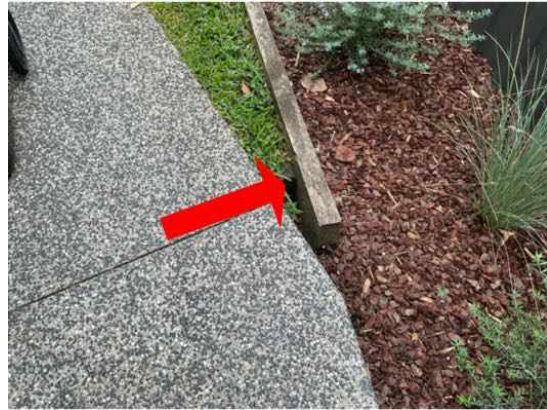
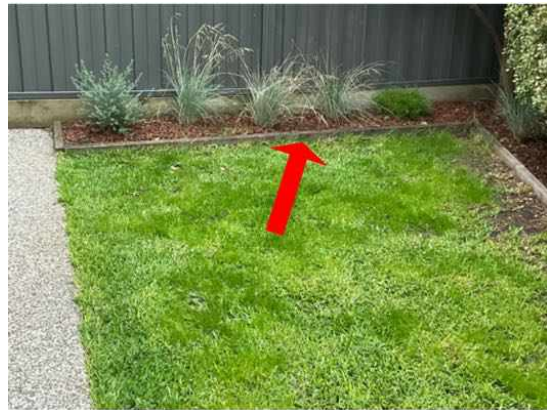
Finding 6.04

Building:	Main Building
Location:	All External Areas
Finding:	Untreated or non-durable timbers in a hazardous environment
Information:	To reduce the risk of timber pest attack it is essential that timber used in a hazardous environment (e.g. in direct contact with the ground or frequently exposed to damp conditions) is of sufficient durability and/or is adequately preservative treated.

Untreated timbers in direct contact with the ground are likely to develop severe wood rot and/or fungal decay if left unattended creating attraction for subterranean termites to infest the timbers from surrounding areas.

If untreated or non-durable timbers are found to be in a hazardous environment it is highly advised that replacement of these building elements be performed as soon as possible to aid the protection of the property against termite / timber pest attack.

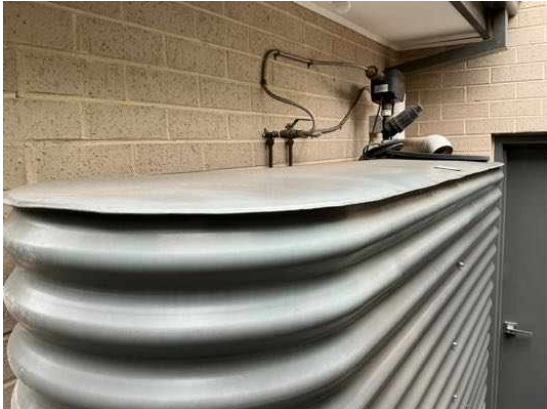
Finding 6.05

Building: Main Building
Location: Exterior walls - left side- water tank
Finding: Water tank strainer blocked
Information: It was noted at the time of the inspection that the strainer to the water tank was blocked with debris. This can cause overflow and enable excessive moisture and water to overflow the tank.

Excessive moisture from the overflow can be conducive to termite activity.

The owners or a general handyman should be engaged to clean the strainer as soon as possible

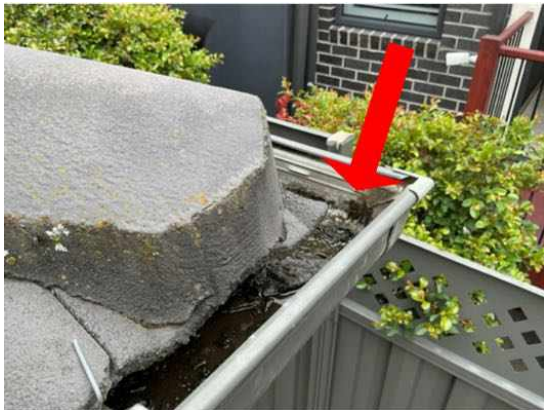
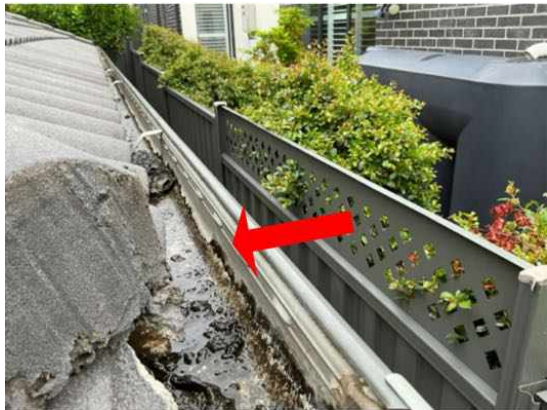
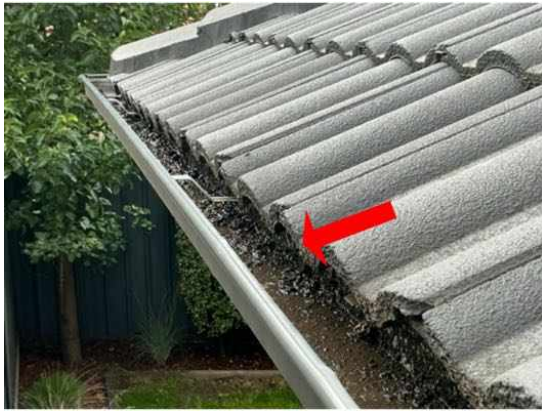
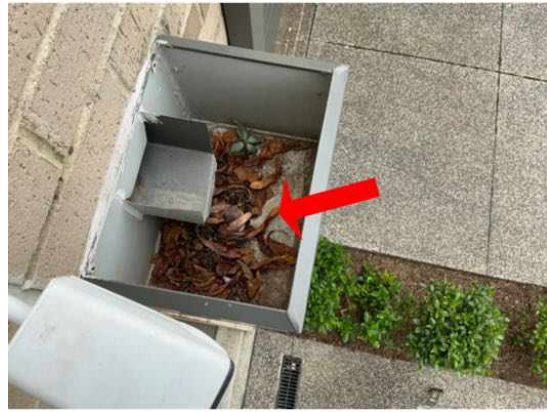
Finding 6.06

Blocked gutters are likely to lead to high levels of moisture in the affected areas. Such moisture will not only cause rust and decay of the associated building materials, but can also provide conditions that are conducive to termite and timber pest activity. Blockages in gutters should therefore be removed immediately to ensure dry conditions are maintained.

Consult a Licensed Plumber for further specific advice on remedial works that may be required. In the interim, it is highly advised that blocked gutters be removed by the homeowner or a general handyperson as a matter of urgency.

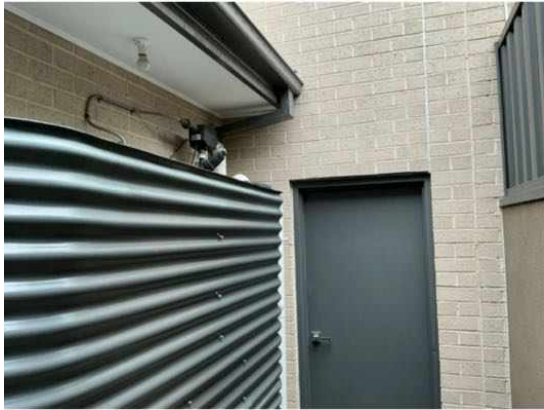
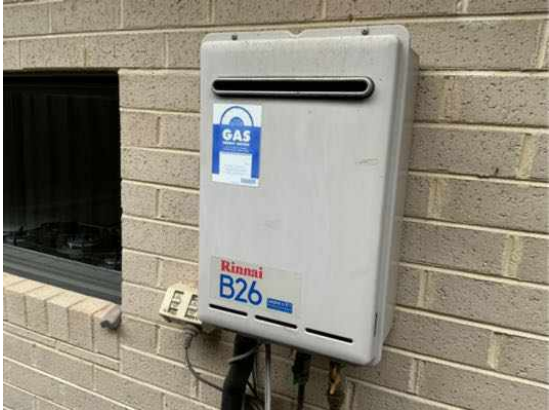
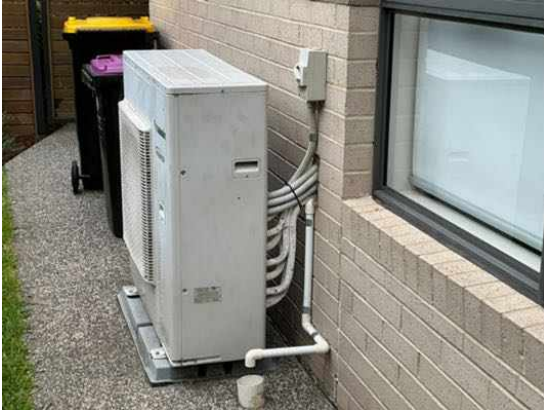
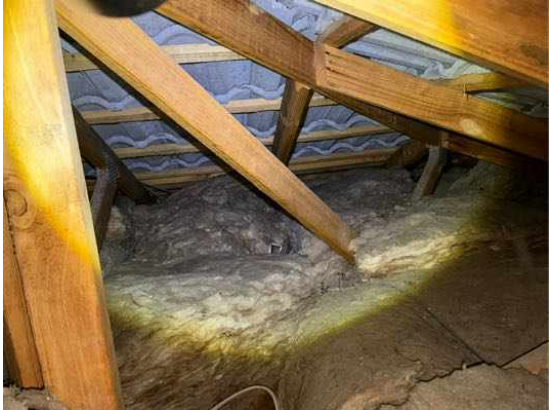
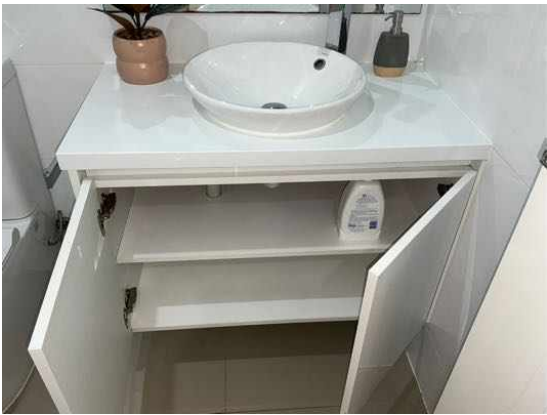
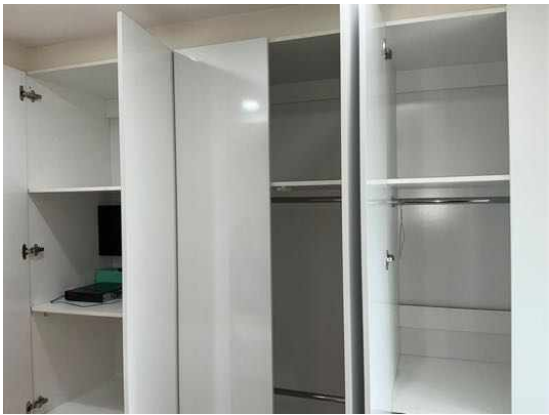
Building: Main Building
Location: All Areas
Finding: Additional Photos - Obstructions and Limitations
Information: These photographs are an indication of the obstructions and limitations which impeded full inspection of the property at the time of inspection. These obstructions can hide an array of defects and should be removed to allow full inspection to be carried out. A re-inspection is recommended once the areas are made accessible.
