Building Inspection Report

Inspection Date: Wed, 11 Mar 2026

Property Address: 18 Ravenhall St, Braybrook VIC 3019,
Australia

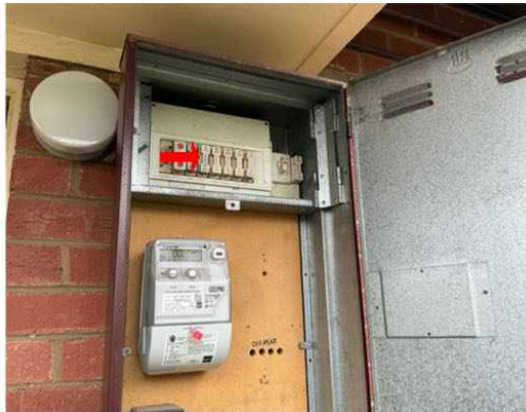
Defects 1.01

Building:	Main Building
Location:	Electrical Switchboard
Finding:	Electrical switchboard - Old ceramic fuses
Information:	The electrical switchboard has old ceramic fuses in place.

While this on its own on is not considered a defect it is noted for the clients consideration that a switchboard upgrade may be required in the short to mid term to improve the functionality of the electrical system. A licensed electrician could be appointed to provide quotation for the works at the client's discretion which may in turn expose other required works to bring the system up to a compliant state.

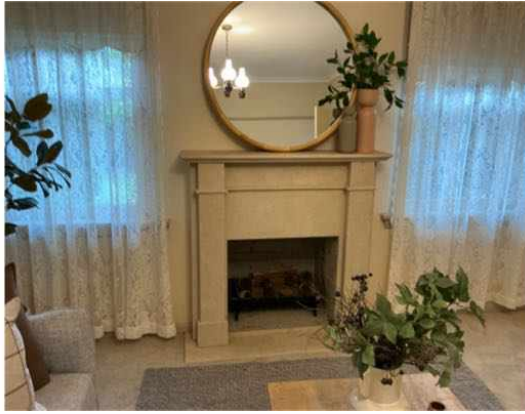
Defects 1.02

Building:	Main Building
Location:	Lounge Room
Finding:	Fireplace
Information:	It is beyond the scope of this inspection report to comment on fireplaces, we recommend a professional chimney sweep check the safety of this fireplace prior to use.

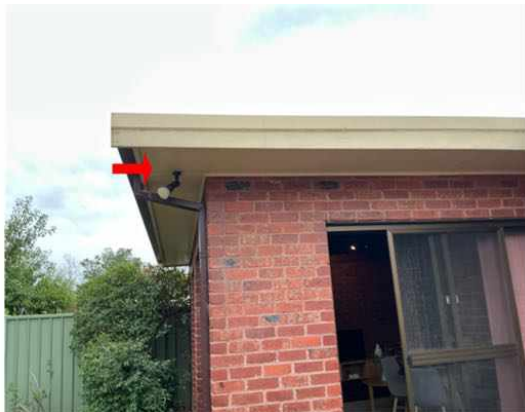
Defects 1.03

Building:	Main Building
Location:	Eaves
Finding:	Asbestos suspected
Information:	Many areas of suspected asbestos containing material were found throughout the property as shown in photos. Reporting on Asbestos is outside the Scope of this Report. This suspected defect is highlighted as a caution only. We suspect, based on our experience in the building industry, that there is a higher risk of the identified building elements containing asbestos.

In the interim, the client is advised to act with caution, especially when considering any damage to building materials, general wear and tear, renovations, extensions, demolition and general maintenance activities due to the suspected presence of Asbestos.

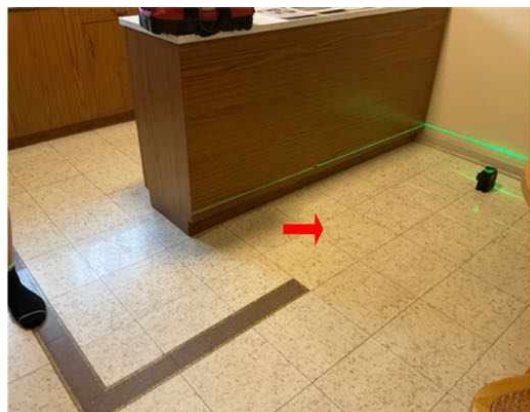
Defects 1.04

Building:	Main Building
Location:	Kitchen
Finding:	Asbestos - Suspected ACM Identified on Site
Information:	Reporting on Asbestos is outside the Scope of this Report. This suspected defect is highlighted as a caution only. We suspect, based on our experience in the building

As Asbestos Reporting is outside the scope of this report, we advise that you consider a separate Asbestos Inspection and Condition Audit, which can include the taking of samples for definitive confirmation of the presence of Asbestos.

In the interim, the client is advised to act with caution, especially when considering any damage to building materials general wear and tear renovations extensions demolition and general maintenance activities due to the suspected presence of Asbestos.

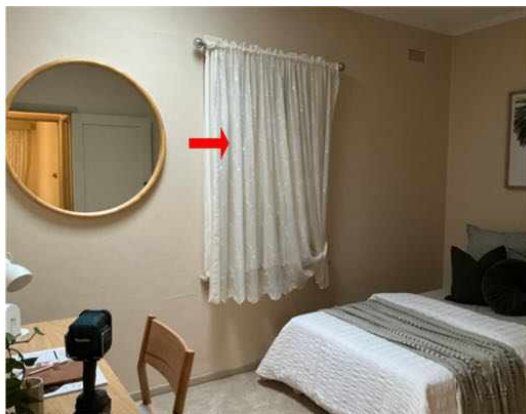
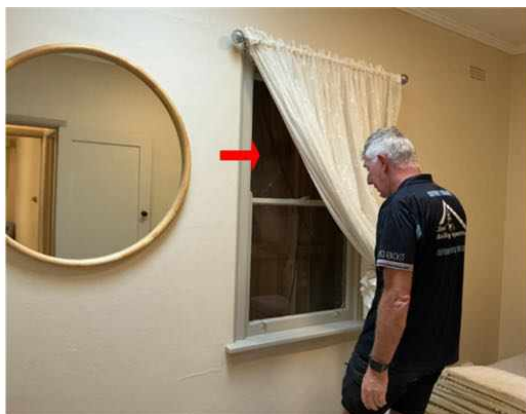
Defects 1.05

Building:	Main Building
Location:	All Areas
Finding:	Window - Cracked
Information:	Cracks were identified in the window in this area. Cracking in windows is generally the result of impact damage, and is likely to develop further when left unmanaged.

The likelihood of this windowpane further cracking and shattering is increased exponentially, providing a safety hazard in the area. The cracked window also impairs the weather tightness of the building, creating potential for minor water leaks.

A qualified glazier is required to repair the window as soon as possible. Depending on the extent of the cracking, replacement of the window may be required. Please be advised that any persons coming into contact with the cracked window should do so with due caution to avoid any personal injury that may ensue.

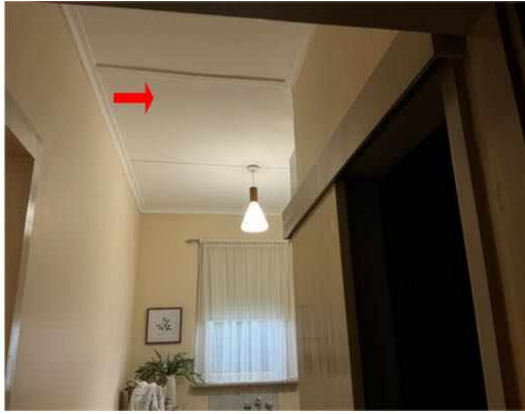
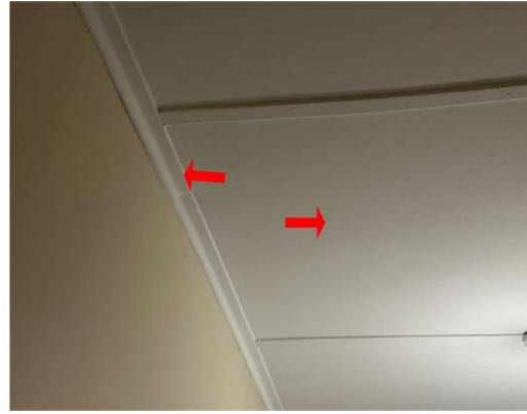
Defects 1.06

Building:	Main Building
Location:	Laundry toilet
Finding:	Asbestos - Suspected ACM Identified on Site
Information:	Reporting on Asbestos is outside the Scope of this Report. This suspected defect is highlighted as a caution only. We suspect, based on our experience in the building industry, that there is a higher risk of the identified building element containing asbestos.

As Asbestos Reporting is outside the scope of this report, we advise that you consider a separate Asbestos Inspection and Condition Audit, which can include the taking of samples for definitive confirmation of the presence of Asbestos.

In the interim, the client is advised to act with caution, especially when considering any damage to building materials general wear and tear renovations extensions demolition and general maintenance activities due to the suspected presence of Asbestos.

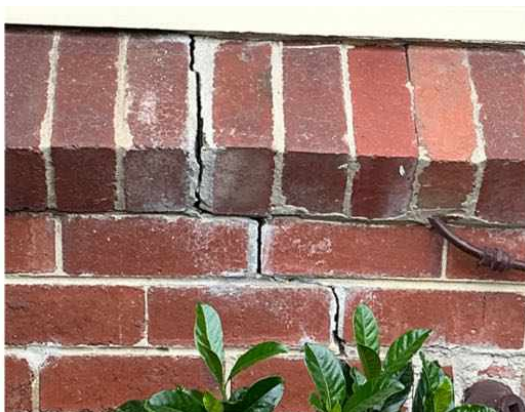
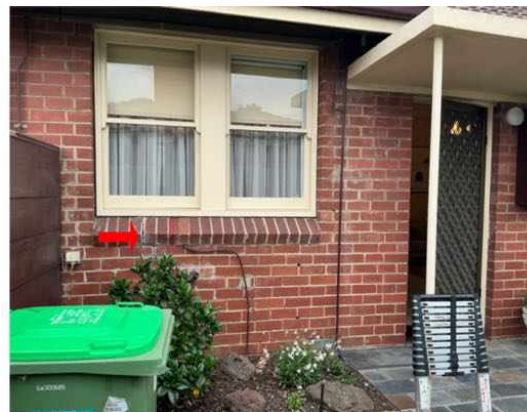
Defects 2.01

Building:	Main Building
Location:	Entry
Finding:	Brickwork - Step cracking
Information:	Step cracking was identified to the brickwork in this area at the time of inspection. Step cracking, which is similar to other forms of cracking, has a variety of possible causes. However, the most common is the subsidence of adjacent footings.

Step cracking is a relatively common defect, and is most likely to occur adjacent to windows, doors and other openings. Mortar failure in the gaps between affected bricks indicates the stresses and tensions affecting the wall.

Where step cracking is extensive or severe, the client is advised to consult a structural engineer. Minor step cracking can be used as a warning sign to address factors causing stress to the wall, which can include the effect of surrounding trees, water leaks, soil erosion, or even the presence of reactive soils in the surrounding area.

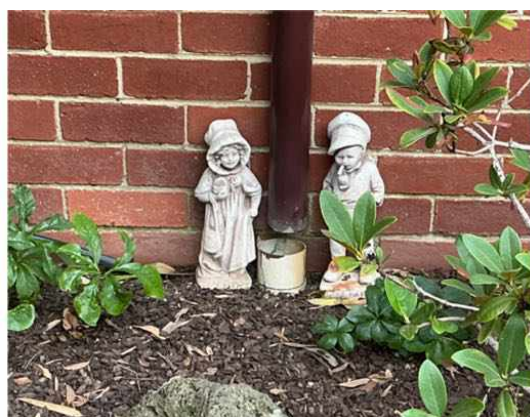
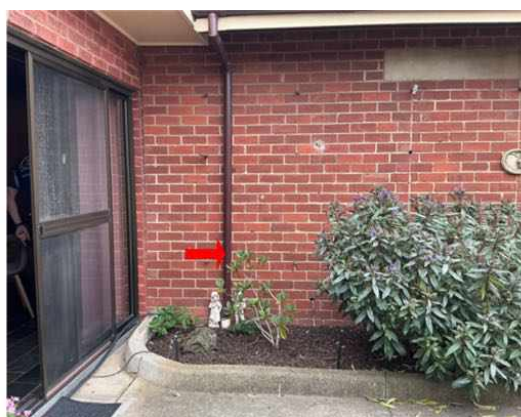
Defects 2.02

Where roof plumbing doesn't drain adequately, the area at the base perimeter can become excessively damp, potentially creating an environment that is susceptible to rust and corrosion of surrounding building elements, as well as attracting termites and other pests.

It is highly recommended that a plumber be appointed to further inspect the area and to install adequate drainage equipment where necessary.

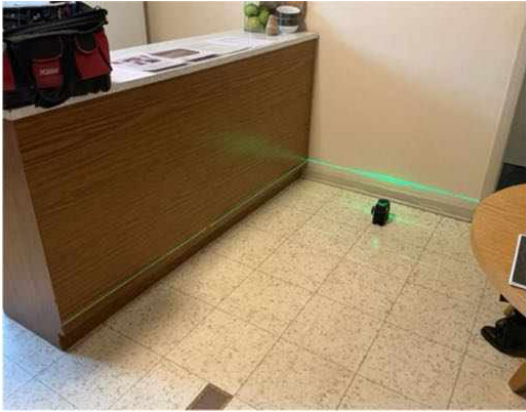
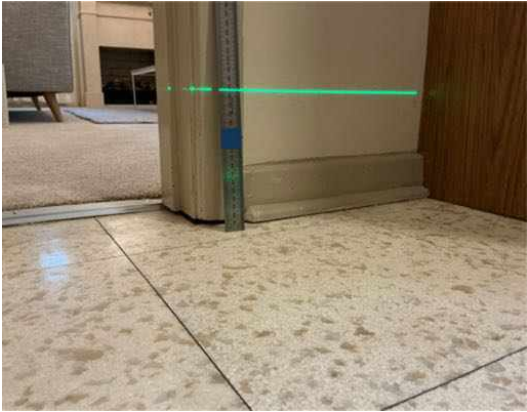
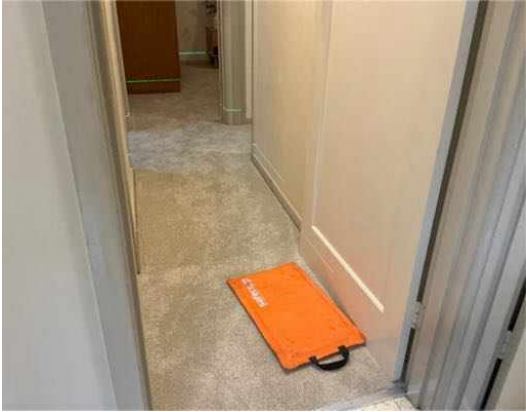
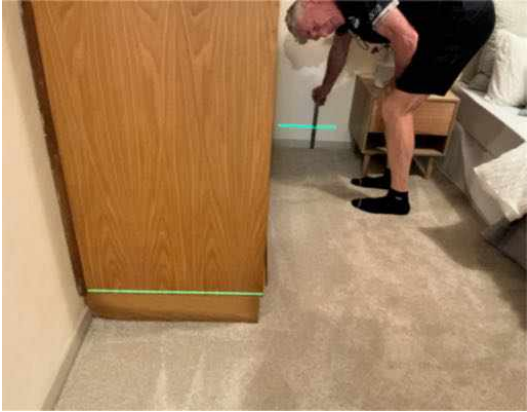
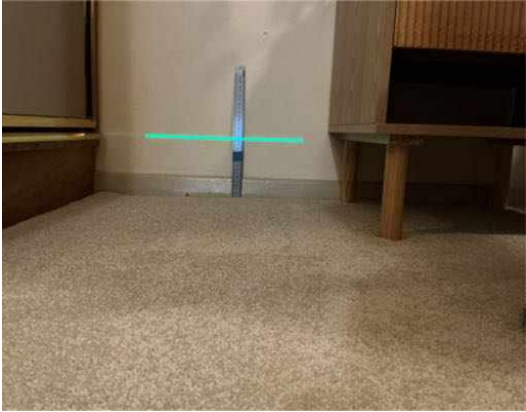
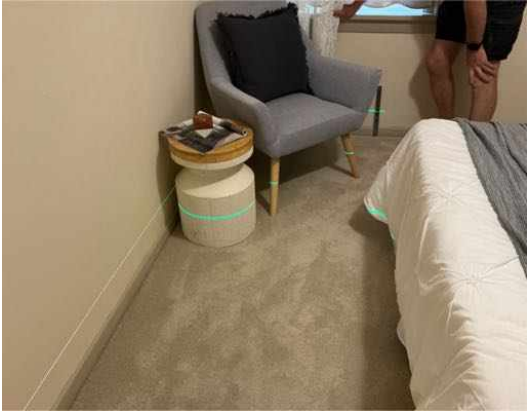
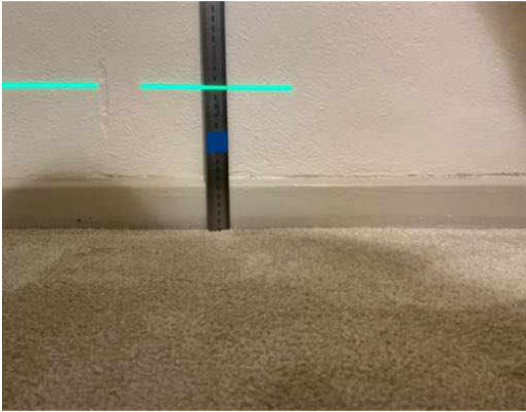
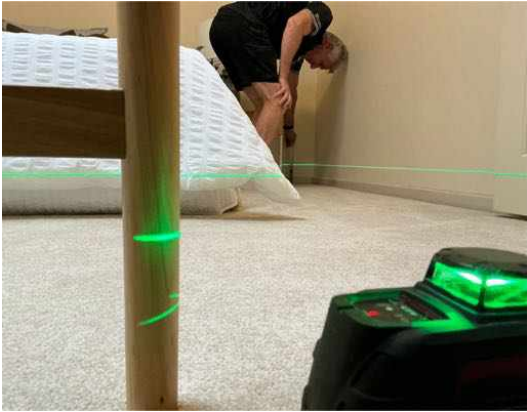
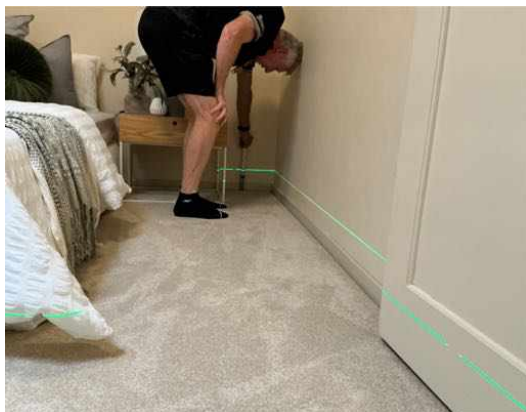
Defects 2.03

Building: Main Building
 Location: All Internal Areas
 Finding: Flooring - Uneven (beyond tolerance)
 Information: The internal flooring in this area is out of level and uneven more than 40mm in some rooms. Uneven flooring may sometimes indicate minor defects such as expected movement of the foundations of the property, but may also indicate subsidence of the associated subfloor stumps.

Flooring was found to be out of level and well beyond tolerance throughout. Uneven floors, binding doors, bouncy flooring, plaster cracking and large door gaps are all indications of movement to the subfloor.

It is suspected that this property will need some form of Restumping or underpinning in order to stabilize and prevent any further the movement. Purchasers should be aware that these works may prove costly and be prepared to meet these costs . This is considered a major defect due to the amount of movement.

It is advised that the flooring be closely monitored to identify any further movement. Where flooring remains relatively unchanged for an extended period of time (i.e. several months), it is likely that this defect has been caused by expected movement of the foundations of the property.

However, where flooring is uneven further, potentially invasive inspection of the subfloor structures and stumps in this area is required. In this case, works to repair are likely to be required, and would be carried out by a registered builder specialising in re-stumping.

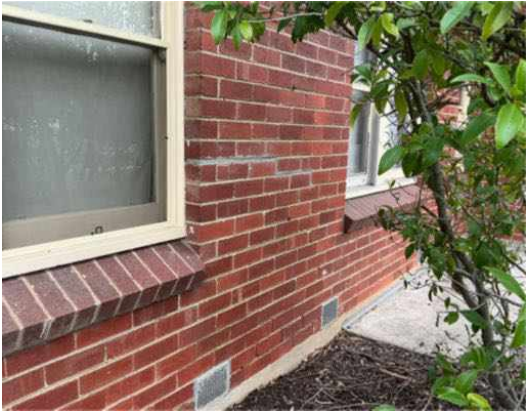
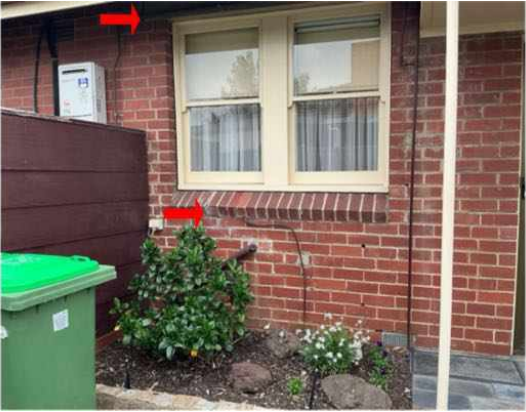
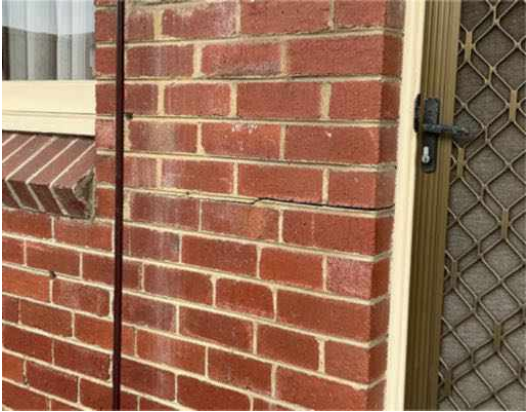
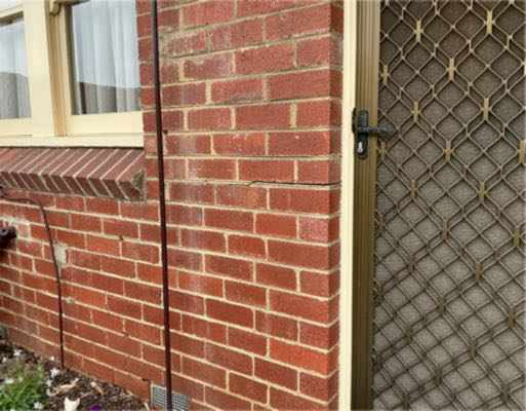
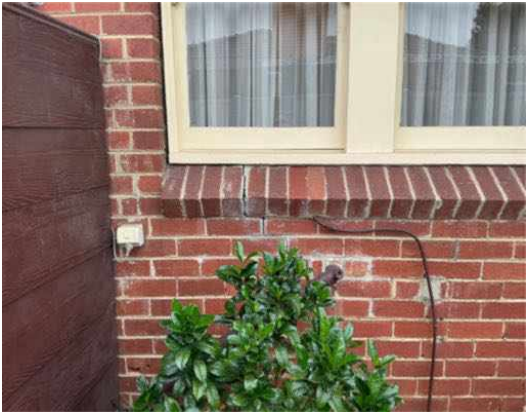
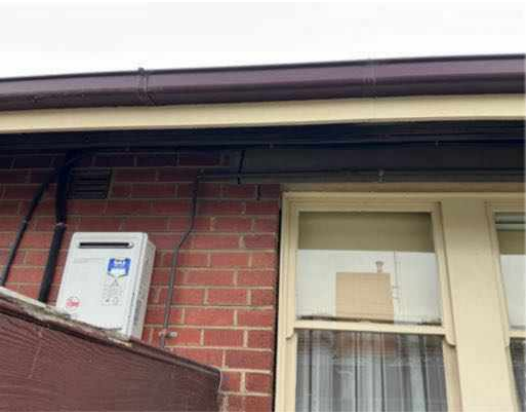
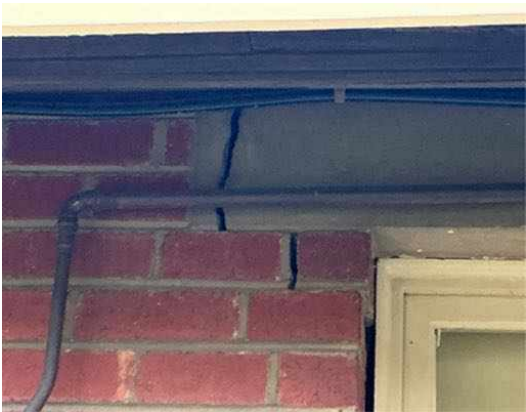
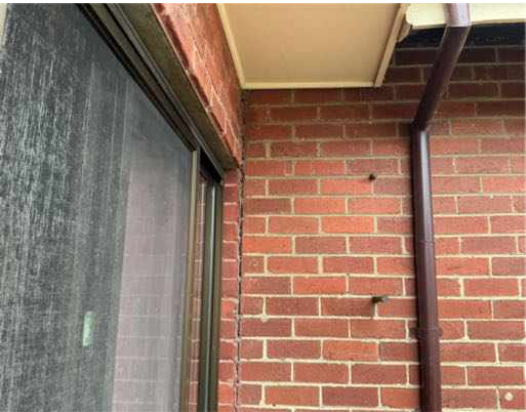
Defects 2.04

Building:	Main Building
Location:	All Areas
Finding:	Brickwork - Cracking [Extensive repairs required]
Information:	Major cracking is evident to the brickwork in this area. When managing this degree of cracking, major extensive repair work is generally required. Such work is likely to involve replacement of sections of affected brickwork.

Structural issues are generally the underlying cause of such cracking. It is suspected that this damage has been created due to movement of key structural elements or general subsidence of associated footings.

Brickwork cracking in excessive 10 mil was found to the external walls, this correlates with the movement found inside and will need to be repaired by a qualified Bricklayer or underpinning expert. This is considered a major defect for rectification.

Always contact a building inspector or engineer should cracks widen lengthen or become more numerous, even after repair works have been completed.

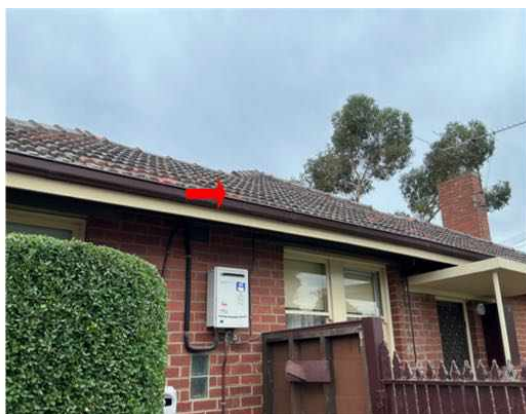
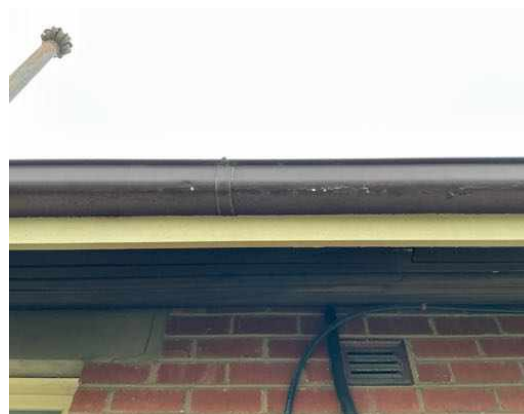
Defects 3.01

Building:	Main Building
Location:	Gutters
Finding:	Roof plumbing - Rusted or corroded
Information:	The roof plumbing has areas of rust and corrosion. It is suspected that this has been caused by blockages, resulting in pooling or standing water, that have prematurely rusted elements of the roof plumbing.

Rusted roof plumbing will generally develop holes and leaks that can affect other building elements with poor drainage of storm water. Poorly drained roof areas will also lead to damp conditions surrounding the base perimeter of the building which, if left unmanaged, can lead to a range of secondary building defects.

Repair and/or replacement of rusted roof plumbing is highly required in order to reinstate the roof drainage system to a fully operational level. To further maintain these areas, gutters should be cleaned frequently, allowing the avoidance of any partial blockages.

A licensed plumber or specialist roof restoration company should be appointed to undertake these works. It is advised that such works be completed as soon as possible to prevent any further damage and deterioration.

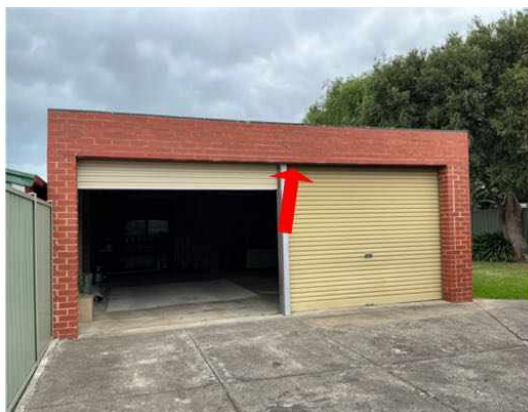
Defects 3.02

Building:	Garage
Location:	All Areas
Finding:	Lintels - Rusted or corroded
Information:	This building element shows evidence of rusting and corrosion, which is likely to have developed as a result of excessive exposure to moisture and or inadequate coatings.

As surface rust provides no protection to the underlying iron, the deteriorating

condition is likely to worsen if not addressed in the short-term future.

Where possible, the use of galvanized (treated) metals or aluminium coated metals aid in rust prevention, as does regular general maintenance. Rust formation can be controlled with coatings, such as paint, that isolate the iron from the environment.

Rusting and corrosion should be managed by ideally removing or limiting the affected surface from exposure to moisture. A registered builder may be appointed to replace any building elements that have been severely affected by rust or water damage.

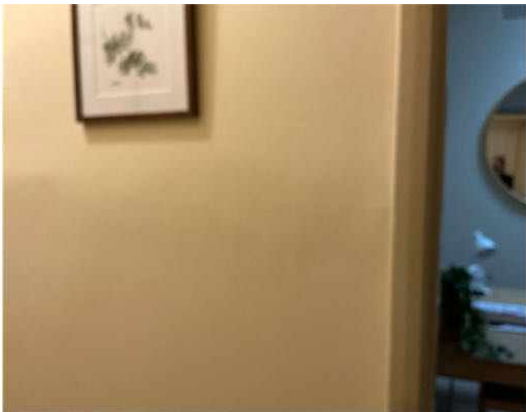
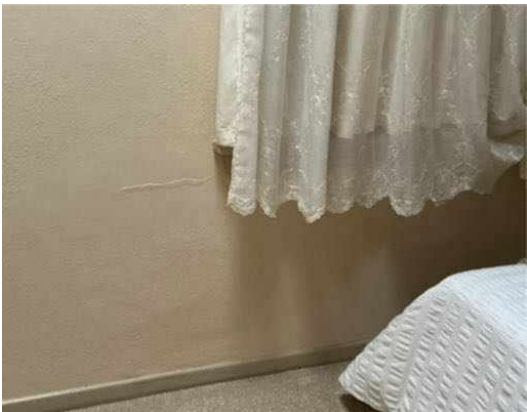
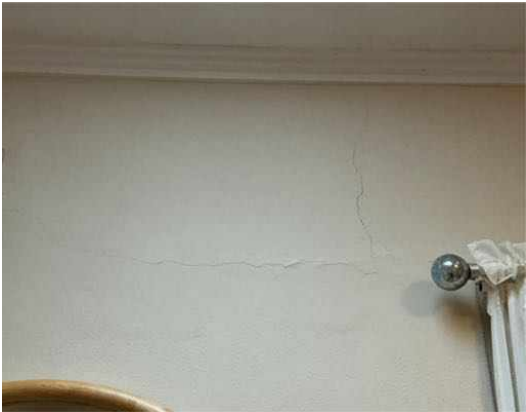
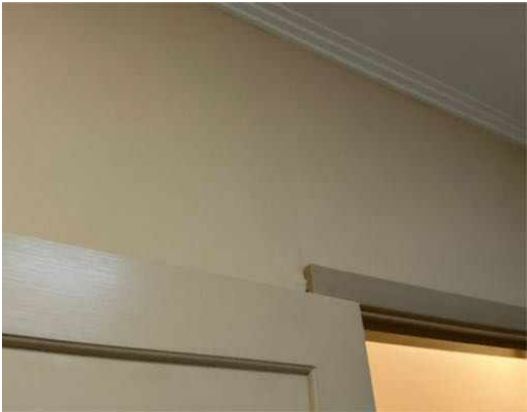
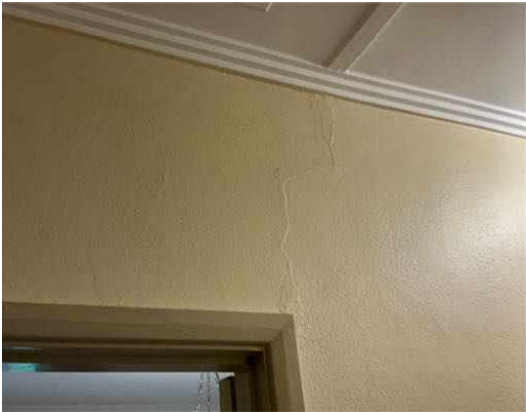
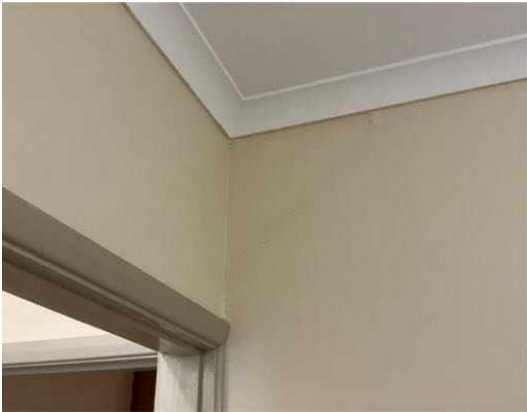
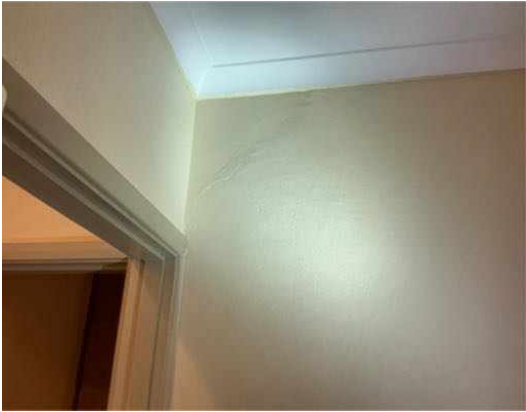
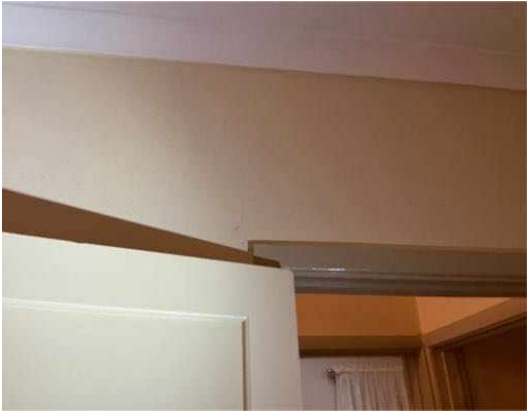
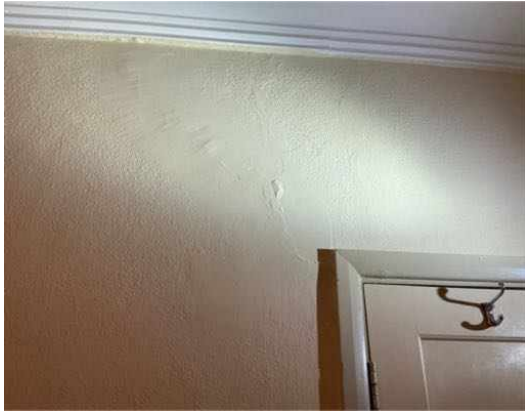
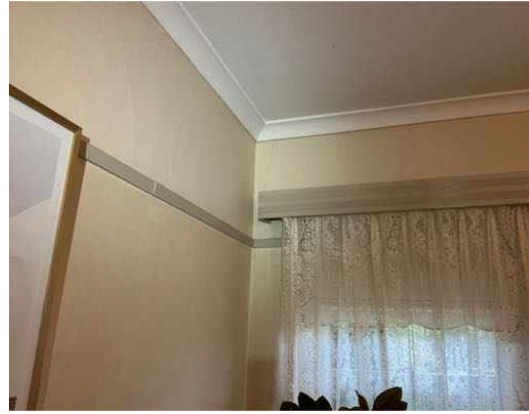
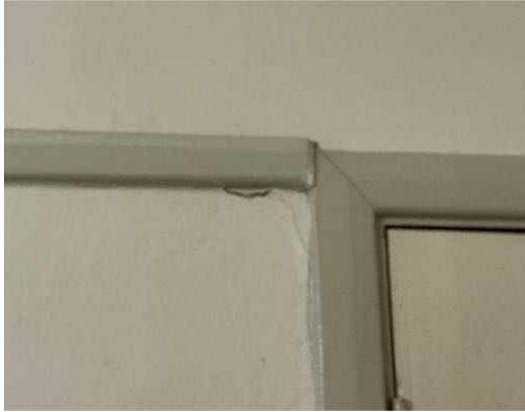
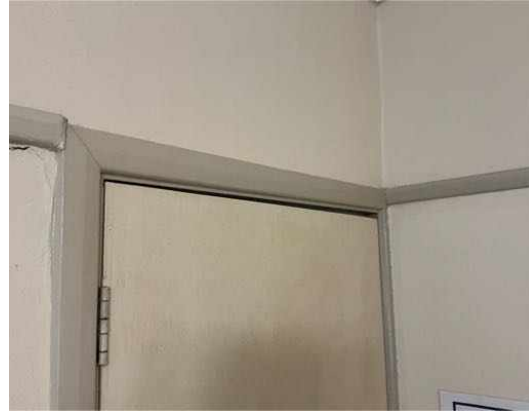
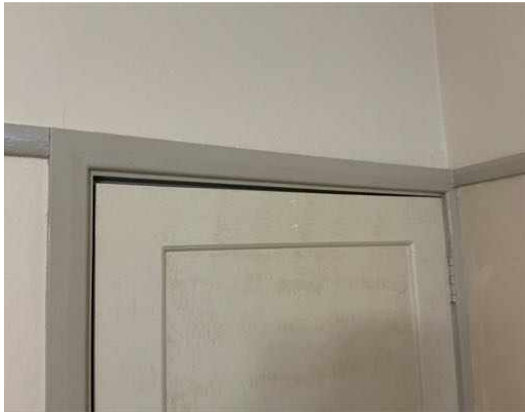
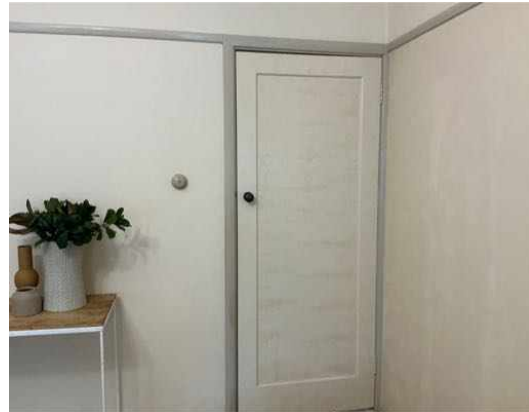
Defects 3.03

Building:	Main Building
Location:	All Areas
Finding:	Cracking - Damage Category 2 - Noticeable (up to 5mm)
Information:	Noticeable cracks are a common occurrence as a result of many primary defects. Such causes may include age, general wear and tear, expected building movement, general expansion/contraction of building materials in different weather conditions, and/or minor failings in the installation or application of building materials.

Noticeable cracks may result in minor sticking or jamming of associated doors and windows, which require easement. However, noticeable cracks are easily filled and repaired. A plasterer can be consulted to install an expansion joint at this point to allow for this movement during different weather conditions.

Monitoring of all cracking should be conducted frequently. Always contact a building inspector should cracks widen, lengthen, or become more numerous. Additionally, your building inspector should also be contacted if associated building elements such as doors and windows become more difficult to operate over time.

Relevant tradespeople, such as carpenters, painters and plasterers, should be appointed to perform remedial works, as deemed necessary.

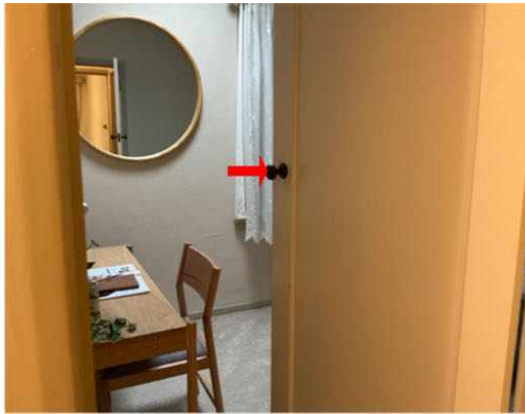
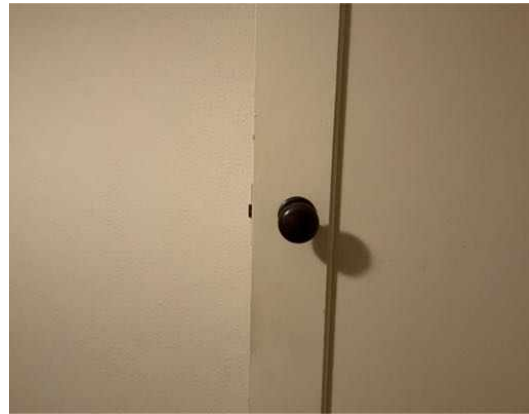
Defects 3.04

Building: Main Building
 Location: Door handles all areas
 Finding: Door - Broken handle
 Information: The door handle in this area was found to be broken at the time of inspection. Breakage occurs generally when the building materials have aged and decayed, but may be indicative of impact damage (accidental or deliberate).

Repair and/or replacement of the broken door handle is advised to improve the operational state of the associated door.

A qualified carpenter or general handyman should be appointed to repair/replace the

door handle at the client's discretion.

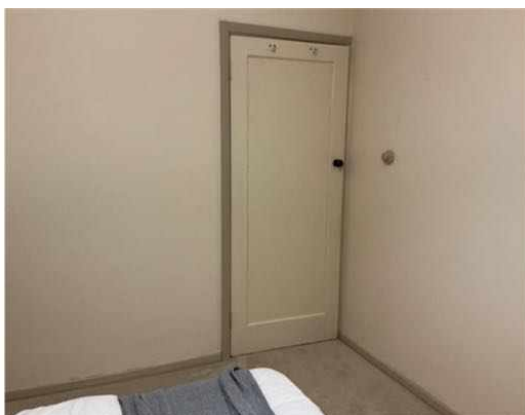
Defects 3.05

Building:	Main Building
Location:	Bedroom
Finding:	Door - Binding/jamming
Information:	Binding and/or jamming of this door is evident during standard operation. This defect inhibits the functionality of the affected door as well as creating potential for secondary defects to associated building elements, such as damage to the floor covering.

A door that binds to flooring or to the associated door frame may have several causes, ranging from minor defects, such as poor installation of the door or deteriorated hinges, through to major structural issues, such as damage to subfloor structures.

Where door binding/jamming appears to indicate major structural issues, a registered builder specialising in re-stumping should be appointed to provide an estimate on the cost of rectification.

For minor causes, a qualified carpenter or general handyperson should be appointed to perform minor rectification works at client discretion.

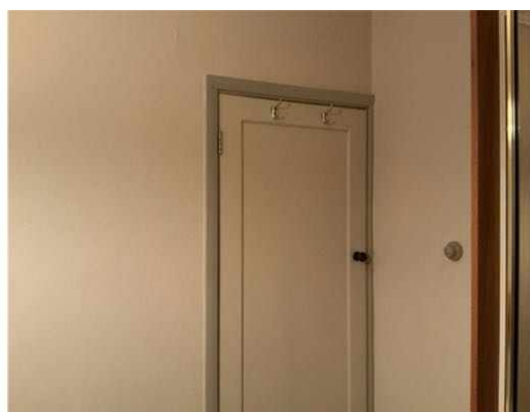
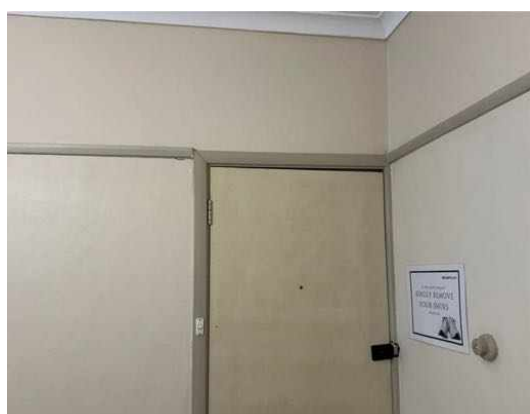
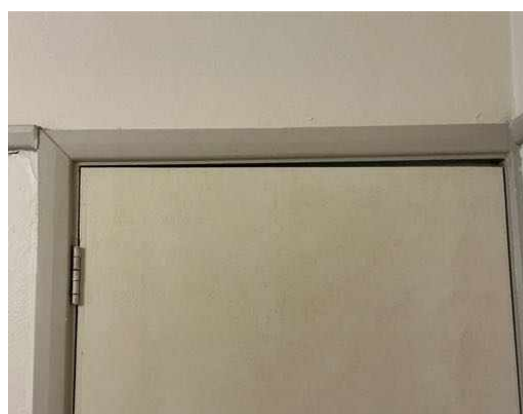
Defects 3.06

Building:	Main Building
Location:	All Areas
Finding:	Door - Gap
Information:	<p>A significant gap was identified between the door and door frame in this area. Where large gaps to the head or foot of door frames appear, it may indicative of a variety of defects, ranging from uneven framework, sagging hinges or uneven flooring.</p> <p>A gap to the head of the door may also indicate movement of the foundation of the property, which is a common occurrence and does not indicate structural damage.</p> <p>A qualified carpenter should be appointed to perform remedial works to restore the door to a fully operational level.</p>

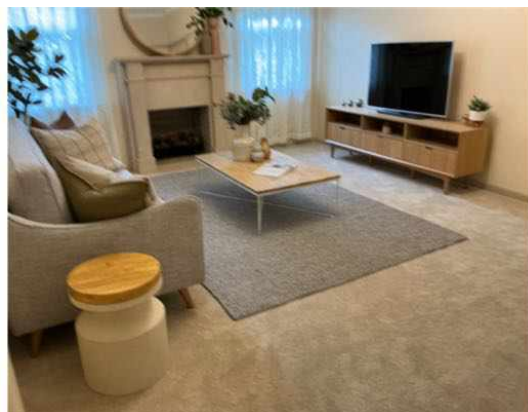
Defects 3.07

Building:	Main Building
Location:	All Areas
Finding:	Floors - bouncy
Information:	<p>The internal flooring in this area was identified as being bouncy at the time of inspection. A bouncy floor surface generally presents as a discernible change in level as they are walked across, in noisy or creaking flooring, or in consequent movement of</p>

Bouncy floors generally indicate that the floorboards or the subfloor structures are coming loose from the joists that they are installed on. Bouncy flooring may also be the result of gaps between flooring and stumps or joist structures, which require packing.

The client is advised to seek quotations for required repairs from a Registered Builder specialising in re-stumping. The potential resolution may range from packing gaps in subfloor structures through to replacement of subfloors stumps and refixing of flooring.

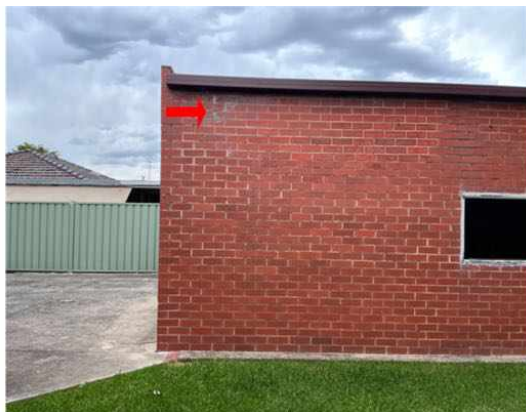
Noted Item

Building: Garage
 Location: All Areas
 Finding: Brickwork - Step cracking
 Information: Step cracking was identified to the brickwork in this area at the time of inspection. Step cracking, which is similar to other forms of cracking, has a variety of possible causes. However, the most common is the subsidence of adjacent footings.

Step cracking is a relatively common defect, and is most likely to occur adjacent to windows, doors and other openings. Mortar failure in the gaps between affected bricks indicates the stresses and tensions affecting the wall.

Where step cracking is extensive or severe, the client is advised to consult a structural engineer. Minor step cracking can be used as a warning sign to address factors causing stress to the wall, which can include the effect of surrounding trees, water leaks, soil erosion, or even the presence of reactive soils in the surrounding area.

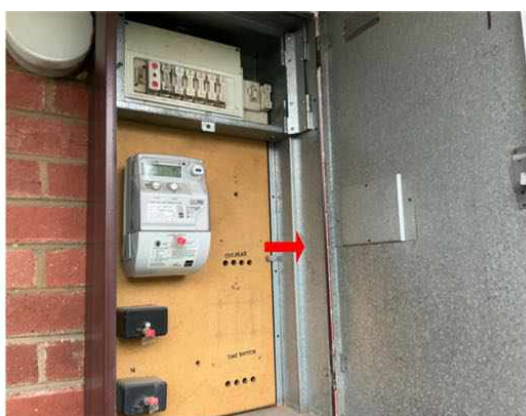
Noted Item

Building: Main Building
 Location: Electrical Switchboard
 Finding: Termite Management System - no evidence of a chemical installation
 Information: The application of a post-construction chemical termite barrier is highly recommended for all properties, particularly if live termite activity has been found on the site previously. Such barriers are highly effective in preventing termite attack on any timber building elements throughout the property.

The client may consider gaining further advice from a pest controller as to the costs and procedures involved with this application. It is recommended that obtaining such advice be a short-term priority.

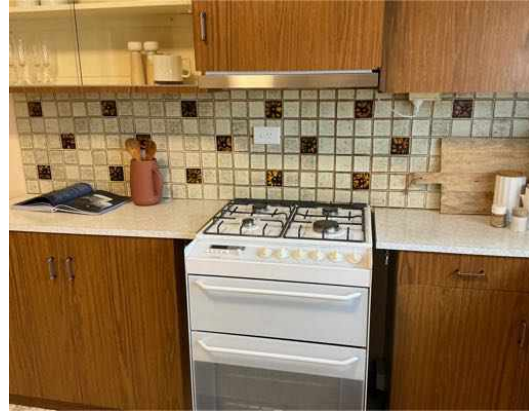
Noted Item

Finding: Warranty - Expired

Information: Where appliances are beyond their warranty period, the owner should be prepared to meet the cost of replacement or repair of the item at any time. The operation of the appliance can not be guaranteed and further inspection by an appropriately qualified tradesperson may be required.
