Building and Timber Pest Inspection Report

Inspection Date: Mon, 9 Mar 2026

Property Address: 7 Louise St, Dapto NSW 2530, Australia

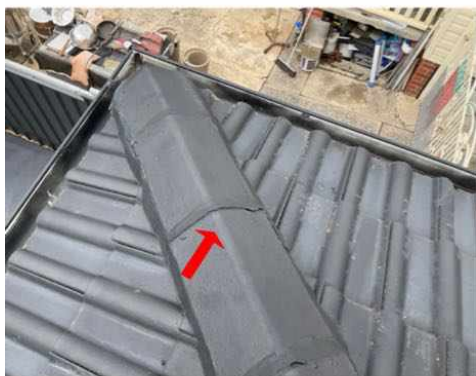
Building:	Building 1
Location:	Roof Exterior
Finding:	Roof tiles - Weathered
Information:	Upon inspection of the exterior roofing, the majority of roof areas were considered to be in good condition. While weathering of the tiles is consistent with the age of the property, maintenance works are required in these pictured areas.

Isolated areas of mortar have come loose and minor cracking is also present. Re-pointing and re-sealing the may be considered as an interim solution by the client to help preserve and extend the life span of the tiles.

Where left unmanaged, deteriorating roof tiles are likely to lead to a number of secondary defects, including minor water leaks and weather exposure to internal roofing structures.

Consultation with a roofing contractor is highly advised to gain advice on cost of remedial works that may be required in the short to medium term. Remedial works are likely to increase the longevity of the exterior roofing structure.

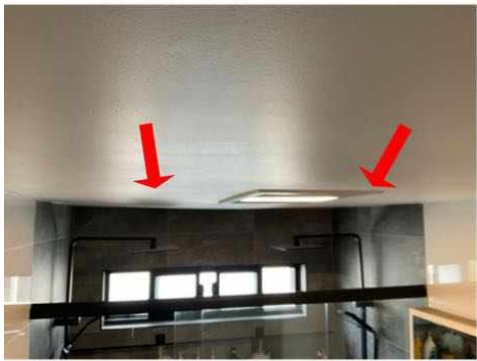
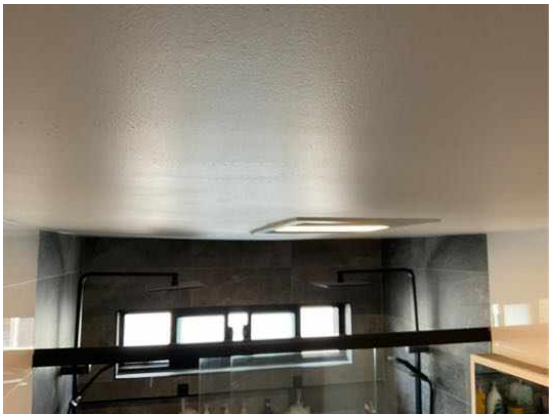
Finding 3.02

Information: Sections of the bathroom ceiling was found to be sagging at the time of inspection. Sagging to the fixed ceiling structure sometimes indicates that the building materials have swollen, due to contact with water, or that fixings (e.g. nails or glue) have become loose and require reattachment. No water damage was found in the roof void.

Where minor sagging is evident here, comparatively minor works, such as re-gluing of ceiling sheets, may be required. Such works may be performed by relevant tradespeople, such as plasterers and painters. Where excessive moisture has caused the roofing structure to swell and sag, the source of the water leak should primarily be identified prior to any remedial works being performed.

The appropriate action should be taken by the client as soon as possible to ensure that any potential further damage is limited.

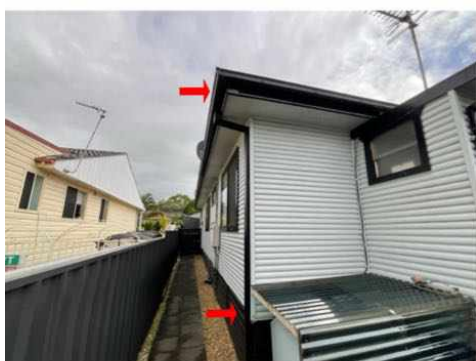
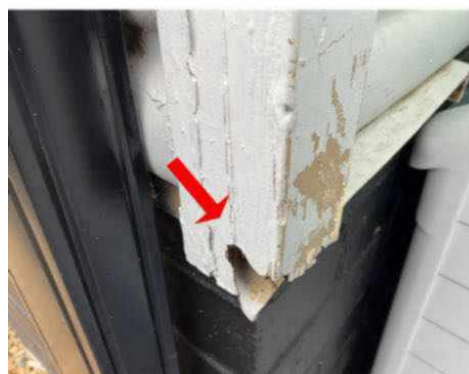
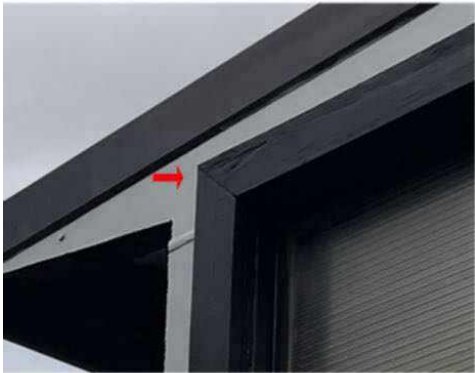
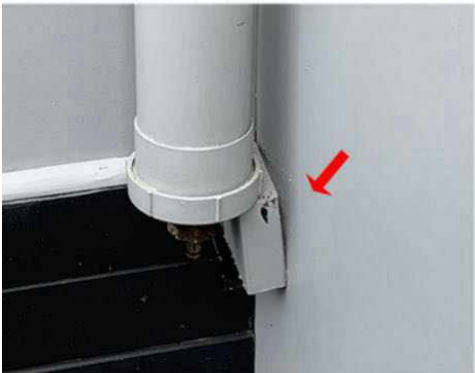
Building:	Building 1
Location:	Pictured areas
Finding:	Wood rot
Information:	The building shows evidence of small areas of wood rot. Wood rot, also known as Fungal Decay, occurs when timbers and other cellulose building materials are exposed to damp conditions on an ongoing basis. This could be the result of exposure to weathering over a prolonged period of time, or the attraction of excessive moisture from other abutting building materials.

Building:	Building 1
Location:	Areas pictured in the wood rot defect
Finding:	Fungal decay - present (localised)
Information:	Fungal decay also known as wood decay or wood rot generally refers to the deterioration of timber elements when in contact with excessive levels of moisture for a prolonged period of time.

In this case, these small areas of the affected timber fascia, barge board and other small areas are in a decaying state and will need bogging up or replacement by a carpenter or licensed builder.

Early intervention and regular maintenance, particularly of exterior timbers, will prolong the useful life of these building elements. Prior to any works being performed, the cause of the moisture that has created the visible wood rot should be identified and addressed in a suitable manner. Replacement of affected timbers may then be a necessary step in protecting surrounding building elements from such deterioration.

A qualified carpenter or registered builder may also be required to replace affected building materials.

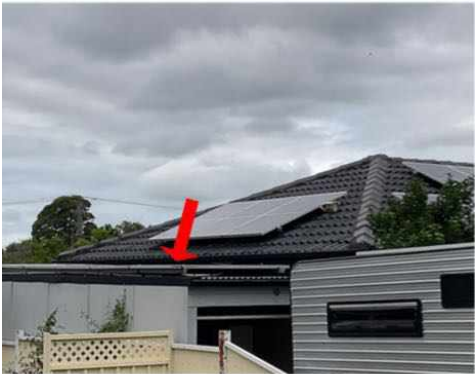
Finding 3.05

Building: Building 1
Location: Pictured areas
Finding: Solar panels - water pooling
Information: Water pooling was observed on the left-side solar panels, indicating possible incorrect installation or inadequate panel pitch, which may reduce efficiency and lead to premature deterioration. Inspection by a licensed solar installer is recommended.

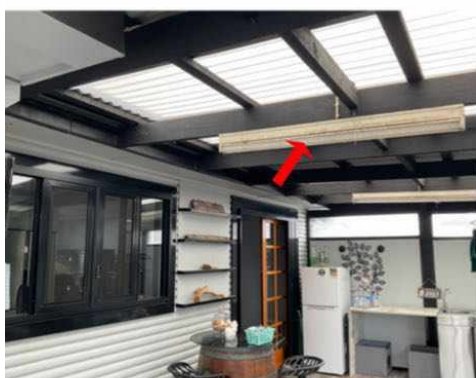
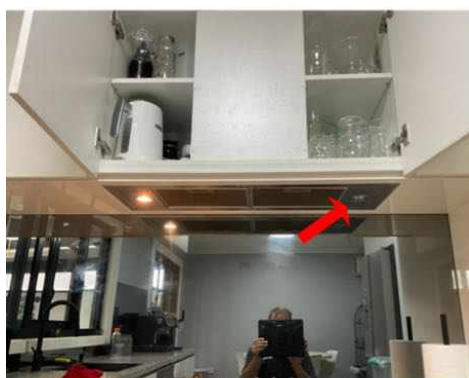
Finding 3.06

Building: Building 1
 Location: Pictured external areas
 Finding: Building elements - loose/damaged/ not working
 Information: Evidence of minor missing or damaged areas was identified at the time of the inspection. These include -

A carpenter would be the trade responsible for rectification of these areas when convenient.

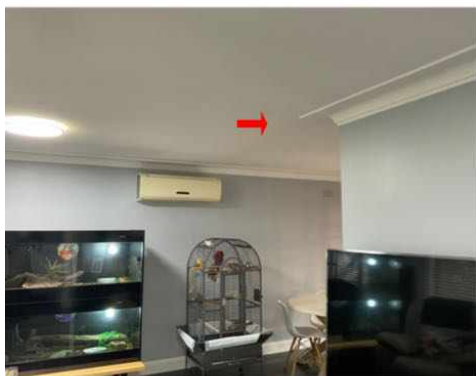
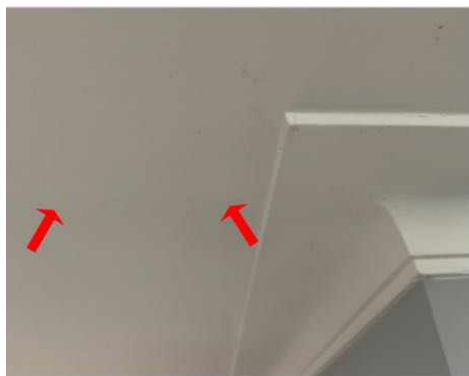
Finding 3.07

Building:	Building 1
Location:	Hall
Finding:	Cracking - Damage Category 1 - Fine (up to 1mm)
Information:	Although fine cracks are quite noticeable, they are often only considered to be an appearance defect, and usually do not indicate any structural damage. Generally, the cause of a fine crack is indicative of a separation between building materials and finishes (e.g. paint, plaster, etc.) along joins.

Cracking of this nature can generally be repaired with minor sanding, filling and/or repainting. Such works should be performed by a qualified painter or a general handyman.

Monitoring of all cracking should be conducted frequently. Always contact a building inspector should cracks widen, lengthen, or become more numerous.

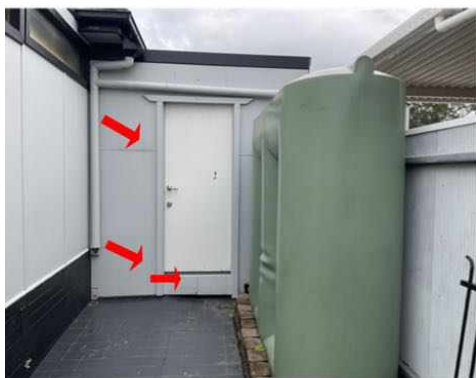
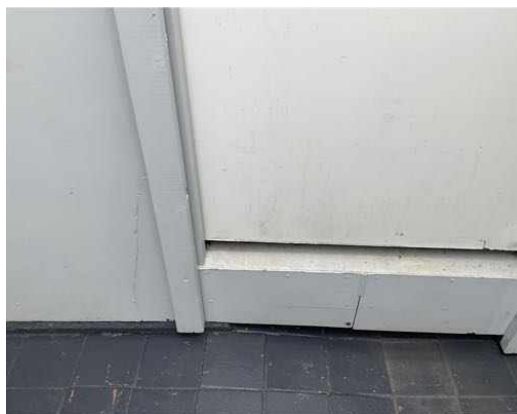
Finding 3.08

Building: Building 1
 Location: Pictured areas
 Finding: Cladding damaged
 Information: Evidence of damage was identified to the left side wall where the cladding has minor damage. A carpenter would be the trade responsible for rectification of this wall area.

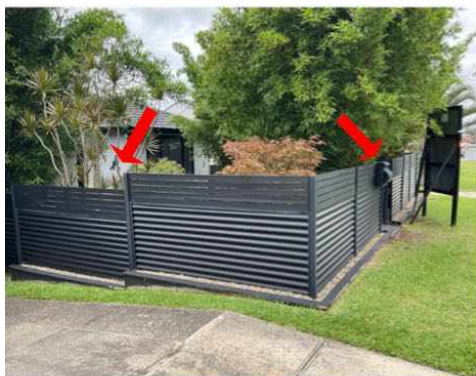
Finding 3.09

Building: Building 1
 Location: Pictured fences
 Finding: Fences damaged - leaning
 Information: Evidence of damage to the pictured fences was identified at the time of the inspection. The likely cause of this fence leaning is not enough concrete used in the post footings.

If left unmanaged this fence may deteriorate further.

It is suggest a fencing contractor be engaged for rectification when convenient.

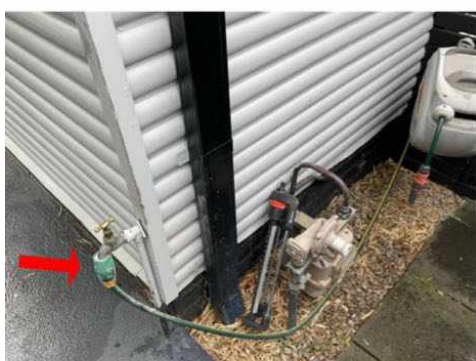
Finding 3.10

Building:	Building 1
Location:	Front right wall
Finding:	Tap - Water hammer
Information:	This tap shows evidence of water hammer being present. Water hammer, a pressure surge resulting when a fluid is forced to suddenly change direction, is a common defect in plumbing fittings, particularly those that are aged and not frequently maintained. Water hammer is generally caused by factors that create high water pressure in the affected plumbing fixture, usually evidenced by a faint banging noise during operation of the affected tap.

Although water hammer is generally considered to be a minor defect, subsequent damage such as erosion of tap hardware and/or water damage to associated building elements is likely to occur if left unmanaged.

A licensed plumber should be appointed as soon as possible to replace any affected tap hardware and perform any remedial works as necessary. Please be advised that the appointment of a cabinet maker or qualified carpenter may be necessary if water damage to associated building elements has occurred.

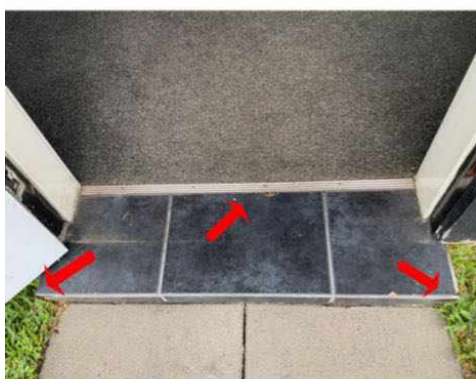
Finding 3.11

Location: Pictured rear room area
 Finding: Building elements damaged
 Information: Evidence of minor damaged areas was identified to Building 2 at the time of the inspection. These include -

1. The door shows minor splitting.
2. The cornice shows minor cracking.
3. Three entrance tiles shows minor cracking.

A carpenter would be the trade responsible for rectification of these areas when convenient.

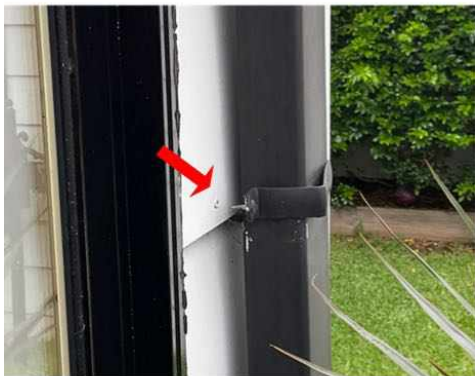
Finding 3.12

Building: Building 3
 Location: Pictured rear room area
 Finding: Building elements damaged
 Information: Evidence of minor damaged areas was identified to building 3 at the time of the inspection. These include -

1. The cladding has a small cracked area and a small missing areas on the right of the door.
2. All internal walls shows very minor plaster damage.
3. The front downpipe is loose requiring refixing.

A carpenter and plasterer would be the trade responsible for rectification of these areas when convenient.

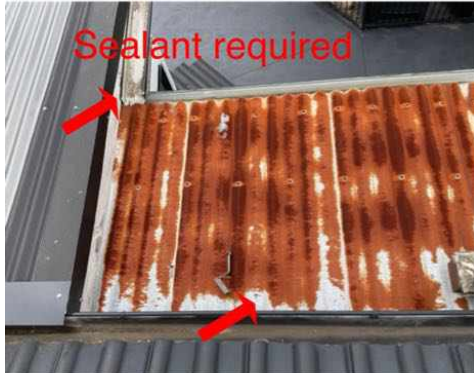
Finding 3.13

Building:	Building 1
Location:	Pictured small rear roof
Finding:	Roof sheets - Rusted
Information:	Upon inspection of the exterior roofing structure, evidence of rust to these sections was identified. If left unmanaged, these degrading joints can allow water ingress to the internal roofing structures, potentially leading to secondary damage of building elements. Accelerated deterioration of the roofing sheets and any associated building elements is also likely to occur.

A roofing contractor should be appointed immediately to assess the damage to the roofing sheets and to perform remedial works as necessary. Works may include replacement of severely affected roofing sheets or minor works such as the application of rust-retardant surface protectors.

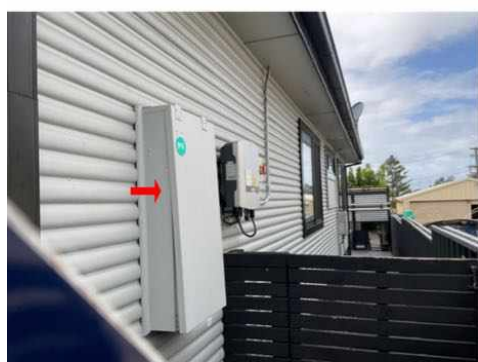
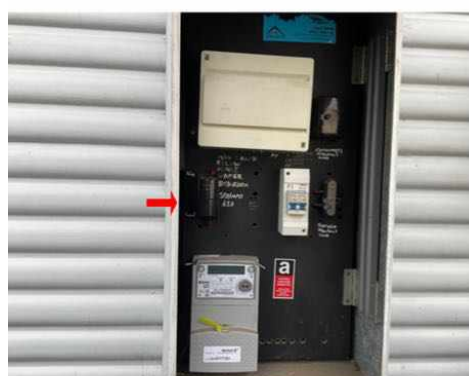
Building:	Building 1
Location:	Meter Box
Finding:	Termite Management System - no evidence of a chemical installation
Information:	The application of a post-construction chemical termite barrier is highly recommended for all properties. Such barriers are highly effective in preventing termite attack on any timber building elements throughout the property.

A durable notice should be placed in the switchboard unit to indicate current termite barriers. At the time of inspection, no durable notice was evident and it appeared as though no chemical termite management system has been installed, with no evidence to suggest preventative works taking place since the property was built.

The client may consider gaining further advice from a pest controller as to the costs and procedures involved with a 'chemical' application. It is recommended that obtaining such advice be a short-term priority.

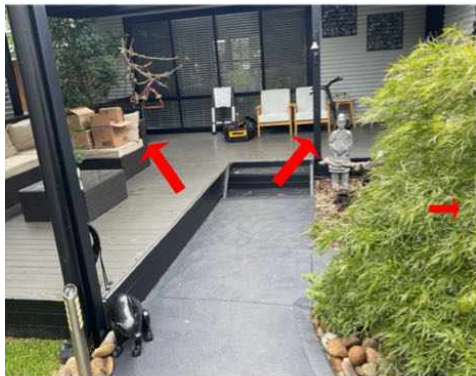
Finding 6.02

Building:	Building 1
Location:	Yard - front
Finding:	Bridging - Vegetation and decking
Information:	Where vegetation and decking obstructs inspection of building elements, also known as bridging as it provides a bridging point for the access of termites, full inspection can not be achieved. Consequently moisture or dampness may be present and the areas becomes conducive to termite activity. Plants and decks against or very close to buildings provide cover, shade and can provide an environment that is attractive to termite infestation.

The removal and replanting of plant species that do not provide "cover" or cutting back of existing vegetation and leaving a small gap between decking and the building walls will assist greatly in preventing Bridging from occurring.

The removal of any such stored building or plant materials that may be conducive to termite activity should be carried out as soon as possible and arrange re inspection to minimize the risk of termite attack.

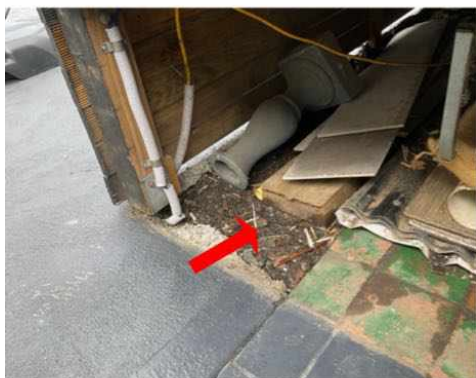
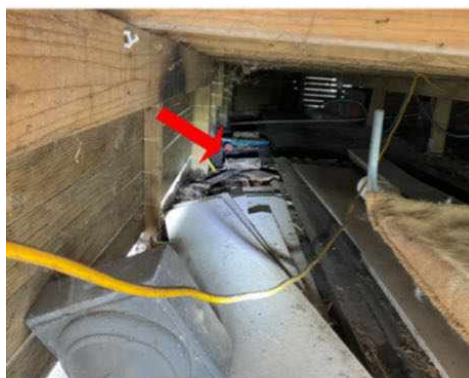
Finding 6.03

Building:	Building 1
Location:	Yard and subfloor areas
Finding:	Timber in contact with the ground
Information:	Any timbers in direct ground contact provide opportunity for concealed termite entry and are likely to be subject to premature rot and decay as the soil retains moisture or damp conditions against the timbers.

Removal of all waste timber that is in direct contact with ground is highly required. This timber is promoting mould and wood rot and is very attractive to termites.

Frequent pest inspections are advised to readily identify any termite activity in these areas.
