# Building and Timber Pest Inspection Report

Inspection Date: Wed, 28 Jan 2026

Property Address: 12 Oxford Cl, Sippy Downs QLD 4556,  
Australia

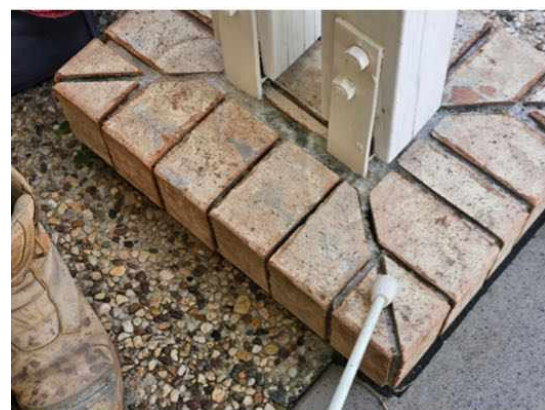
#### Finding 3.01

Building: Main Building  
Location: As shown  
Finding: Brickwork - cracking  
Information: Cracking was identified to the brickwork bases of the front posts at the time of inspection. Cracking of this nature can usually be attributed to movement or minor expansion of the underlying concrete over time.

The repairs are generally easily resolved.

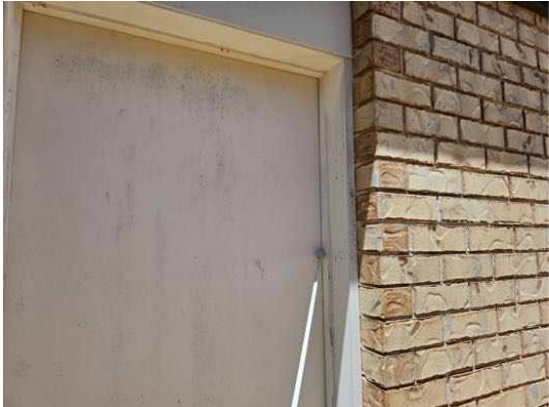
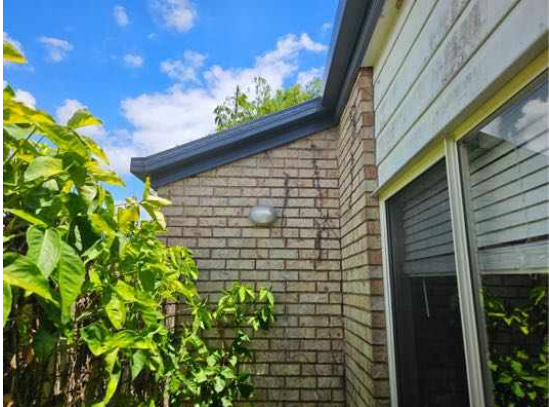
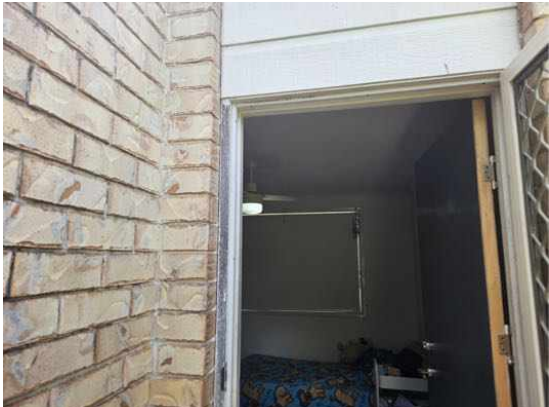
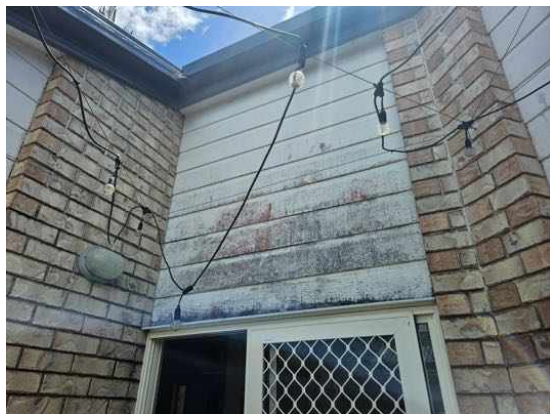
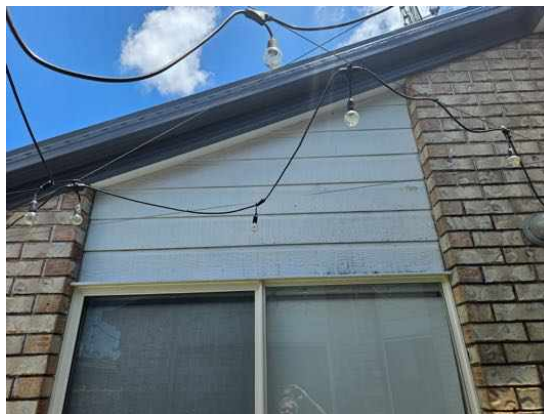
### Finding 3.03

Building:	Main Building
Location:	As shown
Finding:	External painting deteriorated - minor
Information:	The external paintwork of the walls and joinery as shown will require attention to prepare and re-paint in the short term.

A painting contractor could be appointed to perform necessary works to aid the appearance of the affected area and to ensure the area is protected against further deterioration.

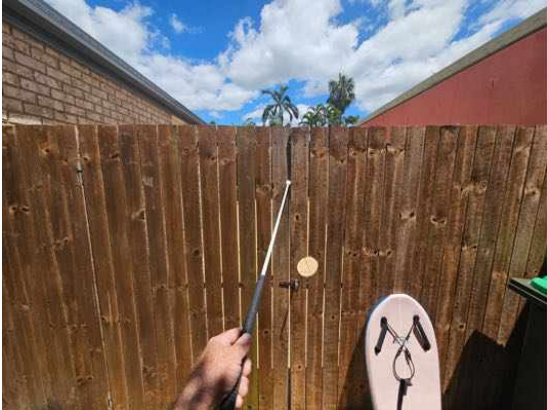
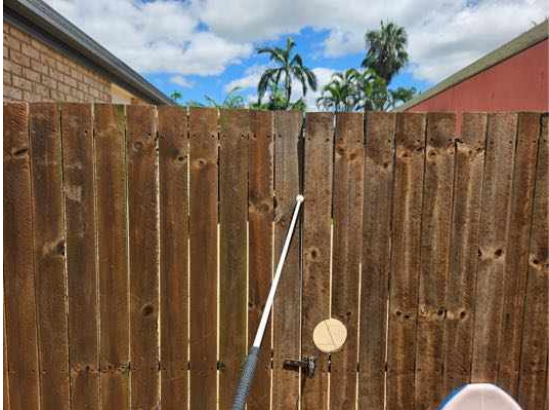
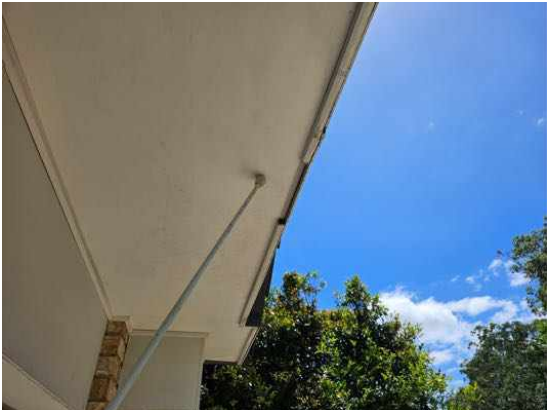
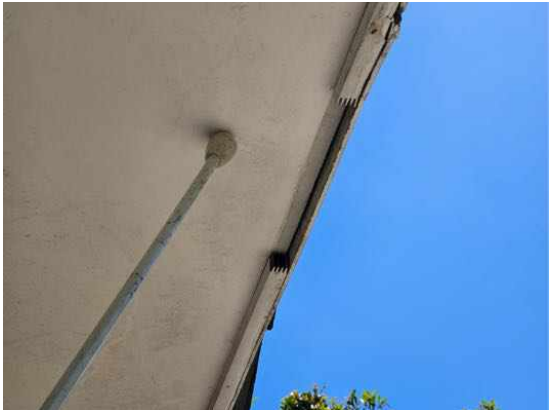
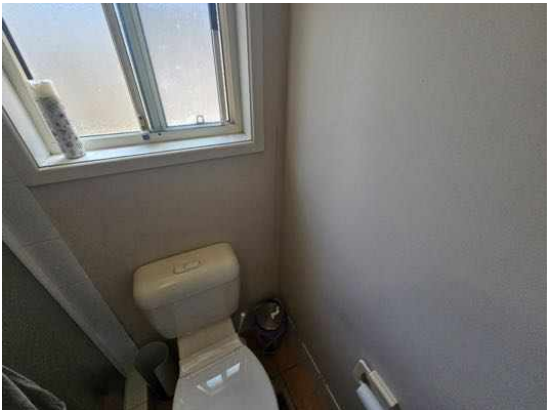
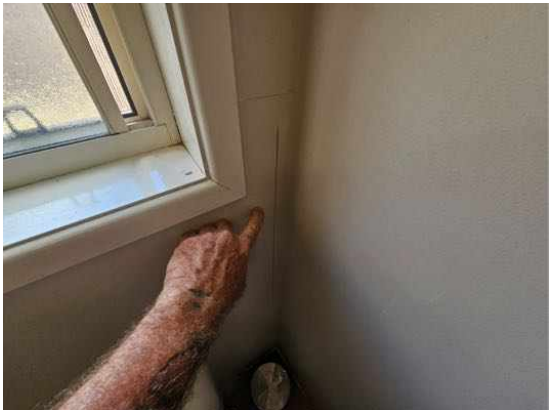
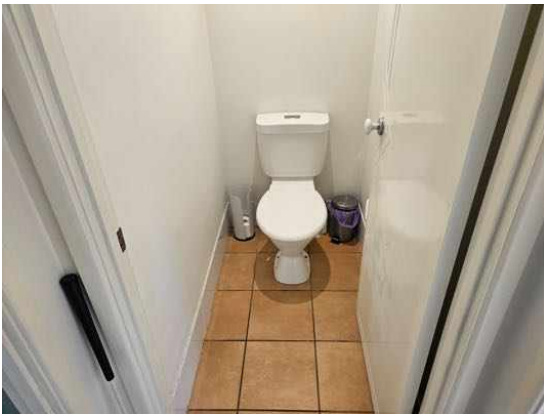
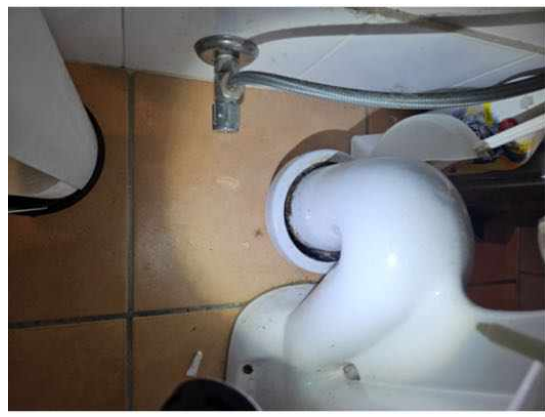
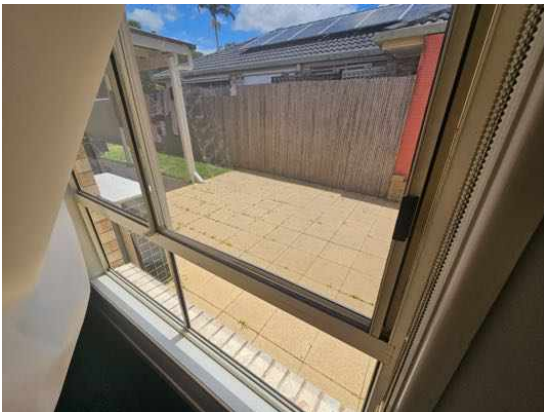
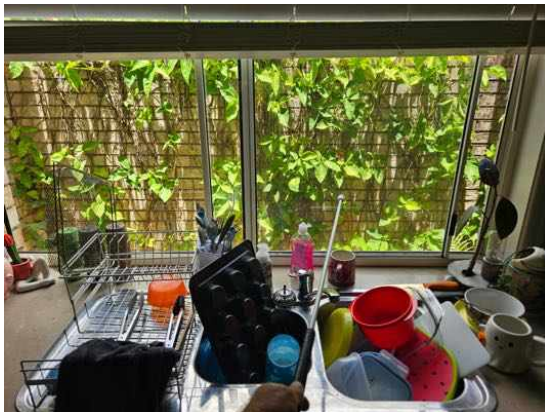
### Finding 3.04

Building:	Main Building
Location:	All Areas
Finding:	Miscellaneous minor defects
Information:	Below are listed the miscellaneous minor defects identified on the day of inspection.

1. Gap at weatherboard / brick on rear gable.
2. Rusted bolt to be replaced on pergola post.
3. Right side gate binds.
4. Beading broken on garage eave.
5. WC, toilet pan seal deteriorated.
6. Master-bedroom and kitchen windows require servicing.

These minor defects should be attended to in the short term to prevent further deterioration.

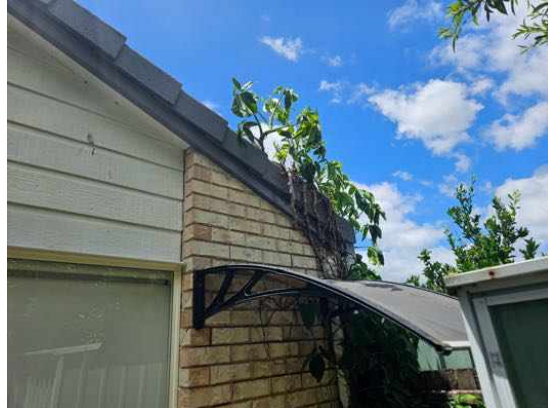
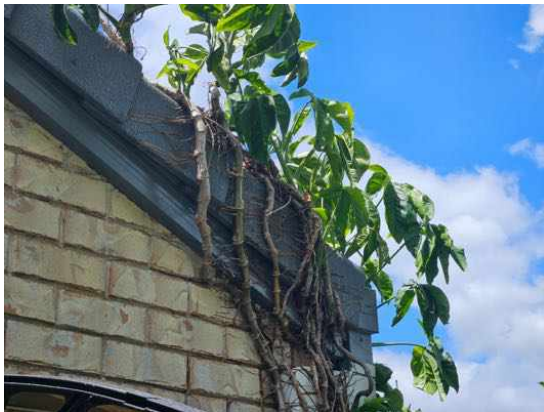
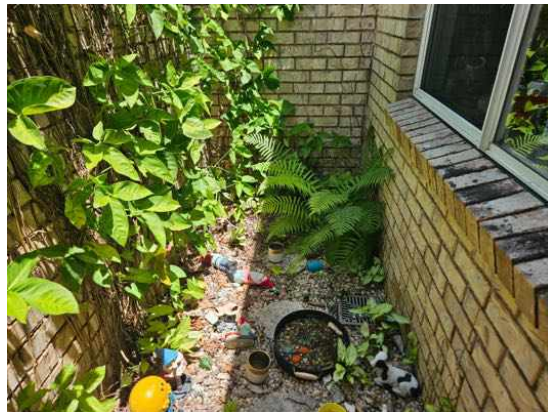
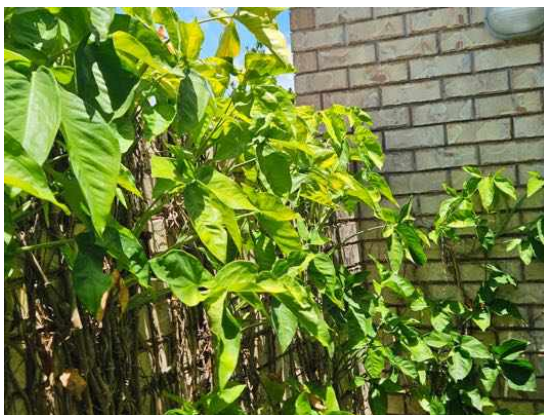
#### **Finding 6.01**

Building: Main Building  
Location: As shown  
Finding: Garden - growing against house.  
Information: It was noted on the day of inspection that the plants, in particular an invasive vine, were growing against the building. This can be at risk of creating an environment for timber pests and vermin to enter the building.

It is recommended that the foliage be cut back to give a clear inspection zone against the building.

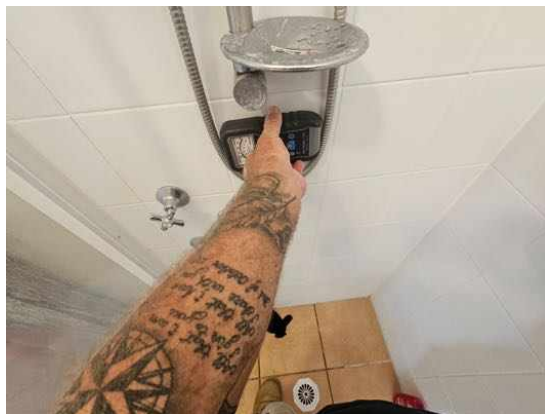
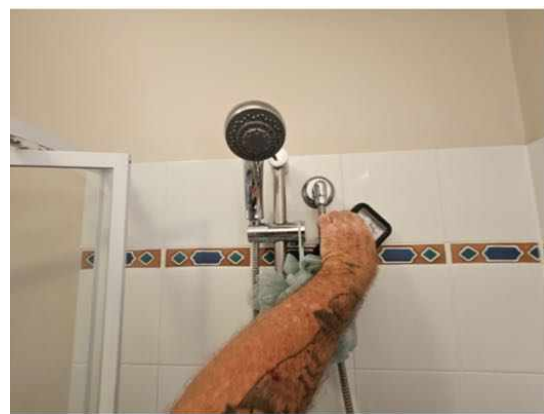
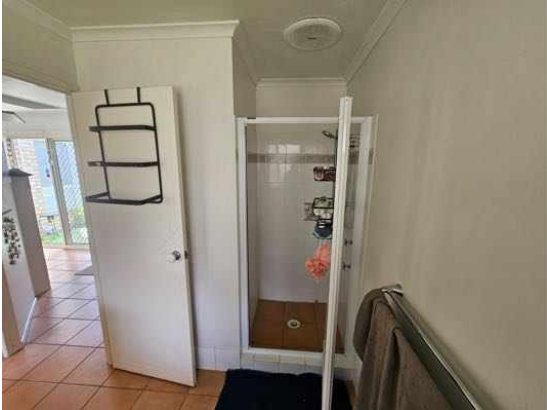
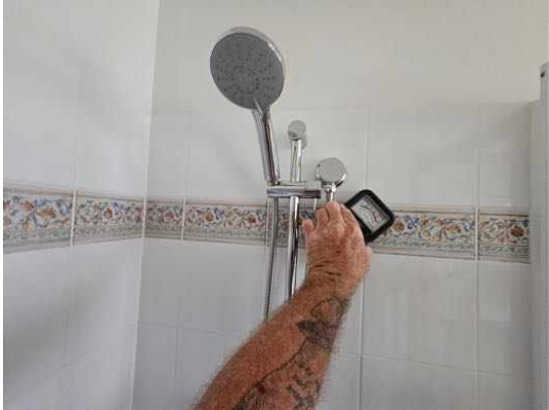
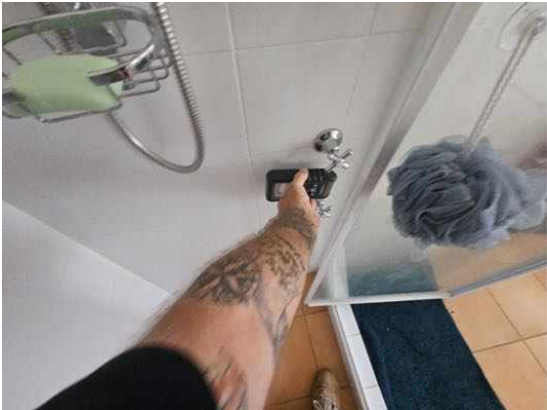
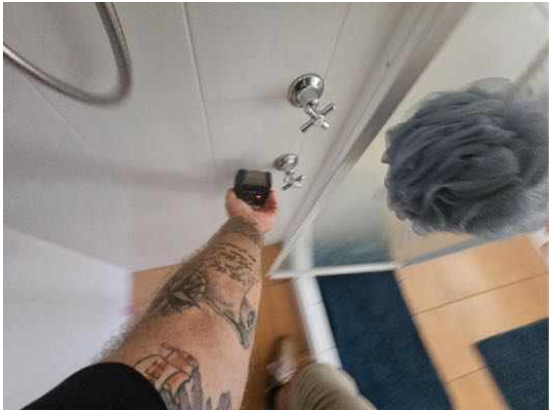
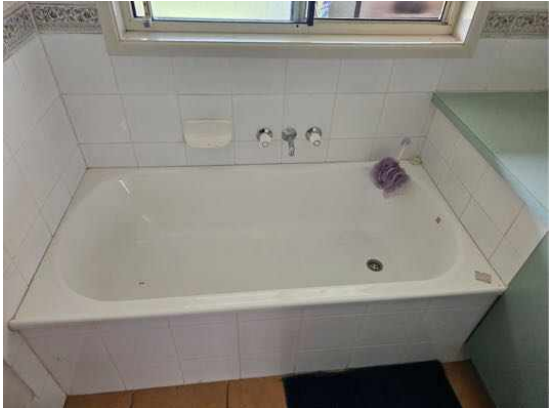
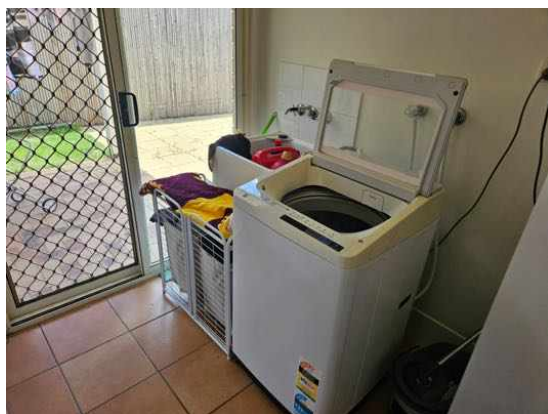
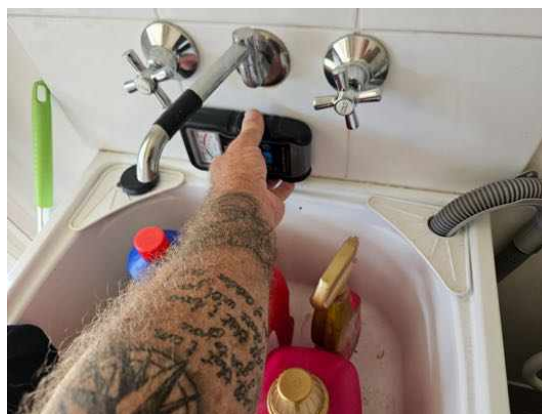
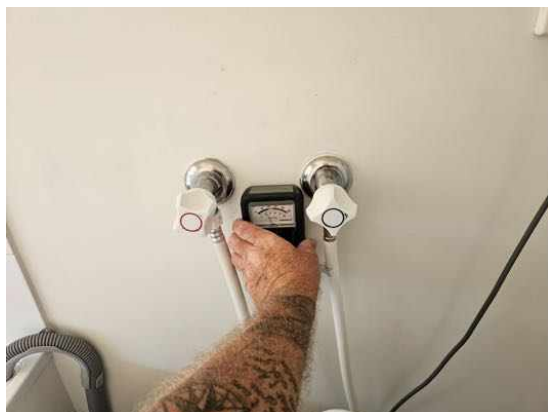
Building: Main Building  
Location: Bathroom, ensuite, laundry  
Finding: No moisture detected in bathroom / ensuite / laundry  
Information: On the day of inspection the showers in the bathroom/s and ensuite, and wall of the laundry are measure for moisture using a "Tramex" moisture meter. During this inspection no moisture was detected in these areas and the tiled / sheeted surfaces appear to be in good order.

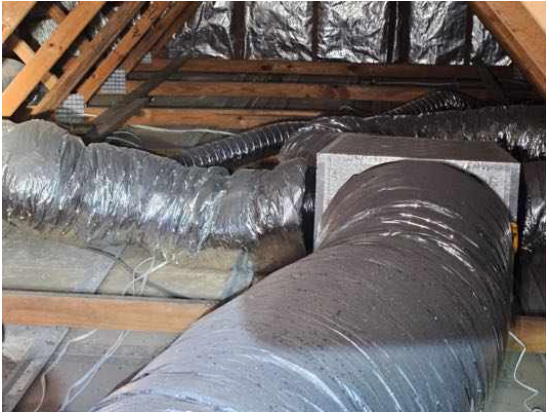
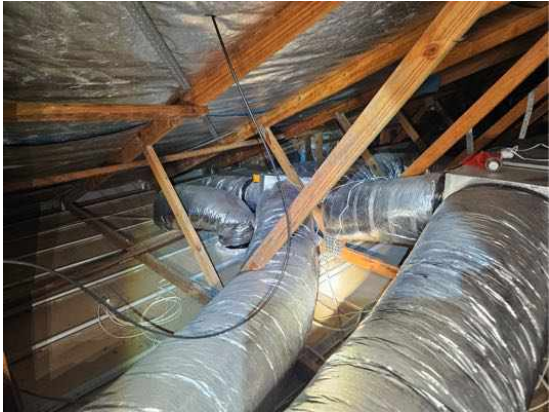
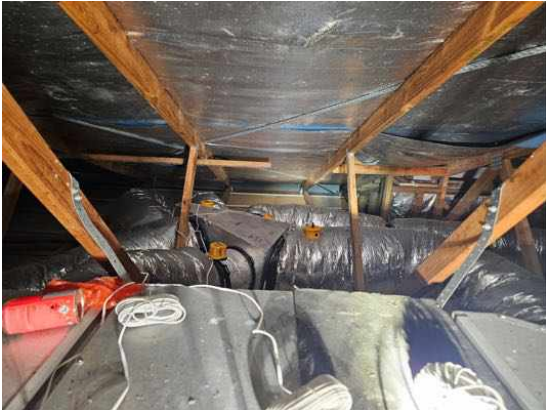
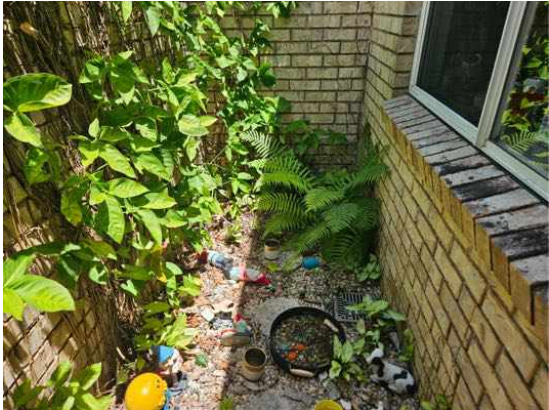
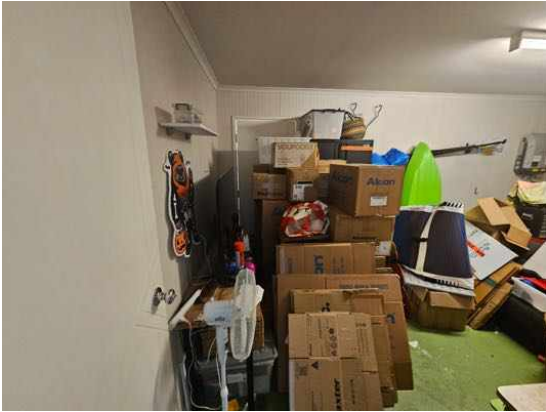
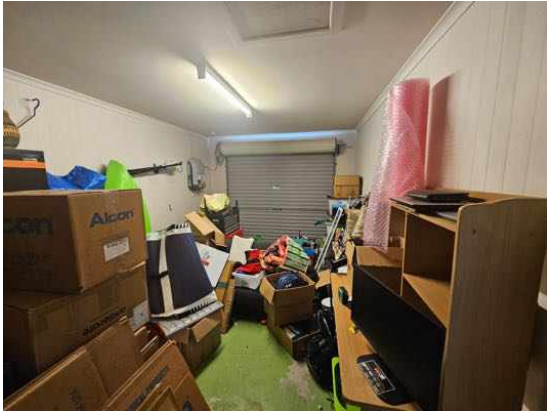
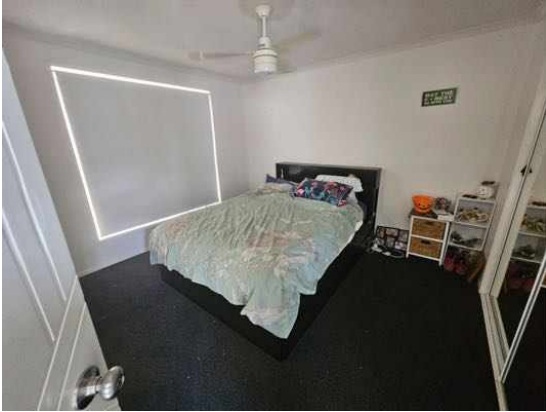
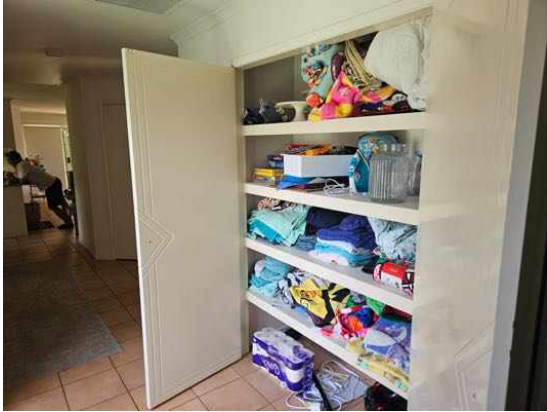
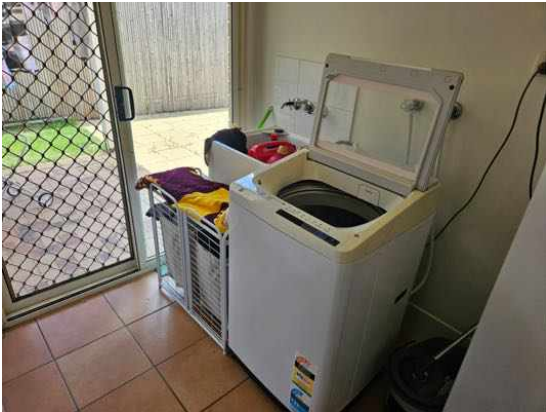
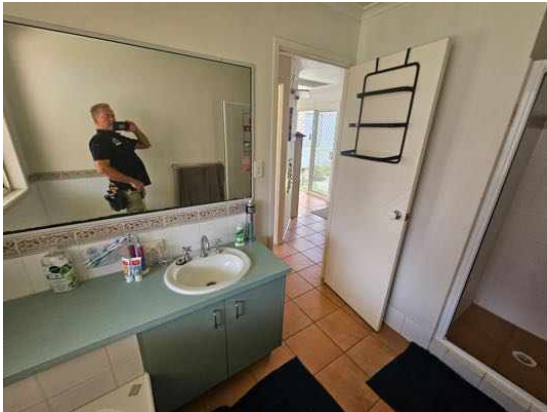
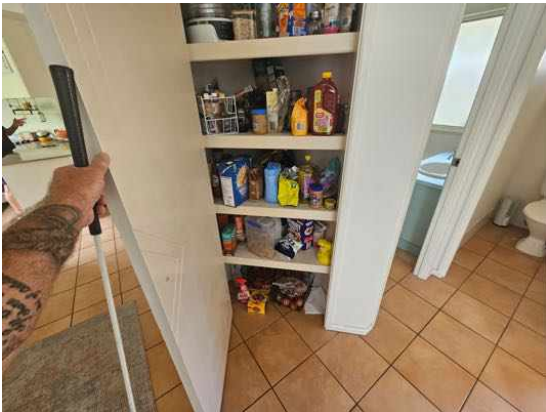
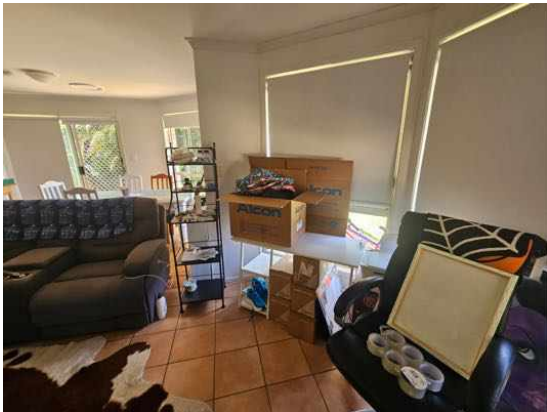
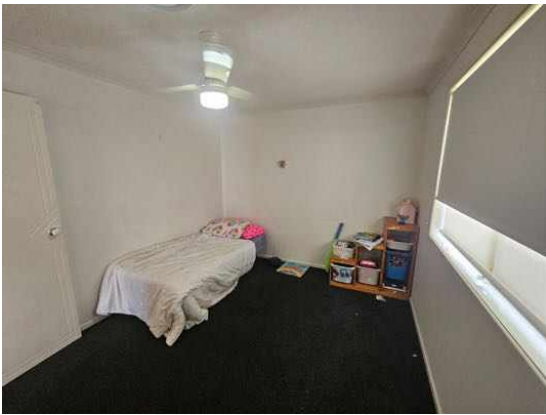
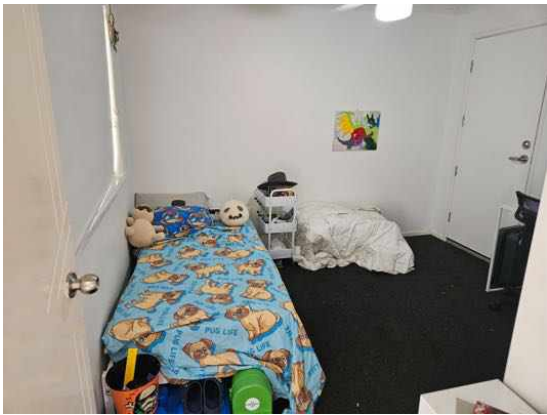
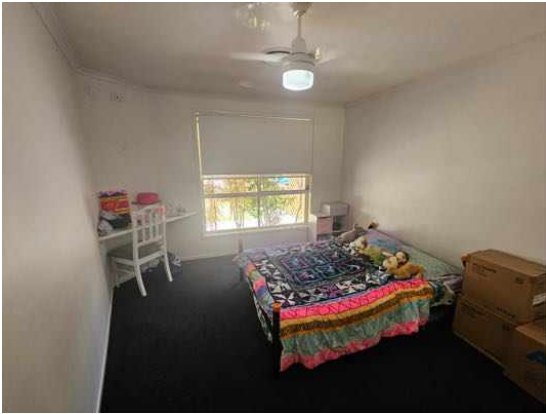
Building: Main Building  
Location: All Areas  
Finding: Additional Photos - Obstructions and Limitations  
Information: These photographs are an indication of the obstructions and limitations which impeded full inspection of the property at the time of inspection. These obstructions can prevent full inspections of the areas shown.

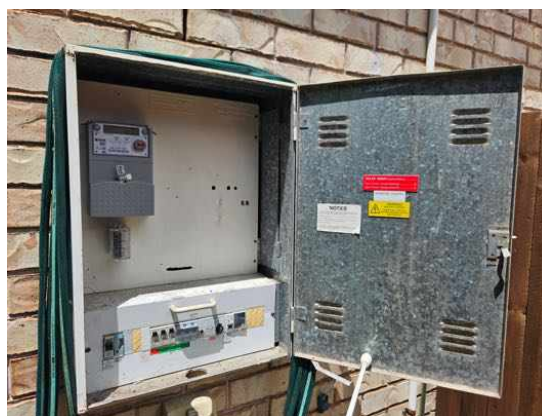
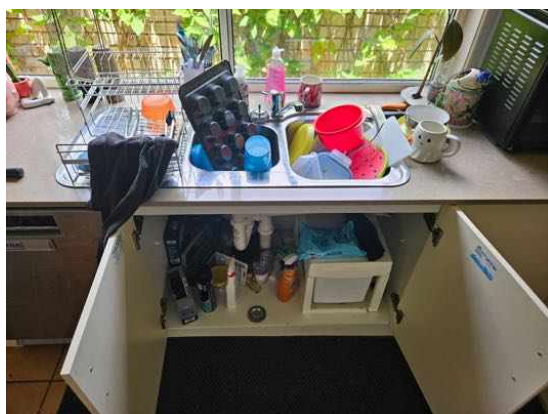
Building: Main Building  
Location: Meter box, kitchen cupboard  
Finding: Durable pest inspection notice - not assessable  
Information: On the day of inspection it was noted that the durable timber pest inspection / treatment notice was missing, not visible or out of date. These notices / stickers are to verify the timber pest inspection dates, the inspector, the currency and type of timber pest system / barrier in place or being used in and around the property.

Annual, or more regular, inspections are crucial in maintaining and managing the properties timber pest risk profile. By not having regular inspections of the property raises the properties risk of undetected defects and damage. Without regular inspection at intervals of not greater than annually the buildings risk profile will categorised as high. Properties with trees within 50m and with gardens close to the building are at greater risk and will have a high risk profile.

It is recommend that a licensed timber pest controller be contacted to assess the properties needs and provide costings for an annual inspection programme.
