# Building and Timber Pest Inspection Report

Inspection Date: Fri, 13 Feb 2026

Property Address: 2/30 Norton St, Wangaratta VIC 3677,  
Australia

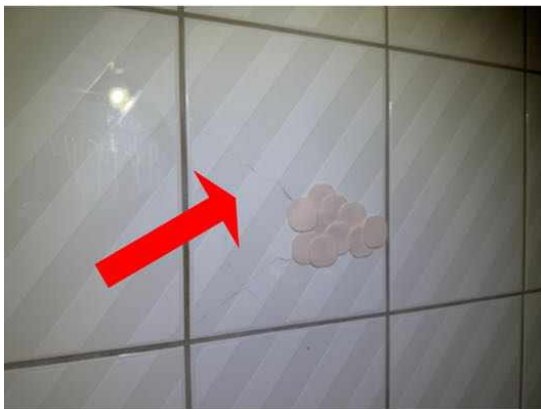
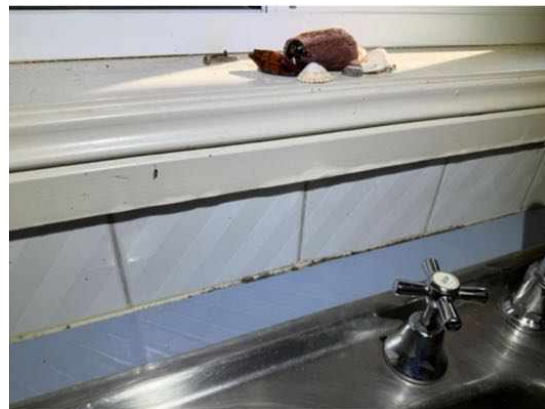
#### Finding 3.01

Building: Main Building  
 Location: Tiled Areas  
 Finding: Weathered Sealant & Cracked Tiles  
 Information: It appears that the sealant is weathered in some tiled areas, a common defect in buildings of a similar age. Some areas of cracked tiles were also noted.

Sealant that comes into regular contact with water should be maintained for the long term care of your property. Recommend engaging a licensed tiling contractor, to provide maintenance works where necessary.

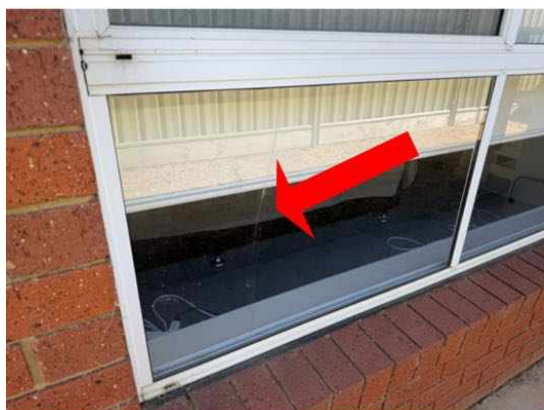
#### Finding 3.02

Building: Main Building  
 Location: Bedroom  
 Finding: Window - Cracked  
 Information: Minor cracking was evident at but not limited to, the bedroom window. Further impact may lead to additional cracking.

It is advised that the client monitor the condition of the window. Should further cracking occur, a qualified glazier should be engaged to replace the window

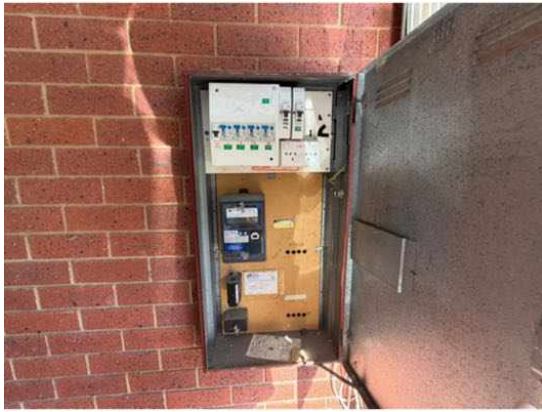
### Finding 6.01

Building: Main Building  
Location: Switchboard  
Finding: Termite Management System - no evidence of a chemical installation  
Information: The application of a termite barrier is recommended, as it appears no termite management system has been installed, with no evidence or durable notice to suggest works taking place. Generally, a durable notice is placed in the meter box to indicate current termite barriers.

Such barriers are highly effective in preventing termite attack on the building and therefore should be installed.

Recommend seeking further advice from a licensed pest controller.

Installation of a termite barrier is recommended as there was no evidence of installation of a previous termite management system. 12 monthly termite inspections, conducted by a qualified termite inspector are also advised. Recommend engaging a licensed pest controller, to provide further advice.

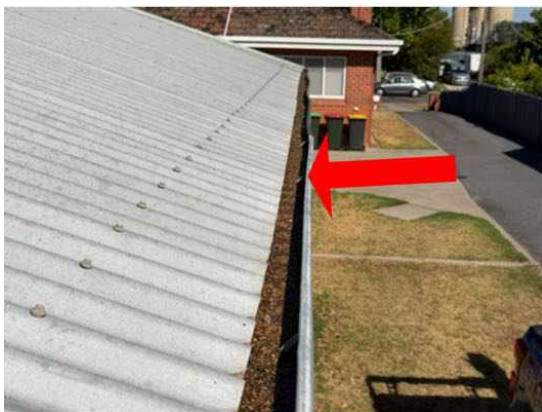
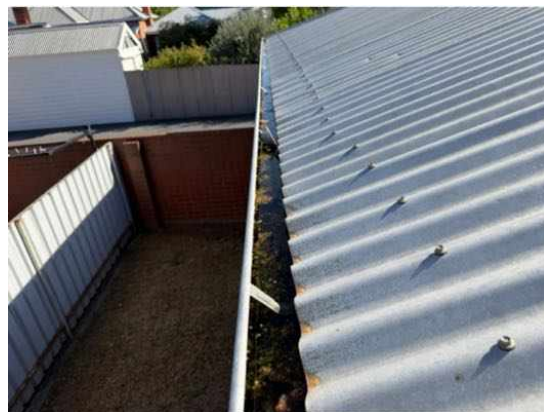
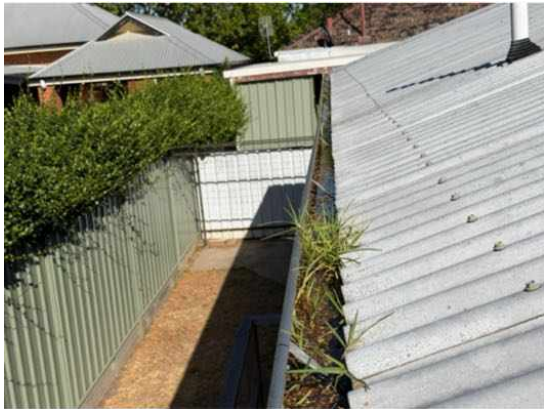
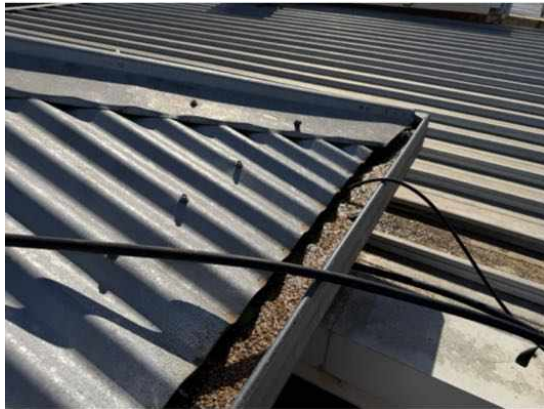
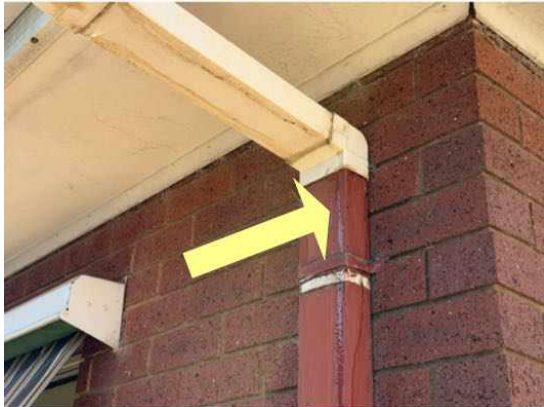
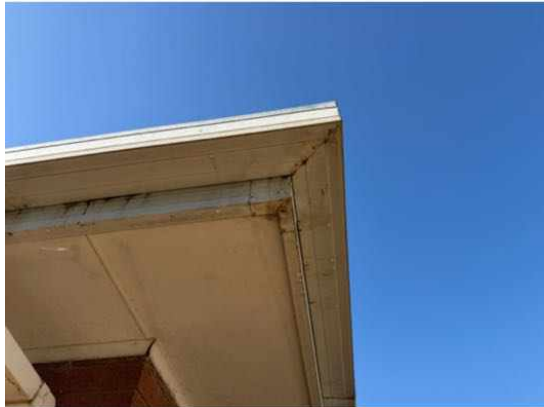
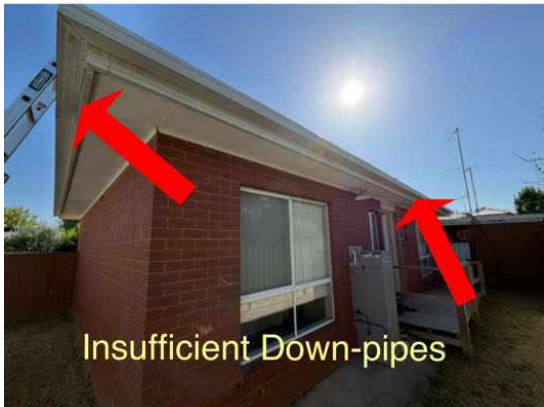
### Finding 6.02

Building: Main Building

Location: Gutters, Downpipes

Finding: Gutters - Debris, Leaking & Water pooling

Information: The gutters were found to be full of water and were leaking in some areas. It is suspected there are insufficient downpipes installed. Water pooling can lead to deterioration of the roof plumbing over time, if neglected, and lead to overflows, creating an environment conducive to termite activity.

A licensed roof plumber should be engaged promptly, to provide further advice & remedial works to ensure adequate roof drainage is achieved. All debris should be cleared promptly to ensure proper drainage and prevent overflows.

The gutters were found to be full of water and were leaking in some areas. It is suspected there are insufficient downpipes installed. A licensed roof plumber should be engaged promptly, to provide further advice & remedial works to ensure adequate roof drainage is achieved. All debris should be cleared promptly to ensure proper drainage.

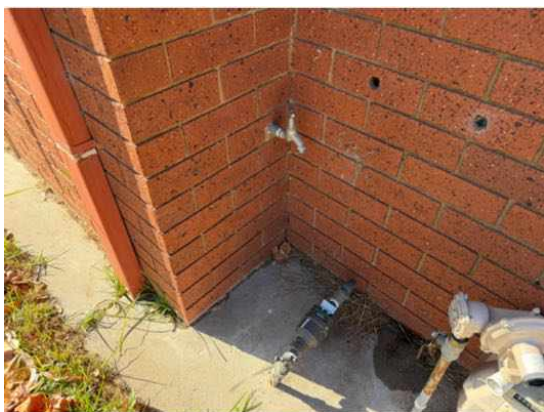
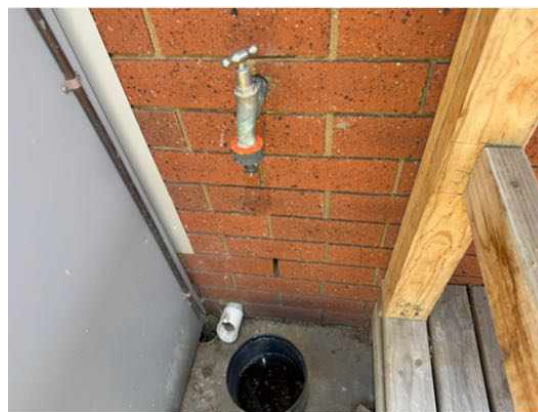
**Finding 6.03**

Building: Main Building  
 Location: All external areas  
 Finding: Potential Water pooling - against property  
 Information: Potential areas of water pooling around the perimeter of the property were identified.

Where insufficient drainage of taps is present, water pooling is likely to occur, and can create areas conducive to timber pests.

Recommend consulting with a licensed plumber to provide further advice.

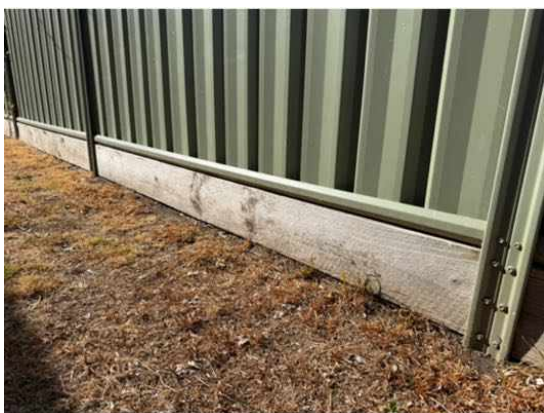
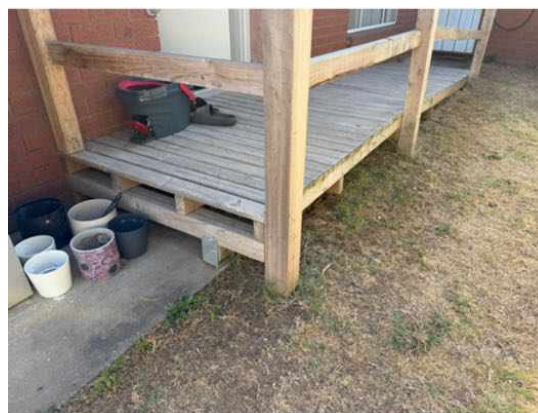
### Finding 6.04

Building:	Main Building
Location:	Landscaping timbers, Decking
Finding:	Timber in direct ground contact - conducive to termites
Information:	Where timber materials are in direct contact with the ground and consequently moisture, they become conducive to termite activity. The landscaping timbers & decking create an environment conducive to termite activity.

Therefore, it is advised that these areas are inspected frequently to identify any early signs of termite activity.

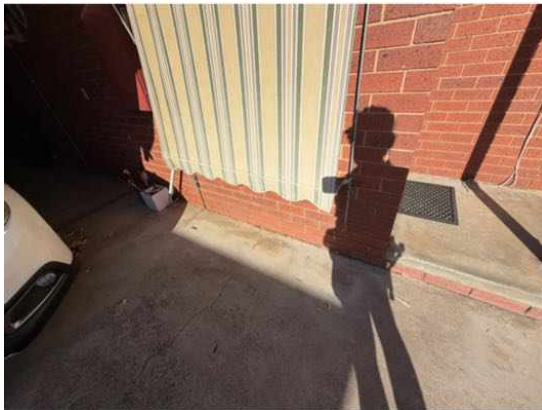
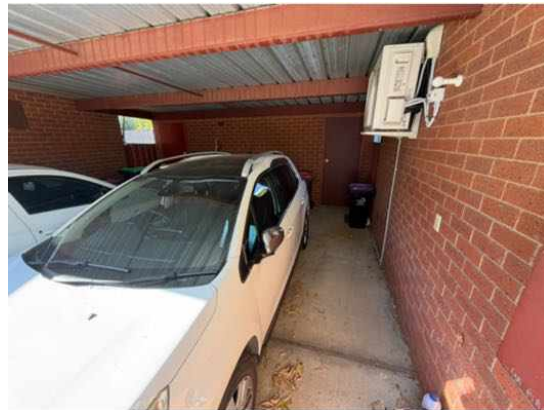
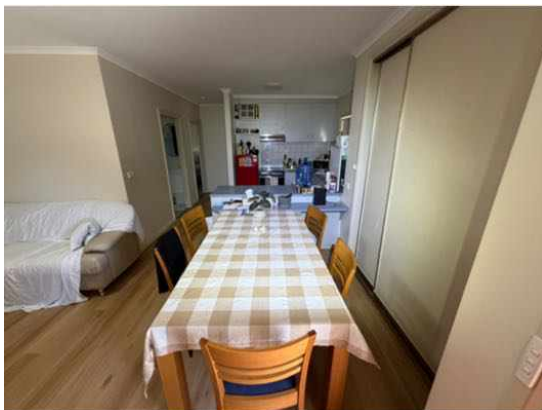
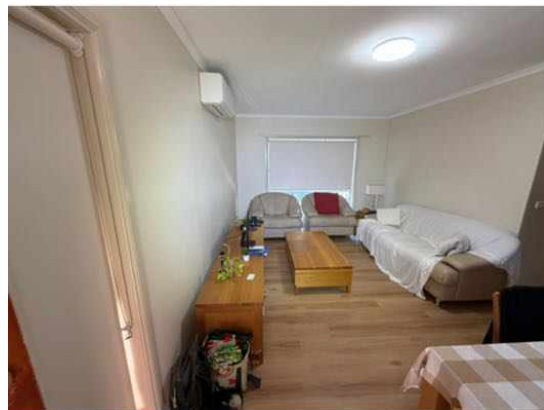
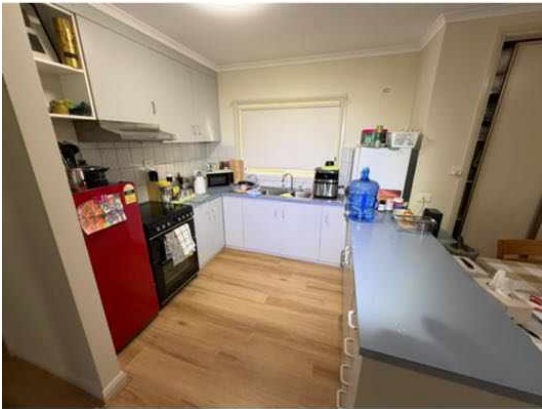
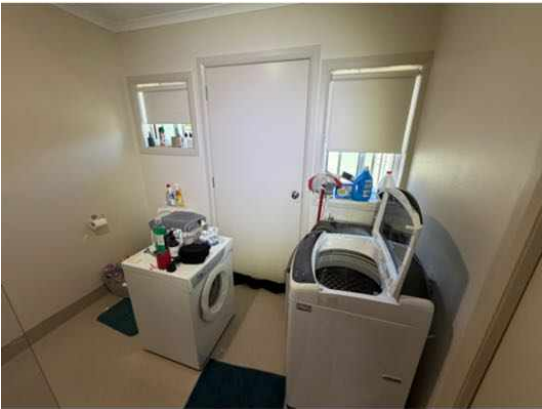
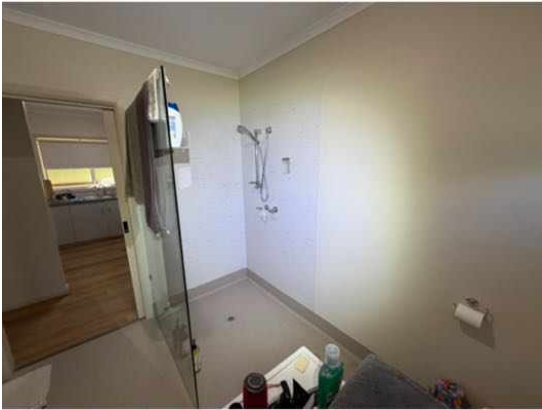
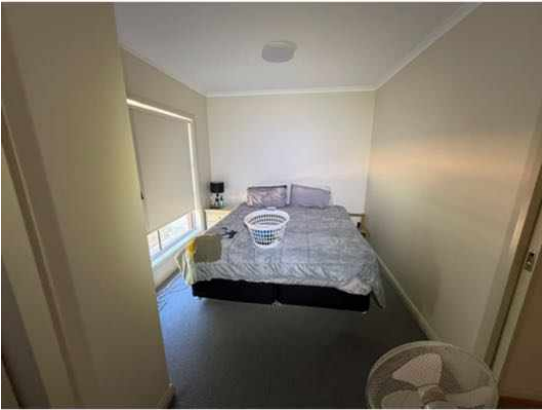
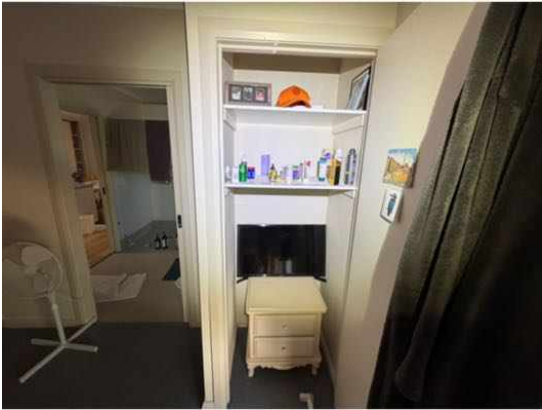
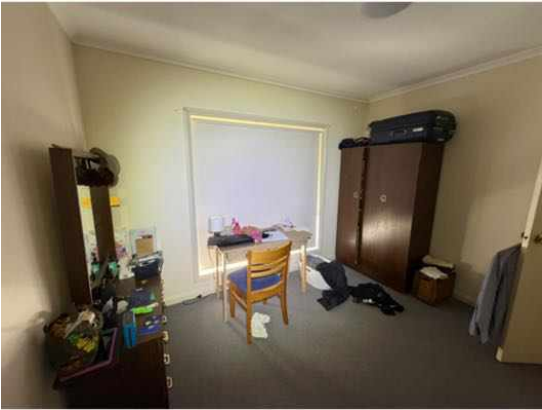
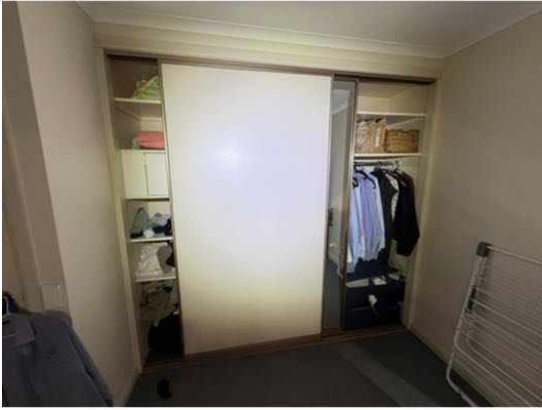
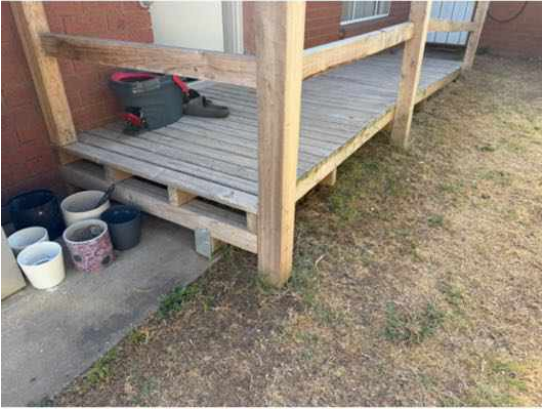
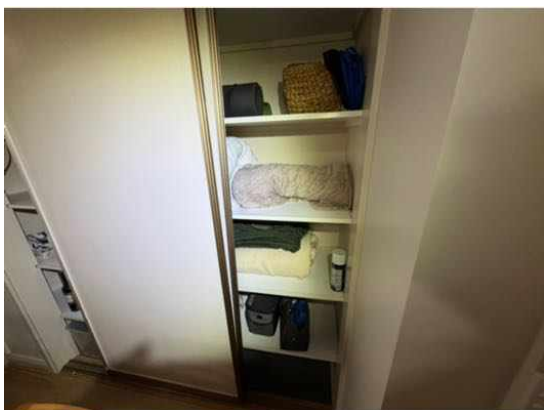
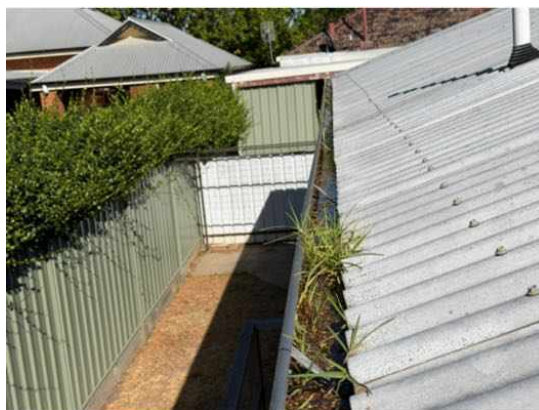
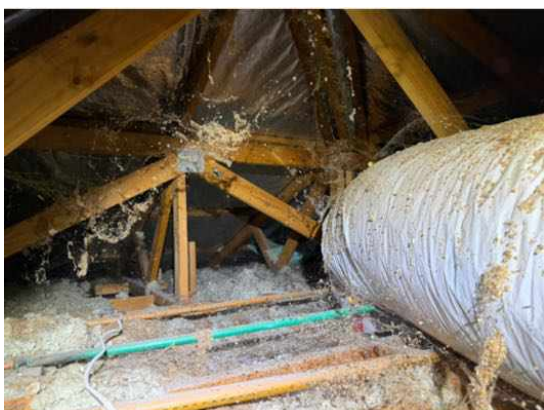
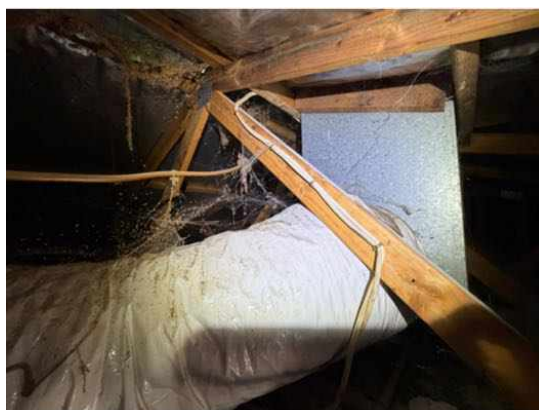
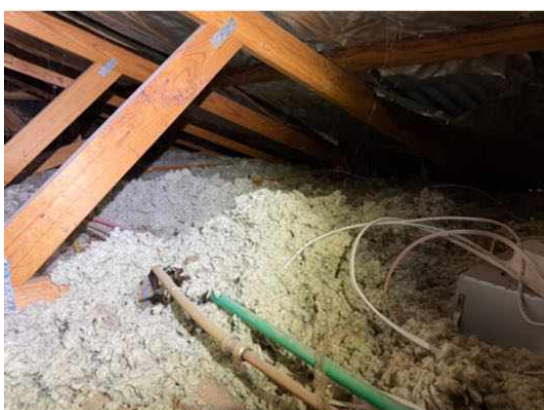
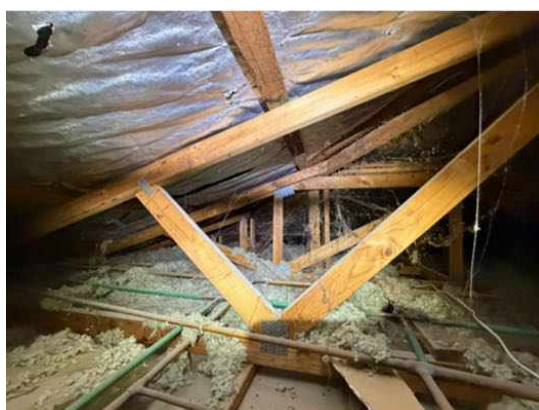
Finding: Additional Photos - Obstructions and Limitations

Information: These photographs are an indication of the obstructions and limitations which impeded full inspection of the property at the time of inspection. These obstructions can hide an array of defects and should be removed to allow full inspection to be carried out. A re-inspection is recommended once the areas are made accessible.

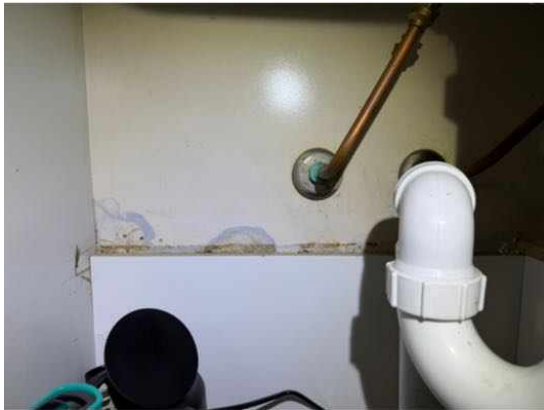
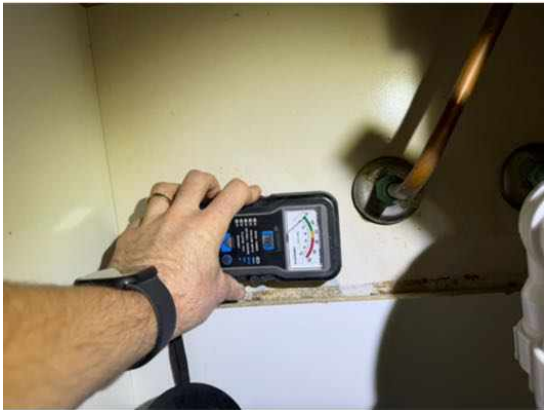
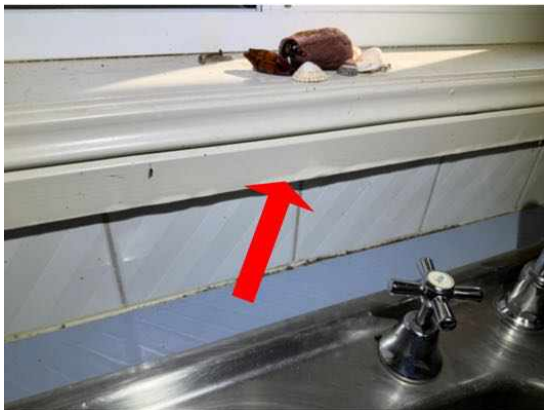
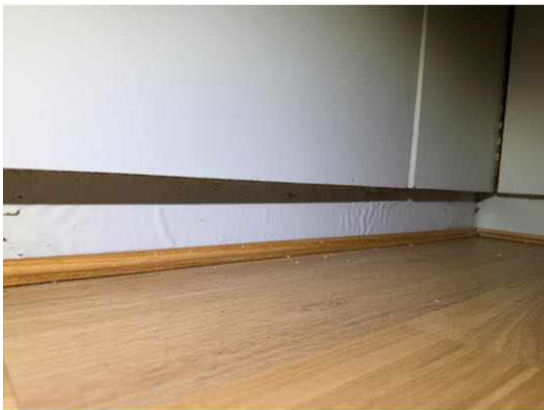
Building: Main Building  
 Location: Kitchen sink  
 Finding: Water Staining Present  
 Information: It appears that water staining was present at but not limited to, beneath the kitchen sink and to the kitchen cupboards. Potential causes of leaking include deteriorated roof cladding or damaged plumbing fittings and fixtures. No high moisture was evident in the area at the time of inspection.

Water staining was identified underneath the kitchen sink. Recommend the client to monitor the area. Should further leaking occur, a licensed plumber should be engaged to provide remedial works.

It is recommended that the client monitor the area and engage a licensed plumber, should the leak persist or return.

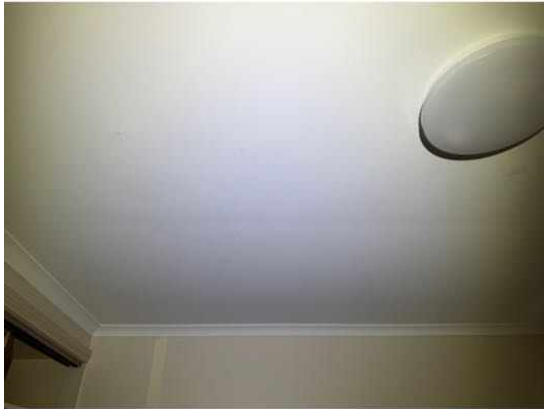
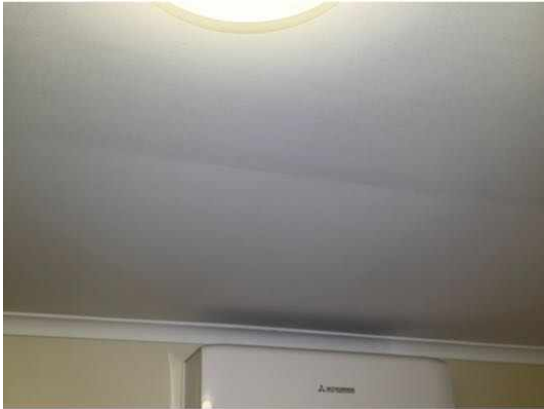
Building: Main Building  
 Location: Bedroom, Lounge room  
 Finding: Ceiling - Minor Sagging  
 Information: Some areas of the ceiling at but not limited to the lounge room and bedroom appear to be slightly sagging at the time of inspection. Causes of ceiling sagging include fixings (e.g. nails or glue) that have become loose and require re-fixing.

Recommend the client to monitor the sagging and engage a licensed plasterer to provide maintenance works, should the sagging develop.

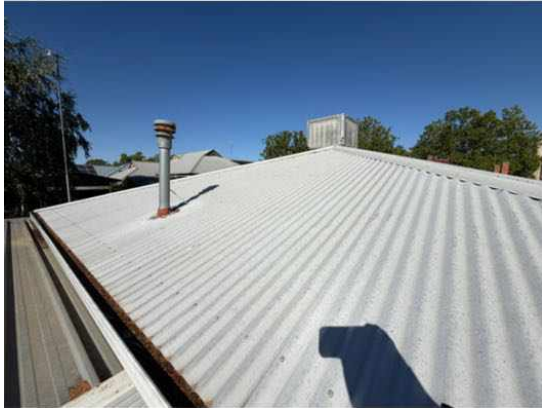
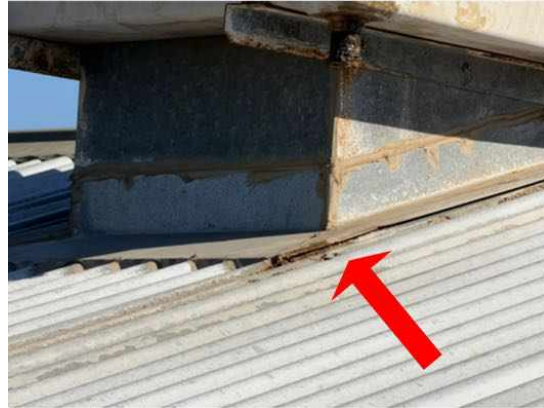
Building: Main Building  
 Location: Roof Exterior  
 Finding: Roof Exterior - General Weathering  
 Information: General weathering was identified to the roof exterior, and roof sealant. While weathering of the roof exterior is consistent with the age of the property, maintenance works are advised. Recommend consulting with a licensed roofing contractor, to provide further advice regarding maintenance works.

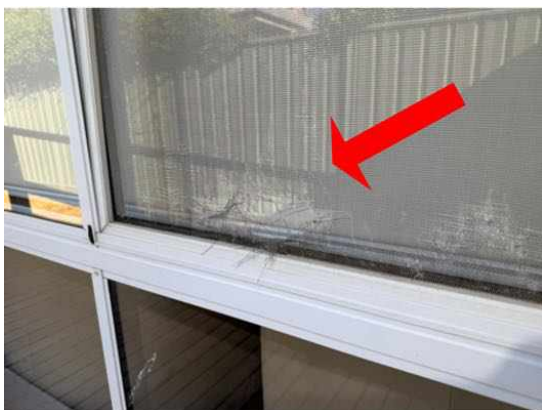
Building: Main Building  
 Location: Fly screen  
 Finding: Flyscreens - Damaged  
 Information: Some fly screens were found to be damaged. This inhibits the functionality of the affected fly screens and windows.

Recommend a general handyman to replace flyscreens at clients discretion.

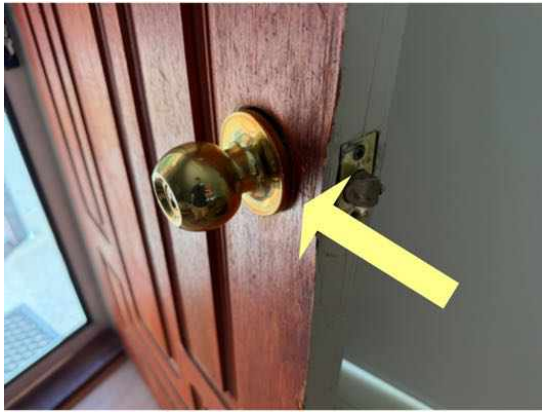
Location: front door

Finding: Door Handle - Loose

Information: It appears that the front door handle was loose and requires adjustment to tighten. A general handyman may be appointed to perform these minor works at the clients discretion.
