Building and Timber Pest Inspection Report

Inspection Date: Fri, 13 Feb 2026

Property Address: 3 Elmslie Cct, West Wodonga VIC 3690,
Australia

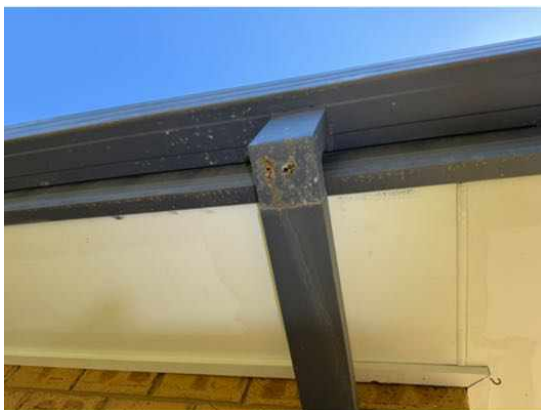
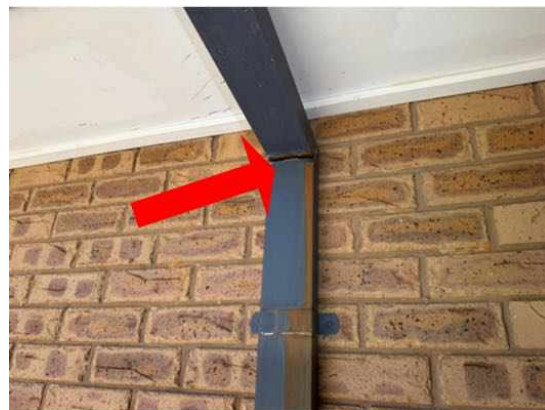
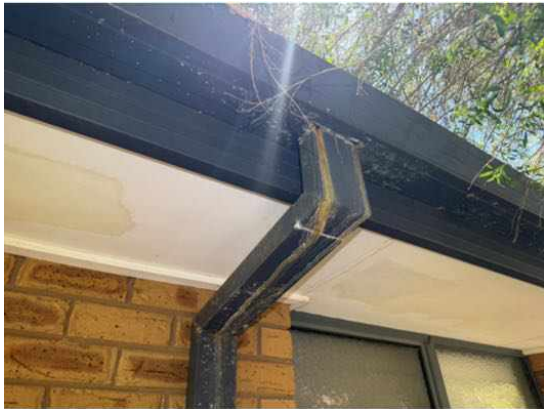
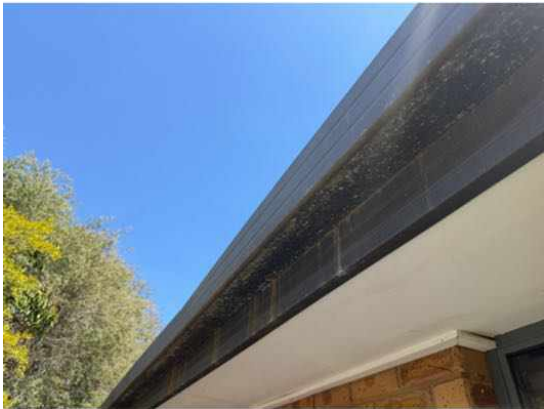
Finding 3.01

Building: Main Building
Location: Down-pipes
Finding: Roof Plumbing - Rust & Leaking
Information: It appears that areas of the roof plumbing (gutters & down-pipes) have areas of rust & leaking. While rust and leaking of roof plumbing is common in buildings of a similar age, maintenance works are advised to avoid creating an environment conducive to termite activity.

It appears that areas of the roof plumbing (down-pipes & gutters) have areas of rust & leaking. Recommend engaging a licensed roof plumber in the short term, to provide maintenance works where necessary.

Recommend engaging a licensed roof plumber in the short term, to provide maintenance works where necessary.

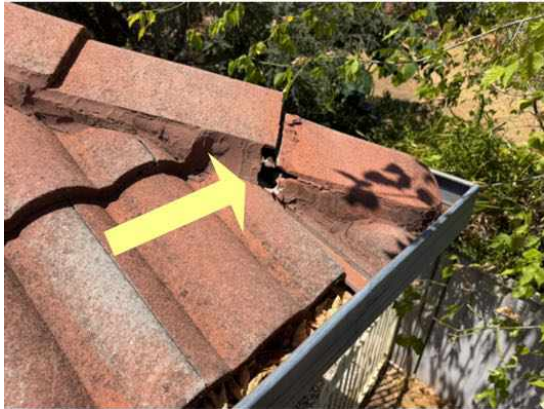
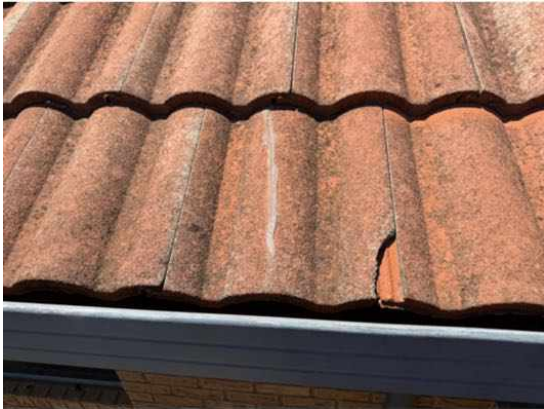
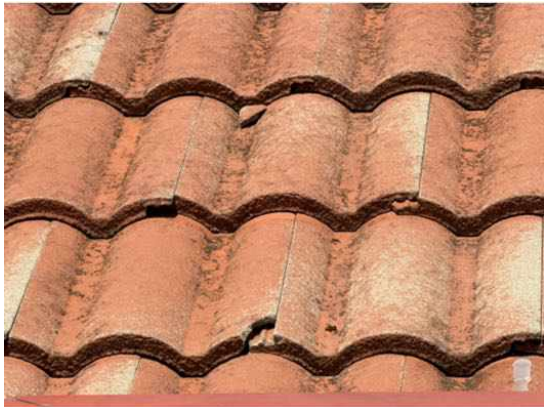
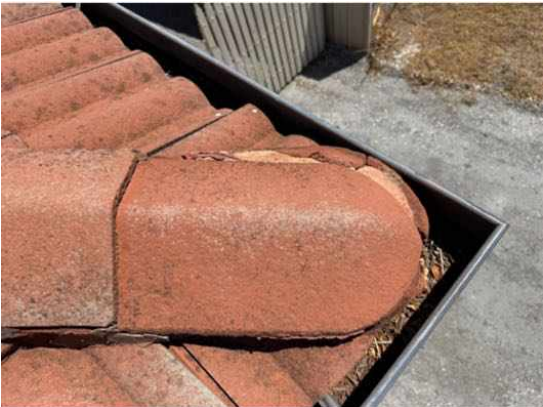
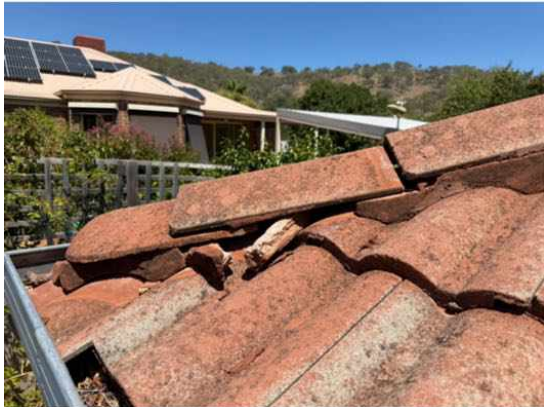
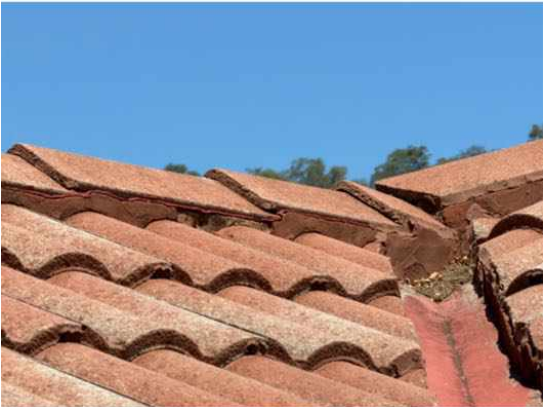
Finding 3.02

Building: Main Building
Location: Roof Exterior
Finding: Roof Exterior - Weathered, Cracking, Slippage
Information: Areas of slipped & chipped roof tiles and cracking in the tile pointing, were identified to the roof exterior. While weathering of the roof exterior is consistent with the age of the property, maintenance works are required. Where left unmanaged, deteriorating and damaged roof tiles are likely to lead to secondary defects, including water leaks.

Areas of slipped roof tiles and cracking in the tile pointing were identified to the roof exterior. Recommend engaging a licensed roofing contractor in the short term, to provide further advice regarding maintenance works needed.

Recommend engaging a licensed roofing contractor in the short term, to provide further advice on maintenance works required and to return slipped tiles to their original positions.

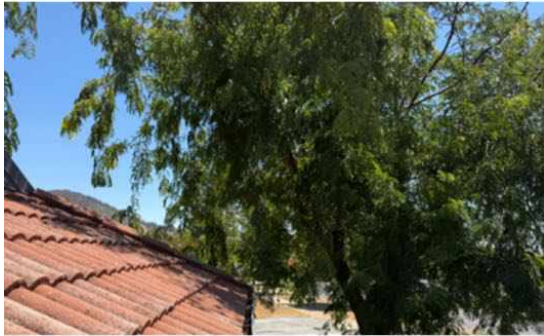
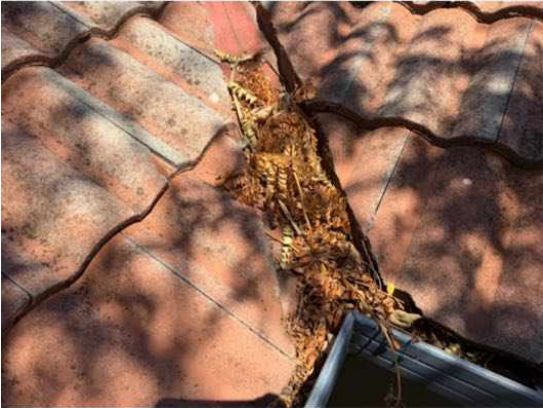
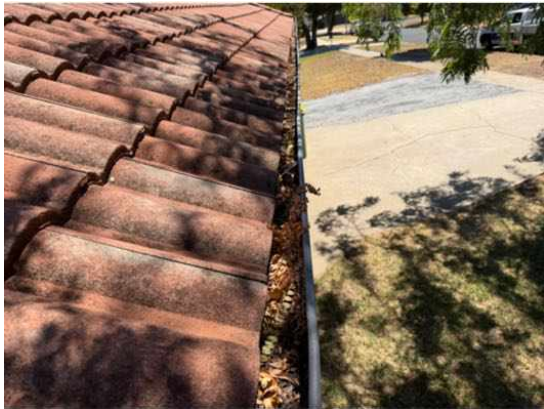
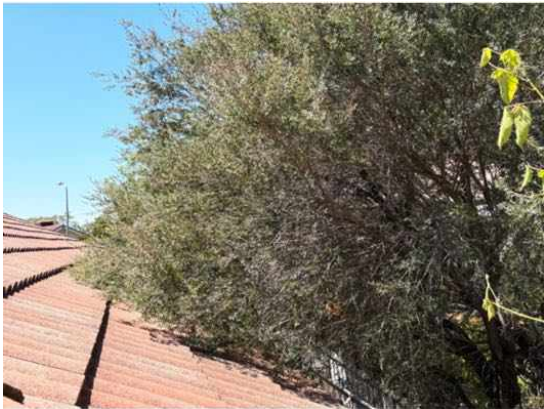
Finding 3.03

Building: Main Building
Location: Guttering
Finding: Debris & Vegetation in Gutters
Information: Debris & overhanging vegetation was identified to areas of the gutters. Gutters should be free of all debris to prevent blockages & accumulated water overflows. Recommend engaging a general handyman to remove all debris from the gutters, and cut back any over overhanging vegetation to prevent debris accumulation and blockages.

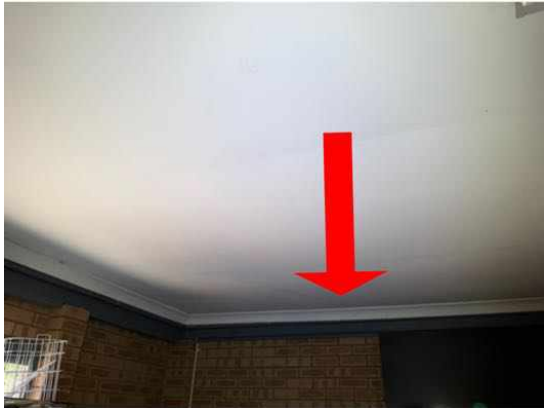
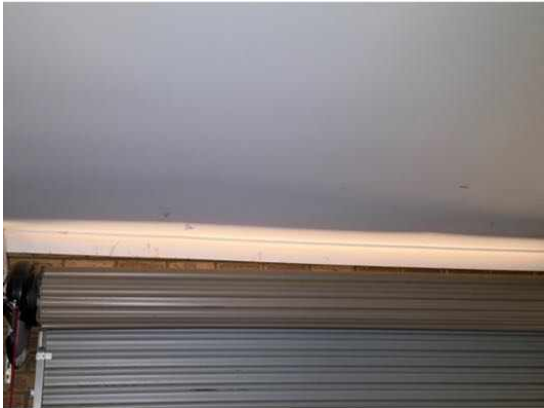
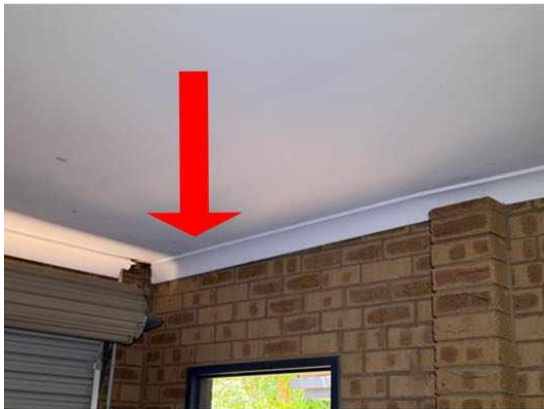
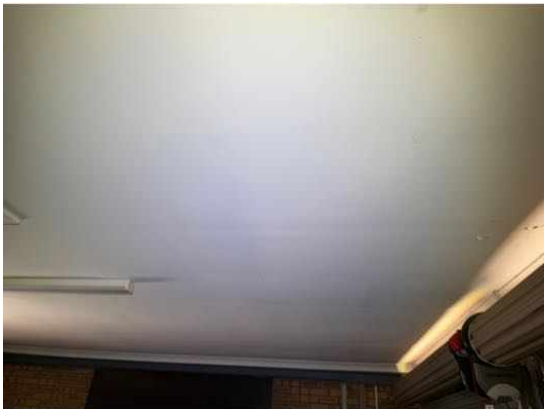
Finding 3.04

Building: Main Building
Location: Garage
Finding: Ceiling - Sagging
Information: Sections of the garage ceiling were found to be sagging at the time of inspection. Causes of ceiling sagging include fixings (e.g. nails or glue) that have become loose and require re-fixing. The client can engage a licensed plasterer, at their discretion to provide maintenance works where necessary.

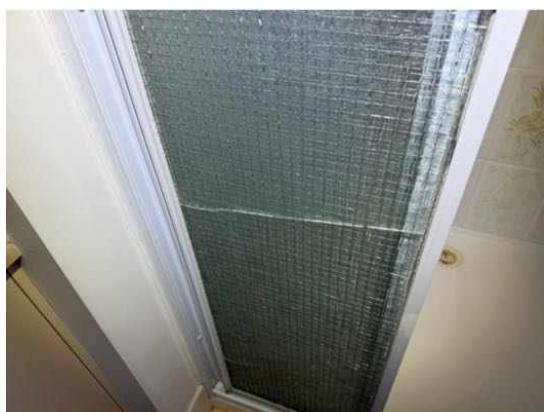
Finding 3.05

| Location: | Ensuite |
| Finding: | Shower screen - Cracked |
| Information: | Cracking was evident to the ensuite shower screen at the time of inspection. While the cracking appears to be minor, any further impact may lead to additional cracking of the shower screen. Recommend that the client monitor the cracking and take care in the area. Should further cracking occur, a licensed glazier should be engaged to replace the shower screen. |

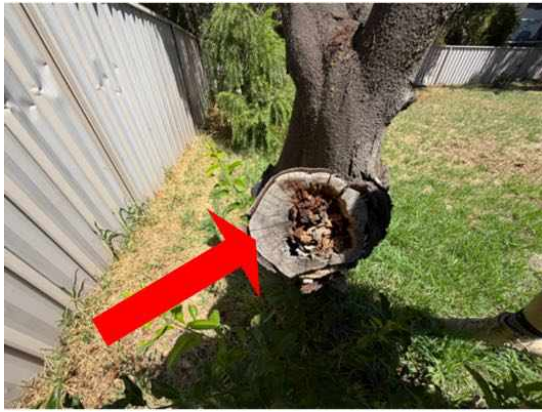
Finding 5.01

| Location: | Rear tree stump |
| Finding: | Evidence of termite damage |
| Information: | It appears that previous termite damage was present at, but not limited to, a rear tree stump. The client should engage a licensed pest controller to provide further advice regarding installation of a termite treatment. 6 monthly ongoing termite inspections, conducted by a qualified termite inspector, are also recommended |

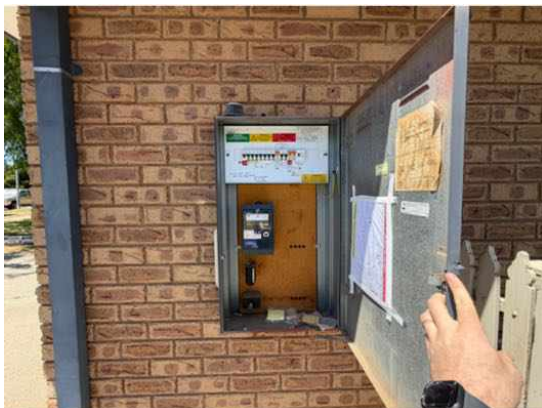
Finding 6.01

| Location: | Switchboard |
| Finding: | Termite Management System - no evidence of a chemical installation |
| Information: | The application of a termite barrier is recommended, as it appears no termite management system has been installed, with no evidence or durable notice to suggest works taking place. Generally, a durable notice is placed in the meter box to indicate current termite barriers. |

Such barriers are highly effective in preventing termite attack on the building and therefore should be installed.

Recommend seeking further advice from a licensed pest controller.

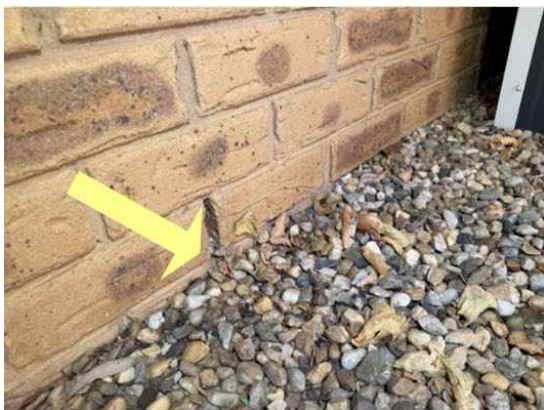
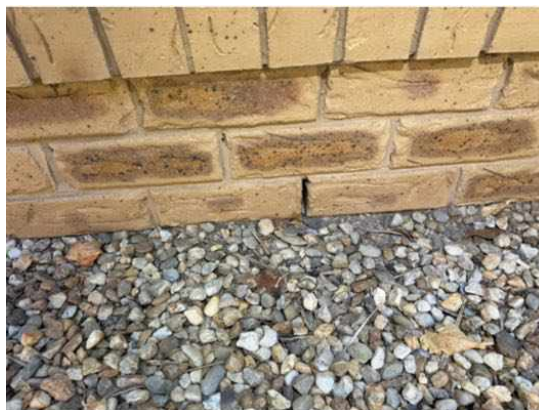
Finding 6.02

| Location: | Left Side House |
| Finding: | Weep holes - Covered |

Information: It appears that the base of some weep holes along the left side of the building, are covered by the external finished ground level. This can restrict moisture escape and can create conducive conditions to termite activity. This can also allow for termites to bypass any termite barriers & allows for concealed entry into the building.

Recommend engaging a licensed landscaping contractor in the short term to lower external ground levels where feasible, and restore adequate weep hole drainage and inspection zones.

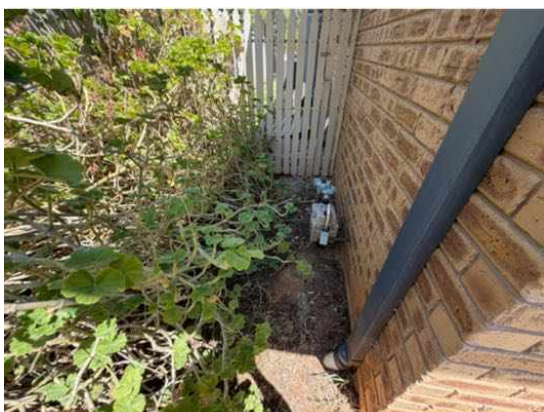
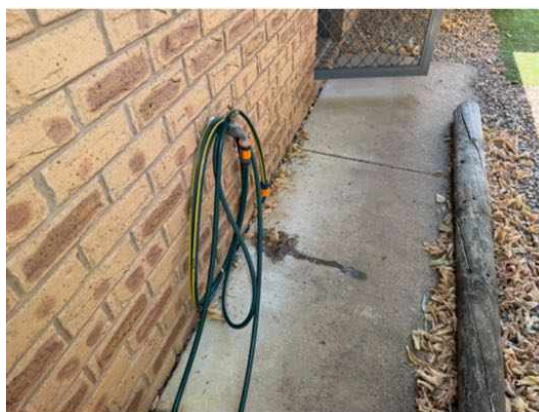
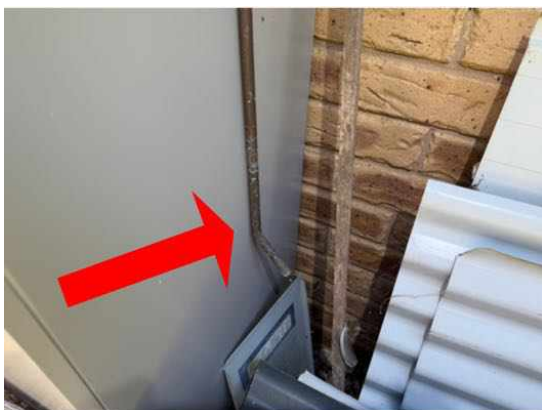
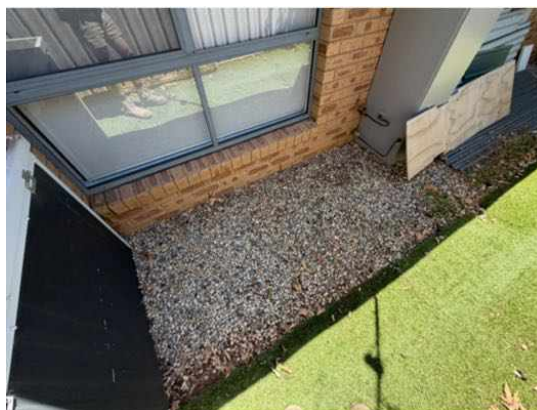
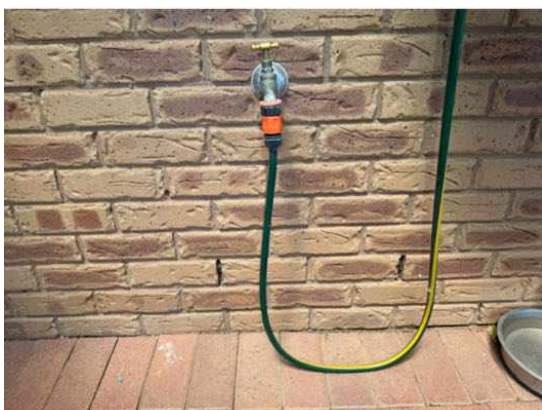
Finding 6.03

Building: Main Building
Location: All external areas
Finding: Potential Water pooling - against property
Information: Potential areas of water pooling around the perimeter of the property were identified.

Where insufficient drainage of taps, hot water system & aircon overflows, and garden beds against the house are present, water pooling is likely to occur, and can create areas conducive to timber pests.

Recommend consulting with a licensed plumber and/or landscaping contractor to provide further advice.

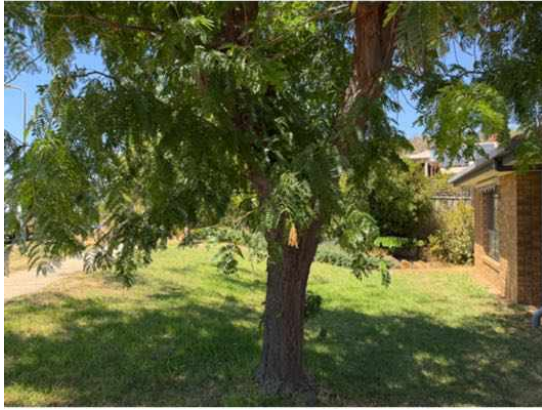
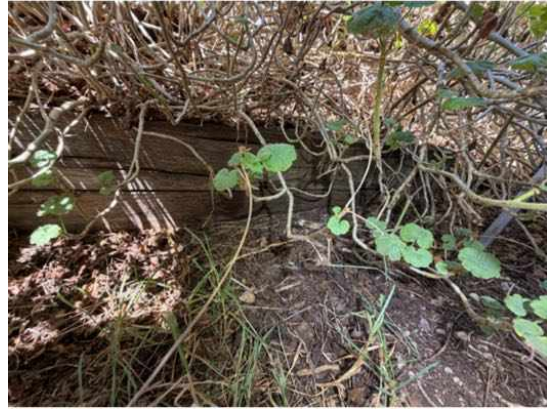
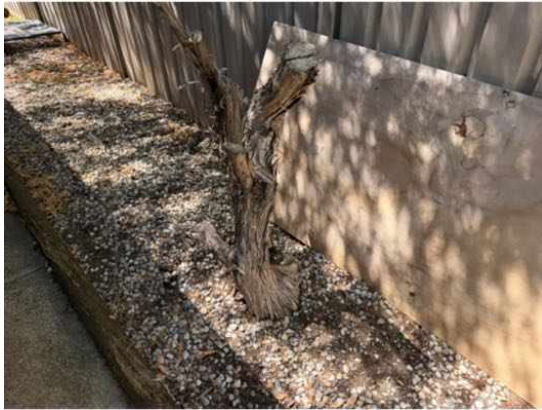
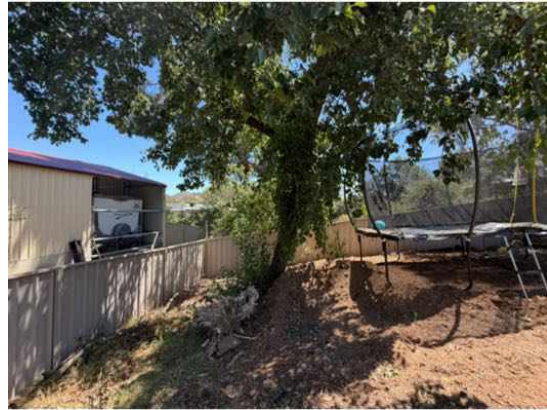
Finding 6.04

| Location: | All External Areas |
| Finding: | Timber in direct ground contact & trees - conducive to termites |
| Information: | Where timber materials are in direct contact with the ground and consequently moisture, they become conducive to termite activity. The tree stumps, landscaping Timbers, and trees surrounding the building create an environment conducive to termite infestation. |

Where feasible, any timbers in direct contact with the ground should be removed and any trees in close proximity to the building should be removed or test drilled (inspected) at least annually to reduce the risk of termite infestation & detect any early signs of termite activity.

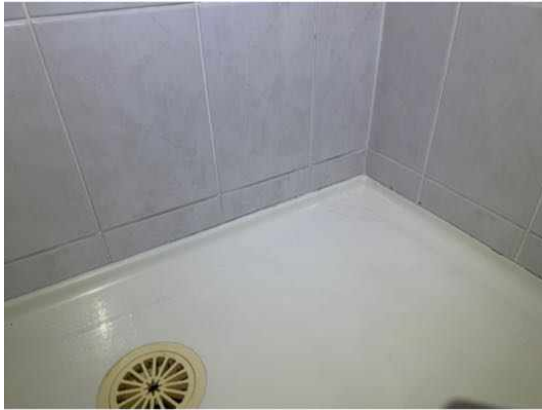
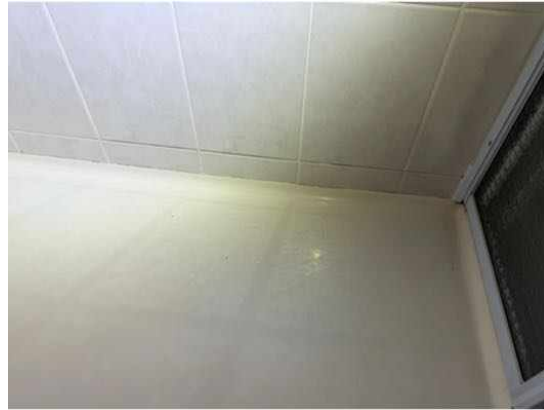
Building: Main Building
 Location: Tiled Areas
 Finding: Sealant and grouting - Monitor & General Maintenance
 Information: It appears that the sealant and grouting in the tiled areas are slightly weathered, a common defect in houses of a similar age.

It is noted for the clients information that sealant and grouting in areas that come into regular contact with water should be maintained.

Should the sealant deteriorate further, a tiling contractor should be engaged to provide maintenance works where necessary to ensure all wet areas are sufficiently sealed.

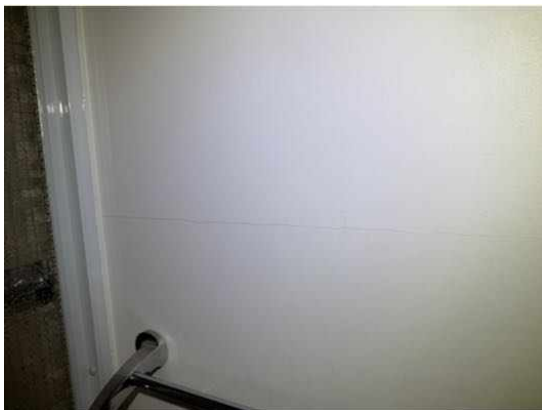
| Location: | Internal Areas |
| Finding: | Plaster - Minor Cracking |
| Information: | There appears to be cracking in some areas of the wall linings. Cracking of this type is common in buildings of a similar age. It is advised that the client monitor these areas. Should cracking widen, lengthen, or become more numerous, the client should consult with their building inspector, for further evaluation. |

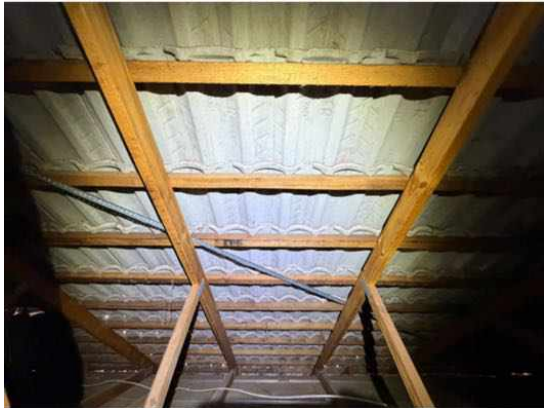
| Location: | Roof Void |
| Finding: | Sarking - Not Present |
| Information: | It is noted for your information that sarking has not been installed on the roof, a common finding in buildings of a similar age. Sarking is a laminated aluminium foil applied to the interior of the roof covering, assists in insulating the property and acting as a vapour-barrier to the roof void. |

The client can consult with a licensed roofing contractor at their discretion, to provide further advice.

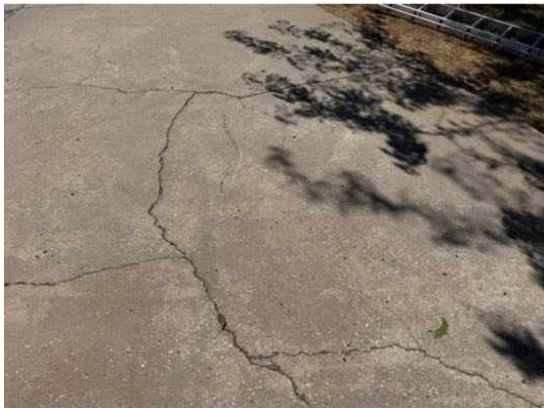
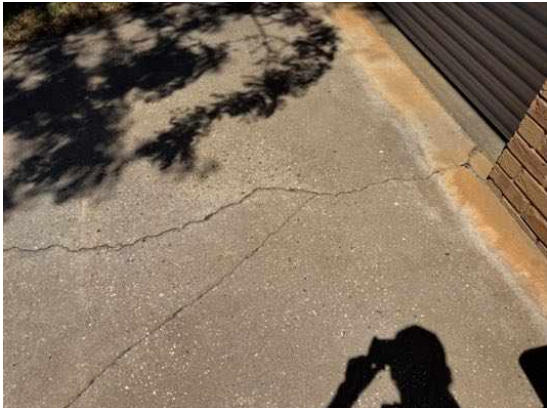
Building: Main Building
Location: Driveway
Finding: Cracking - Pavement
Information: It was noted there is cracking in areas of the driveway. Cracks in the pavement are a common occurrence in houses of a similar age. Recommend that the client monitor the cracking. A licensed concreter can be engaged at clients discretion, should cracks widen, lengthen, or become more numerous.
