Building and Timber Pest Inspection Report

Inspection Date: Tue, 10 Mar 2026

Property Address: 16 Greygums Road, Cranebrook NSW 2749

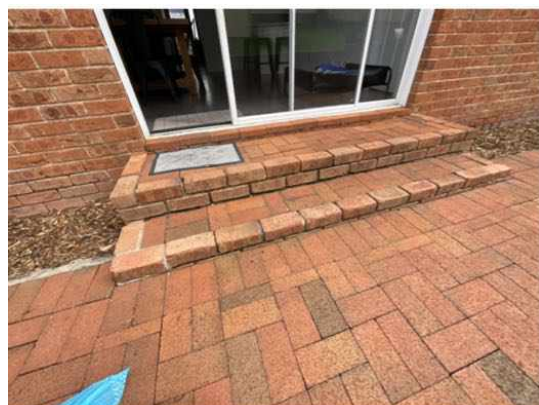
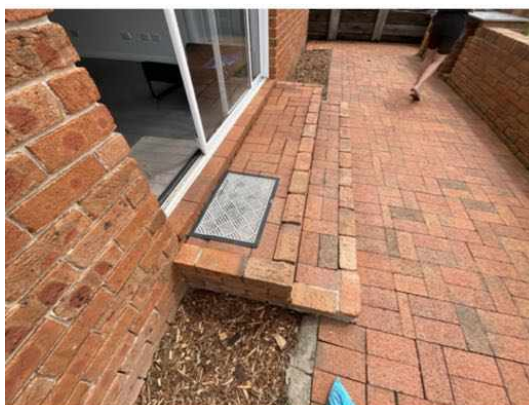
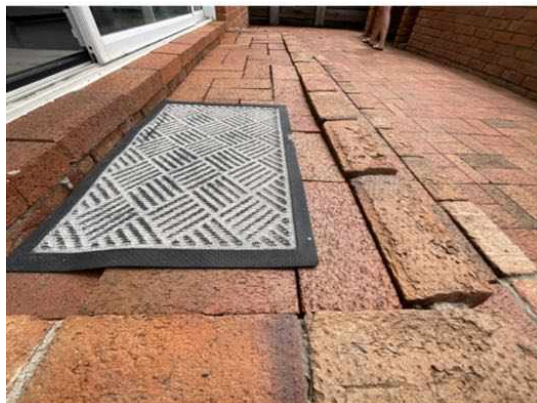
Building: Main Building
Location: Exterior walls - rear
Finding: Safety Hazard – Uneven Rear External Stairs
Information:

At the time of inspection, the rear external stairs were observed to have uneven and inconsistent riser heights, along with irregular brick treads. The variations in tread level and riser height create an uneven walking surface when using the stairs.

Stairs constructed with inconsistent riser heights and uneven treads can present a potential trip hazard to occupants and visitors. Good building practice and relevant construction guidelines generally require stair risers and treads to be consistent in height and depth to provide safe and predictable footing. Irregular stair construction may increase the likelihood of trips, slips, or falls when the stairs are in use.

Although the stairs may have been constructed prior to current standards and retrospective upgrading may not always be practical or cost-effective, it is advisable that the uneven stairs be assessed for possible rectification. Consultation with a suitably qualified builder or bricklayer is recommended to determine appropriate remedial options, which may include re-levelling or reconstruction of the affected stair sections to improve safety. Rectification should be considered in the interests of reducing the potential trip hazard.

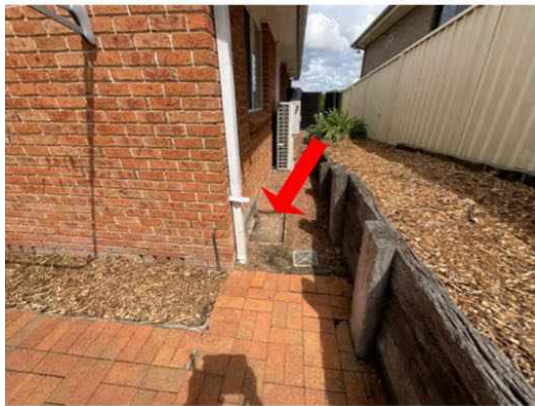
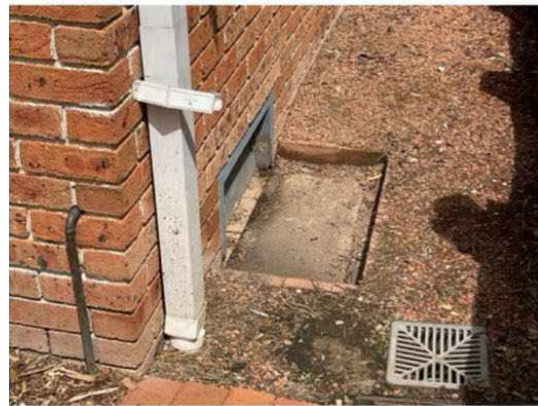
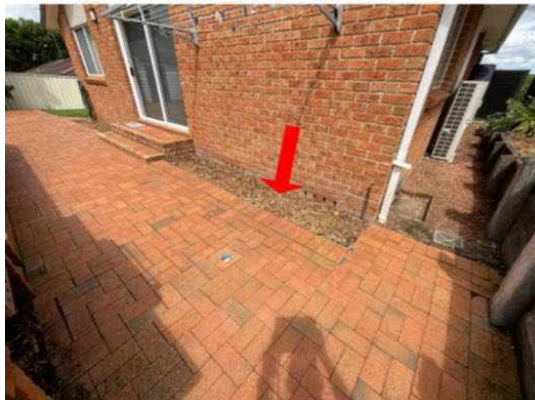
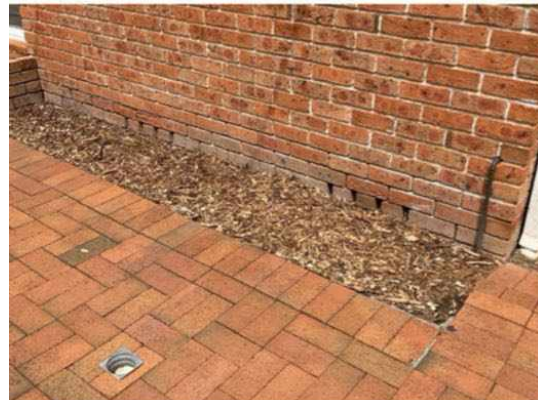
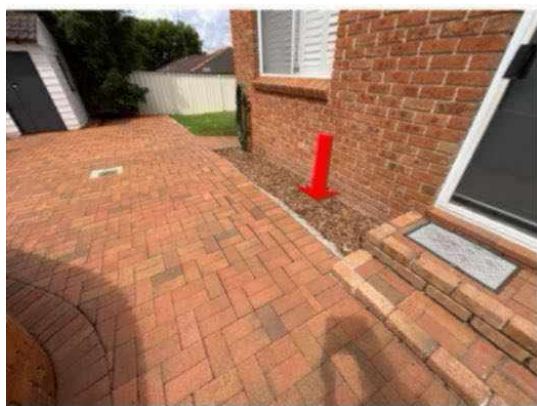
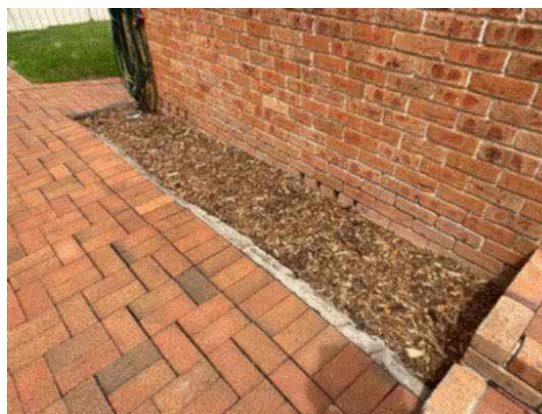
Finding 2.01

Building:	Main Building
Location:	Exterior - Left side & rear
Finding:	Site/Yard drainage - Inadequate.
Information:	Defect / Observation – Inadequate Site Drainage

At the time of inspection, site drainage in this area was found to be inadequate, old garden beds and lowered ground level at the subfloor entrance were observed directly against the perimeter of the building. allowing water to pool against the base of the external walls and further entering under the house. This condition can result in water pooling or retention during rainfall, which may lead to moisture ingress beneath the structure.

Poor surface drainage can lead to moisture ingress and deterioration of materials at the base of walls or foundation movement. Prolonged exposure to standing water may cause rising damp, efflorescence, or corrosion of brickwork and mortar. These conditions can lead to secondary structural or moisture-related defects if not rectified.

To prevent moisture-related damage, ground levels around the dwelling should:

- Provide a minimum 50 mm clearance between finished ground level and the bottom of cladding or wall weep holes (minimum 75 mm where paved and 100 mm where unpaved).
- Be graded to achieve a minimum fall of 1:20 (50 mm over 1 m) away from the building for at least 1 m.

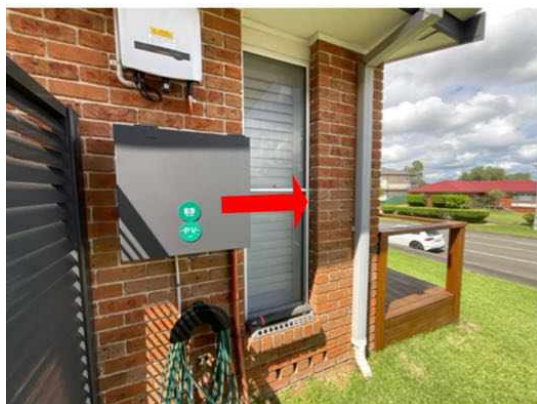
Finding 3.01

Excessive gaps were observed between the window or door frames and the adjacent brickwork. Gaps exceeding 3mm in external wall surfaces are considered a defect in accordance with relevant industry standards and tolerances.

- Gaps in these areas may allow moisture ingress, leading to potential internal water damage
- Can result in air leakage, reducing energy efficiency
- May permit insect or pest entry
- If left unaddressed, can contribute to progressive deterioration of building elements and finishes

Rectification may be undertaken by a general tradesperson to avoid the development of secondary defects.

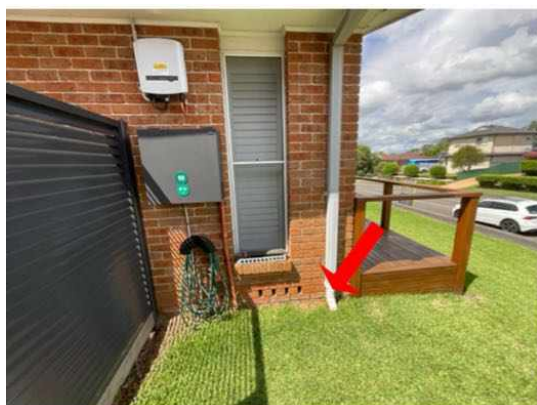
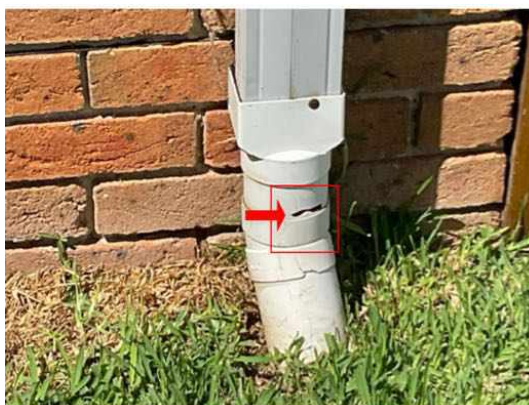
Finding 3.02

Building: Main Building
 Location: Exterior - left side
 Finding: Damaged Downpipe connector
 Information: Observation:

- The roof plumbing (downpipe) in this location has been damaged and is not fully sealed.

- Poorly sealed or disconnected downpipes can result in:
- Water pooling around the base of the building
- Excessively damp conditions at the foundation or subfloor level
- Increased risk of foundation movement

- Rectification is strongly advised.
- A licensed plumber should be appointed to:
 - Inspect the area thoroughly
 - Assess the condition of the stormwater system
 - Repair, replace or properly connect all downpipes to ensure compliant and effective drainage

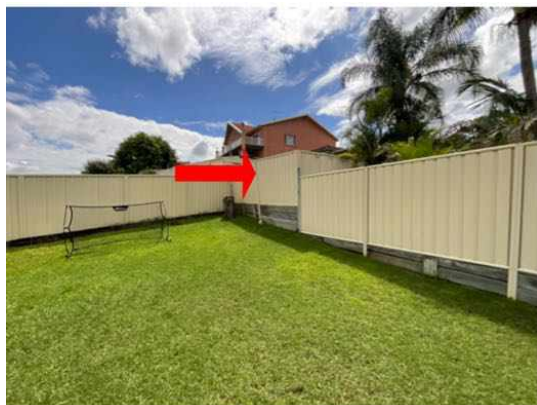
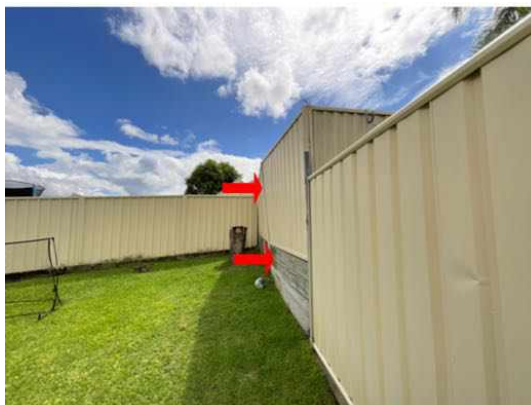
Finding 3.03

Building: Yard
 Location: Fencing - Rear
 Finding: Leaning Boundary Fence & Retaining wall .
 Information: Observation:

At the time of inspection, sections of the boundary fencing and retaining wall were observed to be leaning. This condition is typically caused by natural deterioration due to age, prolonged exposure to weather, or potentially inadequate original installation or maintenance.

While currently considered a minor defect, continued movement or further degradation may result in instability, reduced privacy, or boundary disputes.

Rectification is at the discretion of the client. A licensed fencing contractor or qualified handyman should be engaged to assess the extent of deterioration and carry out repairs or replacement as required.

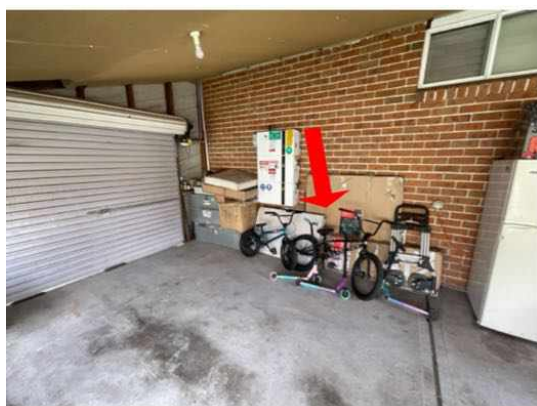
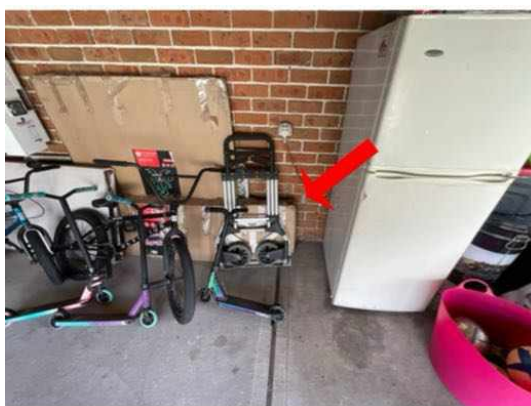
Finding 3.04

Building:	Main Building
Location:	Exterior walls - right side
Finding:	Subfloor Ventilation - Blocked
Information:	It was noted during the inspection that some of the subfloor vents to the brickwork were blocked. Vent holes are designed to allow ventilation of the subfloor and should therefore be kept clean and free of debris or blockages.

Blocked subfloor vents are likely to result in the presence of moisture within the subfloor, creating potential for moisture problems. Additionally build-up of moisture is likely to further attract termite activity to these areas.

Subfloor ventilation can be improved in most cases by addressing the causes such as exposing subfloor vents, installing additional new vents or installing mechanical (forced airflow) ventilation.

A registered builder or ventilation specialist may be appointed to perform these works.

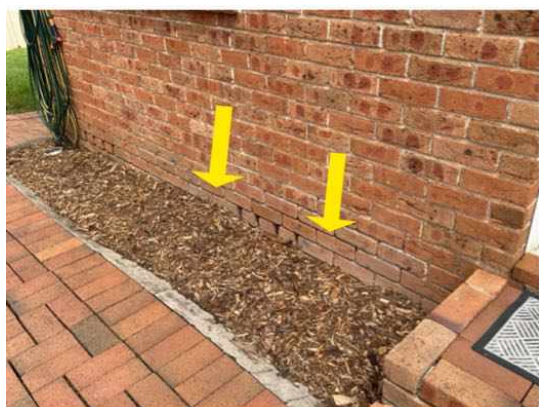
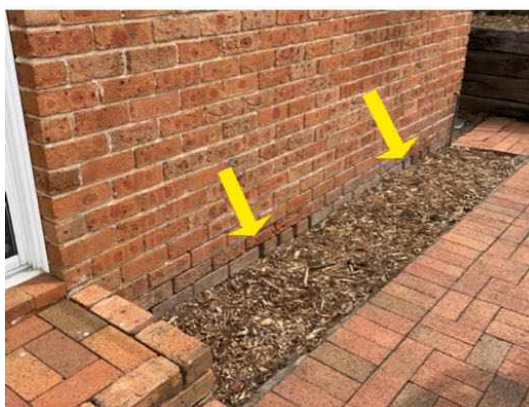
Finding 3.05

At the time of inspection, sections of the brickwork were observed to exhibit surface deterioration consistent with salt attack, commonly referred to as fretting or spalling. This condition is characterised by the gradual breakdown and powdering of the brick face. The surrounding soil conditions may contain elevated levels of soluble salts which can contribute to this type of deterioration.

Salt attack occurs when moisture containing dissolved salts migrates through masonry materials via capillary action. As the moisture evaporates from the brickwork surface, the salts crystallise within the pores of the brick. Over time this crystallisation process can cause the face of the brickwork to deteriorate, leading to fretting, spalling, and progressive loss of the brick surface. If the process continues unchecked, it may gradually affect the durability and appearance of the masonry.

The affected brickwork should be monitored and maintained as required. Where deterioration becomes advanced, repair or replacement of damaged bricks may be necessary. The client may wish to seek advice from a suitably qualified bricklayer or masonry specialist regarding appropriate remedial works and strategies to reduce ongoing moisture exposure to the affected areas. Improvements to site drainage and moisture management around the structure may also assist in limiting further salt

migration into the masonry.

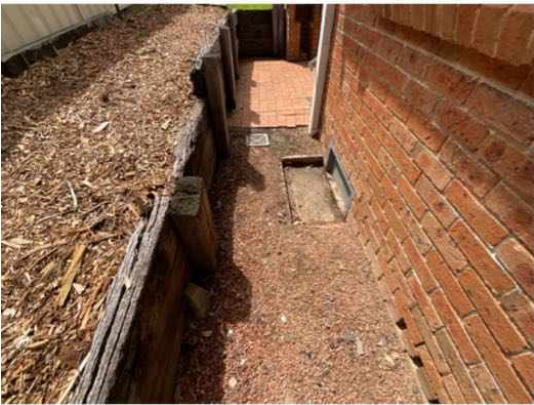
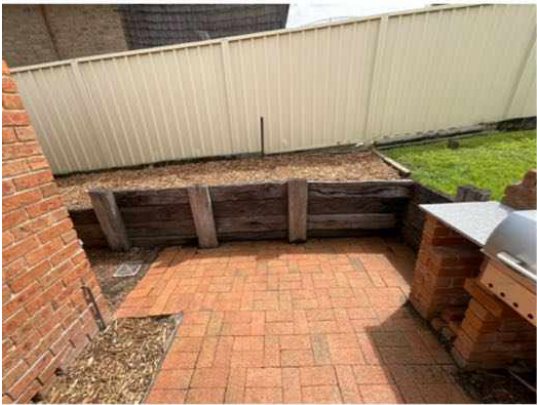
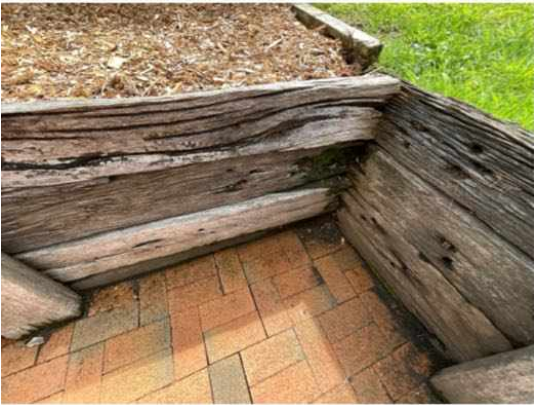
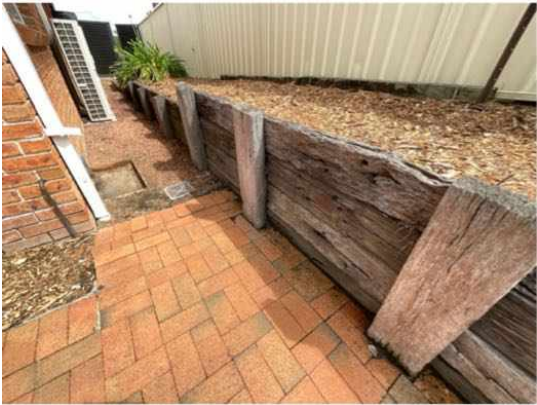
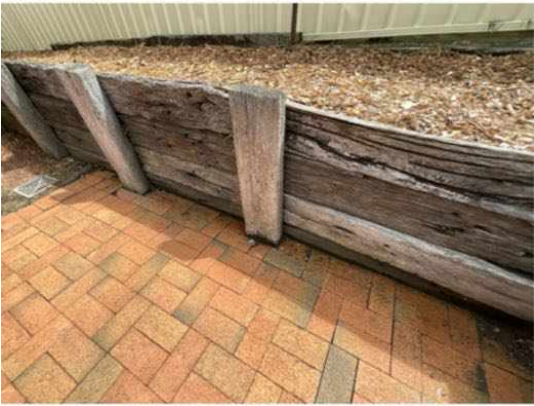
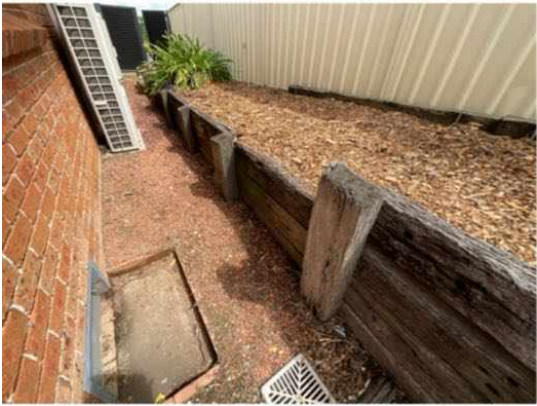
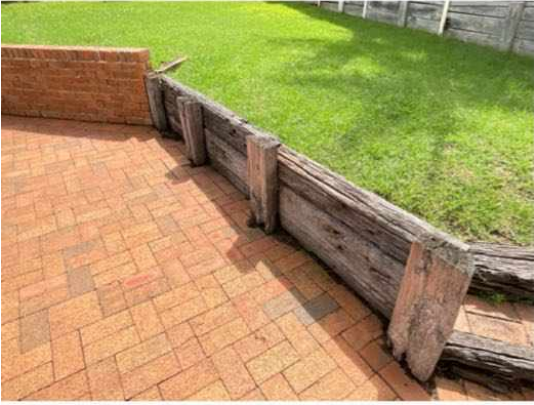
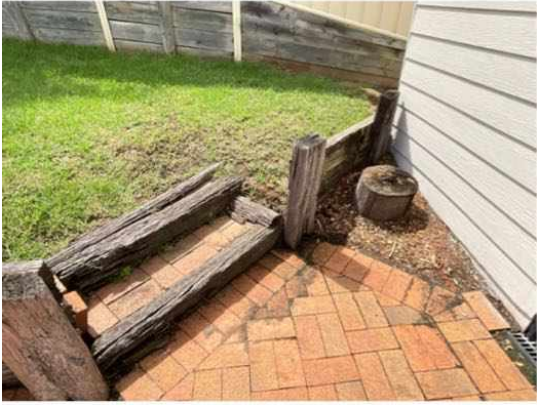
Finding 3.06

Building: Yard
 Location: Exterior - rear
 Finding: Retaining walls - Average condition
 Information:

At the time of inspection, the retaining walls on the property were observed to be constructed from recycled timber sleepers. The retaining structures appeared to be in average condition overall; however, signs of deterioration and timber decay were noted in sections of the wall. The sleepers do not appear to be treated timber and have been exposed to soil contact and external weather conditions over an extended period.

Timber retaining walls constructed from untreated or recycled sleepers are susceptible to gradual deterioration due to prolonged exposure to moisture, soil contact, and varying weather conditions. Over time this commonly results in wood decay or rot, which can reduce the structural integrity of the retaining wall. As deterioration progresses, the retaining wall may lose its ability to adequately retain soil and may eventually fail. In addition, decaying timber and soil contact conditions can create an environment conducive to termite activity.

Although the retaining walls were considered serviceable at the time of inspection, timber decay was evident and further deterioration can be expected with age. Ongoing maintenance, repair, or replacement of deteriorated sections may be required to maintain the structural performance of the retaining system.

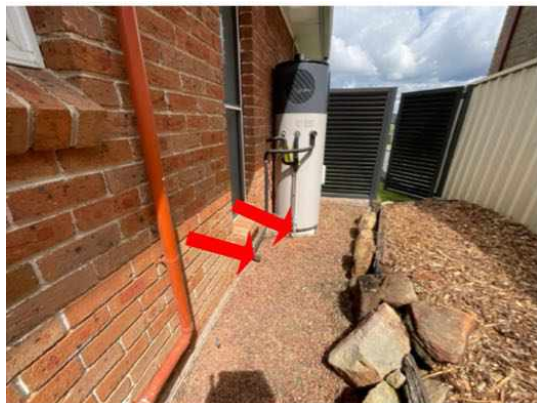
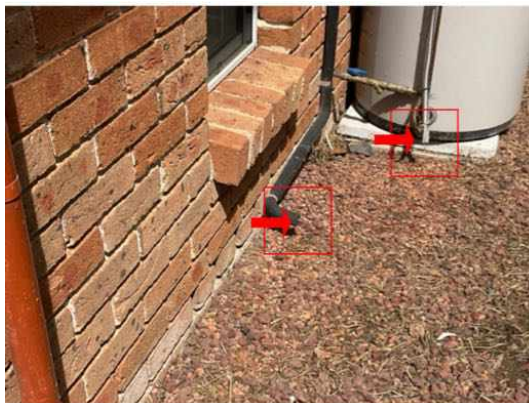
Building:	Main Building
Location:	All External Areas
Finding:	Overflow Management – Risk of Termite Activity..
Information:	Observation: Water Pooling from HWS and Air Conditioning Overflows

Water discharge from the Hot Water System (HWS) pressure relief valve and air conditioning unit overflows was observed discharging close to the base of the structure, contributing to water pooling around the building perimeter.

Persistent moisture near the foundation or subfloor area significantly increases the likelihood of termite activity. Termites are highly attracted to damp environments, and stagnant water near structural elements provides ideal conditions for foraging and infestation.

It is highly recommended that all overflows from the HWS and air conditioning units be redirected away from the building, preferably via fixed drainage or extension piping, to prevent water accumulation near the structure.

These minor corrective works should be undertaken promptly to minimise the risk of both termite ingress and potential structural damage due to ongoing moisture exposure.

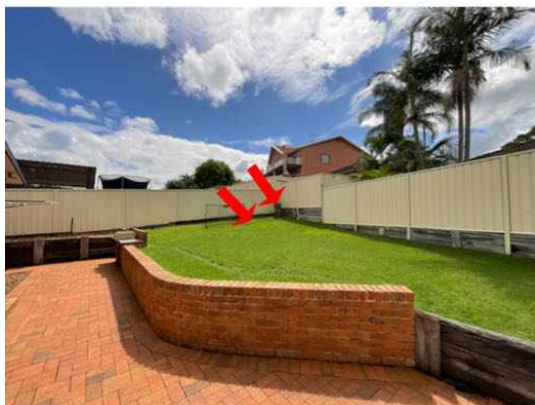
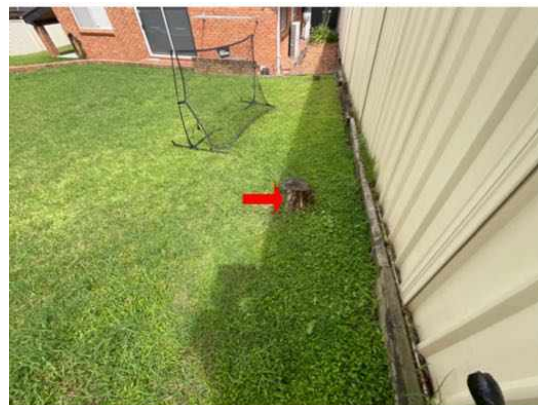
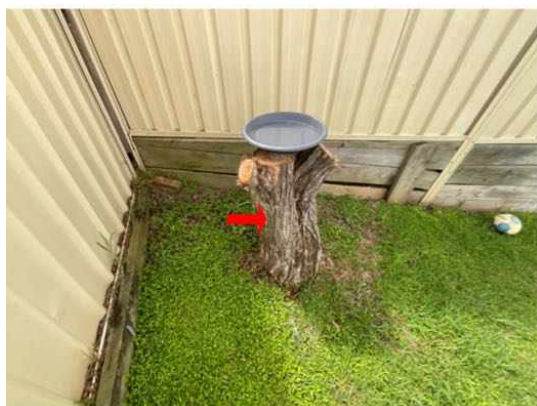
Finding 6.03

Building: Main Building
 Location: Yard
 Finding: Tree Stumps and Termite Risk..
 Information:

- Dead and decaying trees present ideal conditions for termite infestation, due to:
- Readily available decaying wood (food source)
- Moisture retention within the decayed timber
- Shelter and undisturbed environments
- Trees with internal decay can maintain a humid microclimate, ideal for supporting termite colonies.
- Termites can nest deep within dead trees, making detection difficult without invasive methods.
- Stumps and dead trees can act as primary nesting sites, allowing termites to spread to nearby structures, including the house.

- Prompt removal of any dead or decaying trees or stumps is strongly advised to:
- Reduce conducive conditions
- Minimise the risk of termite infestation and structural spread
- If tree removal is not feasible, the following is recommended:
- Test-drilling of any trees or stumps with a diameter exceeding 100mm
- Insert a flexible borescope into the drill hole to inspect for internal signs of:
- Termite nests
- Active termite workings
- Structural decay

- Engage a licensed pest controller to:
- Conduct the drilling and inspection
- Provide professional recommendations based on findings
- Determine the need for chemical treatment or additional management strategies

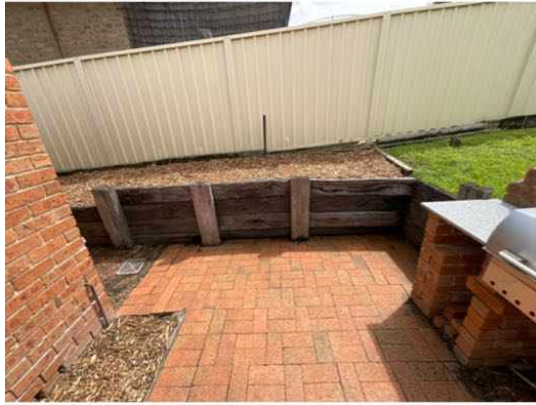
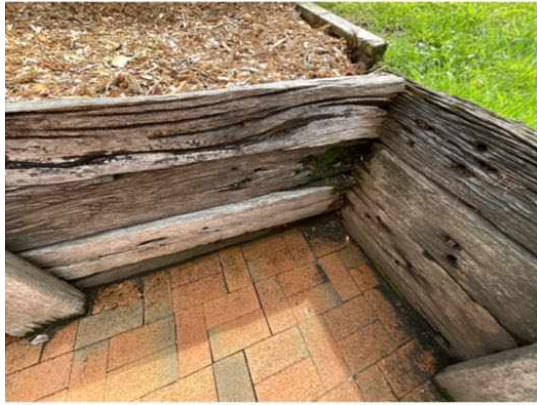
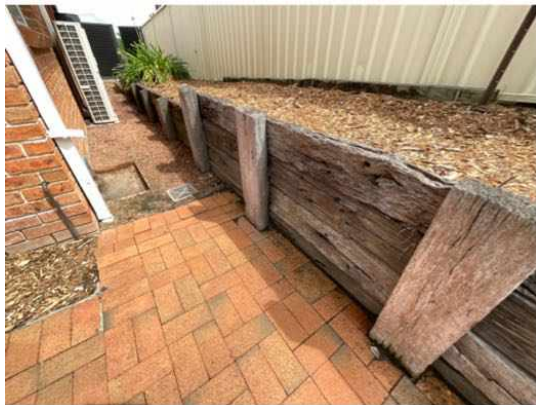
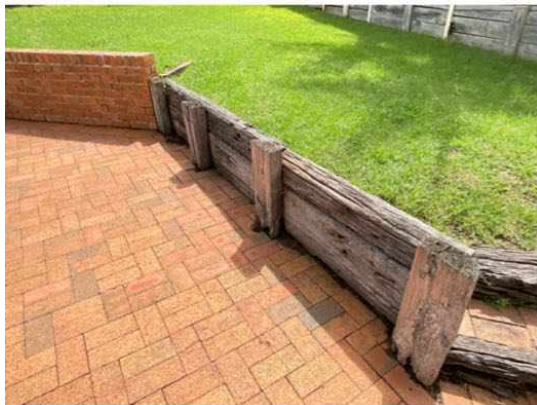
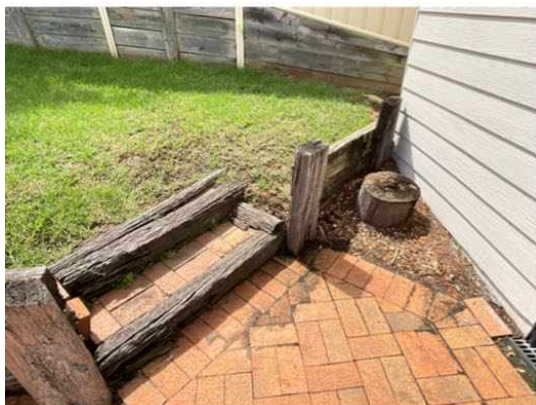
Finding 7.01

Building:	Main Building
Location:	Yard
Finding:	Fungal Decay (Wood Rot) - Identified in landscaping
Information:	Observation: Fungal Decay (Wood Rot) in Landscaping Timbers

During the inspection, landscaping timbers on the property were observed to be deteriorating, with visible signs of fungal decay (wood rot). This deterioration appears to be due to general ageing and long-term exposure to weather conditions.

- Fungal decay occurs when timber or cellulose-based materials are subjected to prolonged moisture exposure, either from direct ground contact, pooling water, or retained moisture from nearby materials.
- Wood rot is a conducive condition for subterranean termite activity, as termites are attracted to soft, damp, and decaying wood that is easier to penetrate and nest in.
- Landscaping timbers in direct contact with soil and moisture are particularly vulnerable to both decay and termite attack, whether they are in use or stored unused.

- All affected or deteriorated landscaping timbers should be removed and replaced with non-susceptible materials (e.g. treated hardwood, concrete edging, or composite alternatives).

- A licensed landscaping contractor should be appointed to carry out these works and assess other timbers in the vicinity for potential replacement.
- Future landscaping works should be designed to minimise timber-soil contact and improve drainage around garden structures to reduce the likelihood of moisture accumulation and pest attraction.

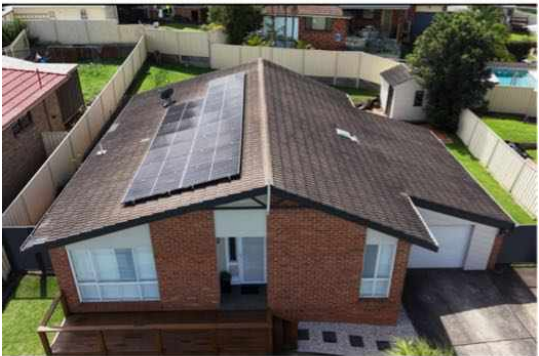
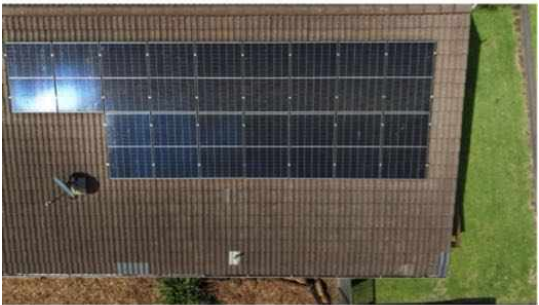
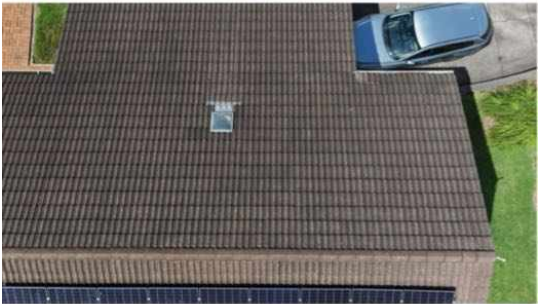
The tiled roof covering appeared to be in generally sound condition at the time of inspection, with no evidence of active leakage observed in accessible areas. Ongoing maintenance, including periodic cleaning of valleys and gutters and maintenance of ridge tile pointing, is recommended to help extend the serviceable life of the roof covering.

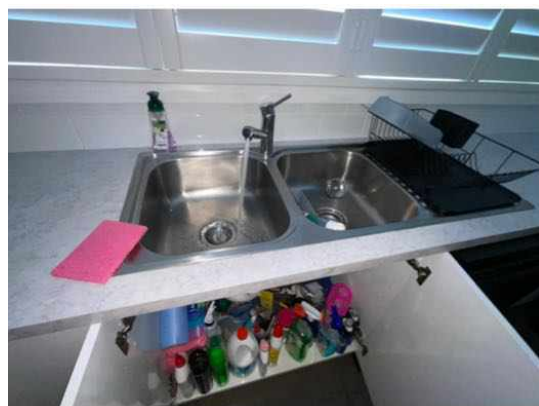
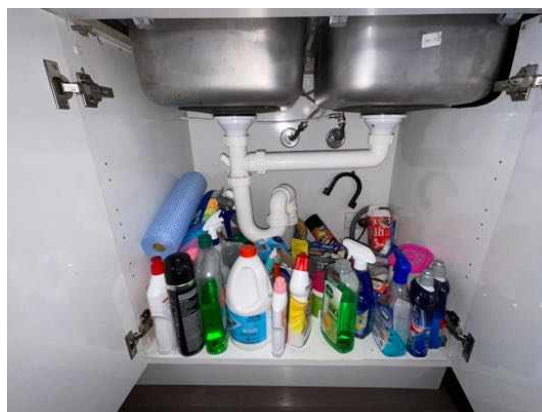
Building: Main Building
 Location: Kitchen
 Finding: Kitchen Sink – Overall Condition & Recommendations.
 Information: Observations:

- Further monitoring and testing are recommended once the tap(s) are in constant use, to identify any drainage issues or signs of slow leaks not evident during the limited inspection.
- For long-term property care, it is advised that sealant and grouting in water-exposed areas be regularly inspected and maintained.
- It is recommended that the stored items beneath the sink be removed to allow for a full re-inspection of the plumbing and cabinetry, ensuring no concealed defects are present.

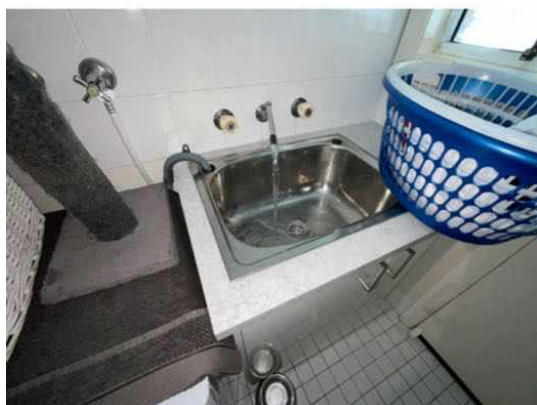
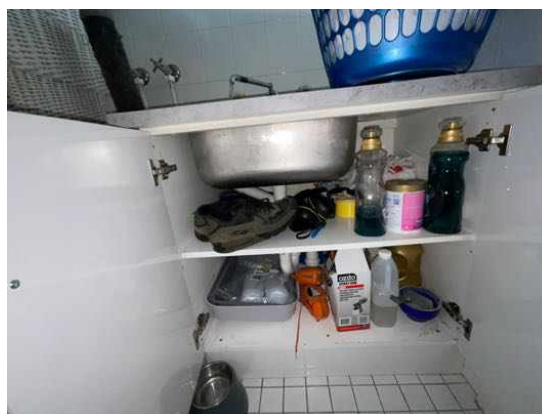
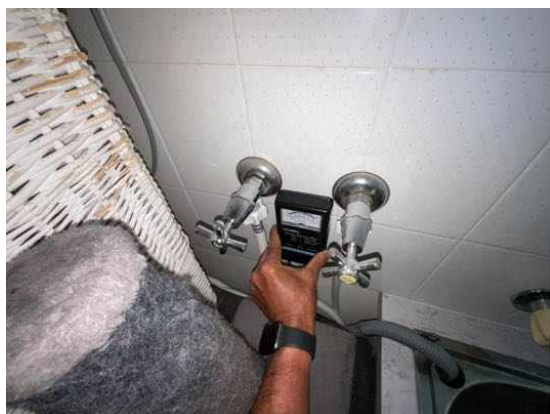
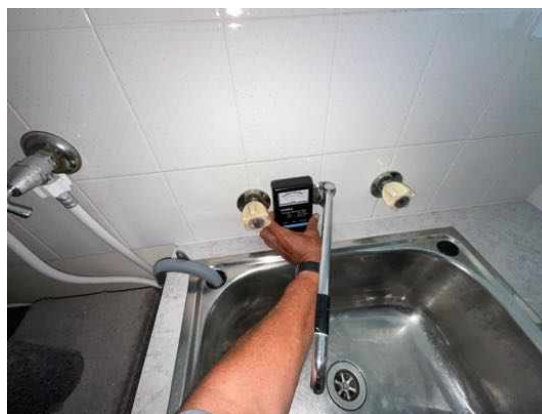
Building: Main Building
 Location: Laundry
 Finding: Laundry - Taps/Plumbing/Drainage.
 Information: Observation: Laundry Tub – Taps, Plumbing, and Cabinetry

- Further monitoring or testing is recommended once the taps are placed into regular use, to ensure no leaks develop over time and that the drainage system continues to perform adequately.
- Flexible and mould-resistant sealant should be applied to junctions between the basin and the wall to prevent water ingress that may lead to damage.
- Regular maintenance and prompt replacement of missing or deteriorated sealant is highly recommended, as this is a common wear-and-tear issue.
- Sealant and grouting in wet areas should be maintained as part of the long-term care and upkeep of the property.
- Where required, a sealant specialist or qualified tiling contractor should be appointed to carry out remedial sealing works.

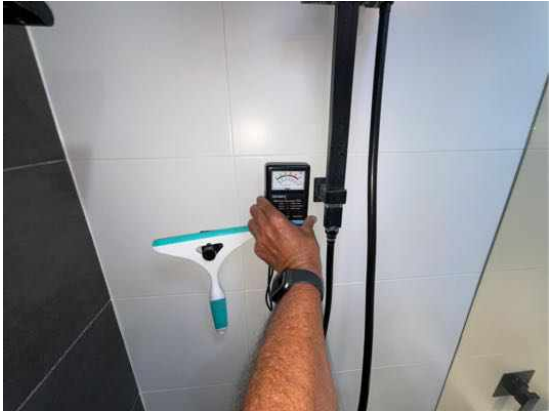
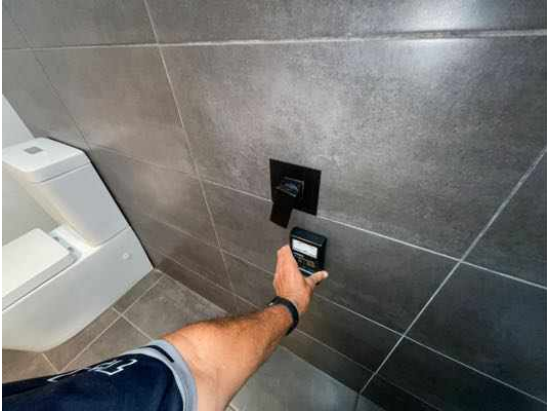
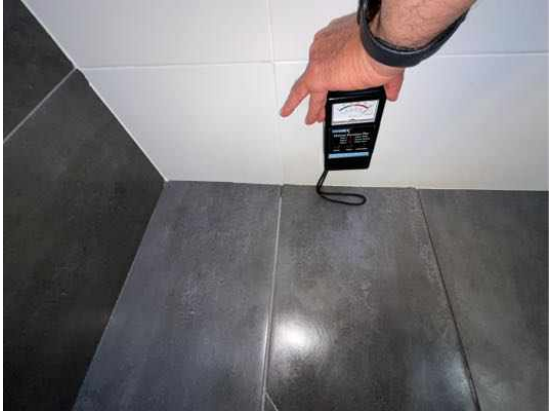
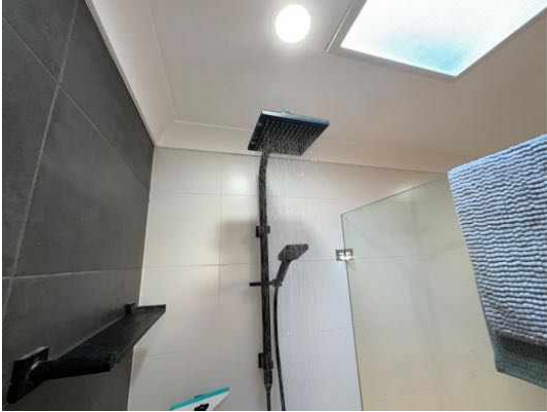
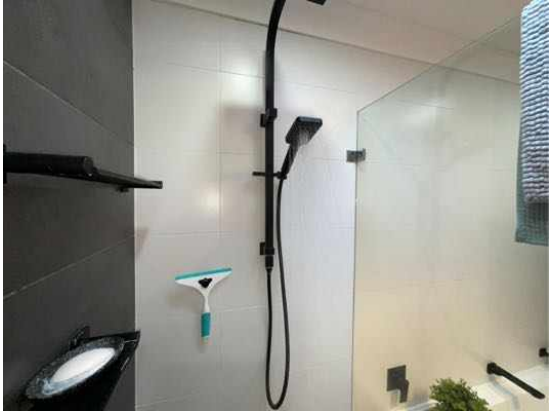
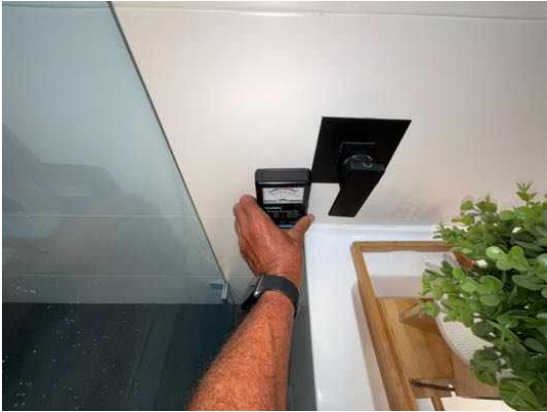
Building: Main Building
 Location: Bathroom
 Finding: Wet Areas - Bathroom(s) - Overall Condition & Recommendations.
 Information: Overall Condition & Recommendations

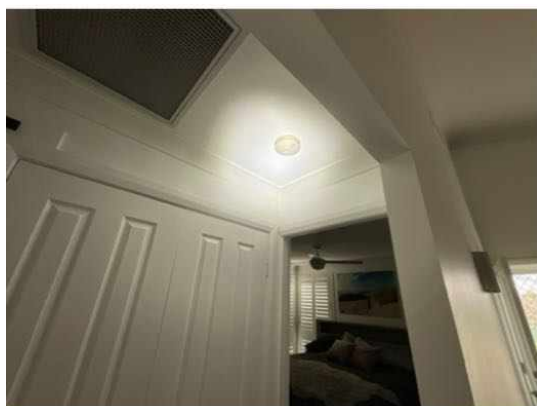
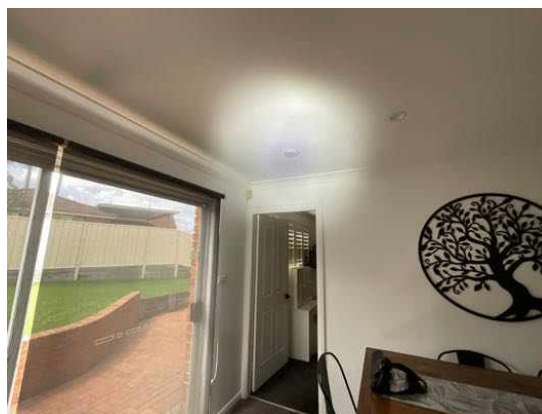
Building: Main Building
 Location: All Areas
 Finding: Smoke Detectors / Alarms.
 Information: Reporting on the presence, type, location, or compliance of smoke detectors or alarms, including hard-wired smoke detection systems and their legislative requirements, is outside the scope of this inspection report.

- All smoke detectors be tested monthly by the homeowner.
- All systems comply with the requirements of AS 3786 and any applicable state-based legislation.
