## Building Inspection Report

Inspection Date: Tue, 13 Jan 2026

Property Address: 12 Ferntree Ave, WARBURTON, VIC, 3799,  
Australia

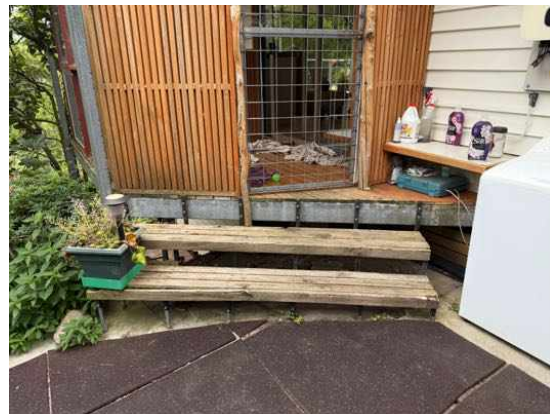
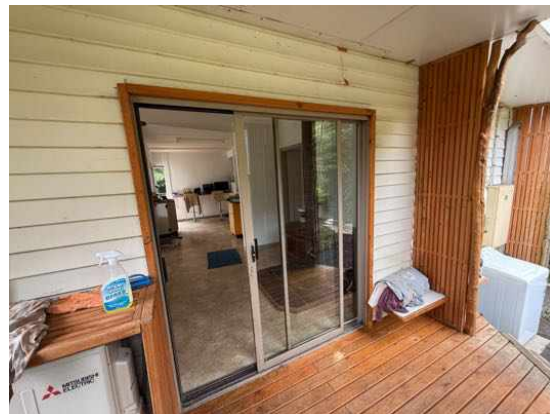
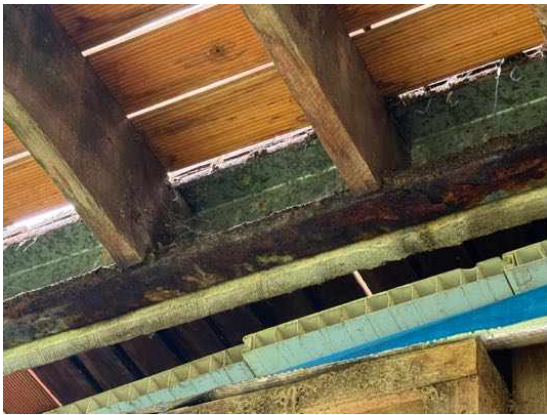
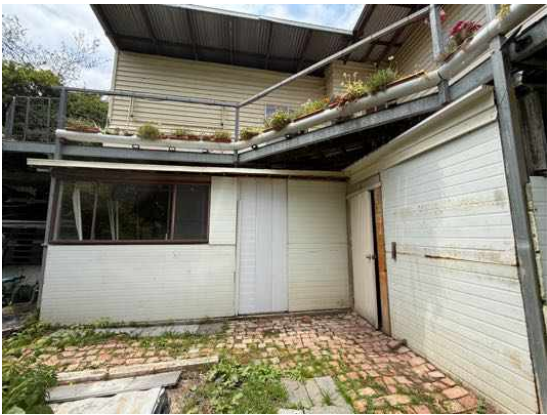
#### Defects 2.01

Building:	Building 1
Location:	Upper front deck and balustrade and roof over > All Areas
Finding:	Front deck - balustrading and roof
Information:	The front deck area balustrade and roof over showed signs of poor building practices and were highly suspected to be not built to meet the National construction code (NCC) and Australian Standards. This report does not cover non-compliance issues however it is the opinion of the inspector that the front balcony deck, balustrade and roof do not appear to have been built or inspected by the relevant authorities. These areas are deemed to be unsafe for occupants and young children and will require action and remedial work to rectify to ensure the front deck, balustrade and roof over meets the required compliance and building codes.

Poor trade practices are generally cause of these types of suspected structural defects and issues. Further inspection will be required by a structural engineer and licensed builder, they should be appointed to further inspect the structural integrity of the affected areas and to assess the safety of the associated structures. The engineer can also nominate a scope of works required for rectification and the licensed builder can appoint the relevant contractors to provide the necessary works to all of these areas deemed to be necessary.

Deck areas, balustrades and roof areas throughout the property: - This inspection of the front deck areas, balustrade and roof does not in any way indicate that these areas has or has not been built with council approval or to the Australian building standards at the time of this inspection. The deck, balustrade and roof structure over these areas, whilst appearing to be providing enough adequate structural support, did not appear to be in a stable condition, it is highly suspected that these areas will not hold the amount of persons the decks total area would hold.

The client is highly recommended to ensure these deck, balustrade and roof structures be inspected by Structural engineer to ensure that these areas complies and meets all council requirements, all contemporary building practices and the current Australian building Standards.

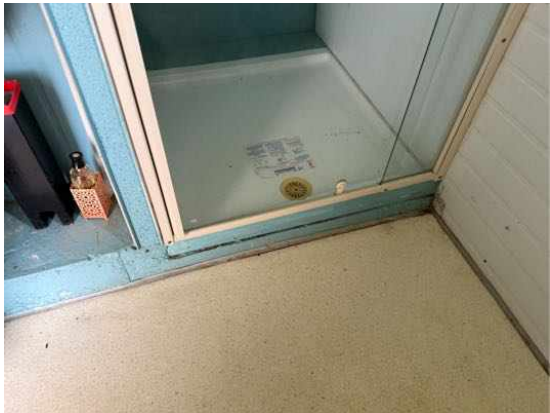
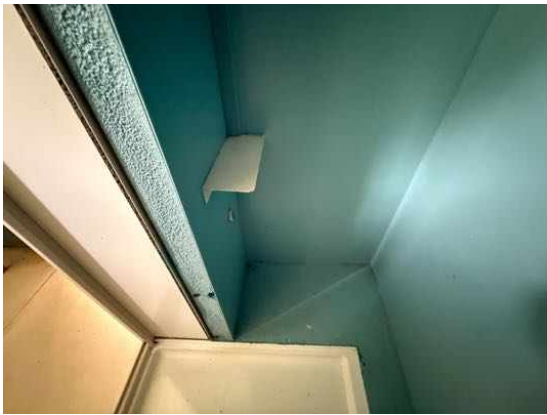
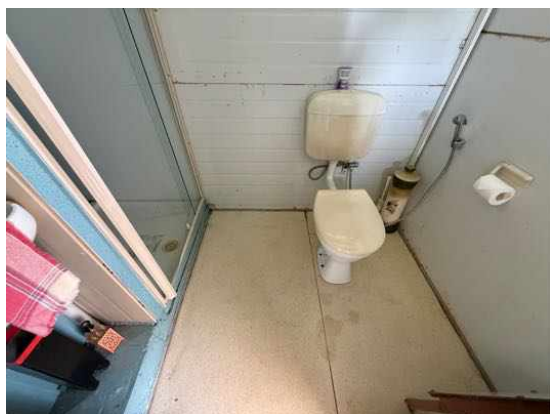
**Defects 2.02**

Building: Building 1  
Location: Lower storey bathroom > All Areas  
Finding: Lower bathroom was not adequately waterproof and does not meet Australian standards  
Information: The lower bathroom was observed to not be tiled or adequately sealed or waterproofed to meet current Australian standards and requirements. The lower bathroom areas require remedial work to prevent major structural damage and structural issues overtime. It is highly recommended that the client appoint a licensed builder to carry out remedial work to rectify to meet current building standards.

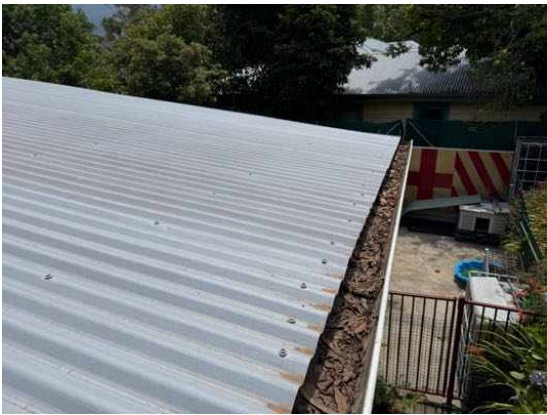
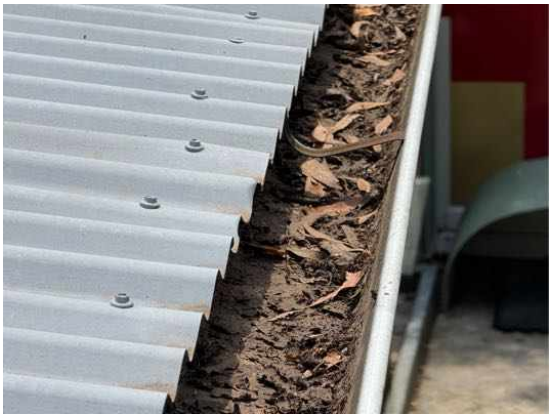
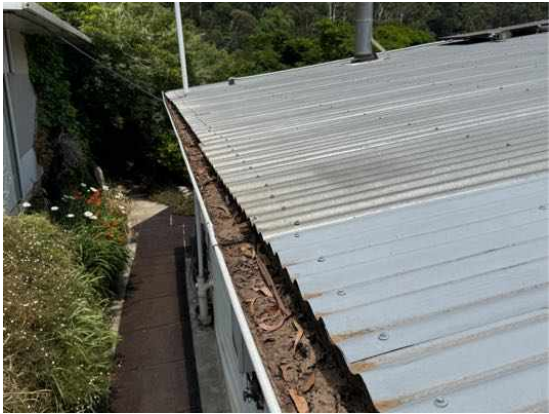
### Defects 3.01

Building:	Building 1
Location:	All Areas > All Areas
Finding:	Gutters
Information:	Upon inspection of the roof gutters were observed to have excessive leaf matter and debris. Roof plumbing structures, such as guttering and downpipes, should be free of all debris to prevent blockages. Blockages of the guttering and downpipes will lead to pooling and accumulated water overflows, which is likely to subsequently flood eaves and exterior walls.

Blocked gutters are likely to lead to high levels of moisture in the affected areas. Such moisture will not only cause rust and decay of the associated building materials, but can also provide conditions that are conducive to termite and timber pest activity. Blockages in gutters should therefore be removed immediately to ensure dry conditions are maintained. Consultation with a licensed roof plumber for further specific advice on remedial works that may be required. In the interim, it is highly advised that blocked gutters be removed by the homeowner or a relevant tradespersons in the near future.

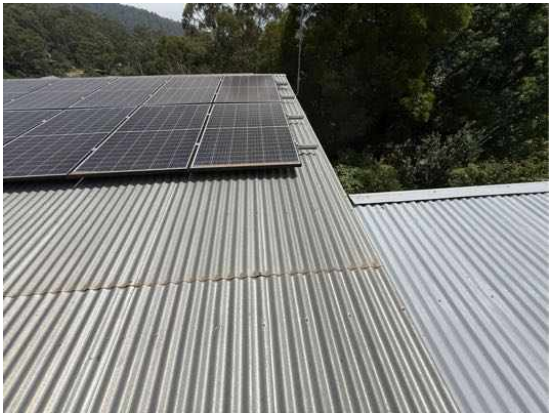
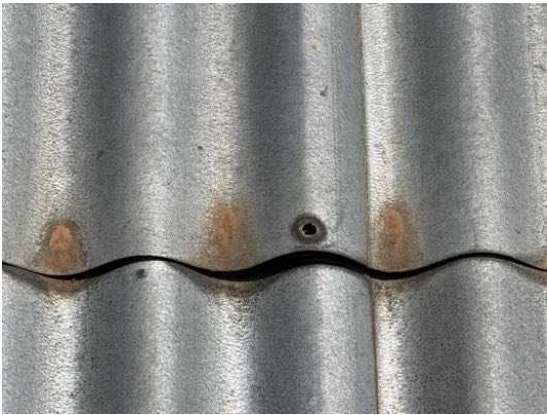
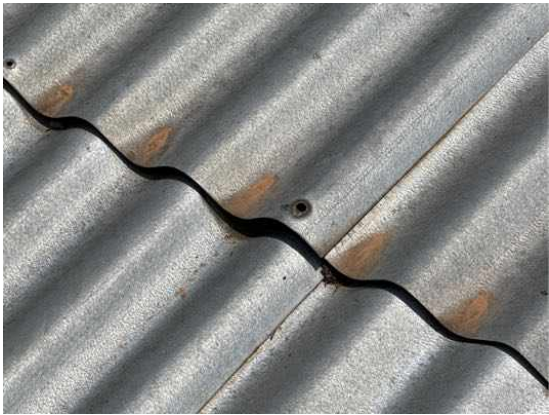
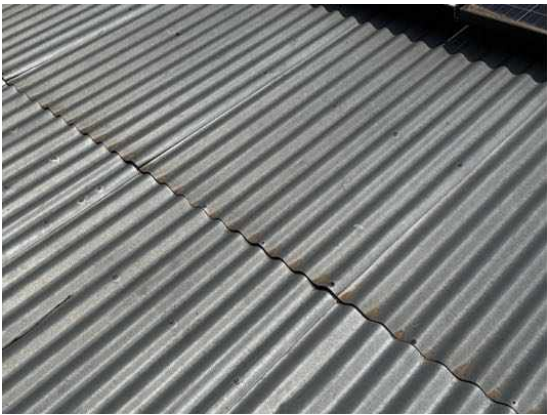
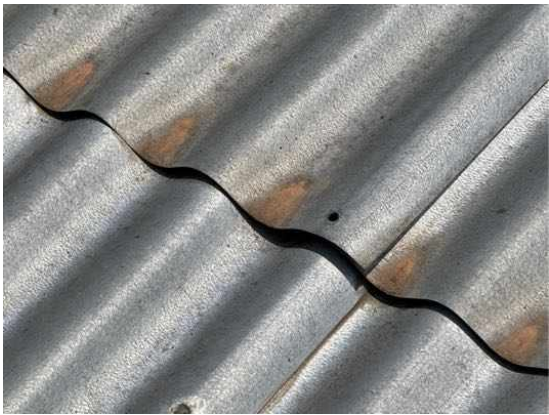
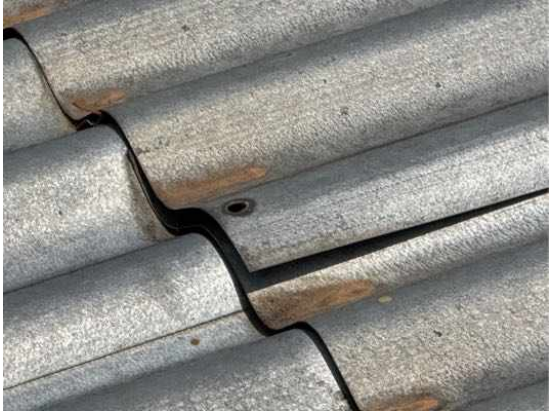
Defects 3.02

Building: Building 1  
Location: All Areas > All Areas  
Finding: Roof sheets - Not secure  
Information: Upon inspection of the exterior roofing it was found that the roof sheets have had previously been fixed, however these fixings have been dislodged and the roofing iron is no longer adequately secured to the adjoining roof structure. Loose roof sheets are susceptible to water penetration, exposing the surrounding associated area to internal roof leaks and water damage.

Adequate fixing of all loose roof sheets should be conducted as soon as possible to ensure no further damage is incurred in the future. The client should appoint a roof plumber or engage the appropriate tradesperson to perform necessary works deemed to be necessary to rectify these areas. This is required in the short term future.

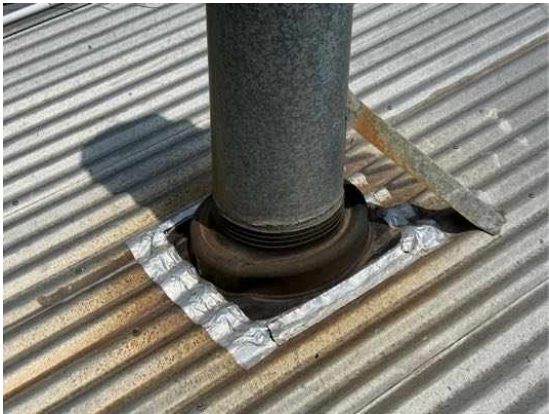
**Defects 3.03**

Building: Building 1  
 Location: All Areas > All Areas  
 Finding: Roof flashing - non-standard  
 Information: The roof flashing that has been installed fireplace chimney roof pipe is not the correct flashing that should be used and not considered to be adequate as a chimney flashing. This type of flashing is normally used as a bottom timber window flashing, it is not suitable as a roof flashing. However at the moment the roof flashing does appear to be in an acceptable condition, (fulfilling its purpose for the moment) in ensuring the roof covering is weather-tight. Client should appoint a roof plumber to remove and replace this flashing as soon as possible, in the short term future.

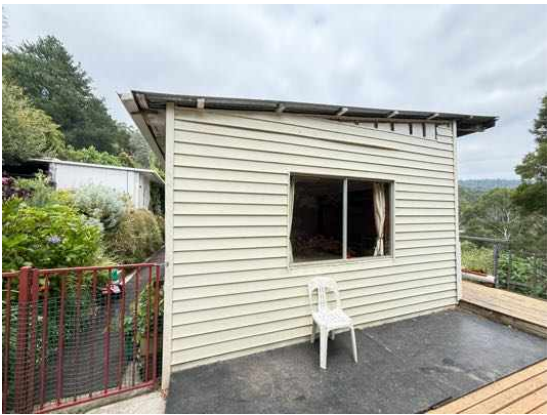
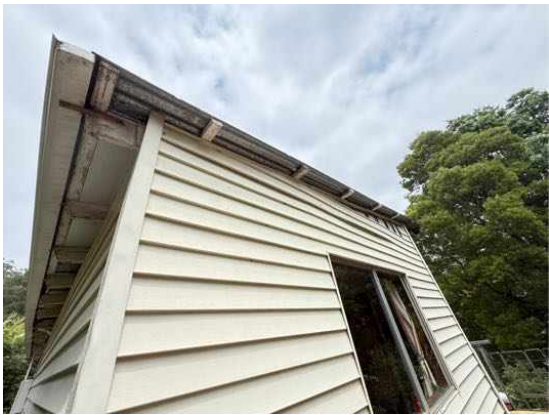
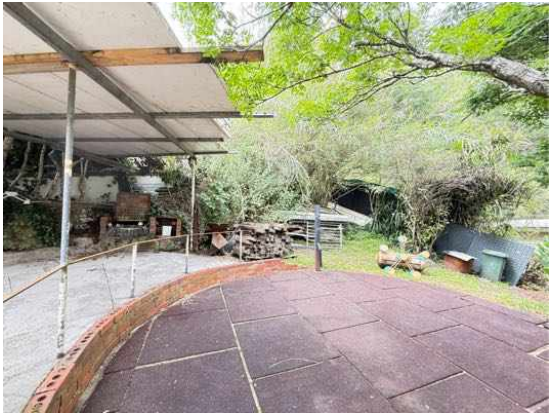
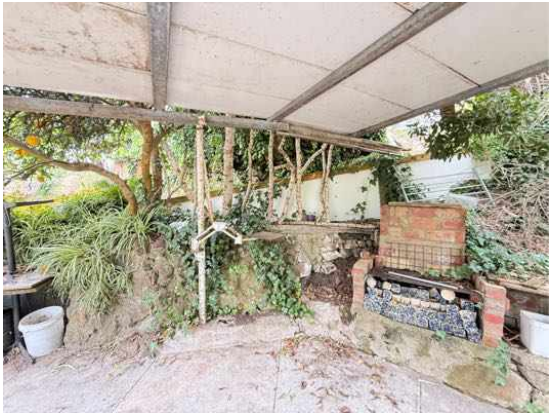
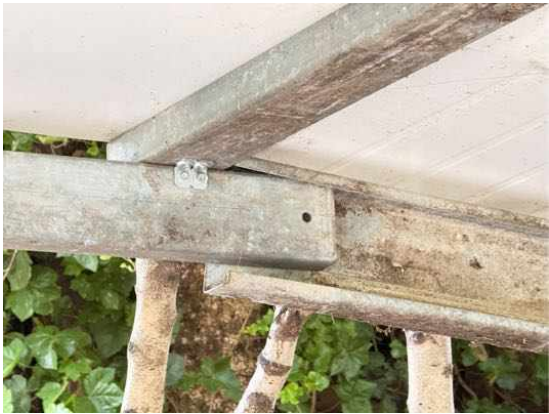
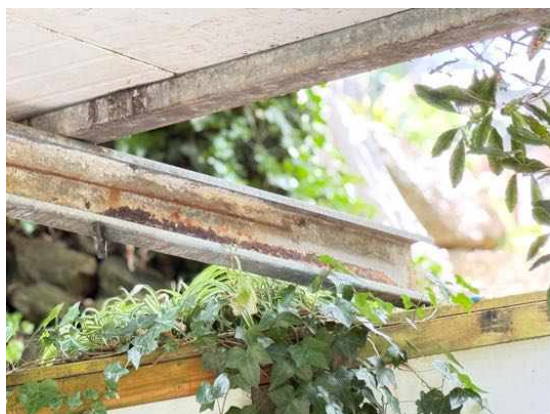
**Defects 3.04**

Building: Building 1  
Location: All Areas > All Areas  
Finding: Flashings, gutter and downpipe missing  
Information: Numerous flashings, gutters and downpipes to numerous structures throughout the property were observed not to have been installed and missing Flashing, gutters and downpipes are designed to keep under roof areas water tight and to direct water flow from the roof structures away and into the stormwater drainage system to prevent excess water and moisture away from the exterior of the home, subfloor and surrounding areas.

Where flashings, gutters and downpipes have not been fitted or are missing, these roof structures will not adequately sealed against water and external weather conditions. It is therefore always necessary to ensure flashings, gutters and downpipes and other relevant drainage is installed around your home.

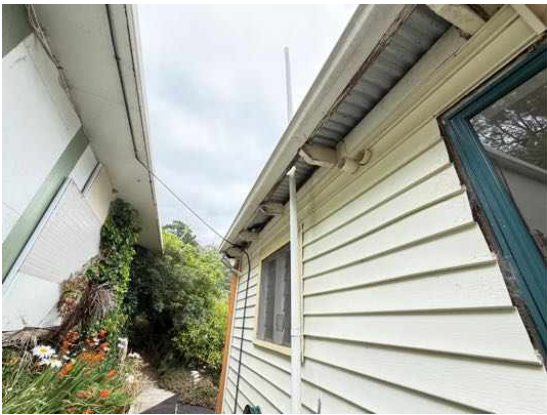
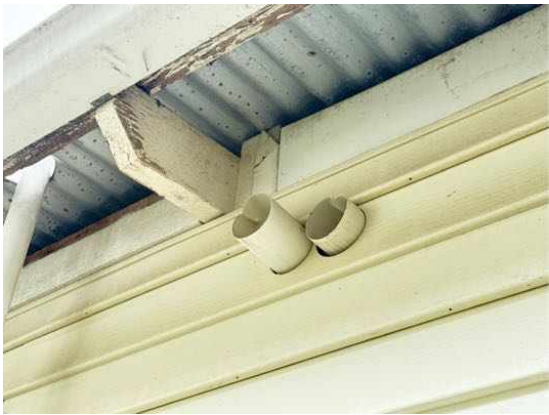
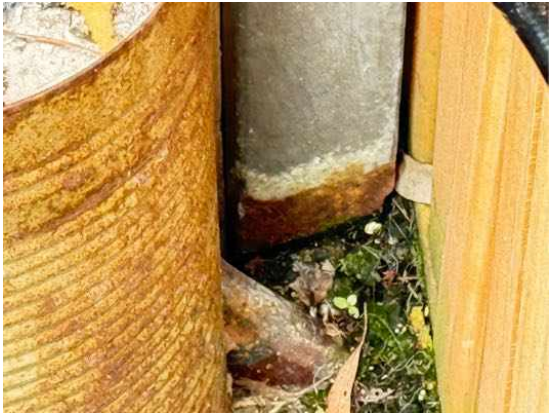
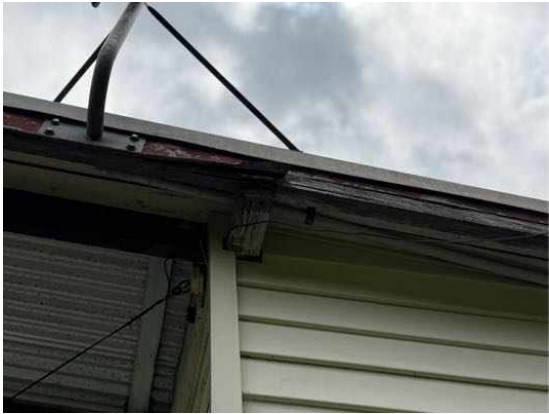
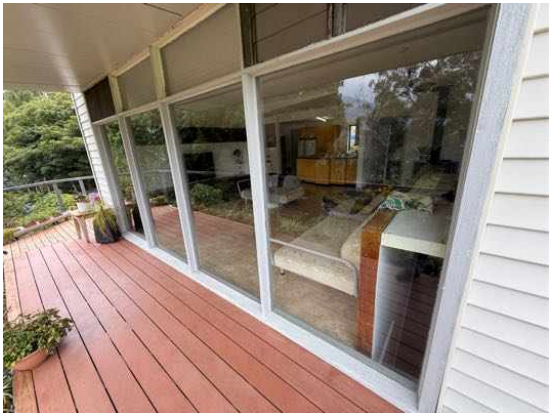
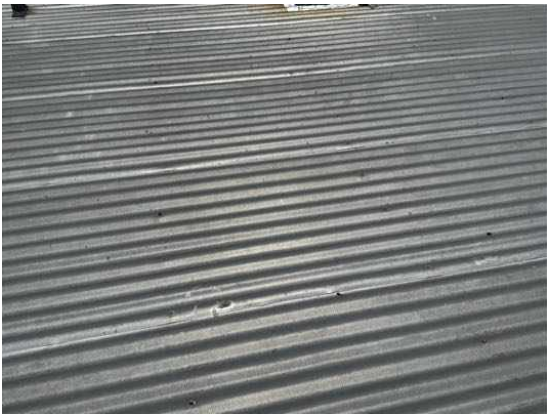
### Defects 3.05

Building:	Building 1
Location:	All Areas > All Areas
Finding:	Building elements that are rusted, corroded and or show wood rot
Information:	Some exterior building elements and materials that show evidence of rust, corrosion or wood rot has likely developed as a result of excessive exposure to moisture, harsh weather conditions and or inadequate coatings. A surface that is found to be rusted or wood rot has damage and is deteriorating, is likely to worsen if not addressed and left unmanaged, it is therefore recommended that the relevant tradespersons remove and rectify these areas as much as possible, clean and re-paint these areas.

Wood rot is suspected to be affecting building elements around the exterior areas. Wood rot, also known as Fungal Decay, occurs when timbers and other cellulose building materials are exposed to damp conditions on an ongoing basis. it is

suspected to be due to frequent exposure to rain and other weather conditions that make these building elements susceptible to accelerated deterioration.

Where possible, the use of galvanized (treated) metals or aluminium coated metals aid in rust prevention, as does regular general maintenance. Rust formation can be controlled with coatings, such as paint, that isolate the iron from the environment. Rusting and corrosion should be managed by ideally removing or limiting the affected surface from exposure to moisture and harsh weather conditions. A qualified painter or other relevant tradespersons may be appointed to paint affected areas and a qualified carpenter to replace any building elements that have been severely affected by rust or water damage.

Early intervention and regular maintenance such as painting will prolong the useful life of these building elements. Prior to any works being performed, the cause of the moisture that has created the wood deterioration or rot should be identified and addressed in a suitable manner. Replacement of the affected building elements may be a necessary step in protecting surrounding areas from secondary defects and deterioration. A qualified carpenter or registered builder may also be required to replace affected building materials deemed to be necessary.

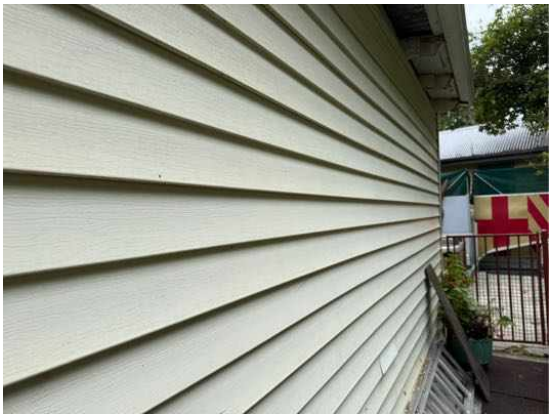
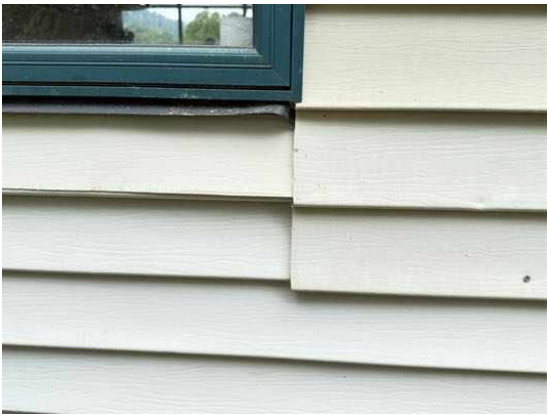
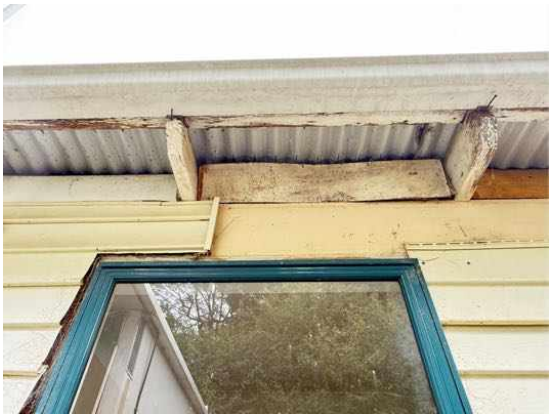
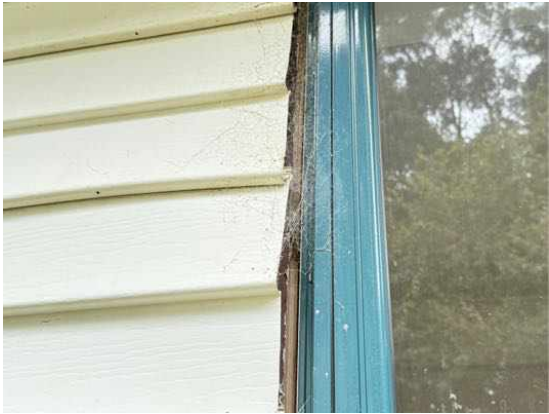
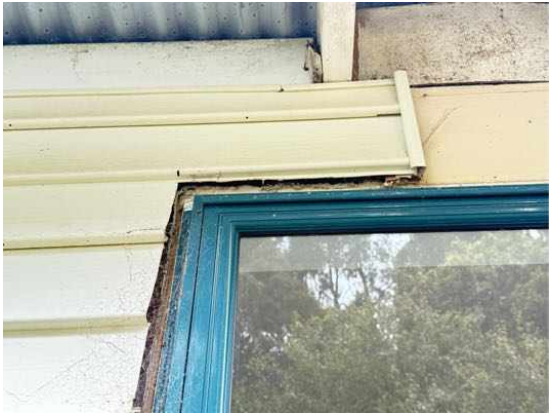
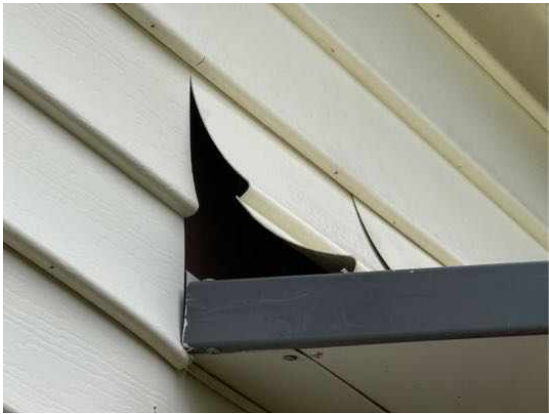
**Defects 3.06**

Building: Building 1  
Location: All Areas > All Areas  
Finding: Numerous broken, dislodged and deteriorated wall linings  
Information: The back room wall linings to the rear of the home, are suspected to have been constructed with the use of a plastic weatherboard construction material. The observable areas of wall sheeting showed numerous areas of observed damage, dislodged or deterioration, indicating that wall linings are not currently adequately sealed and protected from the ingress of vermin, spiders, insects and other pests.

Where the client elects to leave these damaged and deteriorated wall linings, further damage or deterioration to the wall and floor structures is suspected. Remedial work is required to repair these areas in the short- to medium-term as solution to reduce the risk presented by excessive water and moisture.

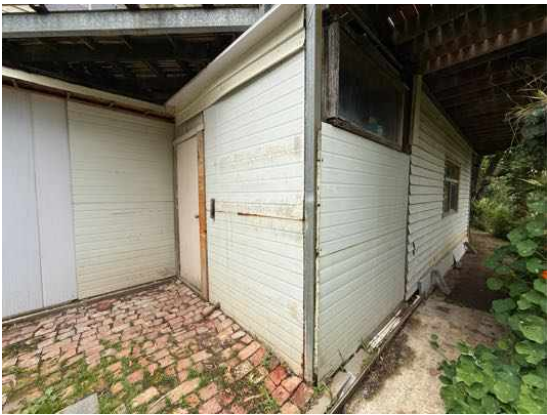
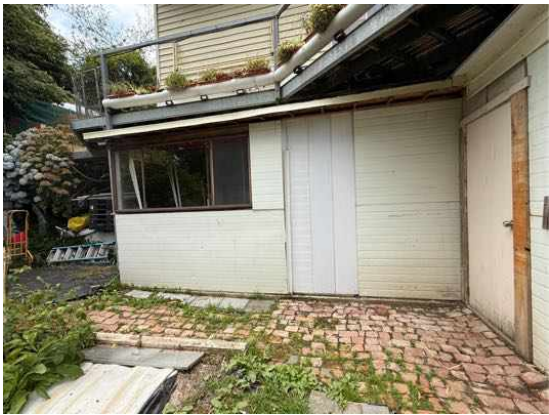
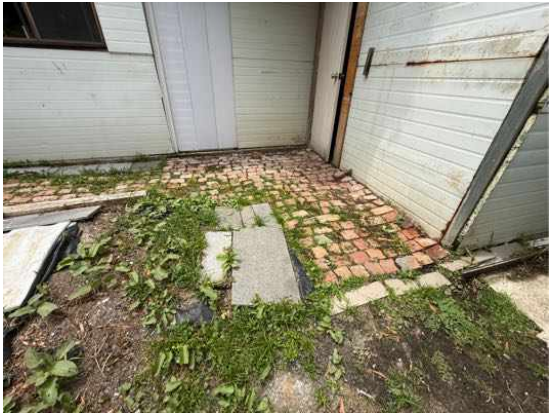
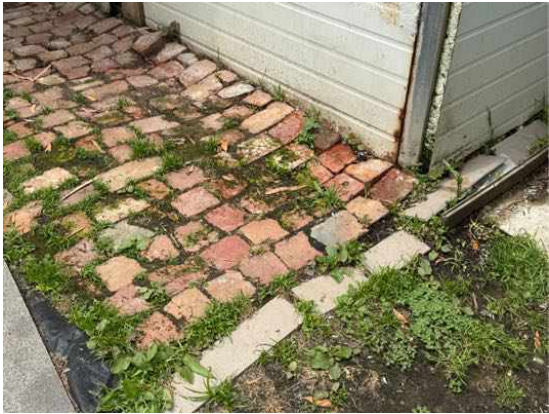
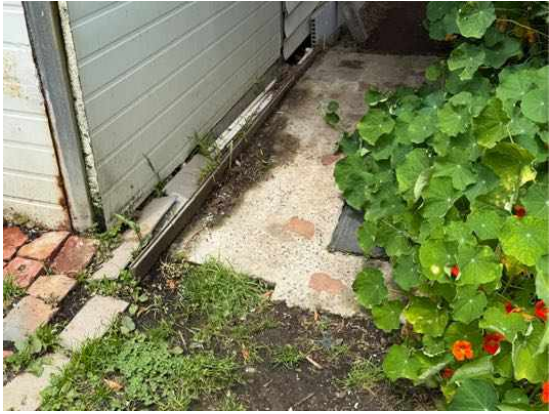
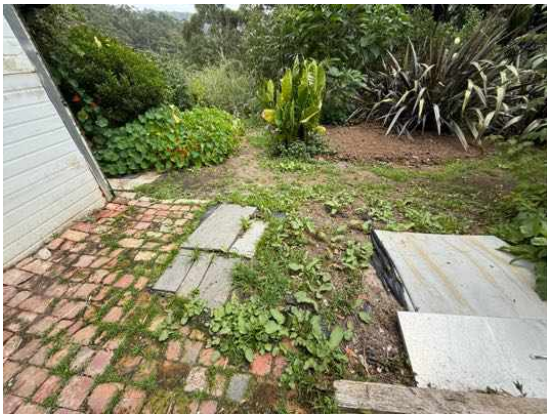
### Defects 3.07

Building:	Building 1
Location:	All Areas > All Areas
Finding:	Exterior paving - Numerous areas of unevenness and undulations
Information:	Numerous areas throughout the exterior areas of paving and paths showed numerous areas of unevenness and undulations. These numerous areas of the external paths and paving were considered to be creating potential trip hazards for children and occupants in these areas. These areas are suspected to have been subjected to tree roots, poor installation, or paving sections have dropped or lifted due poor preparation in the substrate before paving is laid.

Where paving creates a trip hazard, personal injury may ensue if due caution is not taken by occupants and all other persons within this area. Client may consider re-paving of these areas, where required or deemed necessary to remedy these types of situations. Further consultation with a landscaper or other specialists in these areas is recommended.

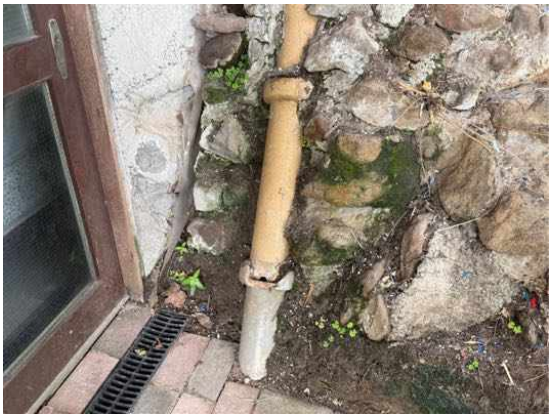
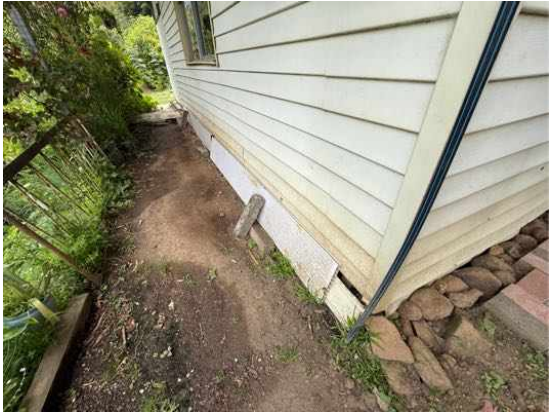
**Defects 3.08**

Building: Building 1  
Location: All Areas > All Areas  
Finding: Site stormwater drainage  
Information: Due to the numerous levels throughout the property, it is important for the excess water and moisture to be drained into exterior perimeter aggy drains or stormwater drainage system. If excessive water and moisture is not restricted it is highly suspected that it will travel under the home and throughout the subfloor areas. It is highly recommended that the client ensure that site drainage is working and free from excess leaf matter, dirt and debris.

suspected to be travelling throughout the subfloor areas. The subfloor areas were not able to be accessed at the time of the inspection, making it impossible to see if adequate stormwater drainage had been installed. These areas are suspected to be highly susceptible to excessive water and moisture from the hill run- off, it will therefore require adequate stormwater drainage - aggy drains directed away from these perimeter exterior walls.

These aggy and stormwater drainage will need to be cleared periodically, all surface drainage and sub soil drainage systems must be protected from debris, soil, sand or any other material which may impede the operation of the site drainage. The purpose of the stormwater drainage is to drain off ground, surface and some sub-surface water and moisture and ensure it gets carried away from areas where secondary defects are possible if left unmanaged.

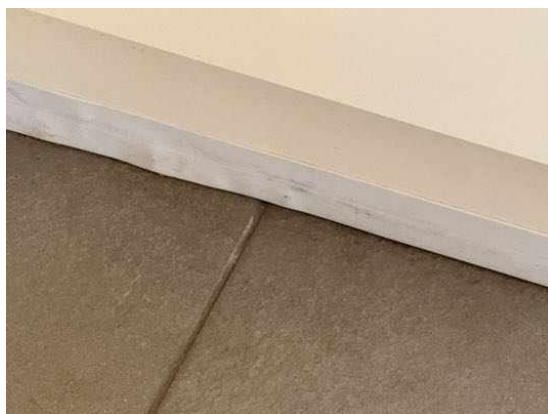
### Defects 3.11

Building:	Building 1
Location:	Kitchen > All Areas
Finding:	Kitchen cabinet doors.
Information:	Several kitchen cabinet doors are showing signs of moisture damage and minor misalignment. While this may detract from the appearance of the cabinetry, the

operational state of the cabinetry appears to be working correctly. To improve operation of the affected cabinets, a qualified cabinet maker may be appointed to provide maintenance and repair where deemed to be necessary. Such works can be completed at discretion of the client.

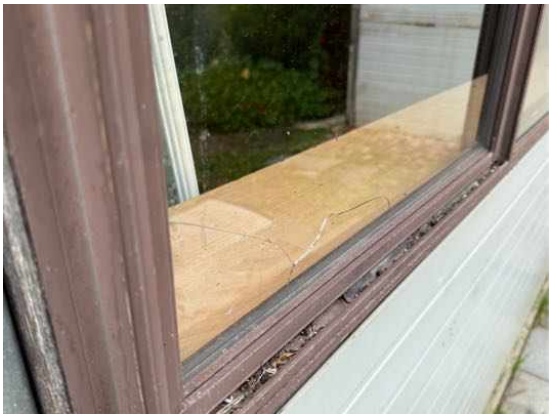
### Defects 3.12

Building:	Building 1
Location:	All Areas > All Areas
Finding:	Broken and cracked glass
Information:	Broken and cracking glass was observed at the time of inspection, this damage is suspected to have been from impact damage at sometime. While the cracked or broken window may be in some cases considered to be minor, any further impact damage sustained to the glass may lead further damage and deterioration or more serious injury to occupants and or additional cracking.

As the cracking provides potential secondary damage to the glass or associated building elements and building materials, repair of the glass may be deemed necessary in the future. Consultation with a glazier to repair or replacement or other remedial works may be required to protect against any further damage.

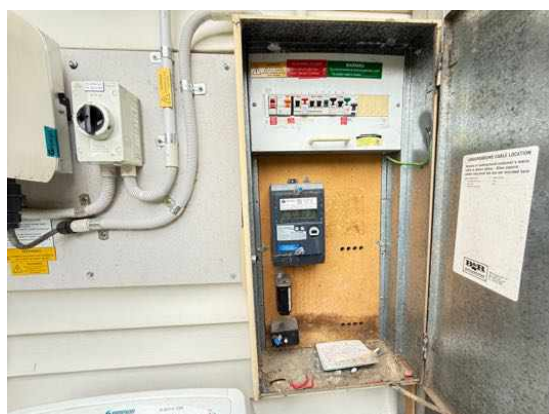
Building: Building 1  
 Location: All Areas > All Areas  
 Finding: Termite Management System  
 Information: At the time of the inspection, an existing application which was installed during the construction of the home was observed at the time of the inspection. Barrier will only be effective for X number of years and client is advised to keep these treatments current and or according to the termite company's recommendations or the durable notice in the meter box. Such barriers are highly effective in preventing termite attack on any timber and other building elements throughout the property.

A durable notice was observed to be placed in the in the meter box area that should indicate when the termite barrier is current to. At the client's discretion, client may make contact with the termite company to ensure home is protected into the future and the procedures involved with the future protection and or reapplication.
