# Building and Timber Pest Inspection Report

Inspection Date: Fri, 13 Feb 2026

Property Address: 5 Hildale Cres, Morayfield QLD 4506,  
Australia

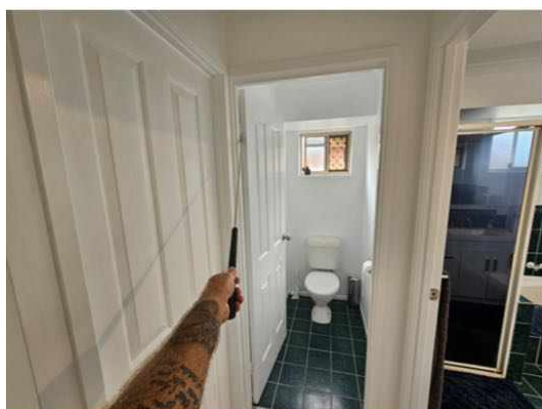
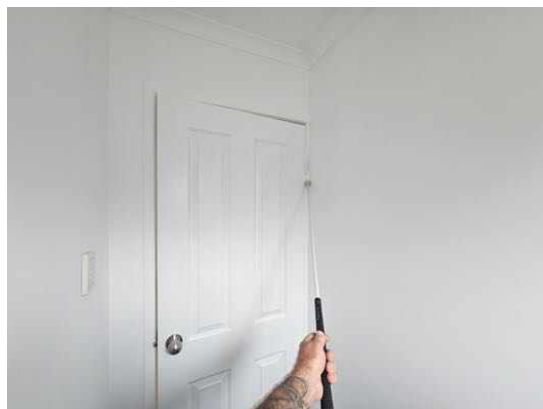
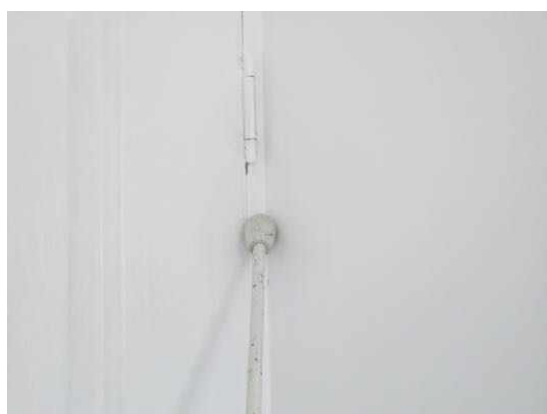
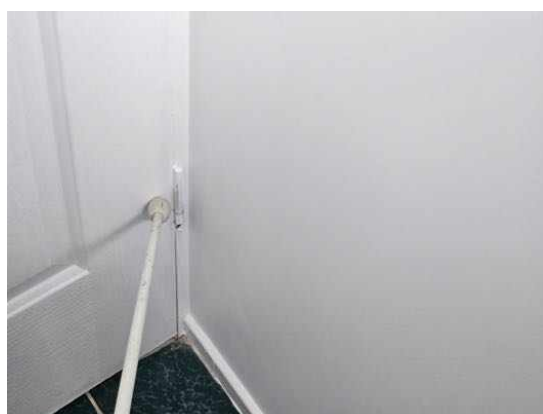
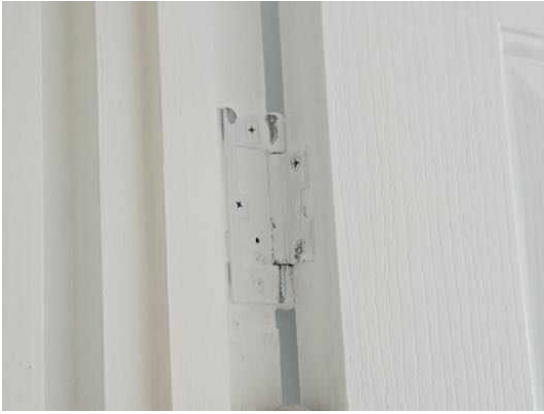
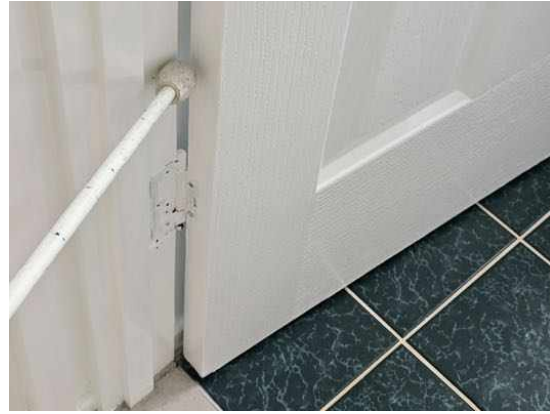
#### Finding 1.01

Building: Main Building  
Location: Toilet (WC)  
Finding: Toilet door - lift off hinge required  
Information: The WC door as inspected on the day did not have lift off hinges fitted.

The BCA requires that the door to a fully enclosed sanitary compartment (WC or toilet) must either open outwards slide or be readily removable from the outside of the compartment. This requirement applies unless there is clear space of at least 1.2 m between the closet pan within the sanitary compartment and the nearest doorway.

The client could employ a licensed carpenter or suitably qualified handy person to replaced the hinges its compliant hardware.

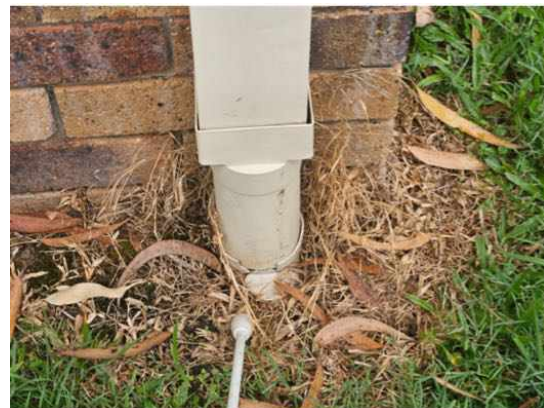
### Finding 3.01

Building: Main Building  
Location: As shown  
Finding: Damaged downpipe  
Information: On the day of inspection it was noted that the downpipe shown is damaged and will require repair.

A licence plumber or suitably qualified handy person could be a shed at the clients discretion to carry out a repair.

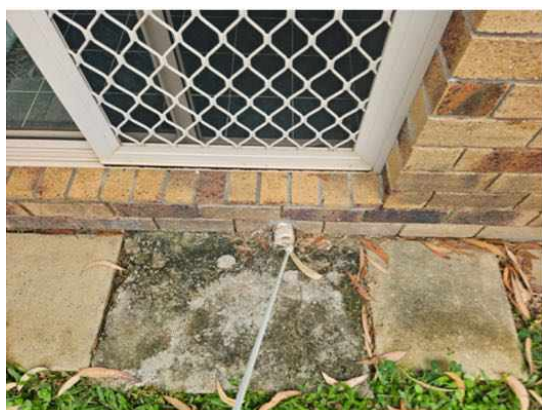
### Finding 3.03

Finding: Dry waste vermin flap - broken

Information: The floor waste in the laundry is a dry waste and the exit point is adjacent to the sliding glass door of the laundry. These waste exit points have a vermin proof flap attached to the external opening.

The flap on the is waste is missing. A replacement should be fitted at the clients discretion to prevent vermin from entering the property.

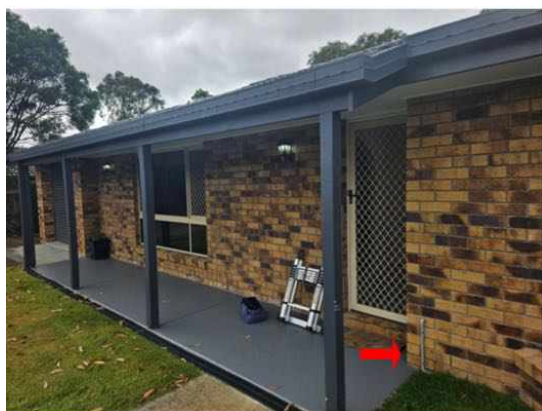
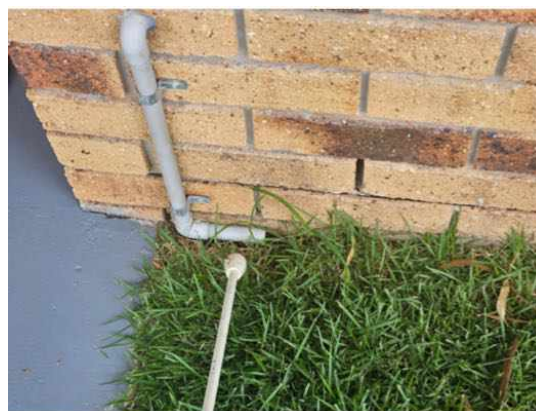
### Finding 6.01

Building:	Main Building
Location:	Front entry
Finding:	Air conditioner - Disconnected drain
Information:	The Air Conditioner (A/C) overflow was found to be disconnected from storm water drainage and could create excessive moisture in the surrounding area.

Such leaking creates an environment which is conducive to an array of defects, including water damage to associated building elements and the attraction of termite or timber pest infestation.

It is recommended that a licensed plumber be appointed to connect the A/C overflow to a drainage source in order to prevent such an environment from being created. An alternative is to extend the overflow further into the garden away from the building perimeter.

These minor works should be carried out in the short term.

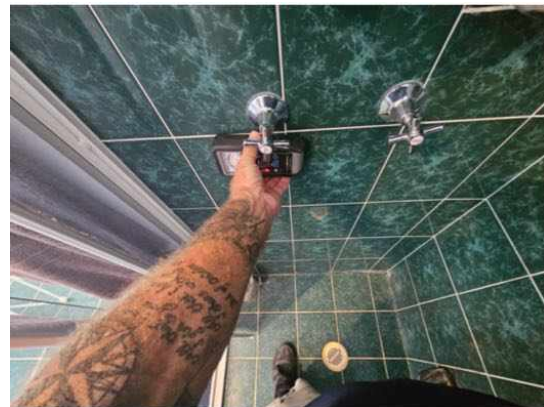
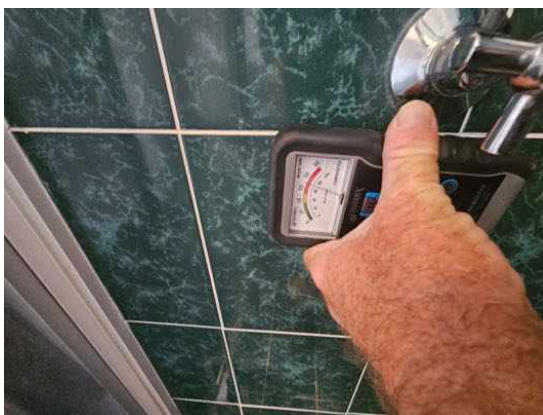
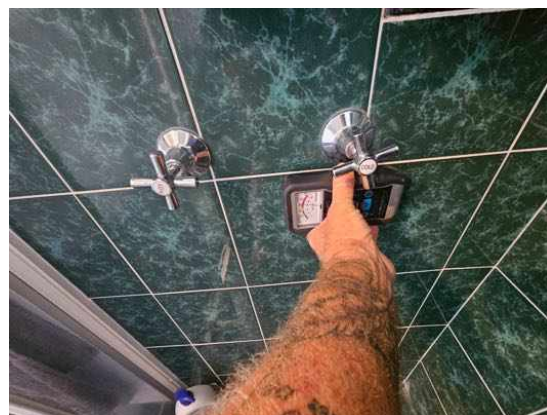
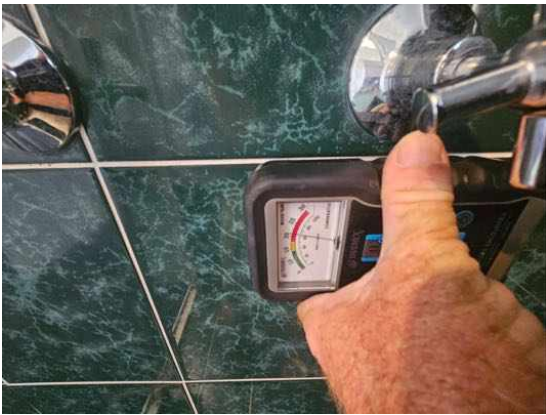
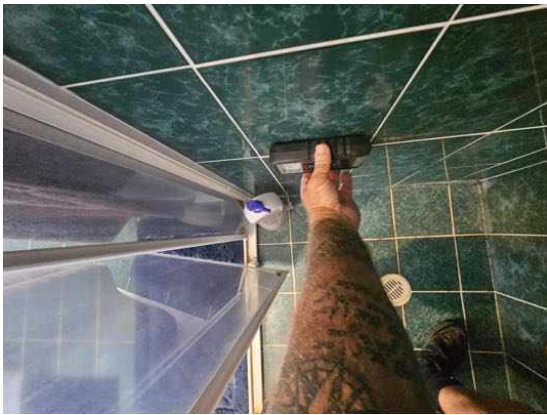
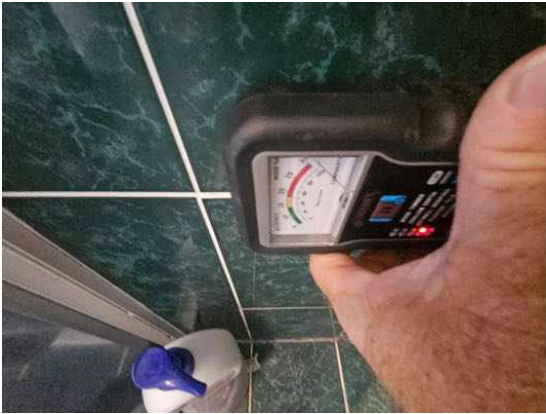
### Finding 6.02

Building:	Main Building
Location:	Bathroom
Finding:	Elevated moisture present at the time of inspection - bathroom
Information:	Elevated moisture was noted in the tiled wall surfaces of the bathroom shower. The moisture was also noted on the opposing side in the toilet. It appears that the focal point is the tap set.

The levels varied at differing points throughout the recess. This could possibly be due to deteriorated grout and silicone sealants and / or plumbing fittings and fixtures. The

grouts and sealants can break down over time and become porous, allowing moisture to enter the wall sheet surface behind the tiles. Some minor cracking and scouring of the grout joints was noted, and the silicone sealant at the tap penetrations seems to be recently applied. It is possible that there was moisture ingress previously found at this localised area and the silicone has been renewed accordingly. A minor pinhole in the sealant of the cold tap was noted.

Plumbing, and shower fittings and fixtures, can be areas of water penetration if not installed correctly and sealed completely. Whenever a fitting is screwed / fitted to the tiled shower walls, the holes and fittings should be sealed with an appropriate sealant to prevent water from entering the wall cavity. This is a common fault.

Elevated moisture can attract timber pests and vermin, and produce conditions that promote timber pest attack, fungal growth and wood decay.

The moisture detected in the shower of the bathroom has aspects identified on the reverse side of the shower recesses. This would warrant further investigation whether by a plumber assessing the plumbing fixtures and / or an invasive inspection of the wall cavity by this inspector.

It is recommended that this be investigated further to assess the cavity moisture levels and the tap set.

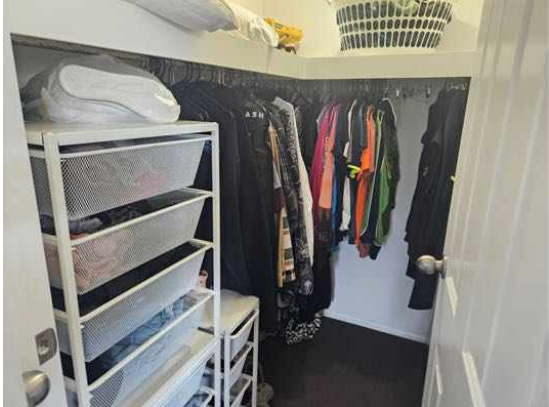
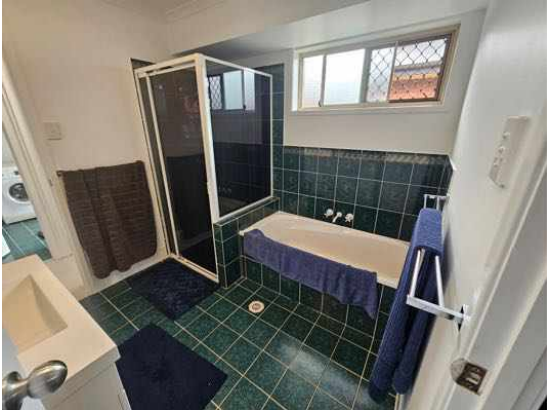
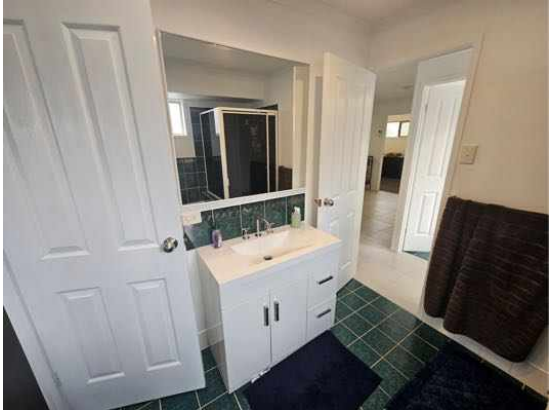
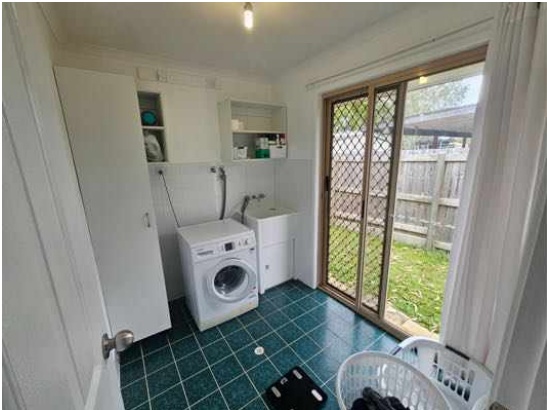
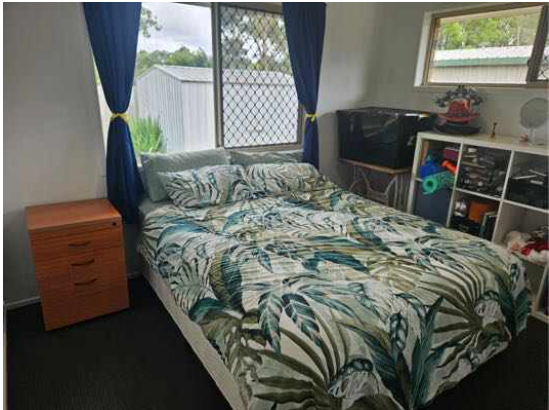
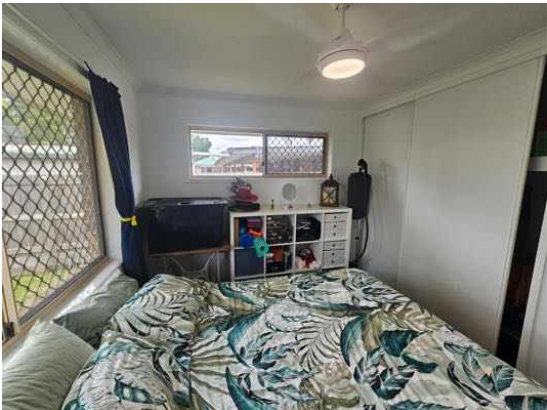
Finding: Additional Photos - Obstructions and Limitations

Information: These photographs are an indication of the obstructions and limitations which impeded full inspection of the property at the time of inspection. These obstructions can prevent full inspections of the areas shown.

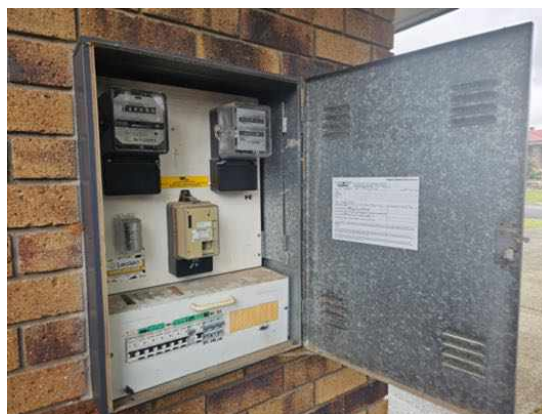
Building:	Main Building
Location:	Meter box, kitchen cupboard
Finding:	Durable pest inspection notice - not assessable
Information:	On the day of inspection it was noted that the durable timber pest inspection / treatment notice was missing, not visible or out of date. These notices / stickers are to verify the timber pest inspection dates, the inspector, the currency and type of timber pest system / barrier in place or being used in and around the property.

It is recommended that a licensed timber pest controller be contacted to assess the properties needs and provide costings for an annual inspection programme.

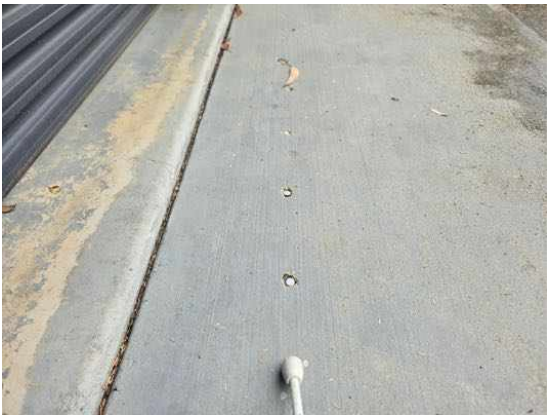
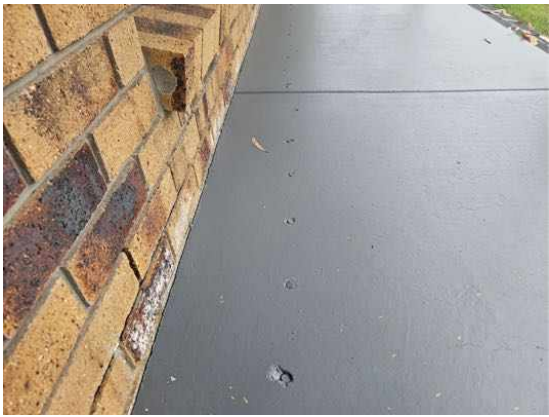
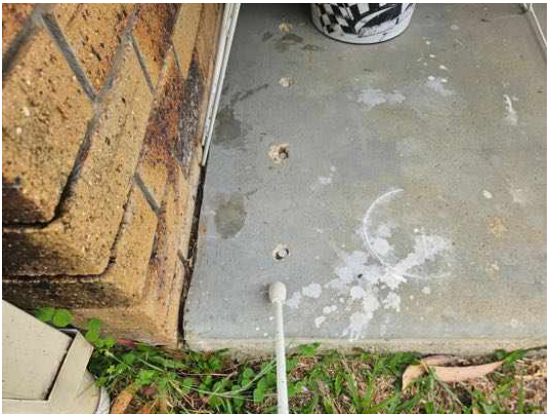
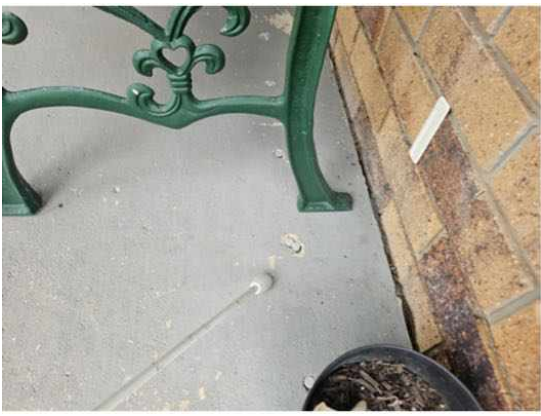
The building employs a chemical drill and inject barrier system to the perimeter. The durable notice shows a renewal date of 2029. In order for a barrier system to be effective, the property must have regular inspections at intervals of not greater than 12 months. Depending on the risk profile attributed to the property, these inspections may be recommended at lesser time periods.
