# Building and Timber Pest Inspection Report

Inspection Date: Thu, 26 Mar 2026

Property Address: 10 Hibiscus Ave, North Avoca NSW 2260,  
Australia

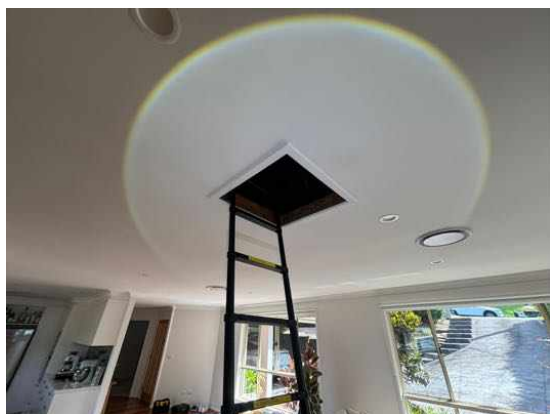
Building:	Main Building
Location:	Roof Void
Finding:	Sarking - Damaged
Information:	Sarking, a laminated aluminium foil applied to the interior of the roof covering, assists in insulating the property and acting as a vapour-barrier to the roof void and, subsequently, to the household.

Where sarking is damaged, both insulation and moisture protection of the property are inhibited. This creates a loss of energy and thus negatively impacts the energy efficiency of the property, allowing potential for moisture ingress from condensation or leaking roof tiles.

It is important to repair any holes or damaged sections of sarking to ensure that the building material is fully functional. A registered roofer should be consulted to provide further advice on this defect and to perform rectification works at client discretion.

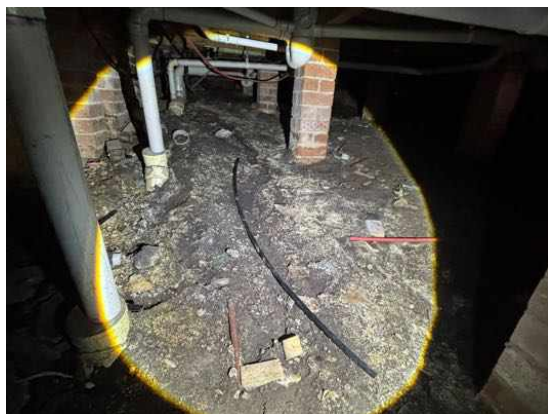
Building:	Main Building
Location:	Subfloor
Finding:	Subfloor Site Drainage - Inadequate
Information:	At the time of inspection, inadequate site drainage was observed under the subfloor,

allowing water to accumulate and fail to drain effectively, creating a hazardous condition. This is a common defect in houses constructed on brick stumps, where poor site grading and limited subfloor ventilation can contribute to ongoing moisture retention. The resulting water pooling may lead to structural deterioration from prolonged dampness, mould and mildew growth, and create conditions conducive to termite activity. These issues can also impact indoor air quality and pose safety risks to occupants.

The client is advised to engage a licensed plumber or builder experienced in drainage and foundation work to assess and implement suitable solutions, such as improving site grading, installing appropriate drainage systems, and enhancing moisture barriers. In addition, the installation of mechanical subfloor ventilation is recommended to improve air circulation, assist with moisture control, and reduce the risk of ongoing damp-related issues.

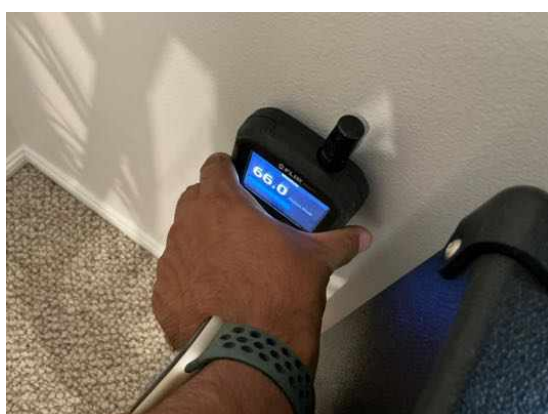
Building:	Main Building
Location:	Front Bedroom, Bedroom 5
Finding:	Damp - Rising (Drainage Issue)
Information:	At the time of inspection, evidence consistent with rising damp was observed. External ground levels were noted to be sloping towards the building, which may facilitate

moisture migration into the lower sections of the walls and flooring.

This condition can contribute to dampness, deterioration of building materials, and ongoing moisture-related issues if not addressed.

It is recommended that external ground levels be reduced where necessary and that site drainage be improved to ensure surface water is directed away from the building. The client is advised to monitor the affected areas over a 12-month period for any signs of progression.

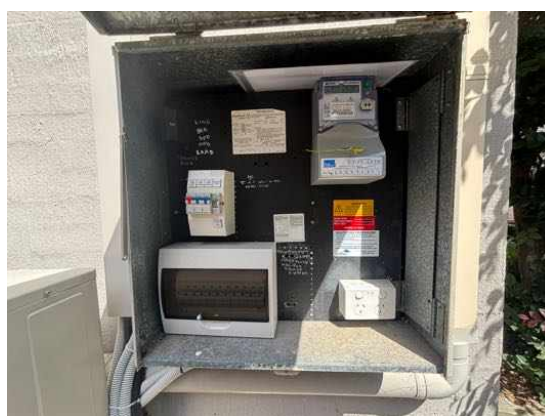
Building: Main Building  
Location: Meter Box  
Finding: Termite Management Recommendation – No Evidence of Chemical Installation  
Information: At the time of inspection, there was no visible evidence of a chemical termite management system installed around the property. Chemical barriers are a key component of termite protection and are particularly important in preventing concealed termite entry into timber elements of the structure.

In accordance with standard requirements, a durable notice should be located within the electrical switchboard to detail any termite protection systems applied, including chemical treatments. No such notice was observed during the inspection.

It is recommended that the client engage a licensed pest controller to assess the suitability of installing a chemical barrier, and to provide advice on associated costs and procedures. This should be considered a short-term priority, particularly if the property has any history of termite activity or is located in a high-risk area.
