Building and Timber Pest Inspection Report

Inspection Date: Wed, 28 Jan 2026

Property Address: 34 Govett St, Broadford VIC 3658, Australia

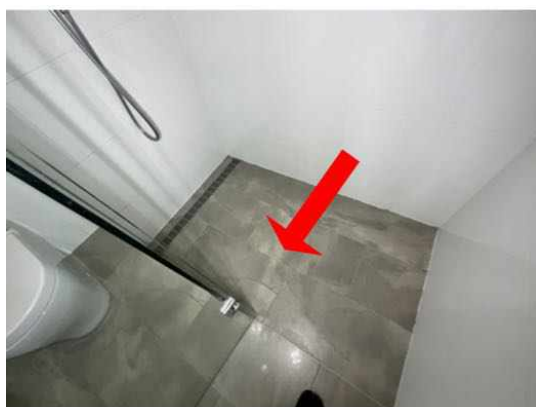
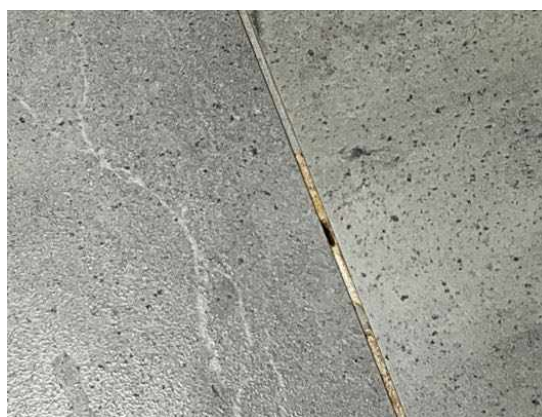
Finding 3.01

Building: Building 1
 Location: Ensuite
 Finding: Inadequate sealant or Grout
 Information: This area has a lack of effective Sealant or Grout. This is allowing the ingress of water to the structure inside the wall.

The presence of water encourages Termite attack, Mould and Fungal Decay.

A Tiler or General Handy person must be contacted as soon as possible to effect repairs and prevent further deterioration.

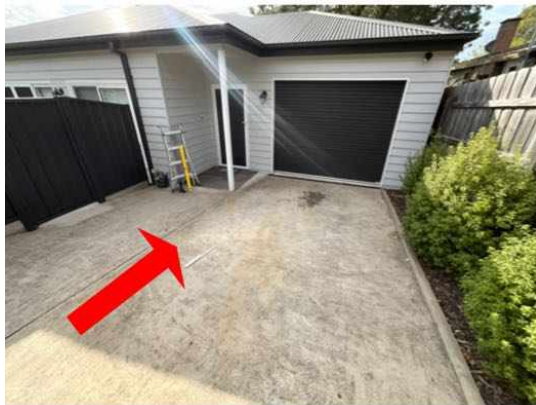
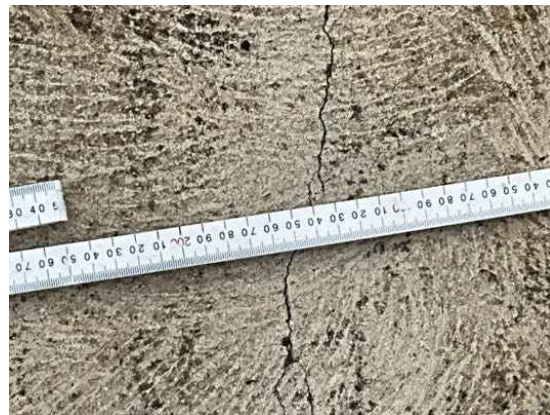
Finding 3.02

Building: Building 1
 Location: Driveway
 Finding: Cracking - External Concrete Paving Damage Category 1 - Fine (less than 2mm)
 Information: Fine cracks were identified in external concrete paving. Although fine cracks are quite noticeable, they are often only considered to be an appearance defect, and usually do not indicate any structural damage. To be considered a Category 1 or fine crack, the crack is found to be less than 2mm in width.

Generally the cause of a hairline crack in existing concrete paving such as driveways and pathways is indicative of the expansion and contraction of the concrete. Such causes are generally due to environmental factors, such as moisture levels, weather conditions, root systems of nearby trees or the soil types on which they are laid.

Fine cracks may also be due to poor original installation of the concrete. Factors such as poor compaction of the sub surface and/or inadequate reinforcing of the slab may create cracking and other secondary defects.

Monitoring of all cracking should be conducted frequently. Always contact a building inspector should cracks widen, lengthen, or become more numerous.

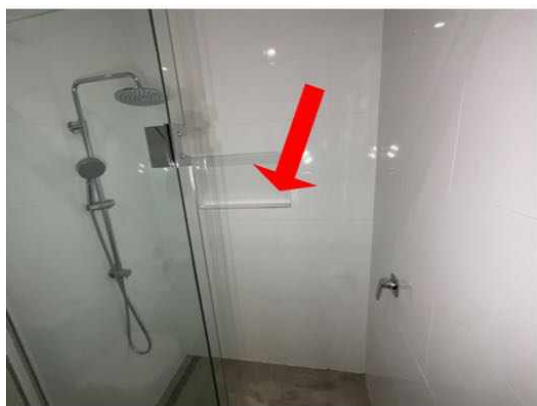
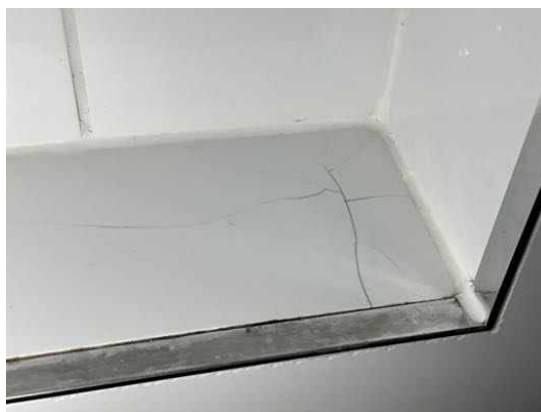
Finding 3.03

Building:	Building 1
Location:	Ensuite
Finding:	Wall Tiles- Cracked
Information:	Cracked tiles within the household detract from the overall appearance of the affected areas, as well as creating potential for water penetration to adjoining building elements. If left unmanaged, water damage may occur as a result of constant water penetration over a prolonged period of time.

While not considered a matter of urgency, replacement of tiles is advised as a solution. A Tiling Contractor may be appointed to perform these works at client discretion.

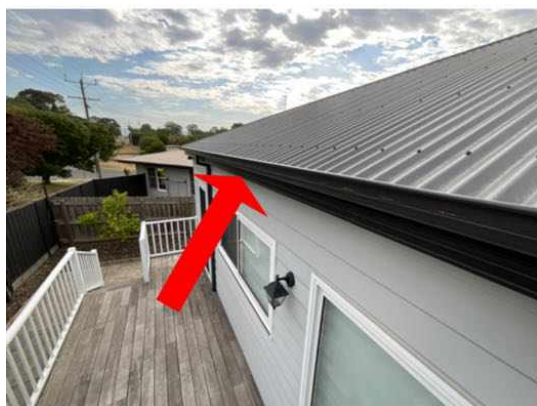
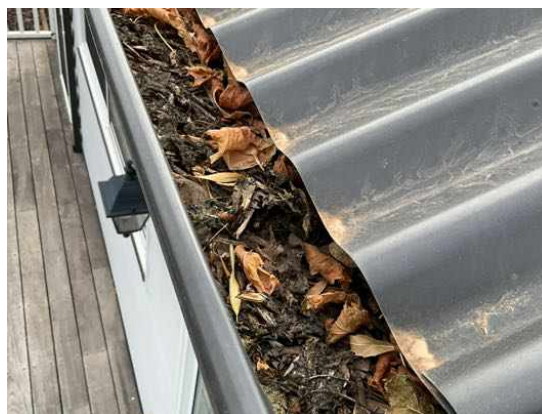
Finding 6.01

Building: Building 1
 Location: Eaves
 Finding: Gutters- Blocked
 Information: Roof plumbing structures, such as guttering and downpipes, should be free of all debris to prevent blockages. Blockages of the guttering and downpipes will lead to pooling and accumulated water overflows, which is likely to subsequently flood eaves and exterior walls.

Blocked gutters are likely to lead to high levels of moisture in the affected areas. Such moisture will not only cause rust and decay of the associated building materials, but can also provide conditions that are conducive to termite and timber pest activity. Blockages in gutters should therefore be removed immediately to ensure dry conditions are maintained.

Consult a Licensed Plumber for further specific advice on remedial works that may be required. In the interim, it is highly advised that blocked gutters be removed by the homeowner or a general handyperson as a matter of urgency.

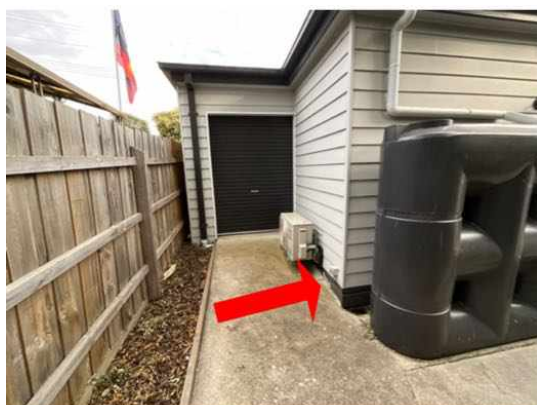
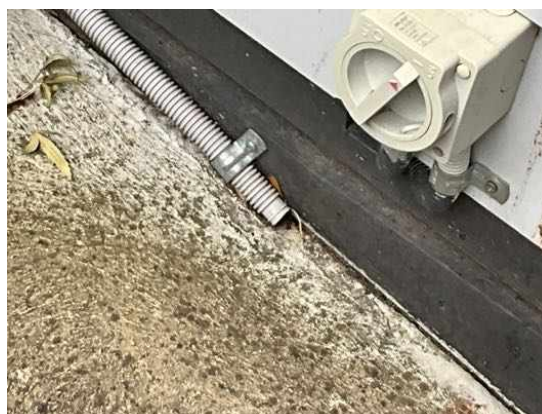
Finding 6.02

Building: Building 1
 Location: Yard - Side
 Finding: Air conditioner - Disconnected overflow
 Information: The Air Conditioner (A/C) overflow was found to be disconnected from storm water drainage and is creating excessive moisture in the surrounding area.

Such leaking creates an environment which is conducive to an array of defects, including water damage to associated building elements and the attraction of termite or timber pest infestation.

It is highly recommended that a licensed plumber be appointed to connect the A/C overflow in order to prevent such an environment from being created. These minor works should be carried out as soon as possible.

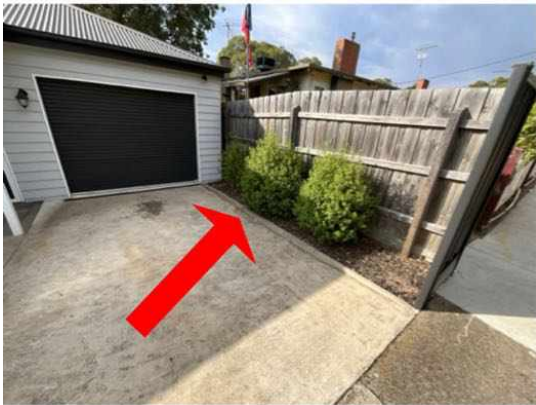
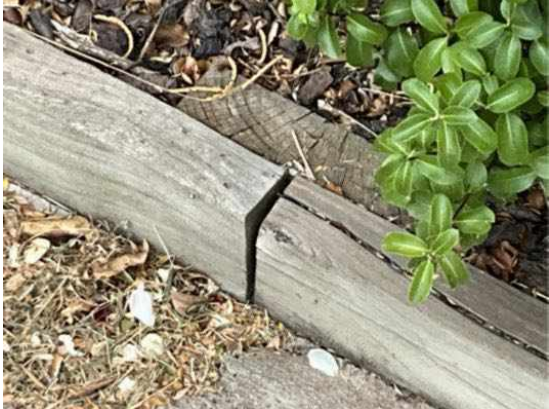
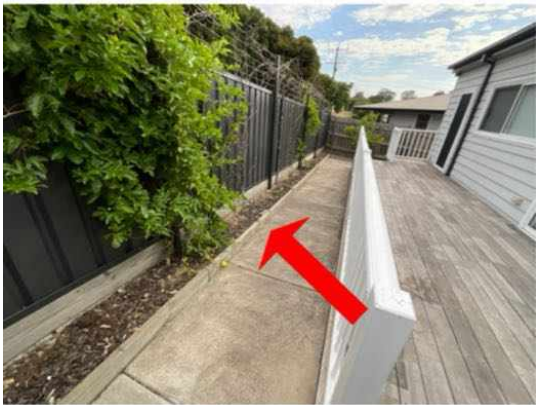
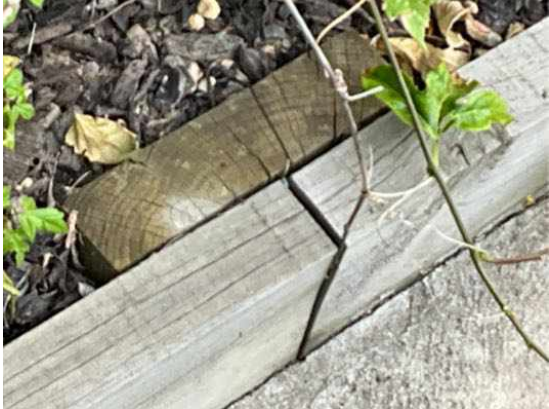
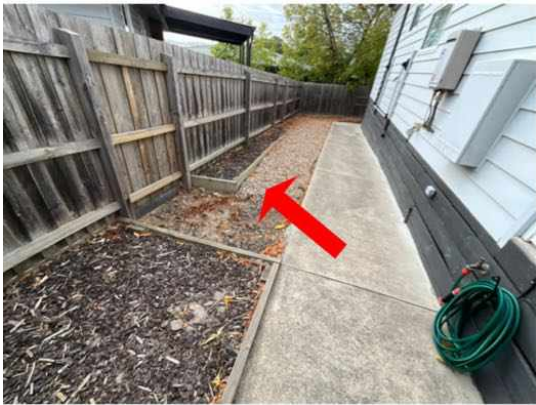
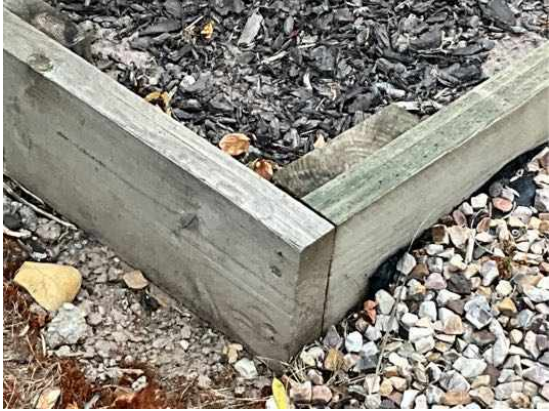
Finding 6.03

Building: Building 1
 Location: Driveway, yard- back
 Finding: Untreated or non-durable timbers in a hazardous environment
 Information: To reduce the risk of timber pest attack it is essential that timber used in a hazardous environment (e.g. in direct contact with the ground or frequently exposed to damp

conditions) is of sufficient durability and/or is adequately preservative treated.

Untreated timbers in direct contact with the ground are likely to develop severe wood rot and/or fungal decay if left unattended creating attraction for subterranean termites to infest the timbers from surrounding areas.

If untreated or non-durable timbers are found to be in a hazardous environment it is highly advised that replacement of these building elements be performed as soon as possible to aid the protection of the property against termite / timber pest attack.

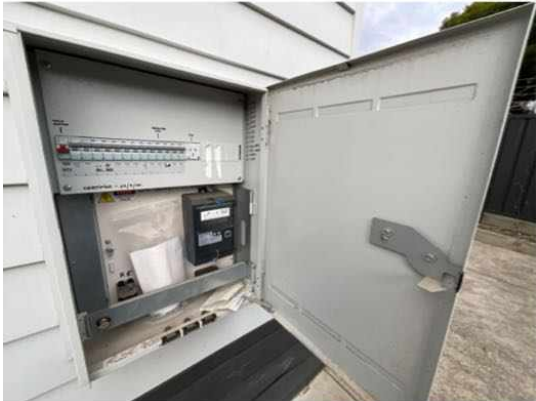
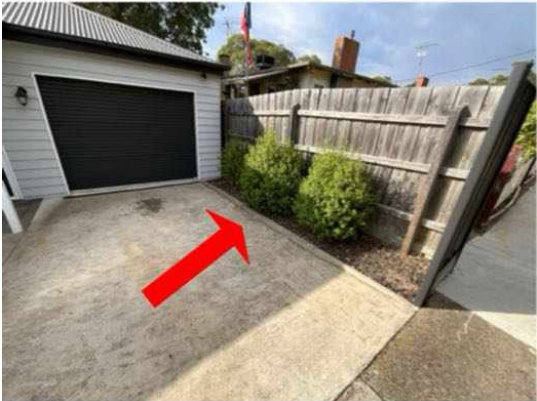
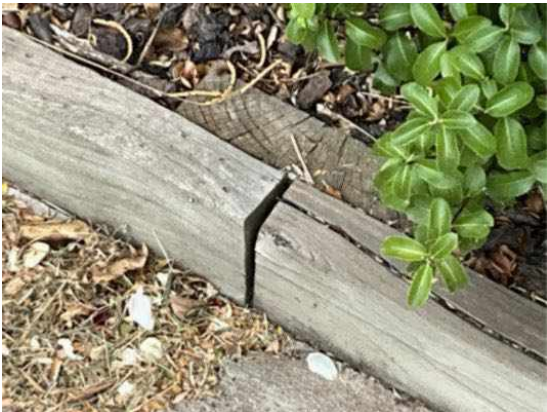
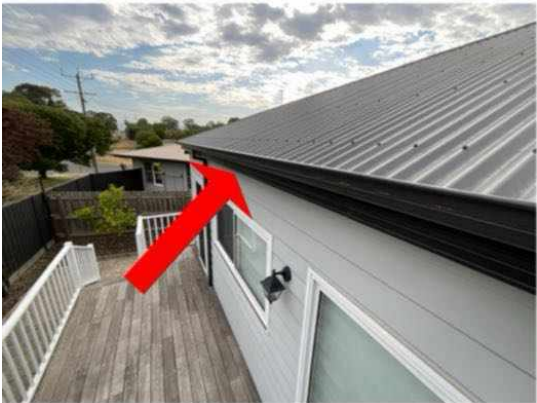
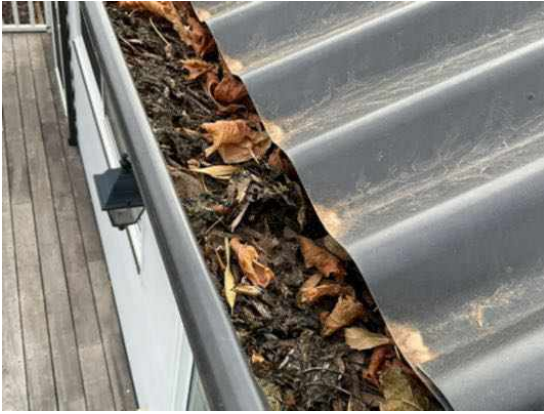
Finding 6.04

Building: Building 1

Location: All External Areas
Finding: Termite Management System - no evidence of a chemical installation
Information: The application of a post-construction chemical termite barrier is highly recommended for all properties, particularly if live termite activity has been found on the site previously. Such barriers are highly effective in preventing termite attack on any timber building elements throughout the property.

A durable notice should be placed in the switchboard unit to indicate current termite barriers. At the time of inspection, it appeared as though no termite management system has been installed, with no evidence to suggest preventative works taking place.

The client may consider gaining further advice from a pest controller as to the costs and procedures involved with this application. It is recommended that obtaining such advice be a short-term priority.

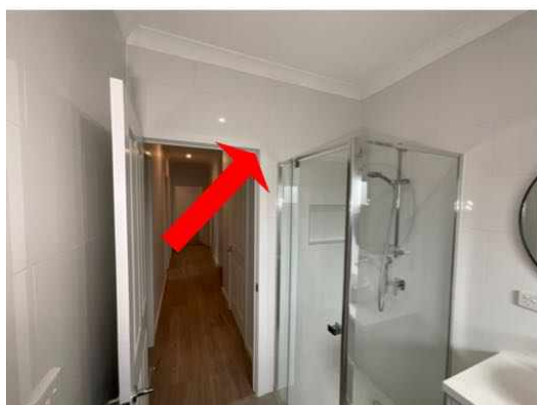
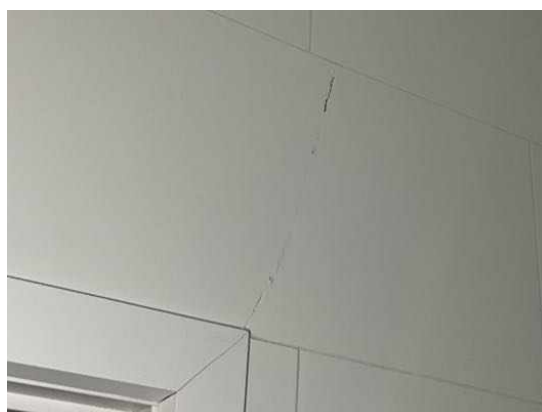
Building: Building 1
 Location: Bathroom
 Finding: Wall Tiles- Cracked
 Information: Cracked tiles within the household detract from the overall appearance of the affected areas, as well as creating potential for water penetration to adjoining building elements. If left unmanaged, water damage may occur as a result of constant water penetration over a prolonged period of time.

A previous attempt at repair can be seen.

While not considered a matter of urgency, replacement of tiles is advised as a solution. A Tiling Contractor may be appointed to perform these works at client discretion.

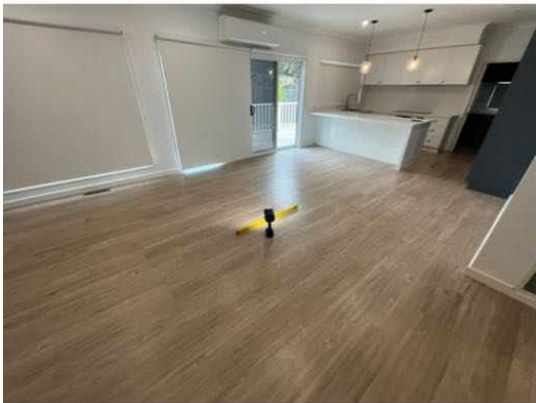
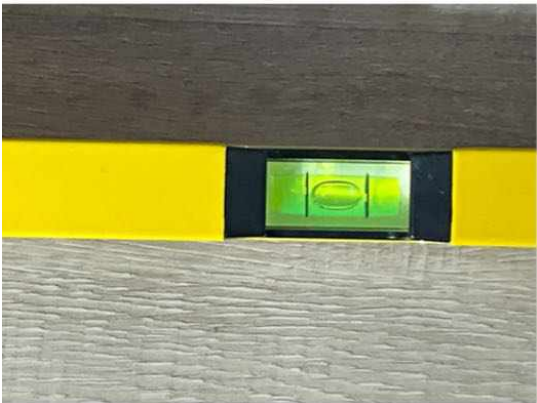
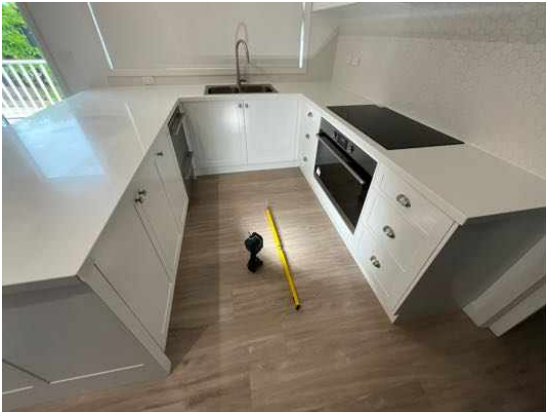
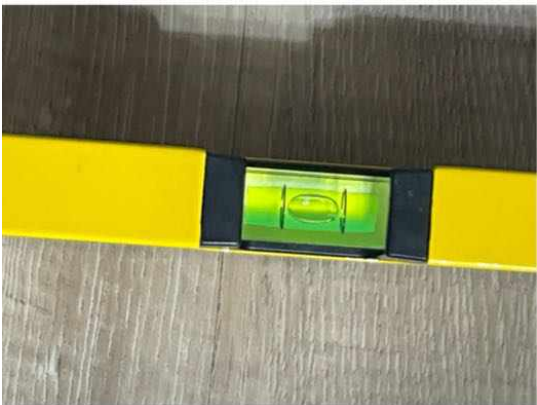
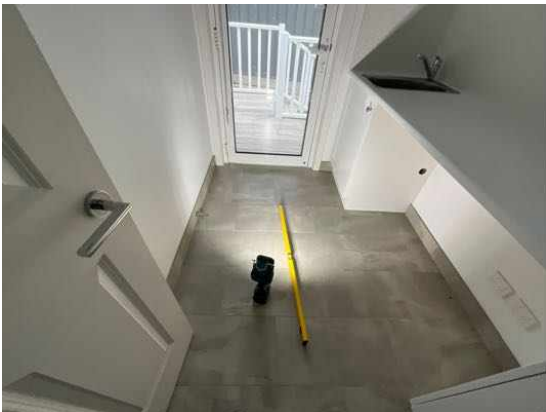
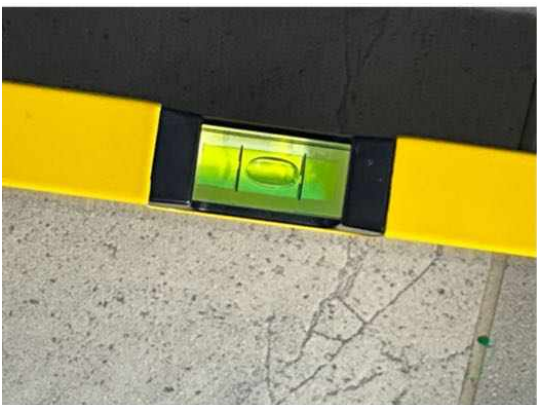
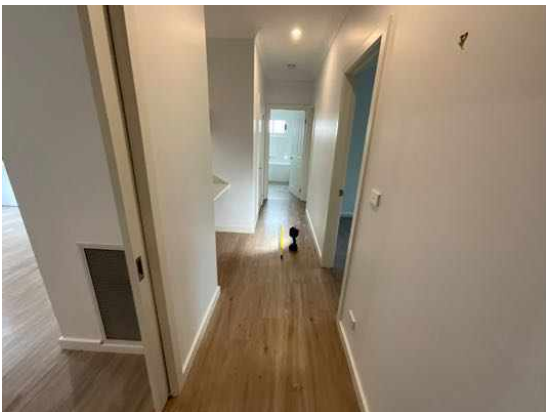
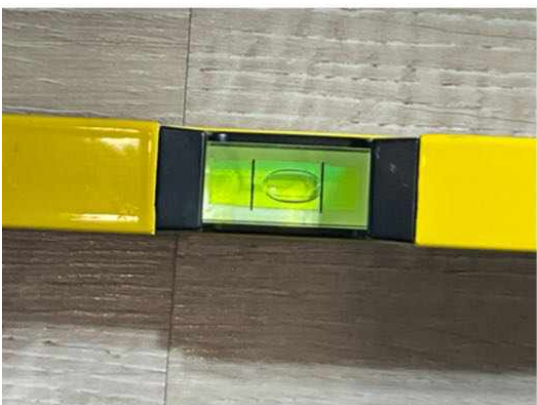
Building: Building 1
 Location: All Internal Areas
 Finding: Flooring- generally level
 Information: The internal flooring in this area is generally level and even. Where slightly uneven flooring is present it is likely to indicate minor defects such as expected movement of the foundations of the property.

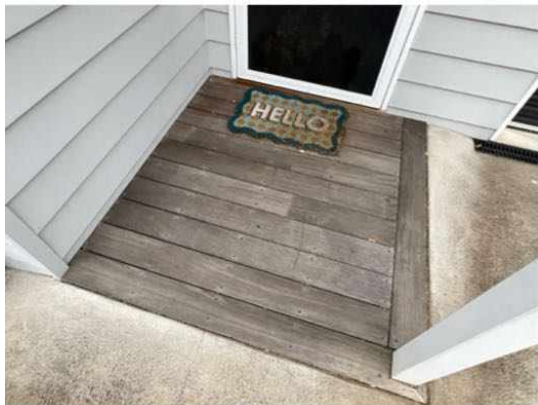
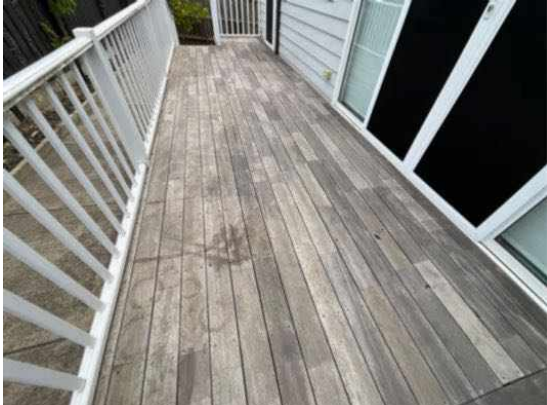
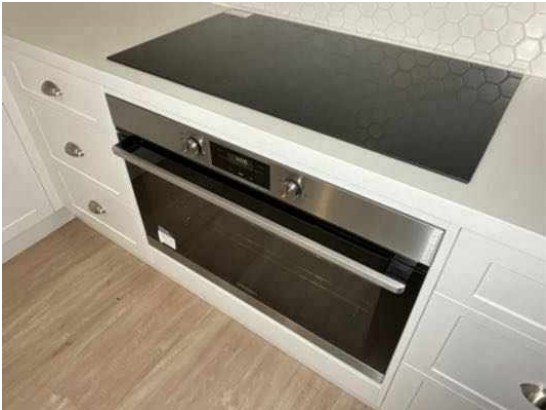
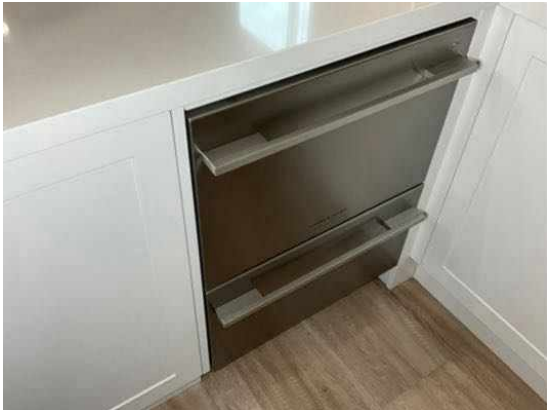
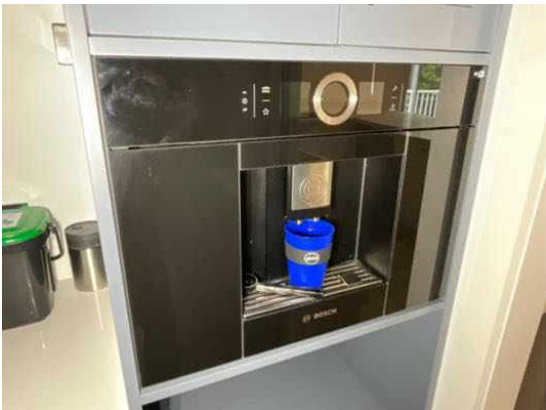
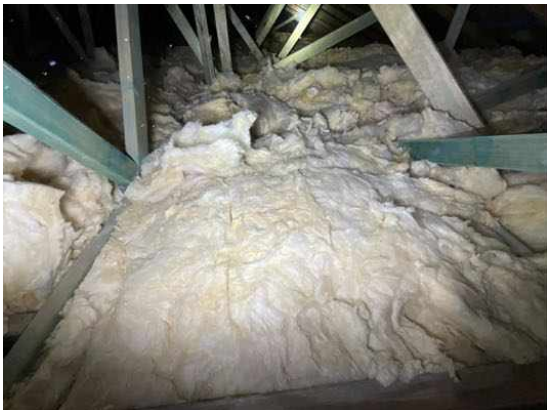
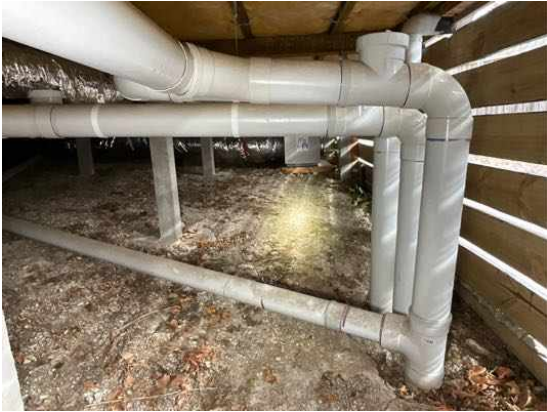
Building: Building 1
Location: All Areas
Finding: Additional Photos - Obstructions and Limitations
Information: These photographs are an indication of the obstructions and limitations which impeded full inspection of the property at the time of inspection. These obstructions can hide an array of defects and should be removed to allow full inspection to be carried out. A re-inspection is recommended once the areas are made accessible.
