Building and Timber Pest Inspection Report

Inspection Date: Fri, 13 Feb 2026

Property Address: 67 Grenade St, Cannon Hill QLD 4170,
Australia

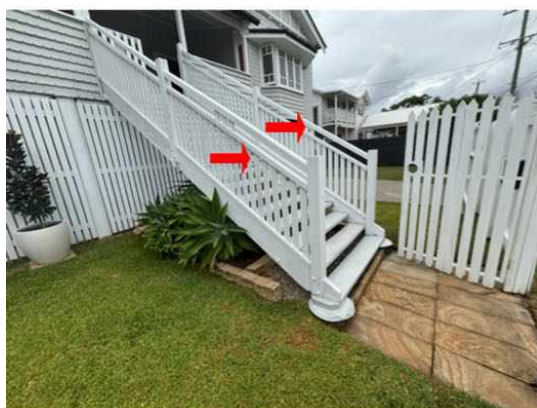
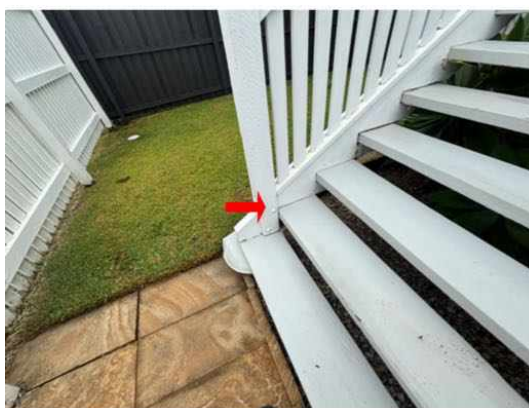
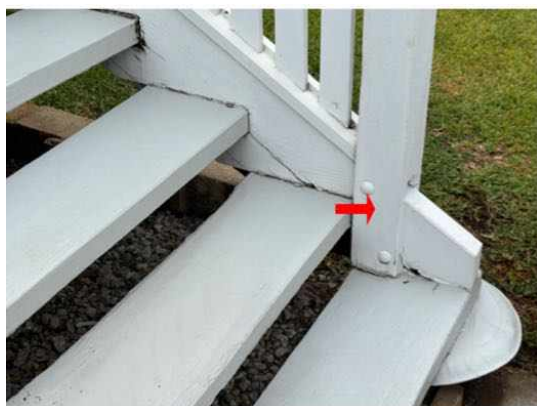
Finding 3.01

Building: Main Building
Location: Front stairs
Finding: Front stairs - excessive movement of handrails
Information: At the time of the inspection, it was noted that there was excessive movement to the hand rails on the front stairs. This may be related to wood rot that was found to the stair risers.

Further deterioration of the front stairs is expected due to wood rot. Works may be carried out to repair the affected areas. Replacement of the front stairs should be considered as a long term solution.

A licensed carpenter could be engaged to secure the hand rails. This should be done as a short term priority.

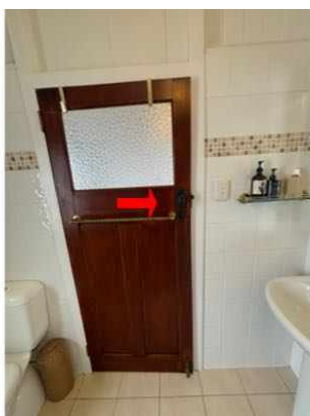
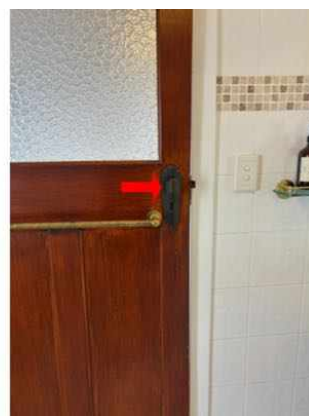
Finding 3.02

Building:	Main Building
Location:	Bathroom
Finding:	Bathroom - door handle not latching
Information:	At the time of the inspection, it was noted that the door to the upstairs bathroom was not latching during normal operation. Whilst detracting from the functionality of this building element, this minor defect may also be a privacy issue. This appears to be from general wear and tear.

A qualified carpenter or building maintenance professional may be appointed to perform rectification works as necessary, at client discretion. If left unattended, further functional impairment is likely to occur.

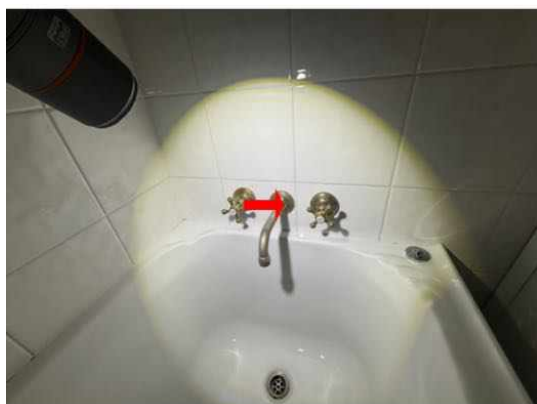
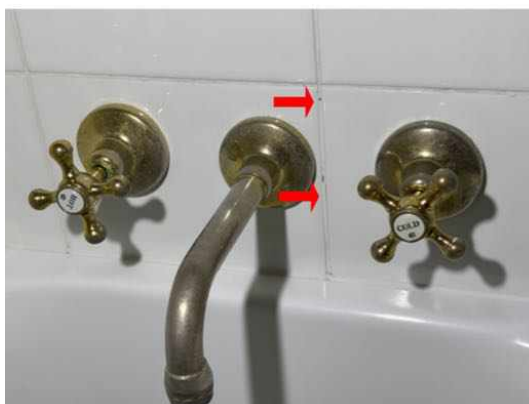
Finding 3.03

Building:	Main Building
Location:	Bathroom
Finding:	Bathroom - grout deteriorating
Information:	At the time of time of the inspection, it was noted that the grout for the wall tiles near the bath tub has deteriorated and in some sections, there are holes in the grout. This may be due to normal wear and tear. Grout replacement is recommended to prevent moisture getting behind the tiles. Normal moisture readings were recorded in the

shower cubicle.

A bathroom specialist should be engaged to assess the grout and provide a solution for this issue. This should be done as a short term priority.

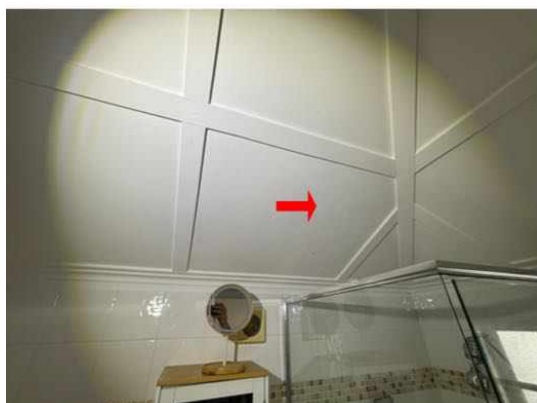
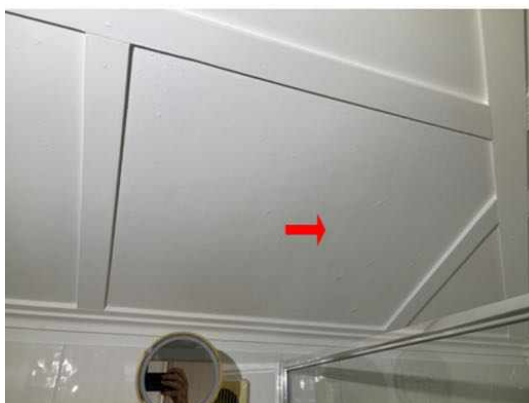
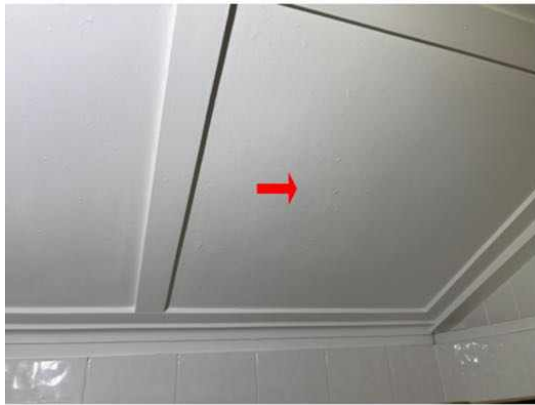
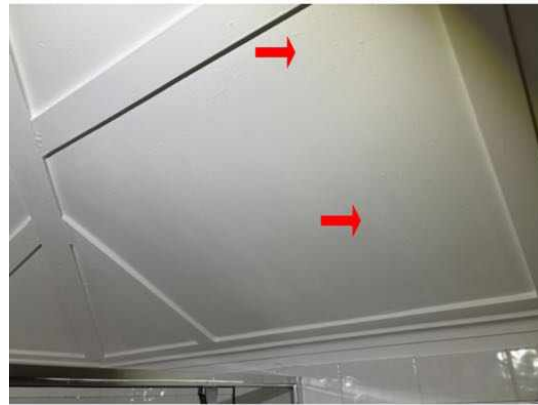
Finding 3.04

Finding: Upstairs bathroom - paint peeling

Information: At the time of the inspection, it was noted that the paint to sections of the ceiling was peeling. This can happen in bathrooms when the ventilation fan is not effective.

Peeling paint can be caused by moisture, poor preparation or age. There was no evidence of moisture found.

A painter or building maintenance professional could be engaged to rectify this issue. This can be done at the clients discretion. Care should be taken when addressing this issue as the bathroom ceilings are likely to be Asbestos Containing Material.

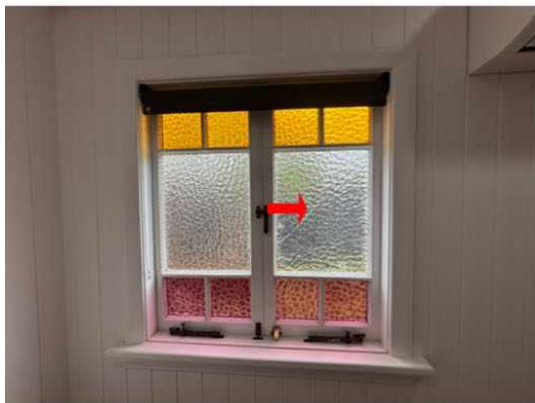
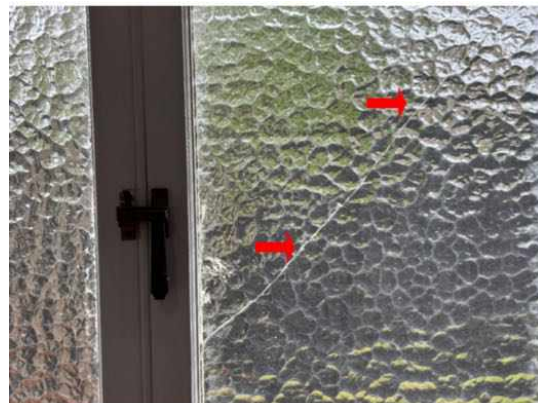
Finding 3.05

Building:	Main Building
Location:	Downstairs bedroom
Finding:	Downstairs bedroom - cracked window glass
Information:	At the time of the inspection, it was noted that there was a cracked window pane in the downstairs bedroom.

A glazier could be engaged to replace the affected glass. This can be done at the clients discretion.

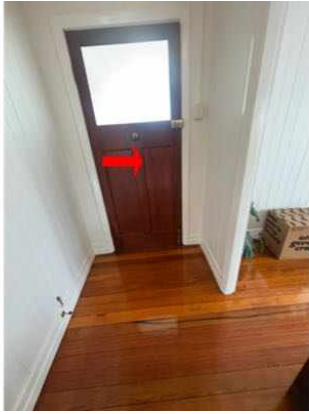
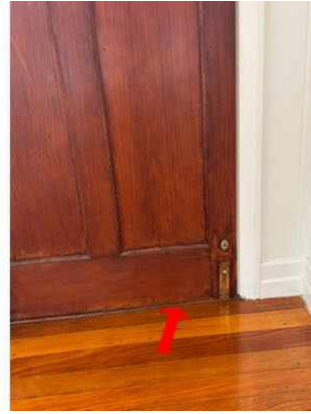
Finding 3.06

Building:	Main Building
Location:	Entry
Finding:	Front door - Binding during normal operation
Information:	At the time of the inspection, it was noted that the front door was binding on the door sill during normal operation. This appears to be general wear and tear. This can be seen as typical of a Queenslander style building.

For minor causes, a qualified carpenter or building maintenance professional should be appointed to perform minor rectification works at client discretion.

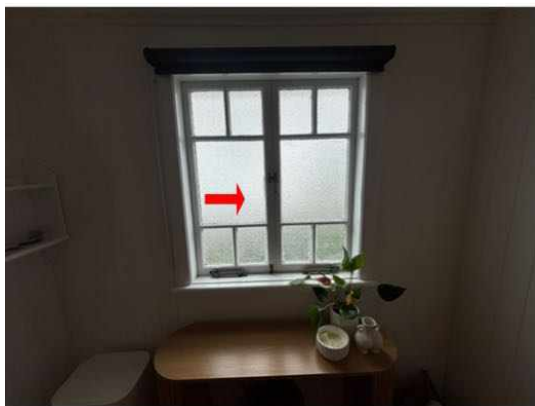
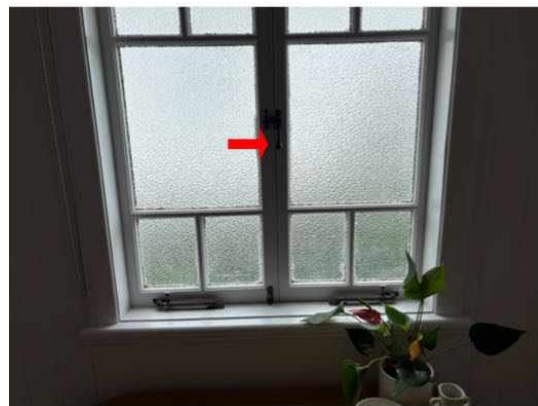
Finding 3.07

Finding: Casement window binding

Information: At the time of the inspection, it was noted that the casement windows in the room outside of the bathroom were binding during normal operation. This makes the window difficult to operate. This appears to be general wear and tear.

A building maintenance professional should be engaged to carry out the necessary repairs. This can be done at the clients discretion.

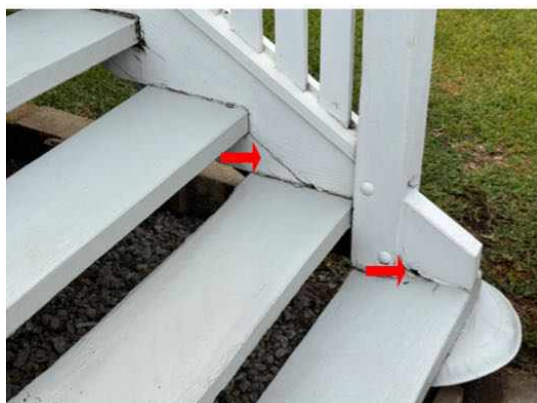
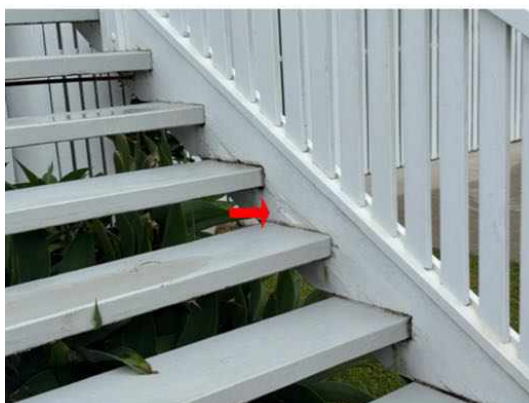
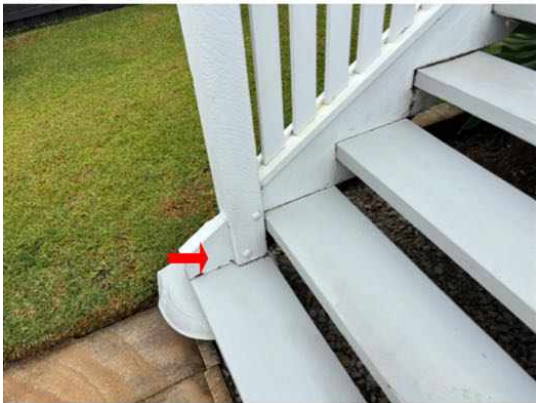
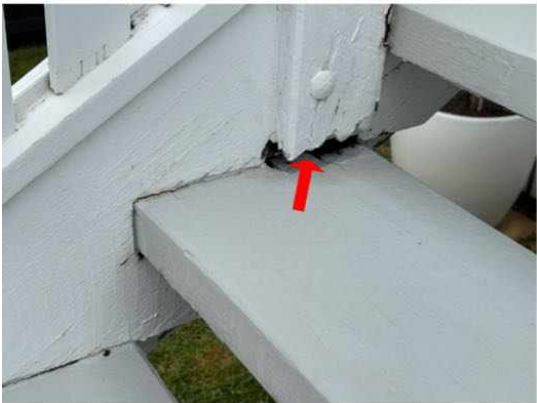
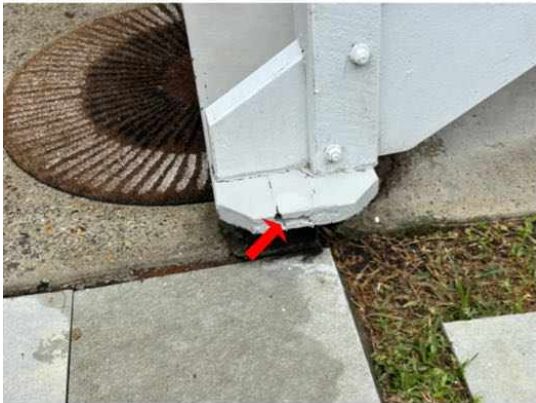
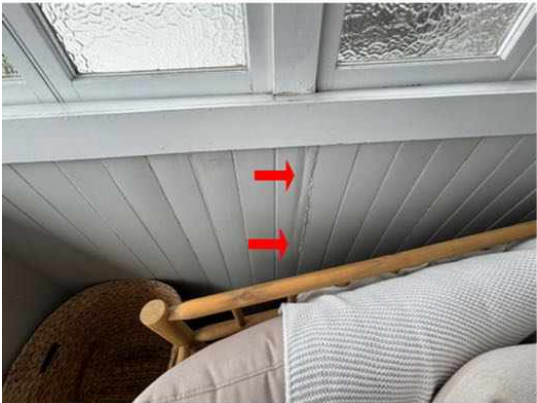
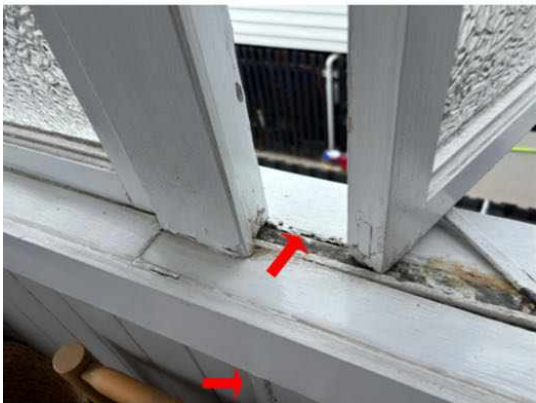
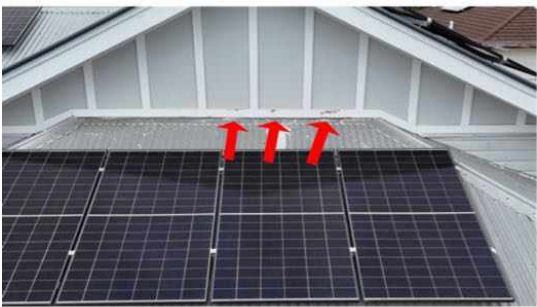
Finding 7.01

Finding: Wood rot

Information: At the time of the inspection, it was noted that there were examples of wood rot to timber building elements found around the dwelling. Examples were found to sections of the front stairs, bottom tread on the rear stairs, wall linings and window sill on the entry deck and timber mouldings to the gable on the right hand side of the dwelling. This may be due to the age of the timber building elements and general weathering.

This building element shows evidence of wood rot. Wood rot, also known as Fungal Decay, occurs when timbers and other cellulose building materials are exposed to damp conditions on an ongoing basis.

Early intervention and regular maintenance, particularly of exterior timbers, will prolong the useful life of these building elements. Prior to any works being performed, the cause of the moisture that has created the visible wood rot should be identified and addressed in a suitable manner. Replacement of affected timbers may then be a necessary step in protecting surrounding building elements from such deterioration.

A qualified carpenter or registered builder may also be required to replace affected building materials.

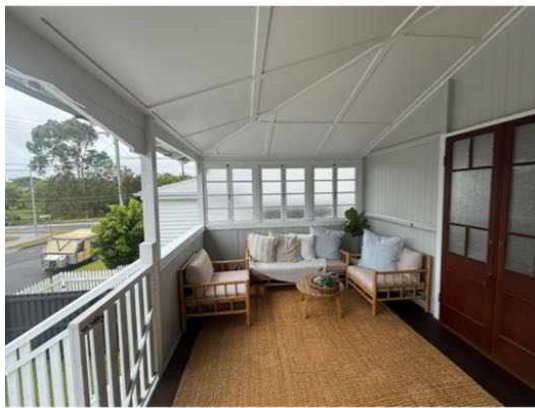
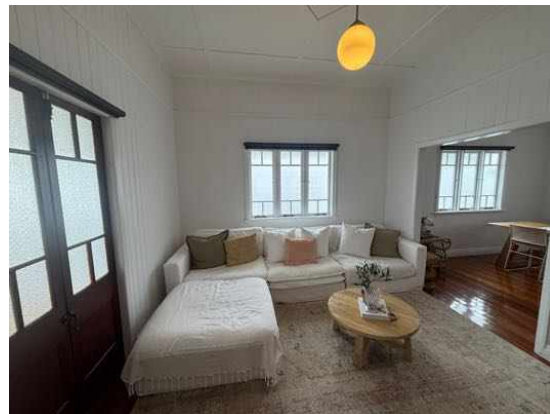
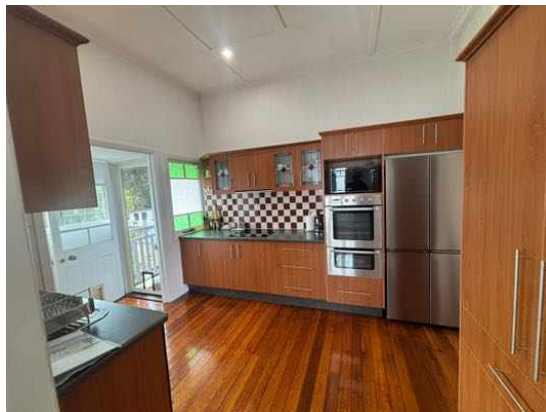
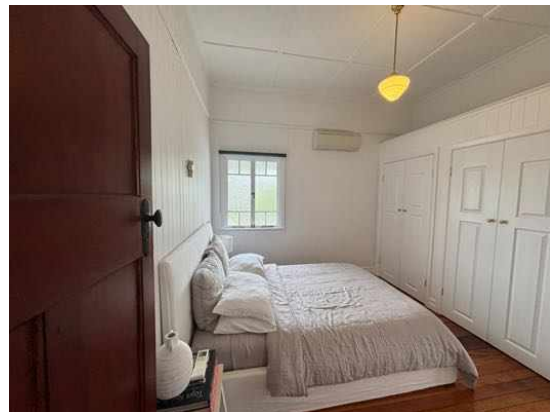
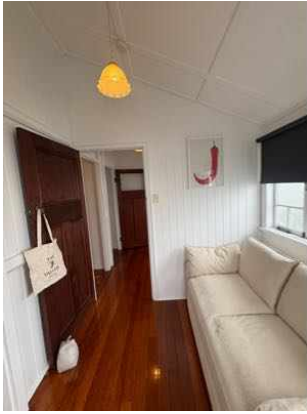
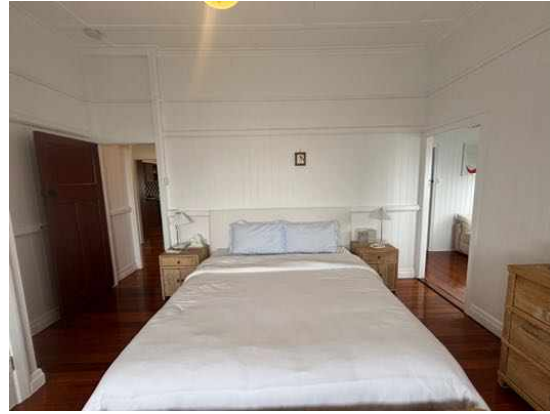
Building: Main Building
Location: All Internal Areas
Finding: Obstructions and Limitations - Internal areas
Information: These photographs are an indication of the obstructions and limitations which impeded full inspection of the property of the internal areas at the time of inspection. These obstructions can hide an array of defects and should be removed to allow full inspection to be carried out. A re-inspection is recommended once the areas are made accessible.

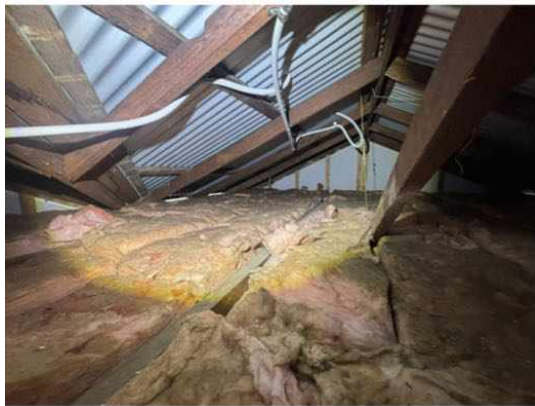
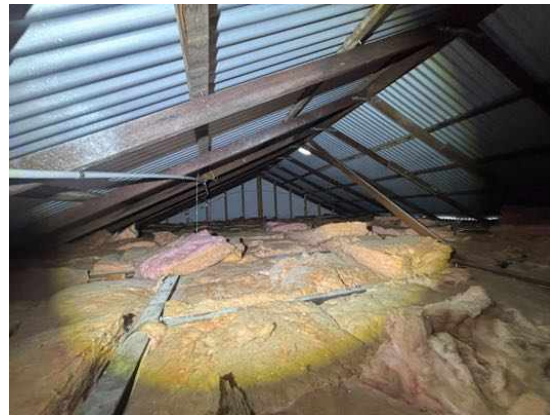
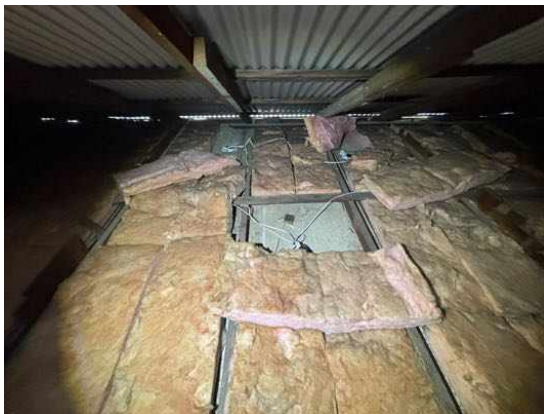
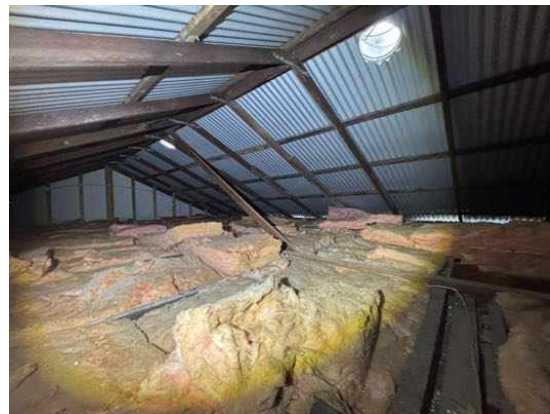
Building: Main Building
 Location: Roof Void
 Finding: Obstructions and Limitations - Roof cavity
 Information: These photographs are an indication of the obstructions and limitations which impeded full inspection of the property of the roof cavity

at the time of inspection. These obstructions can hide an array of defects and should be removed to allow full inspection to be carried out. A re-inspection is recommended once the areas are made accessible.

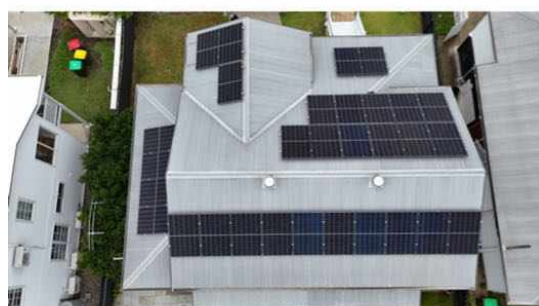
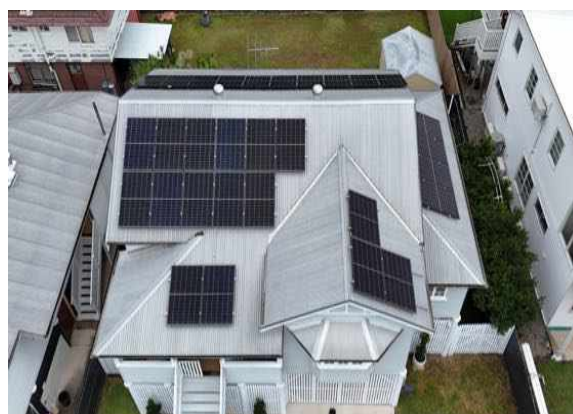
Building: Main Building
Location: Roof Exterior
Finding: Obstructions and Limitations - Roof exterior
Information: These photographs are an indication of the obstructions and limitations which impeded full inspection of the property of the roof exterior

at the time of inspection. These obstructions can hide an array of defects and should be removed to allow full inspection to be carried out. A re-inspection is recommended once the areas are made accessible.

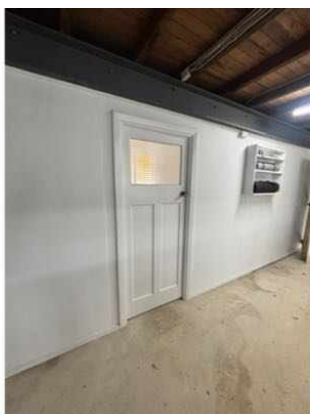
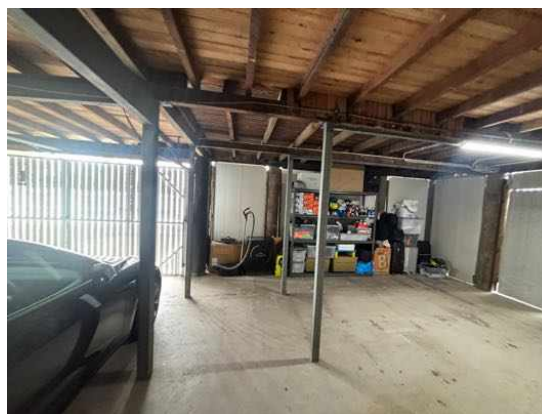
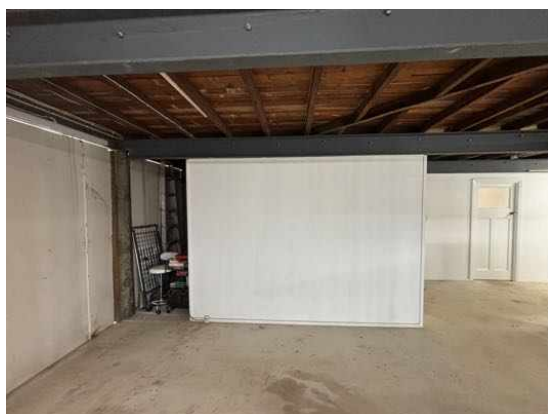
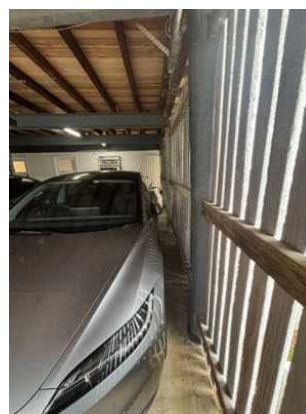
Building: Main Building
Location: Subfloor
Finding: Obstructions and Limitations - Sub floor cavity
Information: These photographs are an indication of the obstructions and limitations which impeded full inspection of the property of the sub floor cavity

at the time of inspection. These obstructions can hide an array of defects and should be removed to allow full inspection to be carried out. A re-inspection is recommended once the areas are made accessible.

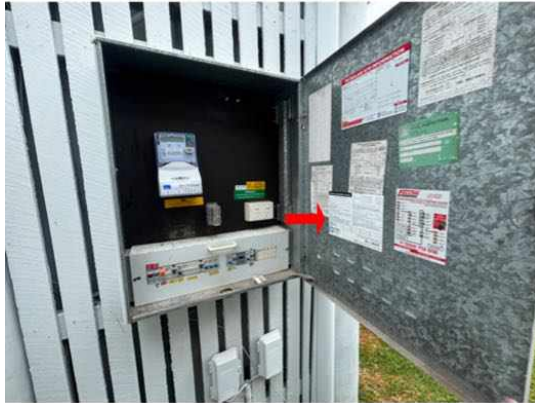
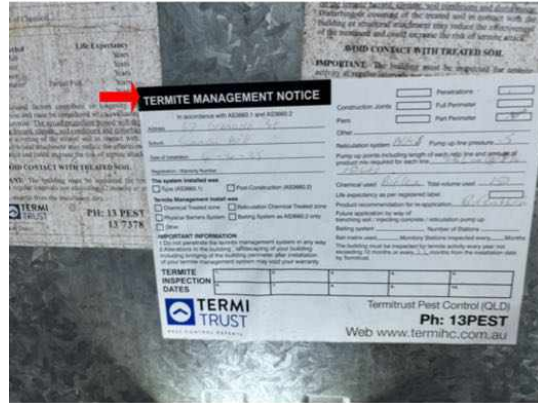
Building:	Main Building
Location:	All External Areas
Finding:	Evidence of a previous chemical termite management system was identified.
Information:	At the time of the inspection, evidence of a previous chemical termite management system was found by way of a durable notice in the electricity meter box.

A chemical termite treatment was carried out in the form of a reticulation system for part of the perimeter. This installation was carried out on the 04/04/2025. The client may wish to enquire of the vendor of the full details of this treatment. A reticulation system will require topping up and as such it is necessary to know the lifespan of the current treatment. These details are not on the durable notice.

A termite and timber pest technician should be engaged to carry out annual termite inspections as per AS 3660 in order to further protect the dwelling. Annual termite inspections must be carried out in partnership with any termite treatment system, physical or chemical, as no termite treatment system can be expected to be 100% effective.
