Building and Timber Pest Inspection Report

Inspection Date: Wed, 18 Mar 2026

Property Address: 75 Kavanagh Rd, Wishart QLD 4122,
Australia

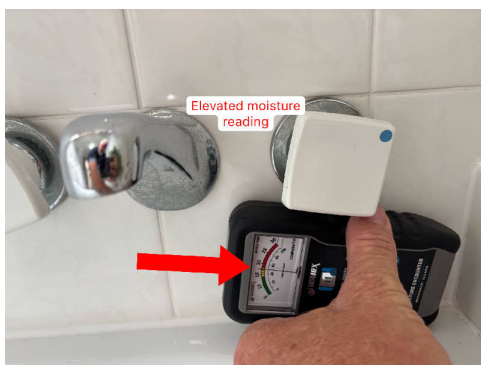
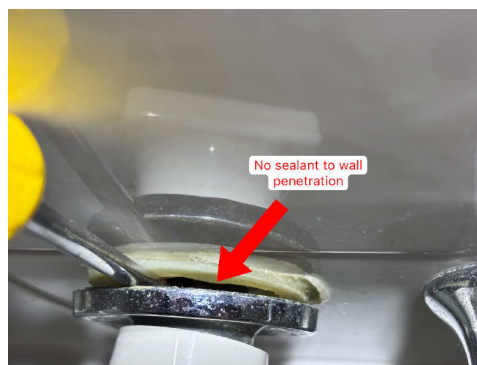
Finding: Family bathroom - elevated moisture reading

Information: At the time of the inspection, it was noted that there were elevated moisture readings below the bath tub cold tap. It was found that there was no sealant to the wall penetrations for the bath tub taps which could allow moisture to get behind the tiles.

A bathroom specialist could be engaged to apply sealant to the wall penetrations. This should be done as a short term priority.

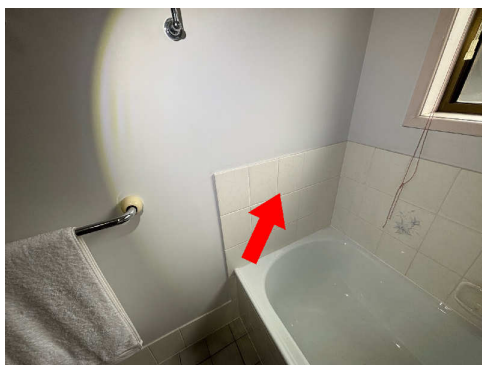
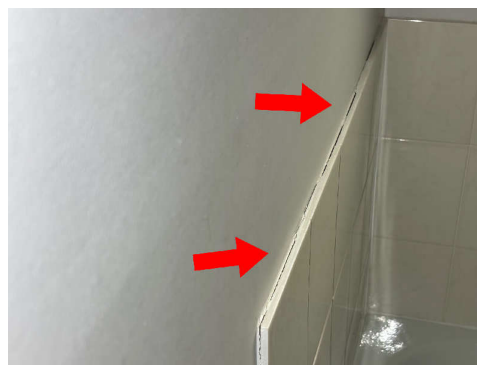
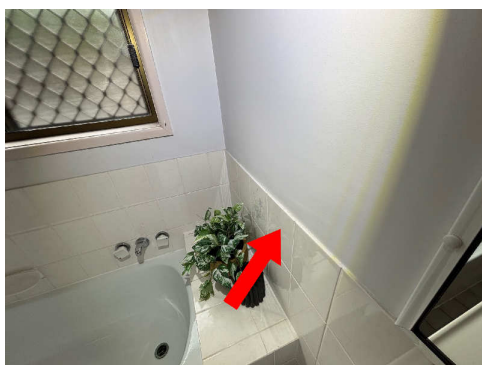
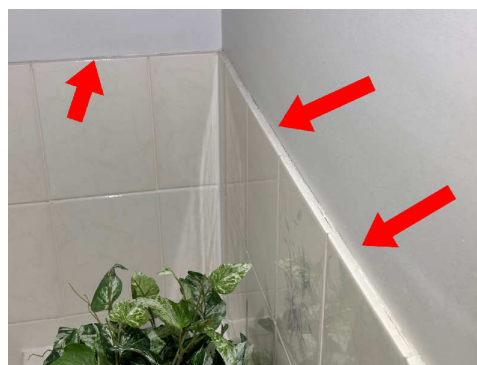
Finding 3.02

At the time of the inspection, it was noted that there was cracking to the top edge of the wall tiles around the bath tub. There is movement to the tiles when pressure is applied. In order to stop the tiles coming away from the wall, sealant could be applied to the top edge as a short term repair for this issue.

A building maintenance professional could be engaged to carry out this repair. This can be done at the clients discretion.

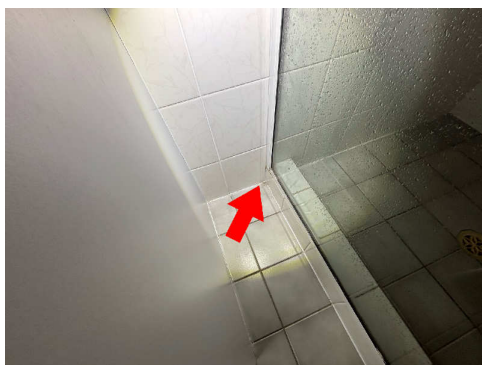
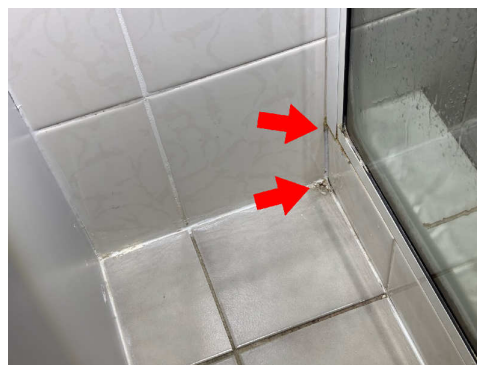
**Finding 3.03**

Building: Main Building
Location: Family bathroom
Finding: Family bathroom - shower screen leaking

Information: At the time of the inspection, it was noted that the shower screen in the family bathroom had a minor leak.

A building maintenance professional or bathroom specialist should be engaged to carry the repairs necessary to stop the water leak. This can be done at the clients discretion.

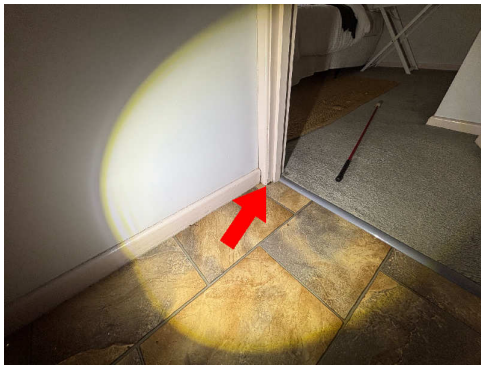
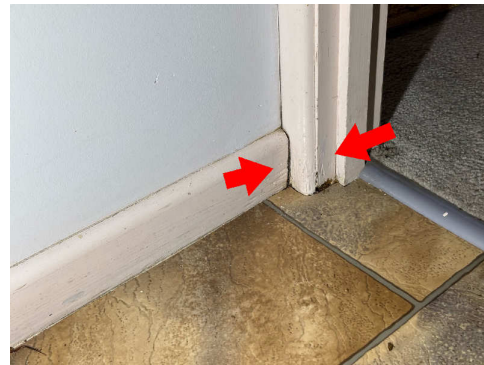
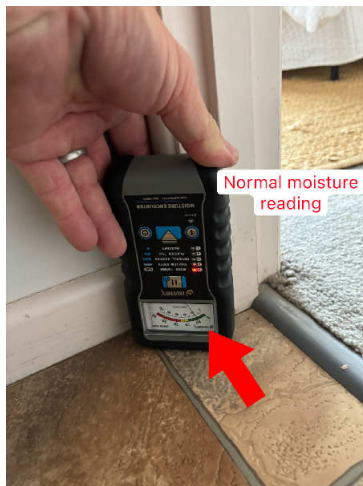
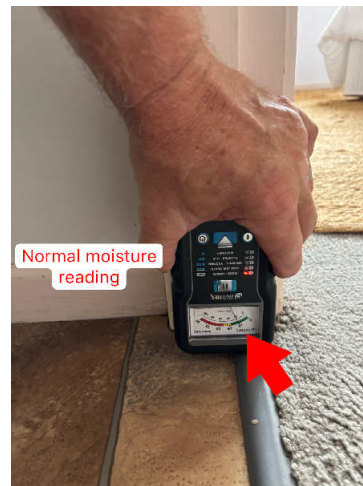
Finding 3.04

Finding: Bedroom 3 - evidence of moisture damage

Information: At the time of the inspection, it was noted that there was evidence of moisture damage to the bottom of the timber door frame to bedroom 3. Normal moisture readings were recorded on the timber door frame which suggests that the leak that caused the damage is inactive. It could not be determined where the moisture may have come from.

The client should monitor this area for any change in appearance.

A building maintenance professional or painting contractor could be engaged to carry out the necessary repairs to the door frame. This can be done at the clients discretion.

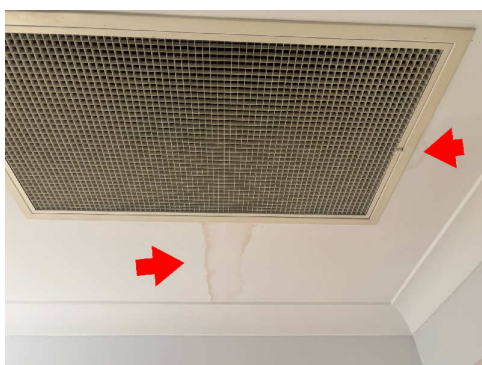
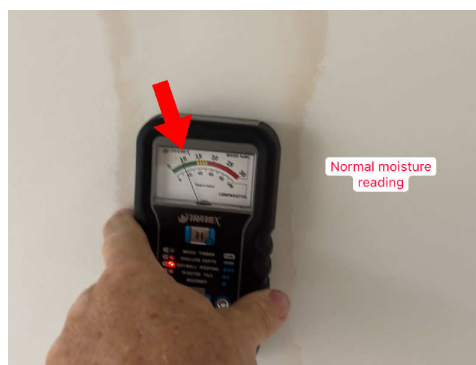
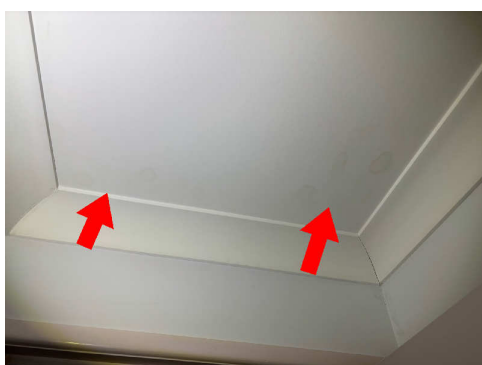
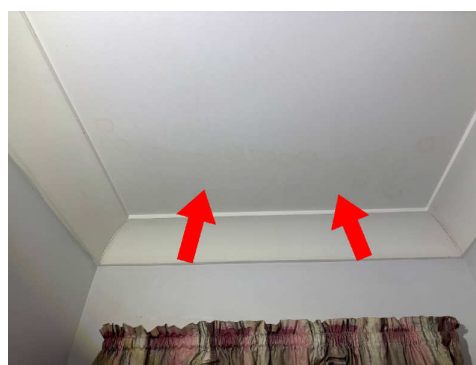
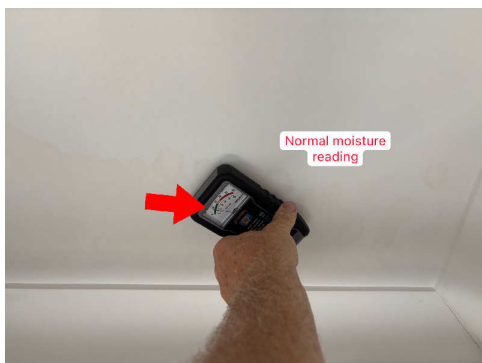
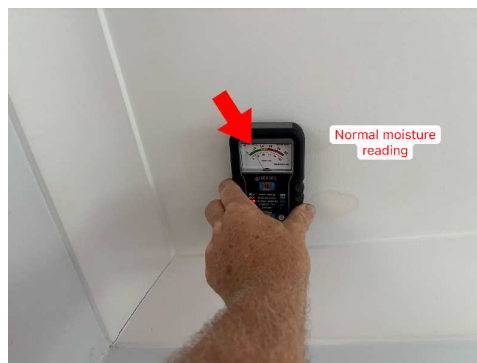
Finding 3.05

Building: Main Building
Location: Hallway and toilet
Finding: Ceiling - Water stained

At the time of the inspection, it was noted that there were water stains on the ceiling in the hallway near the air conditioner vent and in the toilet. Normal moisture readings were recorded in these areas.

Water staining indicates that surfaces have been exposed to excessive moisture over time. The minerals and other elements in the water lead to staining, which may graduate to corrosion and deterioration if left unmanaged.

While mostly an appearance defect, water staining can be indicative of more serious defects, which may be currently concealed by interior ceilings.

Where water staining is active, a licensed plumber must be consulted to identify the cause of the staining and to provide advice on any repair work that may be required. Replacement of any damaged structures is advised.

Conversely, where water staining is old and inactive, affected building materials may be repaired or replaced at client discretion.

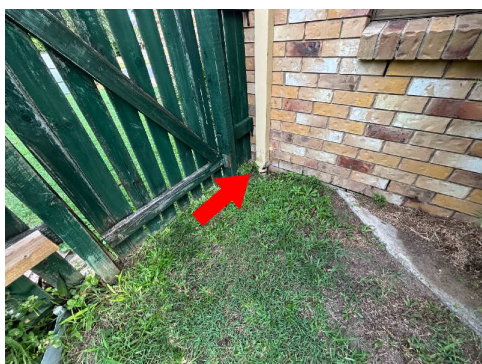
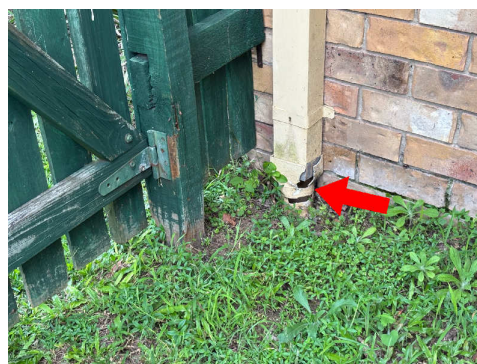
Finding 3.06

Finding: Down pipe - damaged

Information: At the time of the inspection, it was noted that the bottom section of the down pipe at the front of the dwelling is damaged. This affects the functionality of the down pipe and allows water to escape near the foundation.

Excessive moisture next the foundations of the dwelling creates a conducive environment for termite activity and can cause damage to the associated building materials.

A licensed plumber should be engaged to carry out this repair. This can be done at the clients discretion.

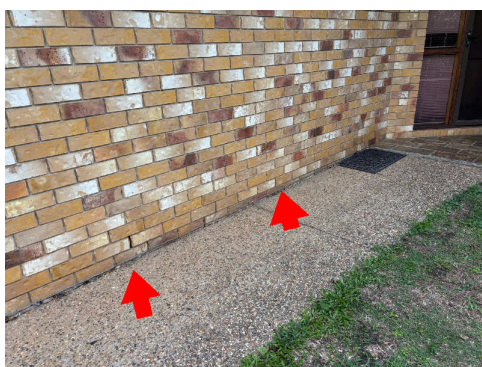
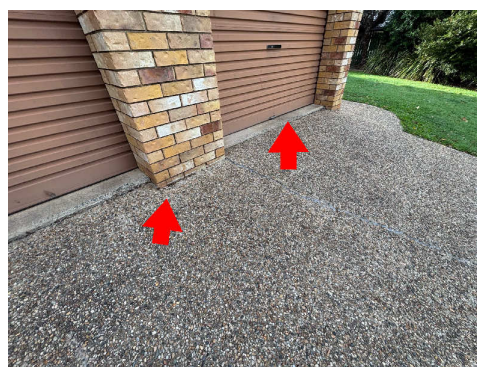
Finding 3.07

Information: At the time of the inspection, it was noted that there is evidence of movement to the concrete driveway and path to the front door. This movement appears to be historic and caused by the dirt below the concrete compacting over time.

If further movement occurs, a concreter could be engaged to replace the concrete driveway and path. This can be done at the clients discretion.

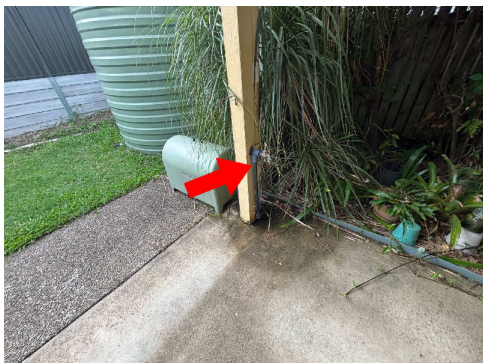
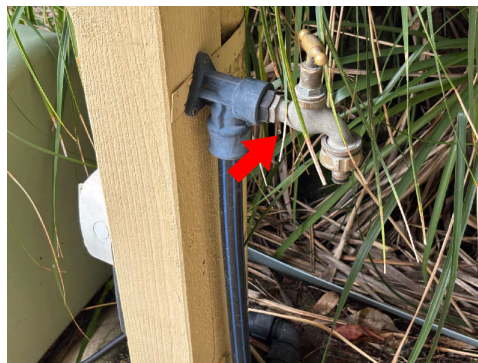
Finding 3.08

Finding: Tank - tap leaking

Information: At the time of the inspection, it was noted that the tap from the water tank is leaking. This may be due to general wear and tear.

A licensed plumber should be engaged to replace the tap. This should be done as a short term priority.

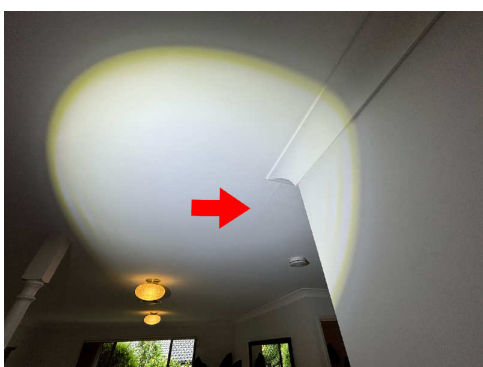
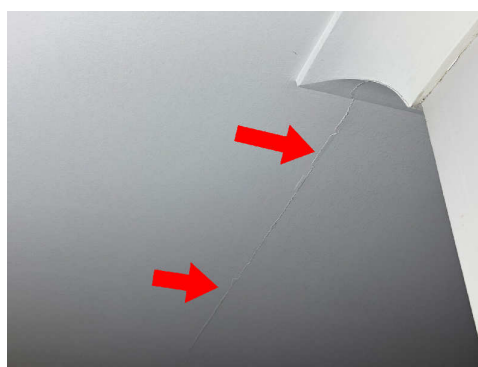
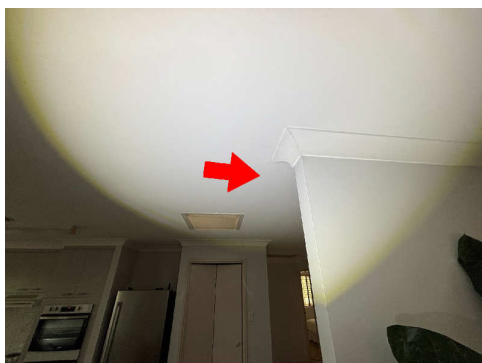
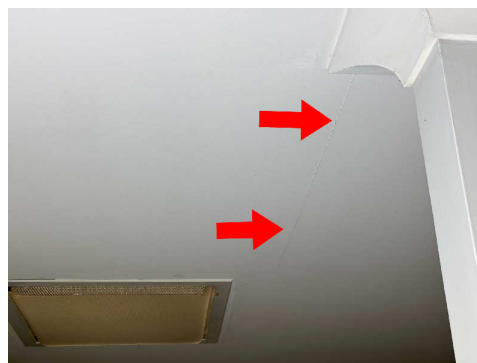
Finding 3.09

Finding: Ceiling lining - cracking

Information: At the time of the inspection, it was noted that there was minor cracking to the ceiling lining in the lounge area. This appears to be general wear and tear and movement of the associated building materials.

The functionality of the ceiling lining is not affected at present. A plasterer could be engaged to repair the cracks. This can be done at the clients discretion.

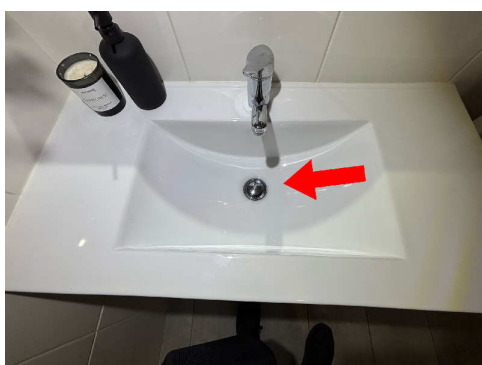
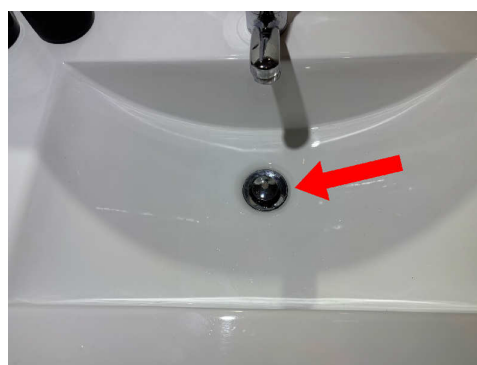
Finding 3.10

Information: At the time of the inspection, it was noted that the pop up plug waste to the vanity in the ensuite was stuck in the open position. The basin cannot be filled.

A licensed plumber should be engaged to replace the pop up plug waste. This can be done at the clients discretion.

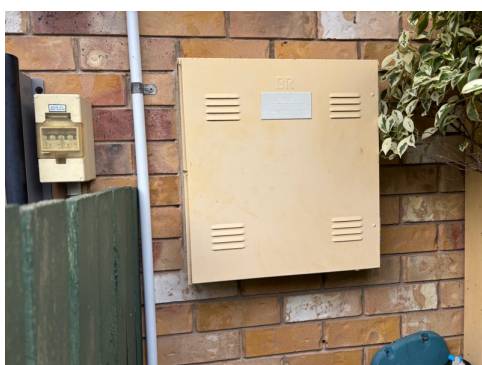
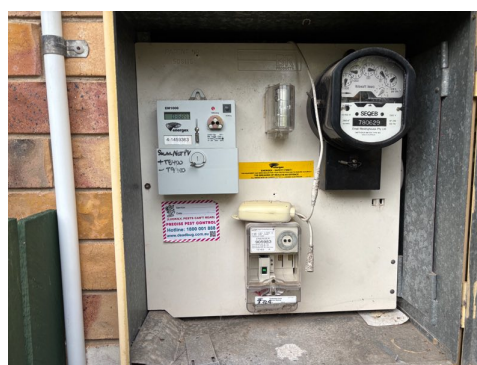
Building:	Main Building
Location:	All External Areas
Finding:	Termite Management System - no evidence of a chemical installation
Information:	At the time of the inspection, no evidence of a chemical termite management system was found. There is no durable notice in the meter box.

A durable notice should be placed in the switchboard unit to indicate current termite barriers. At the time of inspection, it appeared as though no termite management system has been installed, with no evidence to suggest preventative works taking place.

The application of a post-construction chemical termite barrier is highly recommended for all properties, particularly if live termite activity has been found on the site previously. Such barriers are highly effective in preventing termite attack on any timber building elements throughout the property.

The client may consider gaining further advice from a pest controller as to the costs and procedures involved with this application. It is recommended that obtaining such advice be a short-term priority.

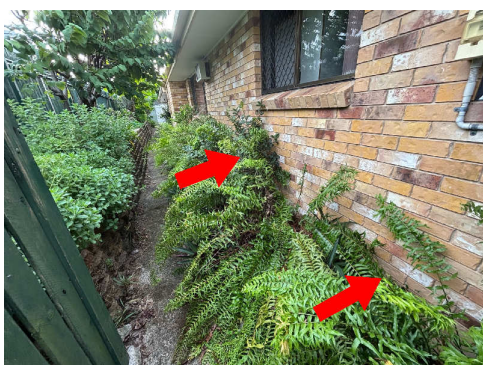
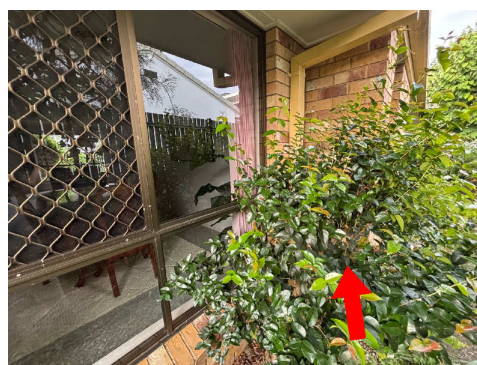
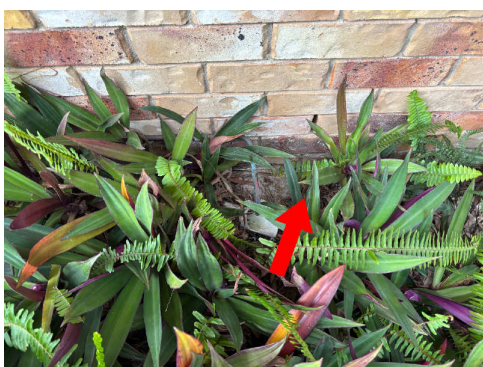
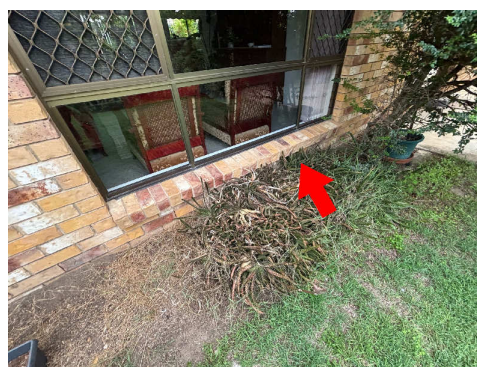
Finding 6.02

Building:	Main Building
Location:	All External Areas
Finding:	Vegetation touching the building

At the time of the inspection, it was noted that there was vegetation touching the building in several locations. This creates a potential access point for termites to enter the building undetected. This is a conducive condition for termite activity.

The client is to ensure that the vegetation is trimmed back to prevent undetected termite entry to the building and to provide a clear inspection area between the vegetation and the dwelling. This should be done as a matter of urgency.

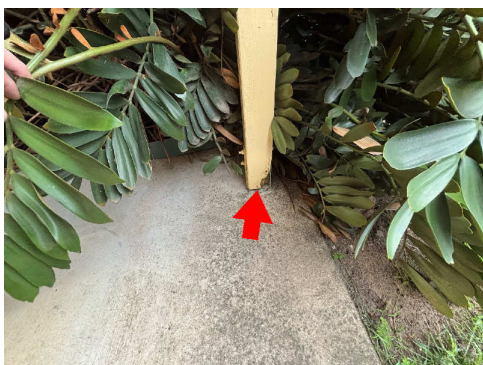
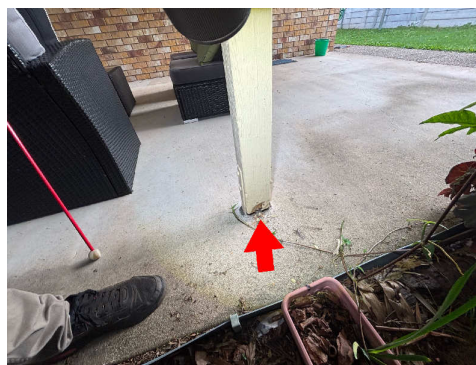
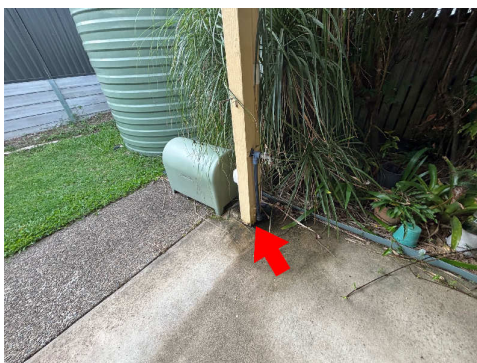
**Finding 6.03**

At the time of the inspection, it was noted that the timber posts for the patio roof were in close contact with the ground at the side of the dwelling. This element is a visual inspection zone at the bottom of the timber posts allowing for potential concealed entry for termites into the dwelling.

Where timber elements are in close contact with the ground and consequently moisture or dampness they become conducive to termite activity. Whether timber is used as a building element part of a fencing structure or stored as an unused item they can provide an environment that is attractive to termite infestation.

When met with excessive moisture timber begins to decay and develop wood rot. Any timbers that are in direct contact with external grounds especially if left untreated or non-durable also provide ingress for subterranean termites into that particular element.

The removal of any such materials that may be conducive to termite activity should be removed as soon as possible to minimise the risk of termite attack.

Annual termite inspections should be carried out in order to further protect the dwelling.

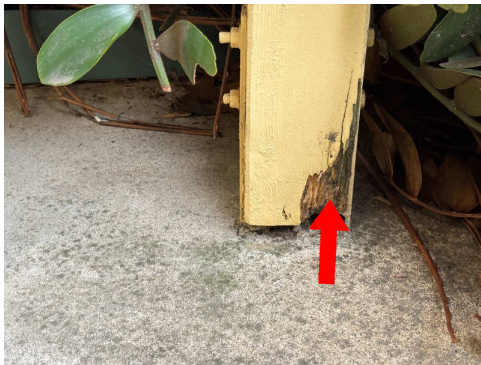
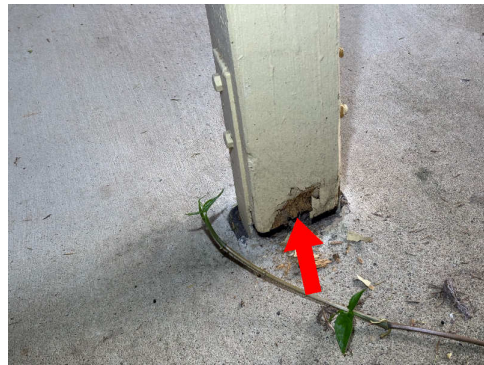
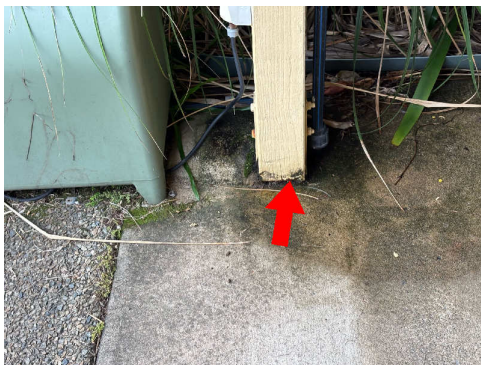
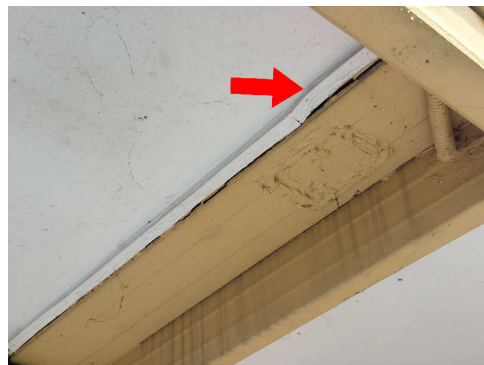
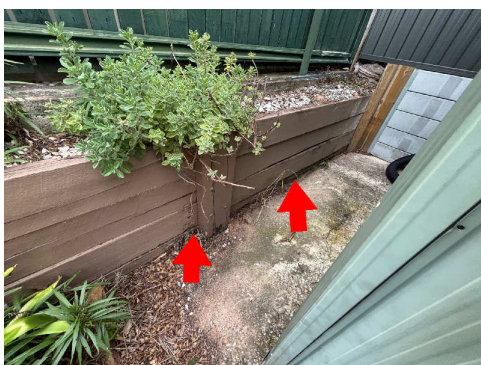
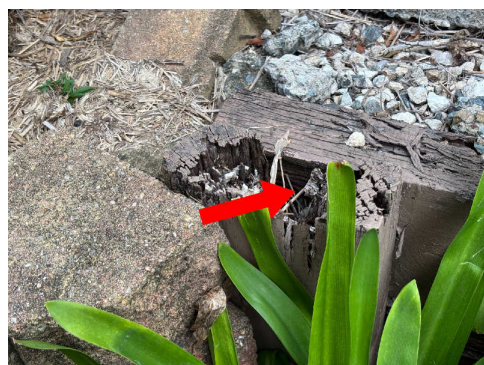
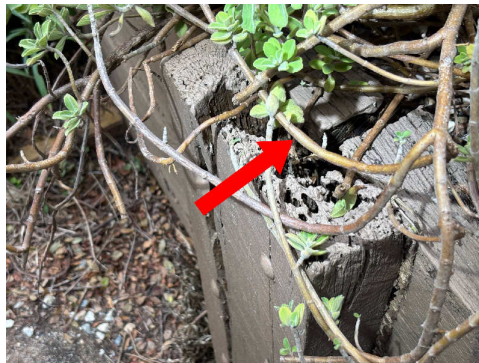
Finding 7.01

Finding: Wood rot

Information: At the time of the inspection, it was noted that there were examples of wood rot to timber building elements found around the dwelling. Examples were found to the timber posts for the patio roof, timber mouldings and the small timber retaining wall at the left rear of the dwelling. This may be due to the age of the timber building elements and general weathering.

This building element shows evidence of wood rot. Wood rot, also known as Fungal Decay, occurs when timbers and other cellulose building materials are exposed to damp conditions on an ongoing basis.

Early intervention and regular maintenance, particularly of exterior timbers, will prolong the useful life of these building elements. Prior to any works being performed, the cause of the moisture that has created the visible wood rot should be identified and addressed in a suitable manner. Replacement of affected timbers may then be a necessary step in protecting surrounding building elements from such deterioration.

A qualified carpenter or registered builder may also be required to replace affected building materials.
